**Coal Combustion Waste Impoundment
Round 7 - Dam Assessment Report**

Lansing Energy (Site # 11)

Alliant Energy
Lansing, Iowa

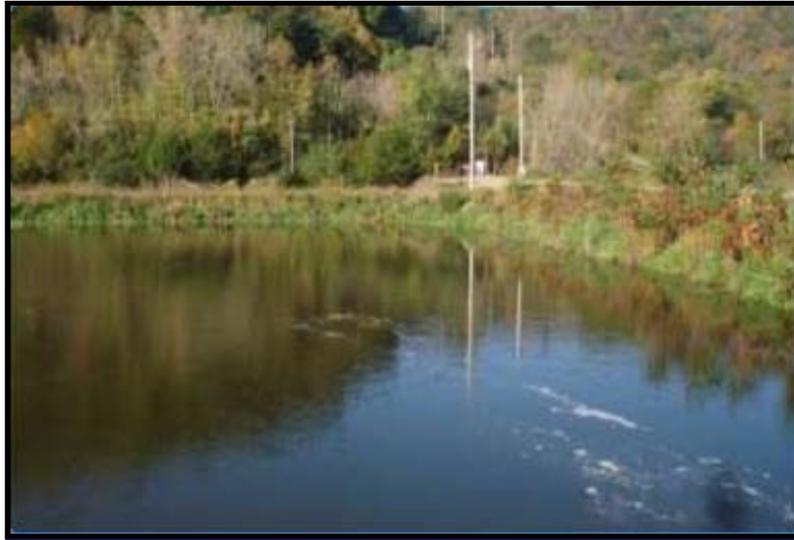
Photograph 1.4. Pond 1 northwest corner inside dike, looking west.

No major depressions, sags, tension cracks or other signs of significant settlement or mass soil movement were observed. No tension cracks which might suggest soil shear failure were observed in the crest or along the edge of the crest.

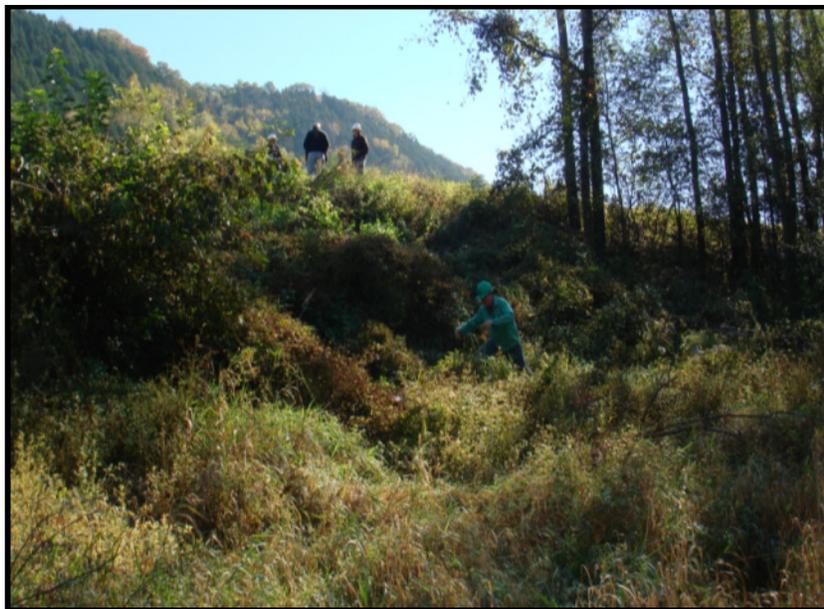
Photograph 1.36. Pond 1 west side outside dike, looking east.

No significant erosion areas were observed. Generally on the west outside slope there was heavy tree growth and fairly thick undergrowth. Photograph 1.36 shows an area on the west outside slope of Pond 1. Rip rap was spread across the entire slope. No other obvious signs of slumps, slides, bulges, tension cracks, seepage, or animal holes were observed. This area does not appear to have any seepage problems. The north side of the access road was generally grassed with some sections of tree growth.

Removal of the trees and brush vegetation along the Ash Pond 1 west outside dike should be completed within a year and proper vegetative plants should be introduced. Alliant recommended the same tree removal action in their internal April 29, 2009 GENCO Standard inspection Guide document.

Alliant should provide structural stability analysis for the Ash Pond 1 west dike. This dike has a 30 foot height as measured from the outside toe to the crest. There are many 2-6 inch trees and other vegetation on the dike that need to be removed. The Ash Pond 1 west dike is the highest of the Lansing Station dikes and failure of the west dike would discharge effluent into the Mississippi River.

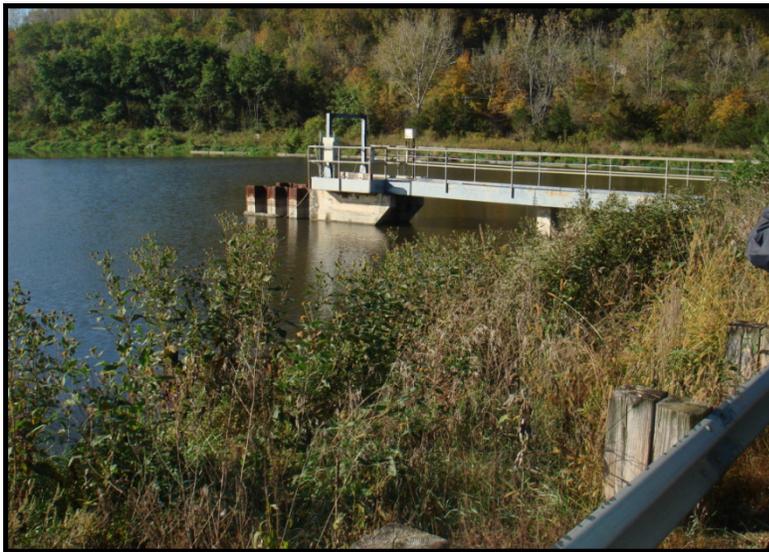
There overflow structure for Ash Pond 1 is located on the north side of the pond, see Photograph 3.1. The outfall structure is a grated concrete square weir inlet box. The concrete inlet box surrounding the inlet was observed to be in good condition. Water was flowing into the box during the visit. The outfall RCP culvert is a 24" RCP culvert.

Photograph 3.1. Pond 1 outfall intake structure, looking west.

It is further recommended that internal inspection of the outlet structures be performed at a frequency of at least once every 6 months and be documented with a written report. .

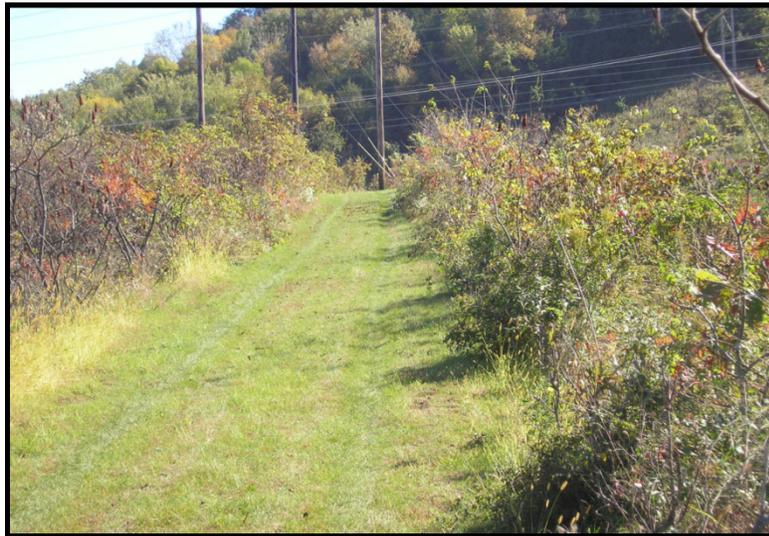
Photograph 2.8. Maintenance road along mid-slope of the embankment of the north dike of Pond 2.

No major depressions, sags, tension cracks or other signs of significant settlement or mass soil movement were observed.

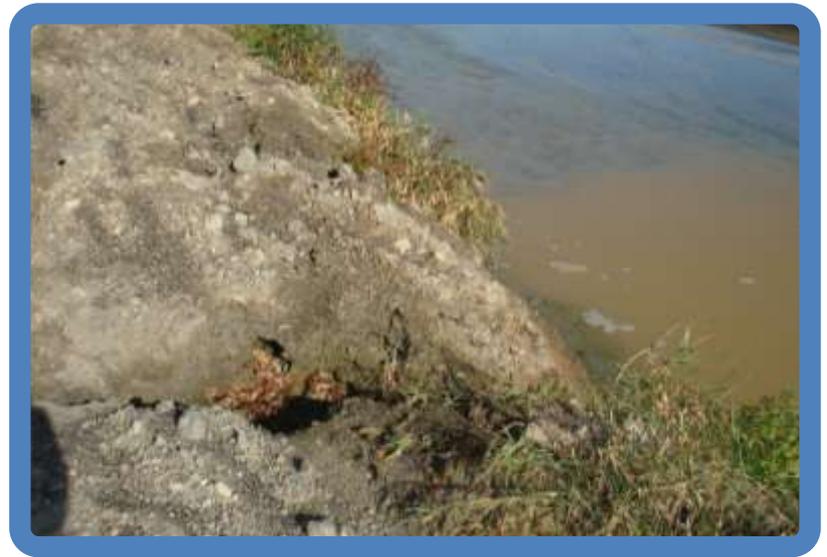
Picture 1.22

Pond 1 Small eroded area adjacent to channelized portion

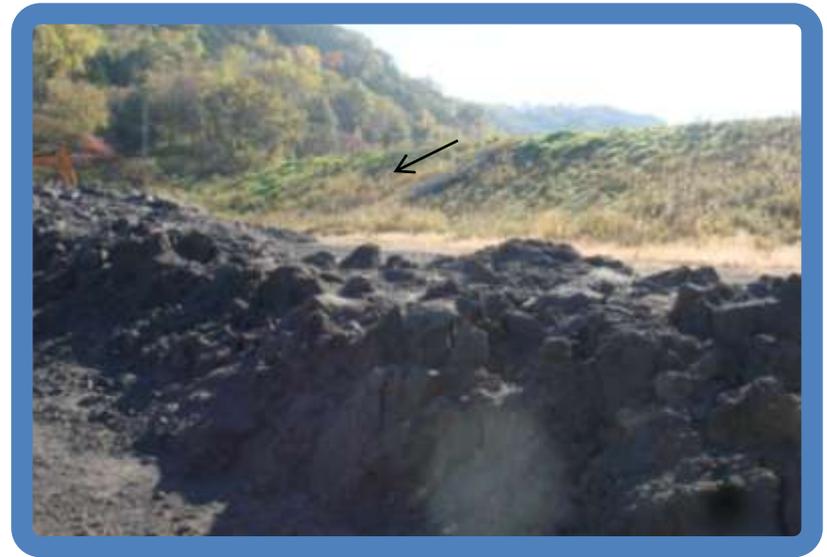
Picture 1.26 Pond 1 Ash spoil on south crest of dike
Landfill in background. Note landfill runoff culvert

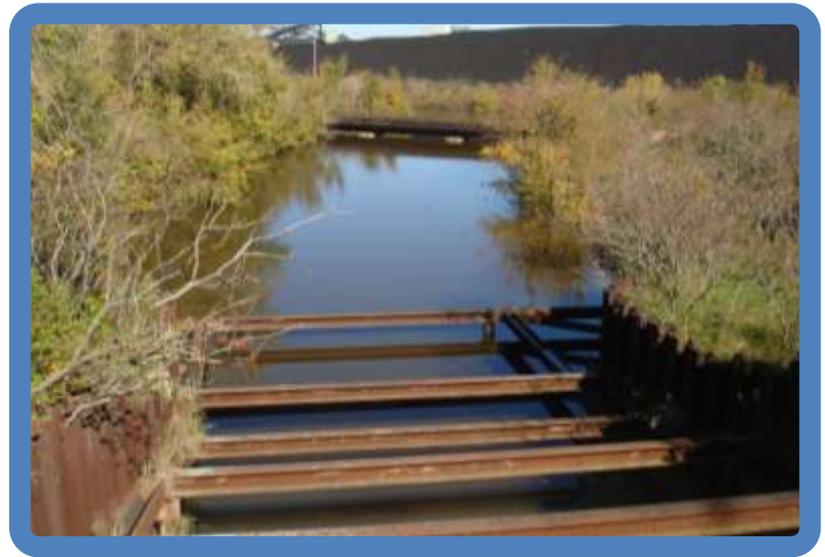
Pond 1 West outside dike Looking south tree covered dike

Removal of tree vegetation and brush vegetation is recommended along all the dike slopes on both dikes is noted previously.
