Coal Combustion Waste Impoundment

Round 7 - Dam Assessment Report

Lansing Generating Station

**Interstate Power and Light Company (IPL)
Lansing, Iowa**

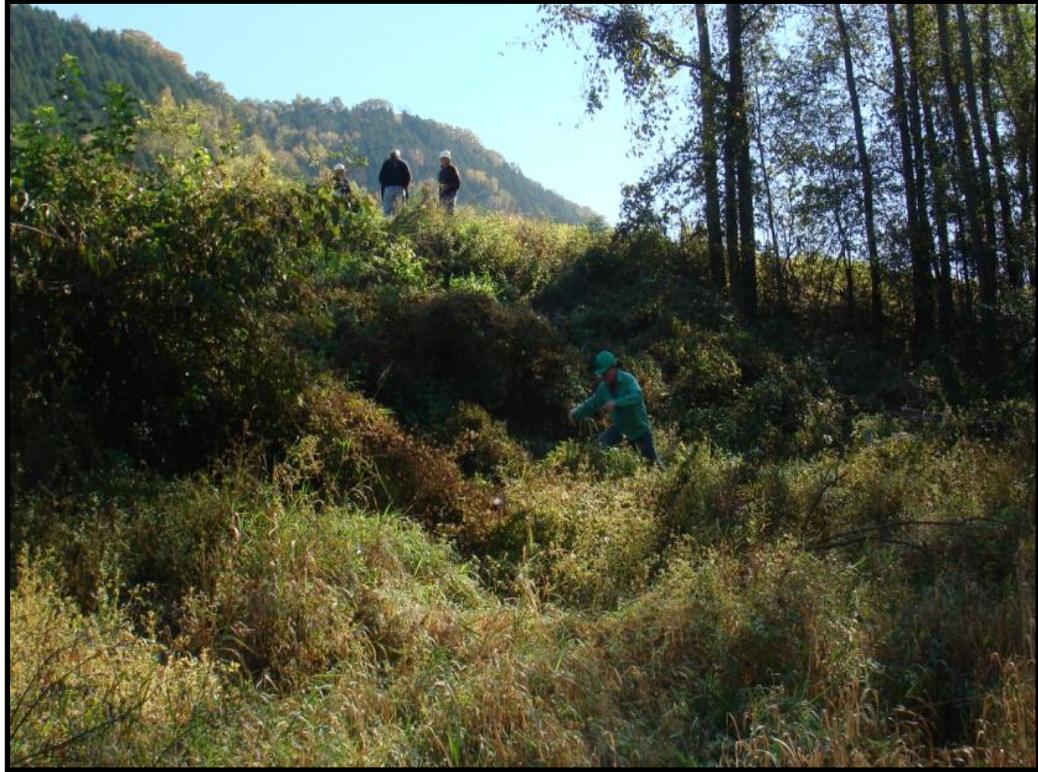
Photograph 5.2.1-1. Pond 1 west side outside dike, looking east.

No significant erosion areas were observed. Generally on the west outside slope there was heavy tree growth and fairly thick undergrowth. Photograph 5.2.1-1 shows an area on the west outside slope of Pond 1. Rip rap was spread across the entire slope. No other obvious signs of slumps, slides, bulges, tension cracks, seepage, or animal holes were observed. This area does not appear to have any seepage problems. The north side of the access road was generally grassed with some sections of tree growth.

Removal of tree vegetation and brush vegetation is recommended along all the dike slopes. Removal of the trees and brush vegetation along the Ash Pond 1 west outside dike should be completed once all regulatory approvals are received from the Army Corps of Engineers and Iowa Department of Natural Resources (IDNR). IPL recommended the same tree removal action in their internal April 29, 2009, GENCO standard inspection guide document.

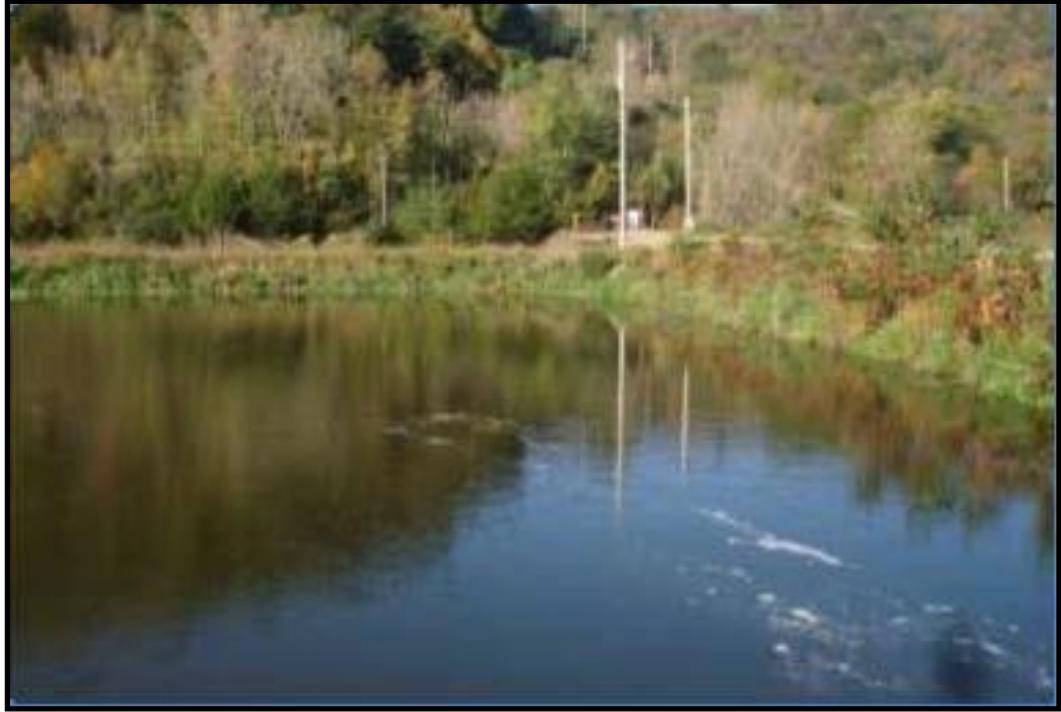
[Photograph 5.2.1-2](#) Pond 1 northwest corner inside dike, looking west.

No slumps, slides, or other signs of shear failure were observed in the visible parts of the slopes above the water level. No significant erosion was noted.

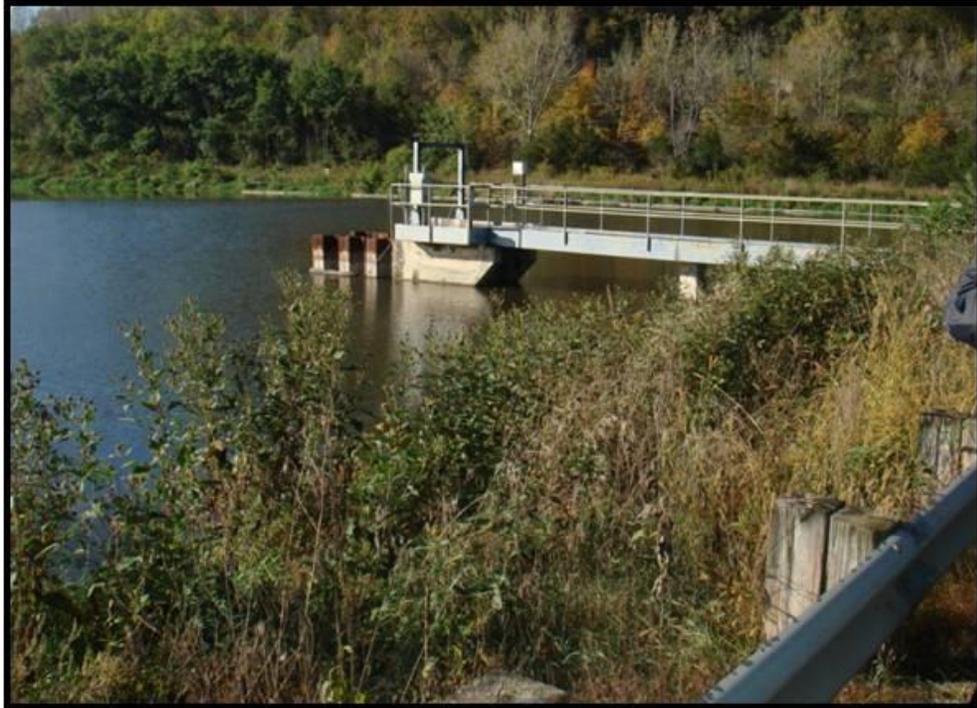
Photograph 5.2.2-1. Pond 1 outfall structure, looking west.

Overflow Structure - The overflow structure for Ash Pond 1 is located on the north side of the impoundment, see Photograph 5.2.2-.1. The outfall structure is a grated concrete square weir inlet box with adjustable stop-logs. The concrete inlet box surrounding the inlet was observed to be in good condition. Water was flowing into the box during the visit. The outfall RCP culvert is a 24" RCP culvert.

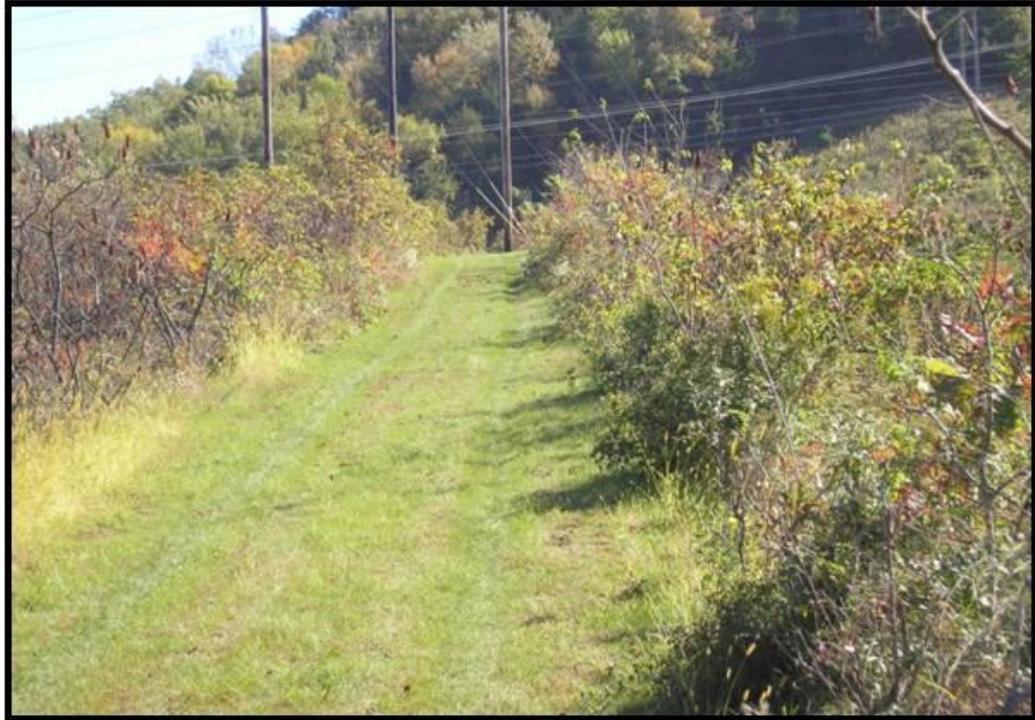
Photograph 5.3.1-1. Maintenance road along mid-slope of the embankment of the north dike of Pond 2.

Crest - The crest around the west north and east sides of Ash Pond 2 join into the access road. The crest around all sides of Ash Pond 2 is accessible with automobiles. Photograph 5.3.1-1 shows the grassed maintenance access road along the outside slope of the north dike of Ash Pond 2.

No major depressions, sags, tension cracks or other signs of significant settlement or mass soil movement were observed.

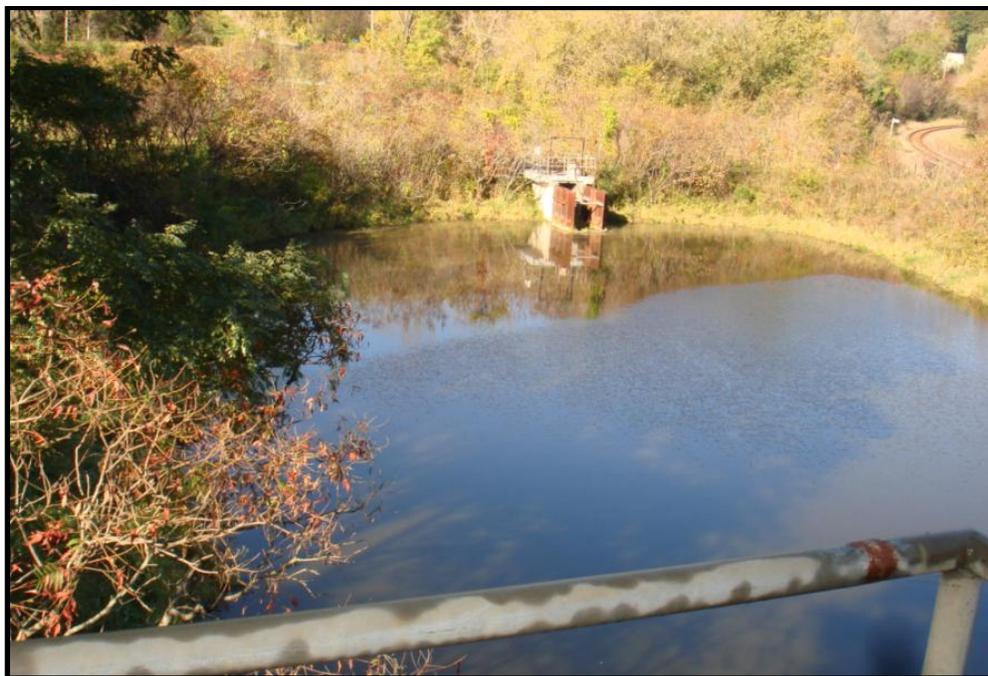
Photograph 5.3.2-1. Pond 2 Outfall structure.

Overflow Structure - The outlet structure from Ash Pond 2, see Photograph 5.3.2-1, discharges to a channel directly connected to the Mississippi River. The water from Ash Pond 2 flows over a 4 foot weir, (adjustable with stop-logs) then drops into a 24 inch CMP culvert that discharges into a channel directly connected to the Mississippi River.

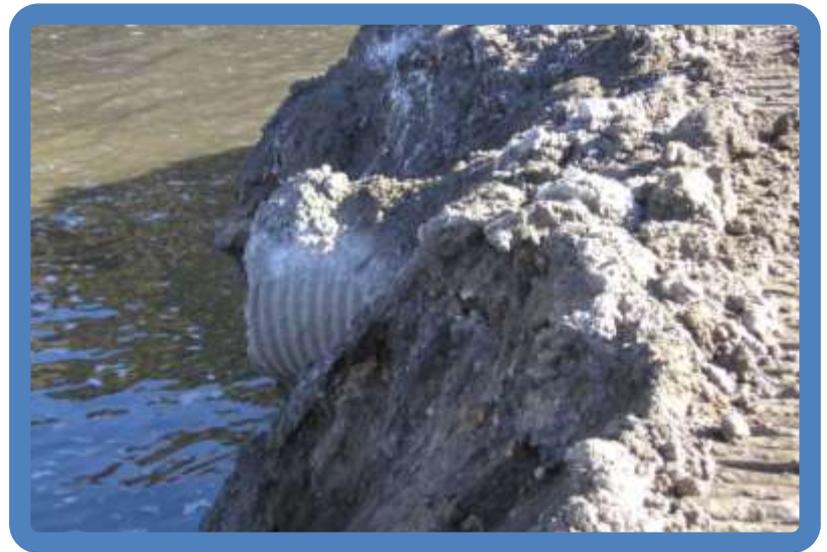
Picture 1.19
Pond 1 Small eroded areas adjacent to channelized portion

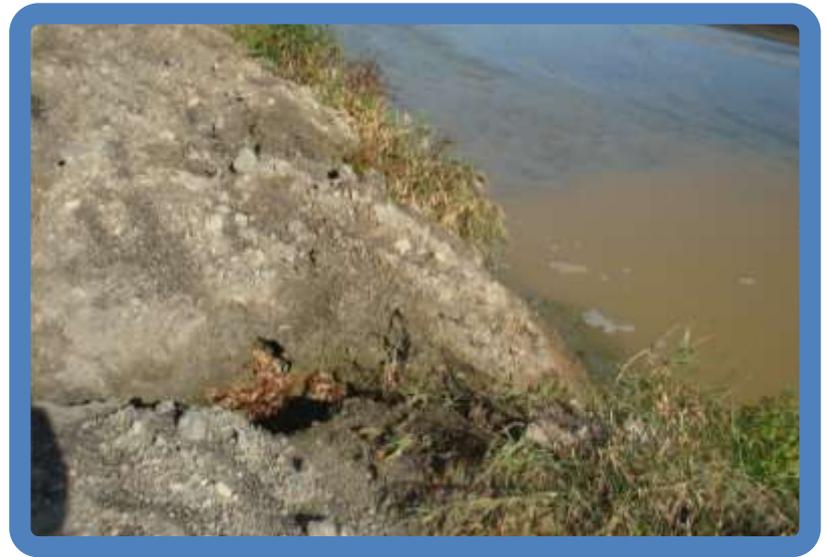
Picture 1.22

Pond 1 Small eroded area adjacent to channelized portion

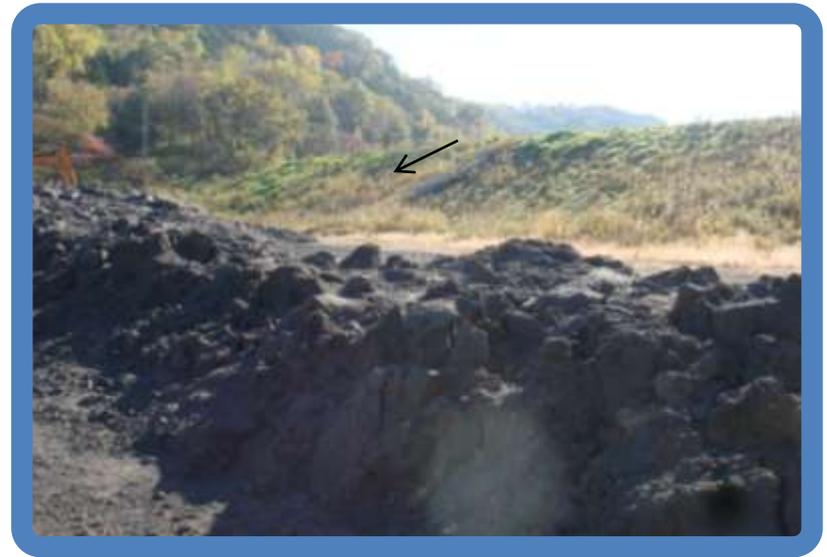
Picture 1.26 Pond 1 Ash spoil on south crest of dike
Landfill in background. Note landfill runoff culvert

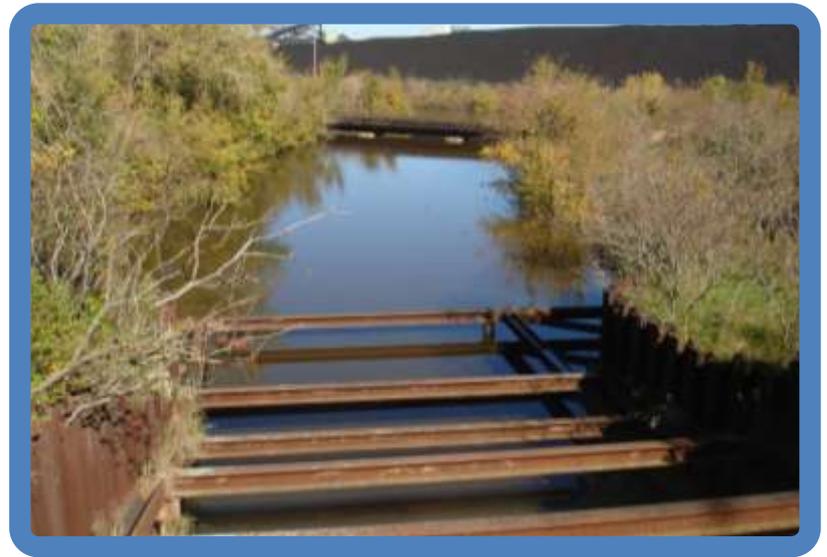
Pond 1 West outside dike Looking south tree covered dike
