**Coal Combustion Waste Impoundment
Round 7 - Dam Assessment Report**

Burlington Generating Station (Site 017)

Fly Ash Impoundment Dikes
Alliant Energy
Burlington, Iowa

November 2010

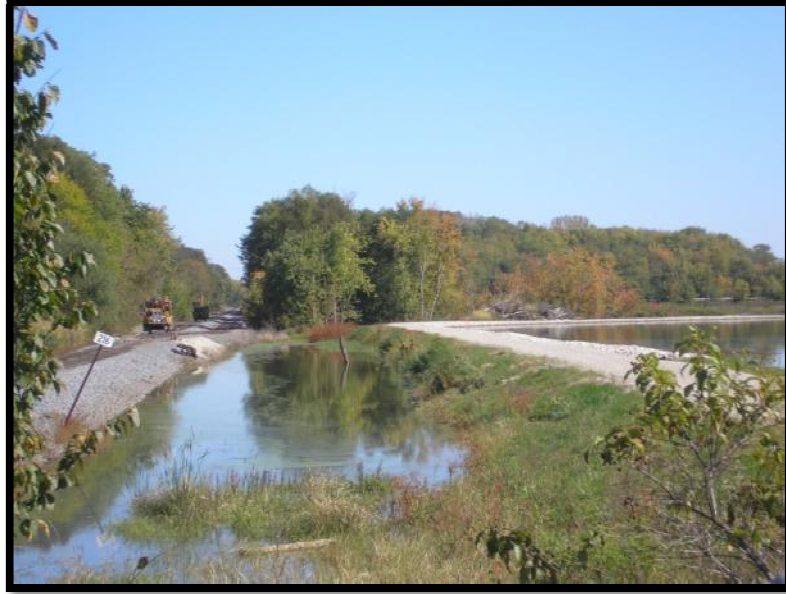
There is a main railroad line along the west side and cross gradient to the Bottom Ash, Ash Pond 1 and Ash Pond 2 impoundments. Based on the heights of the dikes along the western boundaries of those impoundments and the presences of a substantial drainage ditch between the dikes and the railroad, it is not expected that a failure of a western dike would have a significant impact on the neighboring railroad. Figure 2.5- 1 shows the railroad tracks relative to the west boundary of Ash Pond 1. The Ash Pond 1 dike has a height of approximately 5 feet.

Figure 2.5-1: Railroad Right of Way along West Boundary of Ash Pond 1.

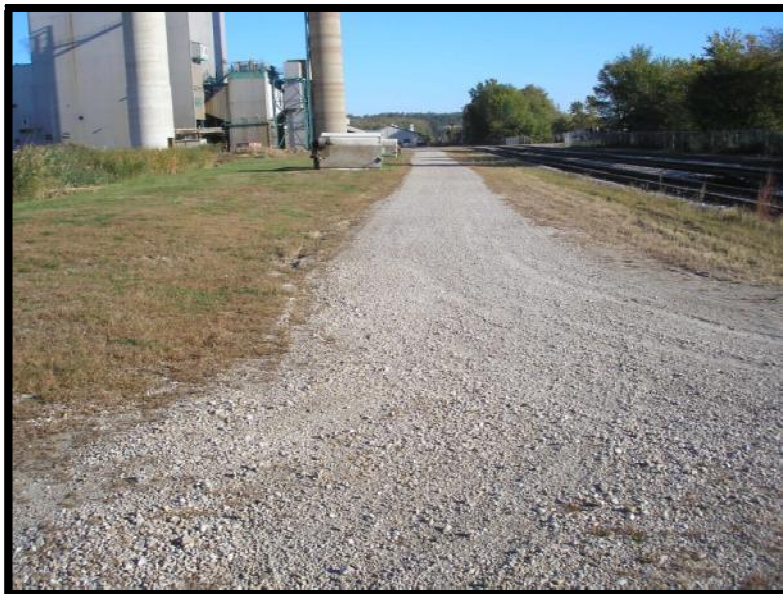
The east boundary of the Ash Seal Pond is formed by an embankment having a crest that supports a wide grassy area, a gravel covered vehicle roadway and three lines of railroad tracks. The crest had no signs of significant depressions, tension cracks or other indications of settlement or shear failure. Figure 5.2.1-1 shows the Ash Seal Pond east dike crest.

Figure 5.2.1-1: Ash Seal Pond East Dike Crest

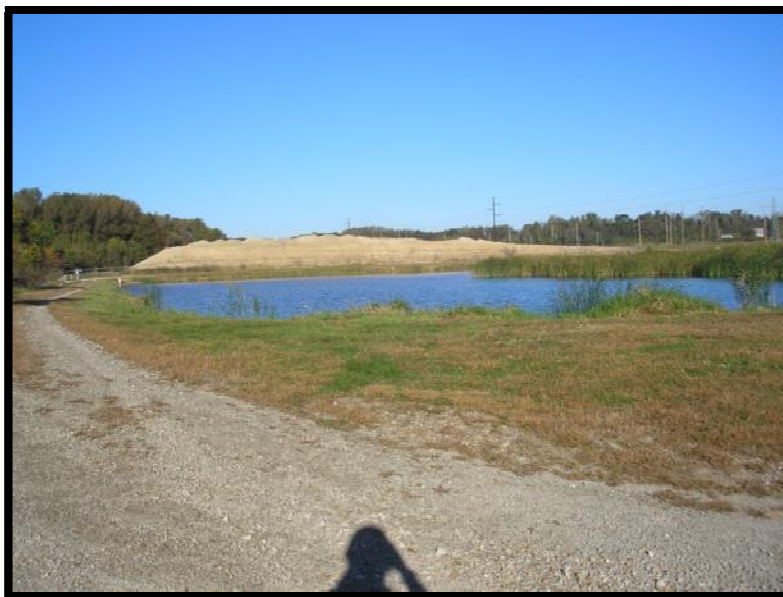
Figure 5.2.1-2: Ash Seal Pond South Dike Crest

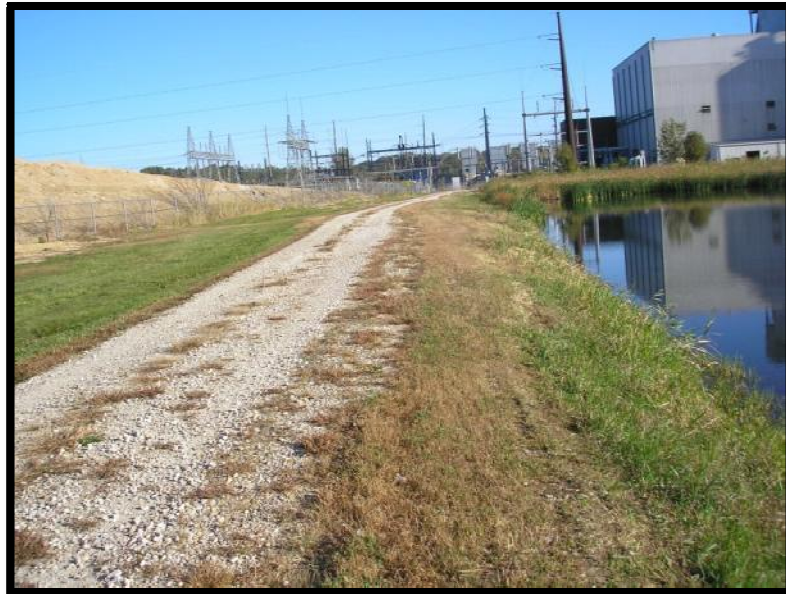
Figure 5.2.1-3: Ash Seal Pond West Dike Crest and Inside Slope.

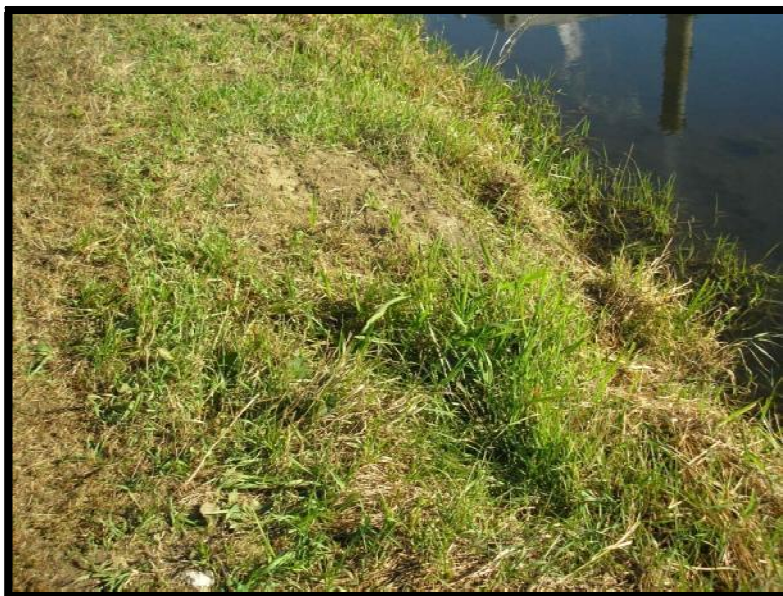
Figure 5.2.2-1: Ash Seal Pond Typical Inside Slope Vegetation Cover

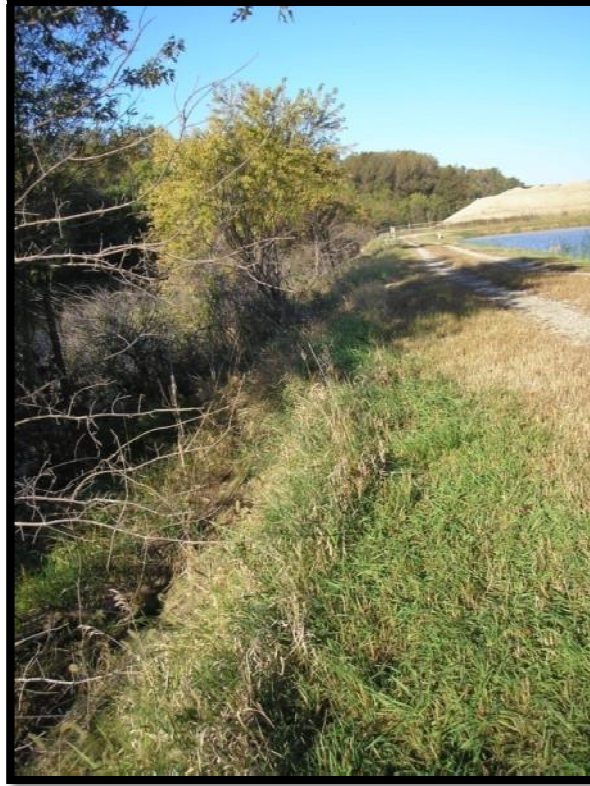
Figure 5.2.3-1: Ash Seal Pond South Dike
Outside Slope

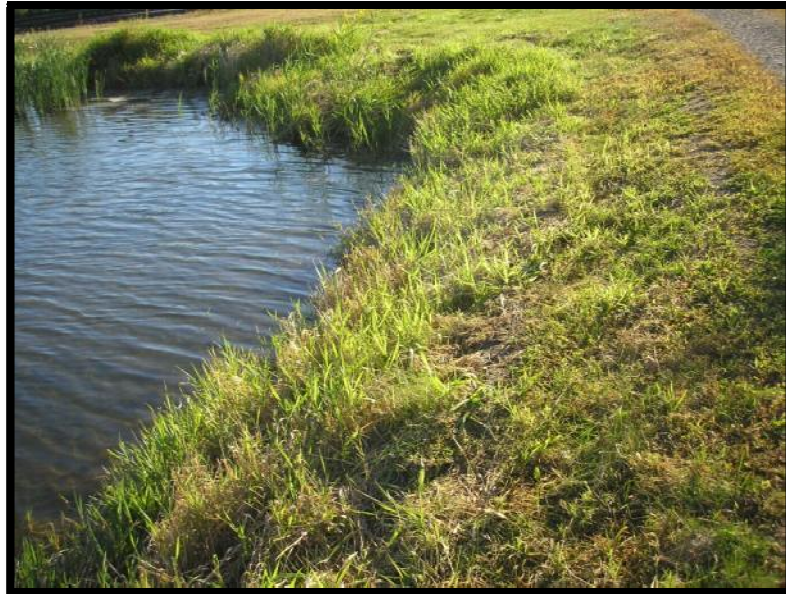
The Ash Seal Pond is a diked impoundment formed by fill on four sides; therefore there are no abutments. Neither erosion nor uncontrolled seepage was observed along the groins. Groin slopes are protected with the same vegetative cover as the adjoining slopes. Figure 5.2.4-1 shows typical conditions observed at inside groins.

Figure 5.2.4-1: Ash Seal Pond Inside Groin at Southeast Corner

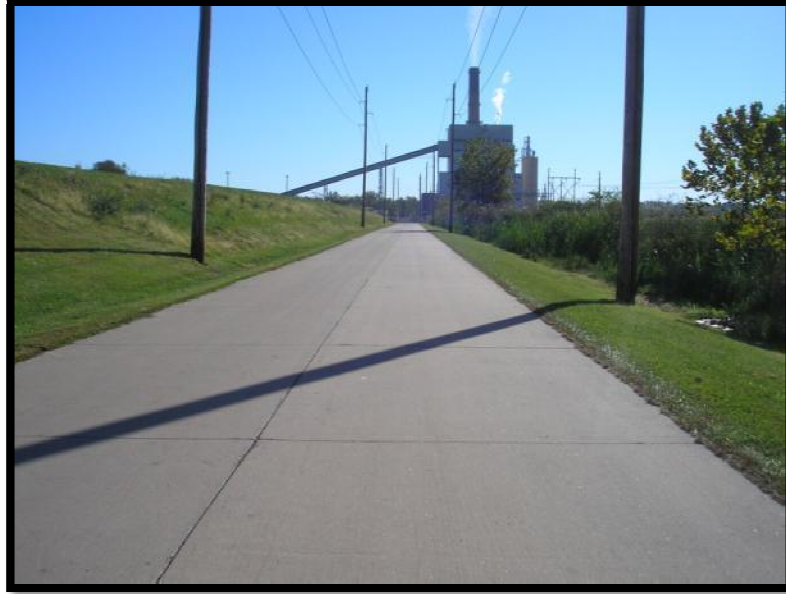
Figure 5.3.1-1: Bottom Ash Pond North Dike Crest

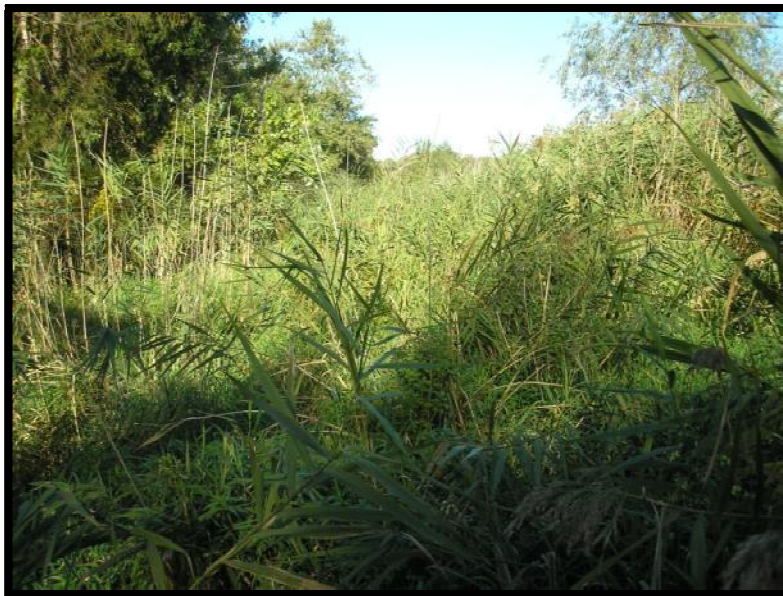
Figure 5.3.1-2: Bottom Ash Pond South Dike Crest.

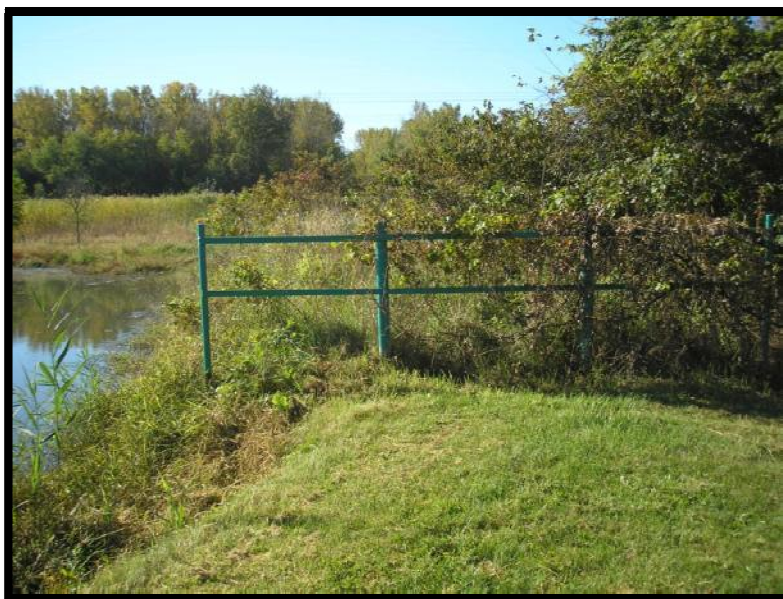
Similar vegetative conditions were observed at the Bottom Ash Pond west dike, except at the northern end of the dike. Figure 5.3.1-3 shows conditions at the northern end of the Bottom Ash Pond west dike. There were no observed scarps, sloughs, bulging, cracks, depressions or other indications of slope instability where observations were possible.

Figure 5.3.1-3: Bottom Ash Pond North End of West Dike

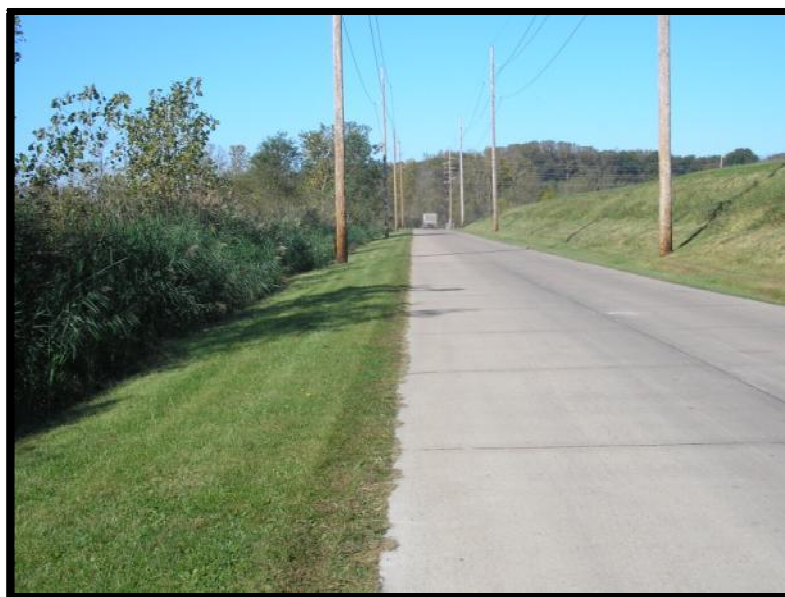
The upstream slope of the Bottom Ash Pond north dike is vegetated with grass, except near the normal pool elevation. Near the normal pool elevation vegetation consisted of small trees and bushes. Figure 5.3.2-1 shows conditions along the upstream slope of the Bottom Ash Pond north dike.

Figure 5.3.2-1: Bottom Ash Pond North Dike - Upstream Slope on Left Side of Photo

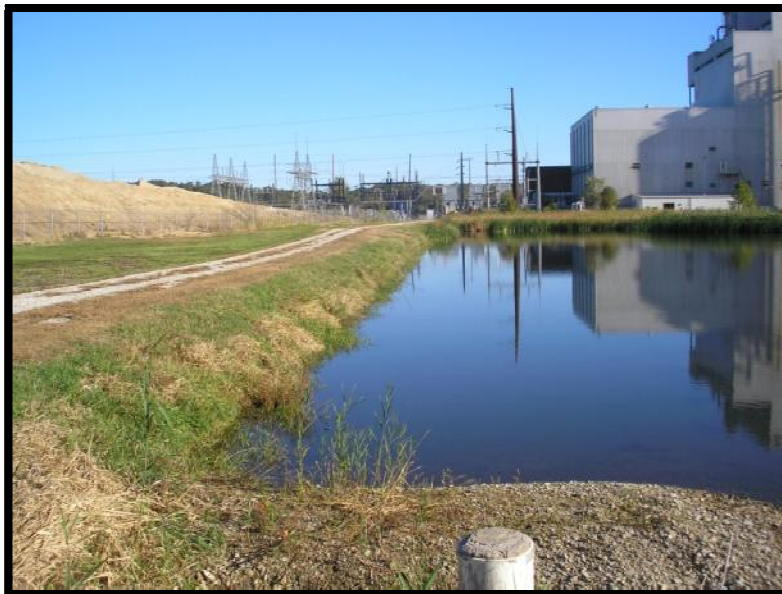
Figure 5.3.2-2: Dry Fly Ash Storage Pile on Bottom Ash East Dike Upstream Slope

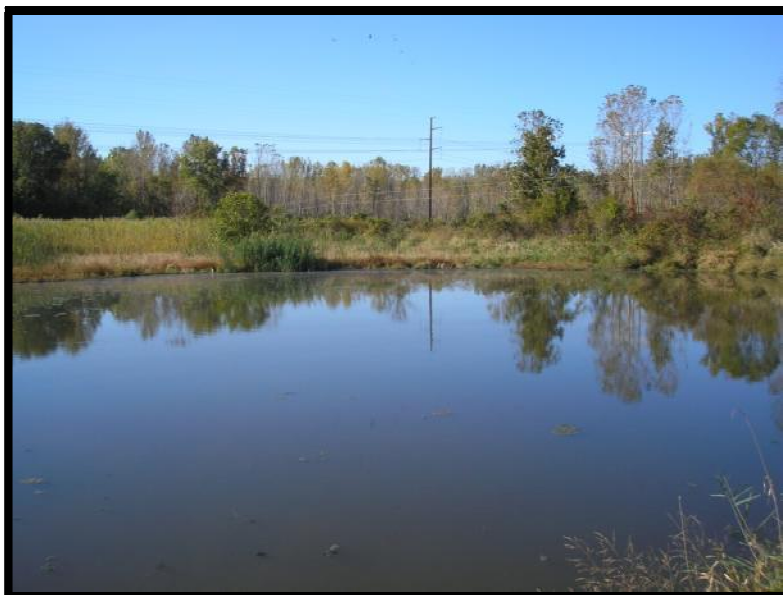
The upstream slopes of the Bottom Ash Pond south and west dikes were generally vegetated with marsh grasses, bamboo and small trees. Figure 5.3.2-3 shows conditions typical of the upstream slope of the west dike.

Figure 5.3.2-3: Bottom Ash Pond Upstream Slopes South and West Dikes

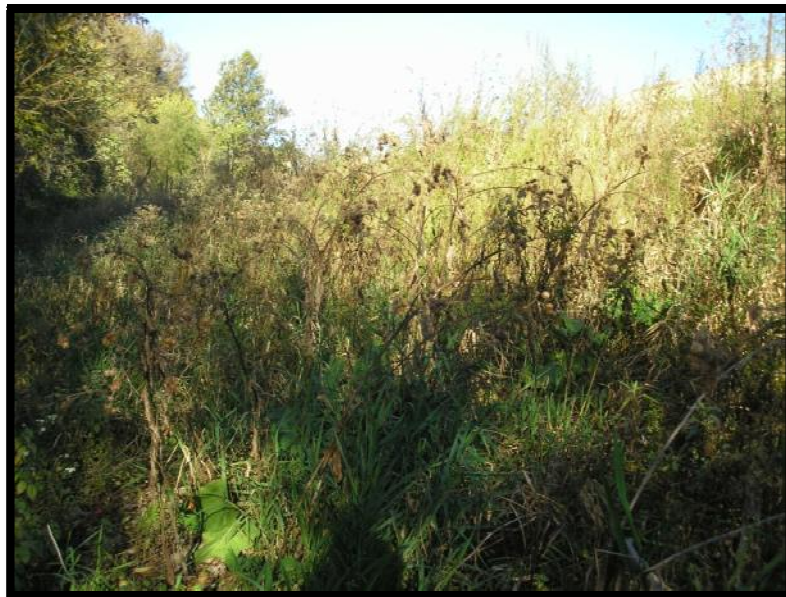
The downstream slope of the Bottom Ash Pond south dike was vegetated with tall grass and weeds, and small bushes. Figure 5.3.3-1 shows typical conditions of the downstream slope of the Bottom Ash south dike.

Figure 5.3.3-1: Bottom Ash Pond Downstream Slope South Dike

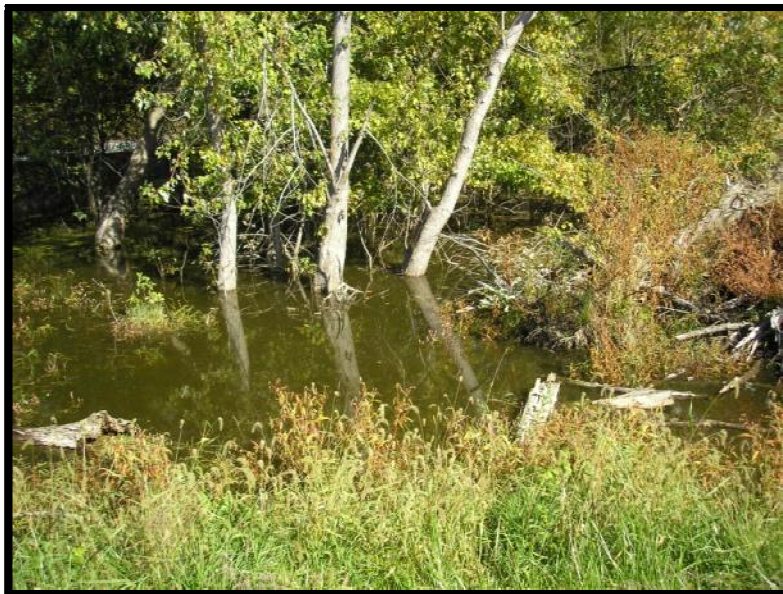
Flooding of the Ash Seal Pond discharge canal resulted in a back-up of the canal to along the toe of the Bottom Ash Pond south dike downstream slope. Figure 5.3.3-2 shows the canal water along the slope toe.

Figure 5.3.3-2: Bottom Ash Pond South Embankment:
Discharge Canal Flooding back-up to
Downstream Slope Toe

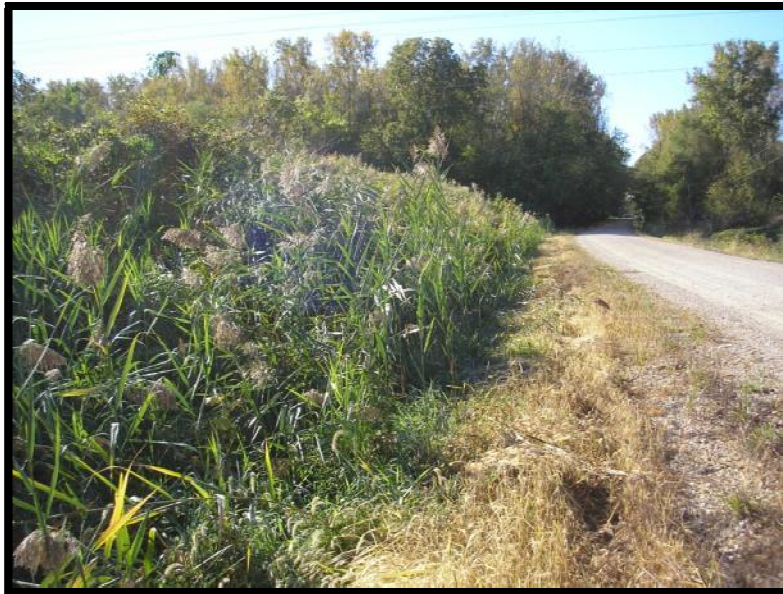
The downstream slope of the Bottom Ash Pond west slope is vegetated with tall plants and small trees. Figure 5.3.3-3 shows conditions along the Bottom Ash Pond west dike downstream embankment. No areas of seepage were observed along the toe of the downstream slope.

Figure 5.3.3-3: Bottom Ash Pond West Dike
Downstream Slope

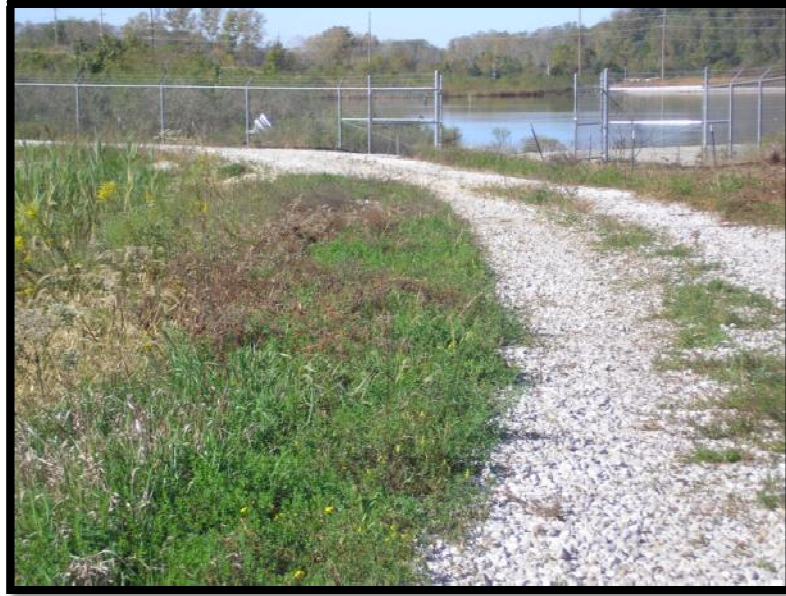
Figure 5.4.4-1: Economizer Ash Pond Crest and Upstream Slope

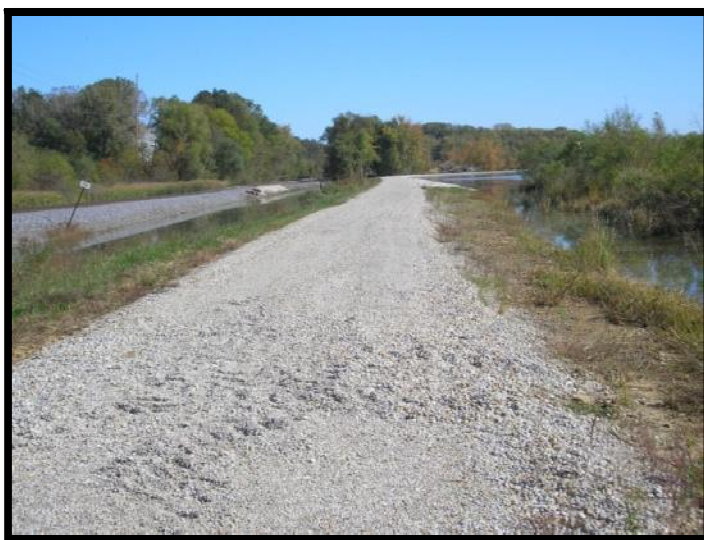
The crest Ash Pond 1 dike had no significant depressions, tension cracks or other indications of settlements or shear failure. The crest of Ash Pond 1 dike is gravel paved for service vehicle access, see Figure 5.5.1-1.

Figure 5.5.1-1: Ash Pond 1 Crest at Southwest End

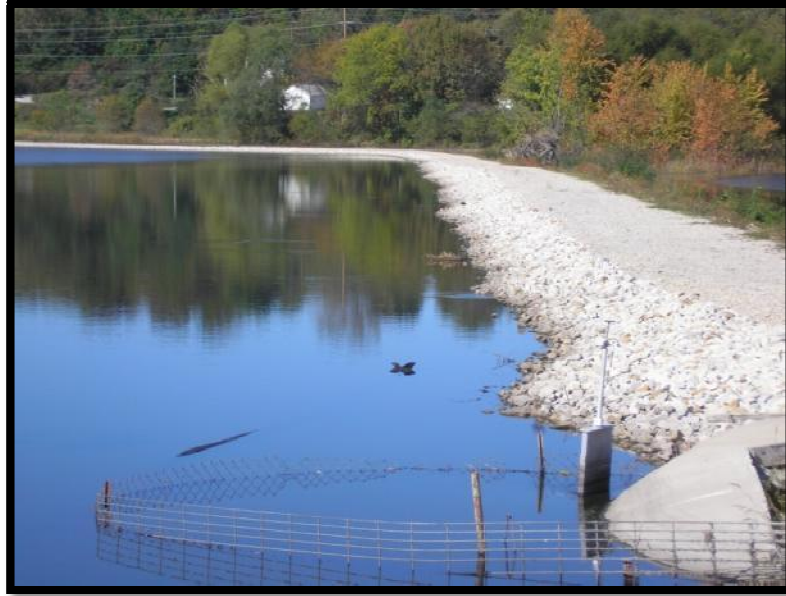
The upstream slope of the Ash Pond 1 dike was protected by crushed stone riprap. There were no observed scarps, sloughs, bulging, cracks, depressions or other indications of slope instability. Figure 5.5.2-1 shows a representative section of the upstream slope of the embankment.

Figure 5.5.2-1: Ash Pond 1 Embankment
Upstream Slope

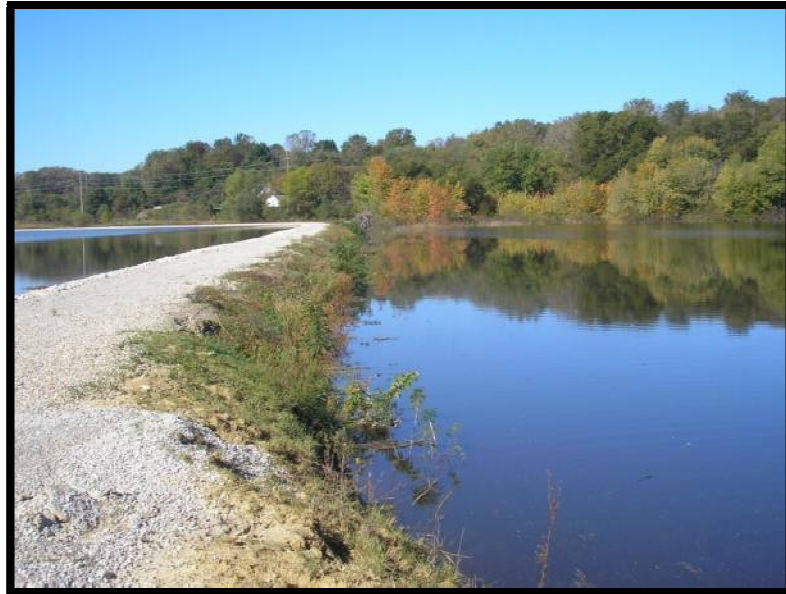
At the east and center portion of Ash Pond 1 the downstream slope is the southern boundary of Ash Pond 2. Above the Ash Pond 2 water level the downstream slope of the embankment is vegetated with small weeds. Figure 5.5.3-1 shows the conditions of the eastern and central portion of Ash Pond 1 dike downstream slope. Ash Pond 2 is on the right side of the photograph.

Figure 5.5.3-1: Ash Pond 1 Dike Eastern and Central Section Downstream Slope

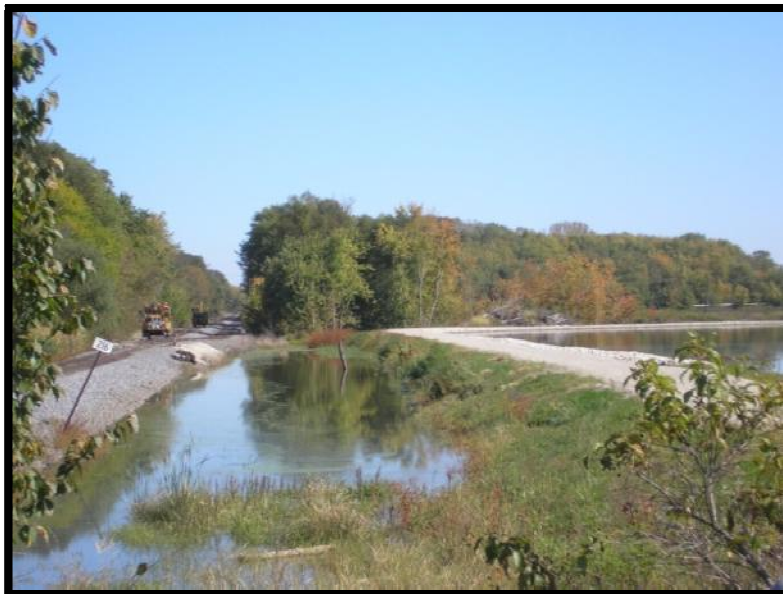
Figure 5.5.3-2: Ash Pond 1 West Section
Downstream Slope

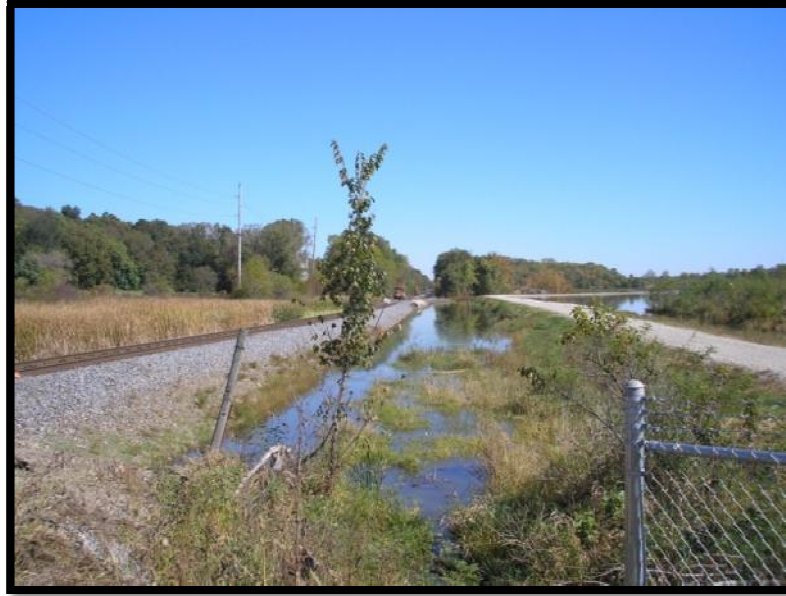
Figure 5.5.4-1: Ash Pond 1 West Abutments

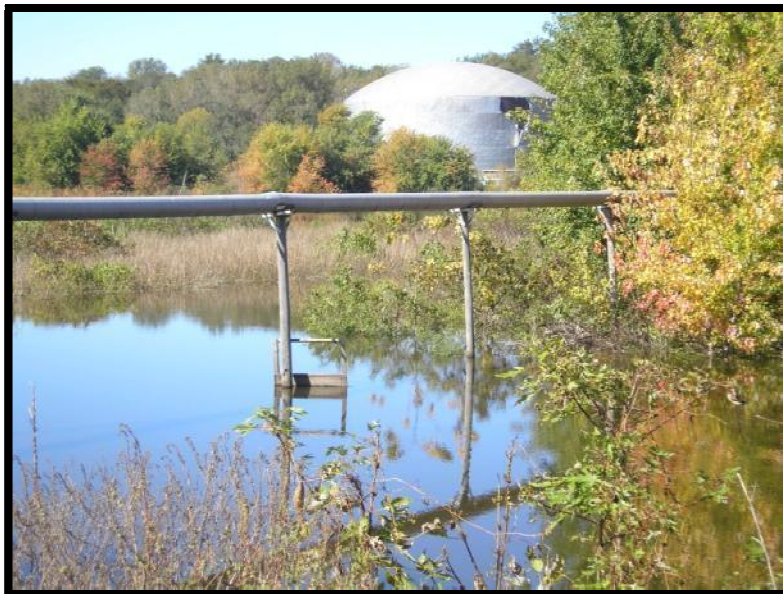
Figure 5.6.1-1: Ash Pond 2 Dike Crest Location beneath Pipe Support Columns.

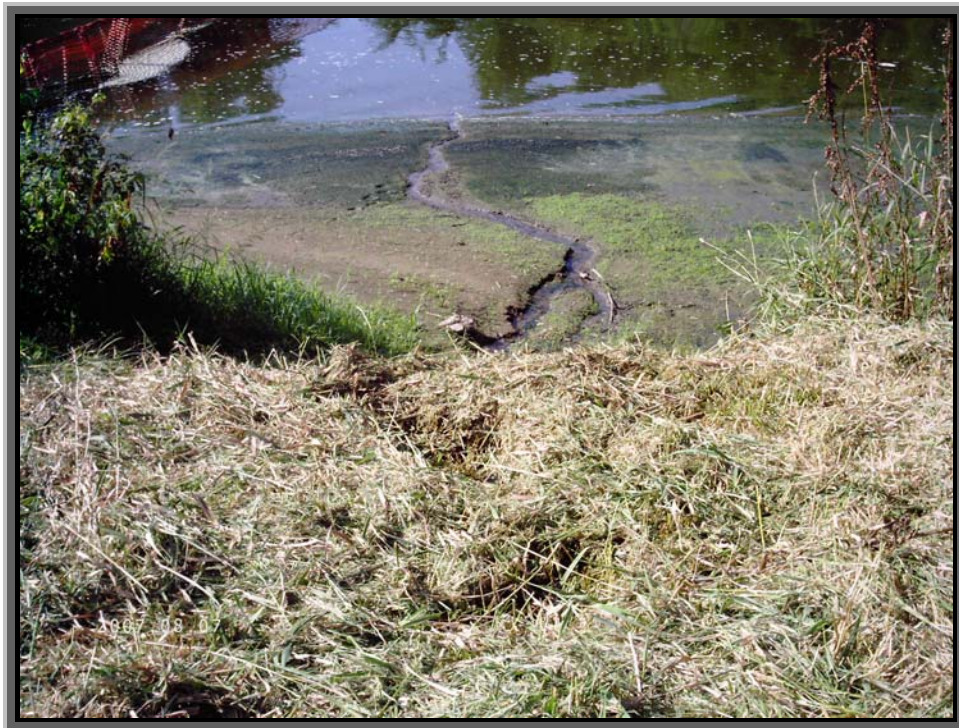
Photo 2) South – Seep Location in from Berm

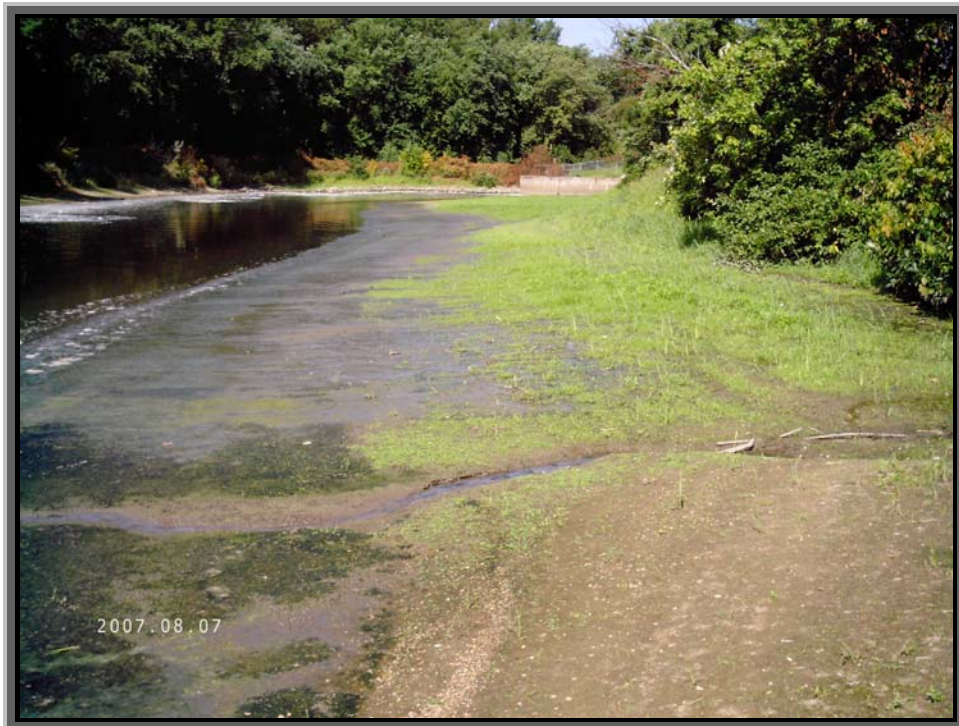
Photo 4) West – Facility Discharge Channel; Continuous Wet Ground after Dry Weather

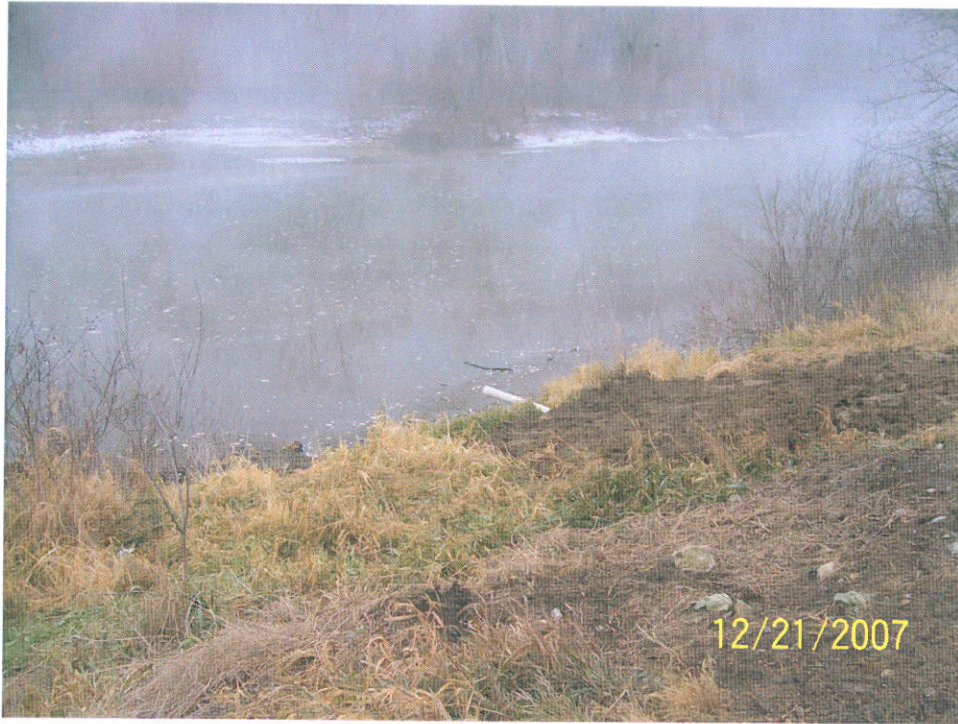
Photograph of drain tile outfall pipe. Old drain tile was determined to be the source of the seep. It was properly plumbed out to daylight so it can be observed in the future.

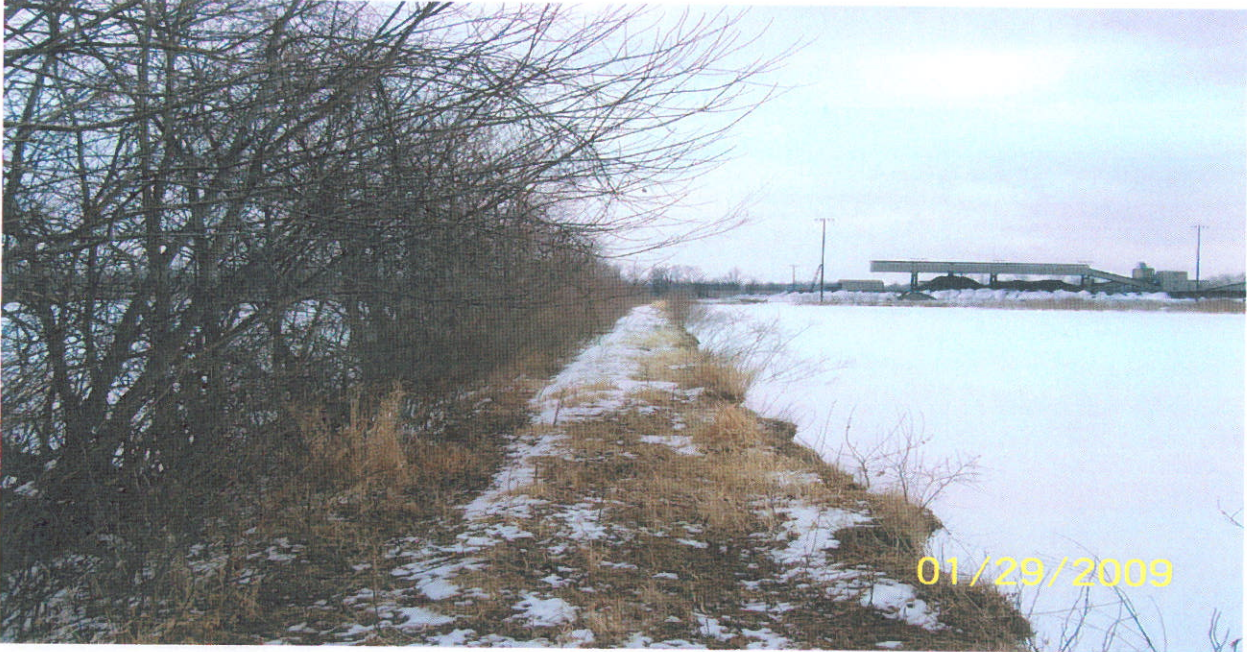
Upper Ash Pond levee prior to rehabilitation

In early 2010, the Ash Pond 1 dike underwent rehabilitation to correct the effects of wave erosion. The rehabilitation included excavation of the damaged areas; importing clay to regarded the levee crest and upstream slope; placing a geotextile membrane on the new subgrade, placing riprap along the upstream slope, and placing crushed stone on the crest (Appendix A – Document 13).
