**DRAFT REPORT  
ROUND 10 DAM ASSESSMENT - MAY 31, 2011  
ALLIANT ENERGY – EDGEWATER GENERATING STATION  
SLAG POND, NORTH POND A, SOUTH POND A, POND B, POND F  
SHEBOYGAN, WISCONSIN**

RE: Assessment of Dam Safety of Coal Combustion Surface Impoundments at the Edgewater  
Generating Station

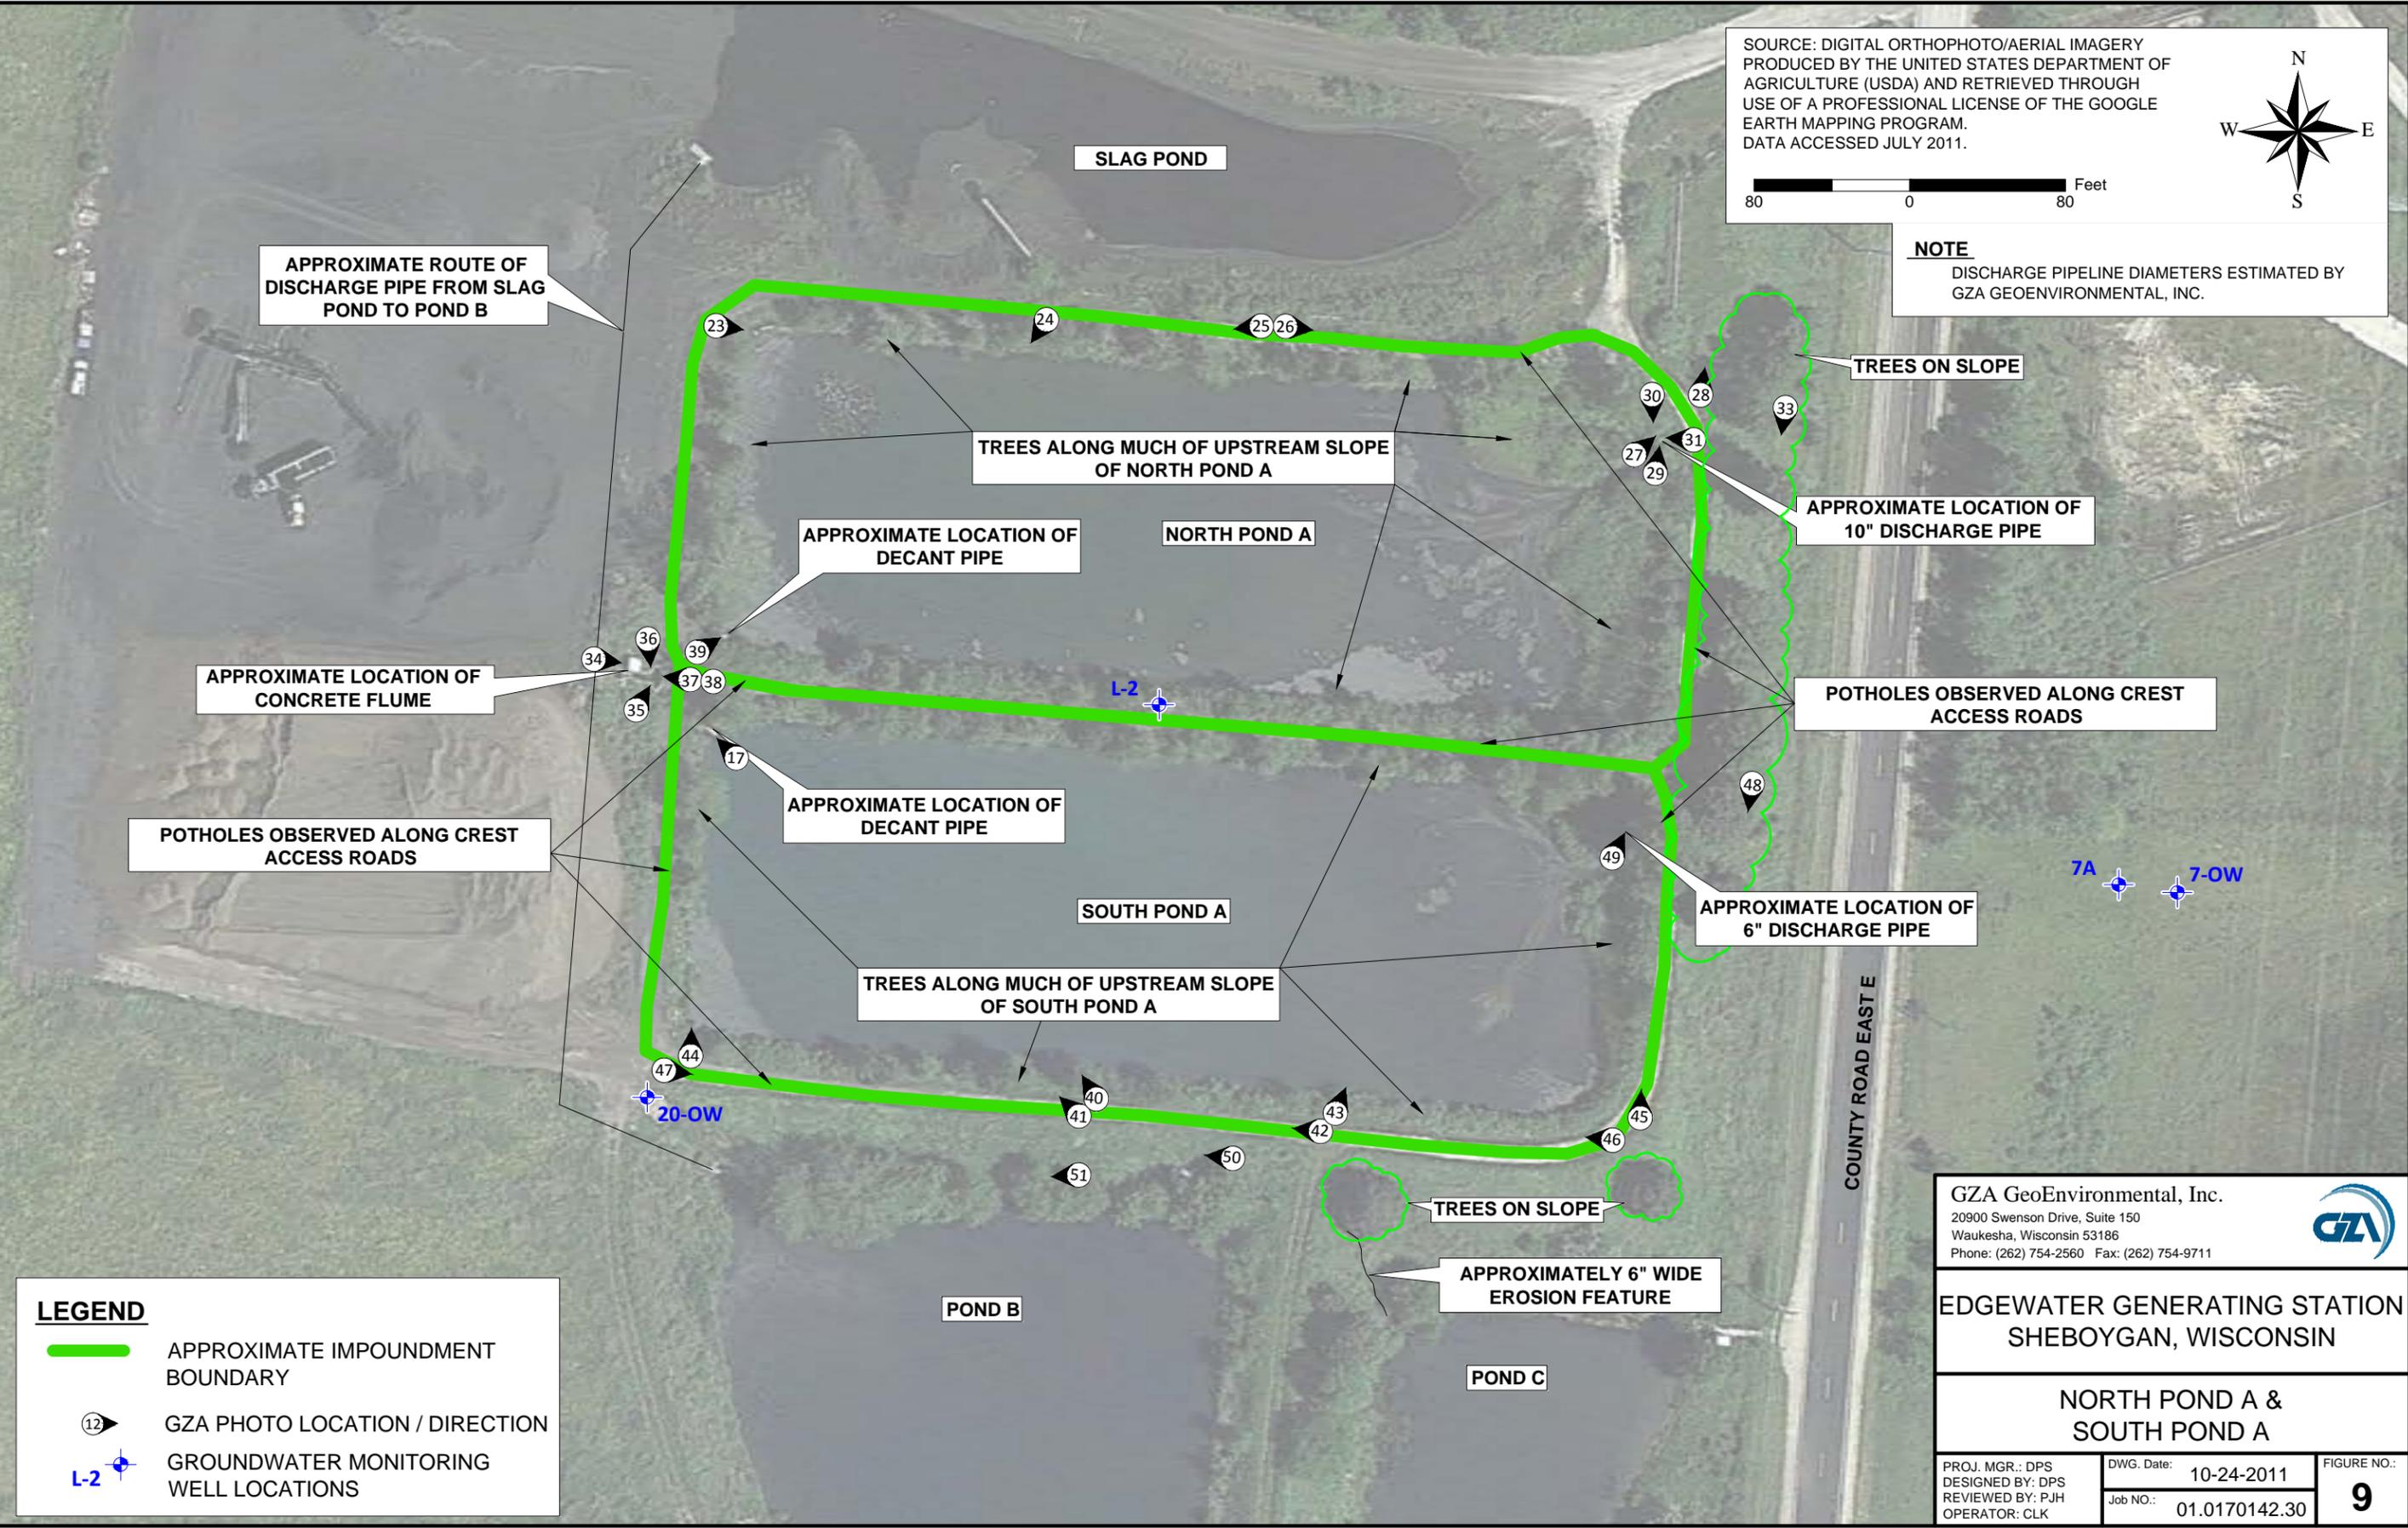
PROJ. MGR.: DPS DESIGNED BY: DPS REVIEWED BY: PJH OPERATOR: CLK	DWG. Date: 10-24-2011 Job NO.: 01.0170142.30	FIGURE NO.: <b>9</b>
--	---	----------------------

APPROXIMATE ROUTE OF DISCHARGE PIPE FROM SLAG POND TO POND B

TREES ALONG MUCH OF UPSTREAM SLOPE OF NORTH POND A

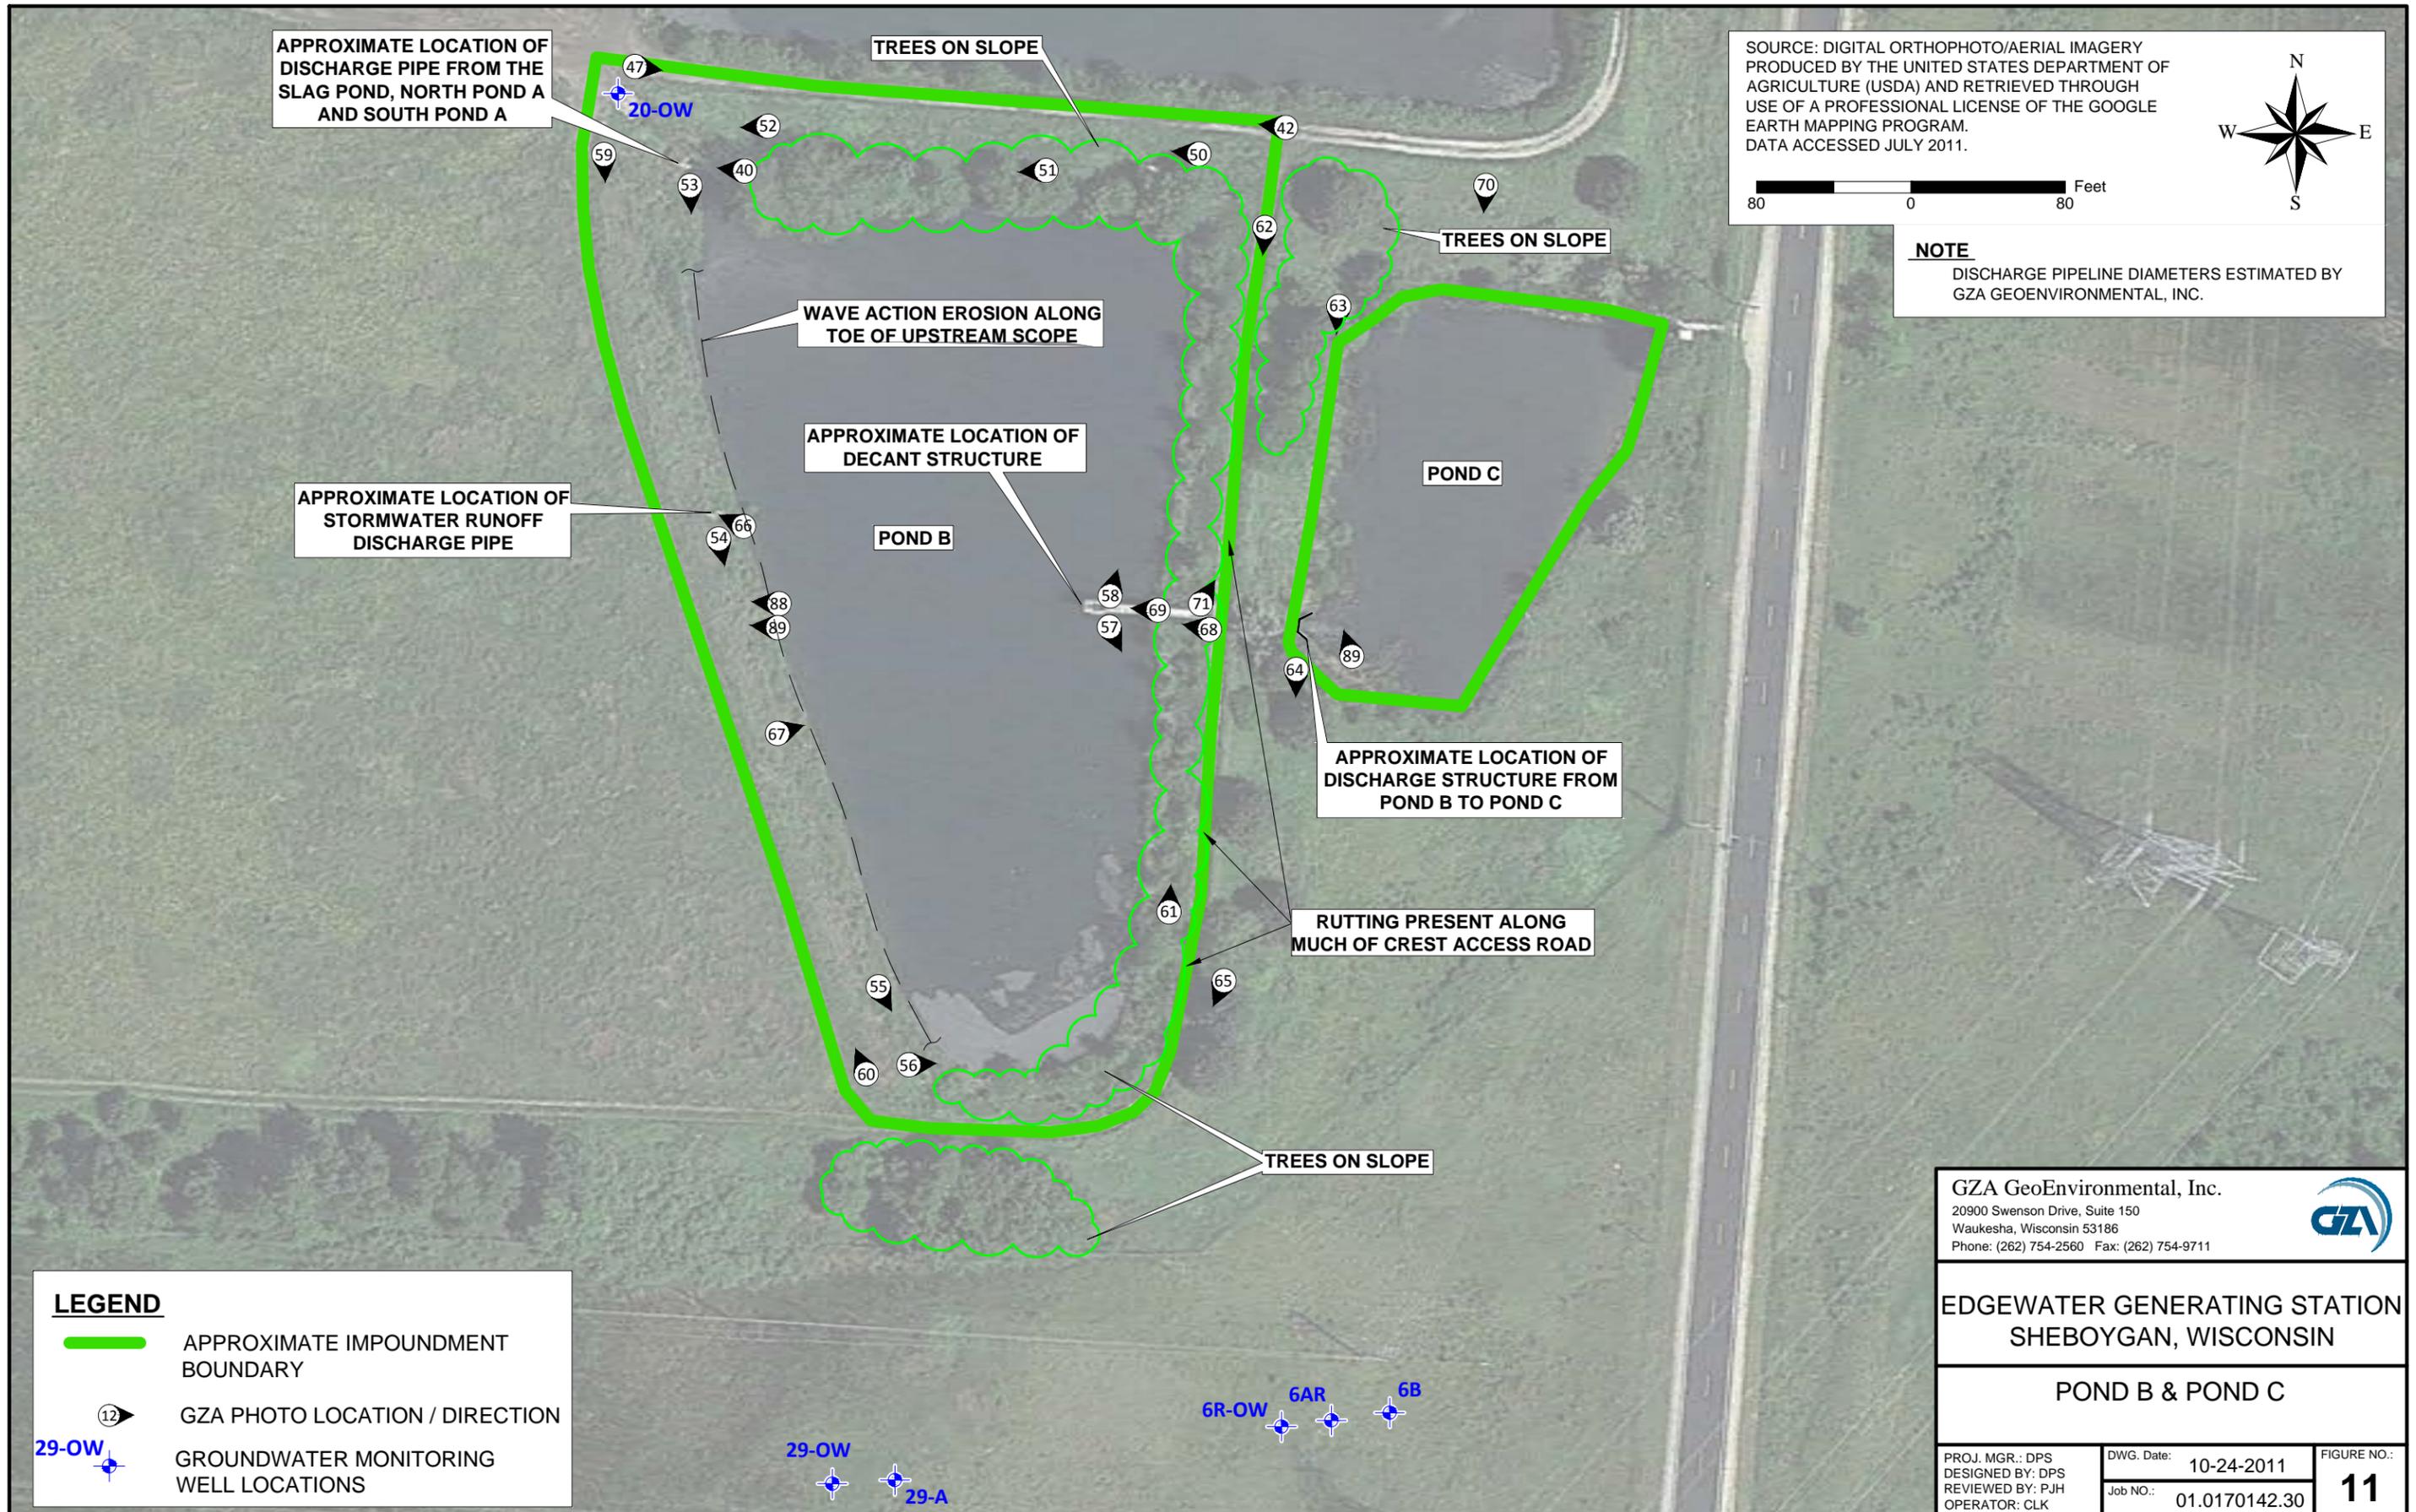
PROJ. MGR.: DPS	DWG. Date: 10-24-2011	FIGURE NO.:
DESIGNED BY: DPS	Job NO.: 01.0170142.30	<b>11</b>
REVIEWED BY: PJH		
OPERATOR: CLK

APPROXIMATE LOCATION OF DISCHARGE PIPE FROM THE SLAG POND, NORTH POND A AND SOUTH POND A

TREES ON SLOPE

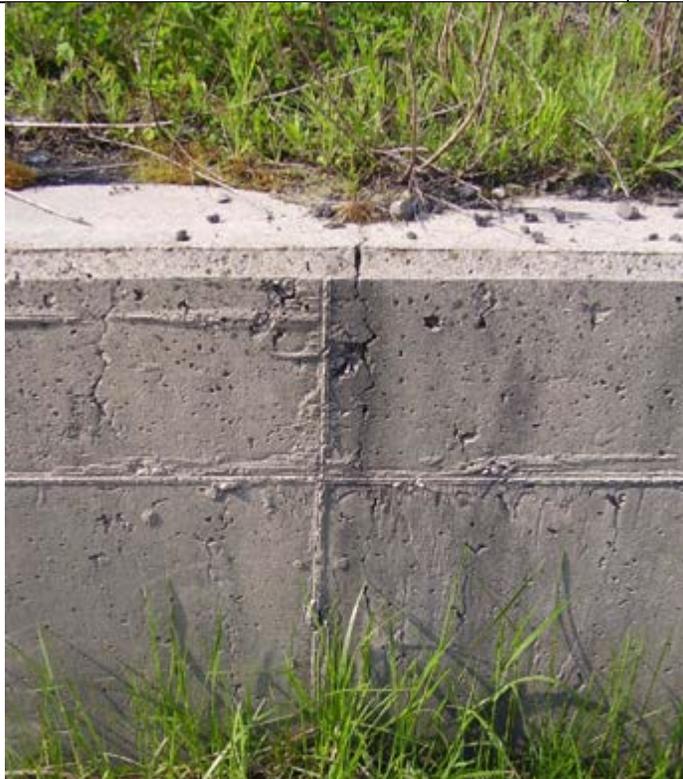
**Description:**  
Cracking in the concrete retaining wall along the downstream slope of the Slag Pond.
