**FINAL REPORT  
ROUND 10 DAM ASSESSMENT  
WISCONSIN POWER AND LIGHT COMPANY – EDGEWATER  
GENERATING STATION  
SLAG POND, NORTH POND A, SOUTH POND A, POND B, POND F  
SHEBOYGAN, WISCONSIN**

RE: Assessment of Dam Safety of Coal Combustion Surface Impoundments at the Edgewater  
Generating Station

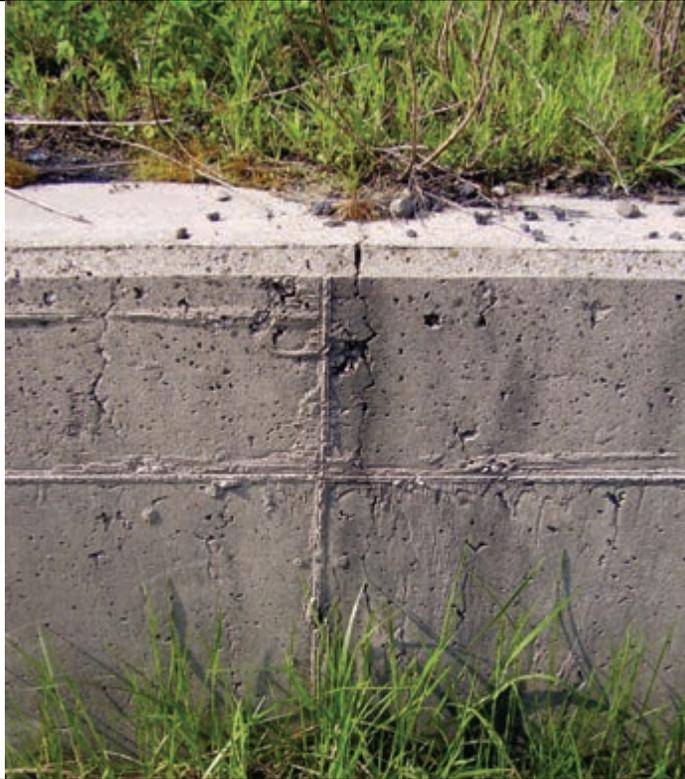
**Photo No.**  
20

**Description:**  
Cracking in the concrete retaining wall along the downstream slope of the Slag Pond.
