**DRAFT REPORT
ROUND 10 DAM ASSESSMENT - JUNE 8, 2011
ALLIANT ENERGY - ROCK RIVER GENERATING STATION
WPDES POND 1, WPDES POND 2, SLAG POND, FINAL WPDES POND
BELOIT, WISCONSIN**

RE: Assessment of Dam Safety of Coal Combustion Surface Impoundments at the Rock
River Generating Station

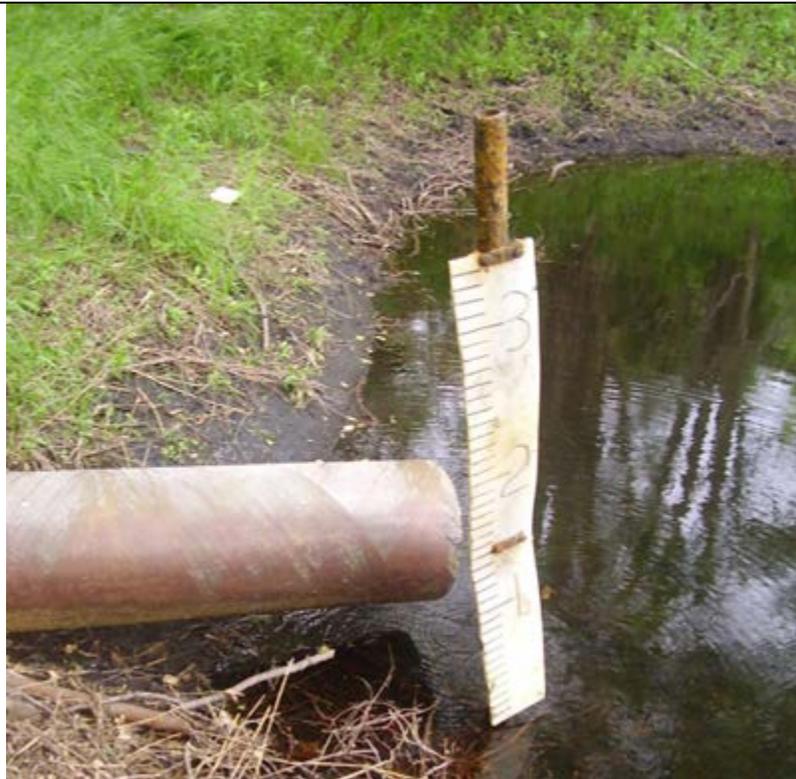
Photo No.
6

Description:
CARP decant structure pipe.

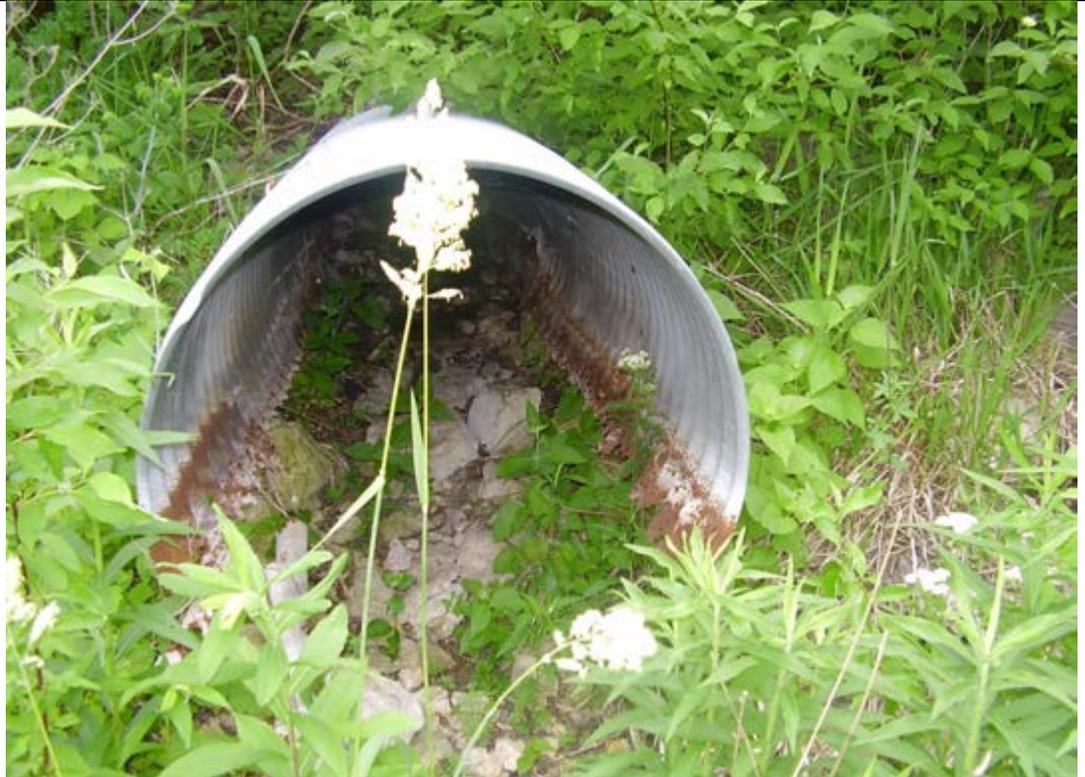
Description:
24-inch diameter CMP
discharge pipe at southwest
corner of the WPDES Pond
1.

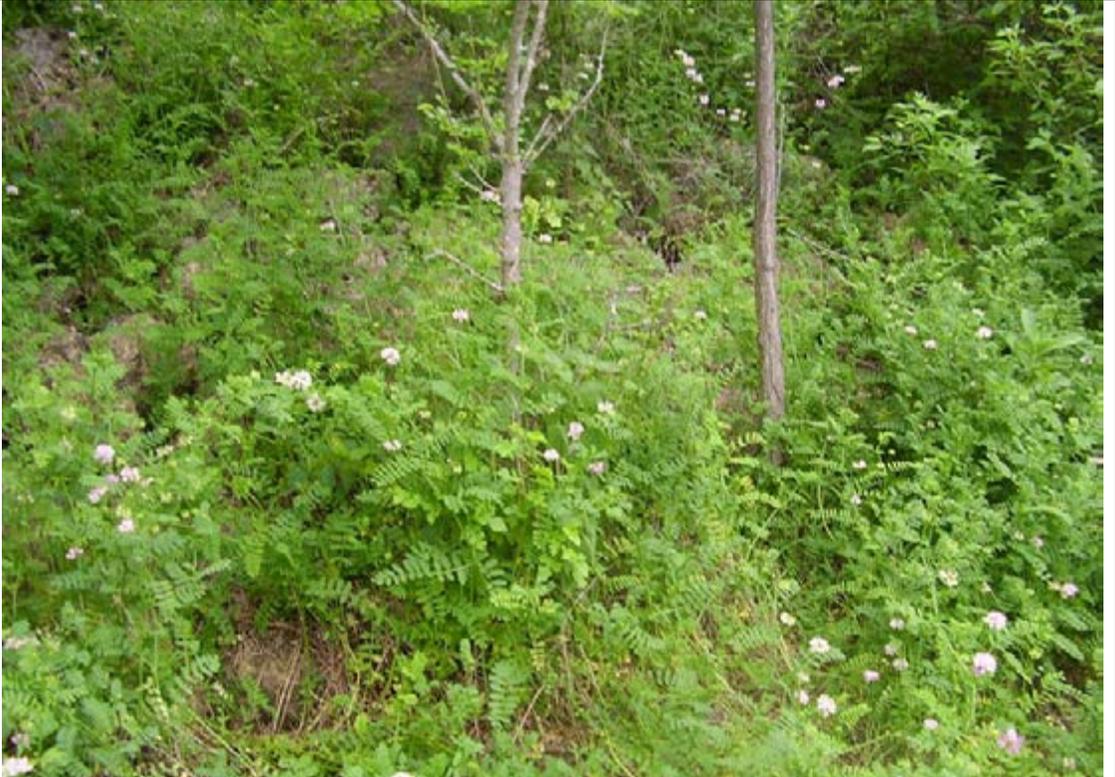
Photo No. 13	Date: 6/8/11
Direction Photo Taken: West

Description:
Upstream slope of the WPDES Pond 1 showing the riprap that is present above the normal operating level.

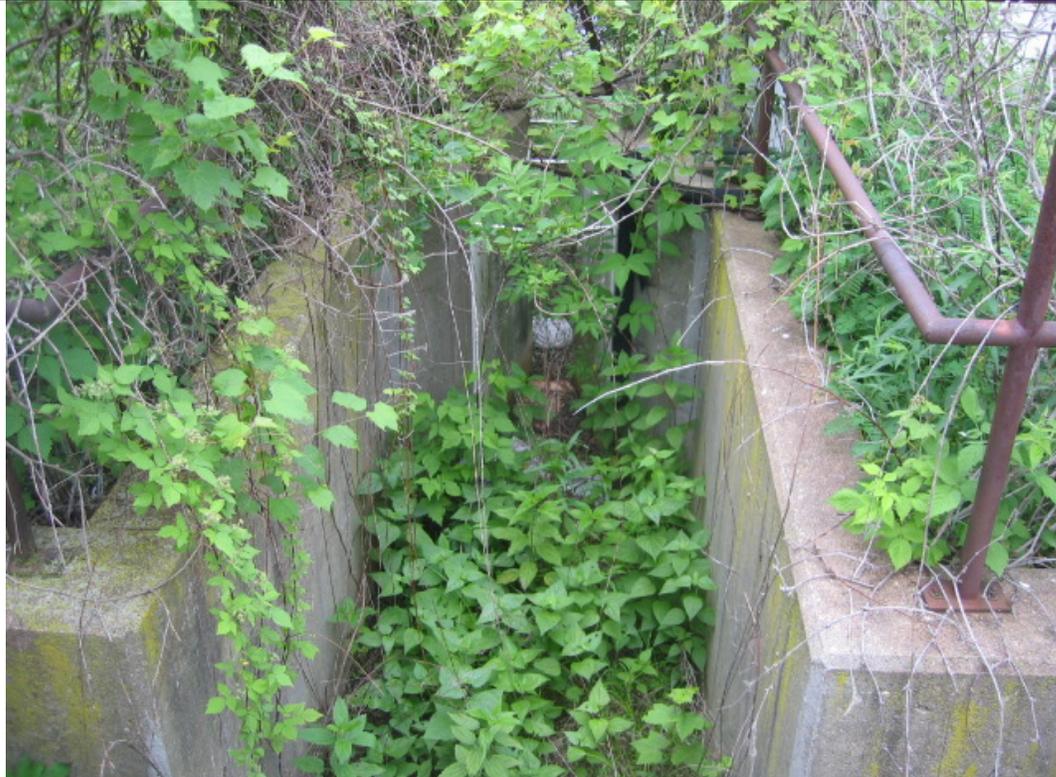
Photo No. 17	Date: 6/8/11
Direction Photo Taken: West

Description:
Weir structure of outfall from WPDES Pond 1 and WPDES Pond 2.

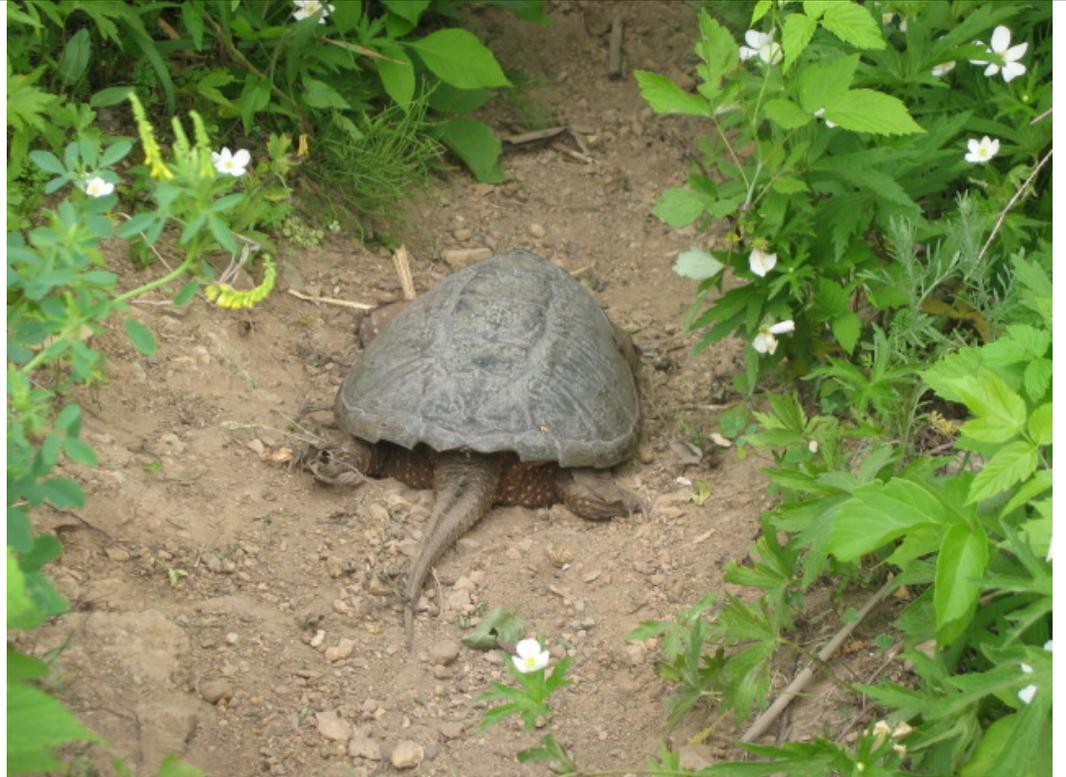
Photo No. 33	Date: 6/8/11
Direction Photo Taken: North

Description:
Turtle crossing upstream slope of the Final WPDES Pond.

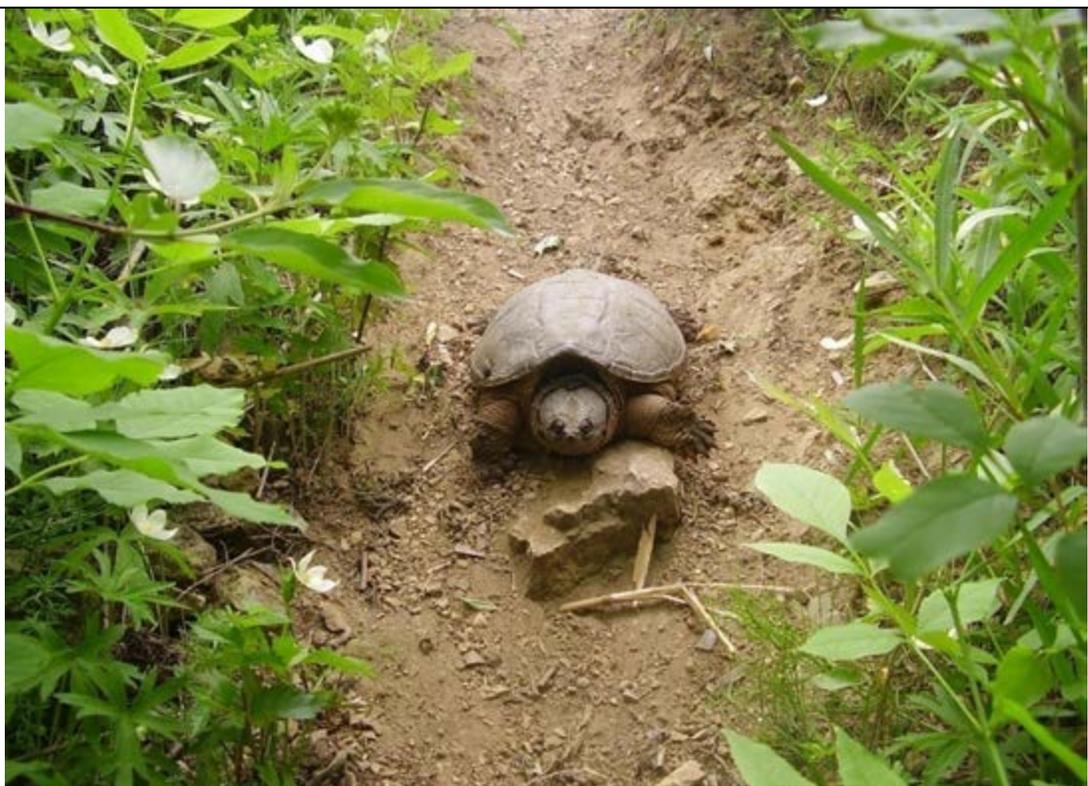
Photo No. 34	Date: 6/8/11
Direction Photo Taken: South

Description:
Turtle crossing upstream slope of the Final WPDES Pond.

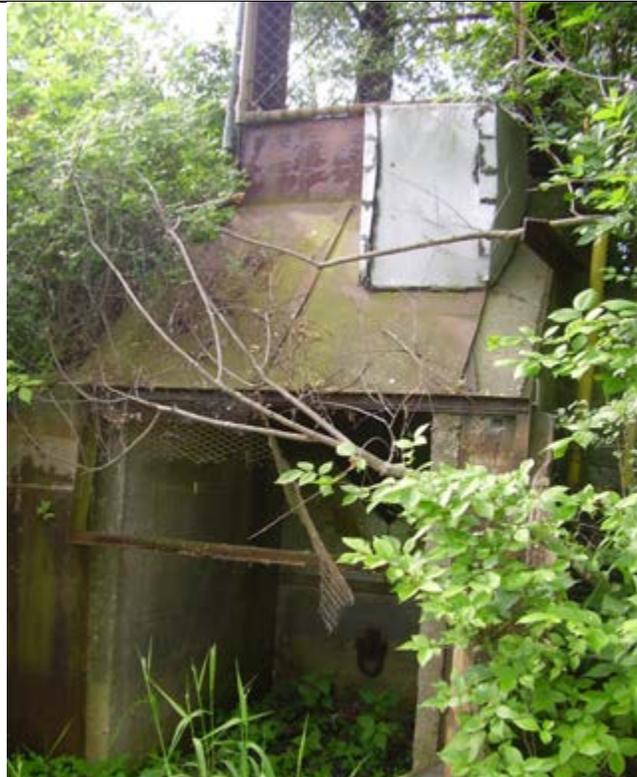
Inlet for discharge structure on the upstream slope of the Final WPDES Pond.

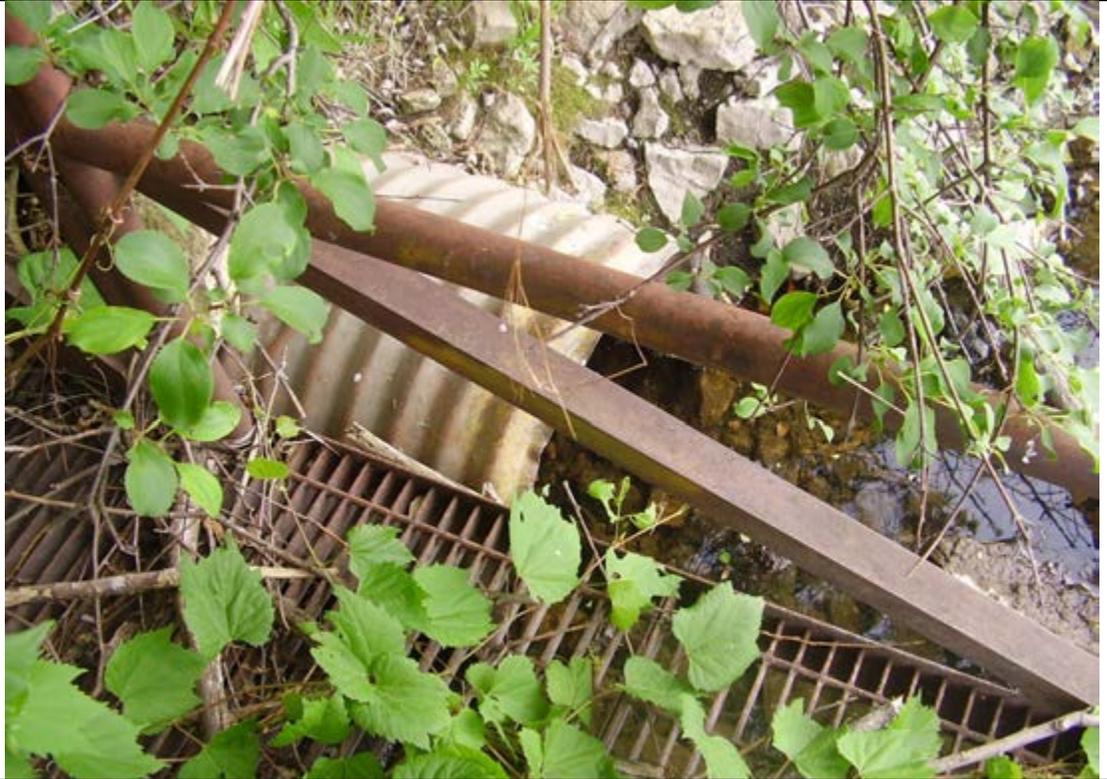
Description:
Discharge pipe from the
Final WPDES Pond. Water
visible is from the Rock
River.

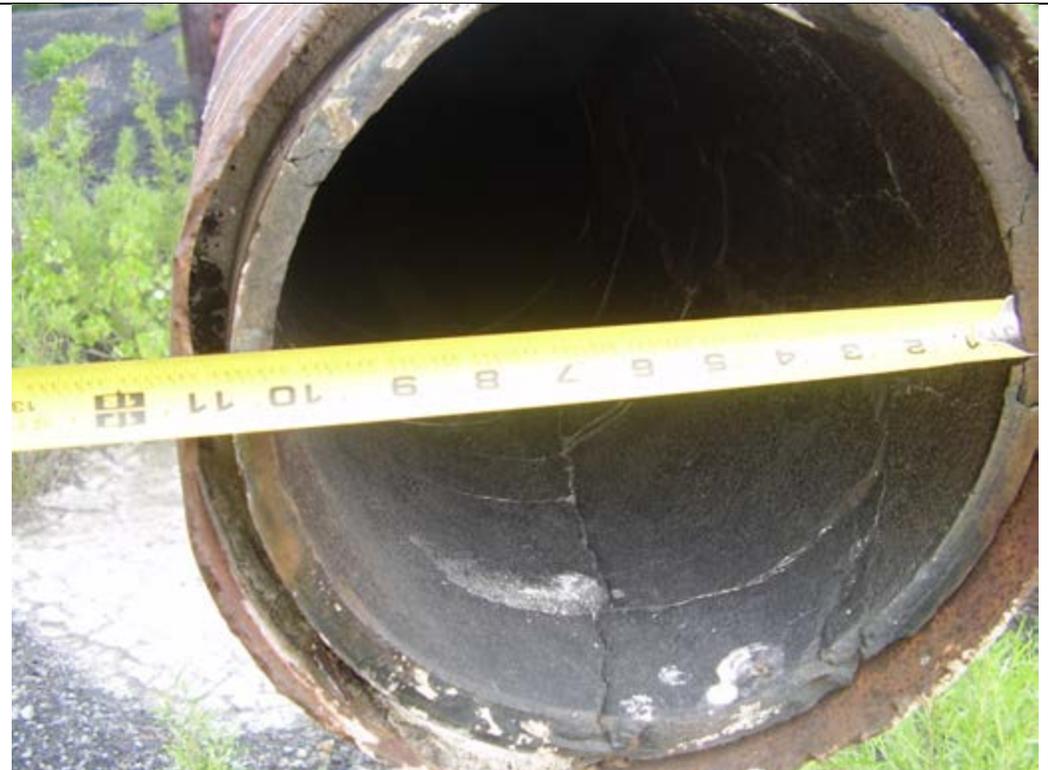
Photo No.
52

Description:
Incompletely abandoned
discharge pipe from the
facility.

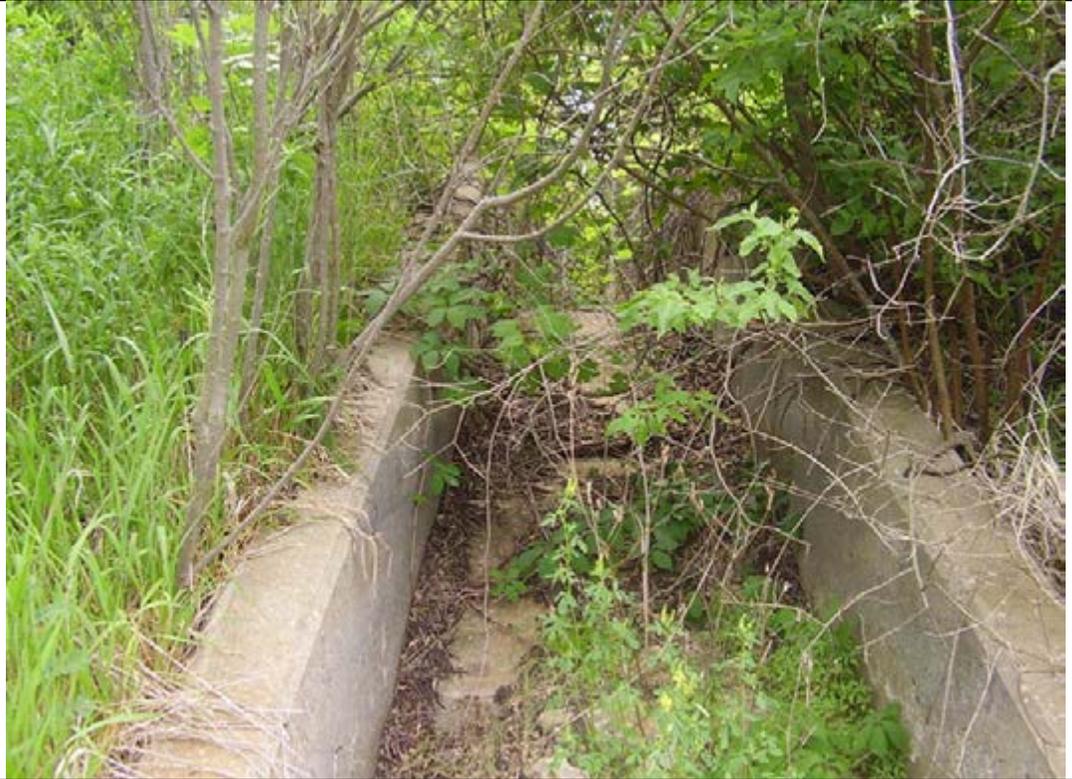
Description:
Spillway for discharge from
the WPDES Pond 1 and
WPDES Pond 2.

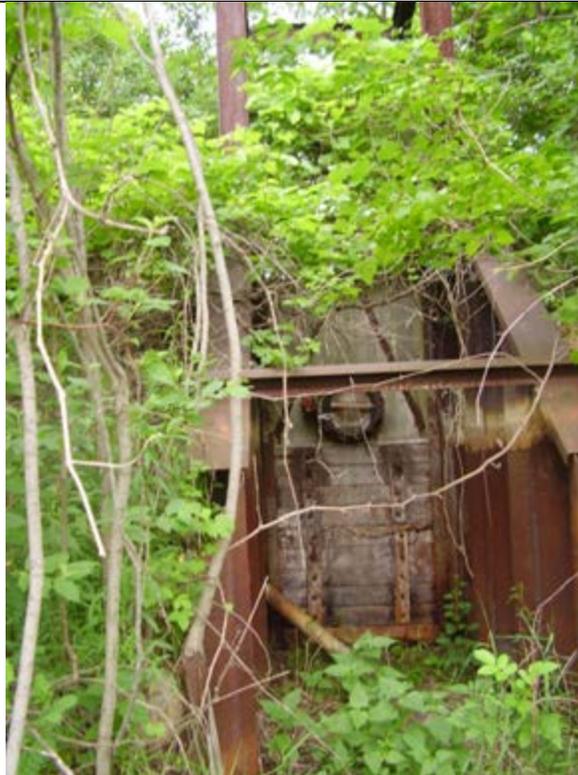
Photo No.
54

Description:
Spillway structure for
discharge from the Slag
Pond into the Final WPDES
Pond.
