**FINAL REPORT
ROUND 10 DAM ASSESSMENT
WISCONSIN POWER AND LIGHT COMPANY - ROCK RIVER
GENERATING STATION
WPDES POND 1, WPDES POND 2, SLAG POND, FINAL WPDES POND
BELOIT, WISCONSIN**

January 31, 2013
GZA File No. 170142.30

RE: Assessment of Dam Safety of Coal Combustion Surface Impoundments at the Rock
River Generating Station

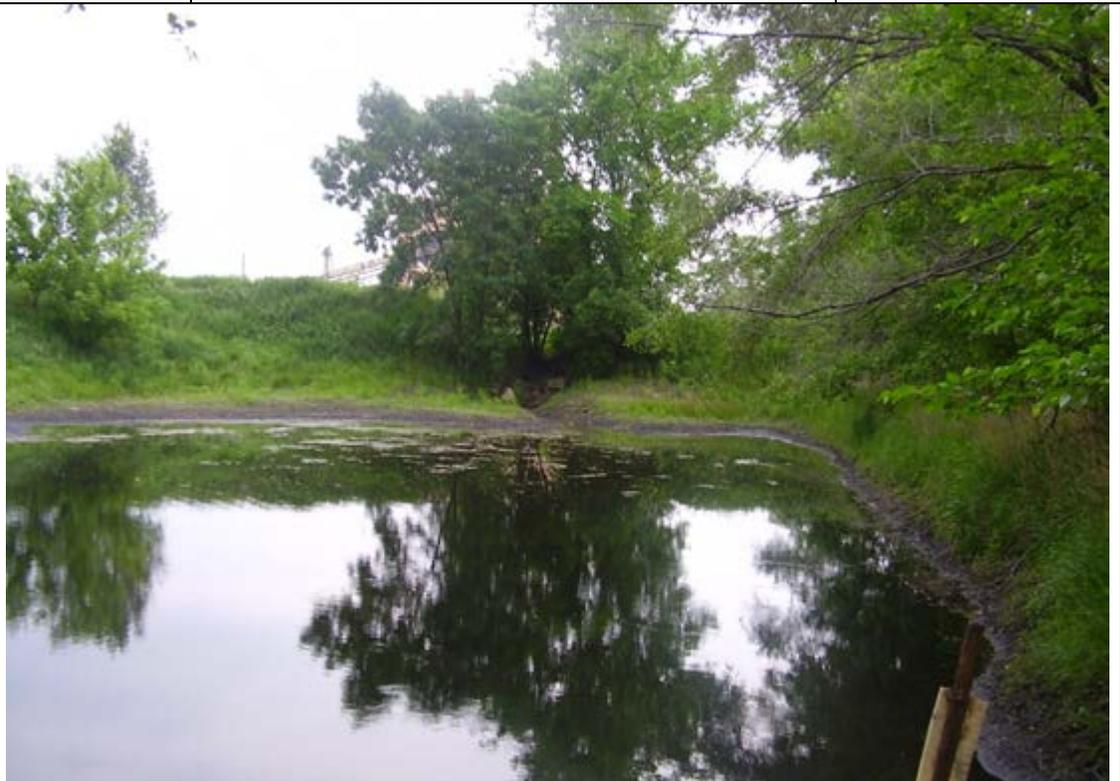
Photo No. 1	Date: 6/8/11
Direction Photo Taken: Northeast

Description:
Upstream slope of the Coal Pile Runoff Pond (CARP).

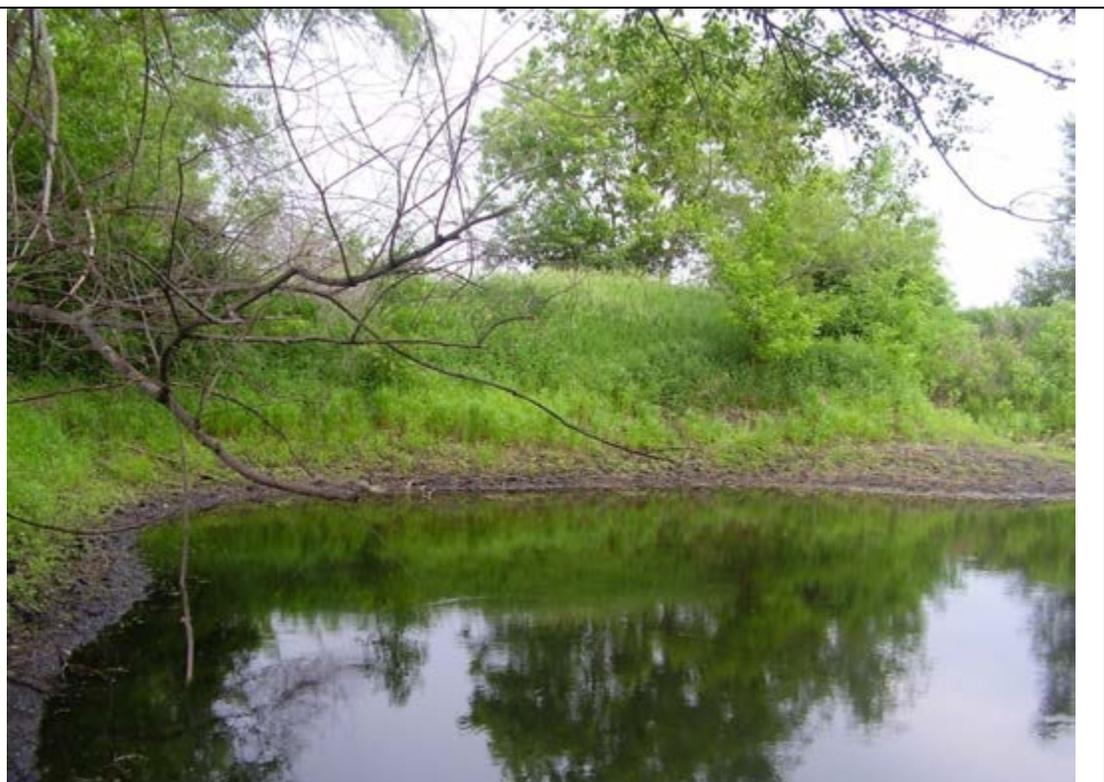
Photo No. 2	Date: 6/8/11
Direction Photo Taken: North

Description:
Upstream slope of the CARP.

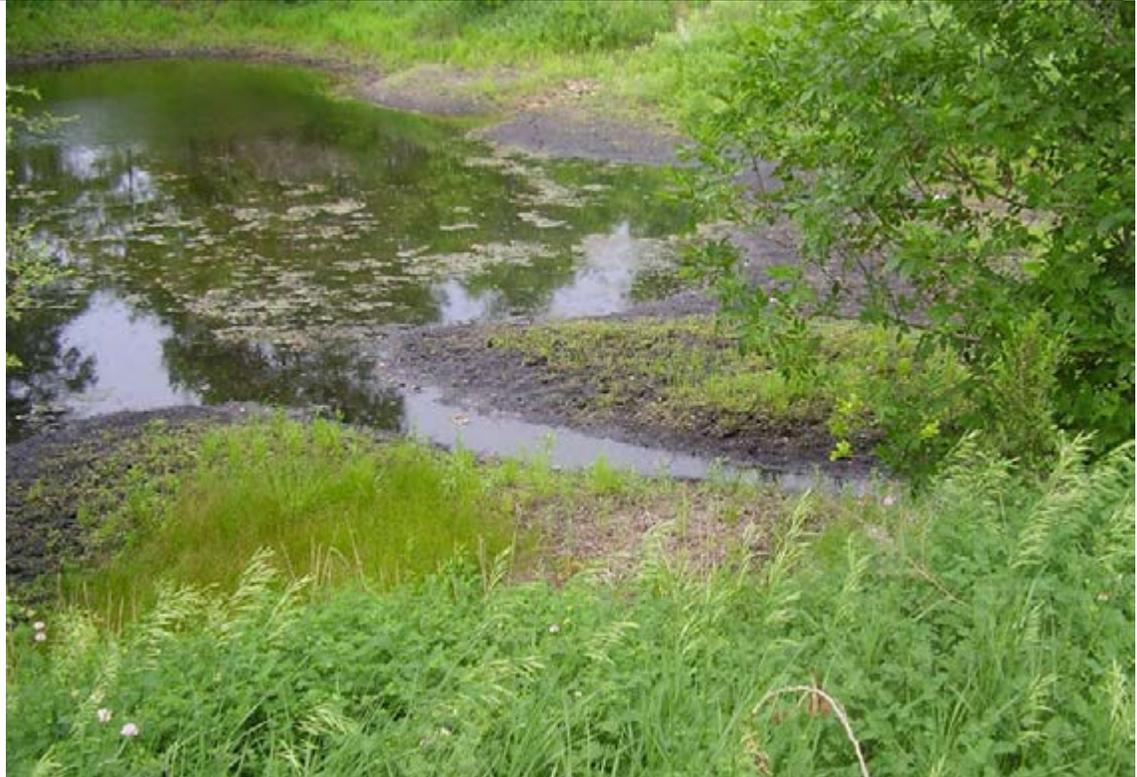
Description:
Upstream slope of the CARP where surface drainage enters.

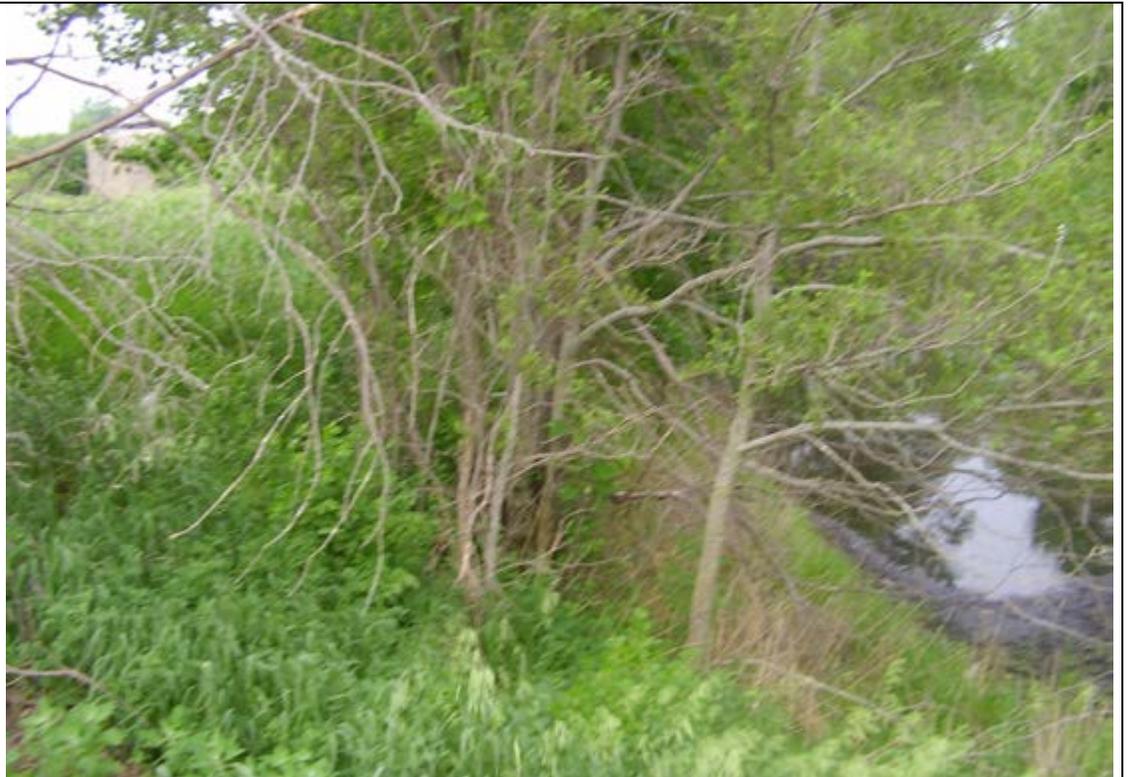
Photo No. 4	Date: 6/8/11
------------------------------	------------------------

Description:
Upstream slope and crest of the CARP.

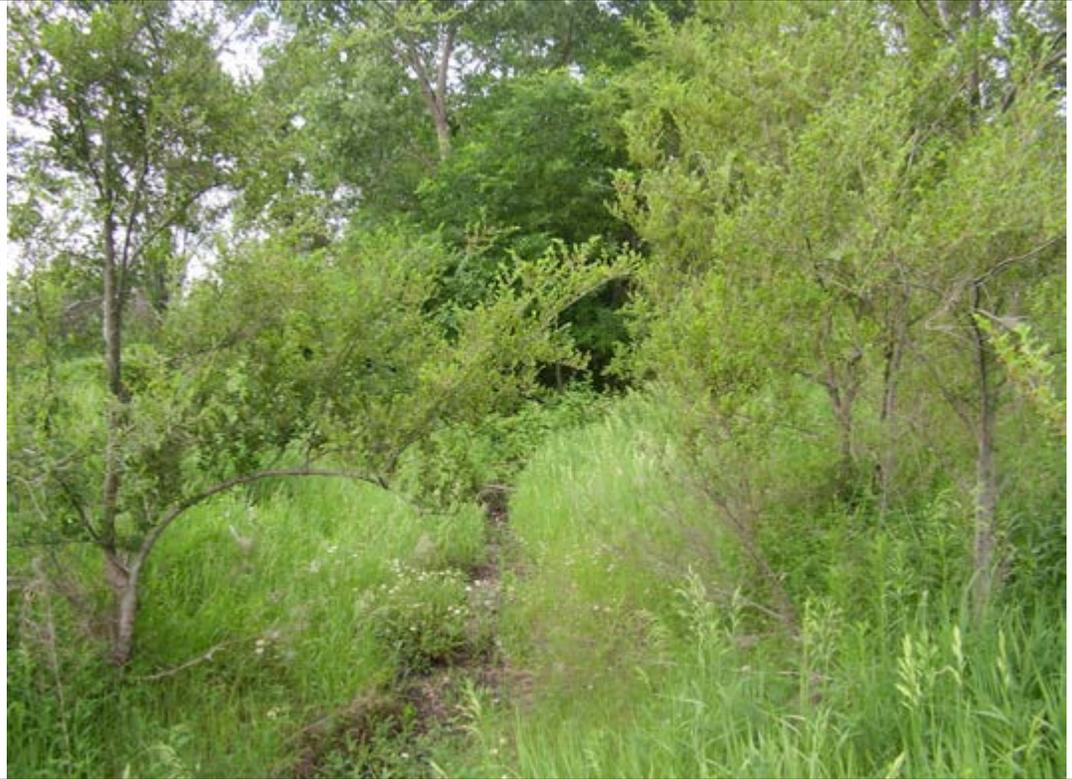
Description:
Crest of the CARP.

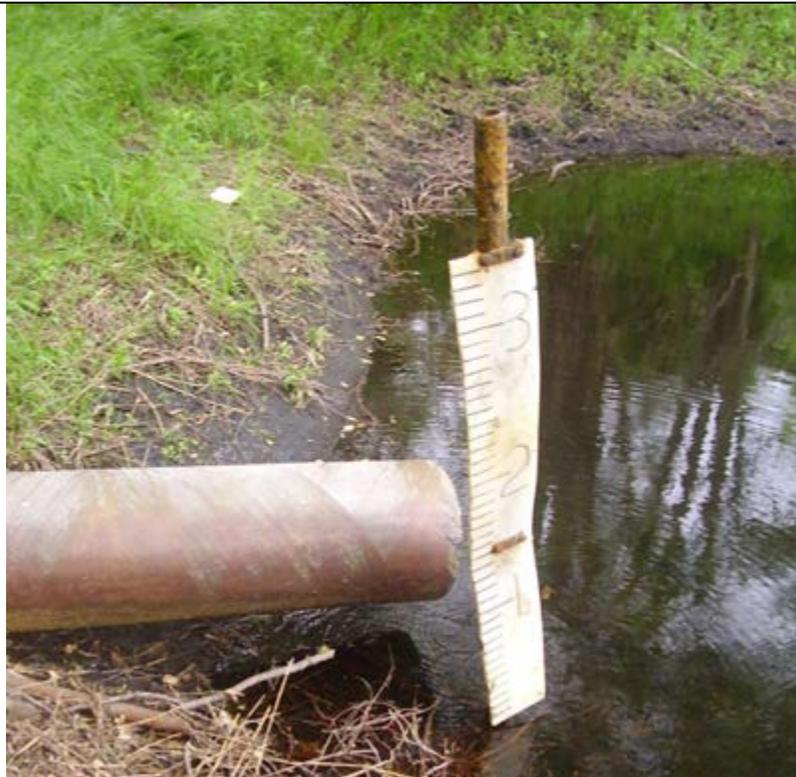
Photo No.
6

Description:
CARP decant structure pipe.

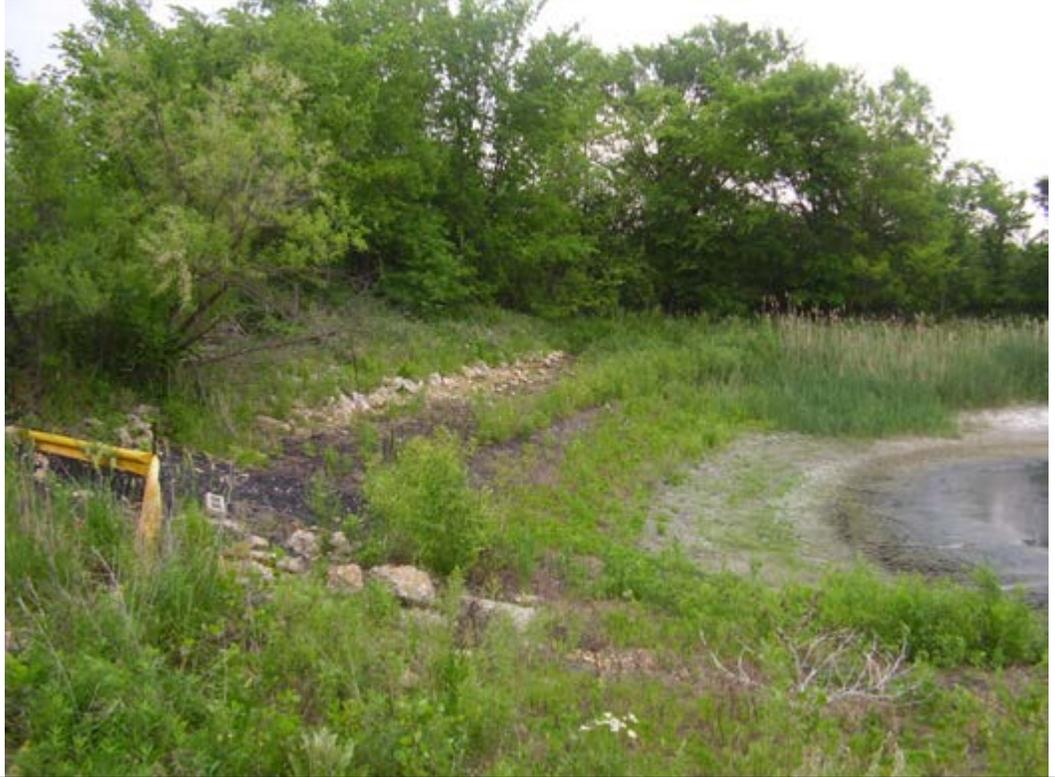
Description:
Upstream slope of the
WPDES Pond 1.

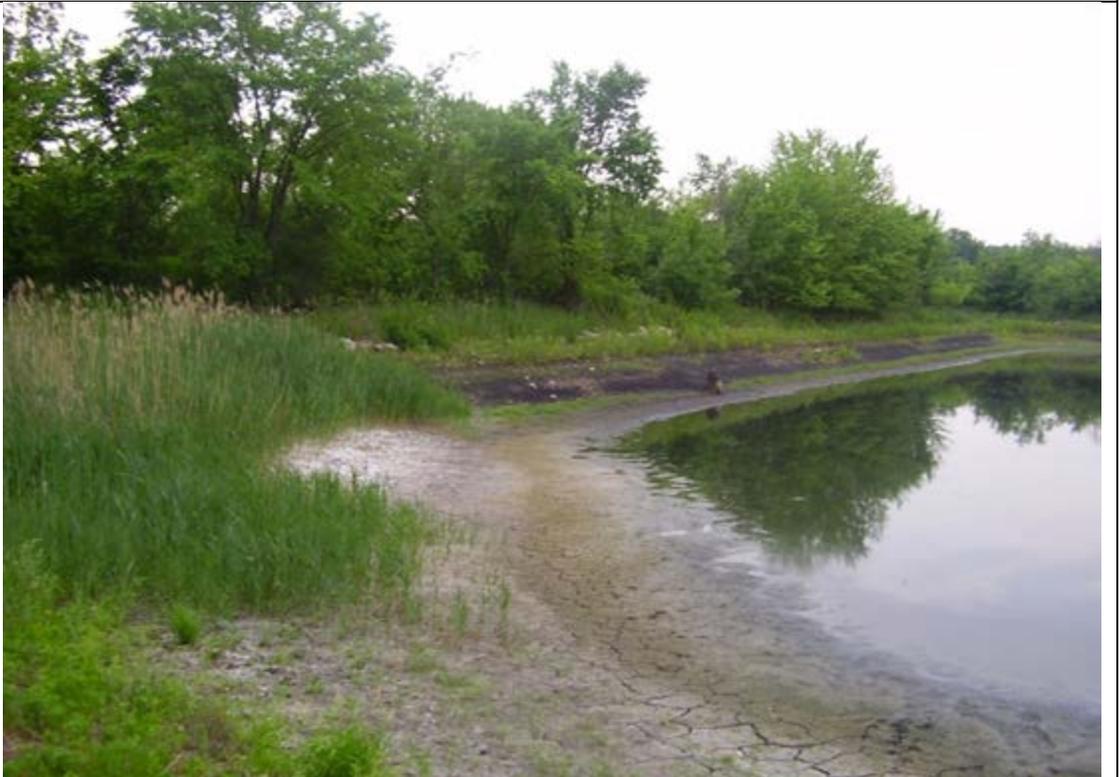
Photo No.
8

Description:
Upstream slope of the
WPDES Pond 1.

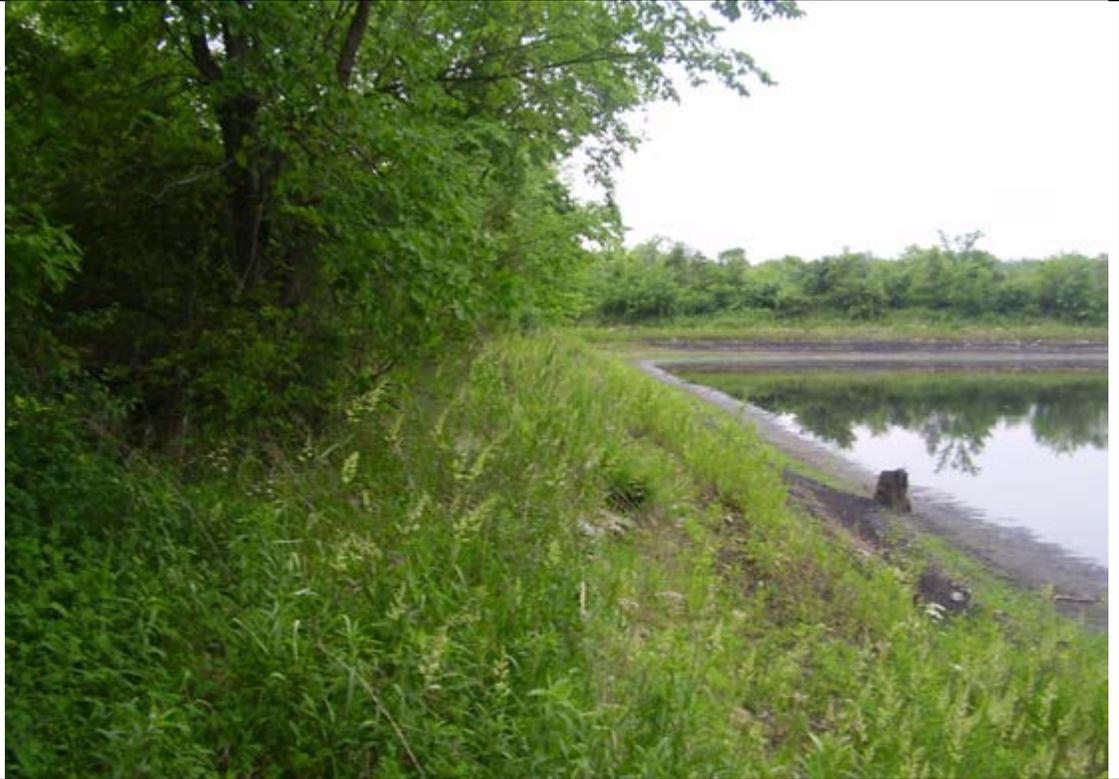
Description:
Upstream slope of the
WPDES Pond 1.

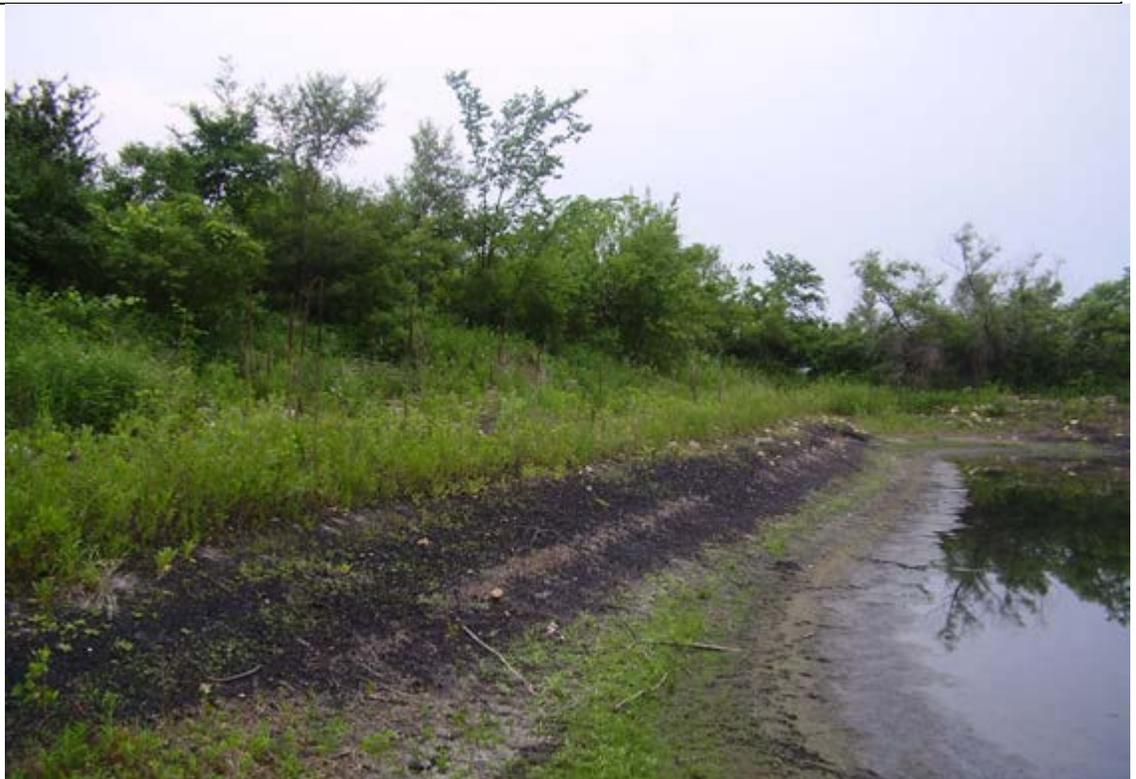
Photo No.
10

Description:
Upstream slope of the
WPDES Pond 1 with
discharge pipe in the
background.

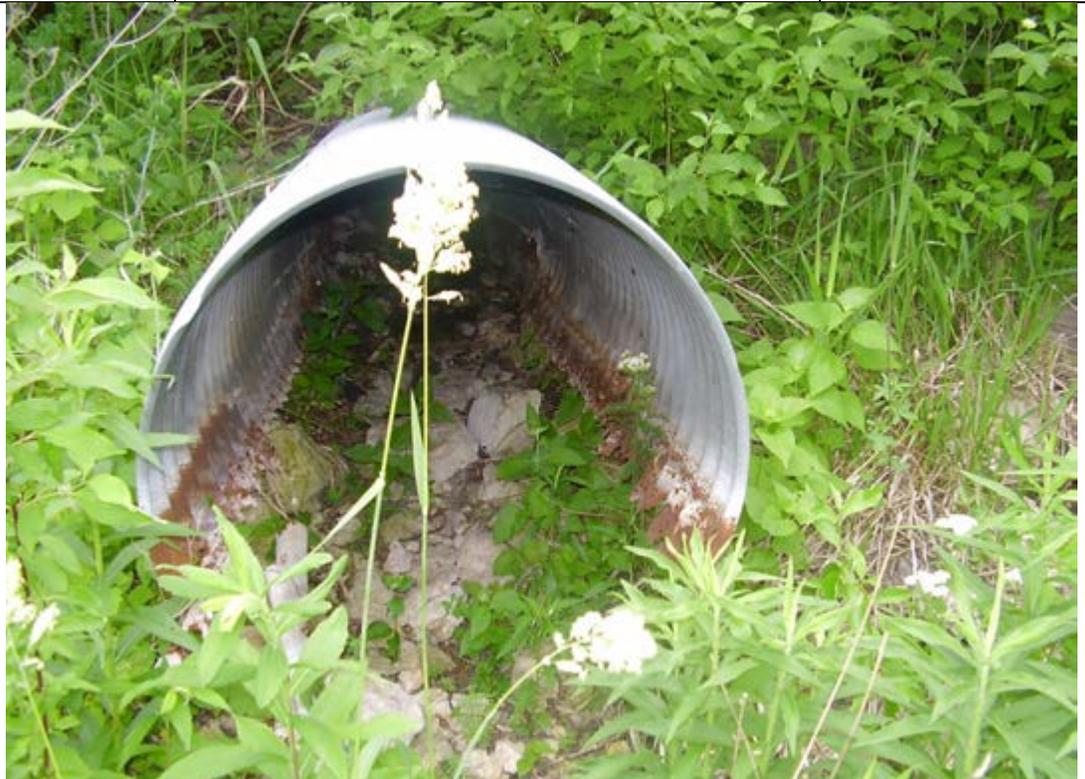
Description:
24-inch diameter CMP
discharge pipe at southwest
corner of the WPDES Pond
1.

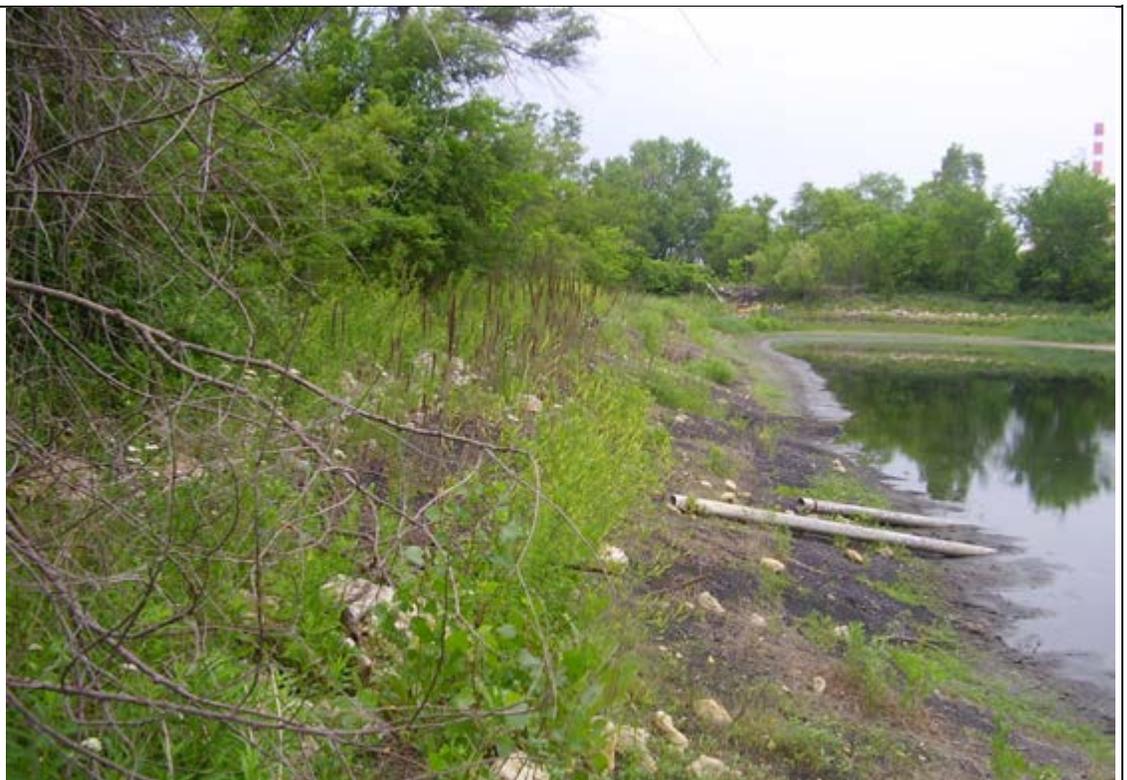
Photo No.
12

Description:
Upstream slope of the
WPDES Pond 1.

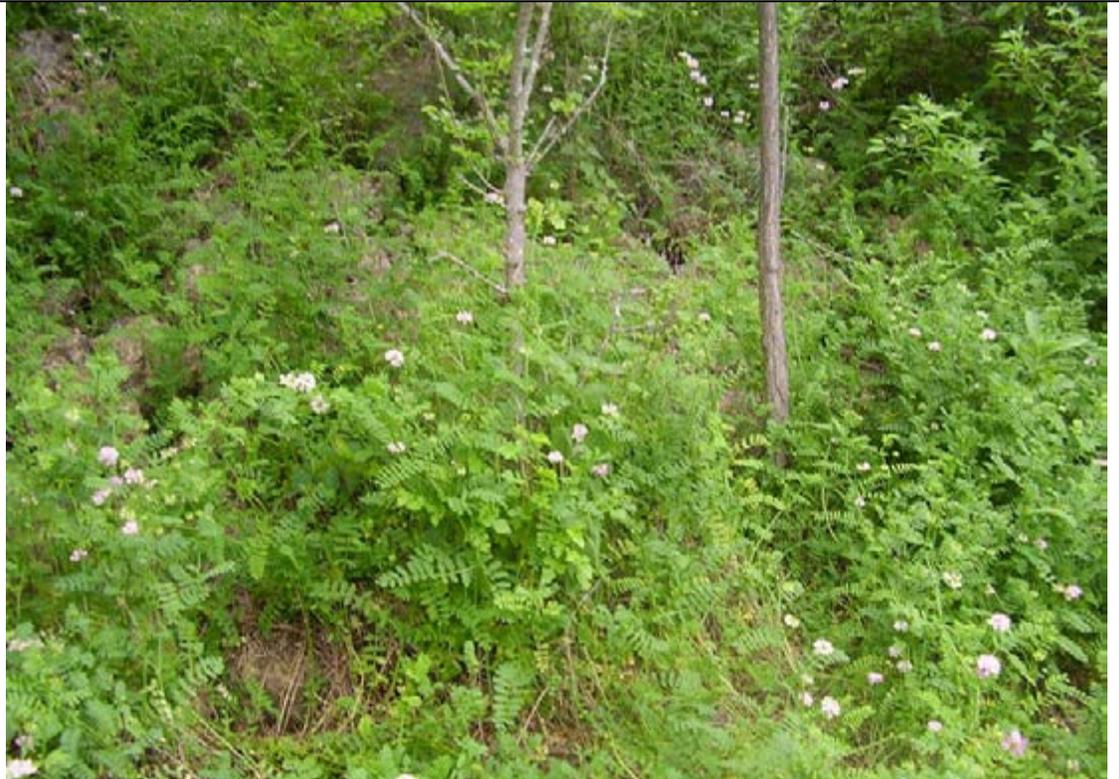
Upstream slope of the
WPDES Pond 1 showing the
riprap that is present above
the normal operating level.

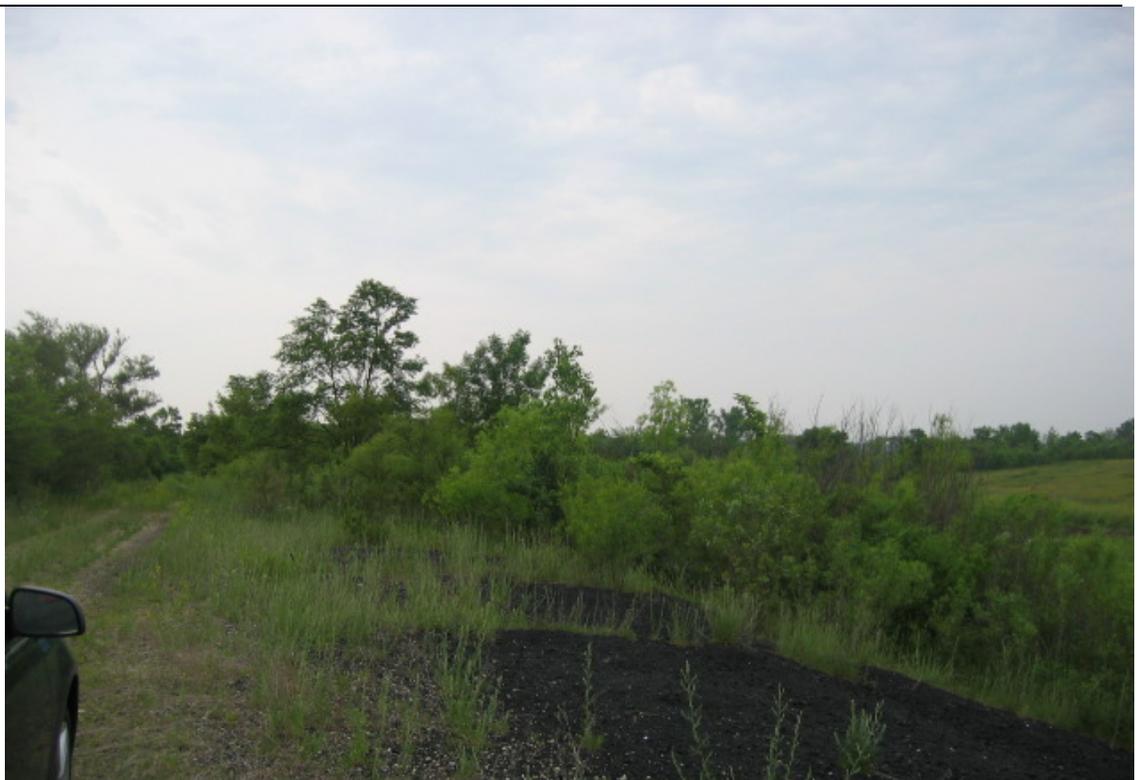
Photo No.
14

Crest of the WPDES Pond 1.

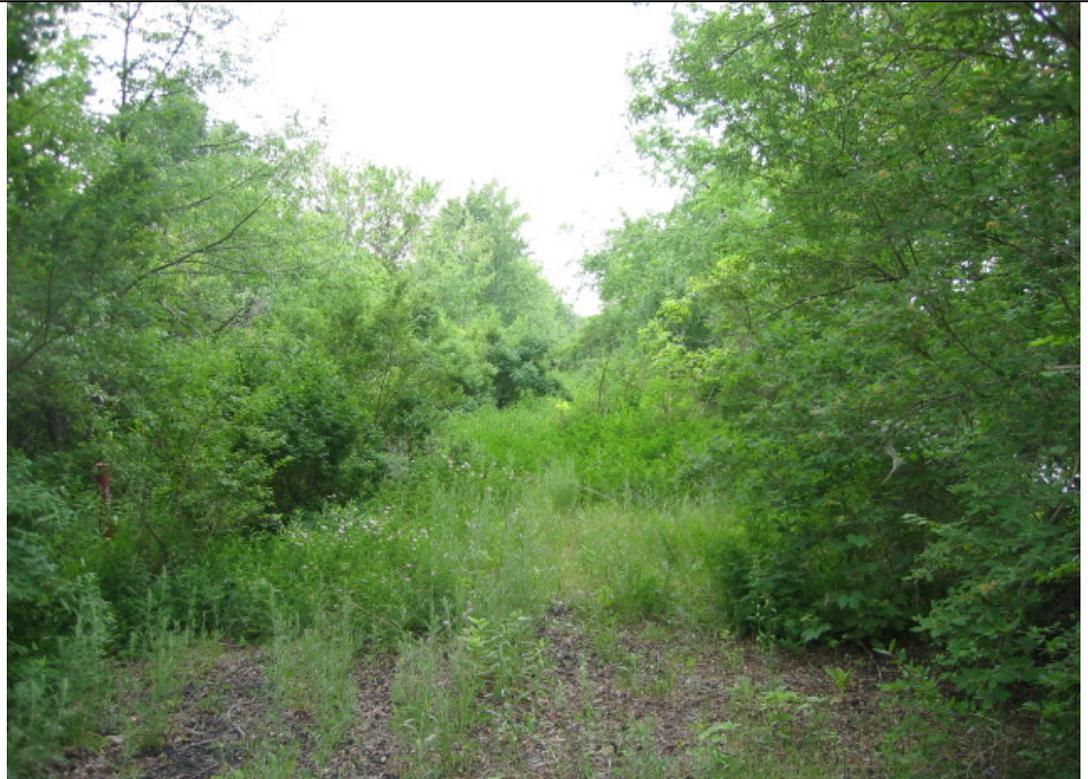
Description:
Crest of the WPDES Pond 1.

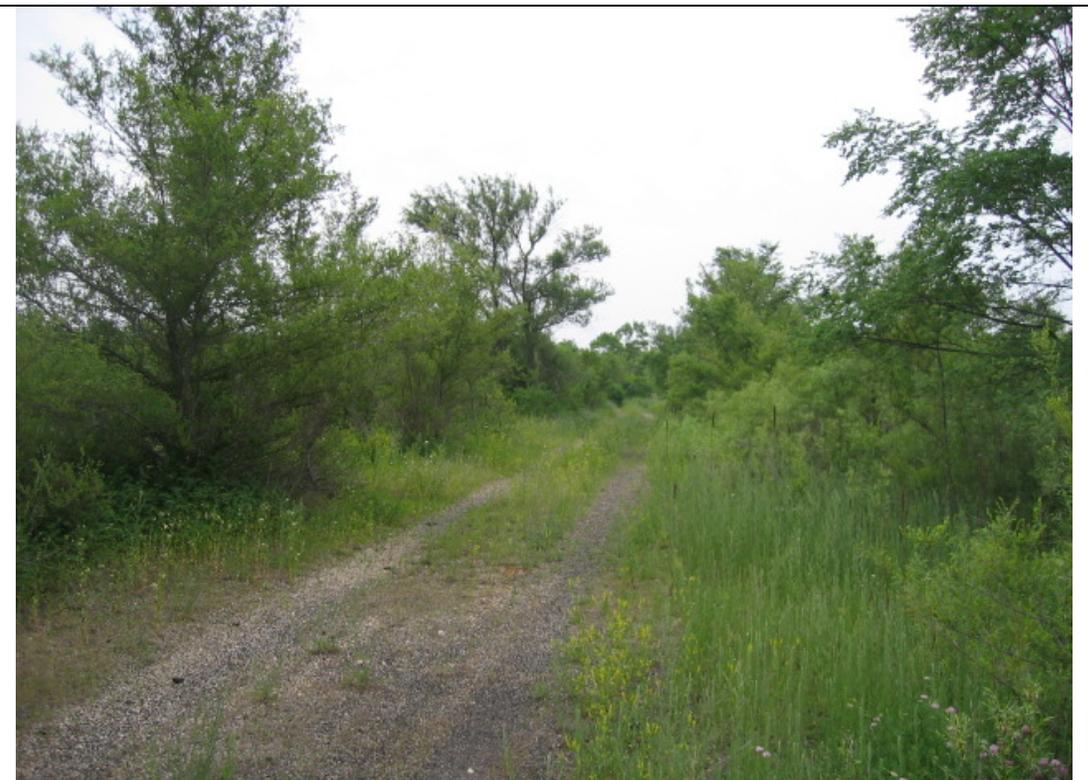
Photo No.
16

Description:
Upstream slope and crest of
the WPDES Pond 1.

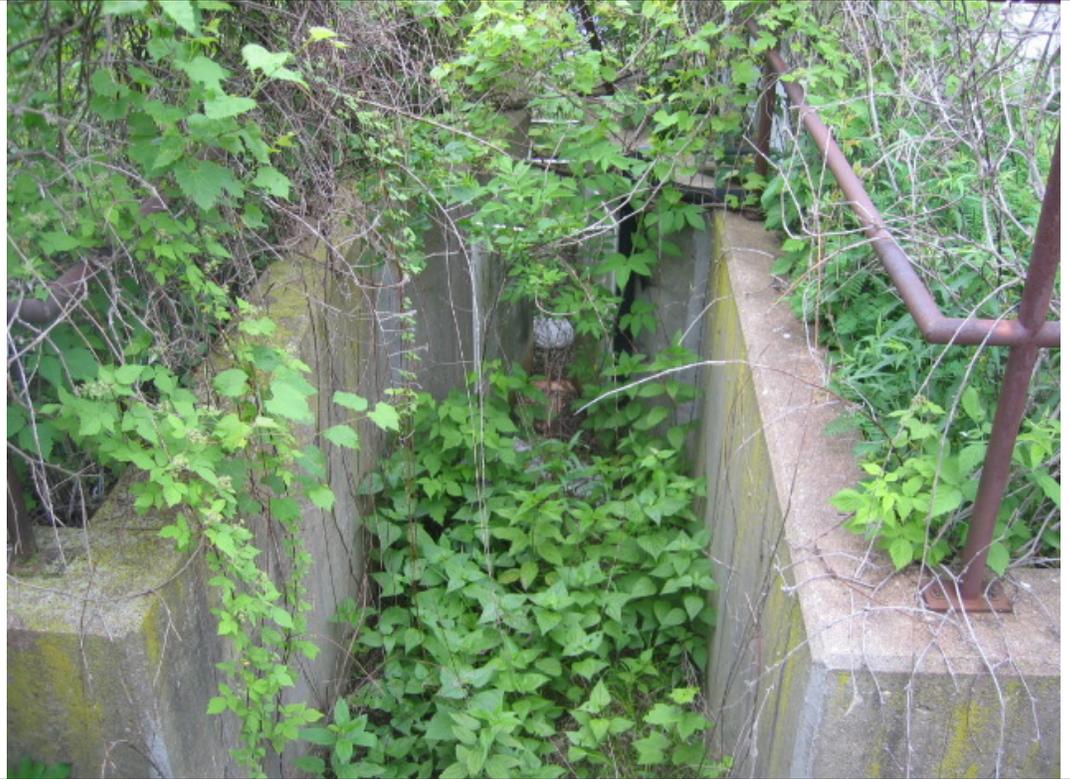
Weir structure of outfall
from WPDES Pond 1 and
WPDES Pond 2.

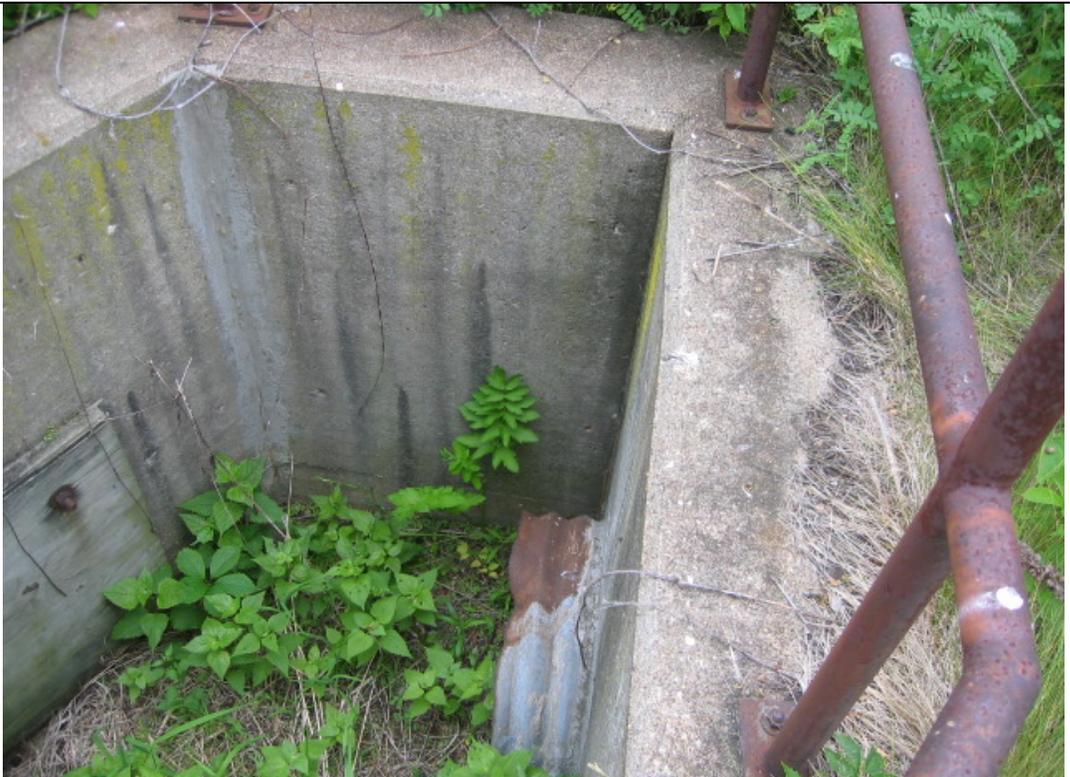
Photo No.
18

Outfall of WPDES Pond 1.

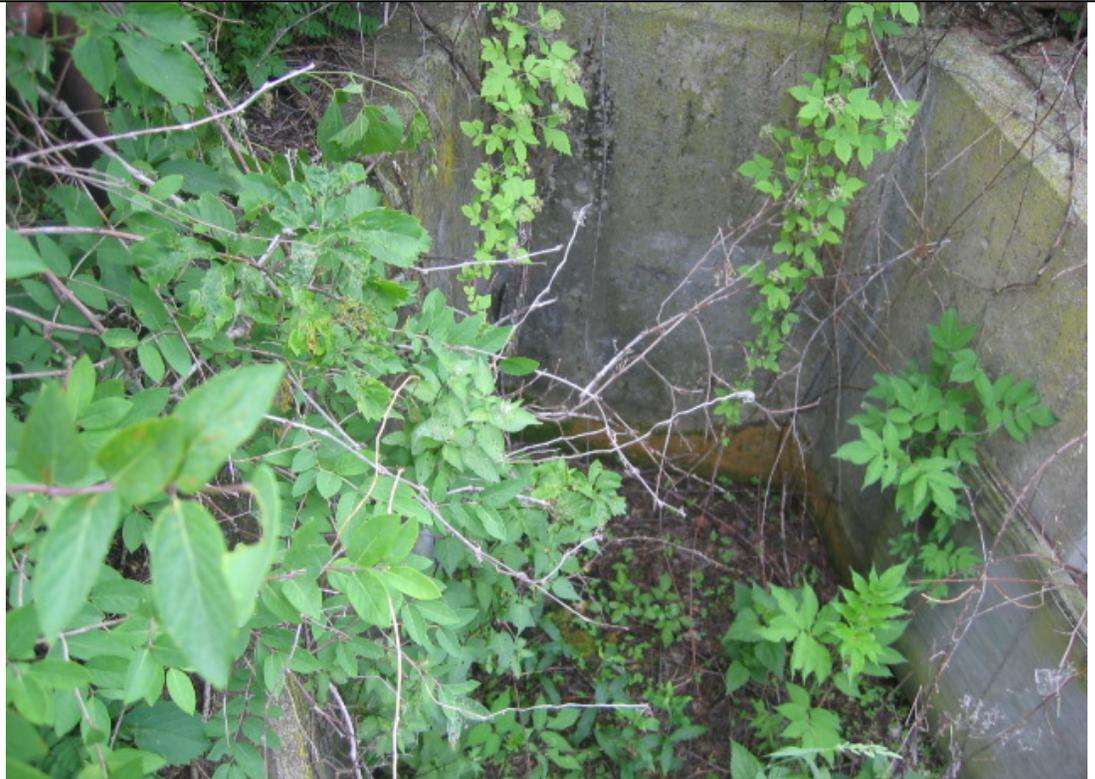
Description:
Outfall structure of WPDES Pond 2.

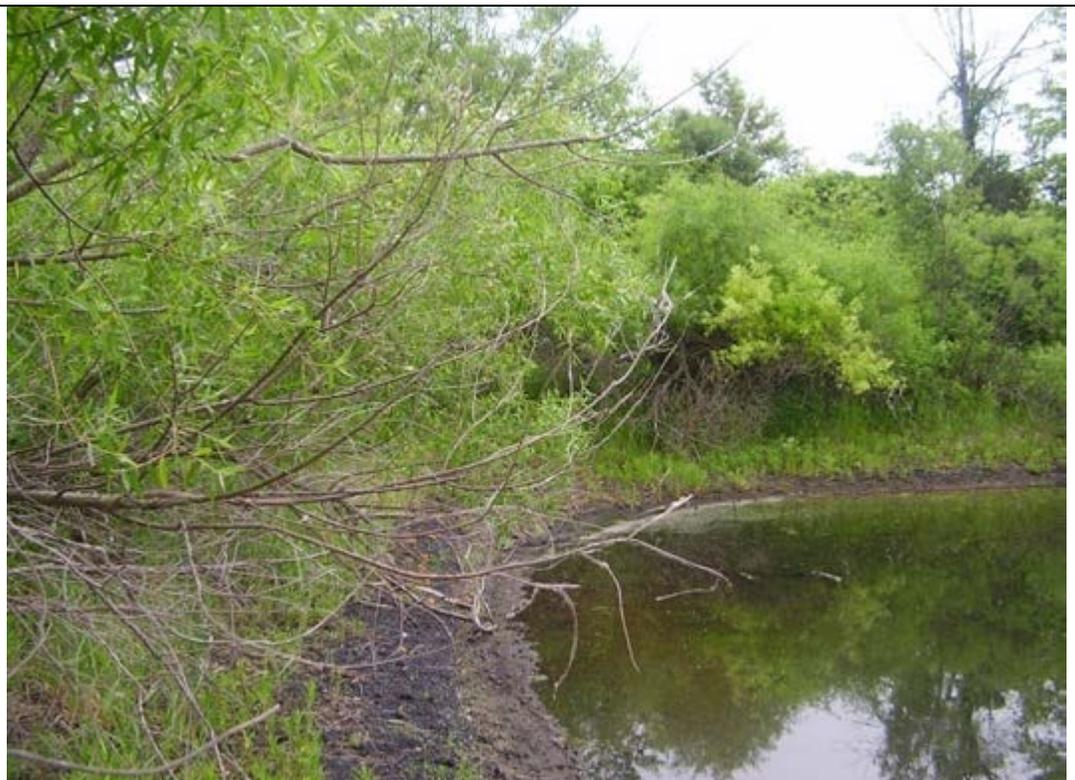
Photo No.
20

Description:
Upstream slope of the
WPDES Pond 2.

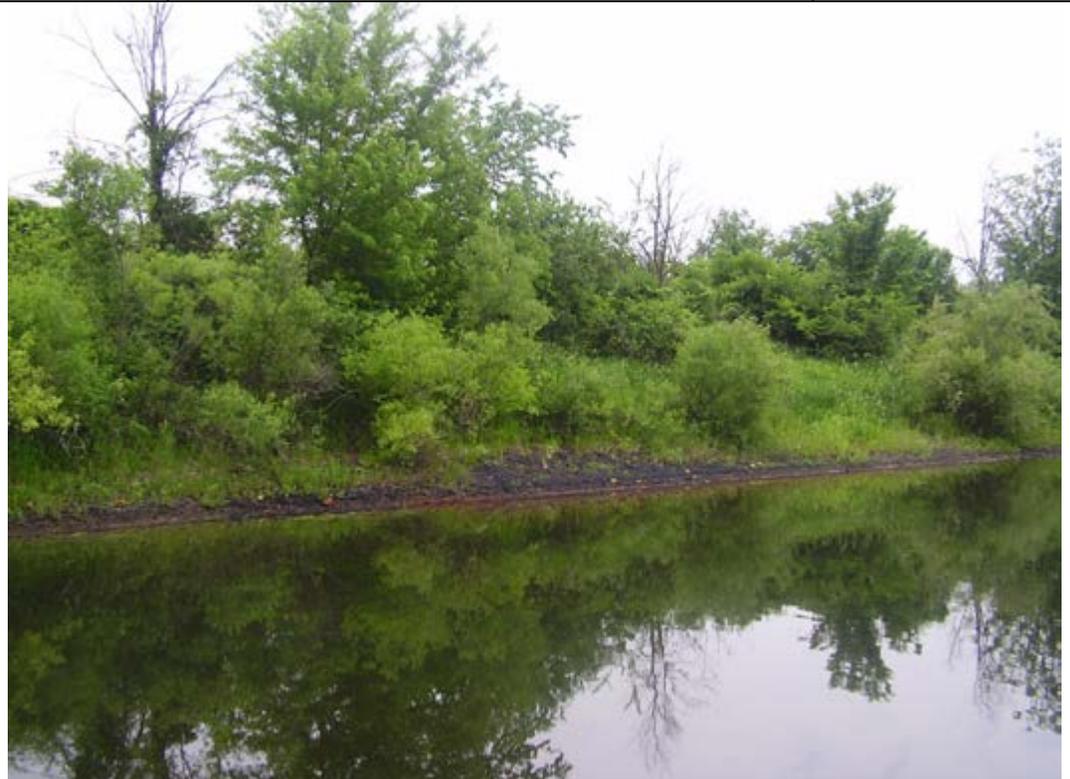
Description:
Upstream slope of the
WPDES Pond 2.

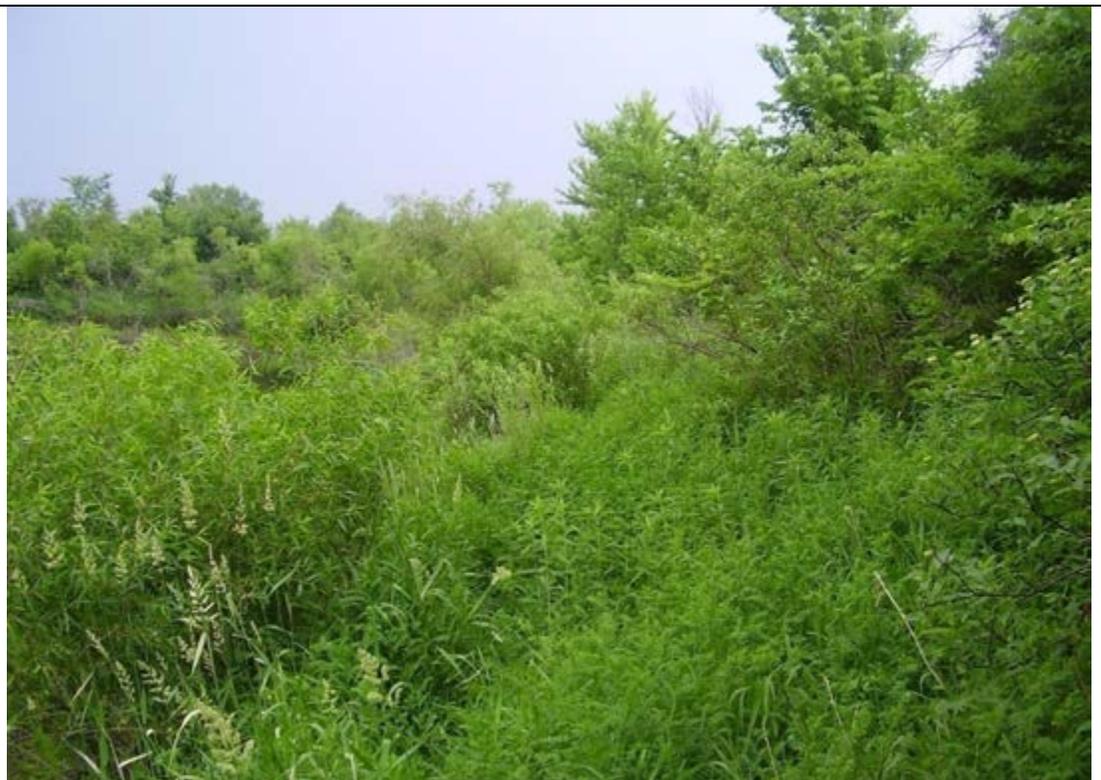
Photo No.
22

Description:
Upstream slope of the
WPDES Pond 2

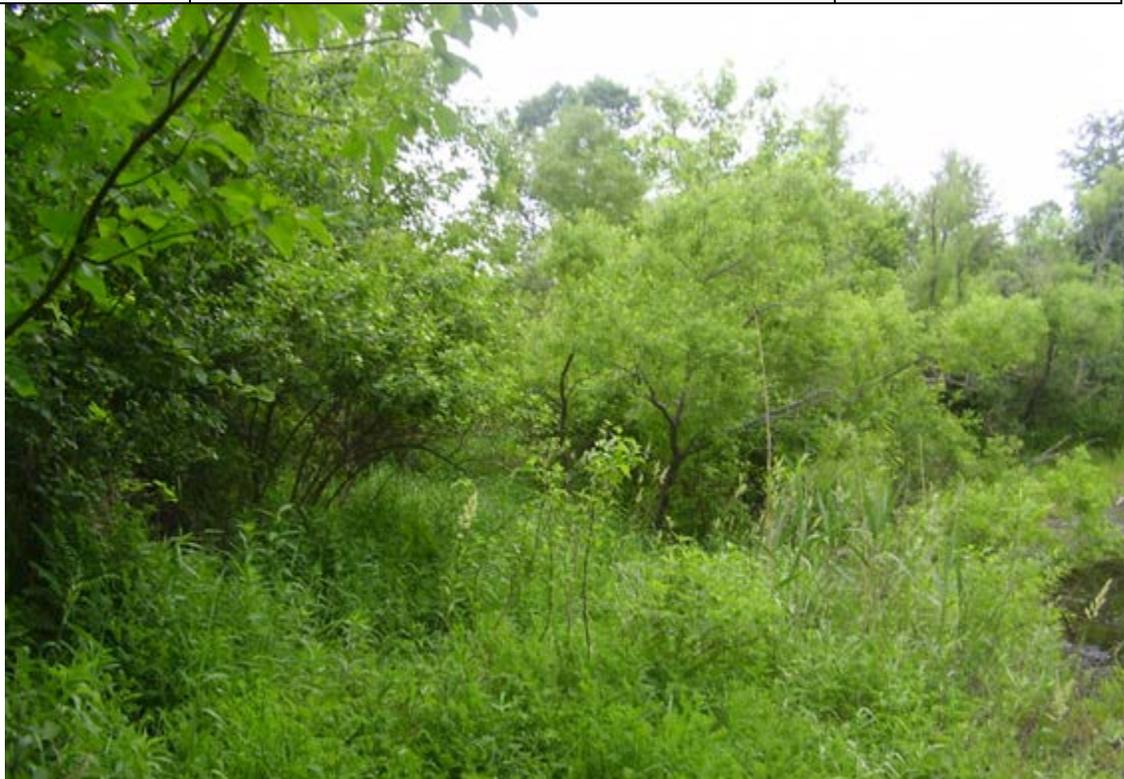
Description:
Upstream slope of the
WPDES Pond 2

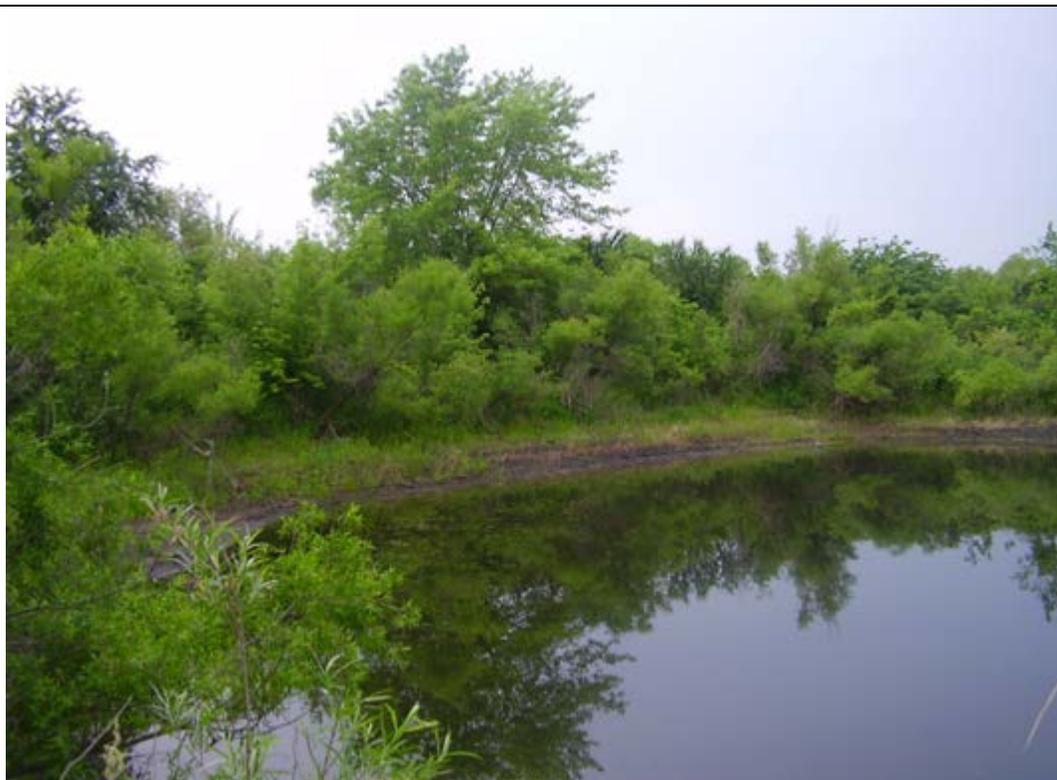
Photo No.
24

Description:
Upstream slope of the
WPDES Pond 2.

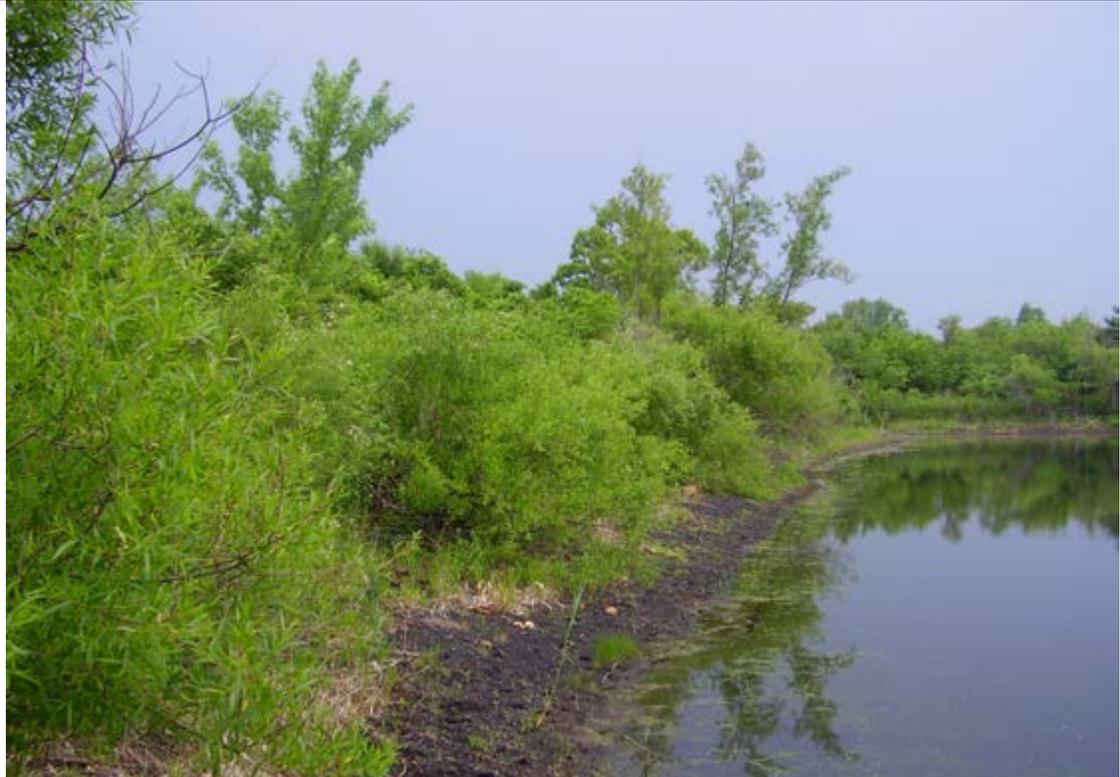
Description:
Upstream slope of the
WPDES Pond 2.

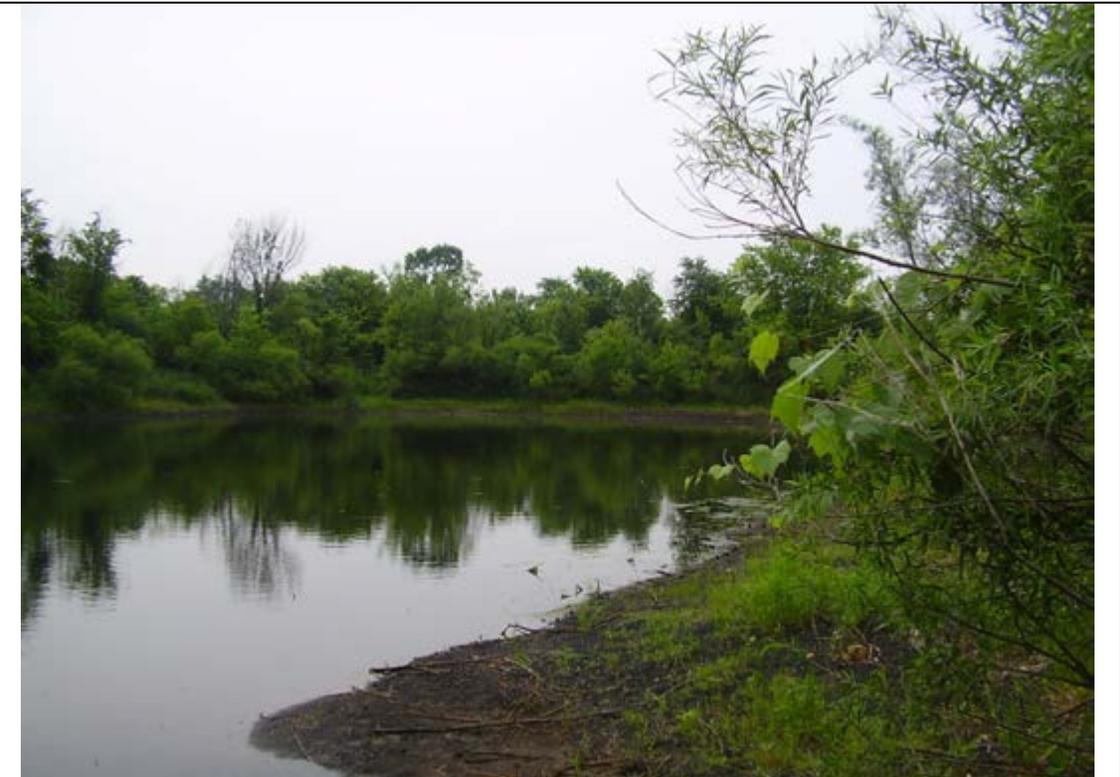
Photo No. 26	Date: 6/8/11
------------------------	------------------------

Description:
Upstream slope of the
WPDES Pond 2.
