**FINAL REPORT
ROUND 10 DAM ASSESSMENT
WISCONSIN POWER AND LIGHT COMPANY - ROCK RIVER
GENERATING STATION
WPDES POND 1, WPDES POND 2, SLAG POND, FINAL WPDES POND
BELOIT, WISCONSIN**

January 31, 2013
GZA File No. 170142.30

RE: Assessment of Dam Safety of Coal Combustion Surface Impoundments at the Rock
River Generating Station

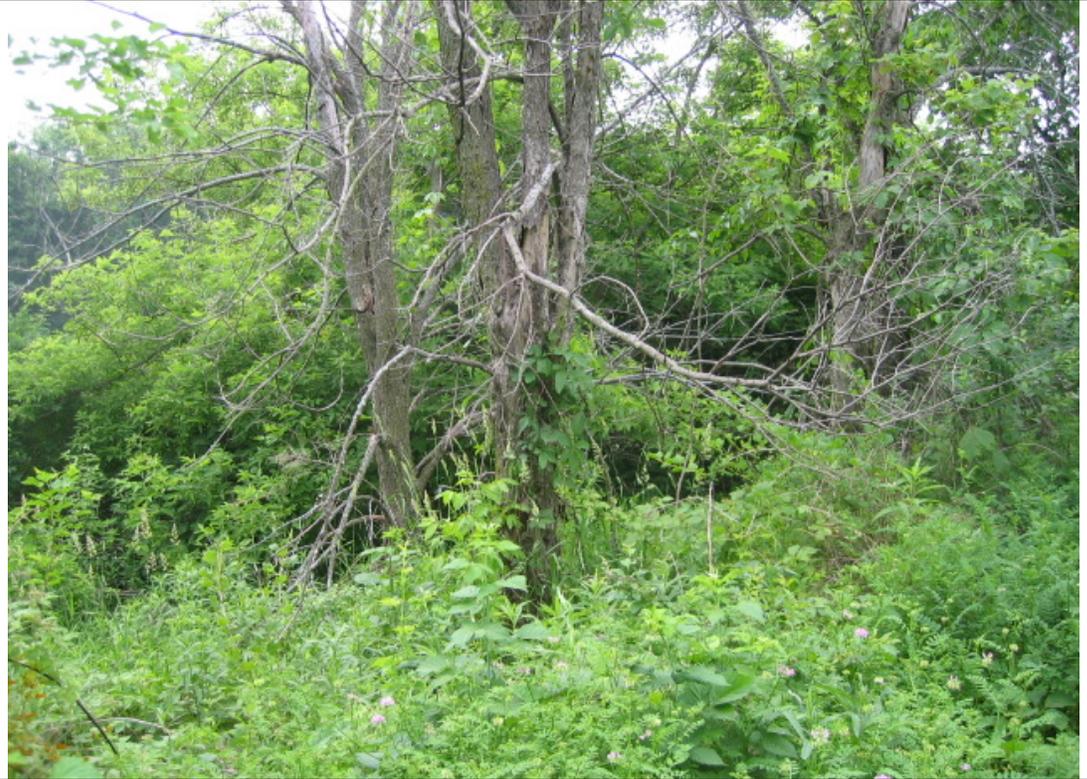
Description:
Crest and downstream slope
of the WPDES Pond 2.

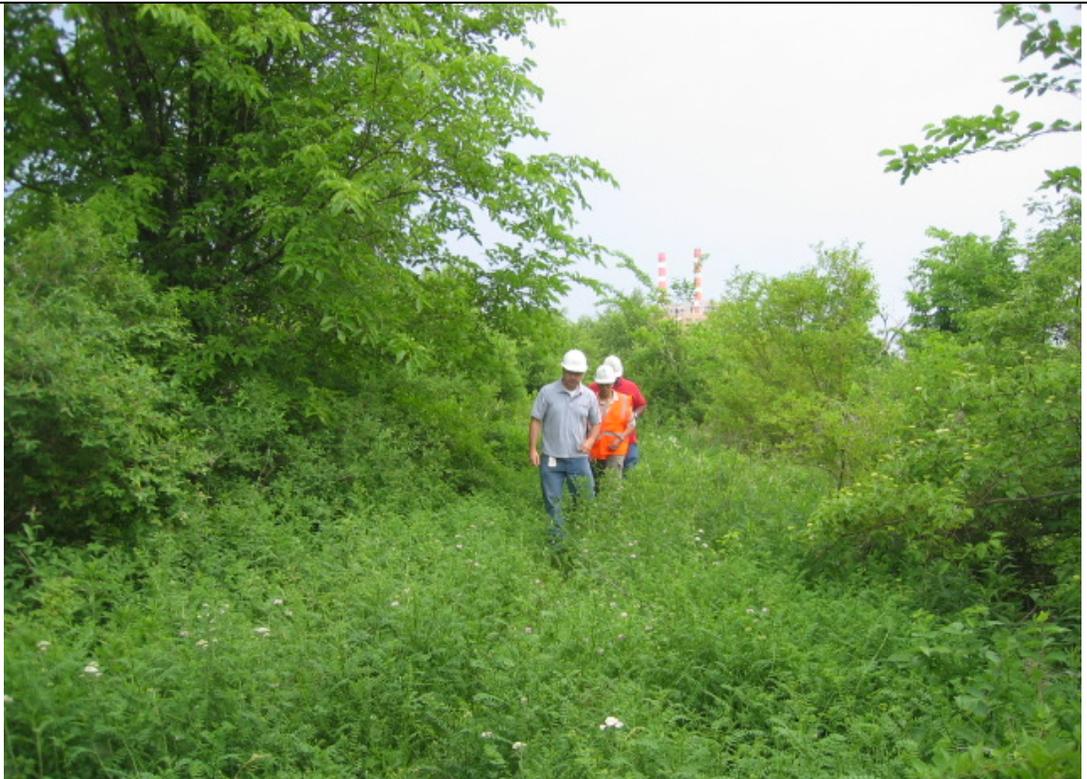
Photo No.
28

Description:
Crest of the WPDES Pond 2.

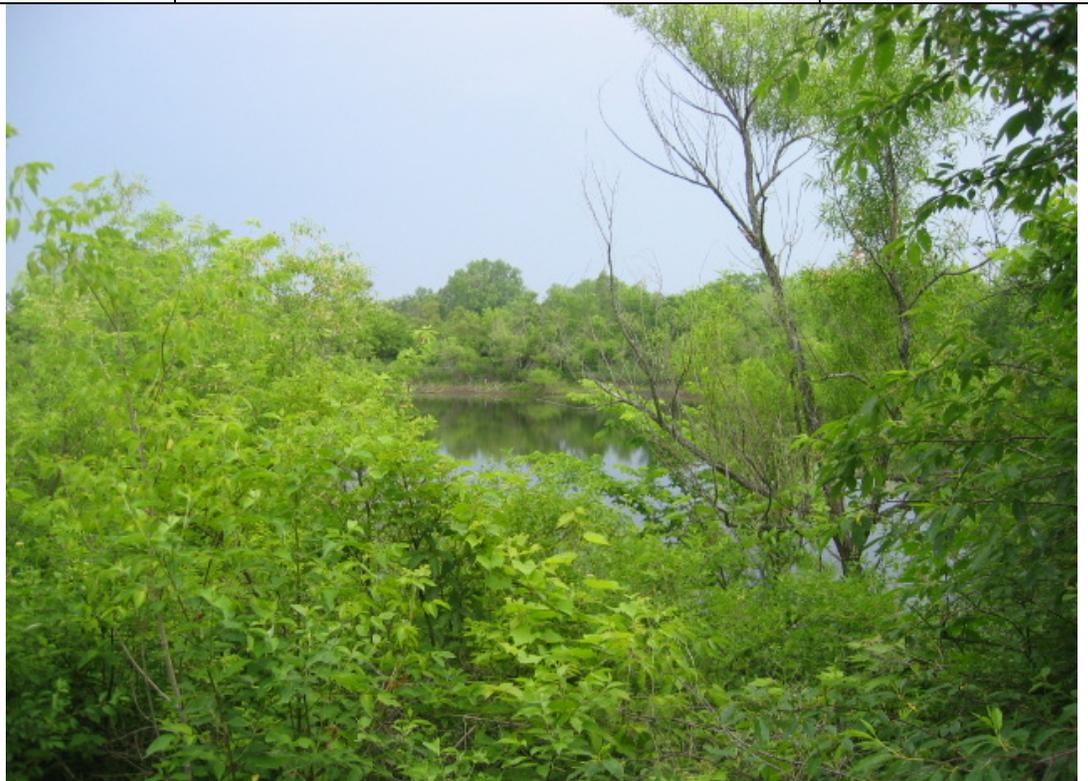
Description:
Crest and downstream slope of the WPDES Pond 2.

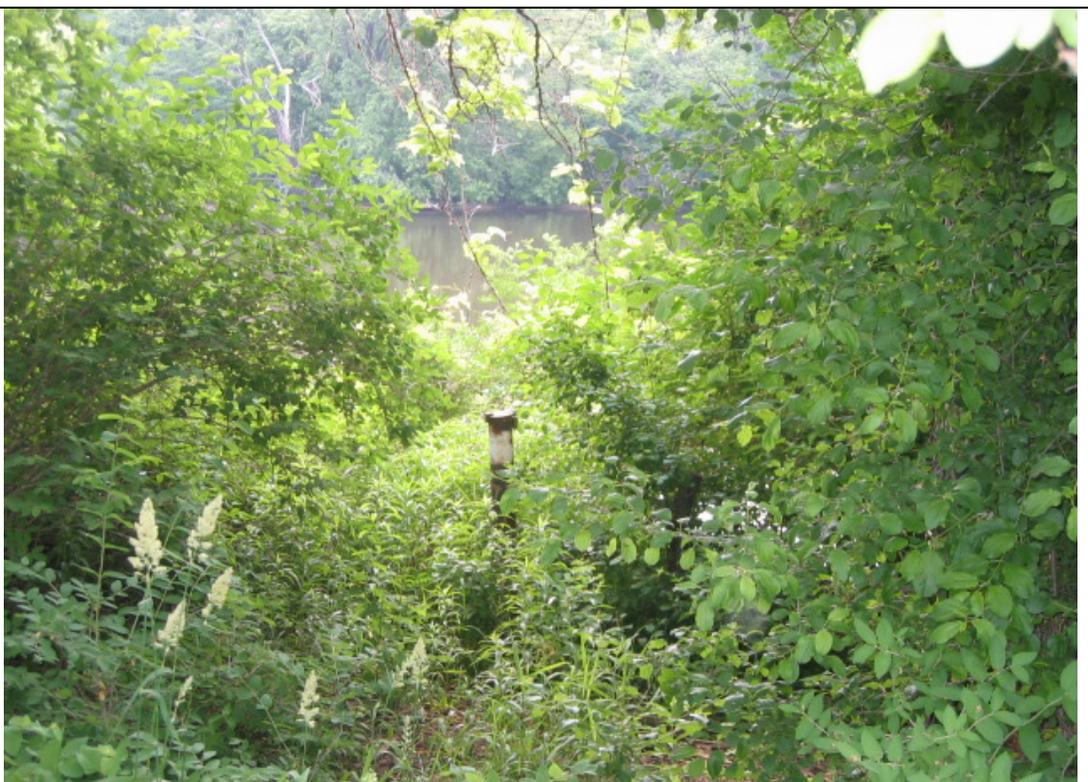
Photo No. 30	Date: 6/8/11
Direction Photo Taken: South

Description:
Downstream slope of the Final WPDES Pond and monitoring well.

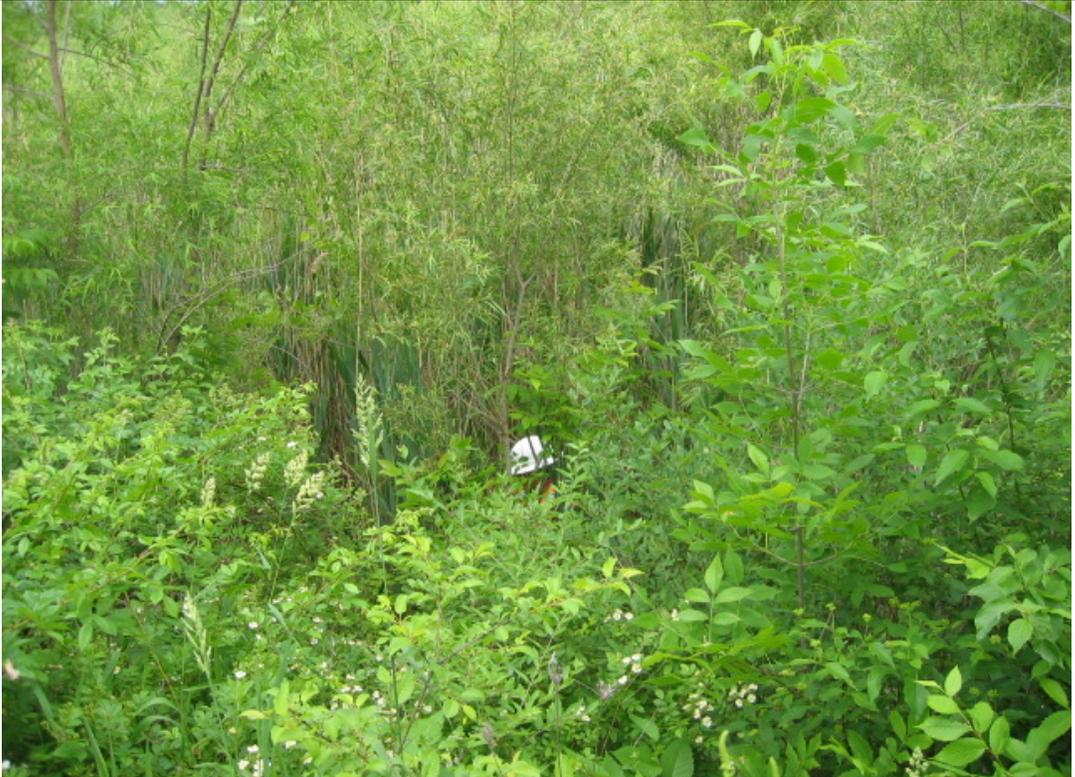
Description:
Upstream slope of the Final WPDES Pond.

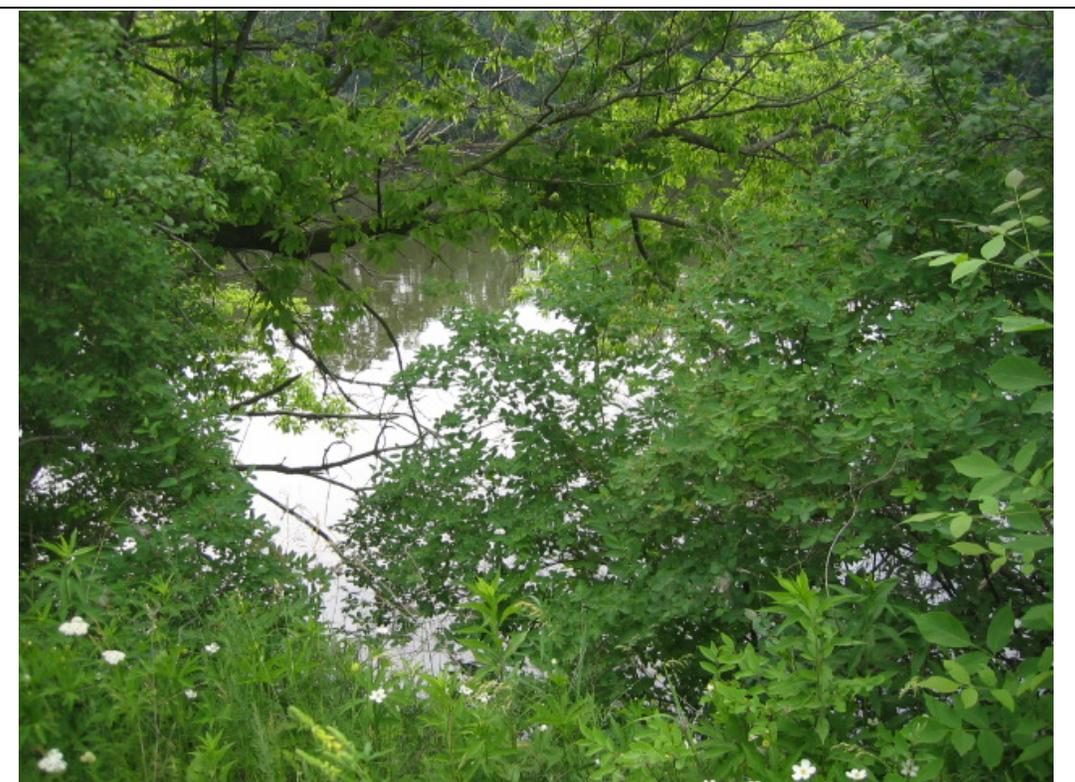
Photo No. 32	Date: 6/8/11
Direction Photo Taken: South

Description:
Looking downstream of the Final WPDES Pond at the water level in the adjacent Rock River.

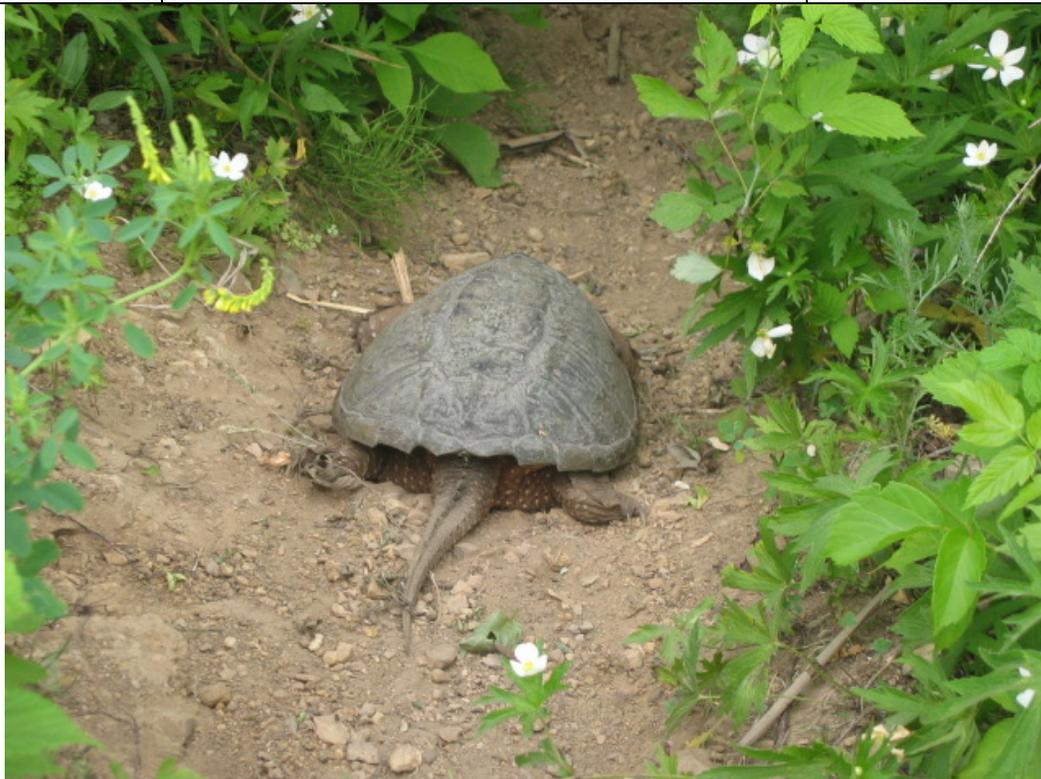
Turtle crossing upstream
slope of the Final WPDES
Pond.

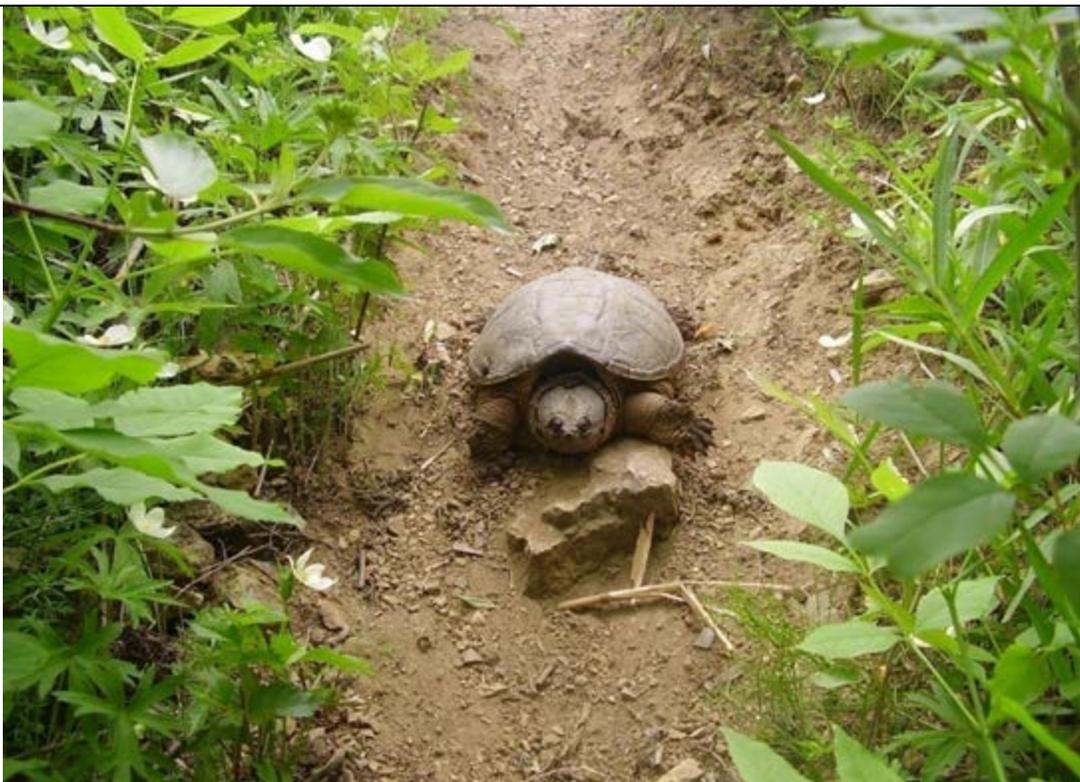
Photo No.
34

Turtle crossing upstream
slope of the Final WPDES
Pond.

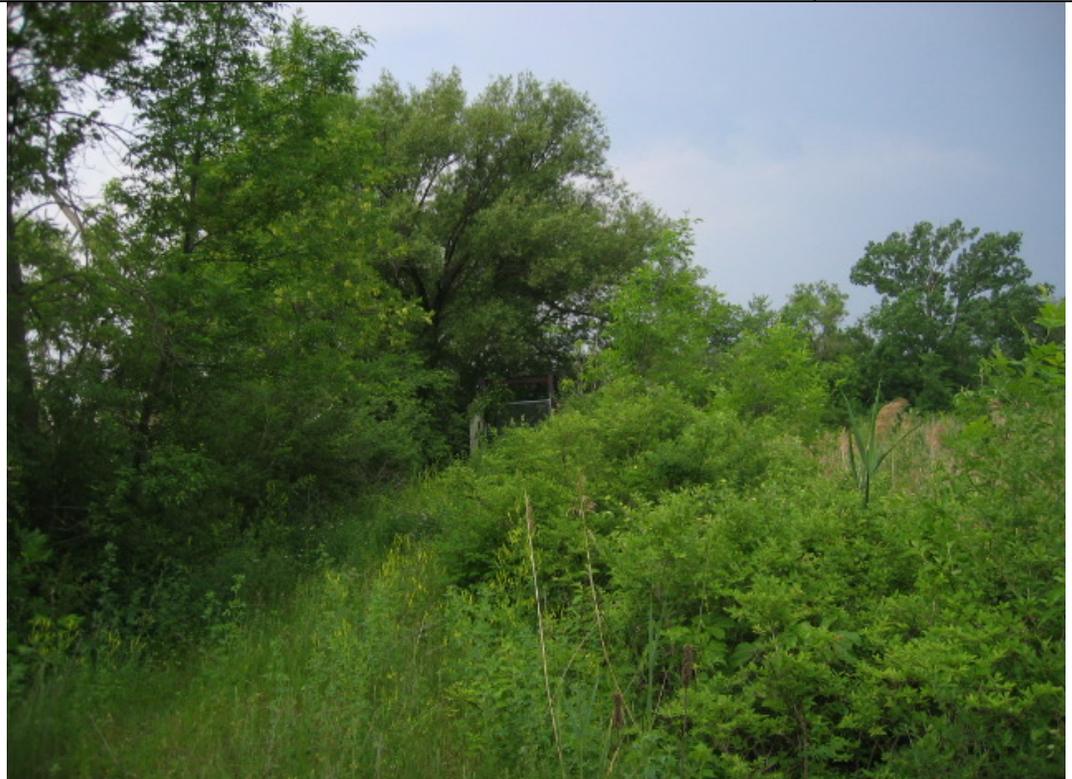
Upstream slope and crest of
the Final WPDES Pond.

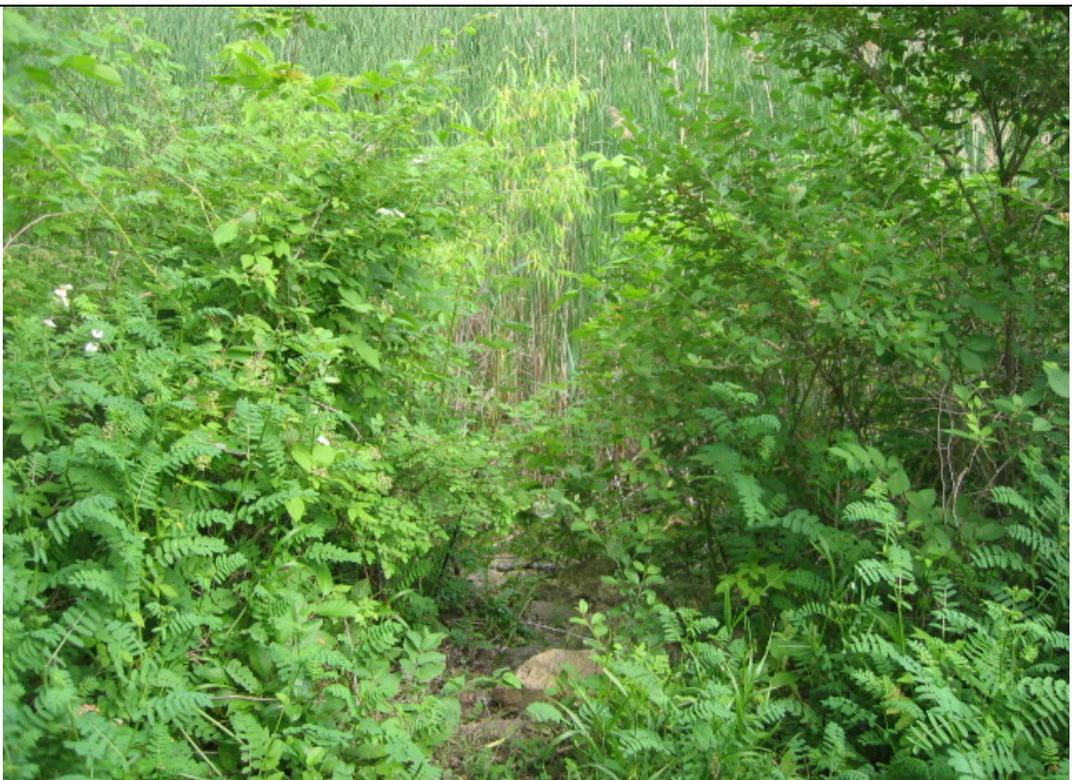
Photo No.
36

Upstream slope of the Final
WPDES Pond.

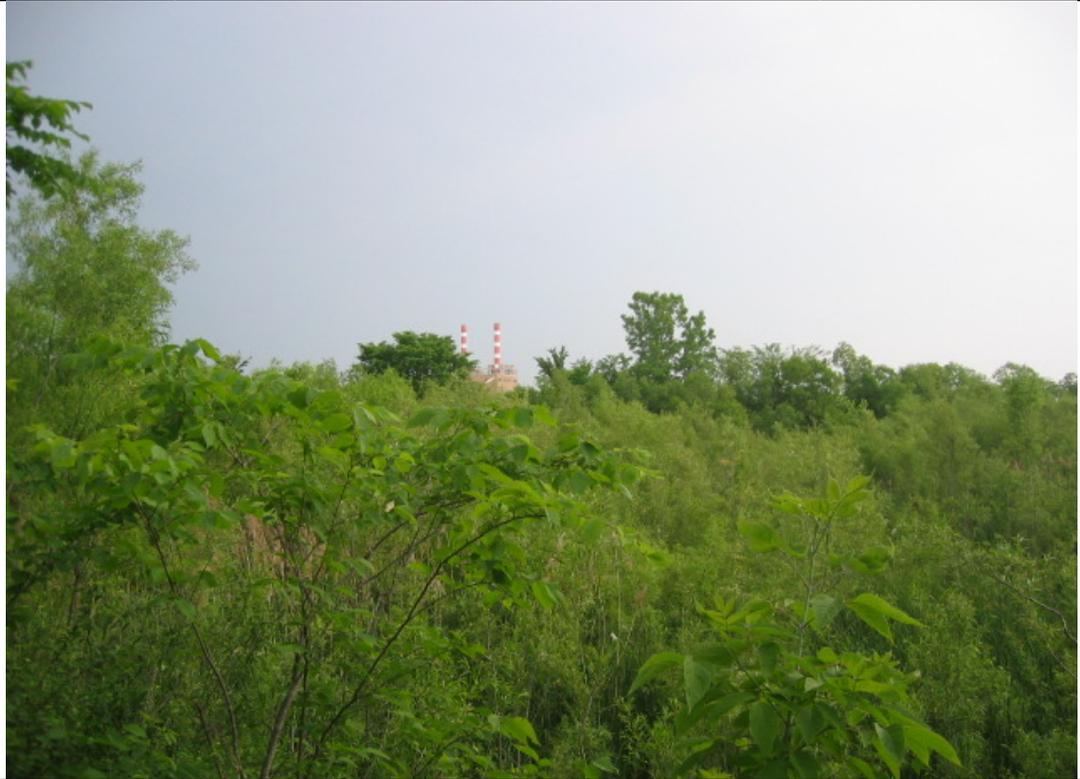
Description:
Upstream slope of the Final WPDES Pond.

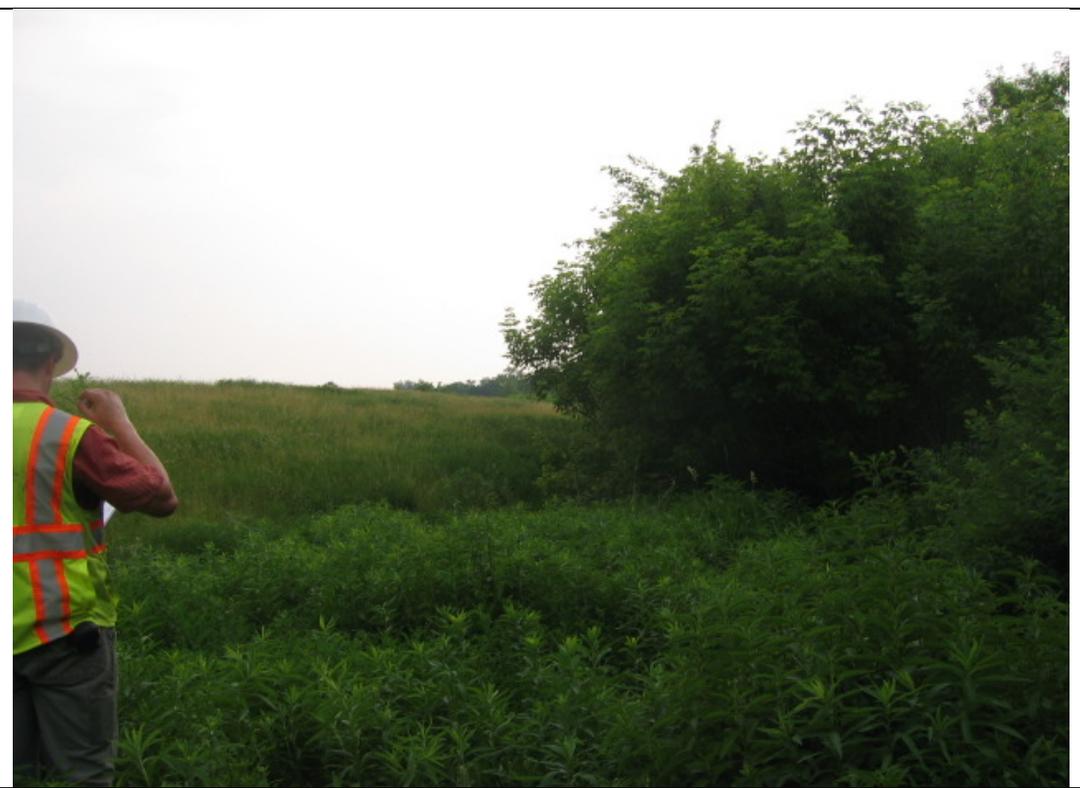
Photo No. 38	Date: 6/8/11
Direction Photo Taken: Southeast

Description:
Upstream slope and crest of the Final WPDES Pond.

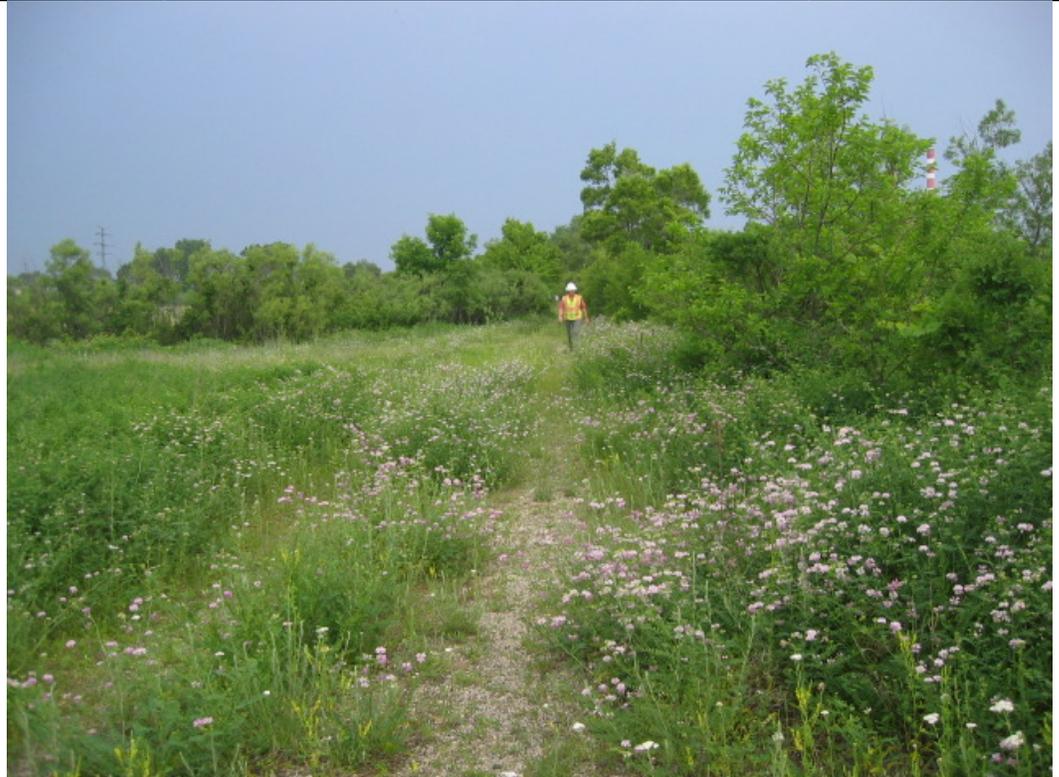
Description:
Crest of the Final WPDES
Pond and the WPDES Pond
2.

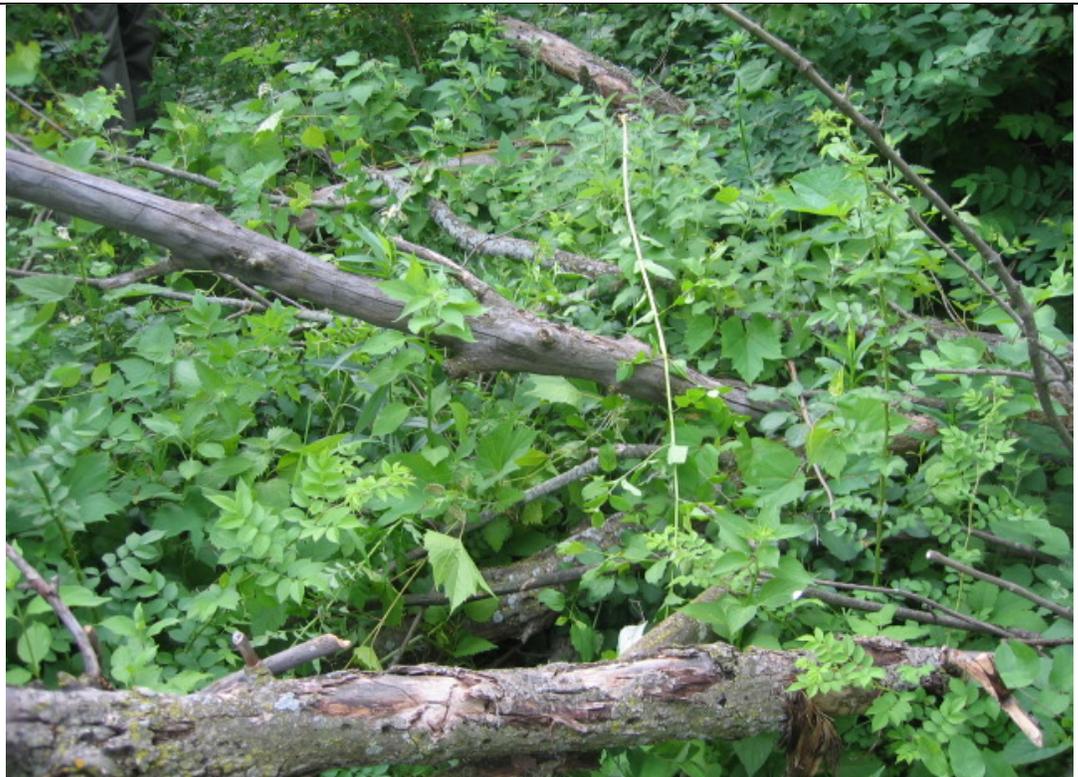
Photo No.
40

Description:
Crest of the Final WPDES
Pond.

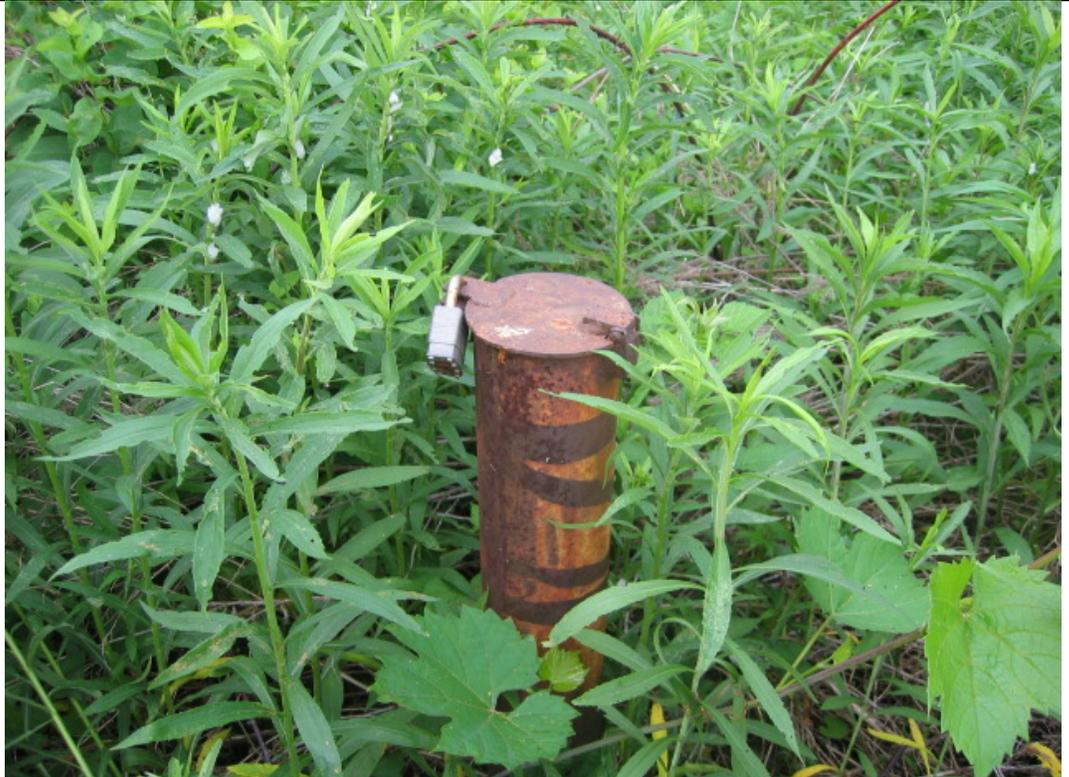
Description:
Monitoring well along the crest of the Final WPDES Pond.

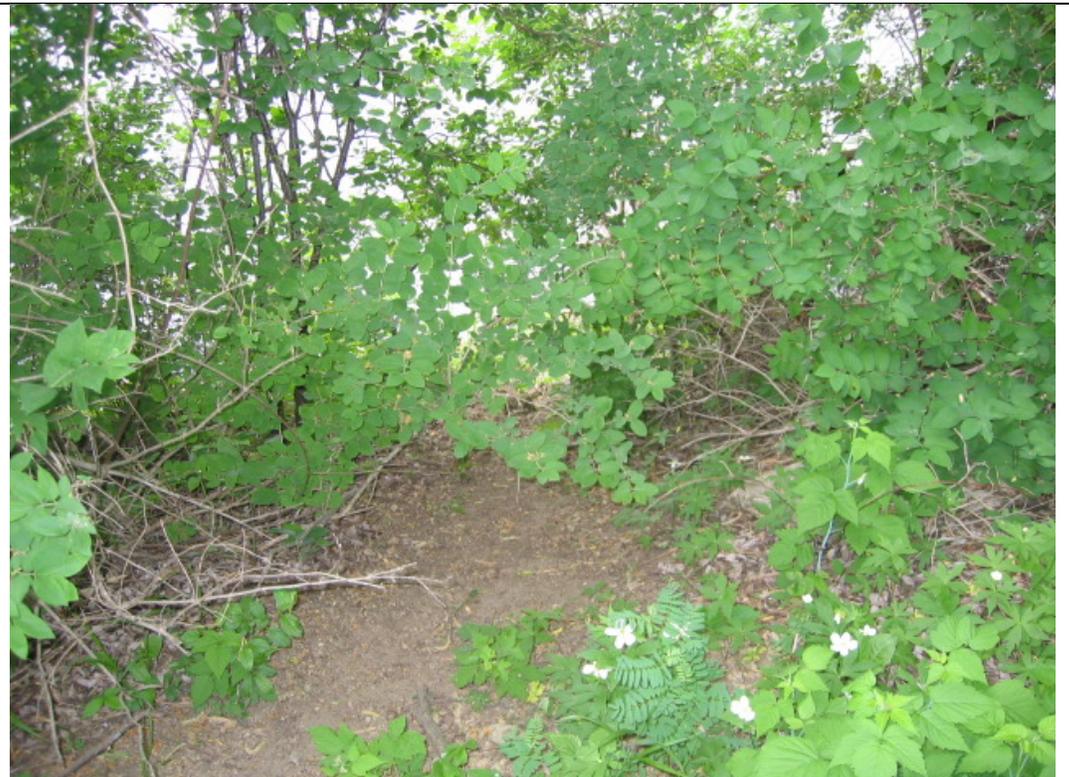
Photo No. 42	Date: 6/8/11
Direction Photo Taken: South

Description:
Downstream slope of the Final WPDES Pond.

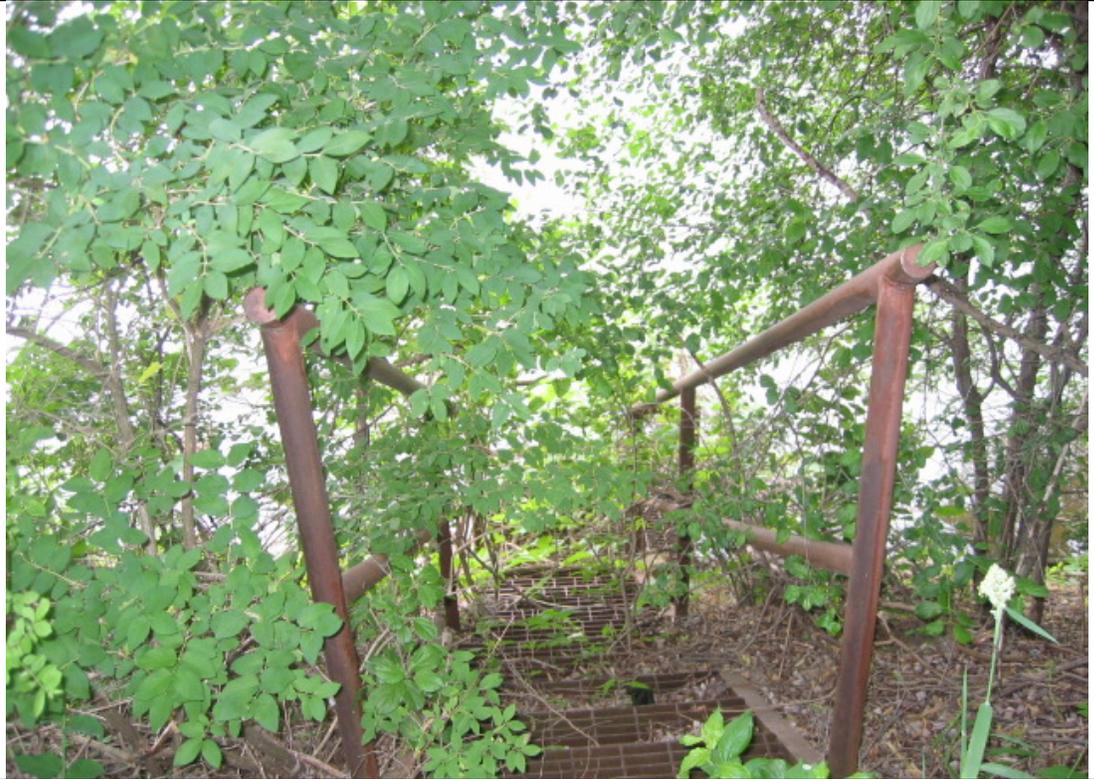
Photo No. 43	Date: 6/8/11
Direction Photo Taken: South

Description:
Stairs on the downstream slope of the Final WPDES Pond at the discharge structure.

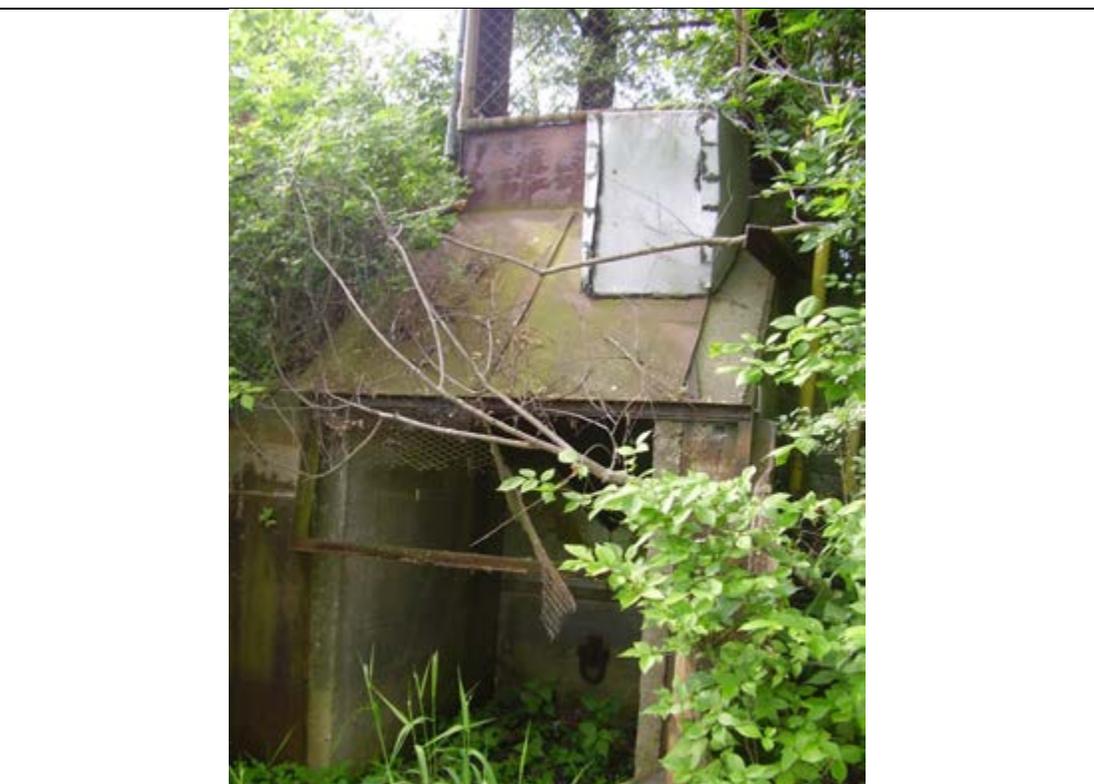
Photo No. 44	Date: 6/8/11
Direction Photo Taken: South

Description:
Inlet for discharge structure on the upstream slope of the Final WPDES Pond.

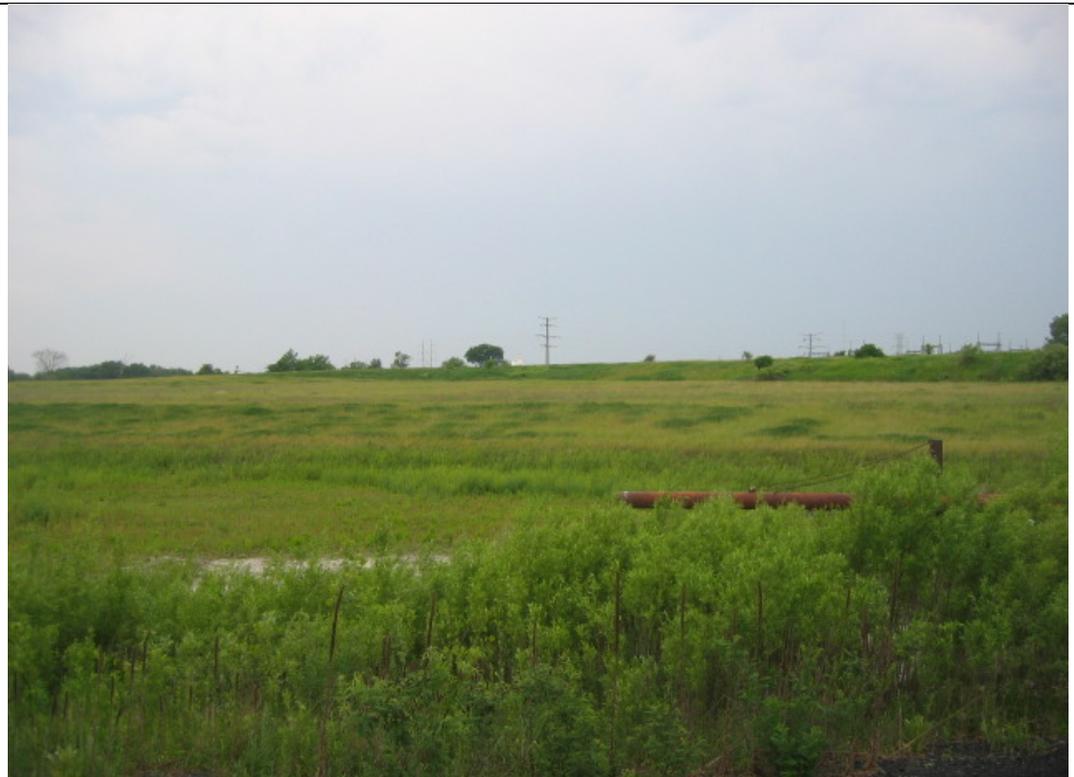
Photo No.
46

Upstream slope of the Slag
Pond.

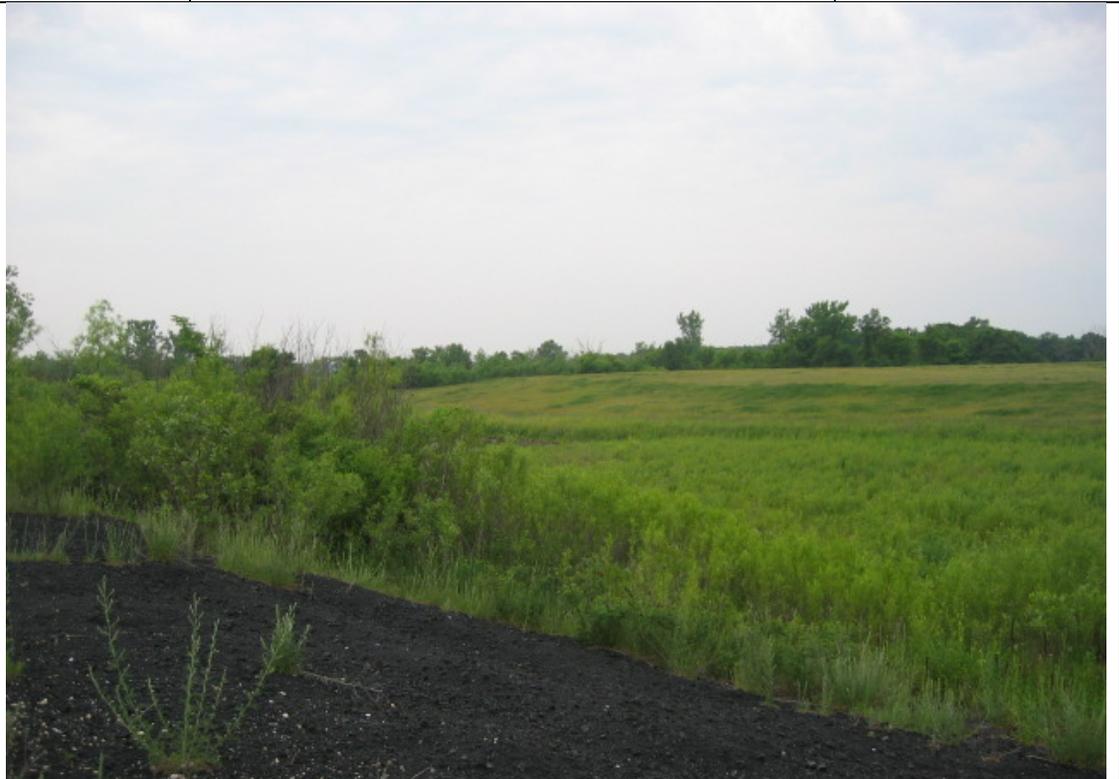
Description:
Upstream slope and crest of the Slag Pond.

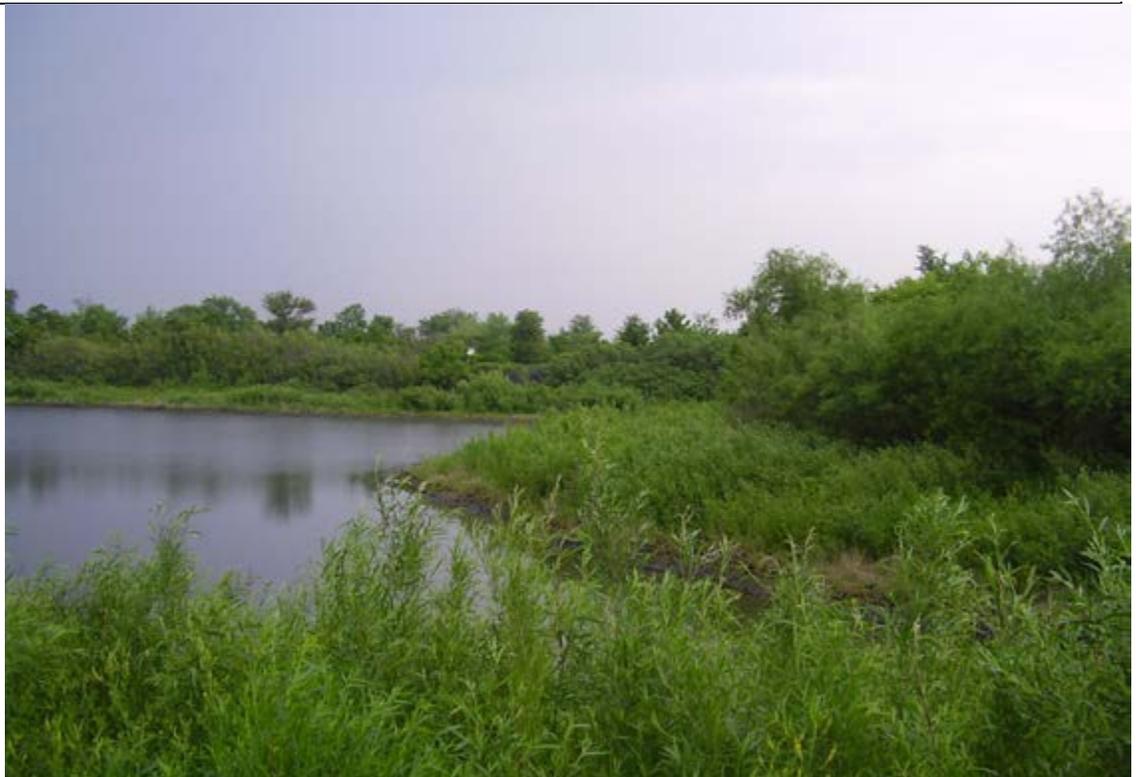
Photo No.
48

Description:
Upstream slope of the Slag Pond.

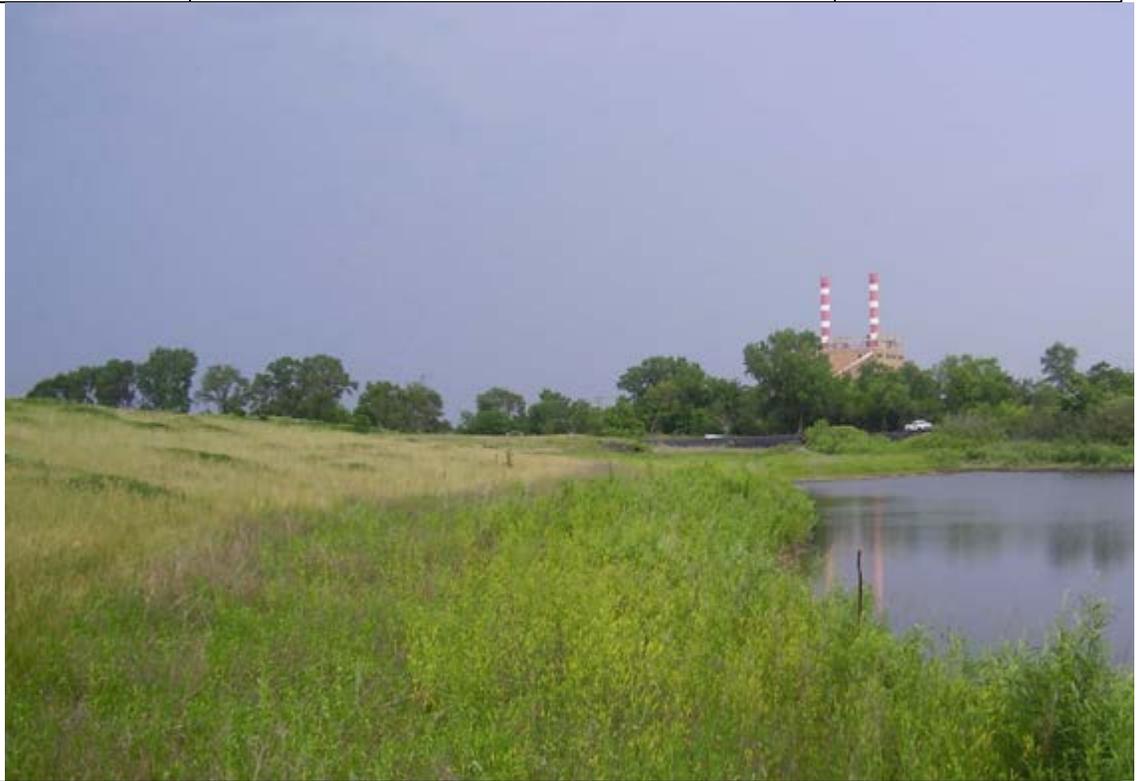
Description:
Upstream slope of the Slag Pond.

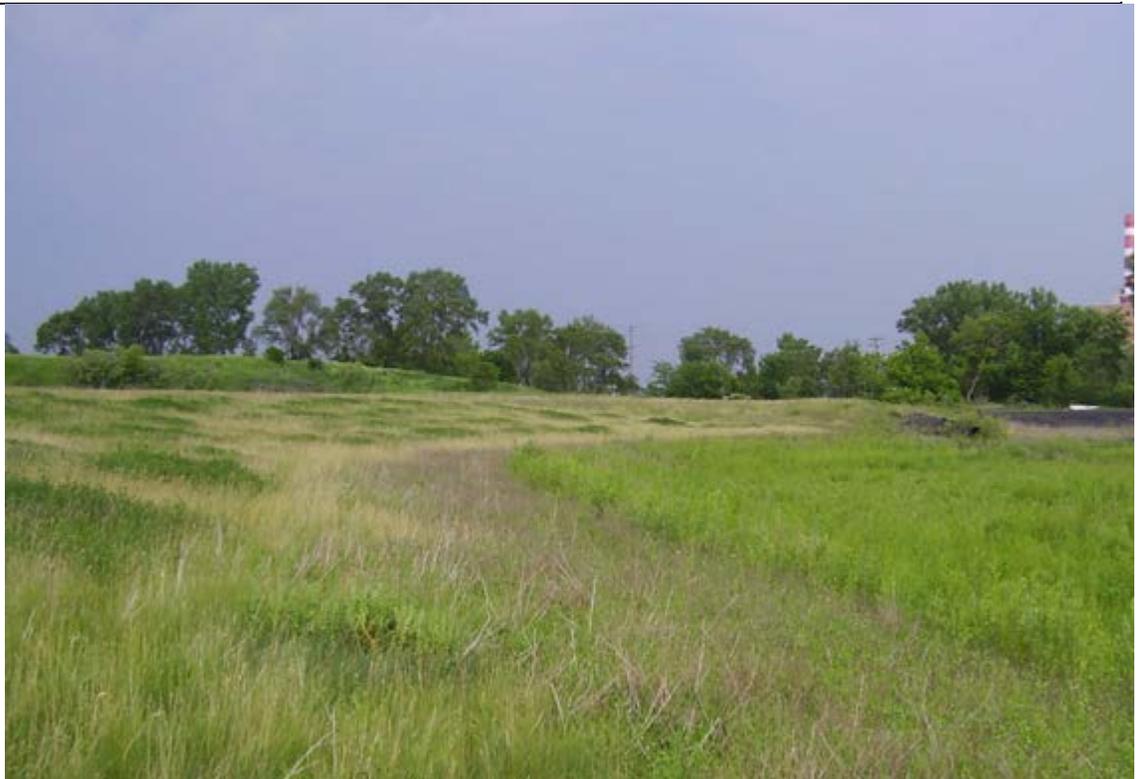
Photo No.
50

Description:
Upstream slope of the Slag Pond

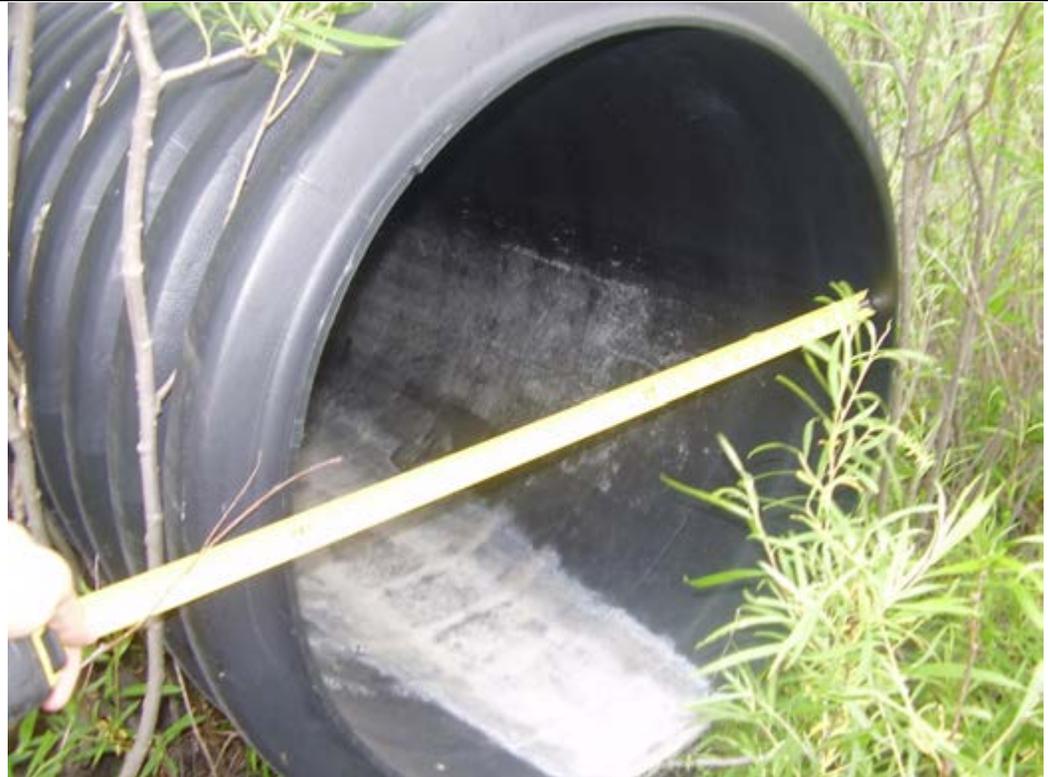
Description:
Discharge Pipe from the
Coal Pipe Runoff Pond.

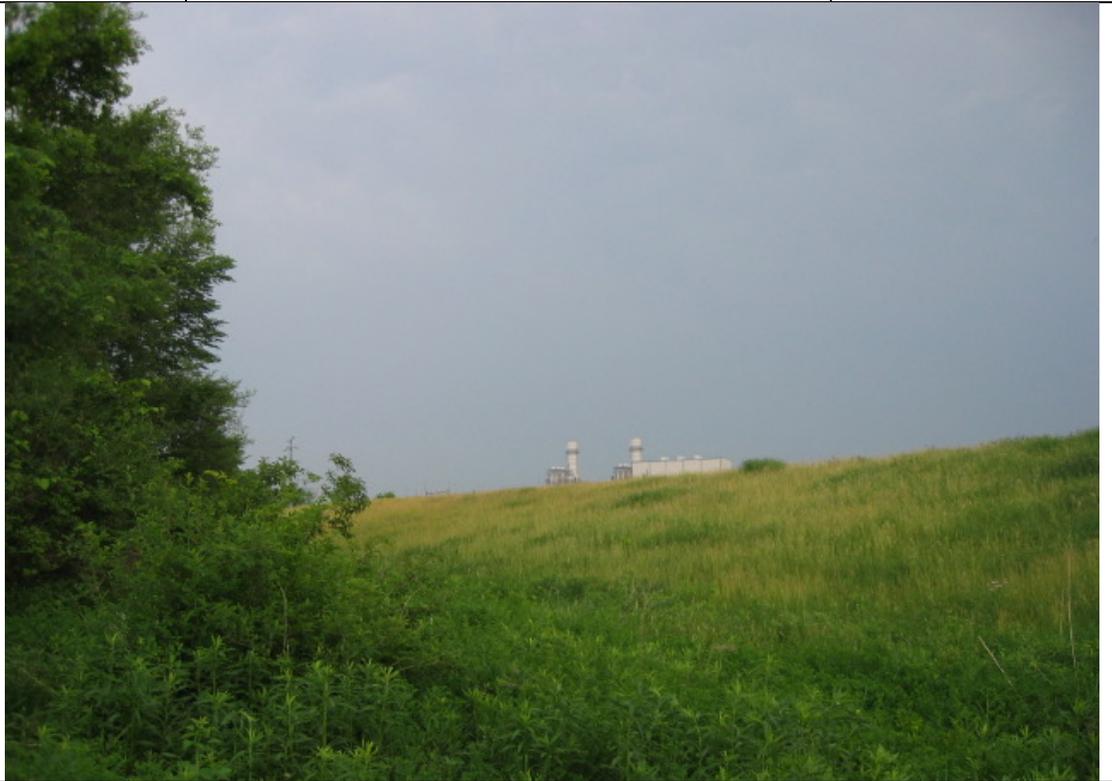
Description:
Upstream slope of the
Landfill.

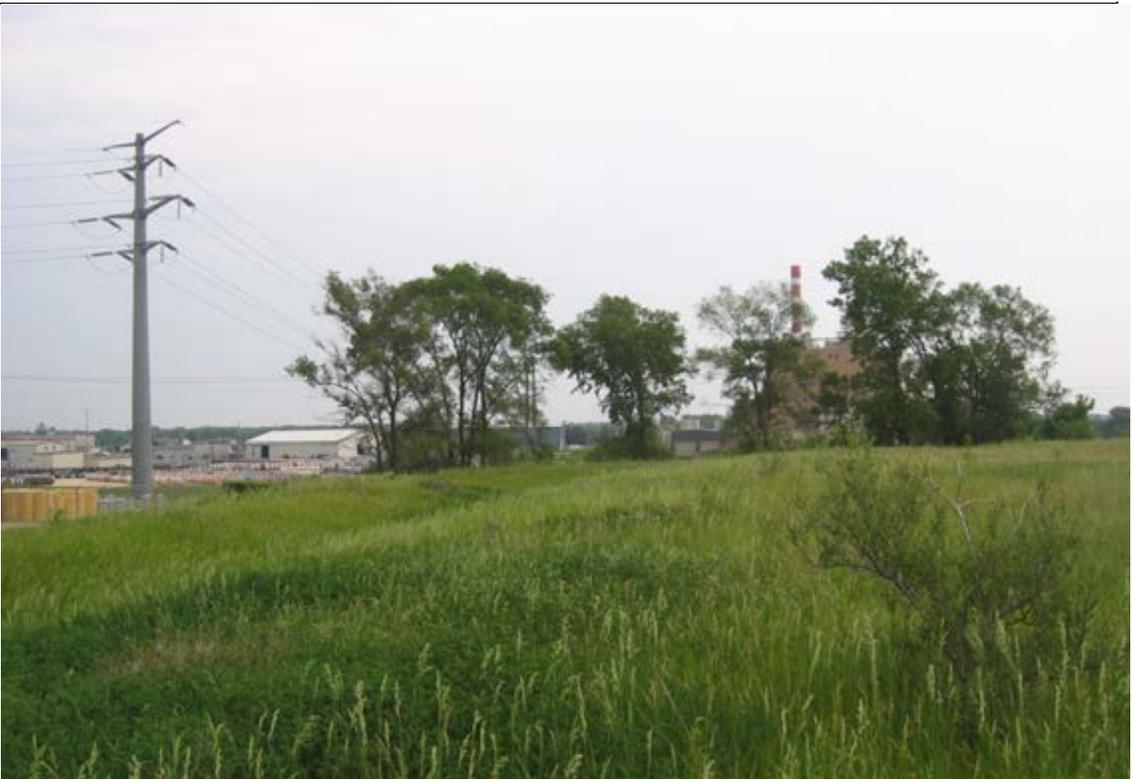
Photo No.
56

Description:
Upstream slope of the
Landfill.
