**FINAL REPORT
ROUND 10 DAM ASSESSMENT
WISCONSIN POWER AND LIGHT COMPANY - ROCK RIVER
GENERATING STATION
WPDES POND 1, WPDES POND 2, SLAG POND, FINAL WPDES POND
BELOIT, WISCONSIN**

January 31, 2013
GZA File No. 170142.30

RE: Assessment of Dam Safety of Coal Combustion Surface Impoundments at the Rock
River Generating Station

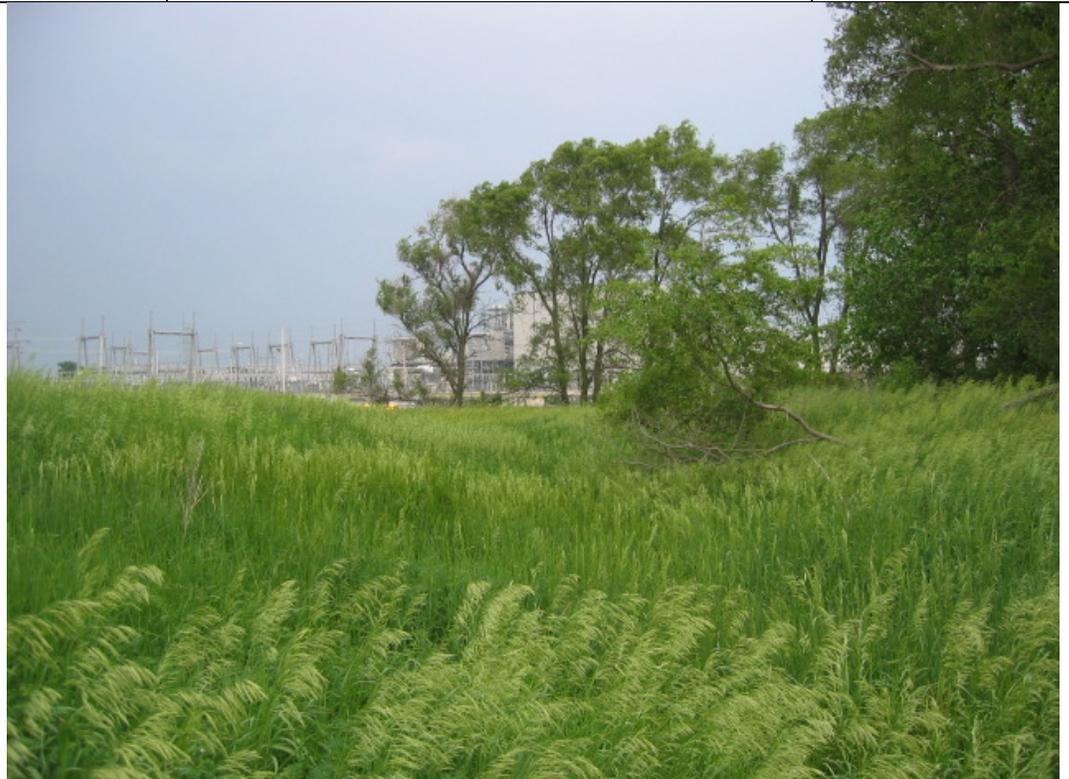
Description:
Upstream slope of the
Landfill.

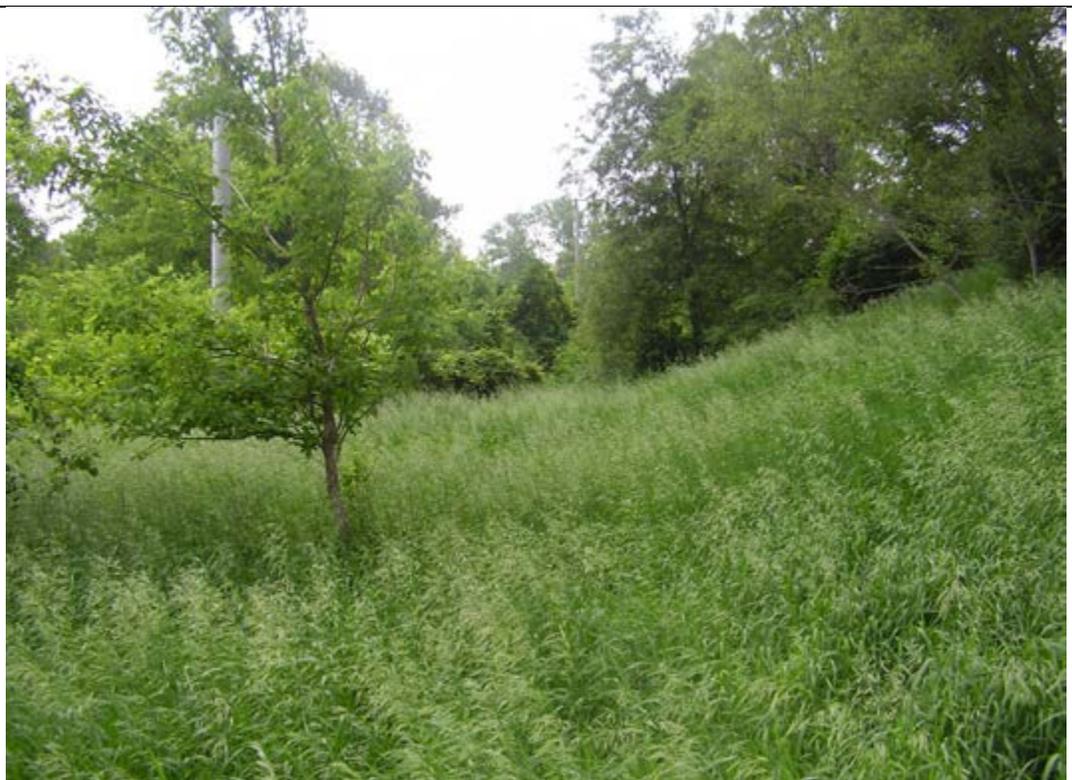
Photo No.
58

Description:
Toe of the Landfill

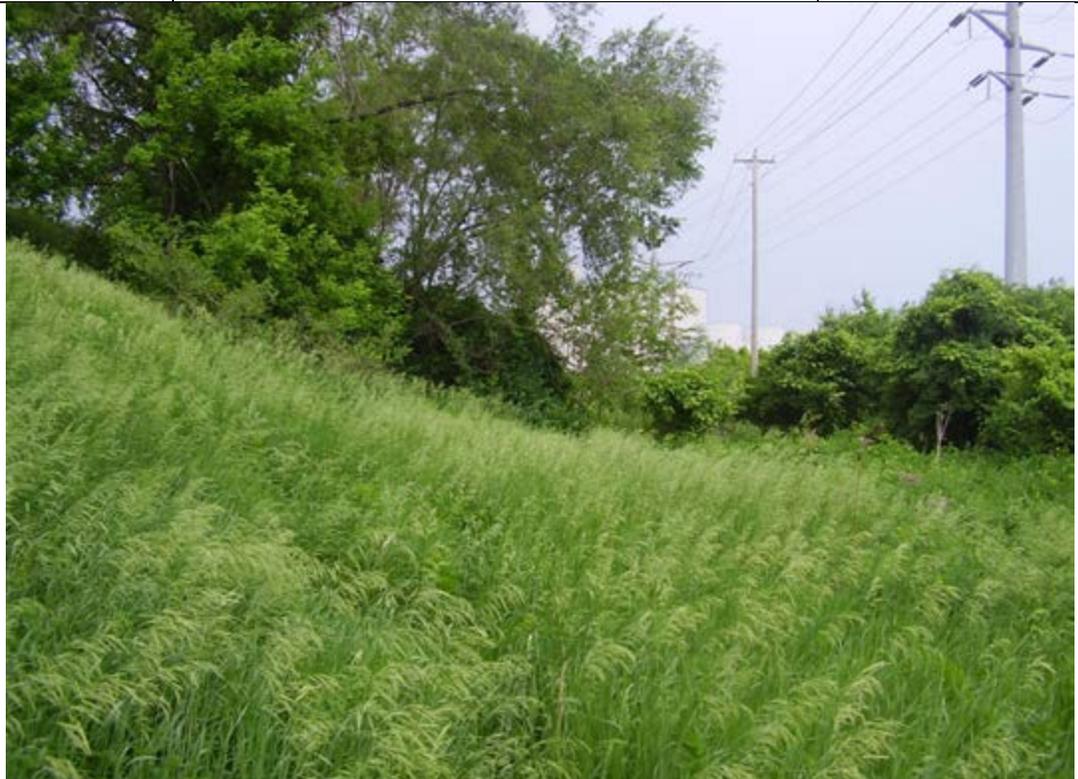
Description:
Toe of the Landfill.

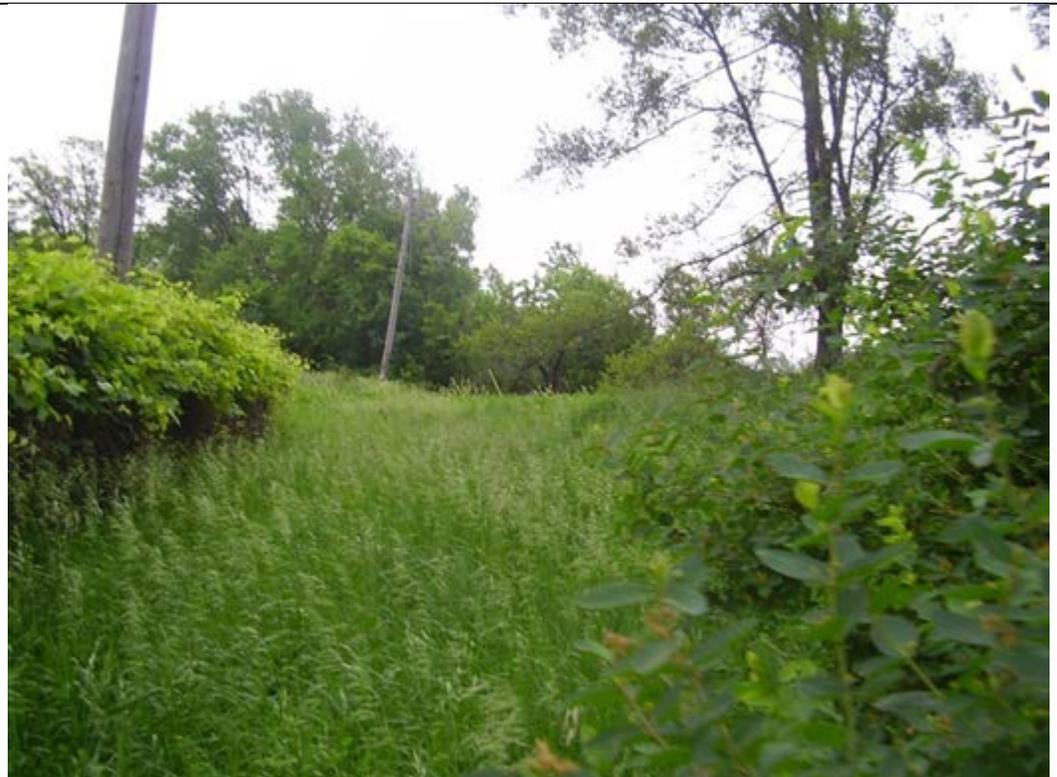
Photo No.
60

Description:
Toe of the landfill.
