**COAL ASH IMPOUNDMENT
SITE ASSESSMENT FINAL REPORT**

**6th Street Power Generating Station
Interstate Power and Light Company
Cedar Rapids, Iowa**

KLEINFELDER PROJECT NUMBER 118953-4

February 28, 2013

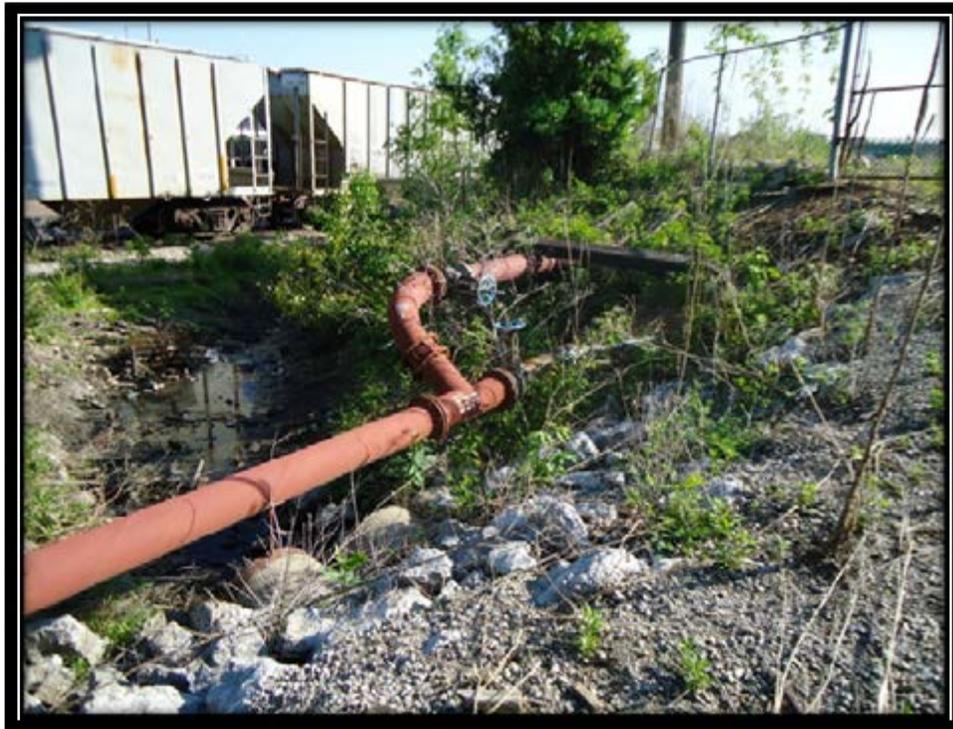
Photo 1 – Discharge Pipes into Ash Ponds
May 24, 2011 NPDES# IOWA-5715109

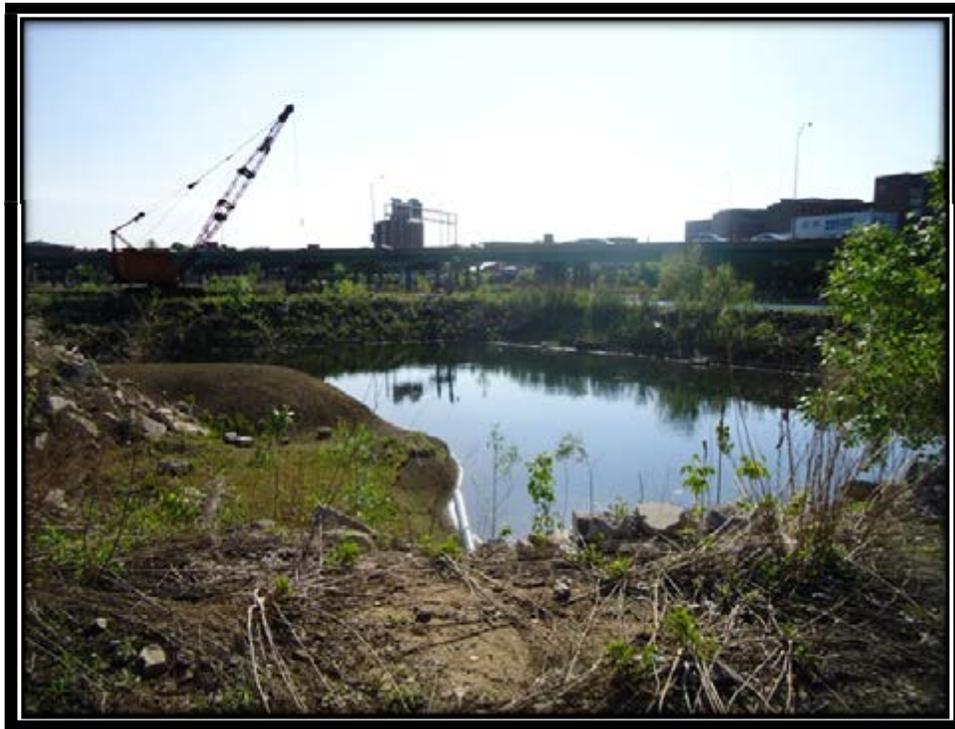
Photo 3 – General Conditions Photograph Ash Pond 1
May 24, 2011 NPDES# IOWA-5715109

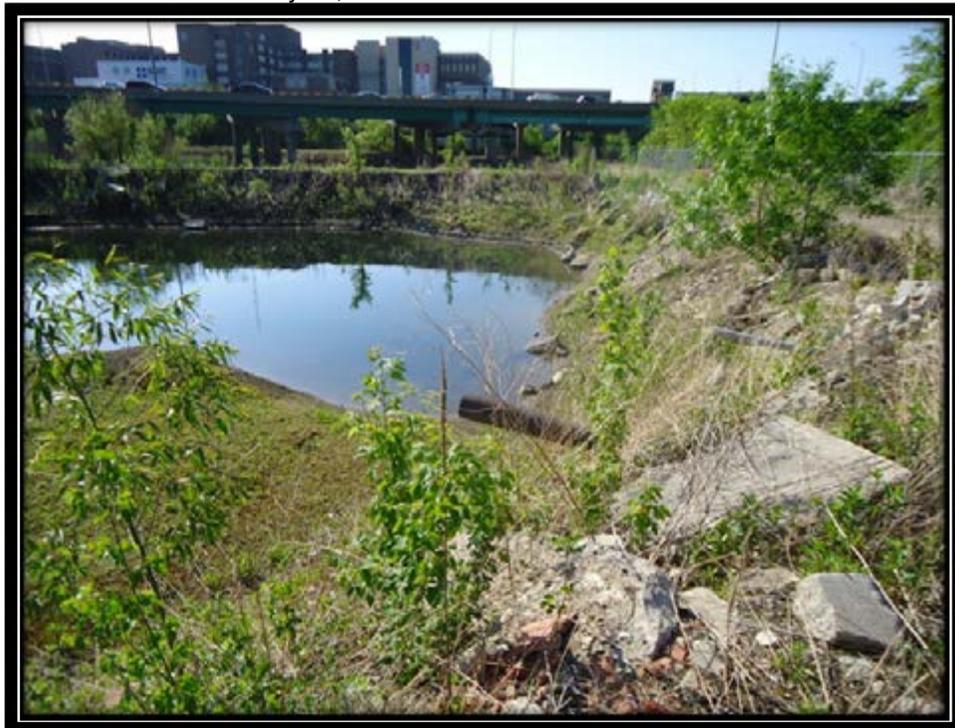
Photo 4 – Sluice Pipe into Ash Pond 1 (note small trees in embankment)
May 24, 2011 NPDES# IOWA-5715109

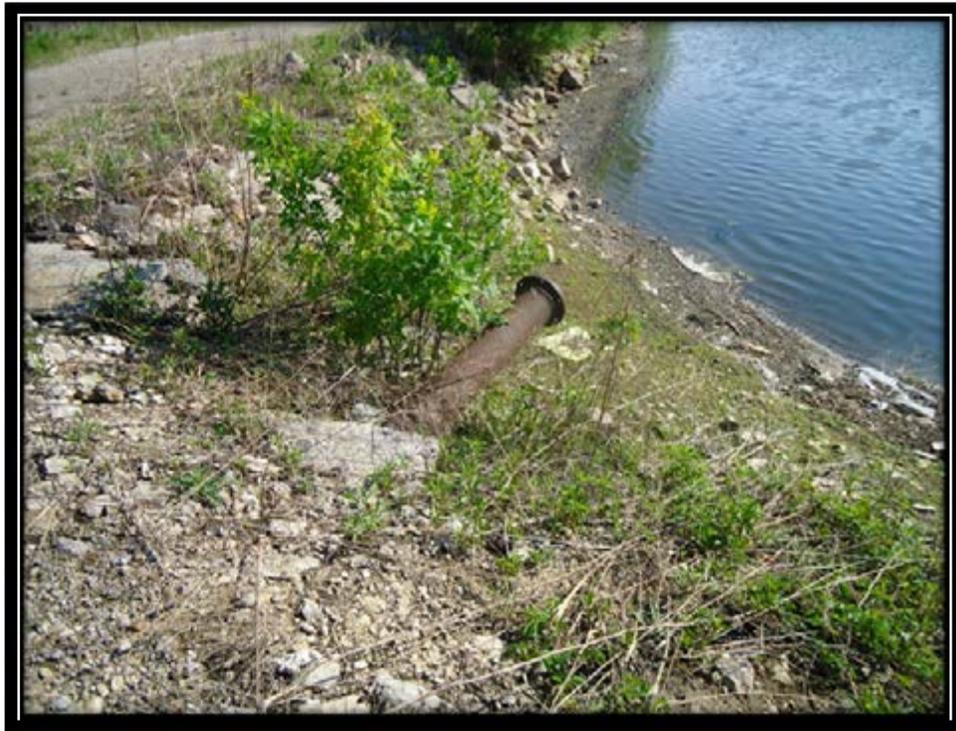
Photo 11 – Ash Pond 3 Unknown Sluice Pipe Approximately 8 Inch Cast Iron Pipe
May 24, 2011 NPDES# IOWA-5715109

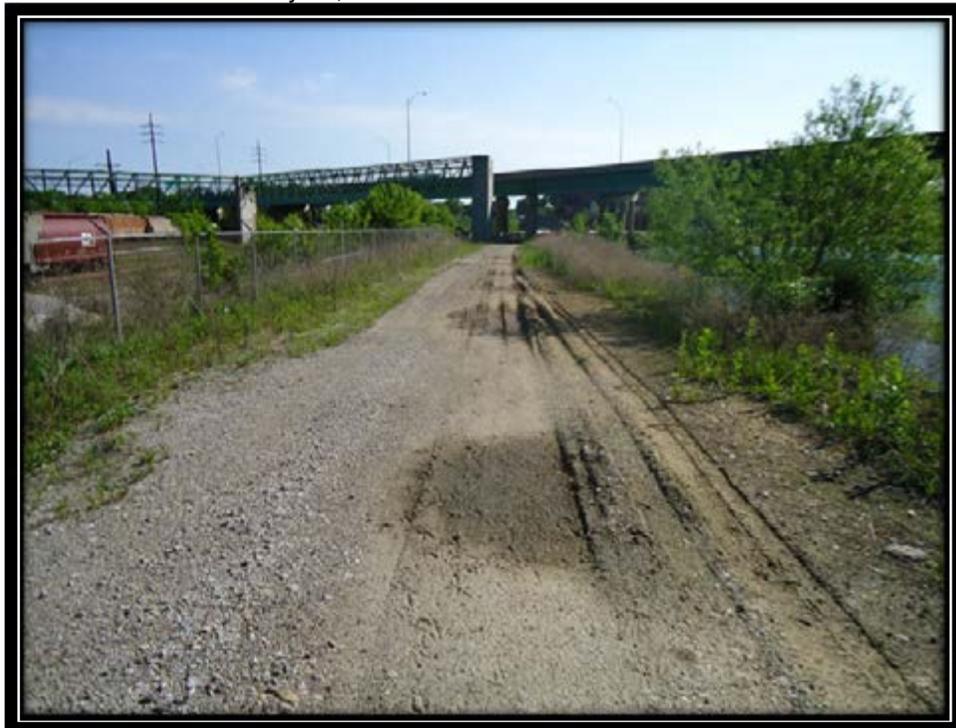
Photo 12 – Ash Pond 3-6 Inch Rutting on Crest
May 24, 2011 NPDES# IOWA-5715109

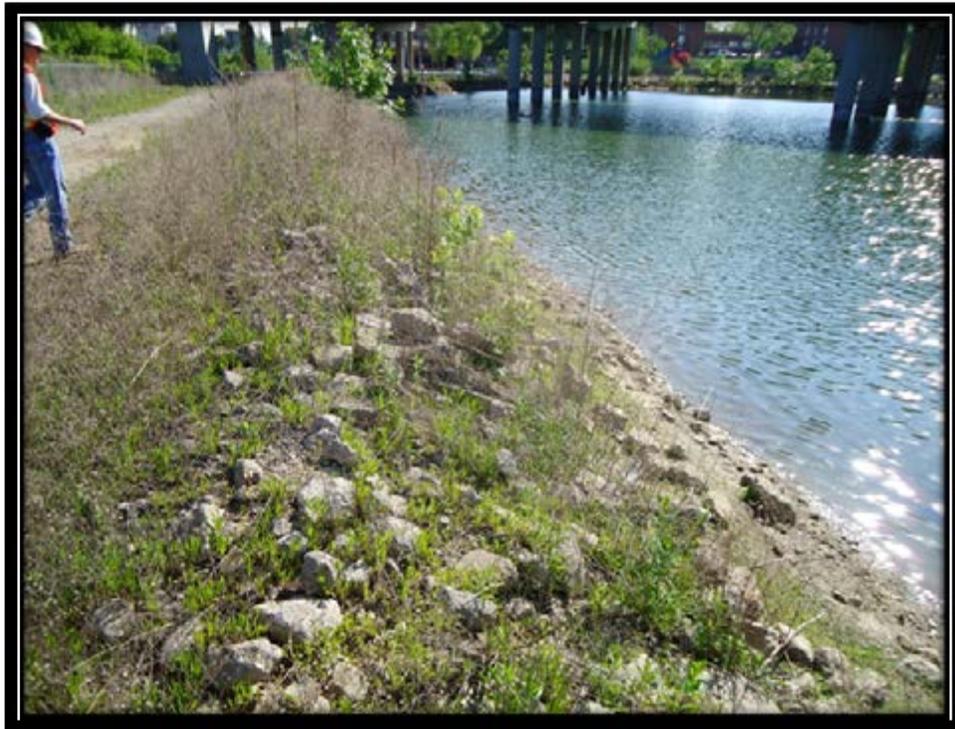
Photo 13 – Ash Pond 3 Vegetated Riprap
May 24, 2011 NPDES# IOWA-5715109

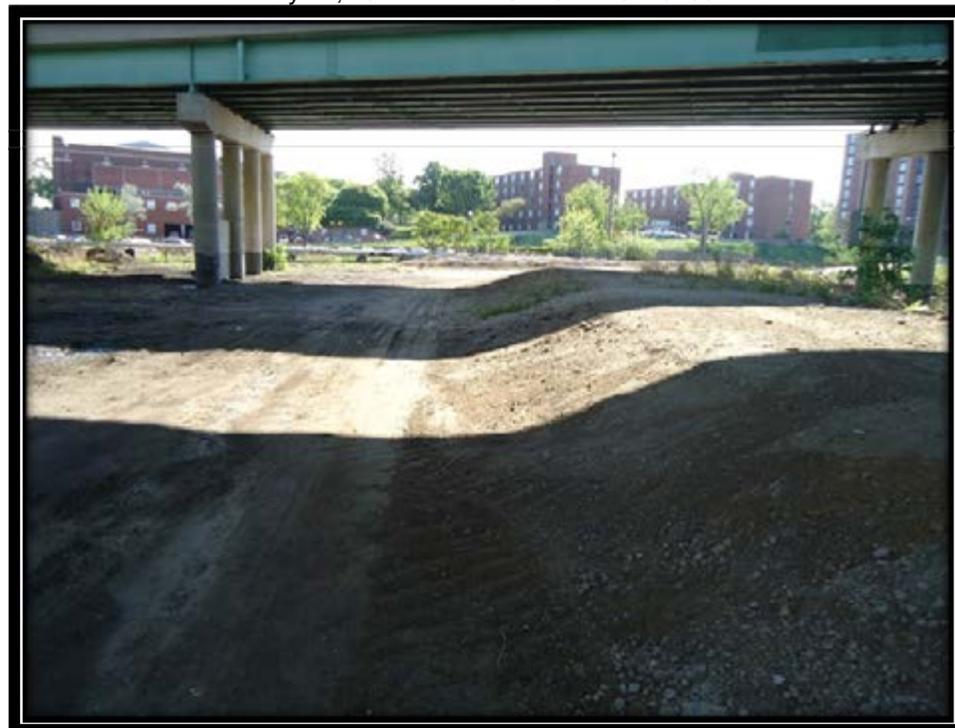
Photo 14 – Ash Pond 3 Embankment (note lack of vegetation)
May 24, 2011 NPDES# IOWA-5715109

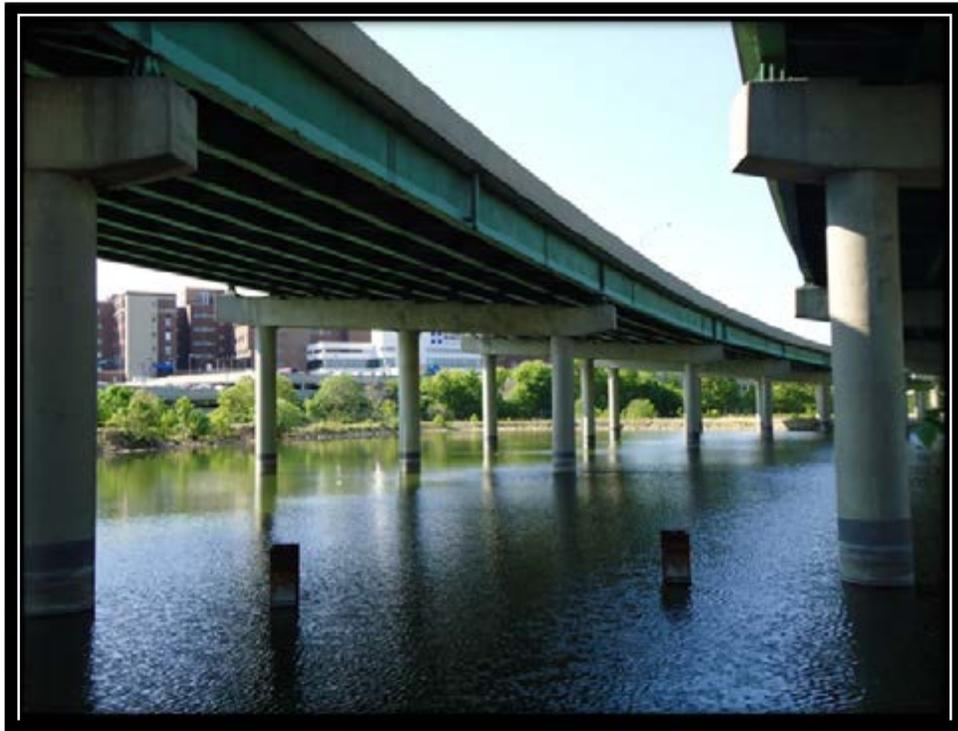
Photo 15 – Downspout from Highway Discharging into Ash Pond 3
May 24, 2011 NPDES# IOWA-5715109

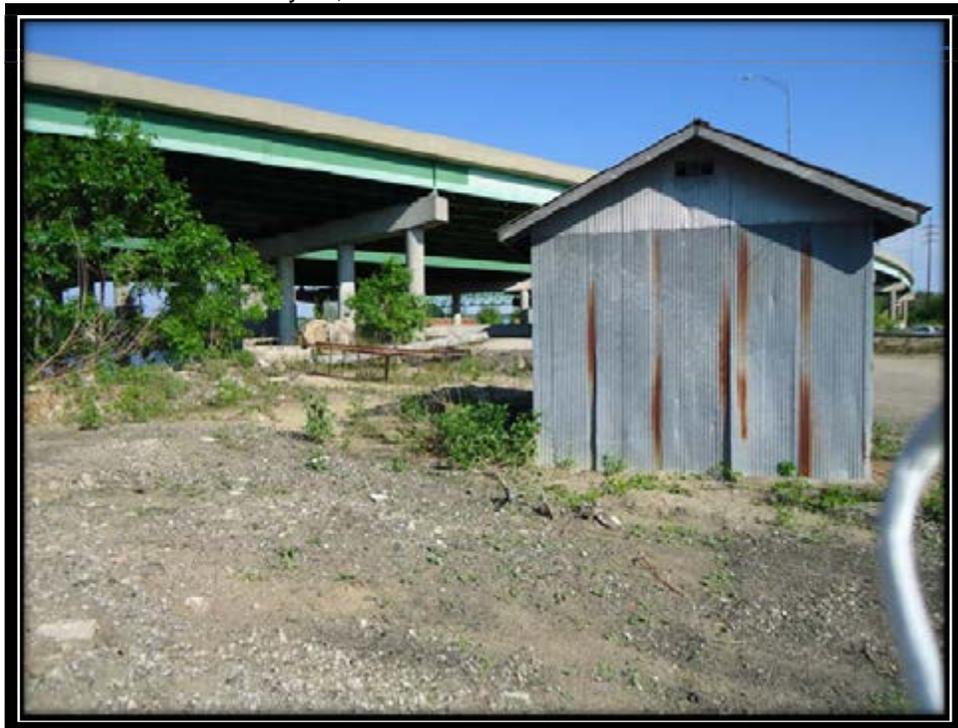
Photo 16 – Debris and Abandoned Building on Crest of Ash Pond 3
May 24, 2011 NPDES# IOWA-5715109

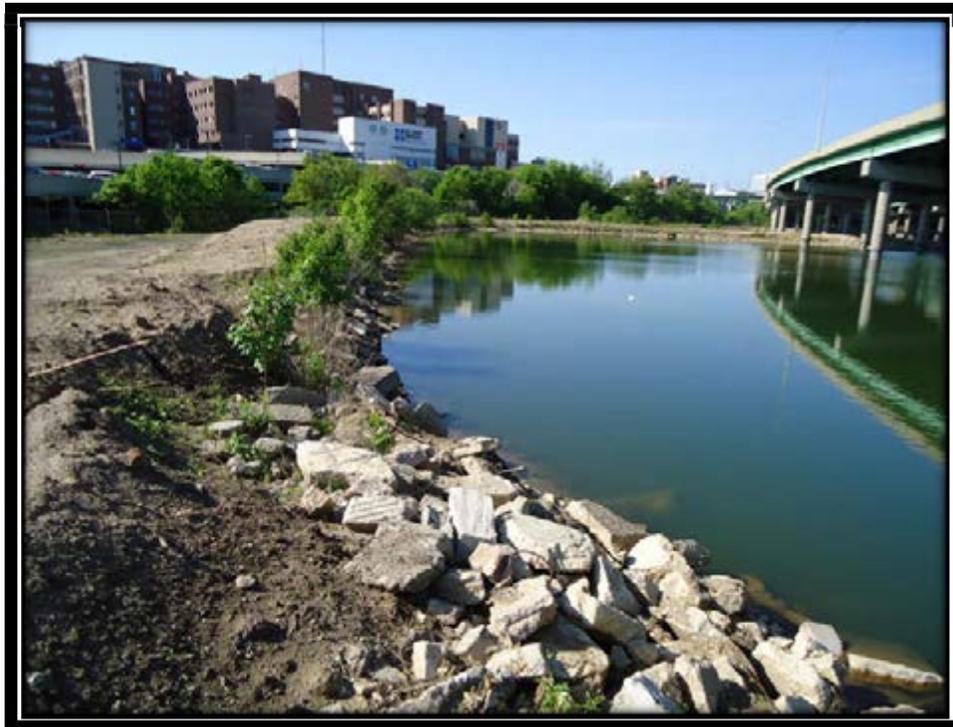
Photo 17 – Ash Pond 3 Concrete Rubble Riprap
May 24, 2011 NPDES# IOWA-5715109

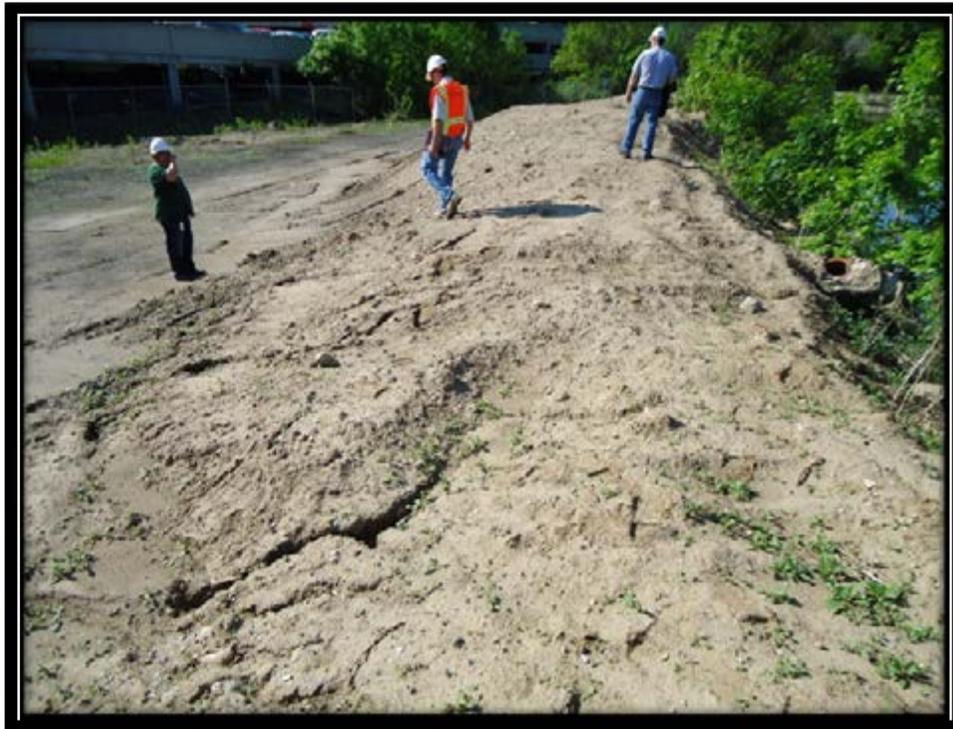
Photo 19 – Ash Pond 3 Embankment (note uncompact soil with a lack of vegetation)
May 24, 2011 NPDES# IOWA-5715109

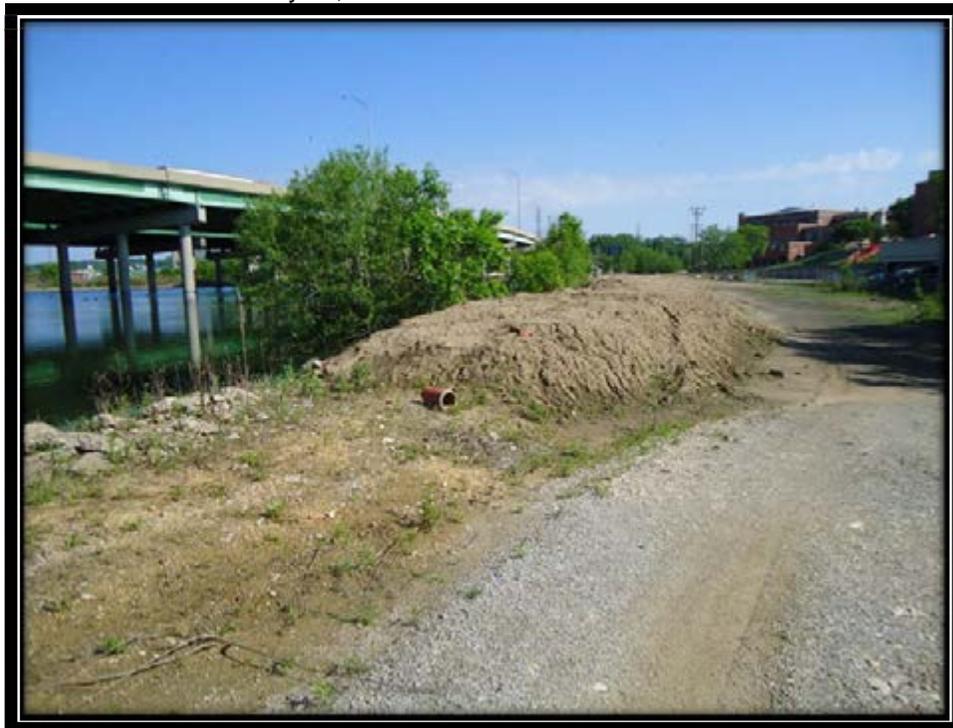
Photo 20 – Ash Pond 3 Embankment (note difference in embankment height)
May 24, 2011 NPDES# IOWA-5715109

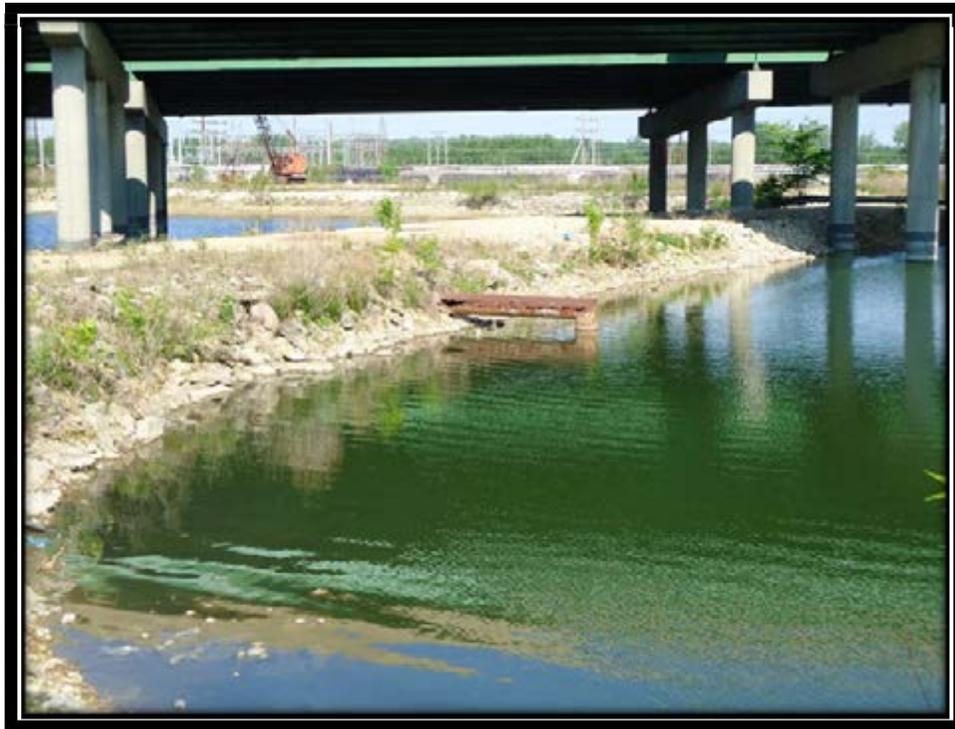
Photo 21 – Ash Pond 3 Outlet Pipe to Ash Pond 4 (note pipe rusted through)
May 24, 2011 NPDES# IOWA-5715109

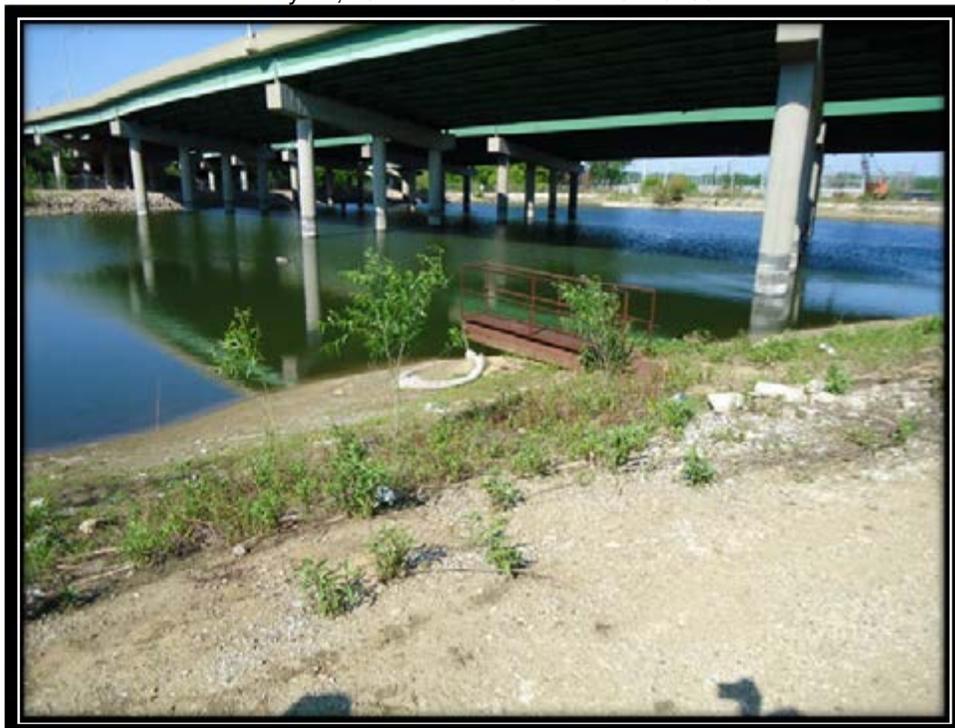
The catwalk structure above the inlet pipe for Pond 4 appears to be weathered and supported by a steel pipe that has significant corrosion almost to the point of structural failure. However, the small catwalk structure does not appear to be essential in the operation of the ash ponds, and the consequences of not being able to access the catwalk appear to be minimal if any.

Photo 22 – Ash Pond 4 Inlet Pipe from Pond 3 (note pipe rusted through)
May 24, 2011 NPDES# IOWA-5715109

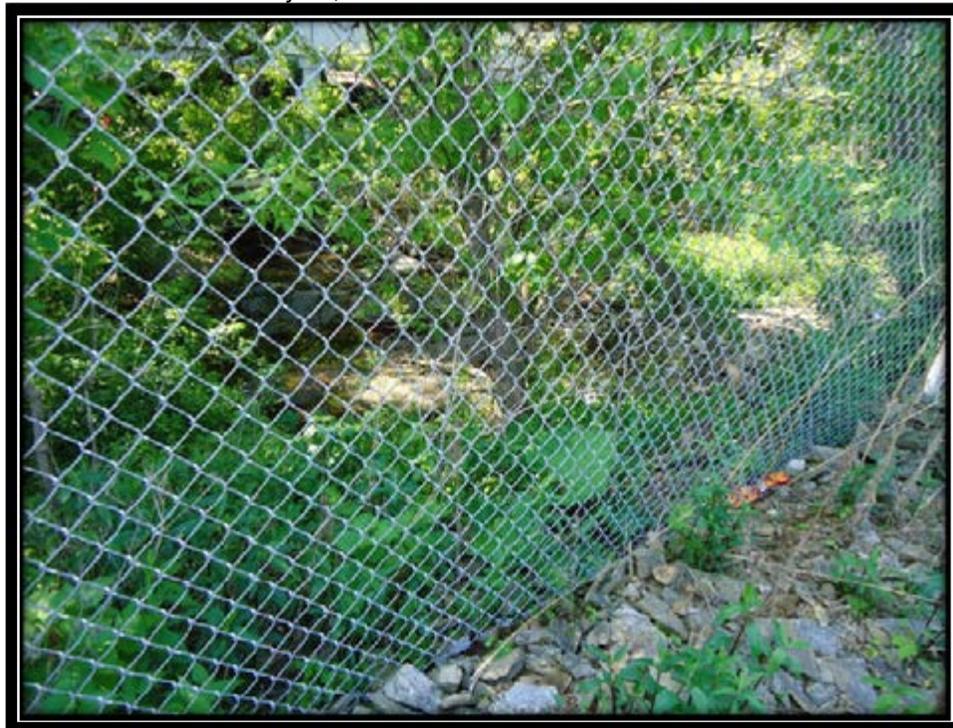
Photo 26 – Ash Pond 4 Downstream Embankment Slope with Heavy Vegetation and Creek at Toe
May 24, 2011 NPDES# IOWA-5715109

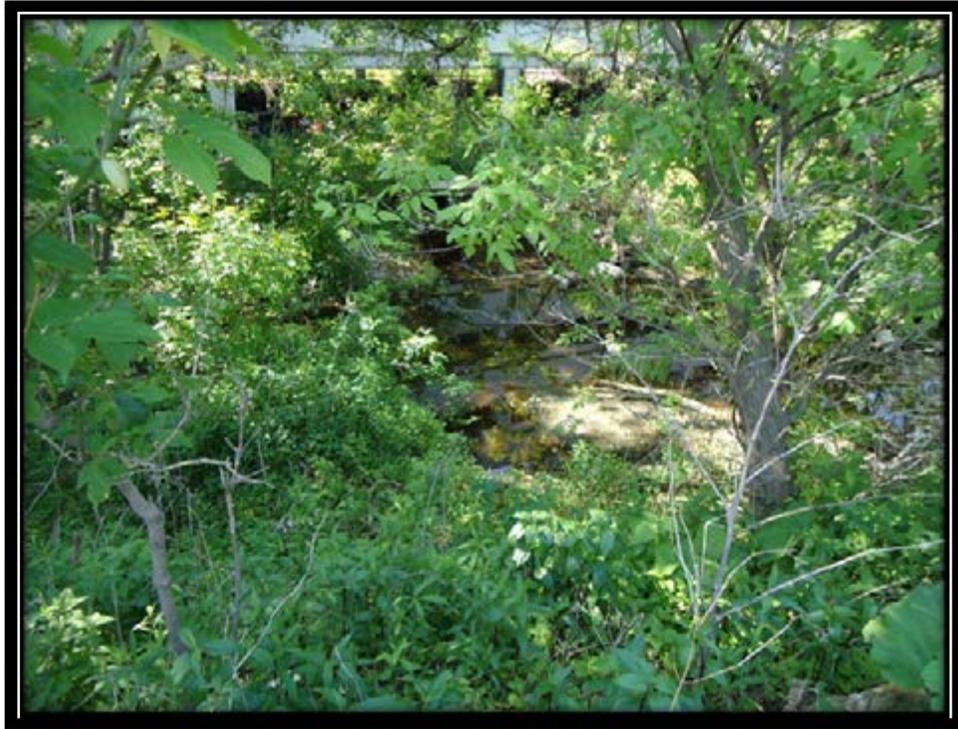
Photo 27 – Ash Pond 4 Landside Embankment Slope with Heavy Vegetation and Creek at Toe
May 24, 2011 NPDES# IOWA-5715109

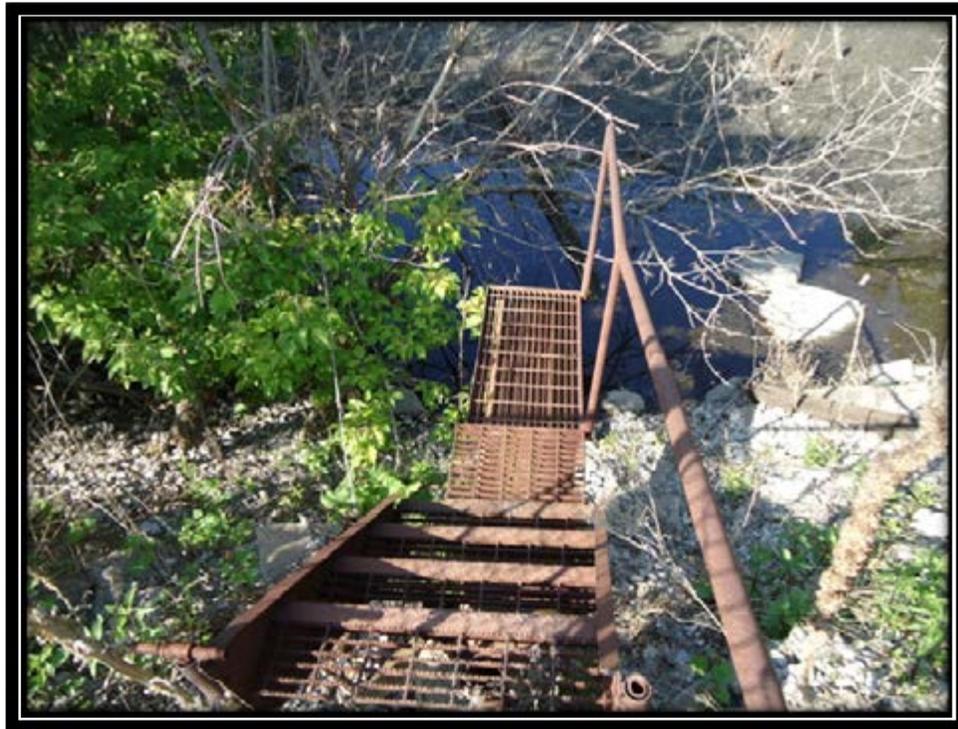
The steel catwalk structure including stairs near the outfall of Pond 4 appears to be in fair condition. The structure as well as the stairs leading to the catwalk appear to be weathered, but not to the point of structural failure. It appears that a handrail support for the stairs is missing, and should be replaced or studied further to determine the effects of the missing support. Due to the age of the facility, continuous assessment and evaluation is merited to determine the condition of the catwalk and stairs as time progresses.

Photo 29 – Ash Pond 4 Outlet Pipe Outfall and Walkway
May 24, 2011 NPDES# IOWA-5715109

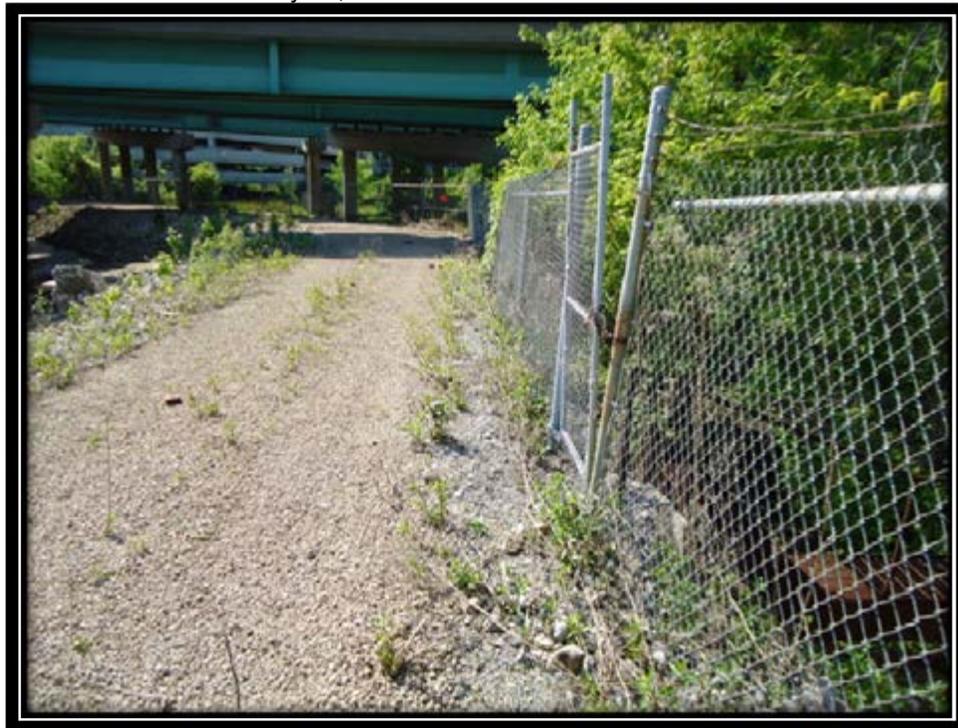
Photo 30 – Ash Pond 4 Fence Penetration at Crest (typical)
May 24, 2011 NPDES# IOWA-5715109

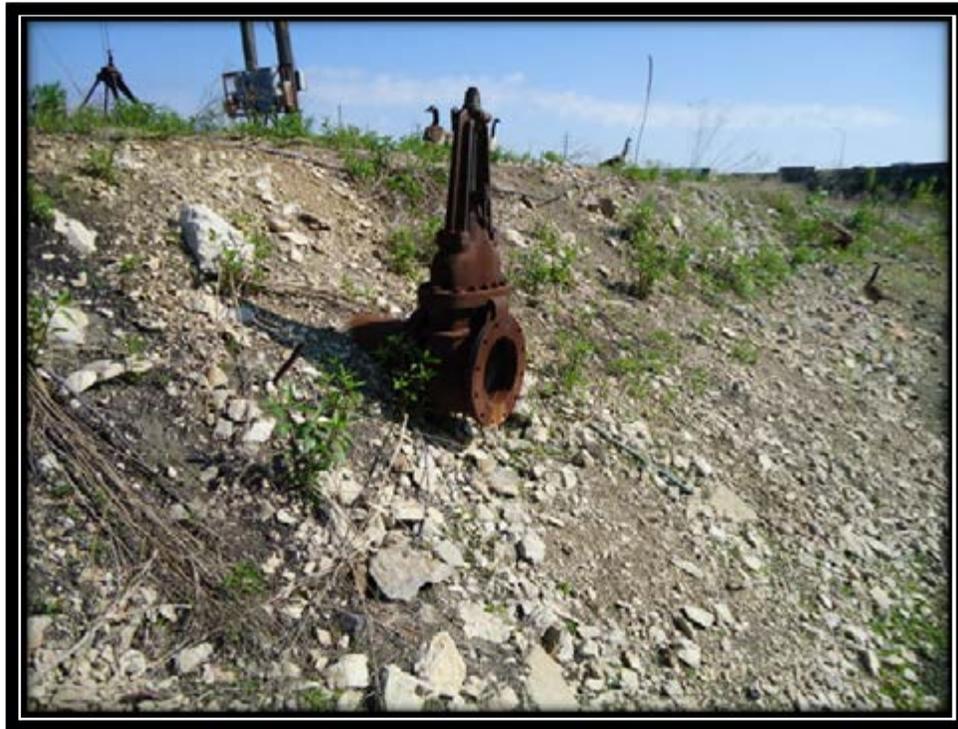
Photo 31 –Ash Pond 4 Inlet Pipe from Ash Pond 1 (note valve)
May 24, 2011 NPDES# IOWA-5715109

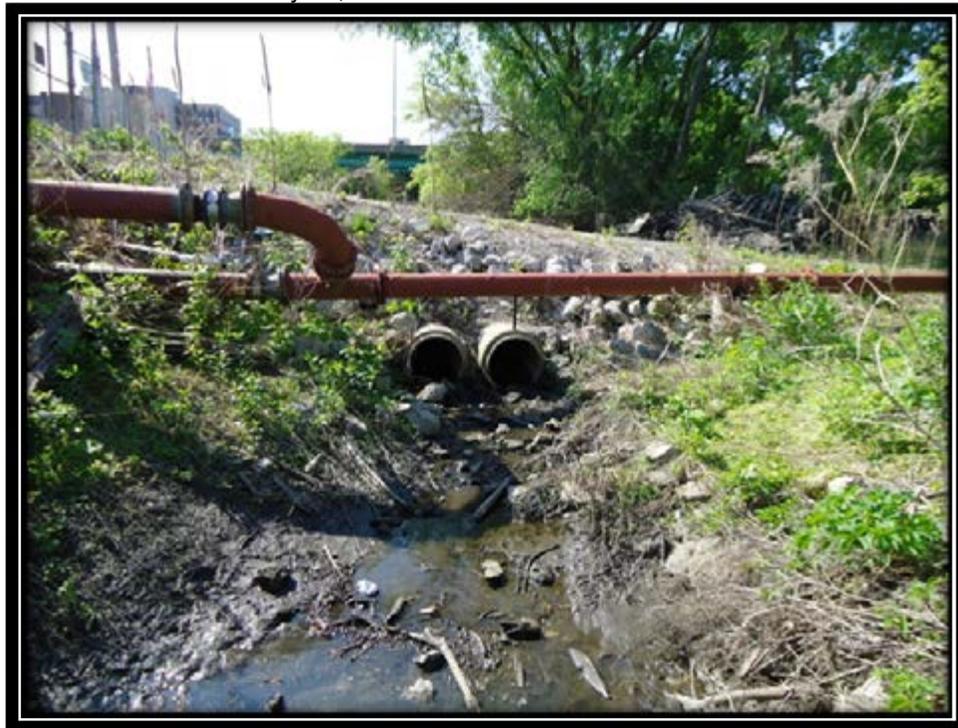
Photo 32 – 24 Inch Reinforced Concrete Pipes in Discharge Channel under Entrance to Ash Ponds
May 24, 2011 NPDES# IOWA-5715109

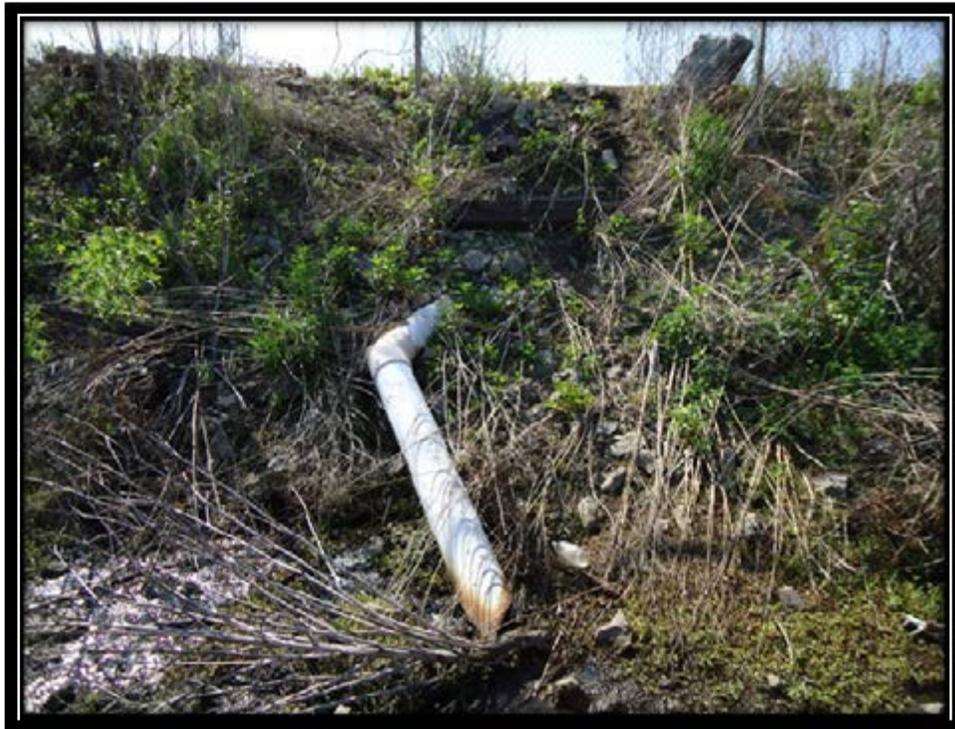
Overall, the downstream slope was in fair to poor condition. Photo 33 at the end of this section shows the condition of the downstream slope. Specific observations include:

- Erosion, some areas close to 6 inches deep, was noted on some of the downstream slope.
- Penetrations into the downstream embankment, including debris (possibly abandoned pipe), were present.
- Grasses, woody bushes and small trees over 1 inch in diameter were observed on the downstream slope.
- No seepage was observed during the site assessment.

Photo 33 – Ash Pond 1 Debris in Downstream Slope of Embankment
May 24, 2011 NPDES# IOWA-5715109

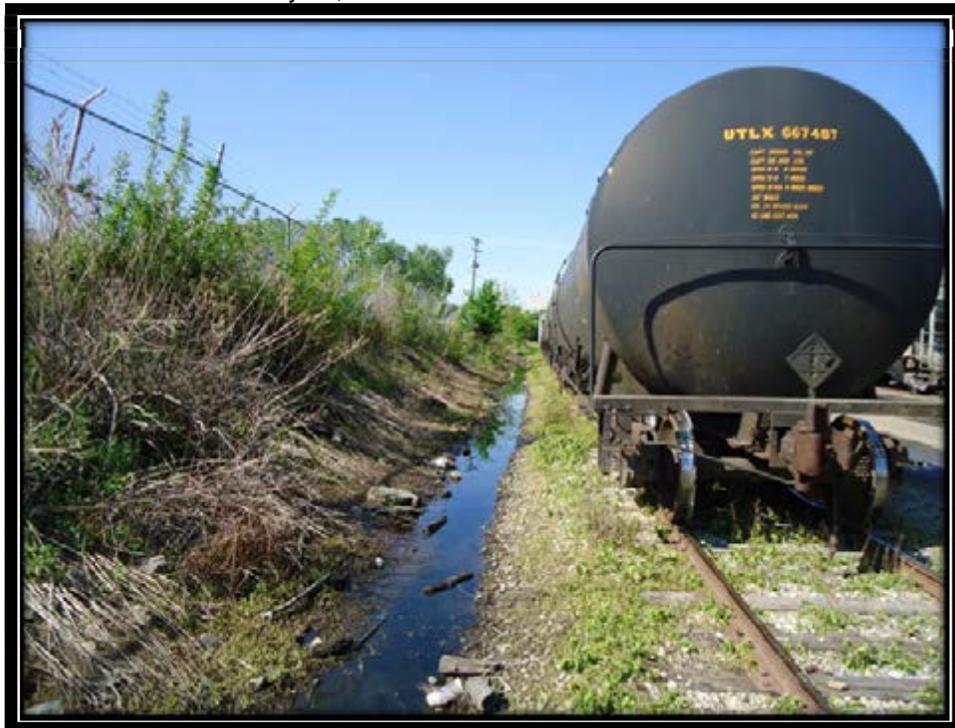
Photo 34 – Downstream Slope of Ash Pond 3 (note ditch at toe)
May 24, 2011 NPDES# IOWA-5715109

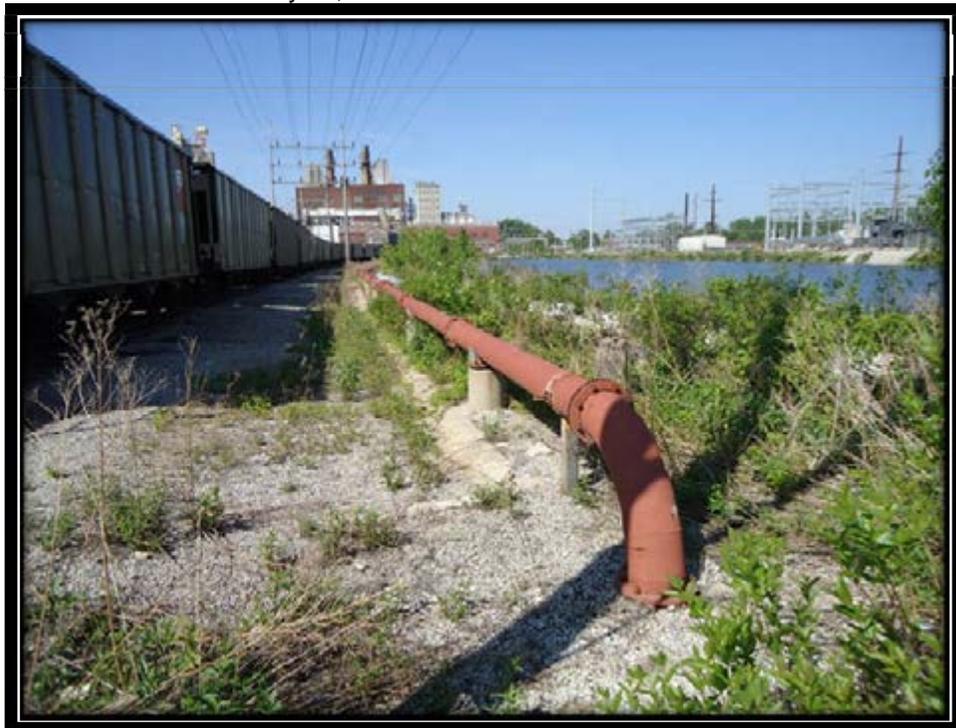
Sluice pipes running from the generating station to the ash ponds appear to be supported on metal and concrete stands that appeared to be weathered, although not to the point of structural failure. Due to the age of the facility, continuous assessment and evaluation is merited to determine the condition of the supports as time progresses.

Photo 36 – Sluice Pipe from Generating Station to Ash Ponds
May 24, 2011 NPDES# IOWA-5715109

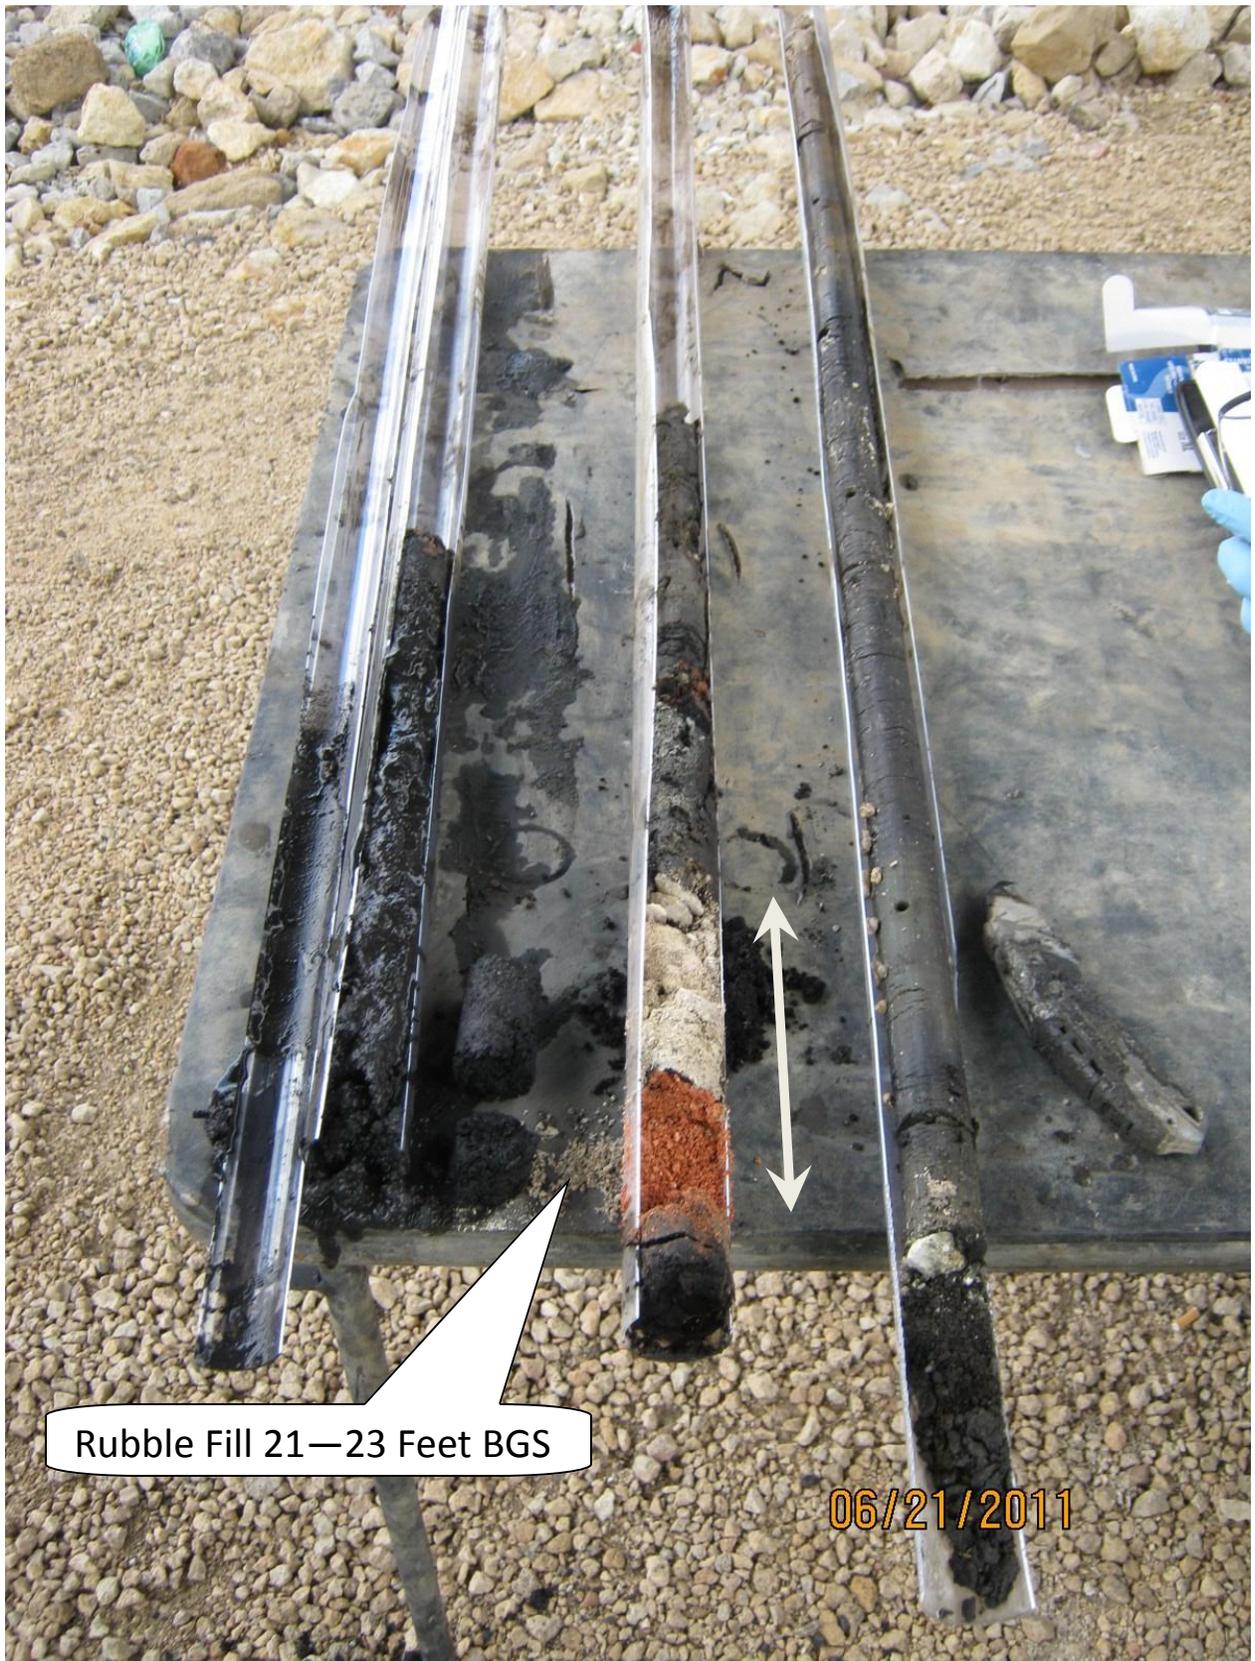
Photograph 1 Rubble Fill at Contact Between Original Ground Surface and CCW (SB-4)
