Report of Dam Safety Assessment of Coal Combustion
Surface Impoundments
Interstate Power and Light Company
Sutherland Generating Station
Marshalltown, IA

AMEC Project No. 3-2106-0191

July 2011

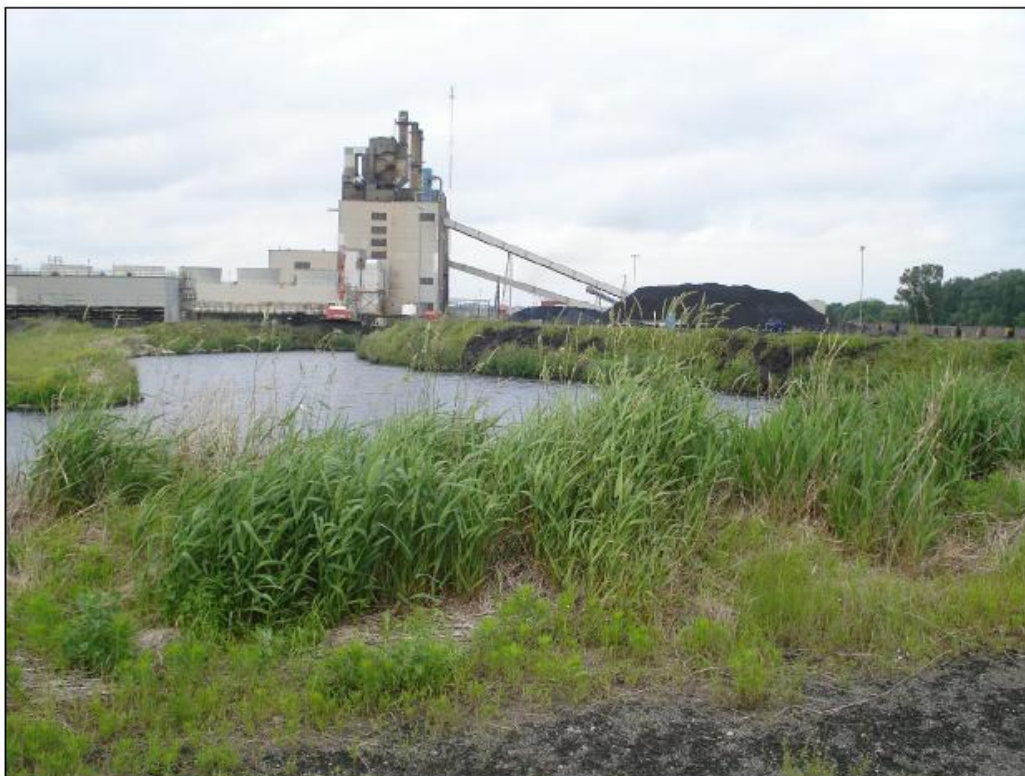
slopes observed at isolated locations and in reaches. Notable reaches include the following locations:

- Area beginning at the inlet from the North Pond extending northeast along the embankment below the ash stockpile area. See photo below presented as SECP-1 in Appendix B.

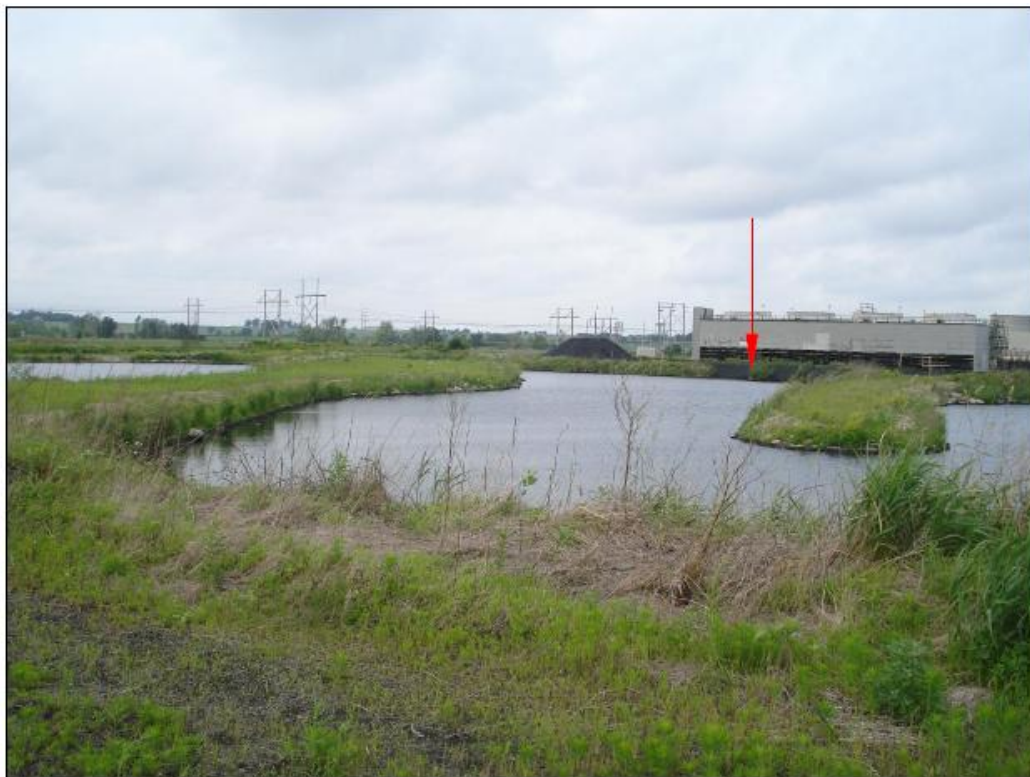
- Area in the vicinity of the inlet from the South Pond and to the north. See Photo SECP-2, below, and Photo SECP-3 presented in Appendix B.

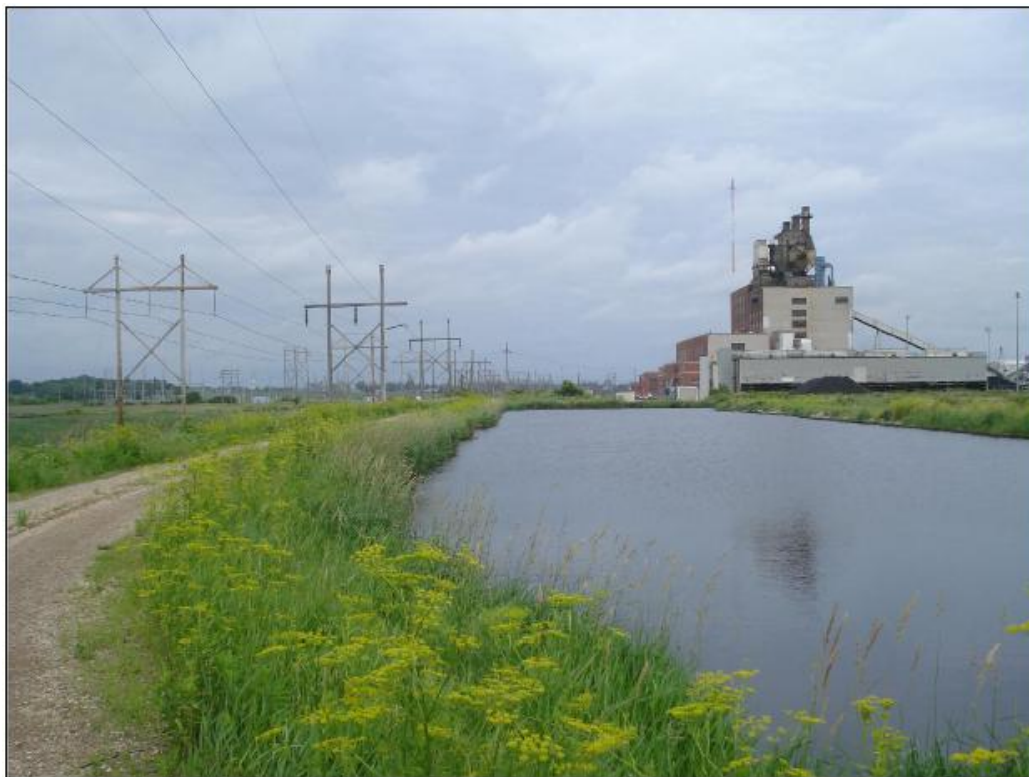
- Local area located to the north of the southwest corner. See Photo below presented as Photo SECP-4 in Appendix B.

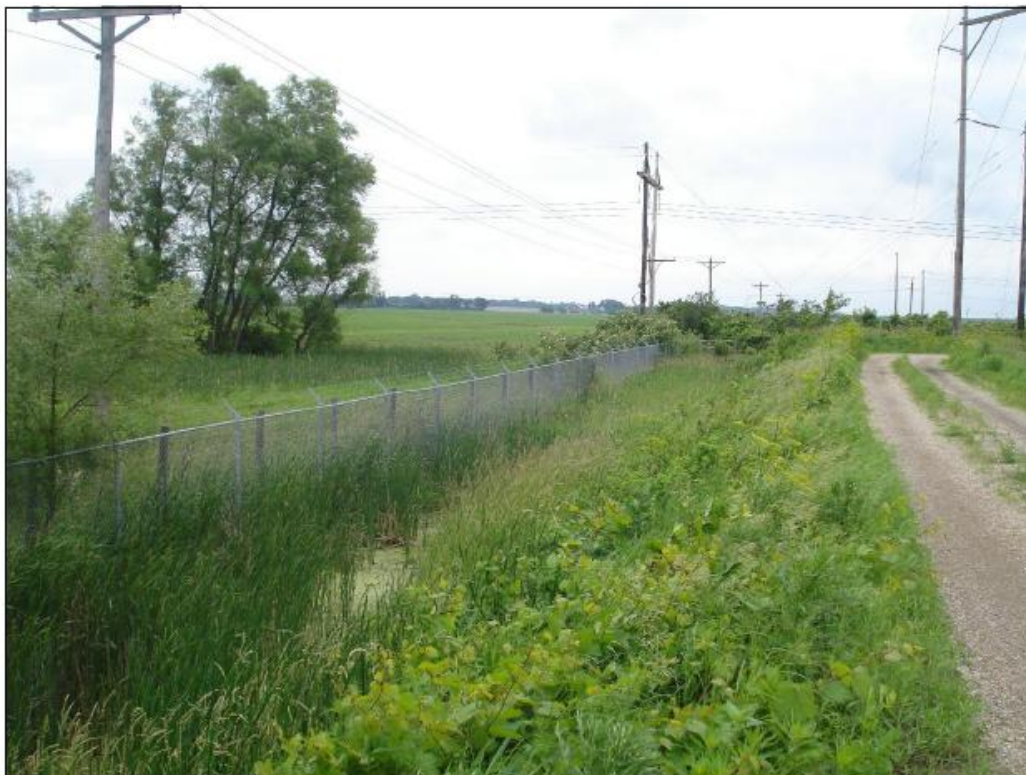
The south and east embankments of the Secondary Pond appear to be the original embankments. Tall grass covered the upstream slopes on these embankments which prevented observations of the surface of the slopes. Based on our observations under these restrictions, the east upstream slope appeared generally to be in fair condition (Photo SECP-13). The south upstream slope was generally in fair condition, but isolated locations of surface slough failures were observed (Photo SECP-4 and SECP-14). The number of locations seemed to increase from east to west. The downstream slopes of the east and south embankment had tall grass which prevented viewing the surface of the slopes (Photos SECP-15 through SECP-18). Based on our observations under these restrictions, the downstream slopes generally appeared to be in fair condition with one exception. The exception consisted of ponded water in an area against the downstream toe on the east embankment. See the following photo presented as Photo SECP-16 in appendix B.

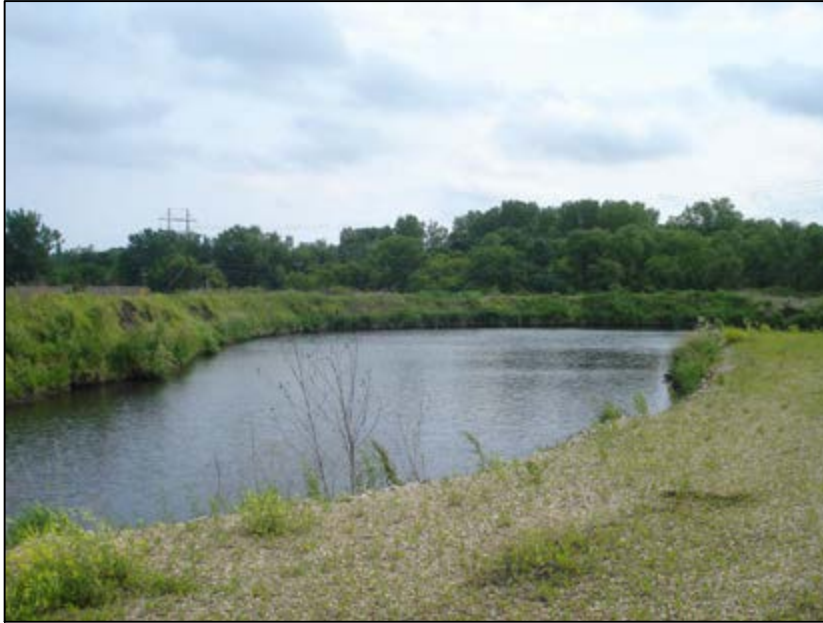
SECP-7

LOOKING NORTHEAST AT INTERIOR OF START OF SECONDARY POND. STEEP SLOPES AND TALL GRASSES ON NORTH BANK

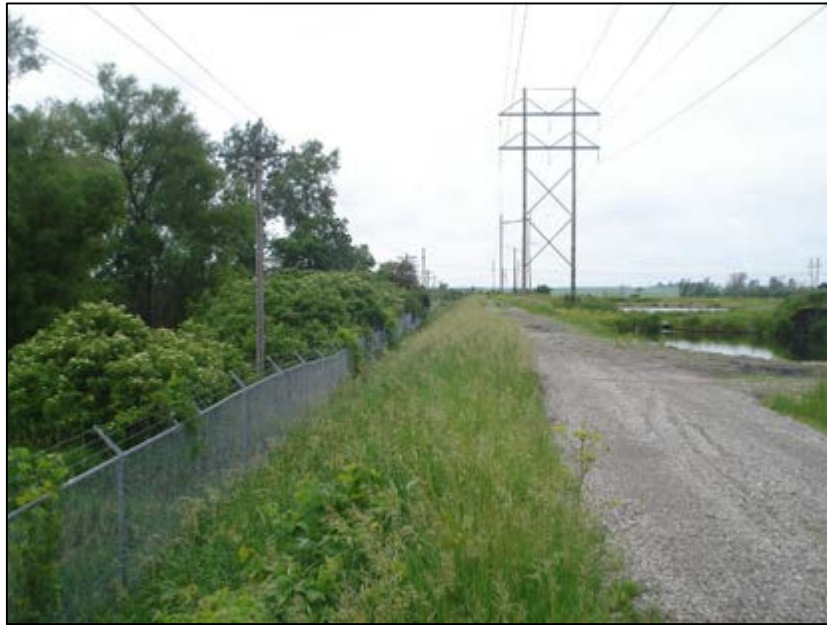
east embankment. This indicates a recent repair and the slopes are in good condition (Photo PP-4). The upstream slopes on the north half of the east embankment were covered with tall grass which prevented observation of the surface of the slopes. Although restricted by these conditions, the upstream slopes viewed from across the pond appeared to be steep and in fair condition (Photo PP-5). The downstream slopes on the east embankment were covered with tall grass which prevented observations of the surface of the slopes. Although restricted by these conditions, no evidence of surface sloughing or other failures were observed on the downstream slopes (Photos SECP-15 and SECP-21).

SECP-15
LOOKING SOUTH AT EAST DIKE CREST AND
DOWNSTREAM EMBANKMENT

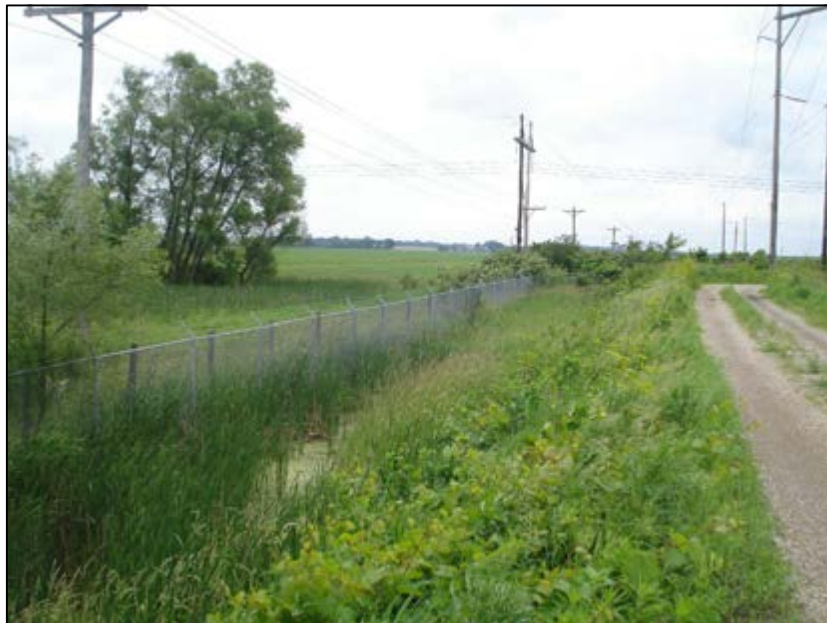
SECP-16
LOOKING SOUTH AT CREST AND DS SLOPE OF EAST DIKE OF
SECONDARY POND, WATER AT TOE OF DOWNSTREAM SLOPE
