**COAL ASH IMPOUNDMENT  
SITE ASSESSMENT DRAFT REPORT**

**Coffeen Power Station  
Ameren Energy Generating Company  
Coffeen, Illinois**

**KLEINFELDER PROJECT NUMBER 112618-3**

**October 15, 2010**

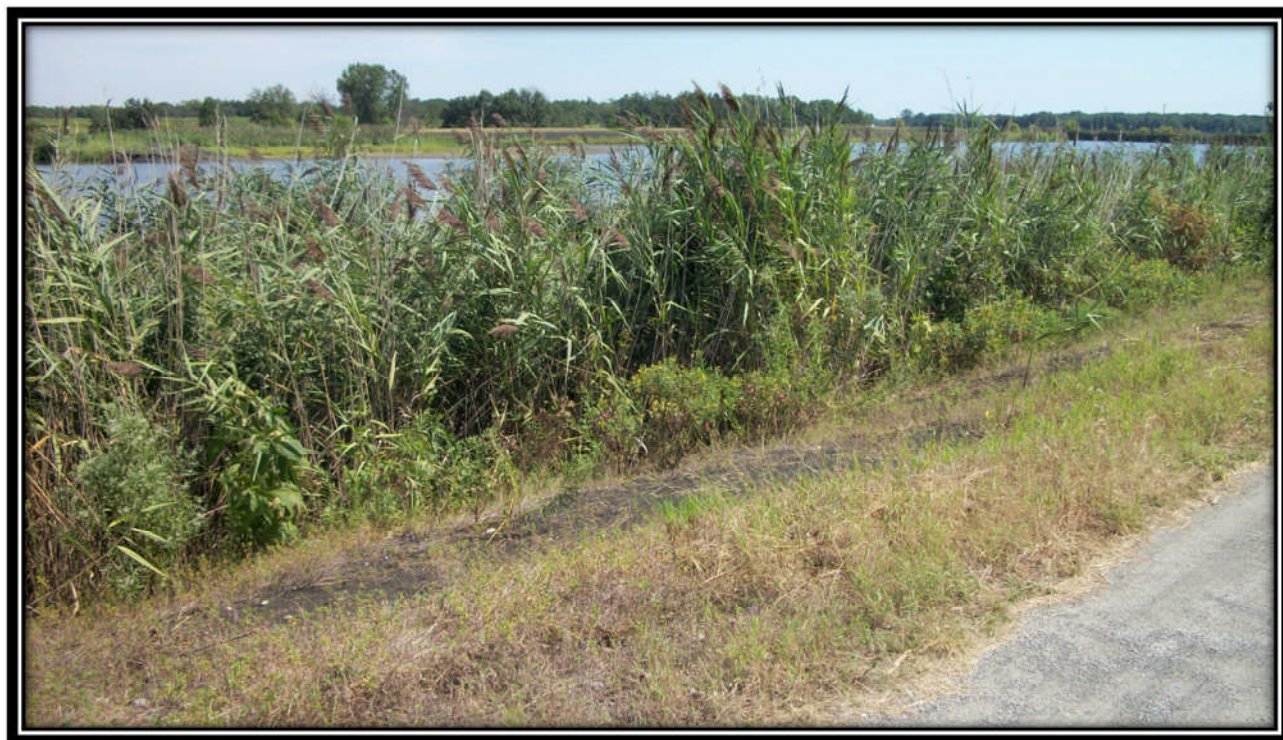
Overall, the upstream slope of the south and east embankments of the impoundment was in fair condition and the remainder of the upstream slope of the impoundment was in good condition. Photographs 2, 3, 5, 6, and 7 in Appendix B show the conditions of the upstream slope of the south embankment; Photographs 18 and 20 in Appendix B show the conditions of the upstream slope of the north embankment. Specific observations include:

Photo 2 – Vegetation on upstream slope of South embankment

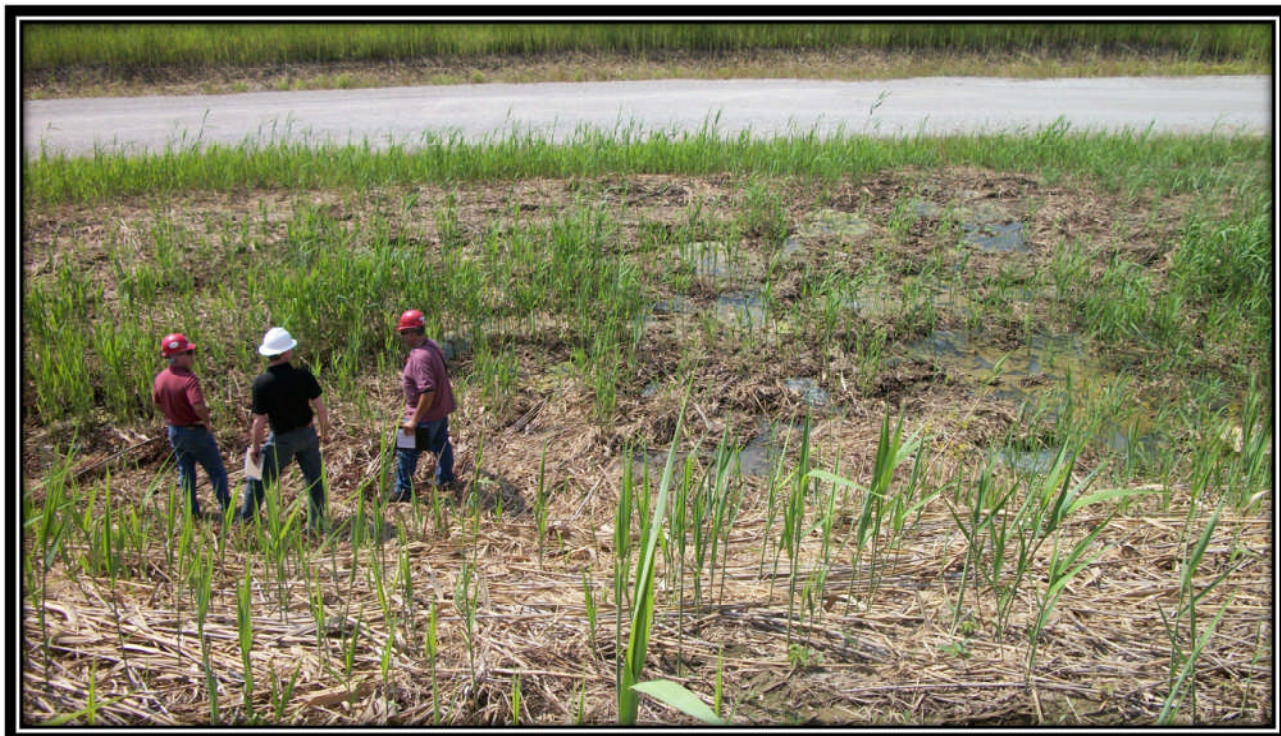
- Ponded water was observed at the toe of the south embankment and portions of the north embankment (see Photographs 4 and 9).
- The toe area had sparse grasses, some bushes, and multiple trees.
- A sheet pile wall supports the toe at the northeast corner of the pond (see Photographs 13, 15, and 16).

Photo 4 – Ponding at downstream toe of South embankment

3. **Establish seepage and ground water monitoring program**  
As discussed in Section, 3.5, ponded water was observed at various locations along the downstream embankment of the Recycle Pond. The presence of water at the downstream toe of the embankment raises questions regarding the integrity and the stability of the embankment. Therefore, a detailed monitoring program should be established to quantify various important factors, including the source of the water (seepage or surface runoff) and, if seepage is the source of the ponded water, seepage quantities through the embankment, the amount of sediments carried by the seepage water, and the fluctuation of ground water levels.

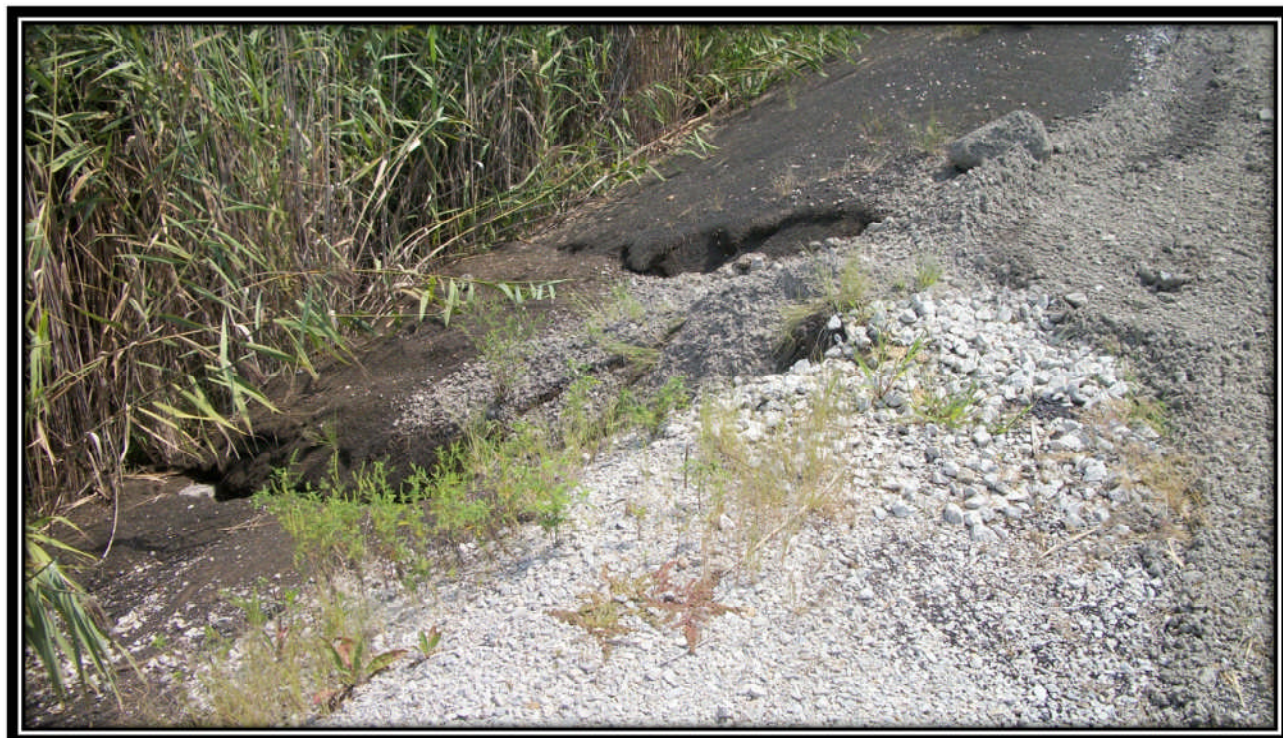
- Erosion rills, 6 to 12 inches deep, were noted on some of the downstream slopes (see Photographs 3 and 5).
- Grasses, woody bushes, and tree stumps were observed on the downstream slope and at the toe of the embankment (see Photographs 10, 19, 21, 22, and 23).
- Shallow sloughing was observed on the downstream slope of the south embankment (see Photographs 8 and 11).

Photo 5 - Erosion

1. **Repair erosion of embankment.** Minor surface erosion was noted at both the Recycle Pond and Gypsum Reclaim Pond. Areas where erosion has occurred should be filled in and re-dressed with appropriate fill in order to prevent erosion from cutting further into the embankments.

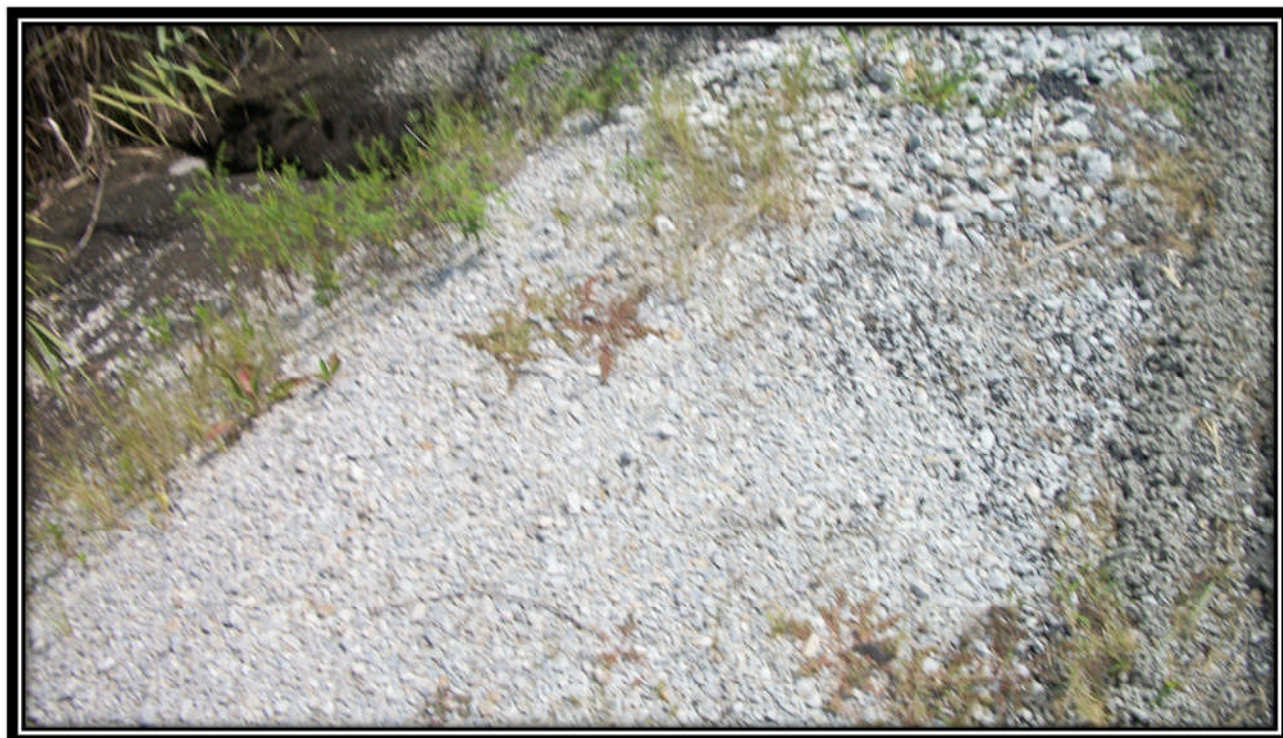
Photo 6 - Erosion

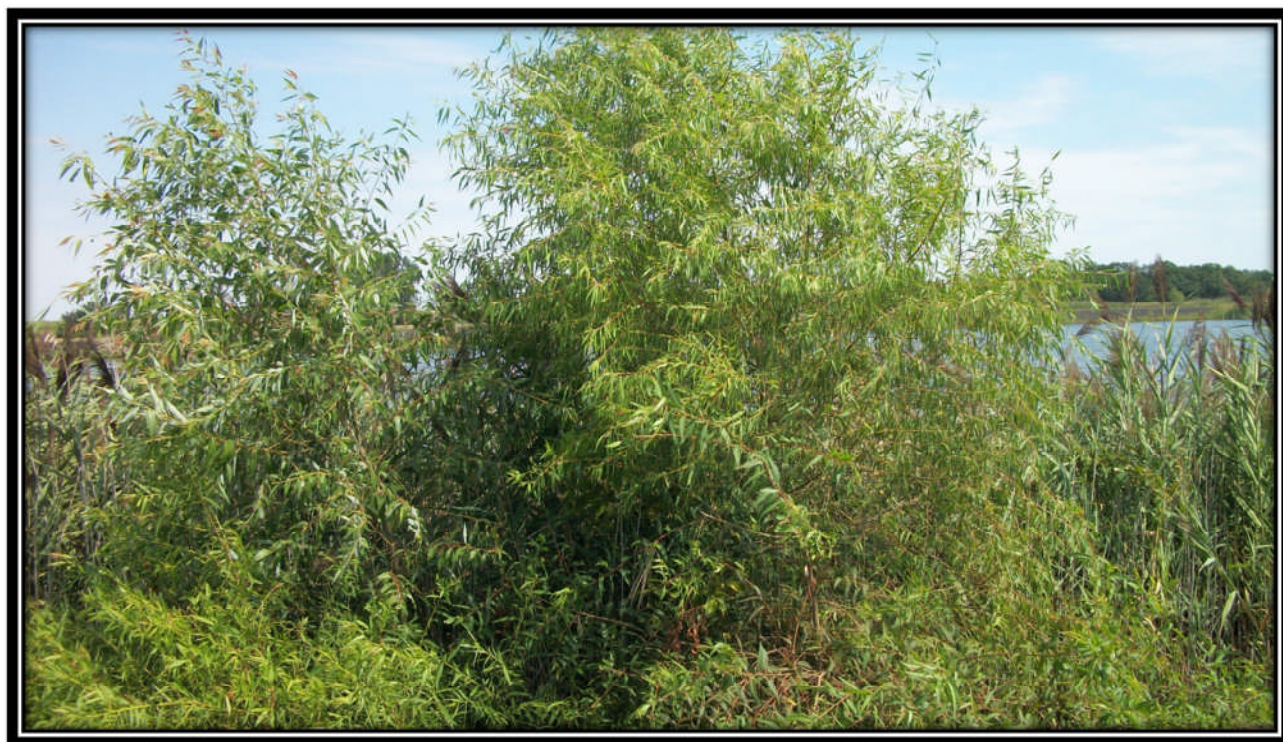
Photo 7 – Tree, approximately 3 inch diameter

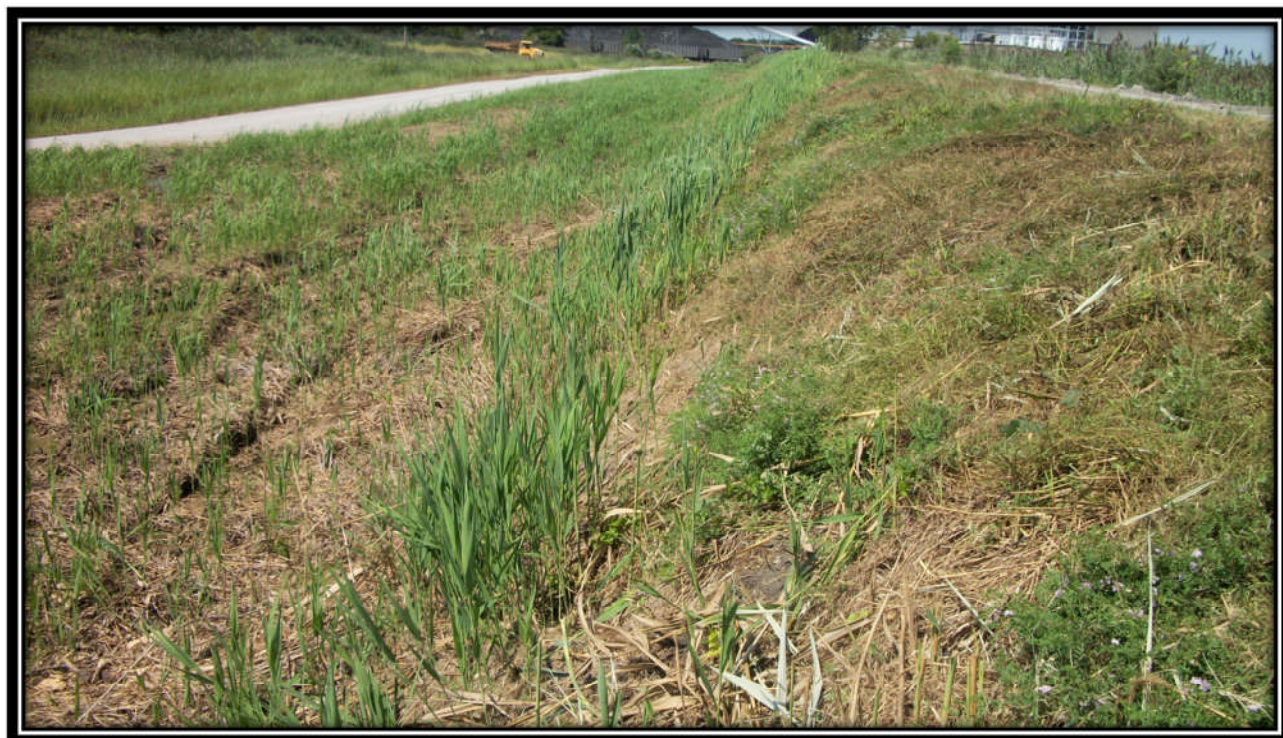
Photo 8 – Shallow sloughing on downstream slope of south embankment

5. **Perform video assessments of CMP outlet on the Recycle Pond.** A video inspection should be performed on this outlet to assess the condition of the conduit and its ability to pass the appropriate design event.
6. **Control vegetation on the upstream and downstream slopes.** Refer to Federal Emergency Management Agency's (FEMA) Manual 534, "Impact of Plants on Earthen Impoundments", for guidance on vegetation removal. This manual is available on the FEMA website.
7. **Repair sloughs on South and East embankments of Recycle Pond.** Minor sloughing on the south and east embankments should be repaired with engineered fill and sod cover re-established.

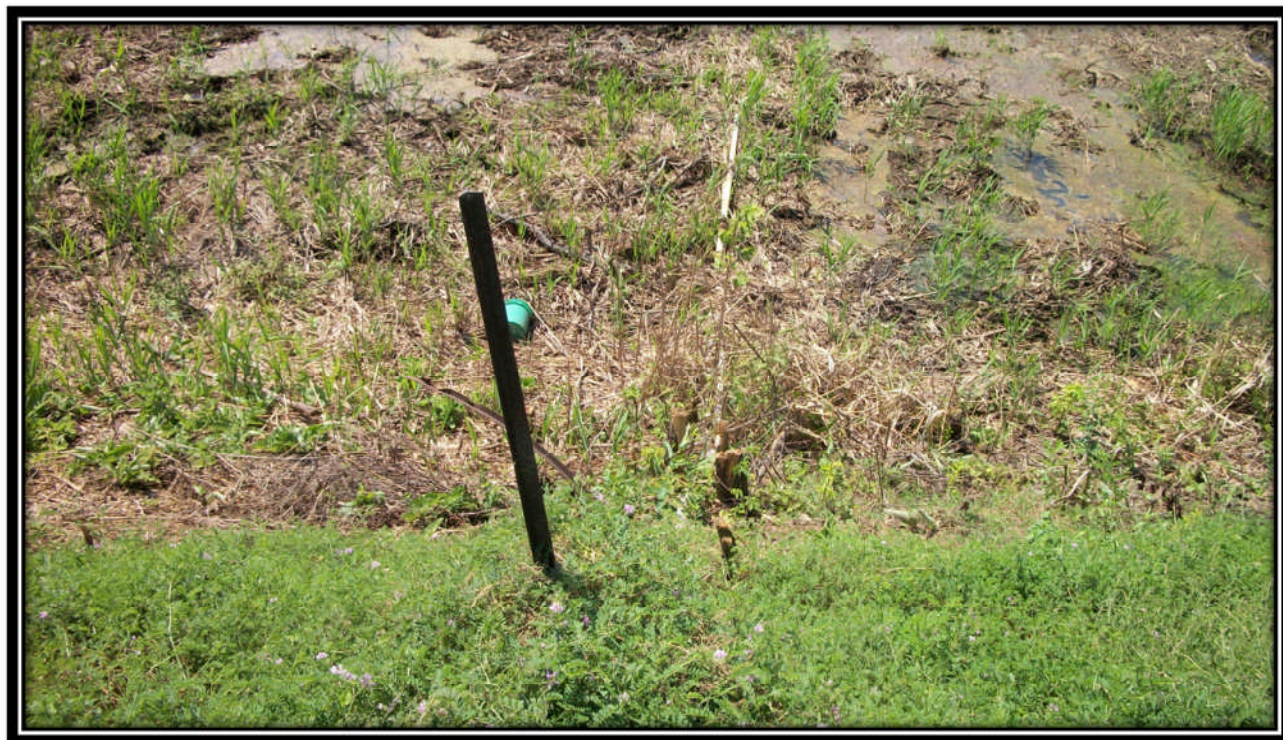
Photo 9 – Abandoned pump crossing

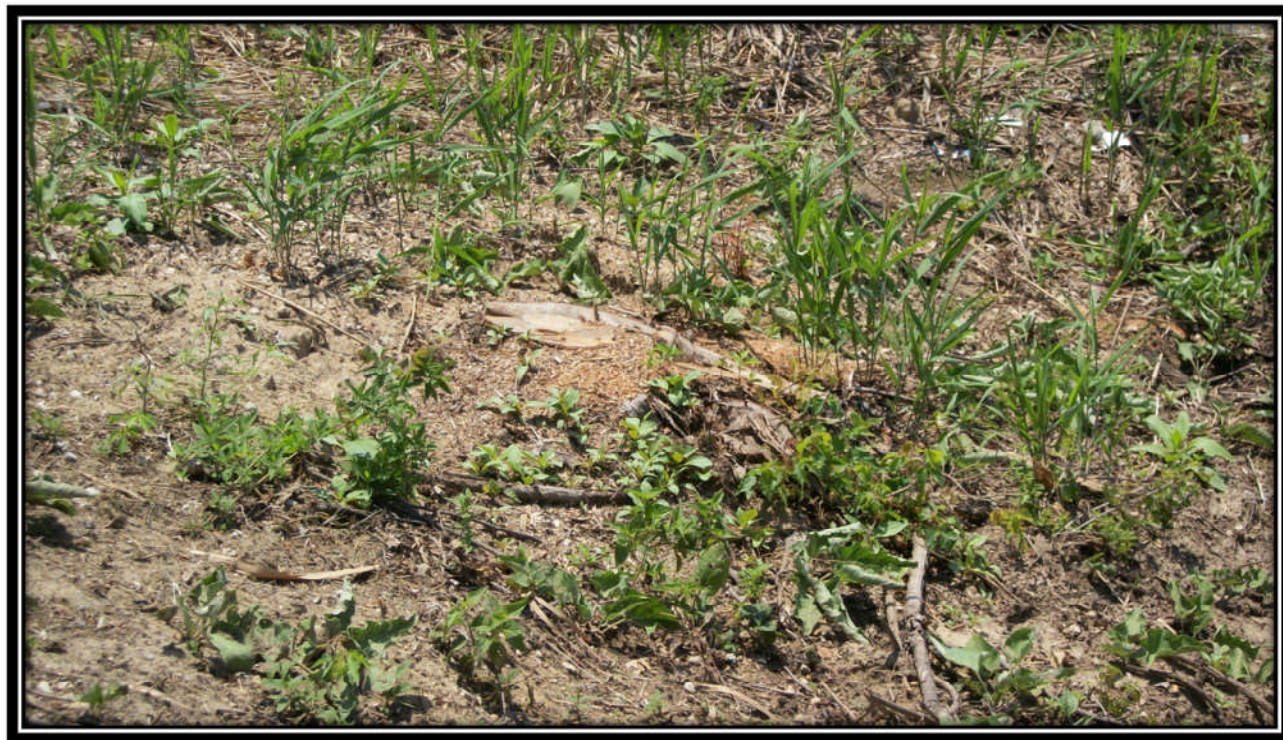
Photo 10 – Large tree stump mid-slope

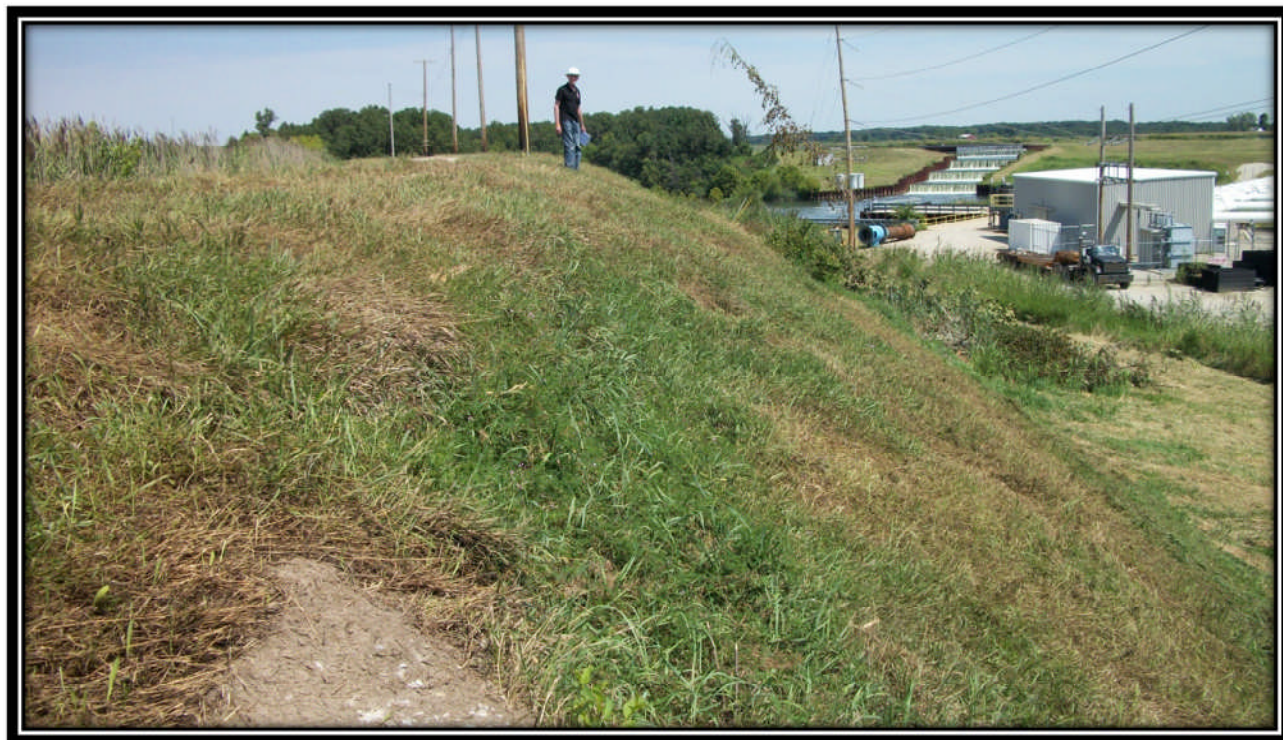
Photo 11 – East embankment looking North with minimal scarps

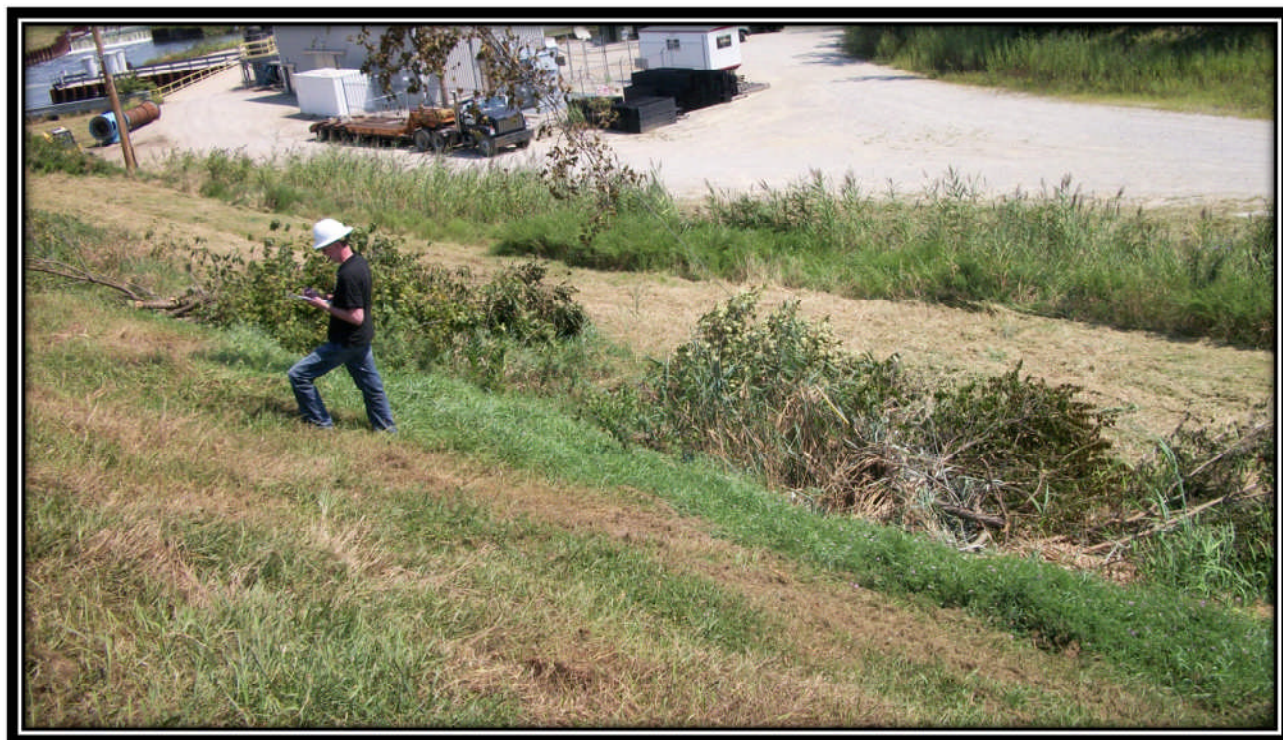
Photo 12 – Debris at downstream toe of East embankment

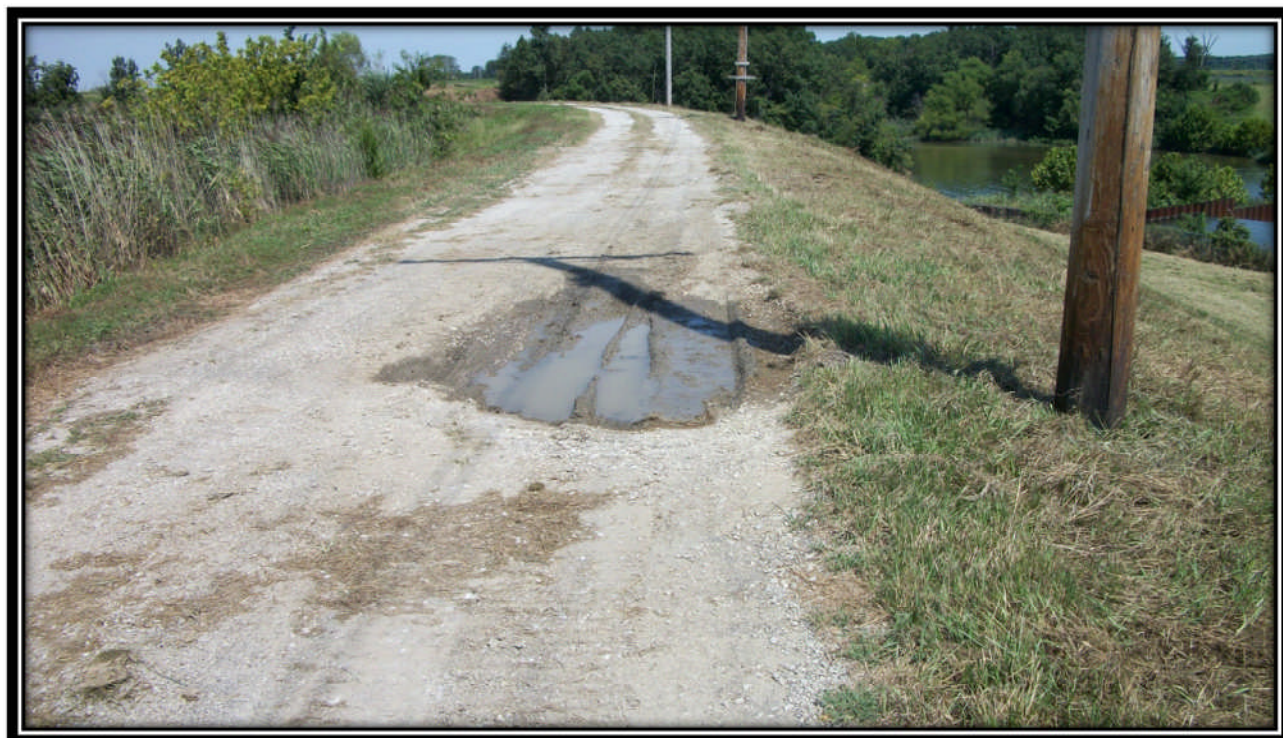
Photo 14 – Rutting on crest

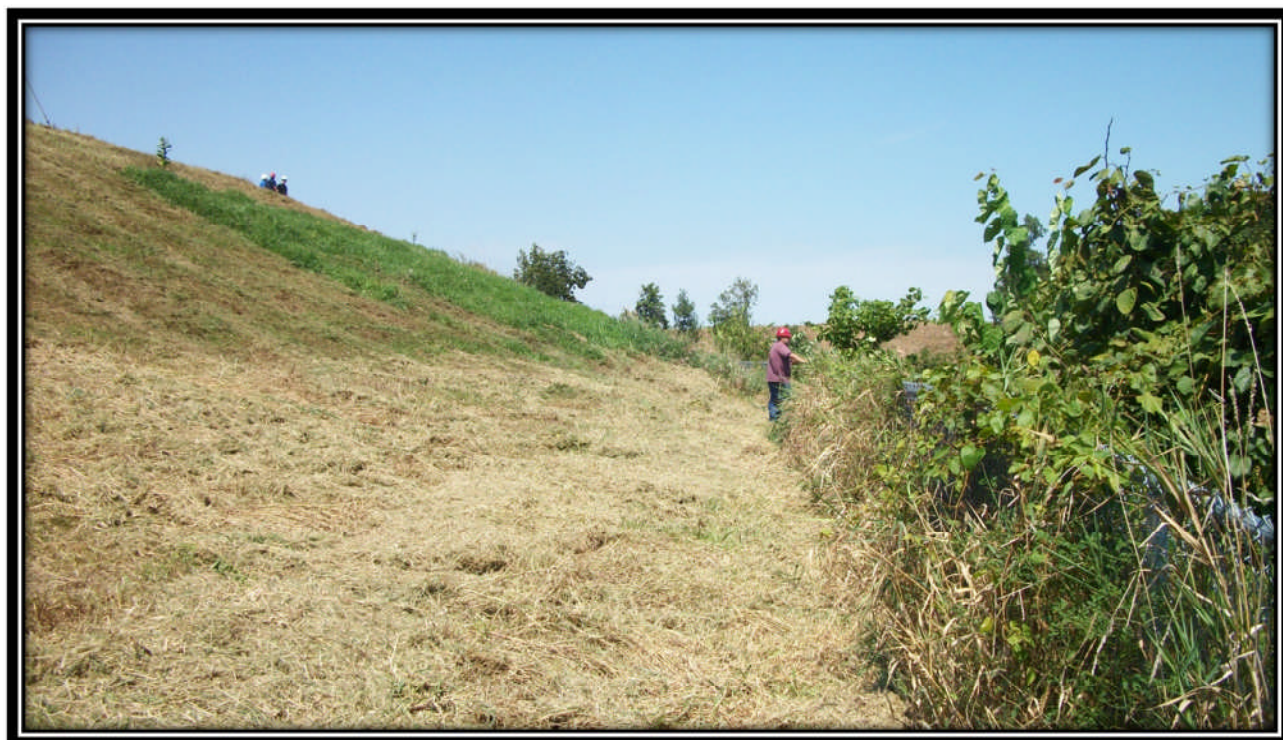
Photo 15 – Downstream of Northeast corner to sheetpile wall

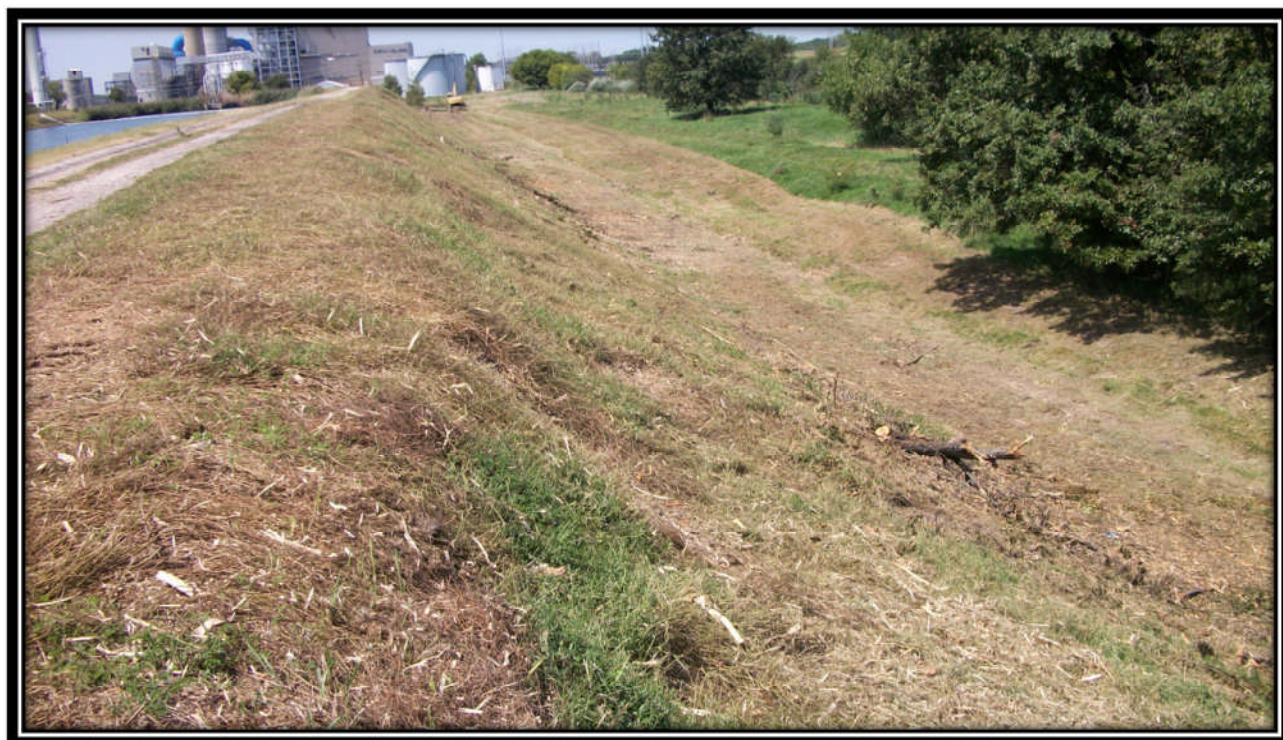
Photo 19 – Slope failure along downstream slope

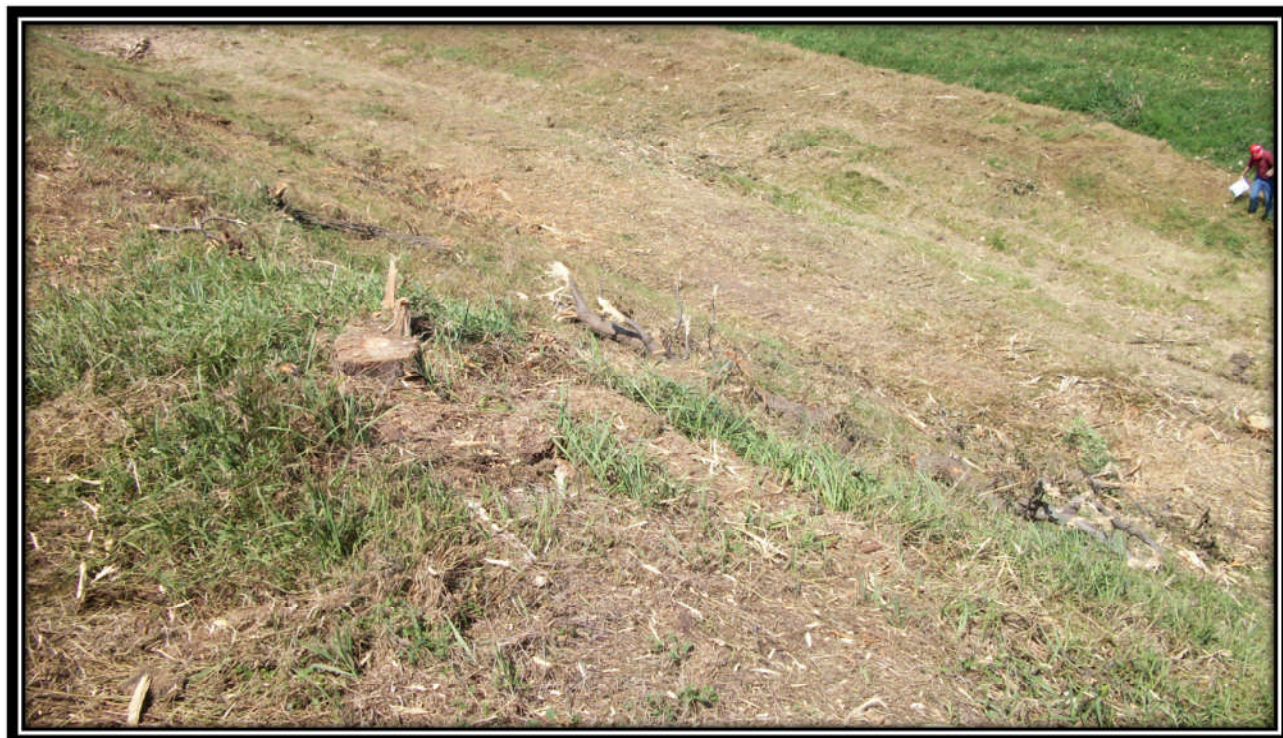
Photo 21 – Tree stumps

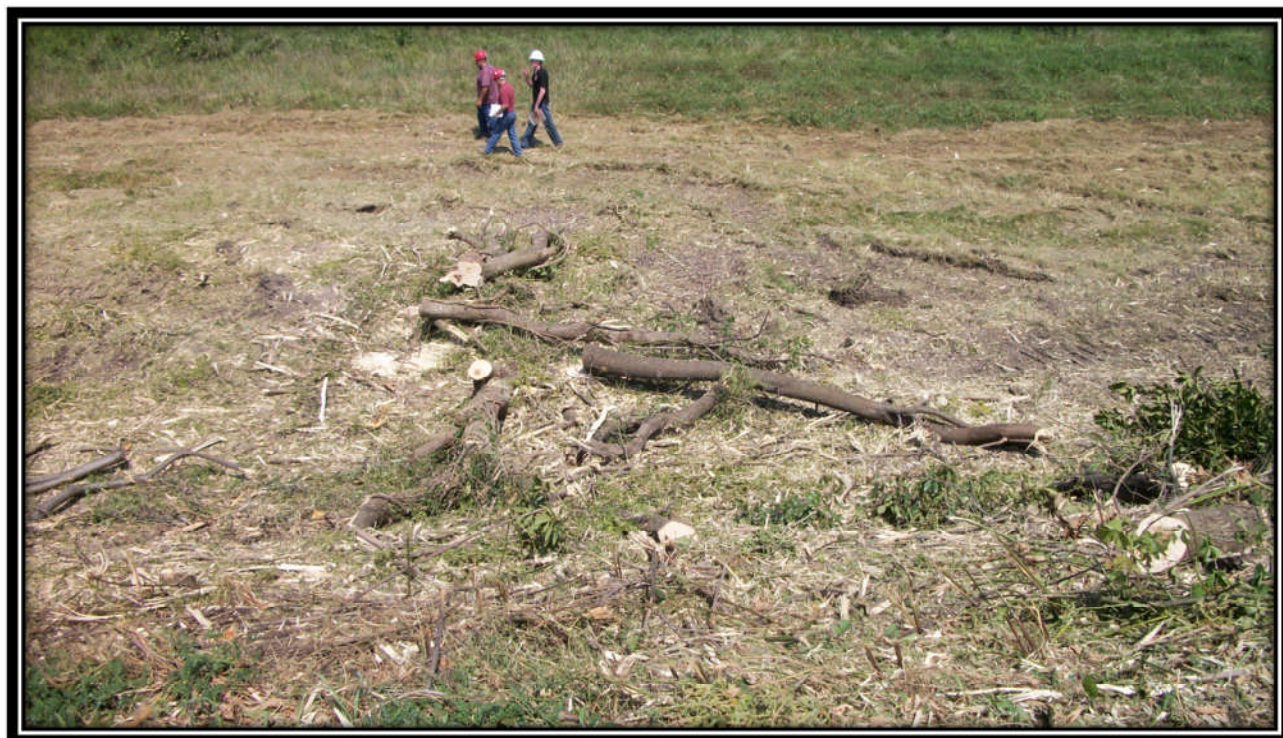
Photo 22 – Debris on downstream slope of North embankment

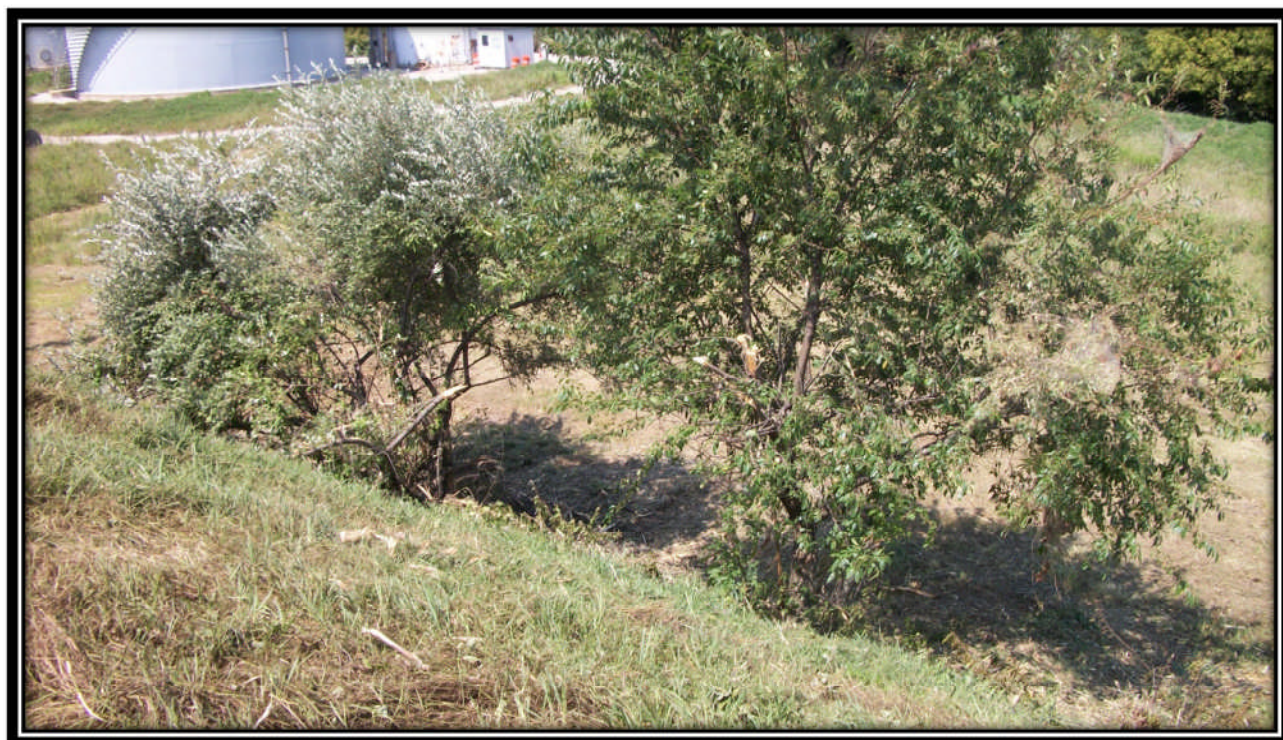
Photo 23 – Trees on downstream slope

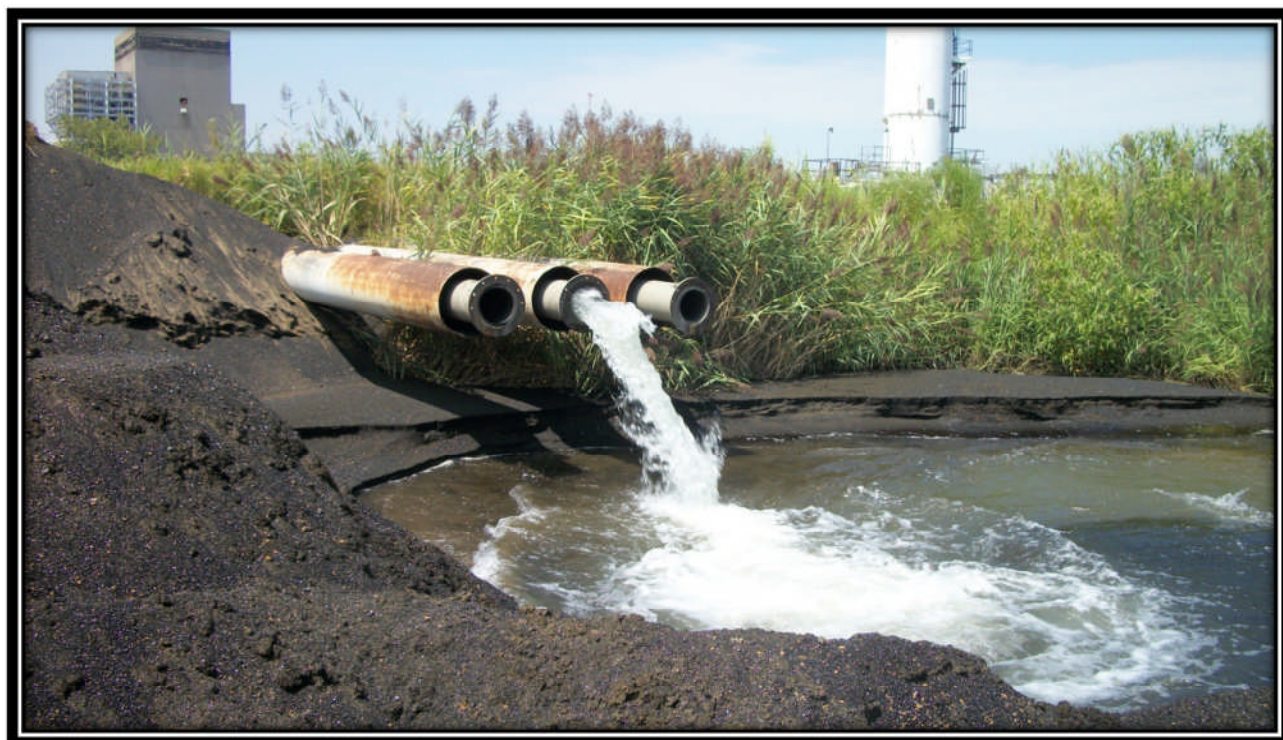
Photo 31 – Ash pond discharge outlet pipes
