COAL ASH IMPOUNDMENT SITE ASSESSMENT REPORT

**Coffeen Power Station
Ameren Energy Generating Company
Coffeen, Illinois**

KLEINFELDER PROJECT NUMBER 112618-3

April 2011

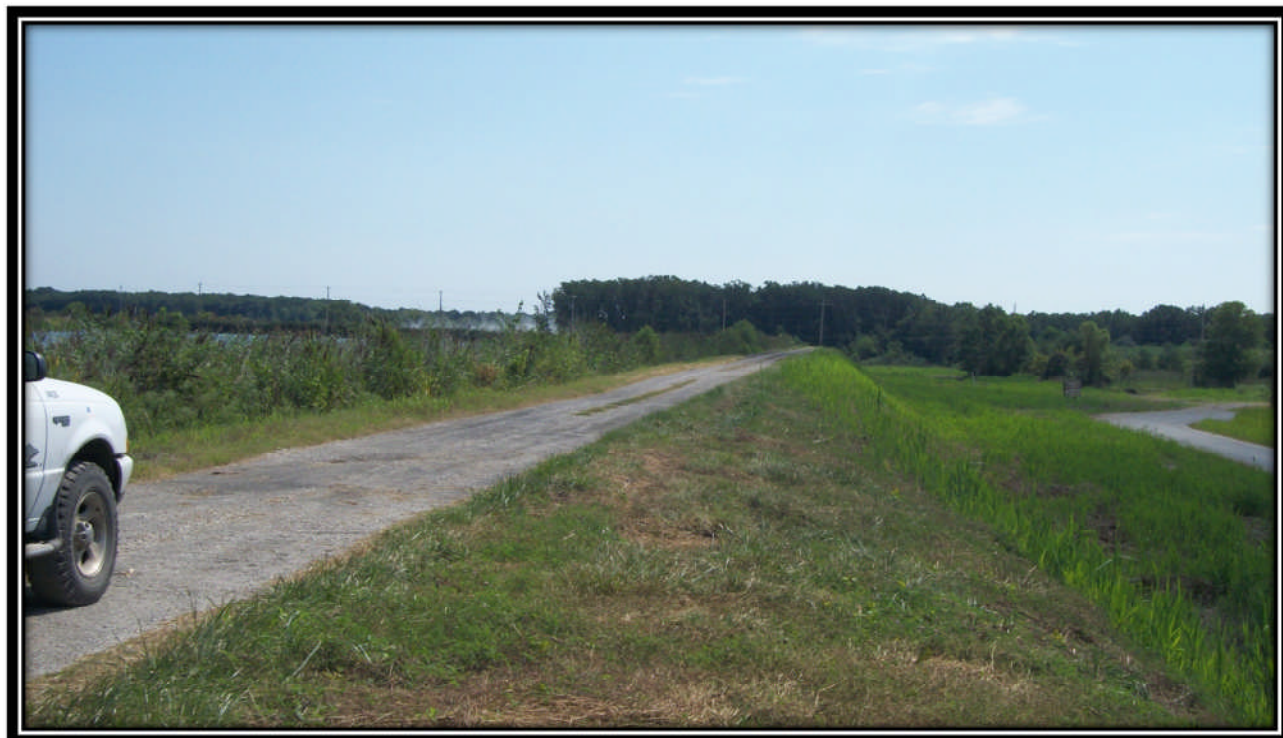
Overall, the crest of the impoundment was in satisfactory condition. Photographs 1, 14, and 18 show the condition of the crest. Specific observations include:

Photo 1 – Looking East along South embankment

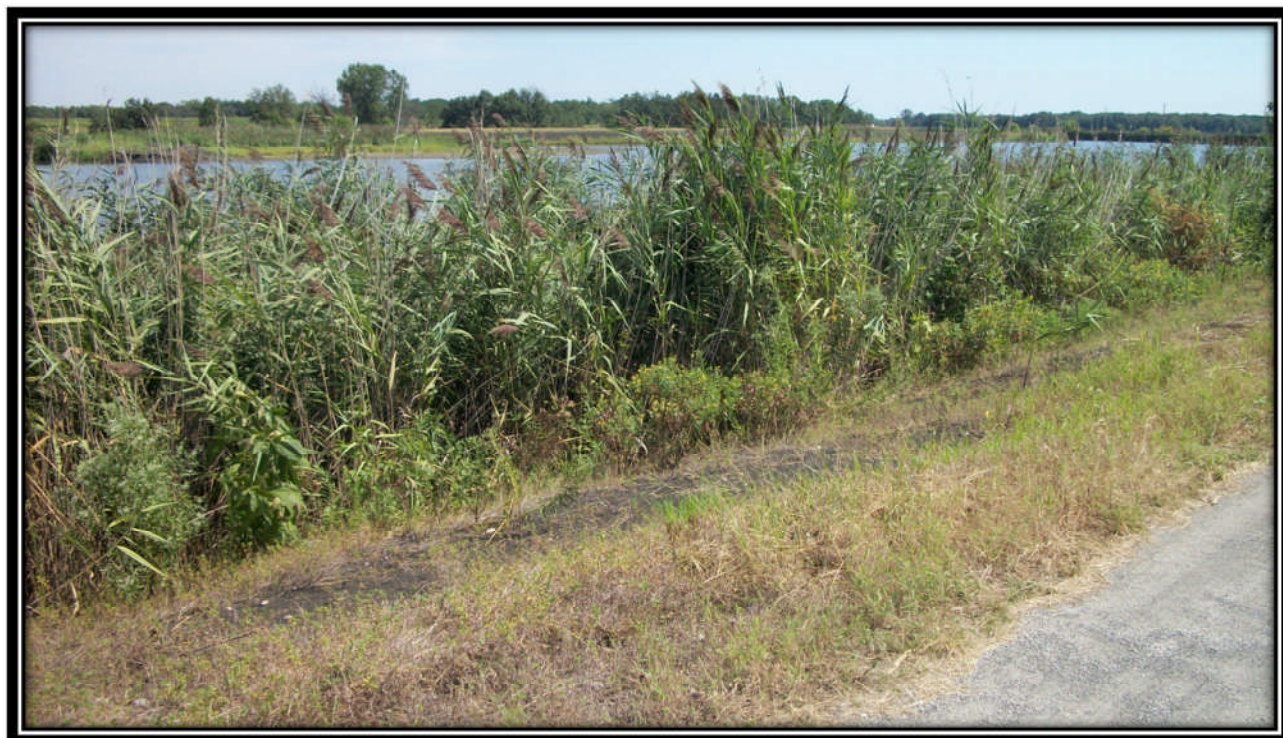
Overall, the upstream slope of the south and east embankments of the impoundment was in fair condition and the remainder of the upstream slope of the impoundment was in satisfactory condition. Photographs 2, 3, 5, 6, and 7 in Appendix B show the conditions of the upstream slope of the south embankment; Photographs 18 and 20 in Appendix B show the conditions of the upstream slope of the north embankment. Specific observations include:

- The upstream slope was laid back at approximately 1.5H:1V, based on visual observations. This varies from the construction documents provided by Ameren, probably due to the build-up of bottom ash on the embankment. However, it is possible that cleanout operations at the Recycle Pond could have cut into the embankment and steepened it over time.
- Minor erosion rills, less than 6 inches deep, were noted on some of the upstream slopes.
- Grasses and woody bushes were observed on the upstream slope for the majority of the south and east embankments of the impoundment.
- Mowing/Vegetation control had not been completed on the majority of the upstream slope.

Photo 2 – Vegetation on upstream slope of South embankment

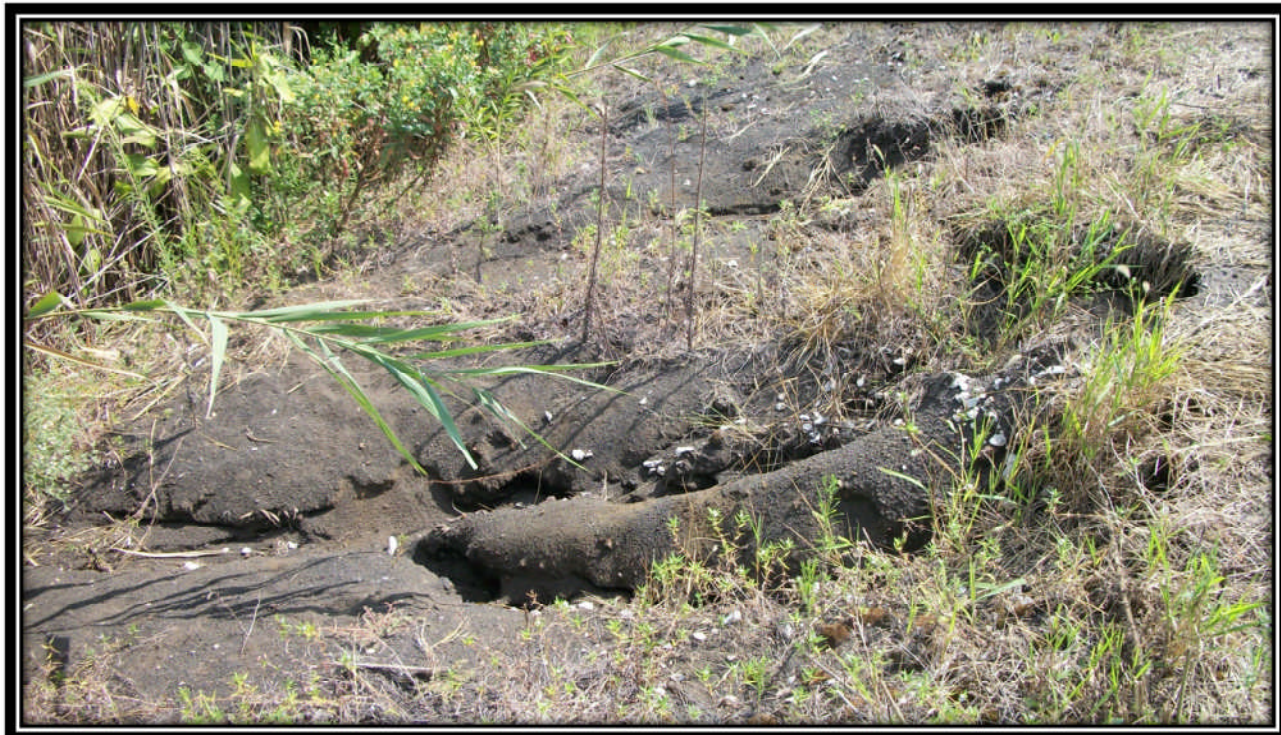
- Erosion rills, 6 to 12 inches deep, were noted on some of the downstream slopes (see Photographs 3 and 5).
- Grasses, woody bushes, and tree stumps were observed on the downstream slope and at the toe of the embankment (see Photographs 10, 19, 21, 22, and 23).
- Shallow sloughing was observed on the downstream slope of the south embankment (see Photographs 8 and 11).

Photo 3 – Gulleys on upstream slope of South embankment

1. **Repair erosion of embankment by 08/01/2011.** Minor surface erosion was noted at both the Recycle Pond and Gypsum Reclaim Pond. Areas where erosion has occurred should be filled in and re-dressed with appropriate fill in order to prevent erosion from cutting further into the embankments.

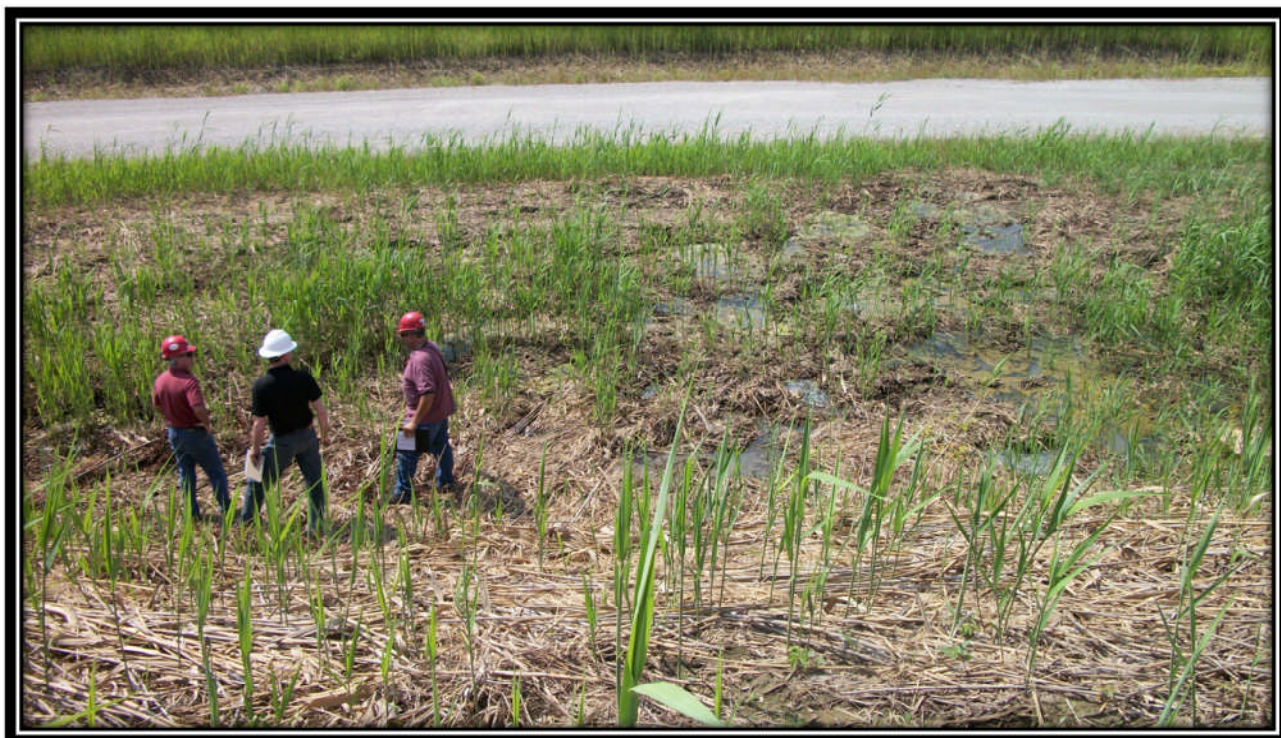
- Ponded water was observed at the toe of the south embankment and portions of the north embankment (see Photographs 4 and 9).
- The toe area had sparse grasses, some bushes, and multiple trees.
- A sheet pile wall supports the toe at the northeast corner of the pond (see Photographs 13, 15, and 16).

Photo 4 – Ponding at downstream toe of South embankment

3. **Establish seepage and ground water monitoring program by 08/01/2011.** As discussed in Section, 3.5, ponded water was observed at various locations along the downstream embankment of the Recycle Pond. The presence of water at the downstream toe of the embankment raises questions regarding the integrity and the stability of the embankment. Therefore, a detailed monitoring program should be established to quantify various important factors, including the source of the water (seepage or surface runoff) and, if seepage is the source of the ponded water, seepage quantities through the embankment, the amount of sediments carried by the seepage water, and the fluctuation of ground water levels.

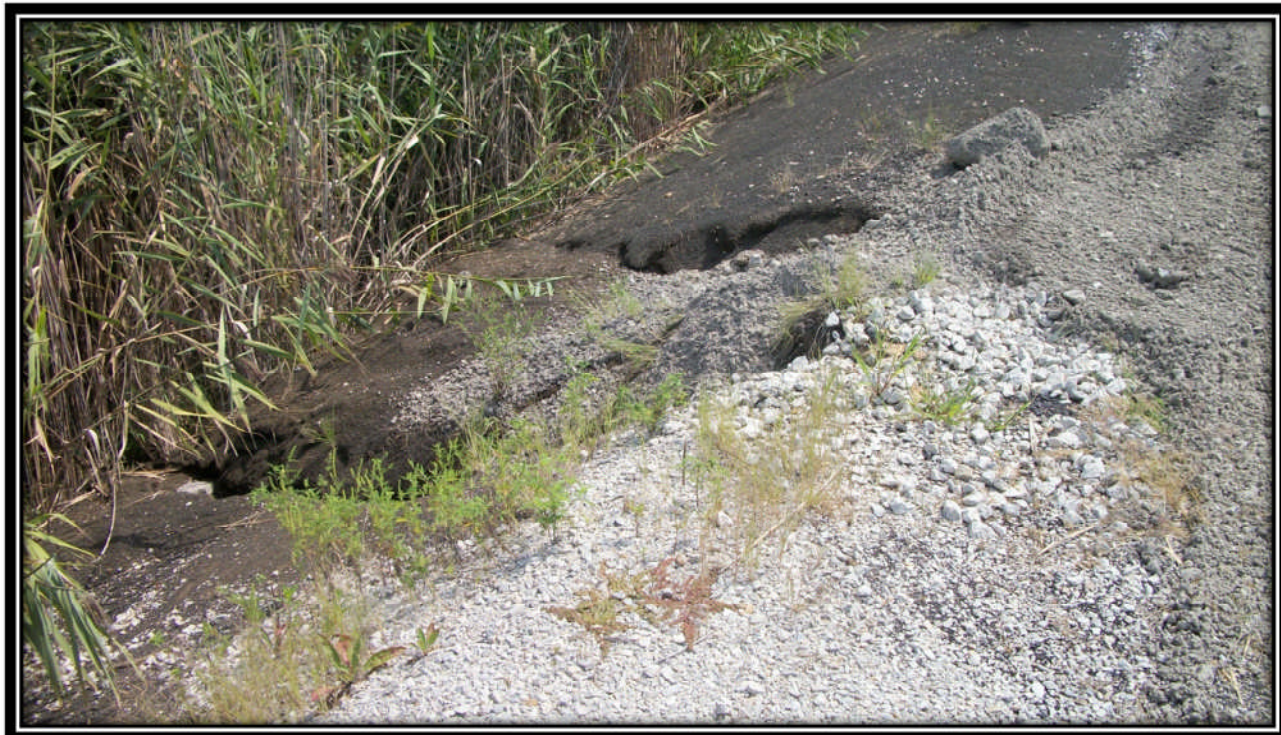
Photo 5 - Erosion

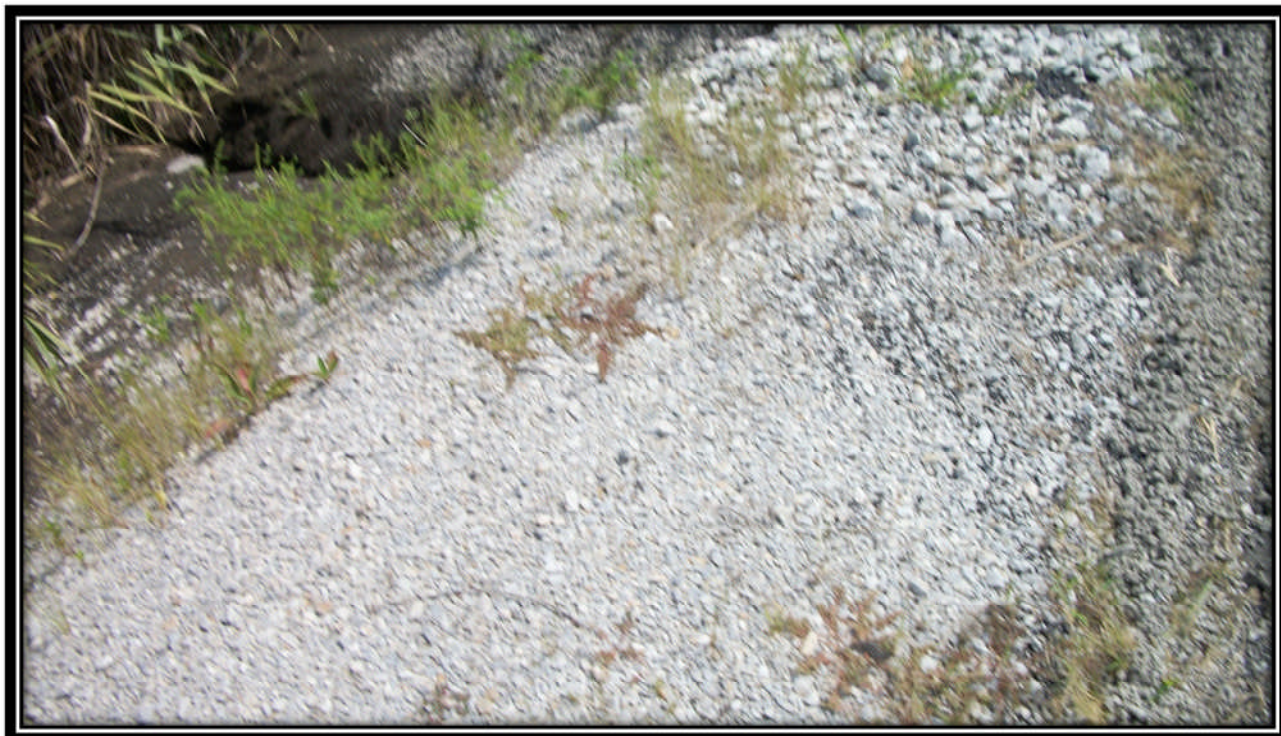
Photo 6 - Erosion

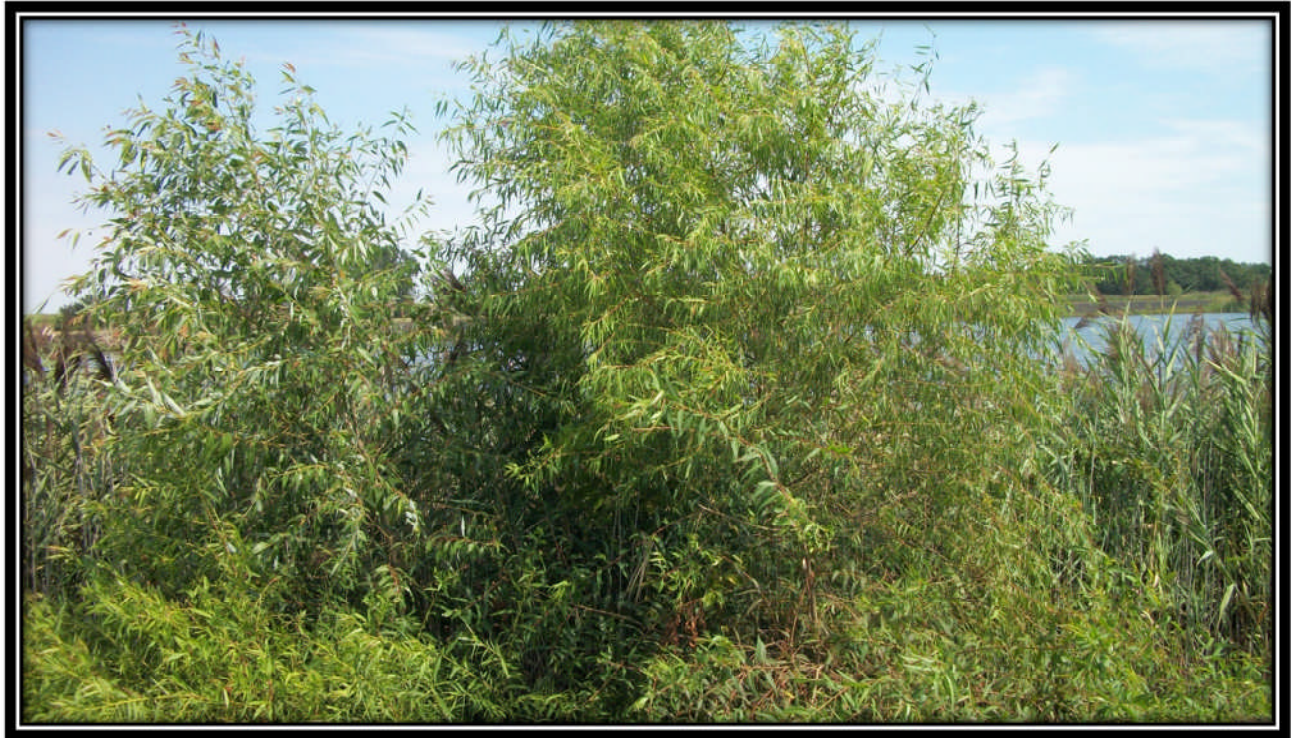
Photo 7 – Tree, approximately 3 inch diameter

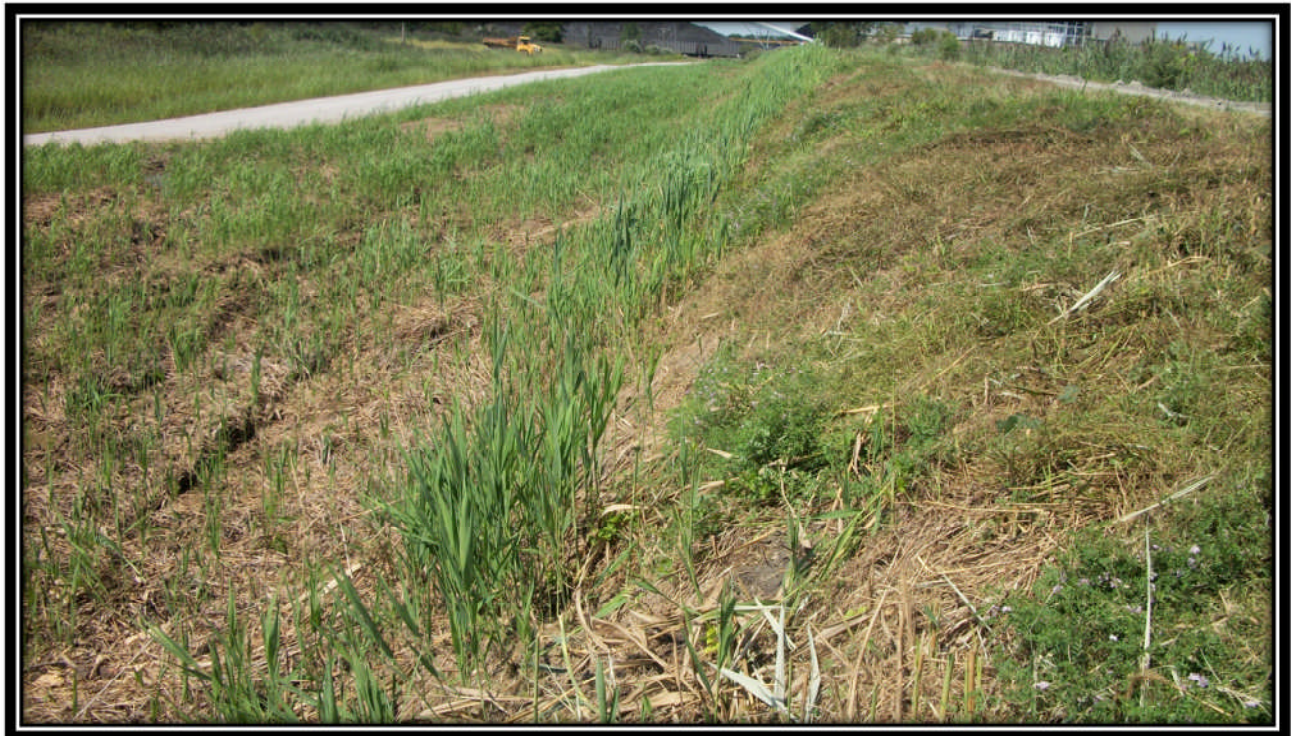
Photo 8 – Shallow sloughing on downstream slope of south embankment

5. **Perform video assessments of CMP outlet on the Recycle Pond by 08/01/2011.** A video inspection should be performed on this outlet to assess the condition of the conduit and its ability to pass the appropriate design event.
6. **Control vegetation on the upstream and downstream slopes by 08/01/2011.** Refer to Federal Emergency Management Agency's (FEMA) Manual 534, "Impact of Plants on Earthen Impoundments", for guidance on vegetation removal. This manual is available on the FEMA website.
7. **Repair sloughs on South and East embankments of Recycle Pond by 08/01/2011.** Minor sloughing on the south and east embankments should be repaired with engineered fill and sod cover re-established.

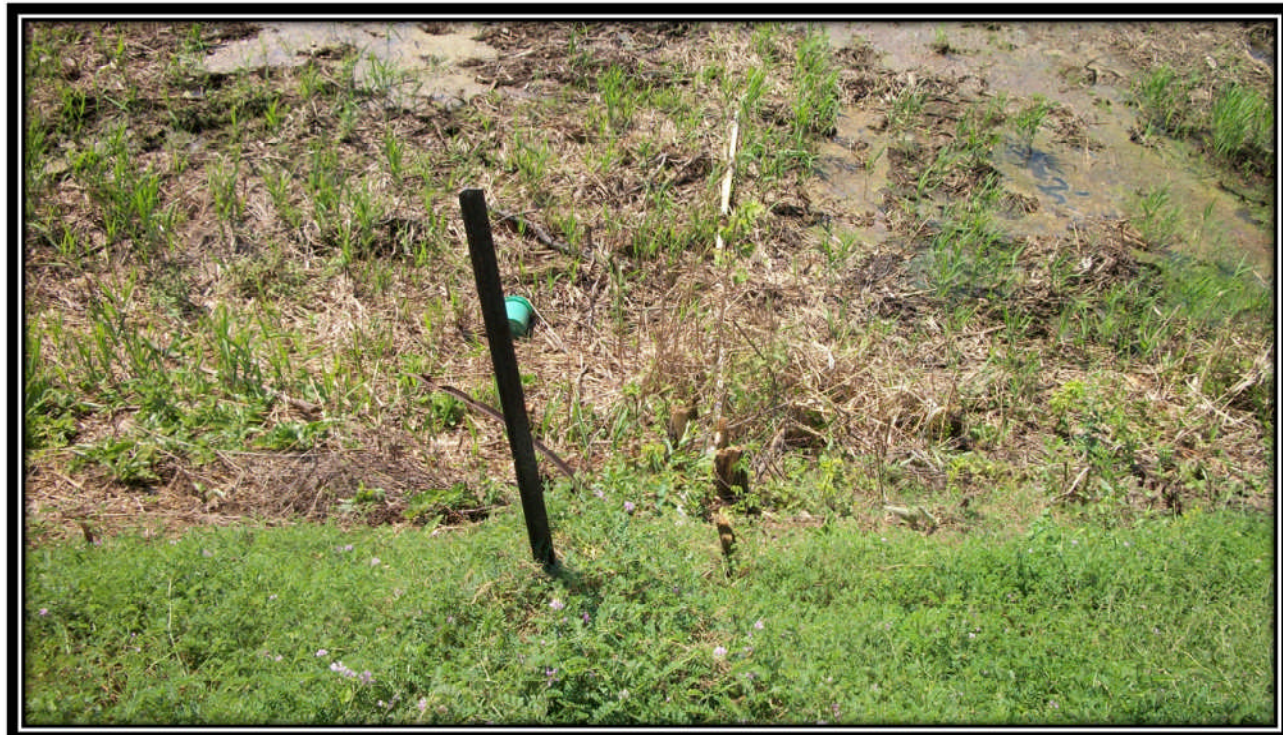
Photo 9 – Abandoned pump crossing

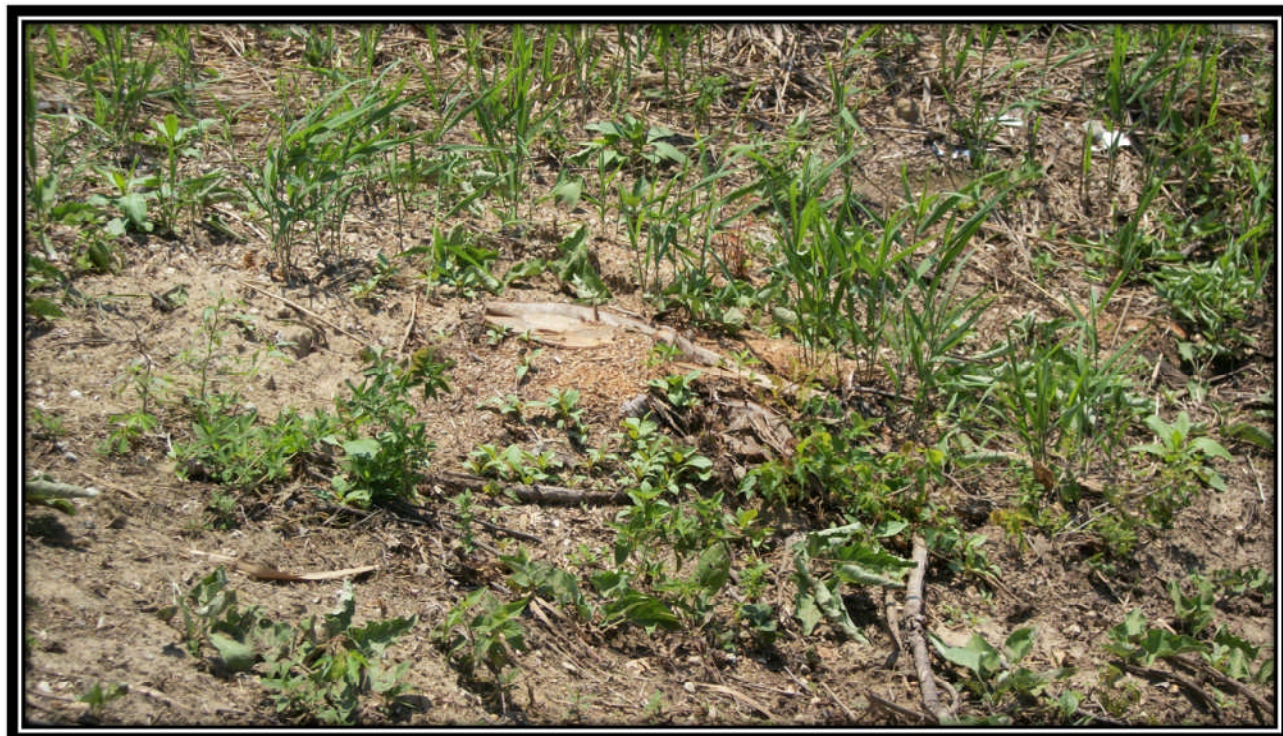
Photo 10 – Large tree stump mid-slope

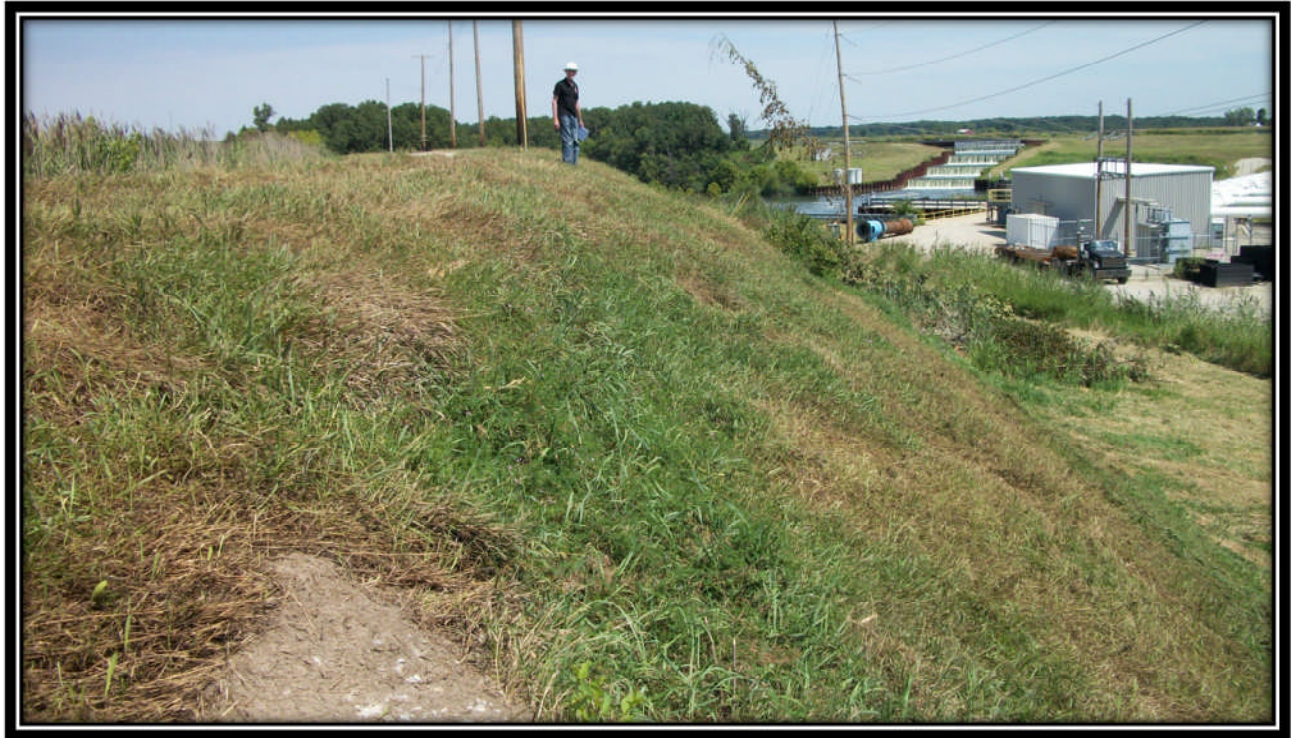
Photo 11 – East embankment looking North with minimal scarps

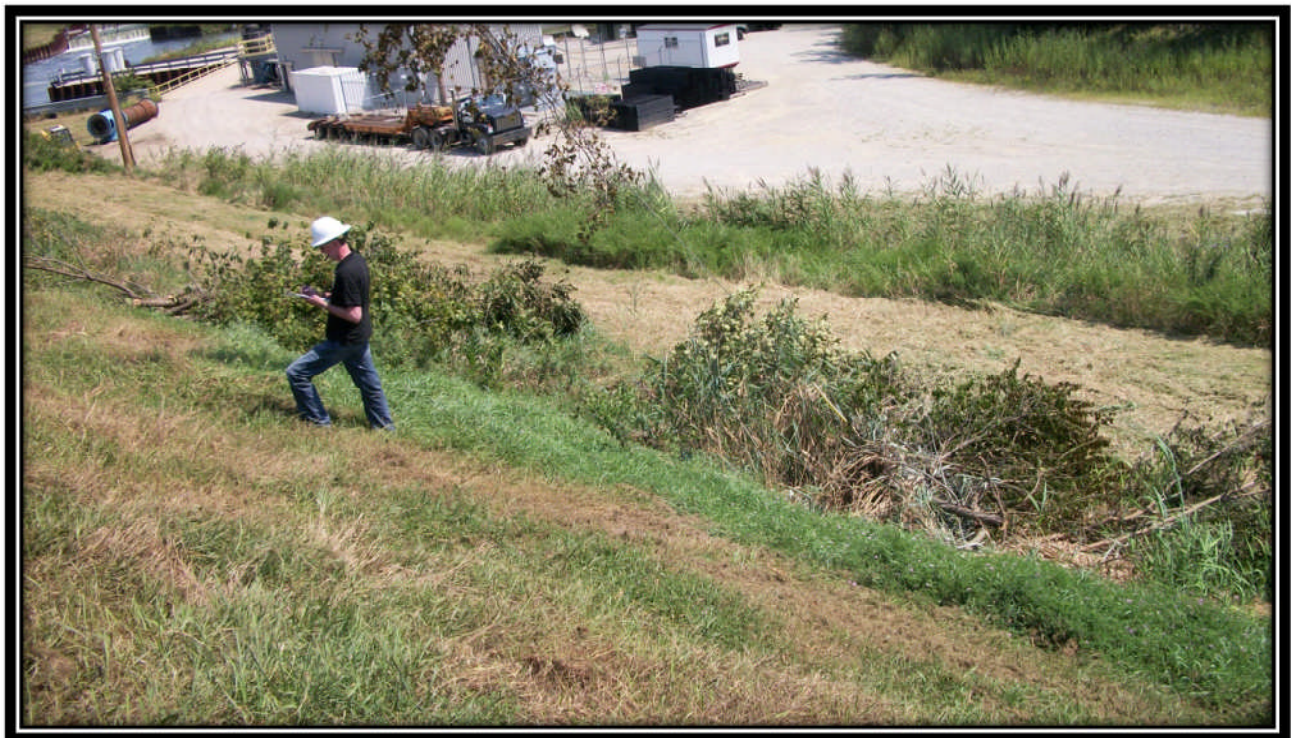
Photo 12 – Debris at downstream toe of East embankment

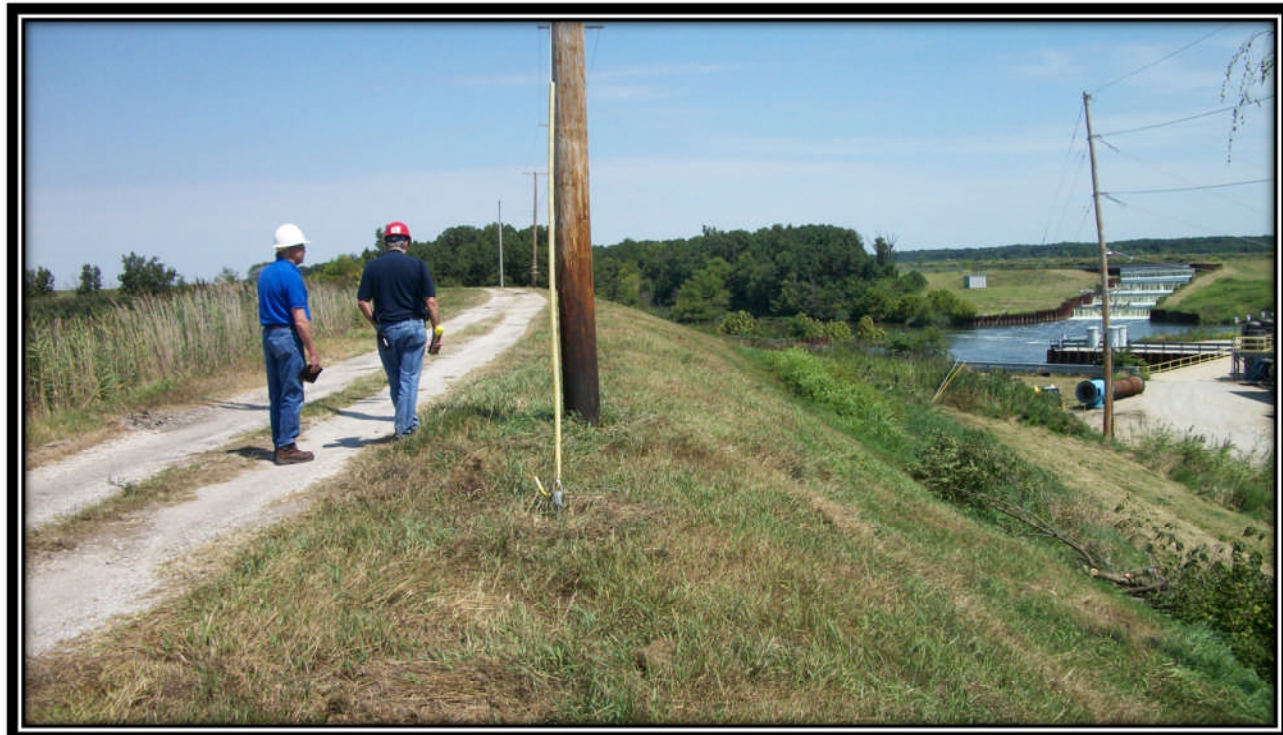
Photo 13 – Looking North on East embankment

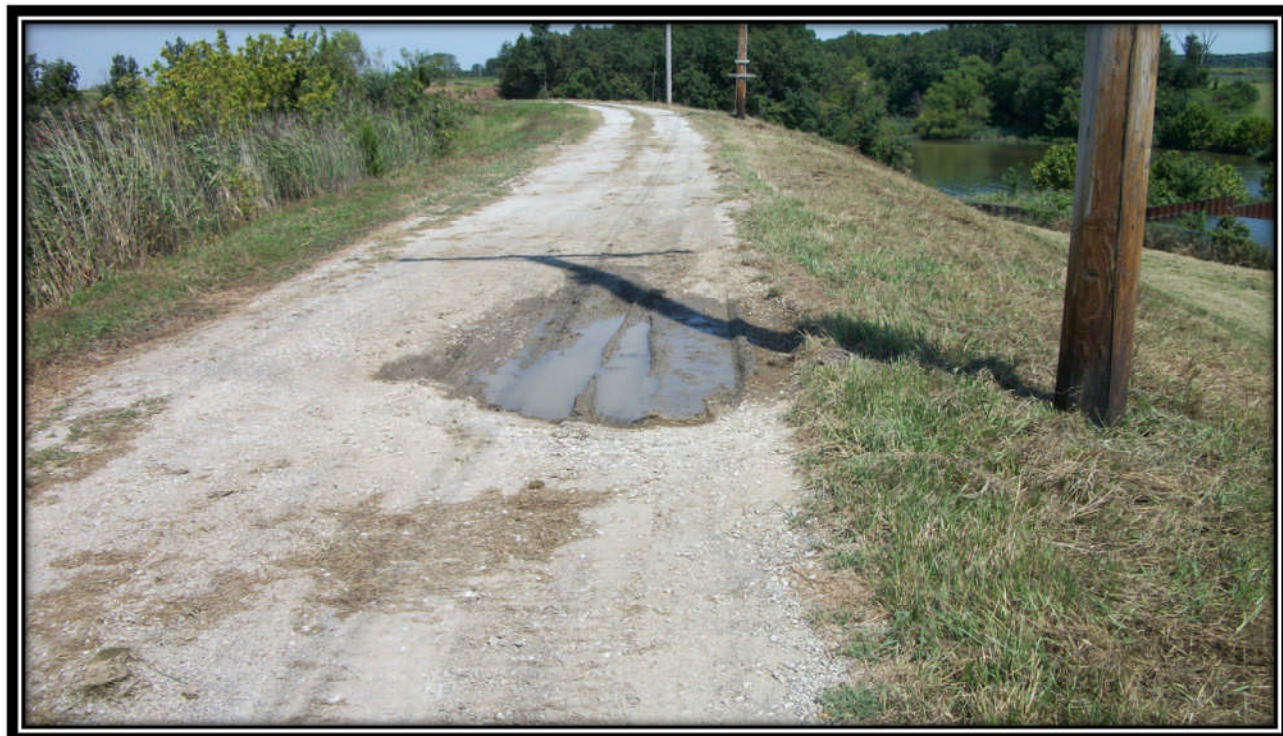
Photo 14 – Rutting on crest

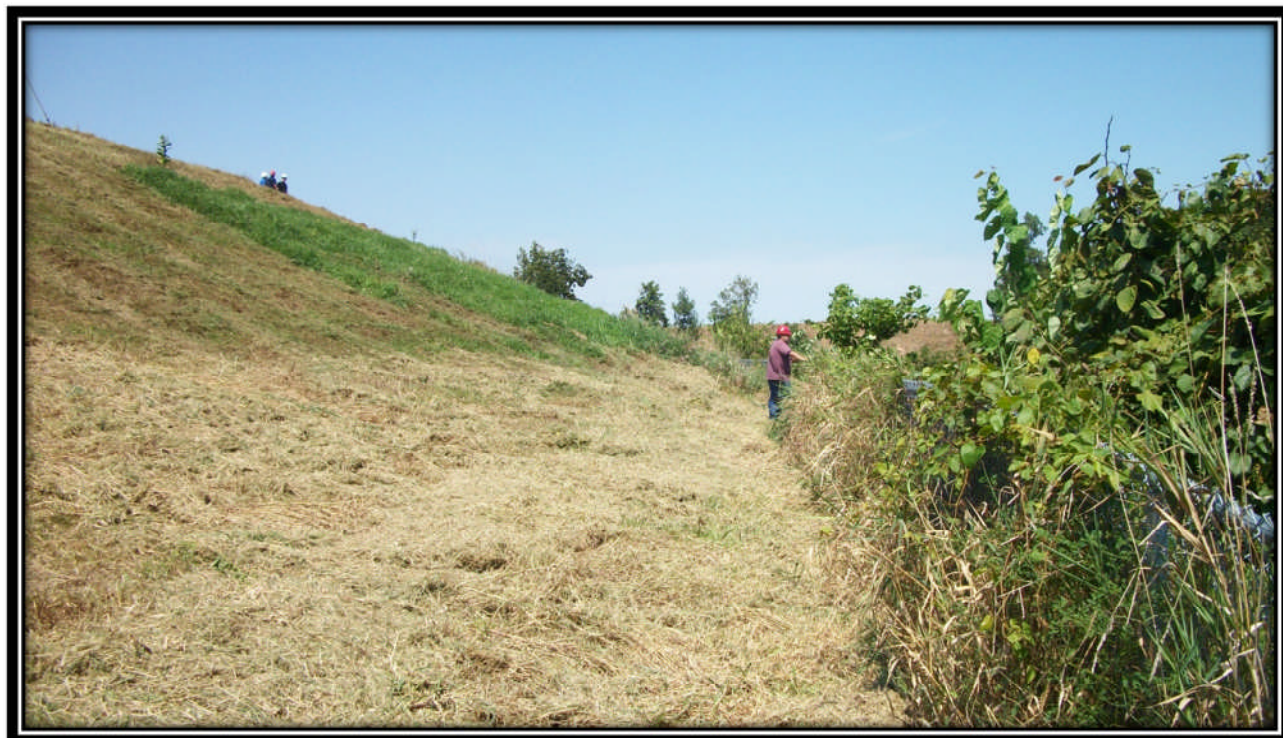
Photo 15 – Downstream of Northeast corner to sheetpile wall

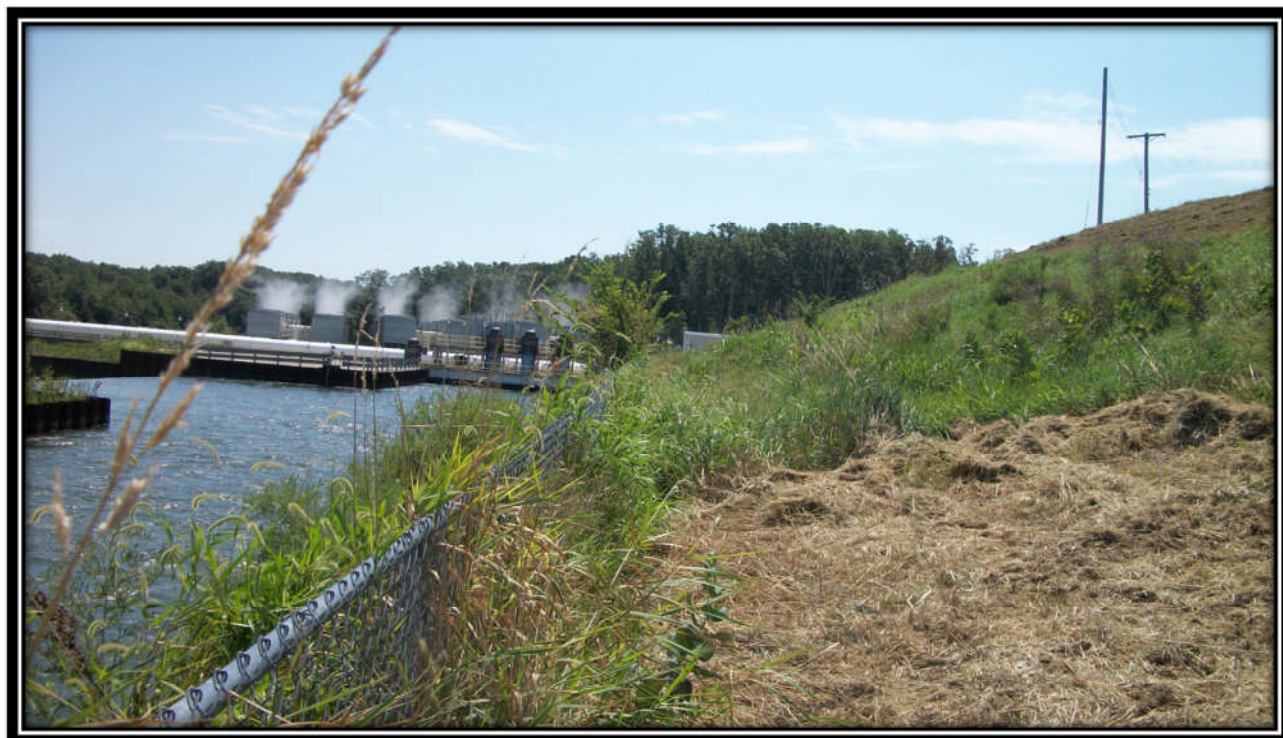
Photo 16 – Downstream of Northeast corner to sheetpile wall

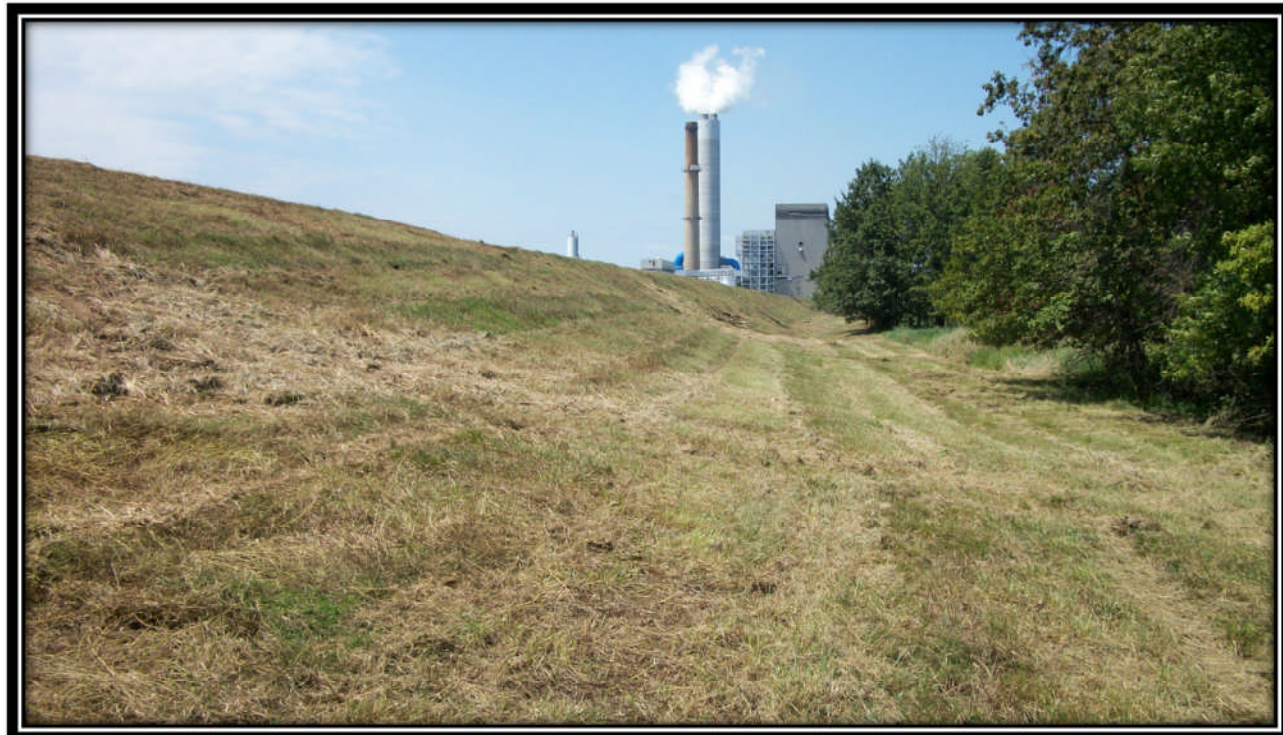
Photo 17 – Looking West along North embankment at the downstream slope

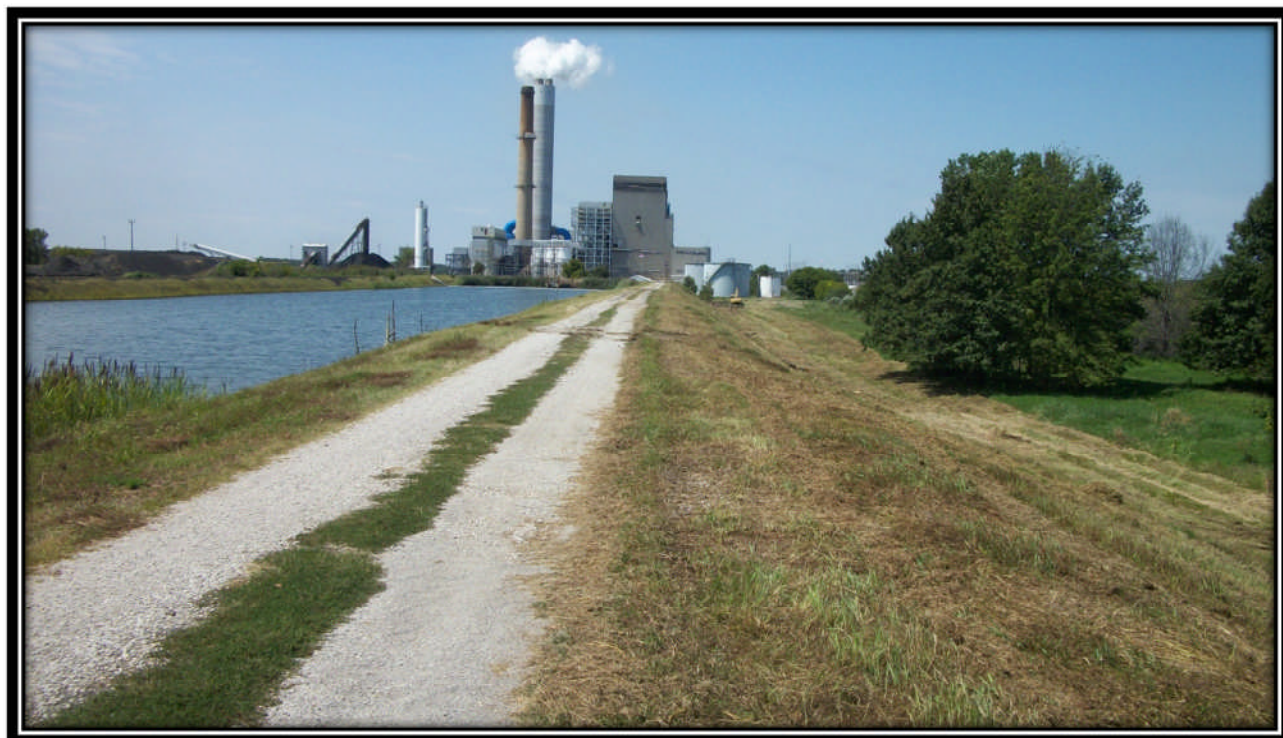
Photo 18 – Looking West along North embankment at the crest

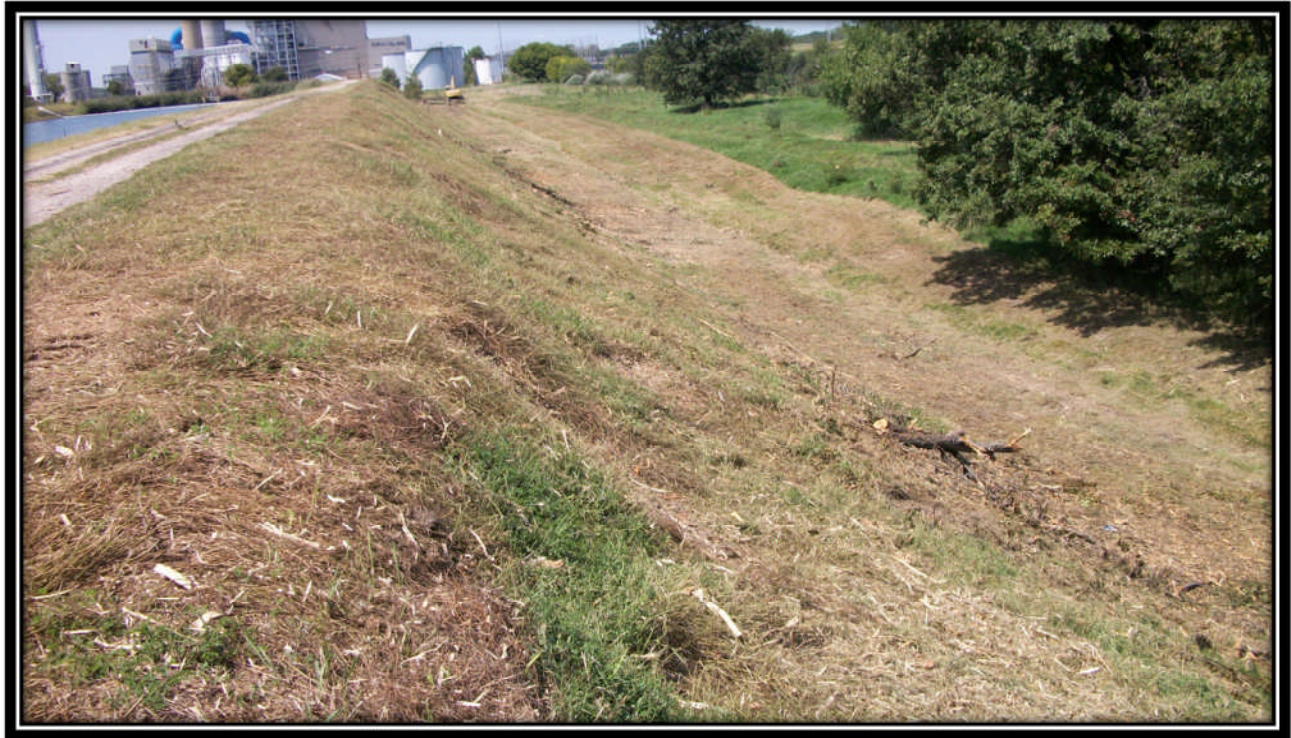
Photo 19 – Slope failure along downstream slope

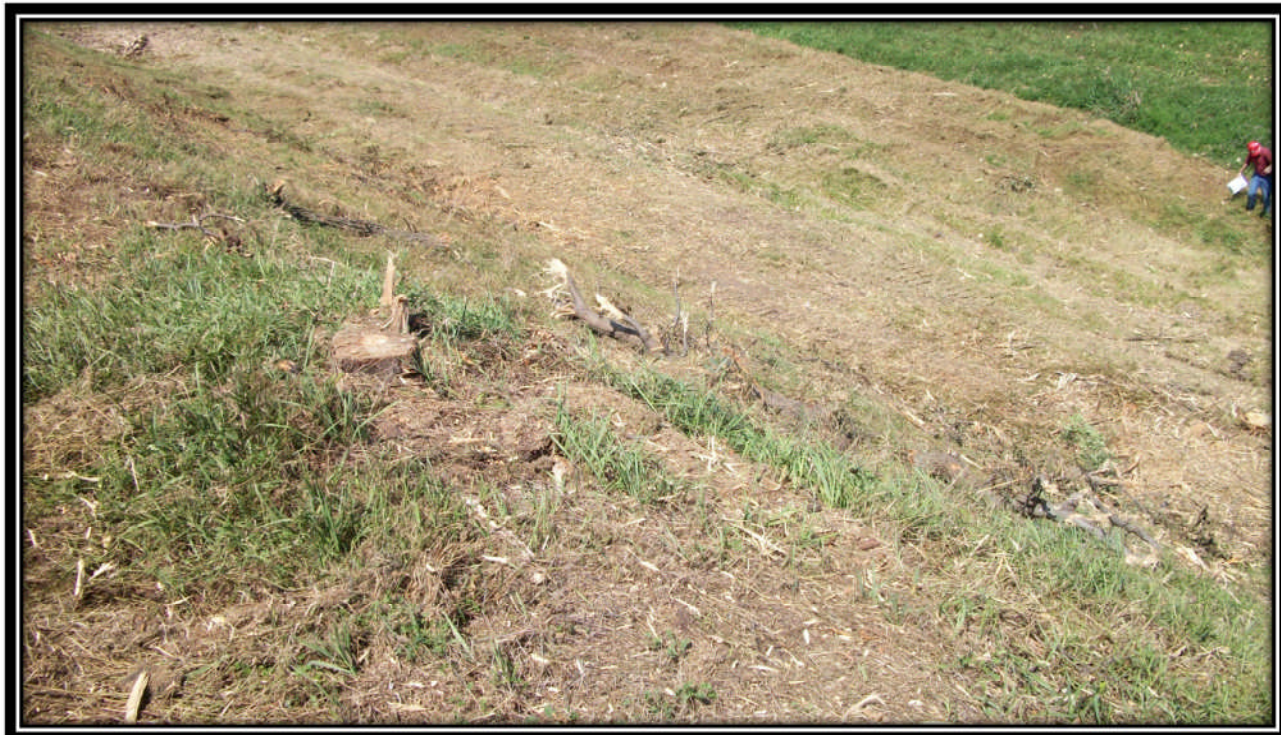
Photo 21 – Tree stumps

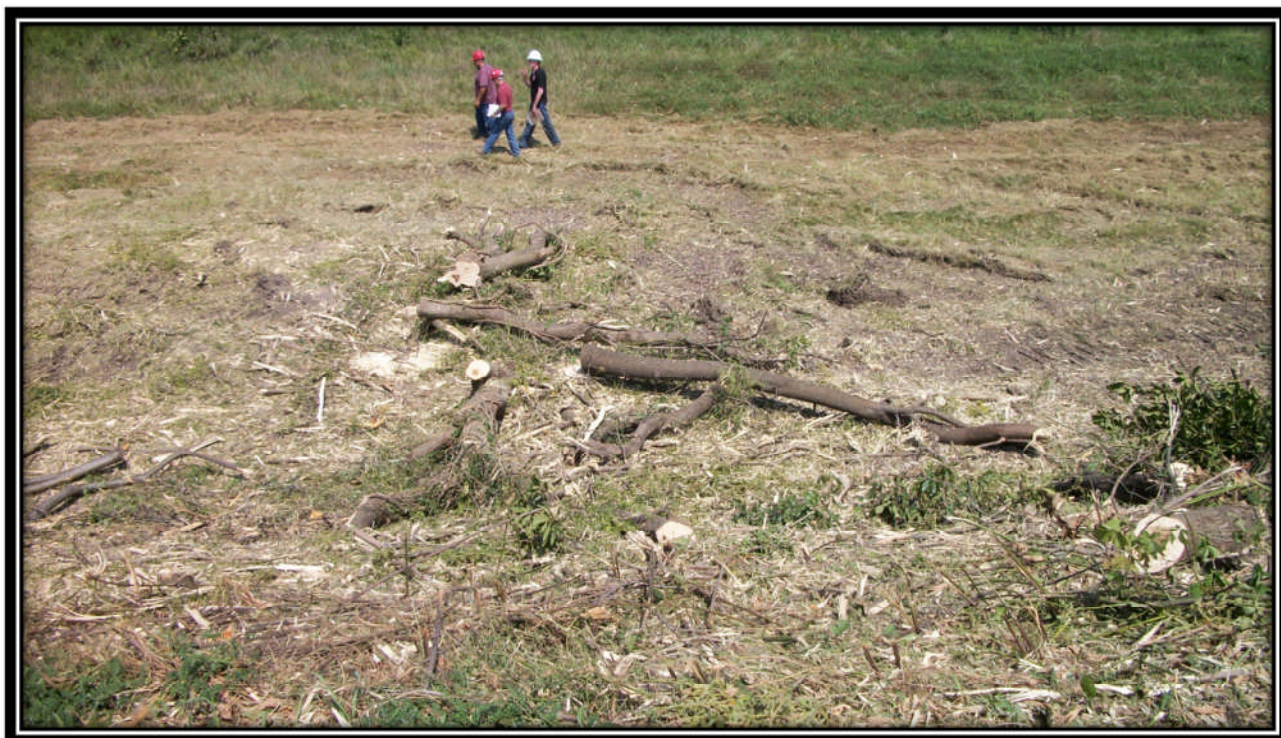
Photo 22 – Debris on downstream slope of North embankment

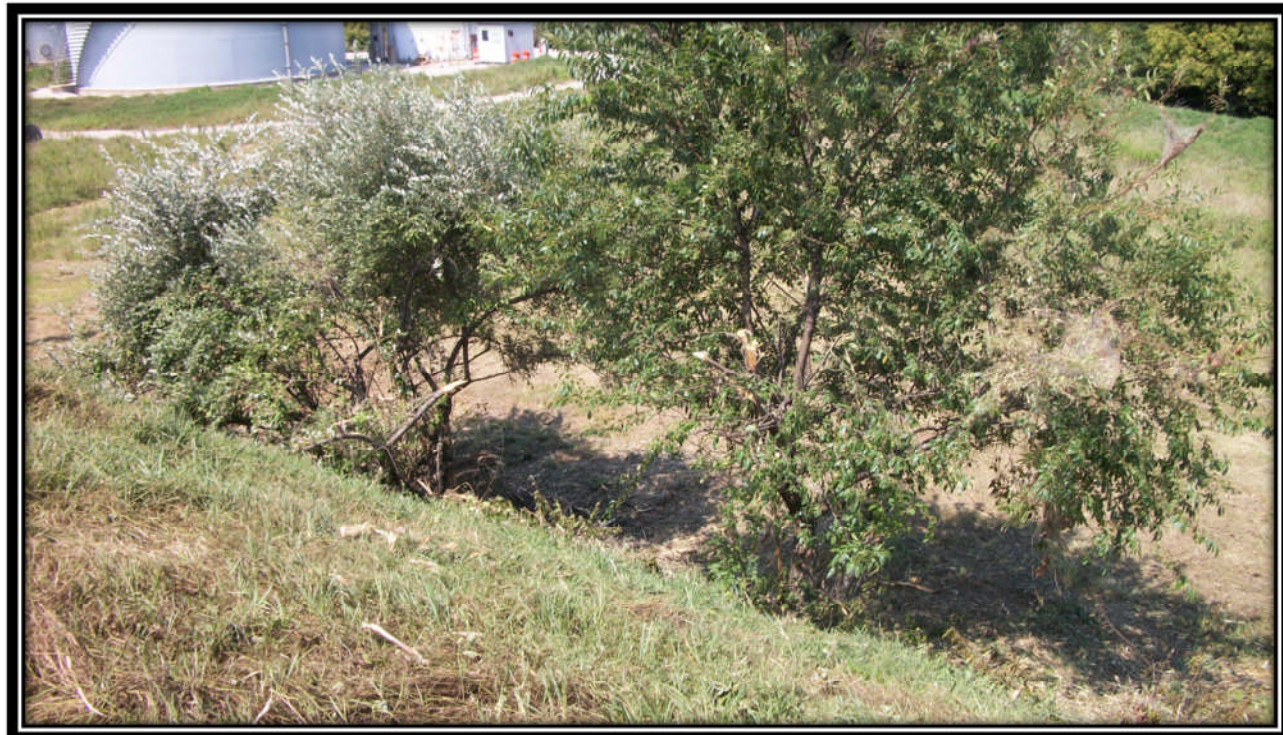
Photo 23 – Trees on downstream slope

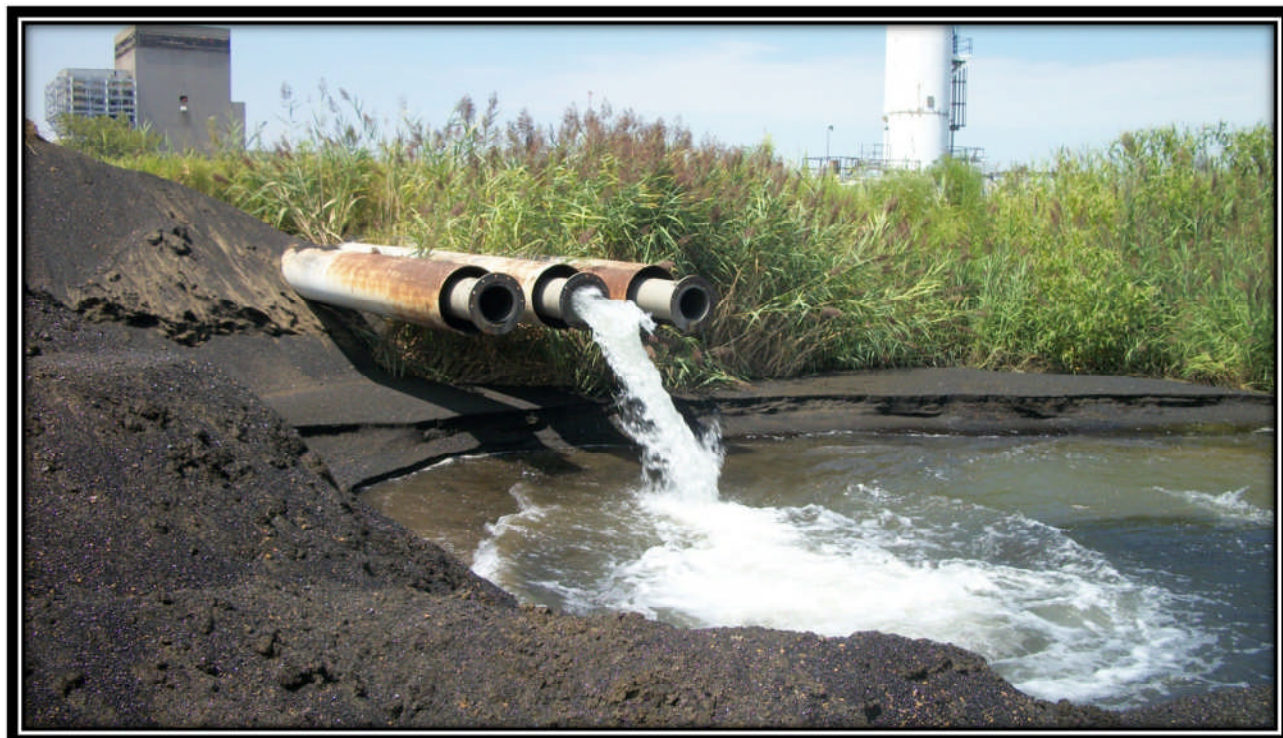
Inflow into the Recycle Pond is via metal piping on the west side of the impoundment, as well as precipitation that falls directly onto the pond. The inlet pipe can be seen in Photograph 31 in Appendix B. The inlet pipe appears to be in satisfactory condition.

Photo 31 – Ash pond discharge outlet pipes
