COAL ASH IMPOUNDMENT SITE ASSESSMENT REPORT

**Coffeen Power Station
Ameren Energy Generating Company
Coffeen, Illinois**

KLEINFELDER PROJECT NUMBER 112618-3

April 2011

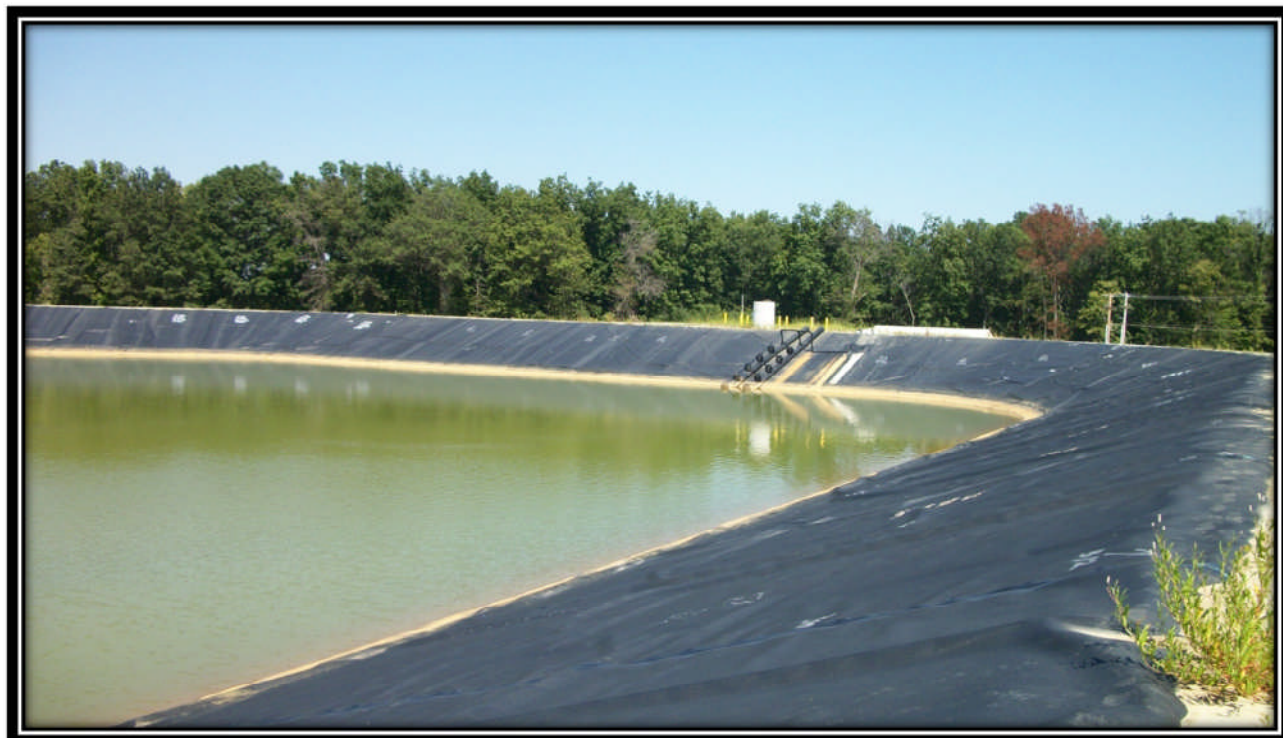
Overall, the upstream slope of the impoundment was in satisfactory condition. Photograph 33 in Appendix B shows the typical condition of the upstream slope. Specific observations include:

Photo 33 – Looking East from South embankment

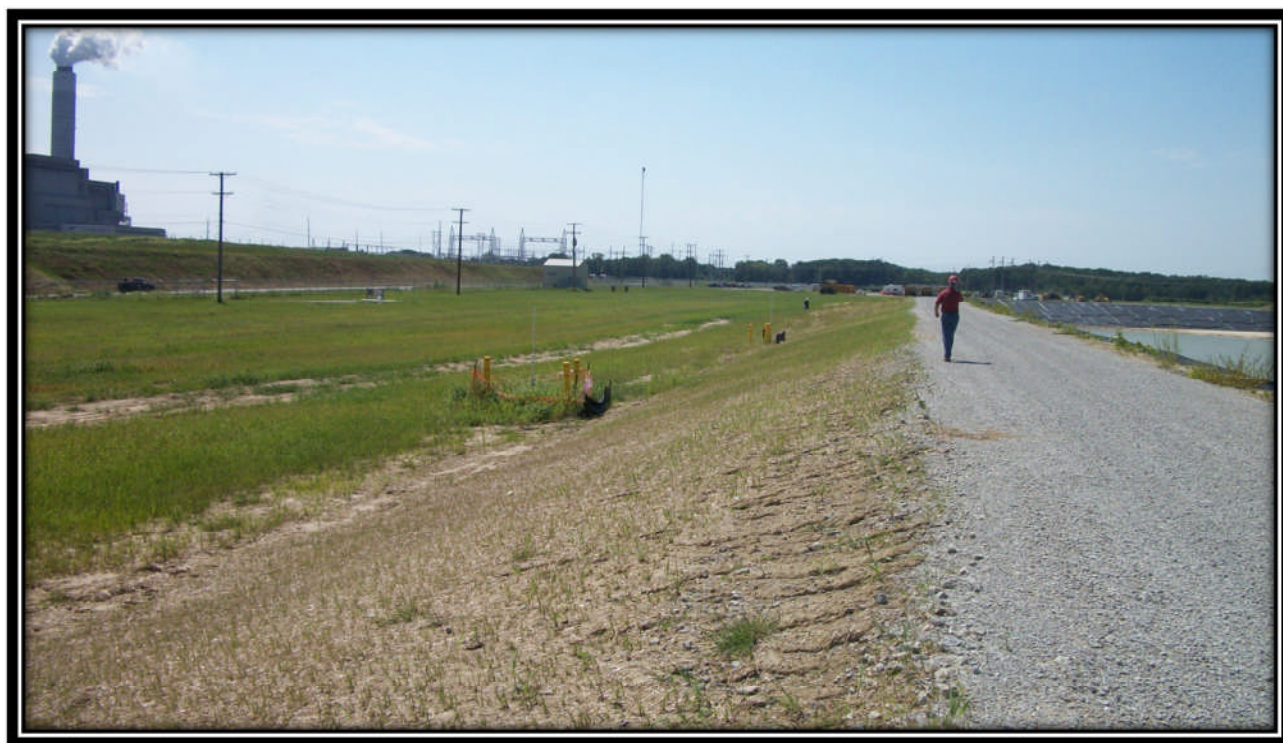
Overall, the downstream slope was in satisfactory condition. Photograph 36 shows the typical condition of the downstream slope. Specific observations include:

The toe areas of the embankment were in satisfactory condition. See Photographs 36 and 45 for the condition of these areas. Key features and observations of these areas include:

Photo 36 – Looking West along downstream slope of South embankment

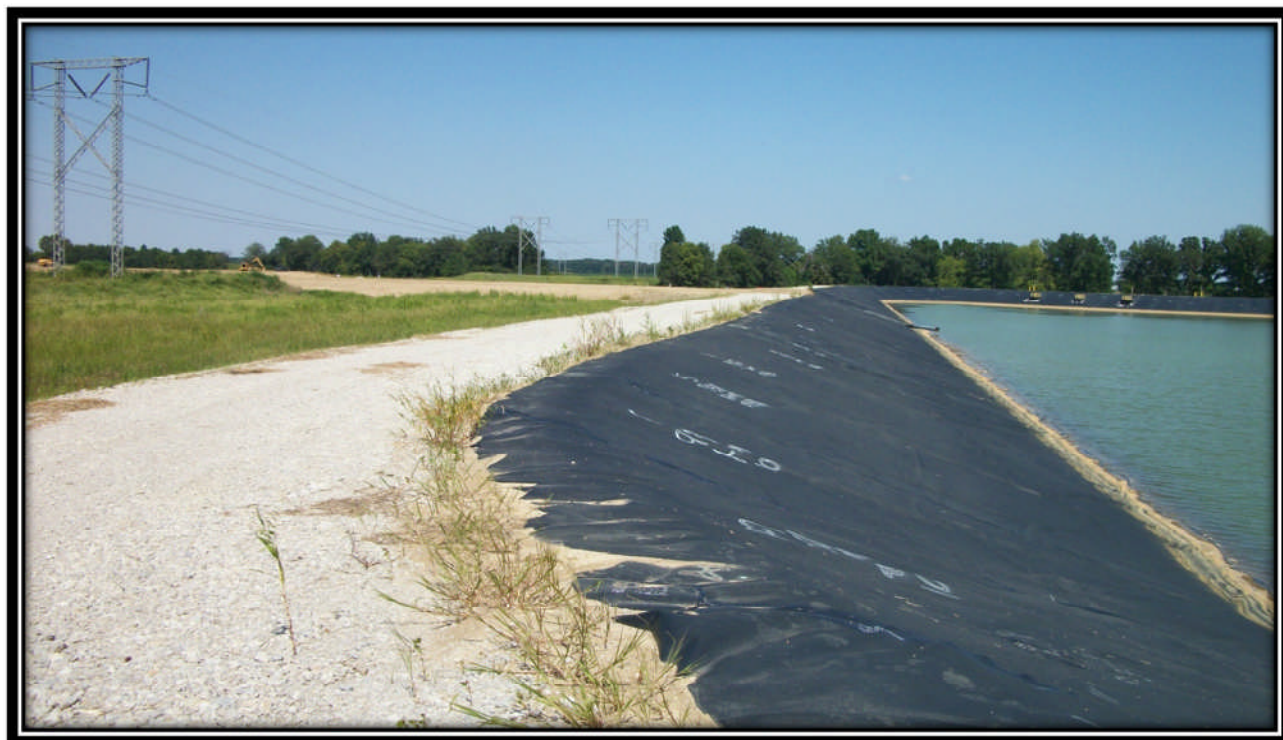
Overall, the crest of the impoundment was in satisfactory condition. Photograph 38 shows the typical condition of the crest. Specific observations include:

- The impoundment crest is a gravel road.
- Very sparse grasses were observed on the upstream side of the crest.
- No major depressions or rutting were noted on the impoundment crest.

Photo 38 – Looking East along North embankment
