**COAL ASH IMPOUNDMENT
SITE ASSESSMENT FINAL REPORT**

**E.D. Edwards Power Generating Station
Ameren Energy Generating Company
Bartonville, Illinois**

KLEINFELDER PROJECT NUMBER 112618-2

May 10, 2011

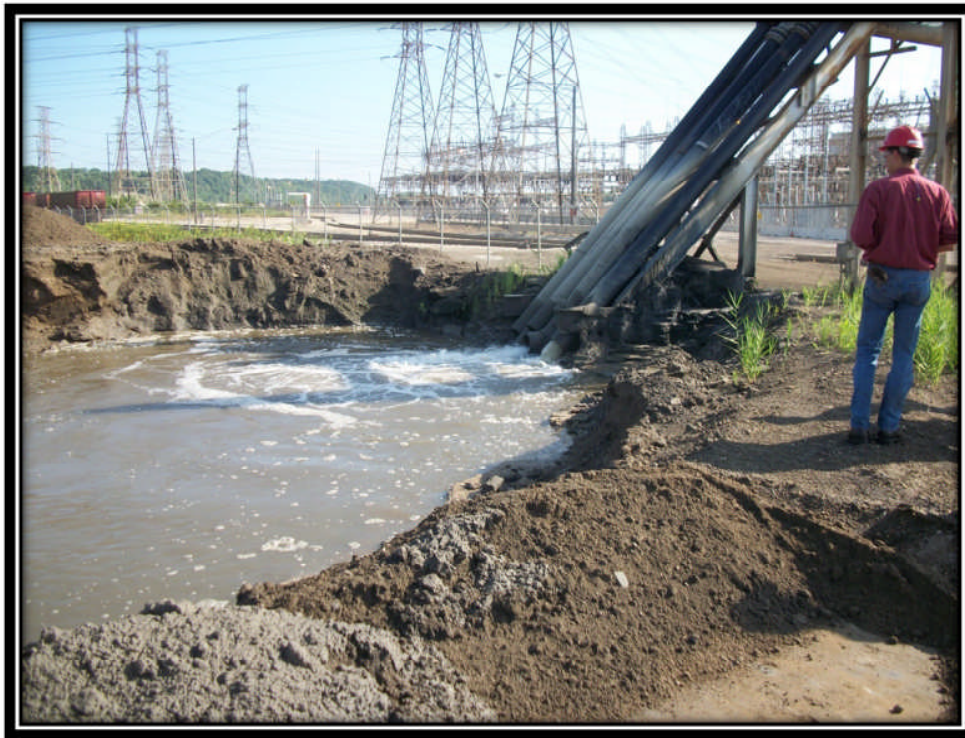
Photo 1 – Sluice Pipes at the Inlet to the Ash Pond

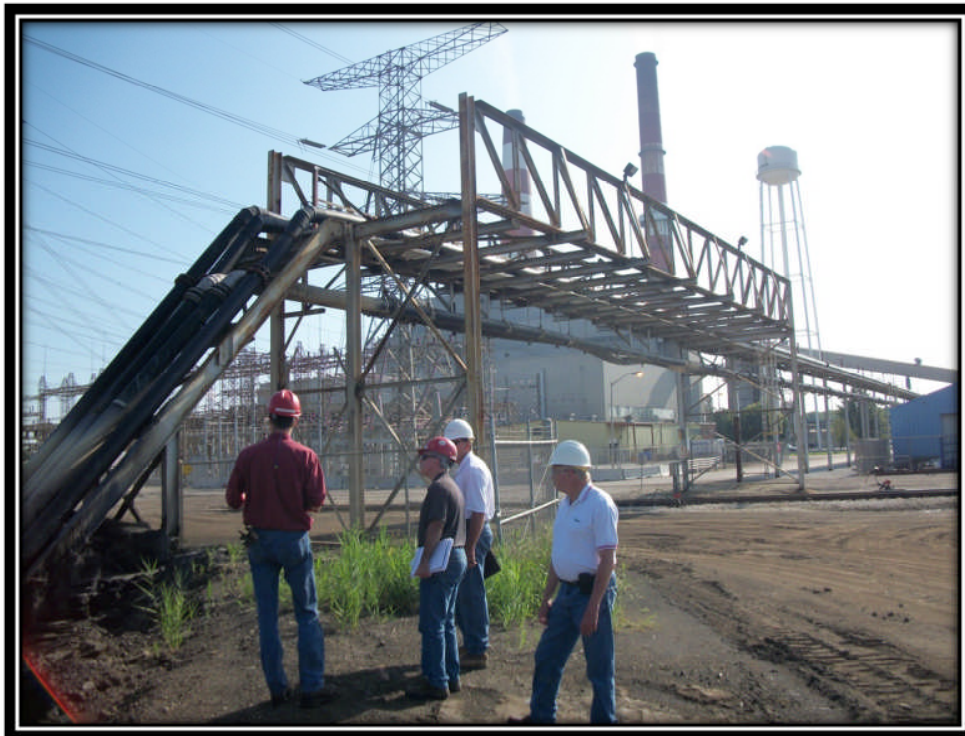
Photo 2 – Elevated Sluice Pipe Structure

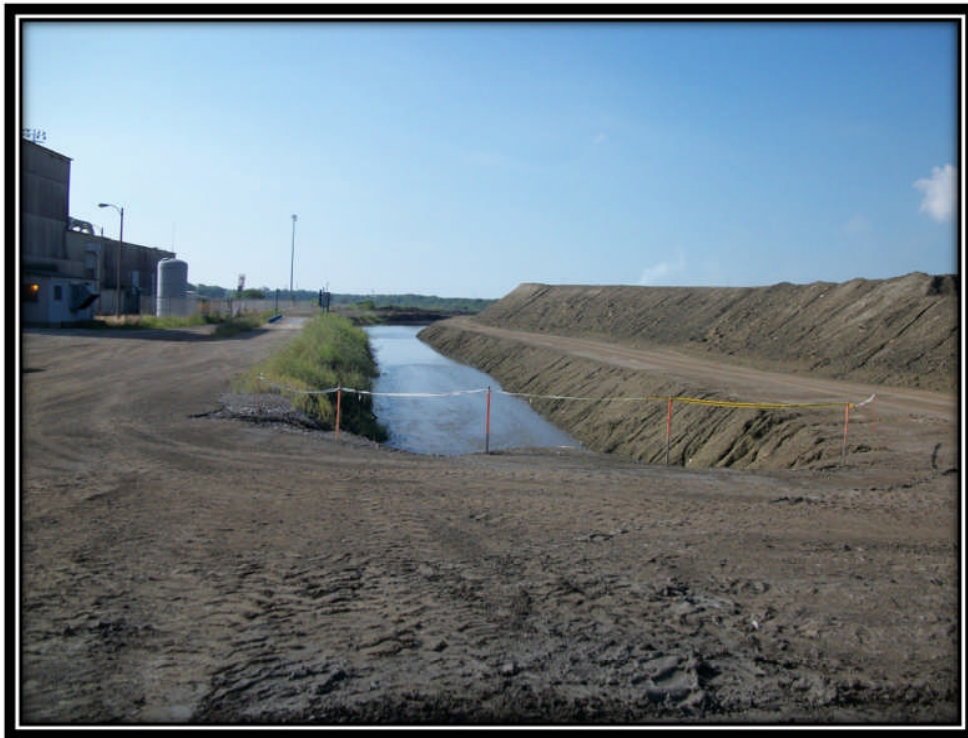
- The impoundment crest is a gravel road with railroad tracks over the majority of the western embankment.
- Sparse grasses and bushes were observed on the crest.
- No major depressions or rutting were noted on the impoundment crest.
- Minor erosion was noted on crest in multiple locations. This erosion was typically less than six inches in depth and typically appeared on the edges of the crest, where grade breaks occurred when transitioning to embankment slopes.

Photo 3 – Active Ash Pond Settling Channel

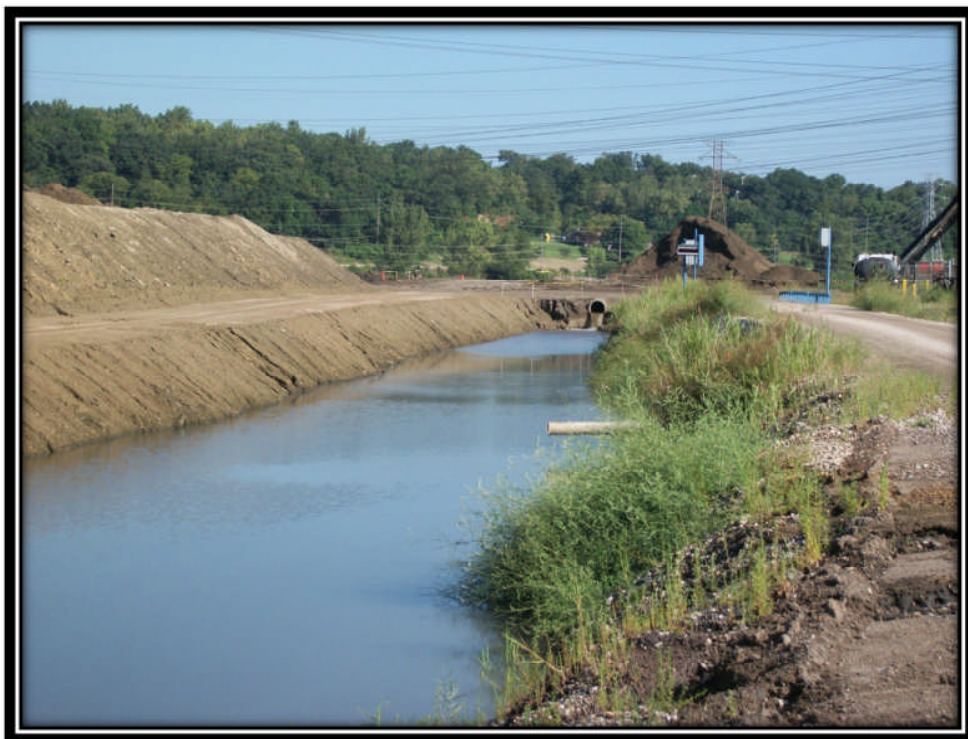
- The upstream slope was laid back at approximately 2H:1V.
- Grasses and woody bushes were observed on the upstream slope. No vegetation with a stem diameter greater than 1 inch was noted during the inspection.
- Grasses, bushes, and woody debris were observed on the slope.
- Penetrations into the ash pond embankment were noted on the upstream slope. These penetrations were in the form of various stormwater pipes.
- Minor erosion, less than 6 inches, was noted during the inspection on the upstream slopes.

Photo 4 – Active Intake Pipe and Ash Settling Channel

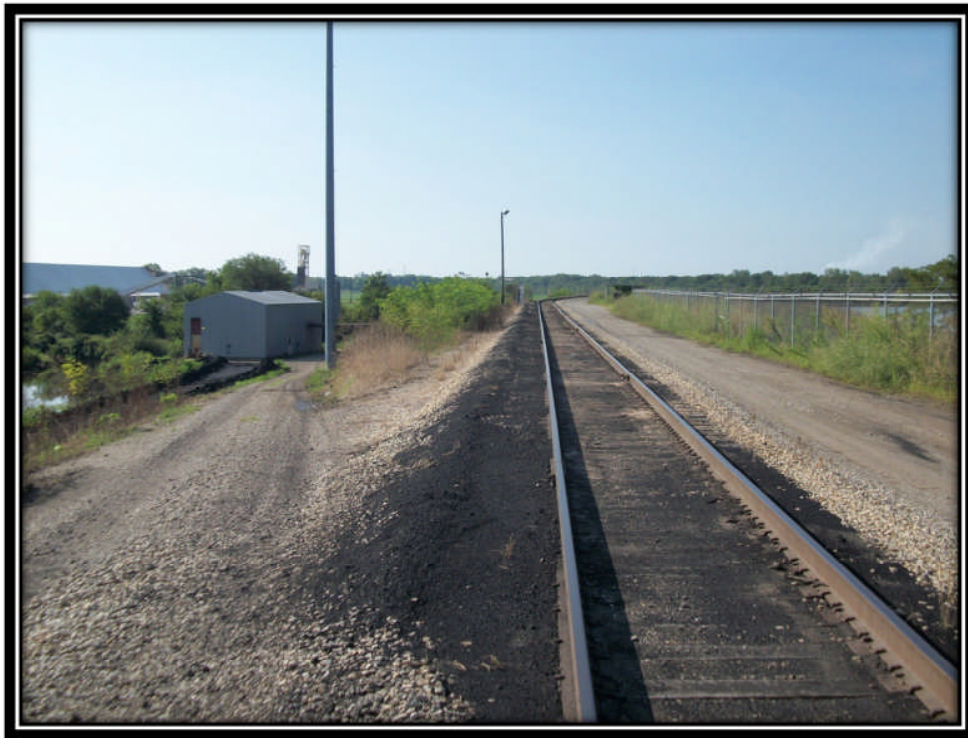
Photo 5 – Railroad Tracks on Crest of Ash Pond and Clarification Pond Embankment

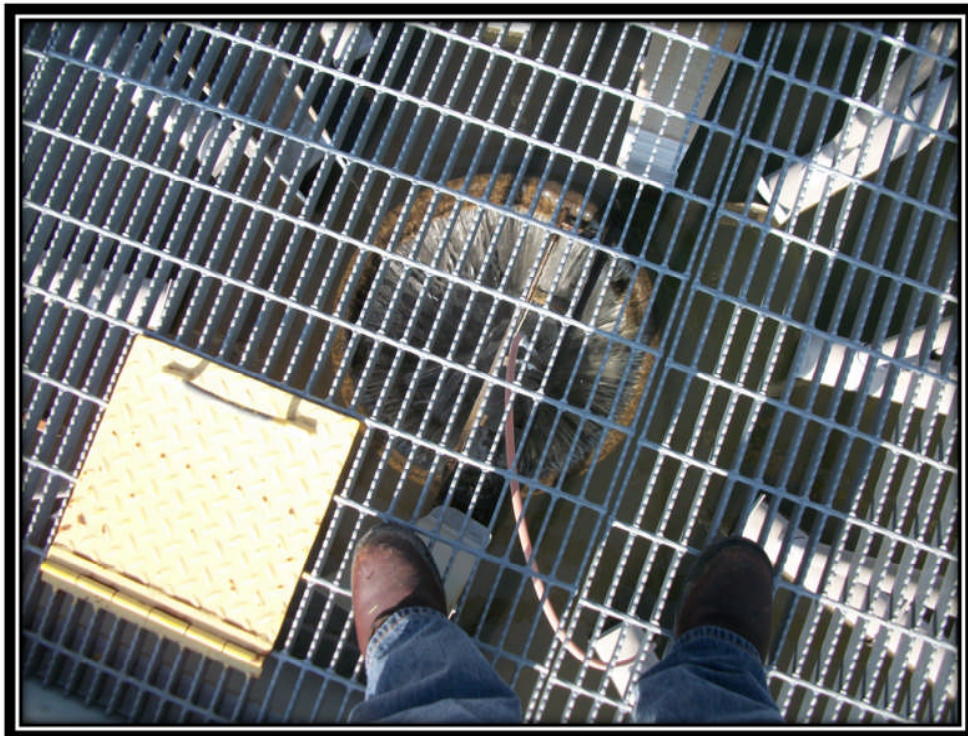
Photo 6 – Inlet Piping for Clarification Pond Outlet Works

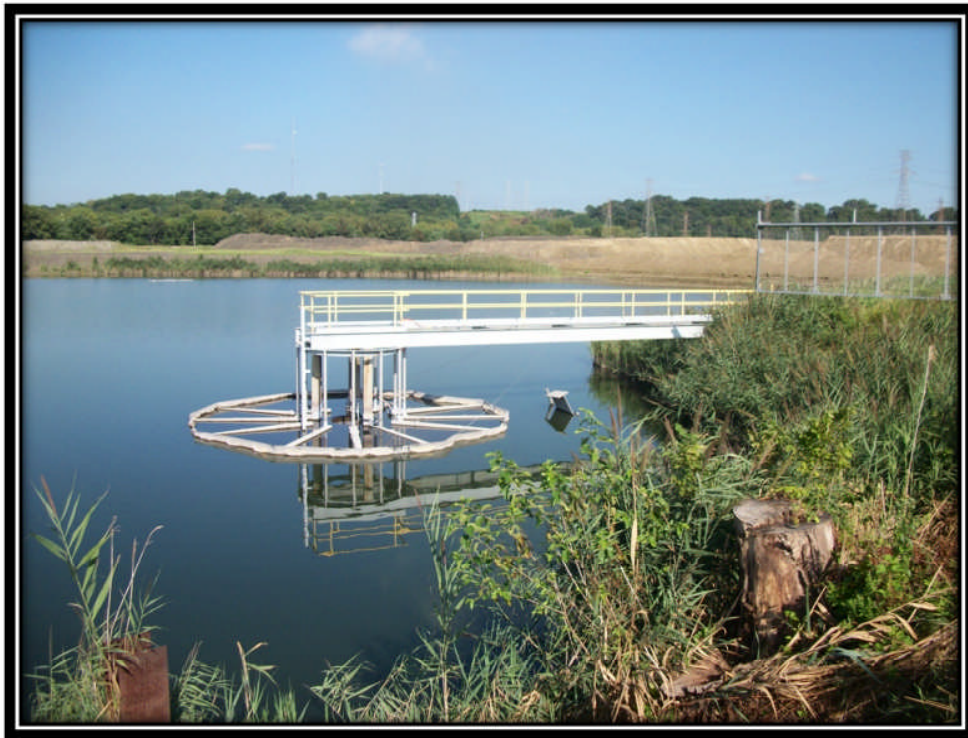
The clarification pond includes an outlet structure with a catwalk access platform. As-built drawings for this structure were not available for our review, so we were unable to make a structural evaluation of the access platform. According to an inspection conducted in March 2010, the outlet structure was stated as being in good condition. Based on our visual assessment, the catwalk bridge access portion appears to be in good condition, and the outlet superstructure within the pond appears to be intact with minor corrosion.

Photo 7 – Outlet Works Access Platform

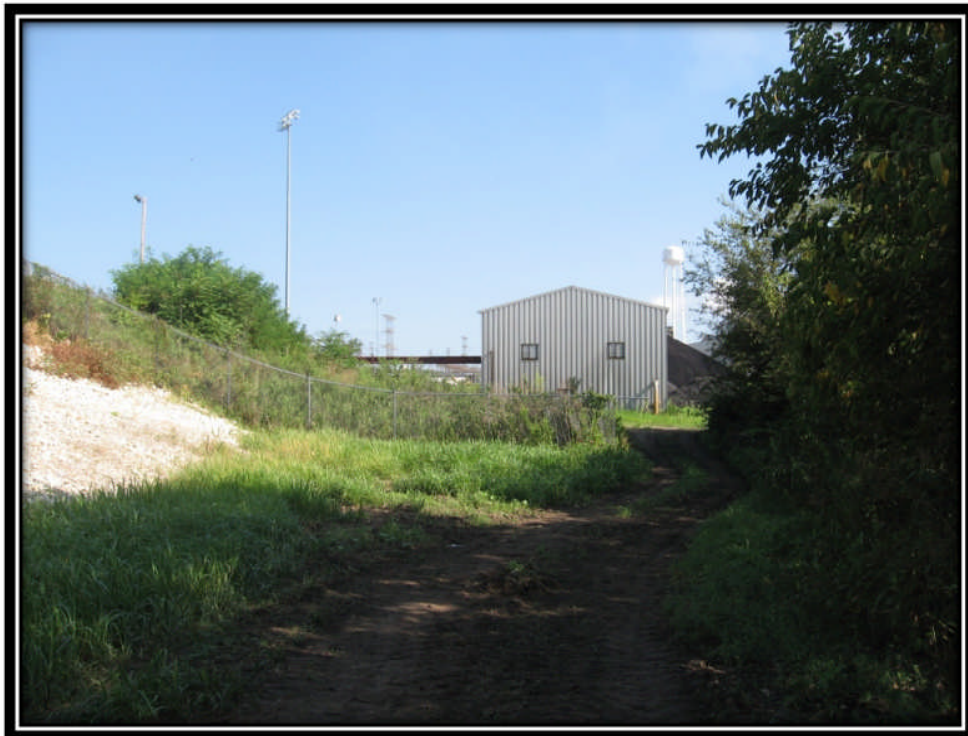
- On the toe of the southern and eastern embankments, vegetation had been cleared for at least 15 feet from the toe and the area had been recently mowed.
- Minor erosion, less than 6 inches deep, was noted at some locations of the southern embankment toe.

Photo 8 – Cleared Toe of Downstream Slope on Eastern Embankment

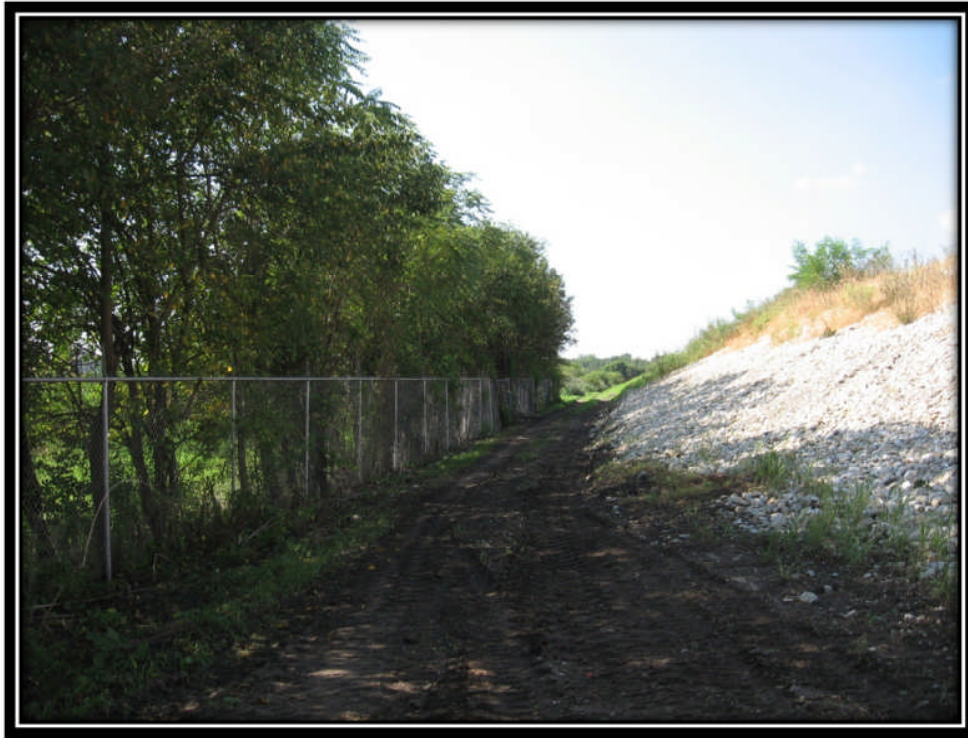
Photo 9 – Cleared Toe of Downstream Slope (Note Riprap and Minor Rutting)

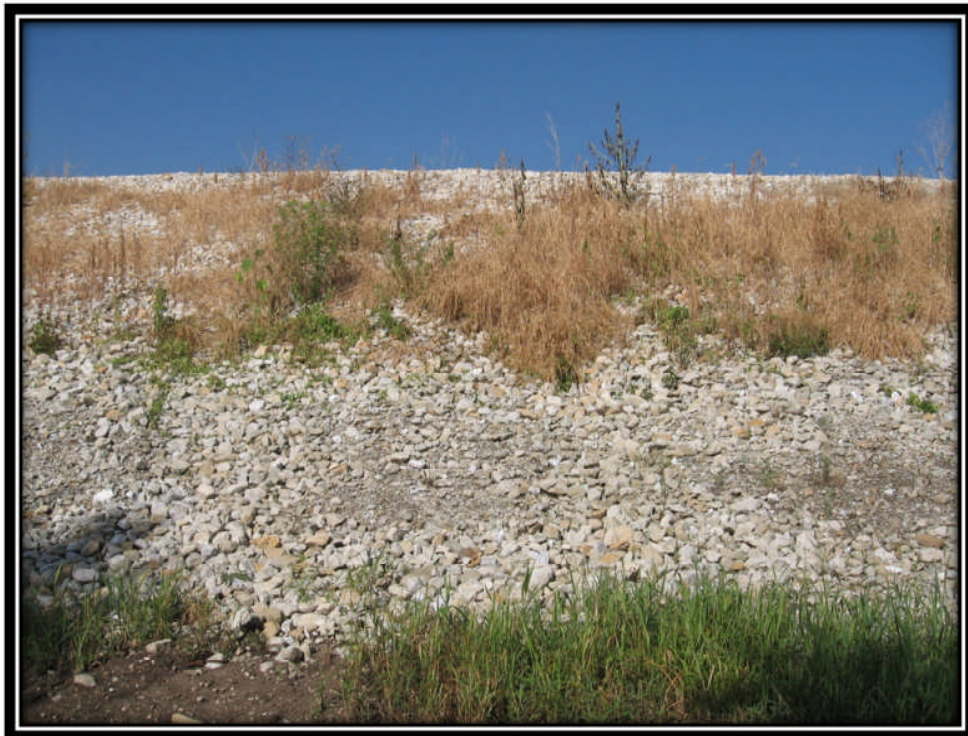
Photo 10 – Vegetated Riprap on Embankment Slope (Typical)

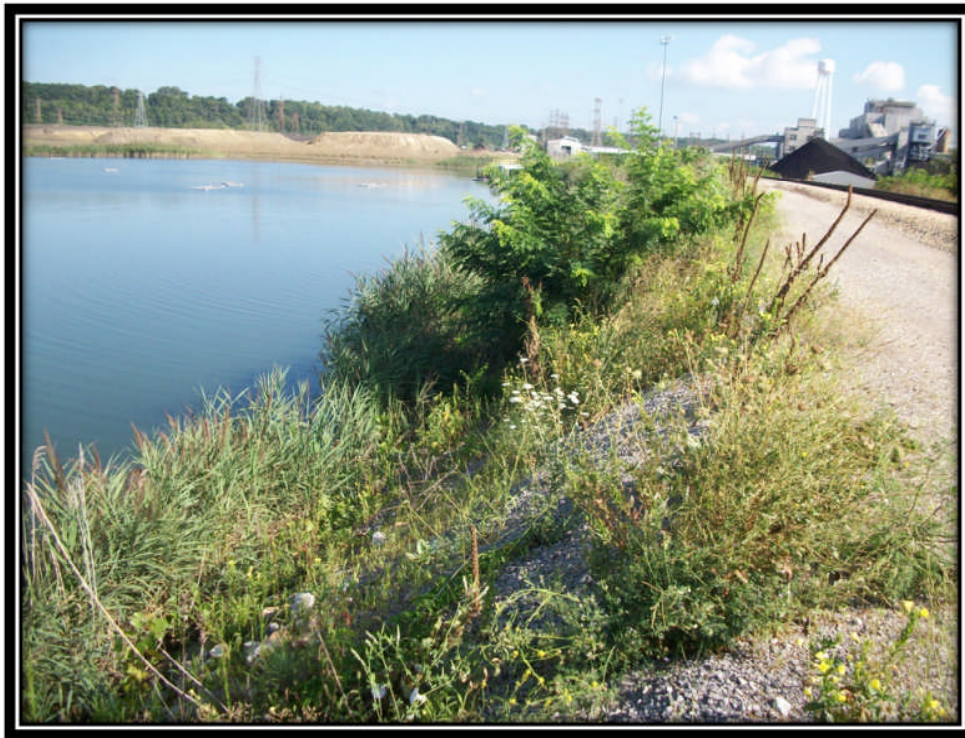
- The impoundment crest is a combination of a gravel road, railroad track embankment, and vegetated embankment.
- Grasses and bushes were observed on the crest.
- No major depressions or rutting were noted on the impoundment crest.
- Some significant erosion, greater than 6 inches, was noted on the crest in multiple locations. This erosion typically appeared on the edges of the crest where grade breaks occurred when transitioning to embankment slopes.
- Lack of vegetation was noted in multiple locations along the crest.

Photo 11 – Vegetation on Upstream Slope of Clarification Pond (Note Steep Slopes)

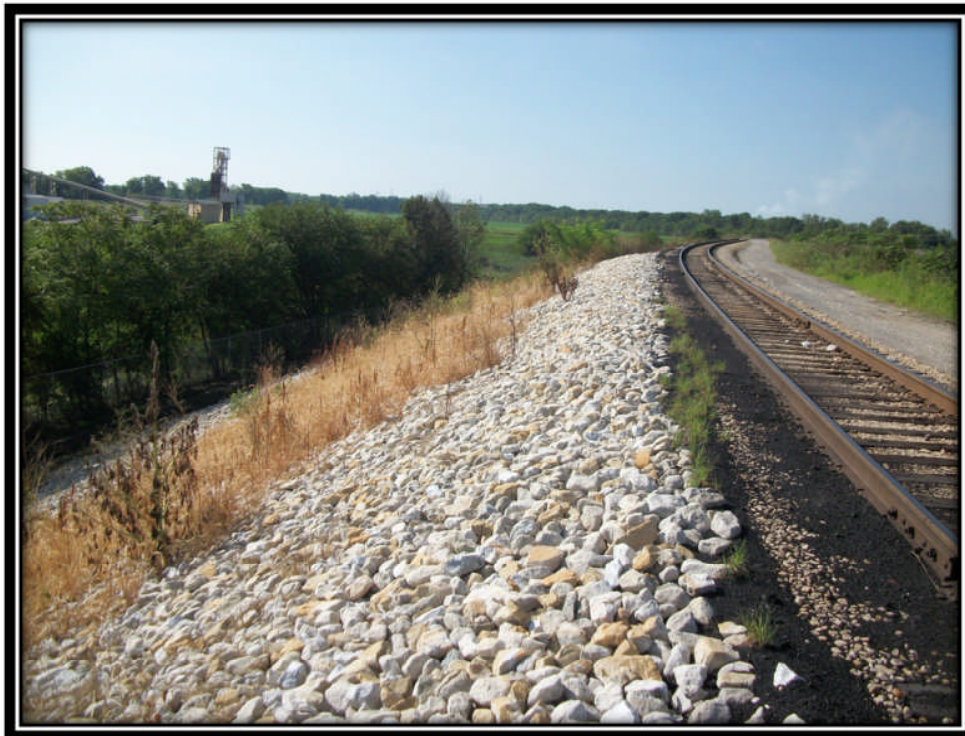
- The downstream slope was laid back at approximately 2H:1V
- There were areas of riprap slope protection present on the downstream slope. This riprap had been vegetated in some locations but was mostly clear of vegetation.
- Significant erosion, greater than 6 inches deep, was noted on some of the downstream slopes, particularly on the southern embankment of the impoundment.
- Grasses and woody bushes were observed on the downstream slope and at the toe of the embankment for the majority of the impoundment.
- Penetrations into the downstream slope included manholes and power line poles.

Photo 12 – Riprap and Railroad Tracks at Crest of Clarification Pond Embankment

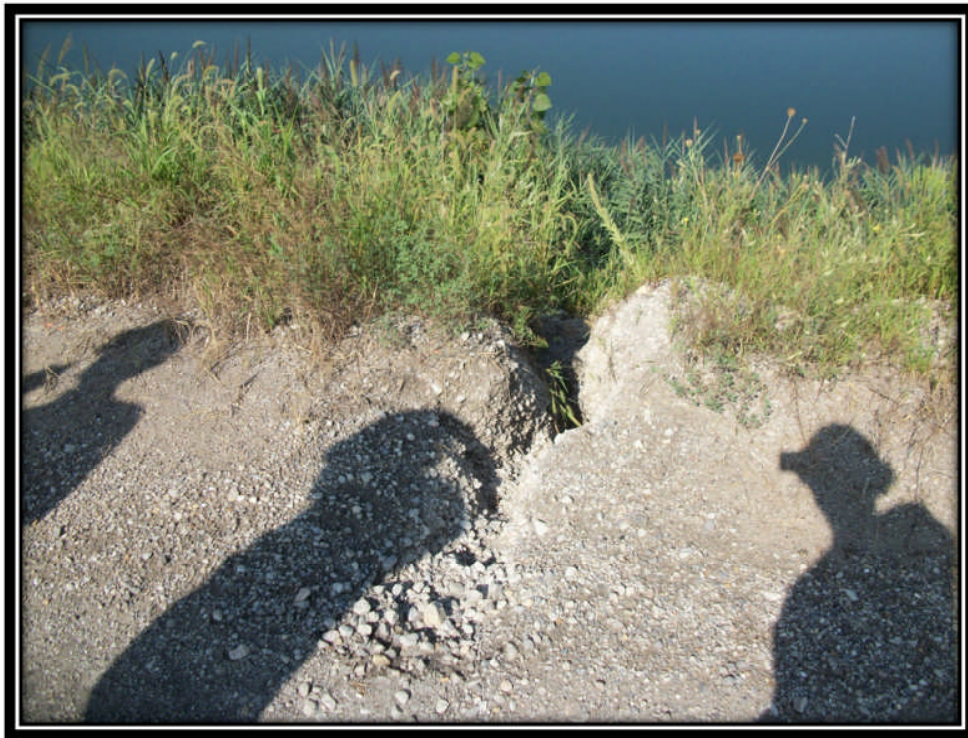
Photo 13 – Minor Erosion on Crest of Clarification Pond (Typical of Ash Pond and Clarification Pond)

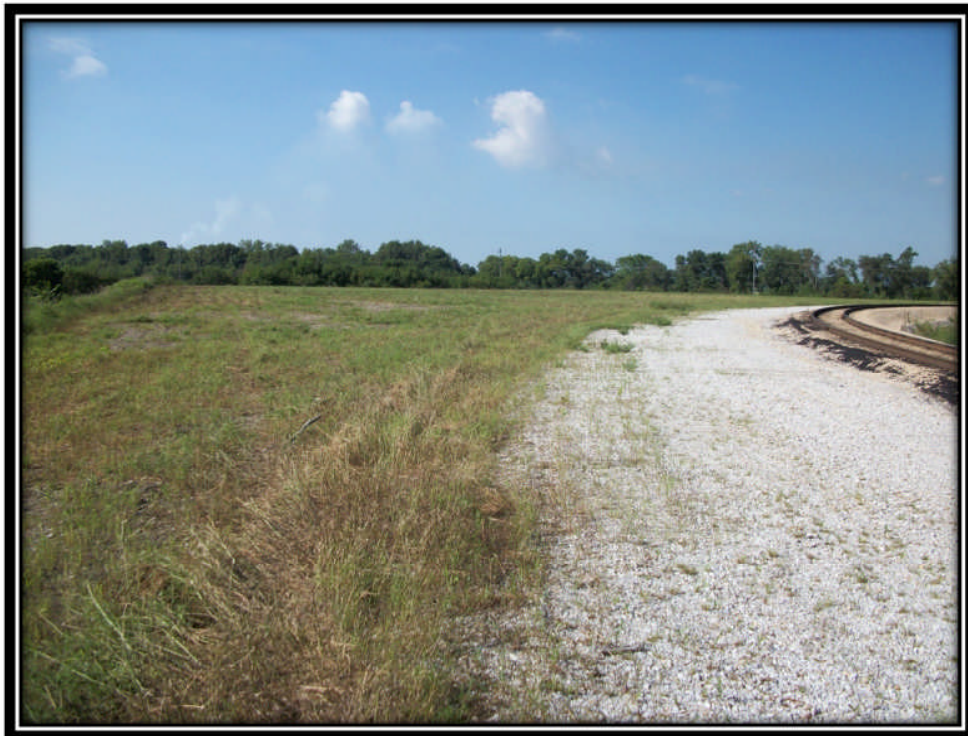
Photo 14 – Area of Clarification Pond Filled in After Completion of Railroad Improvements

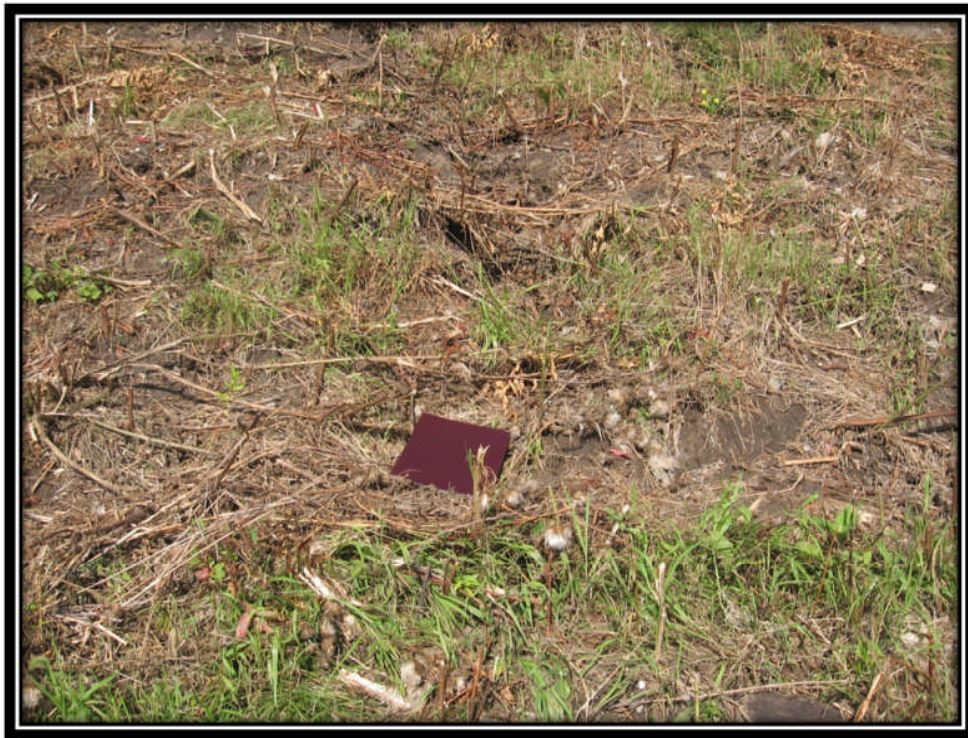
Photo 15 – Area of Sparse Vegetation and Erosion on Embankment Slope and Toe

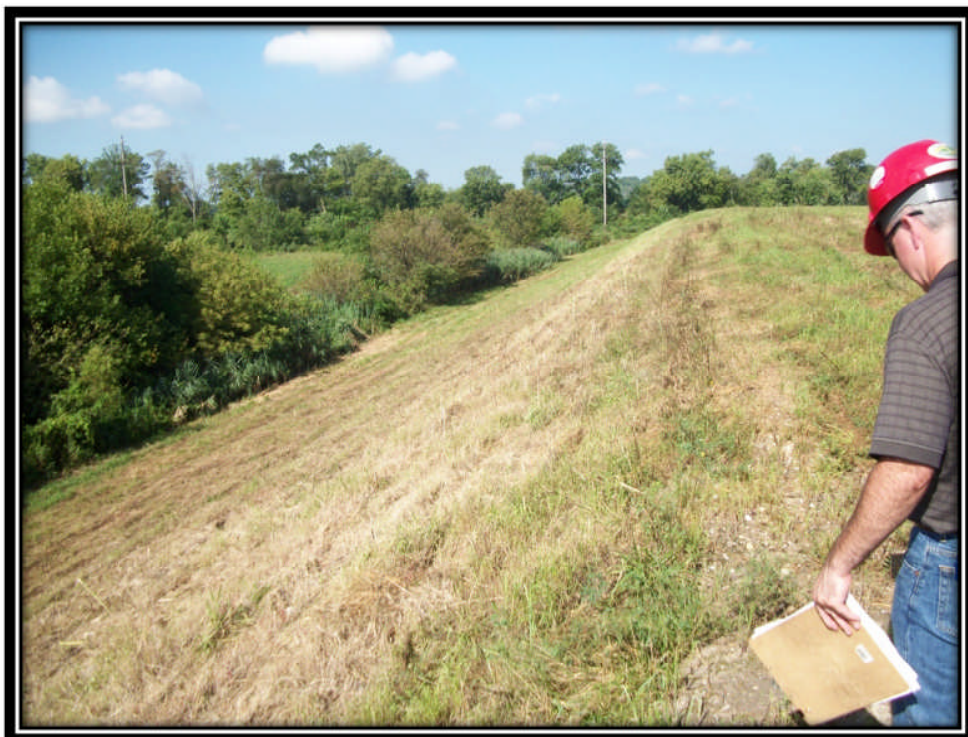
Photo 16 – Typical Southern Embankment of Clarification Pond

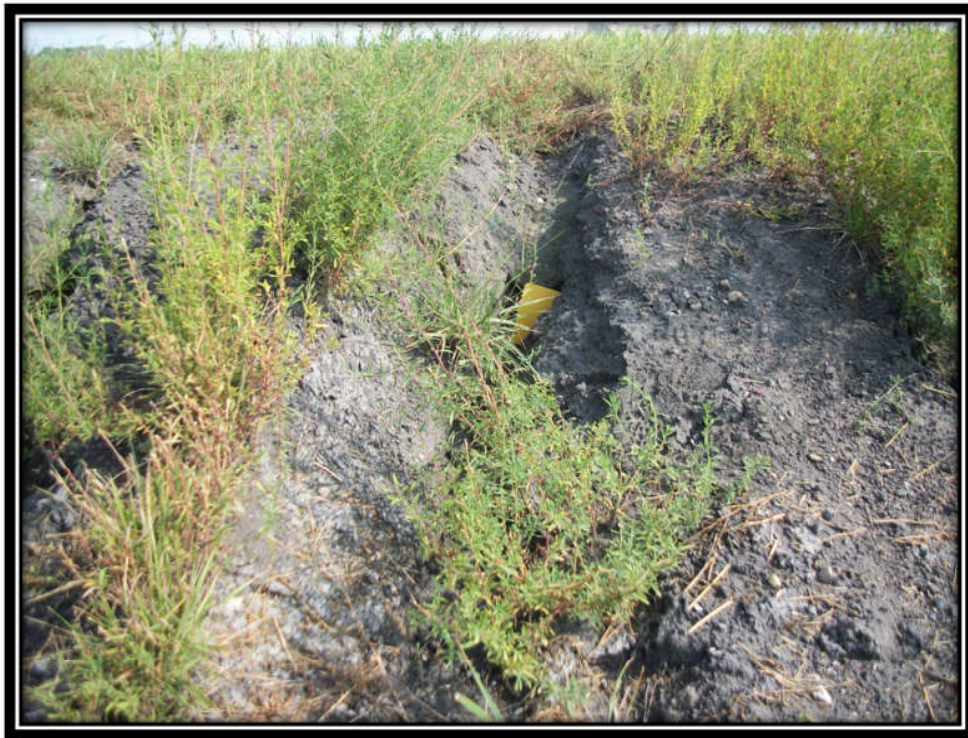
Photo 17 – Erosion Greater than 12 Inches Forming on Downstream Slopes of Southern Embankment

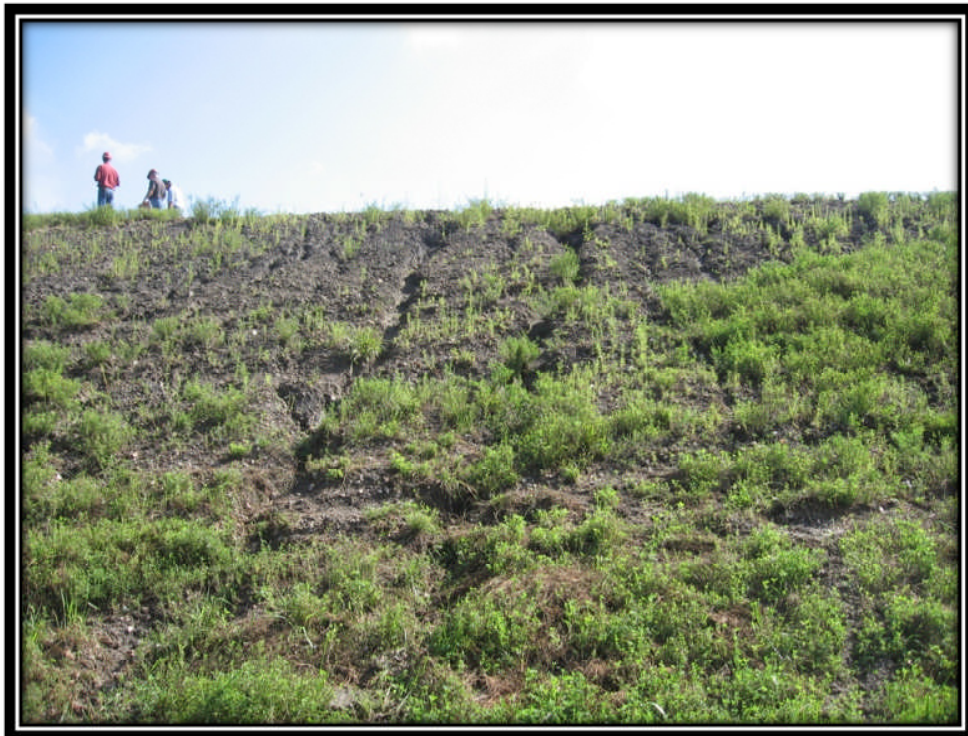
Photo 18 – Erosion and Sparse Vegetation on Downstream Slopes of Southern Embankment

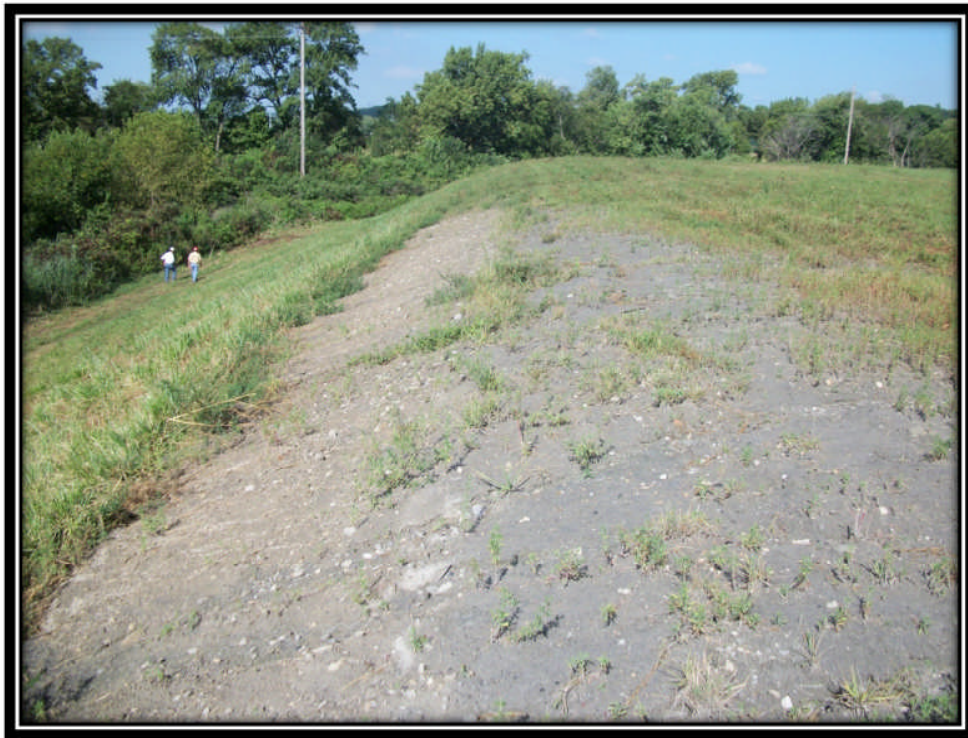
Photo 19 – Sparse Vegetation on Crest and Downstream Slope of Southern Embankment

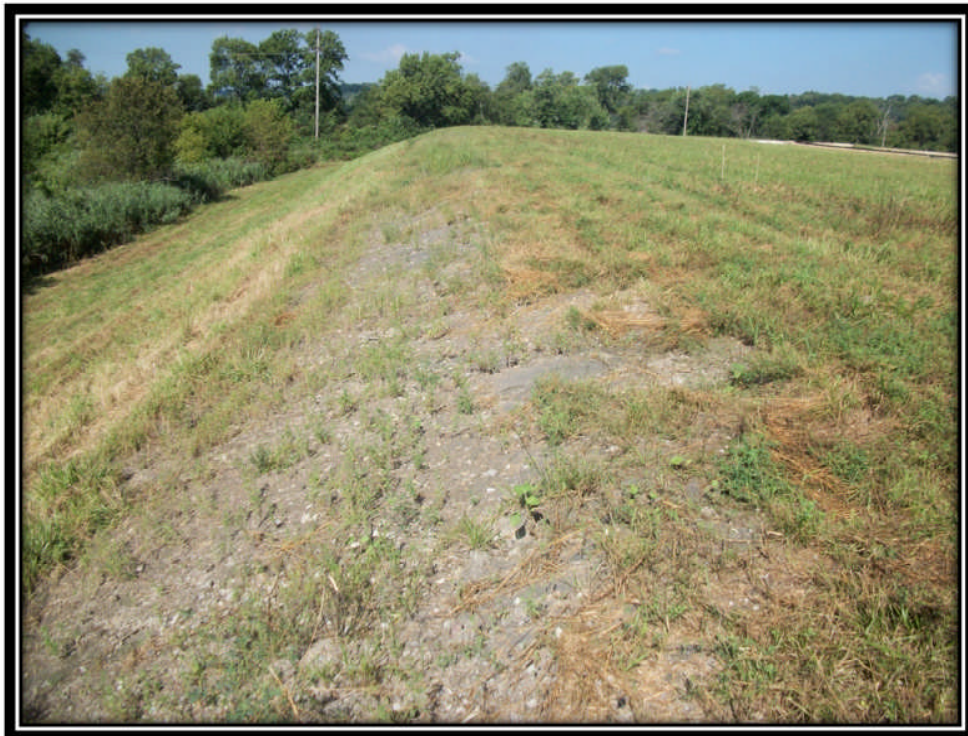
Photo 20 – Sparse Vegetation on Crest and Downstream Slope of Southern Embankment

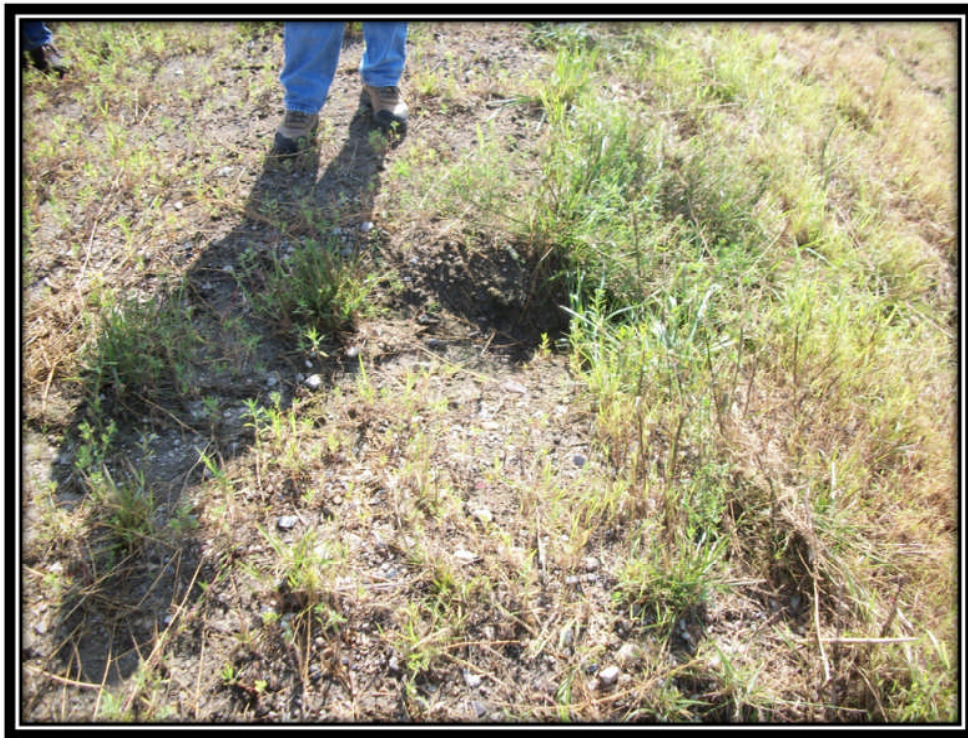
Photo 21 – Erosion on Southern Downstream Slopes and Crest (Typical)

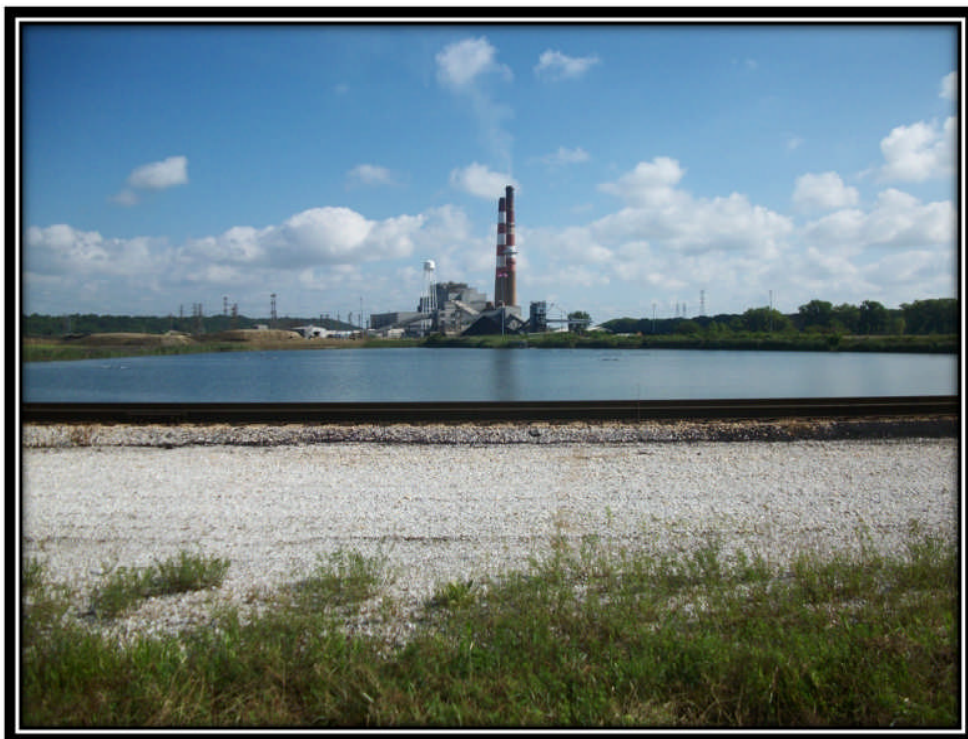
Photo 22 – Clarification Pond General Condition

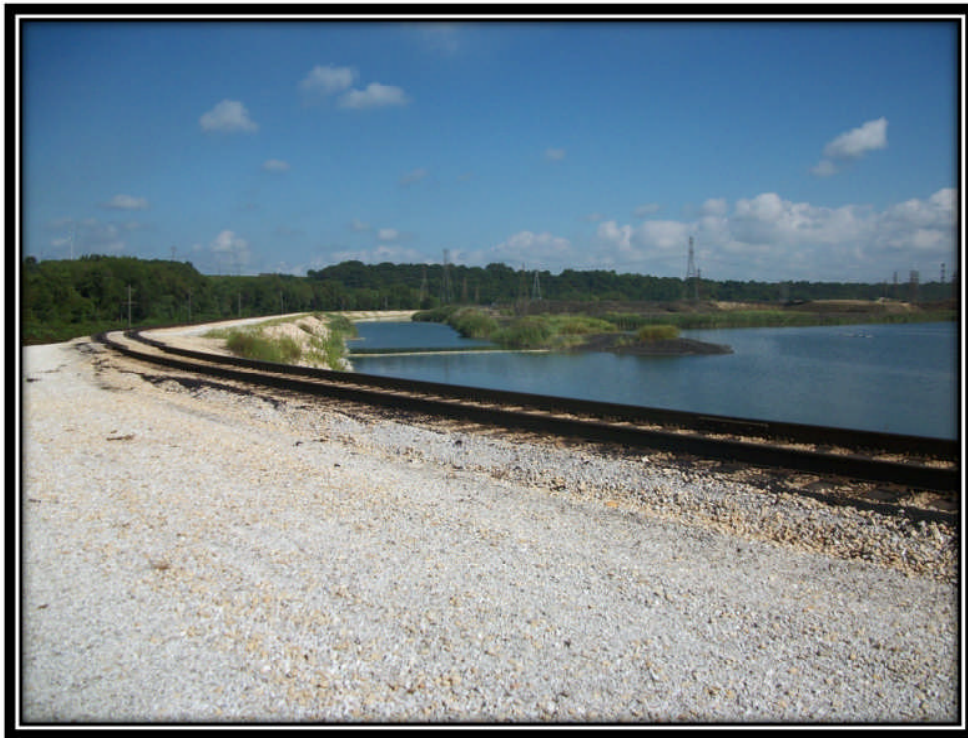
Photo 23 – Clarification Pond Inlet Channel

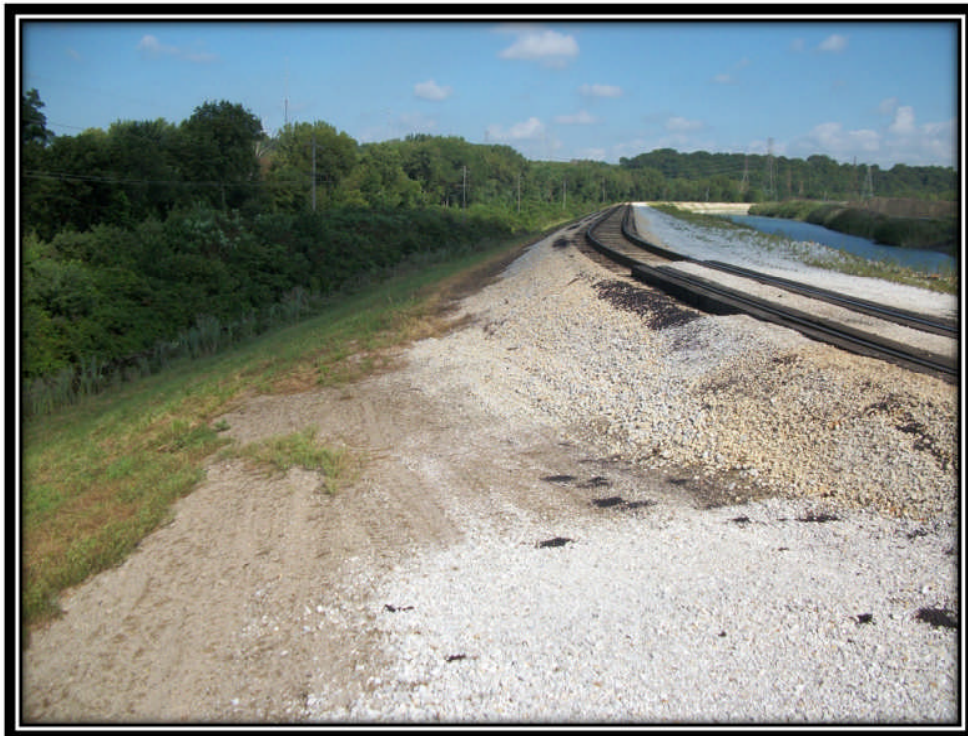
Photo 24 – Original Embankment with Raised Railroad Embankment Improvements Visible

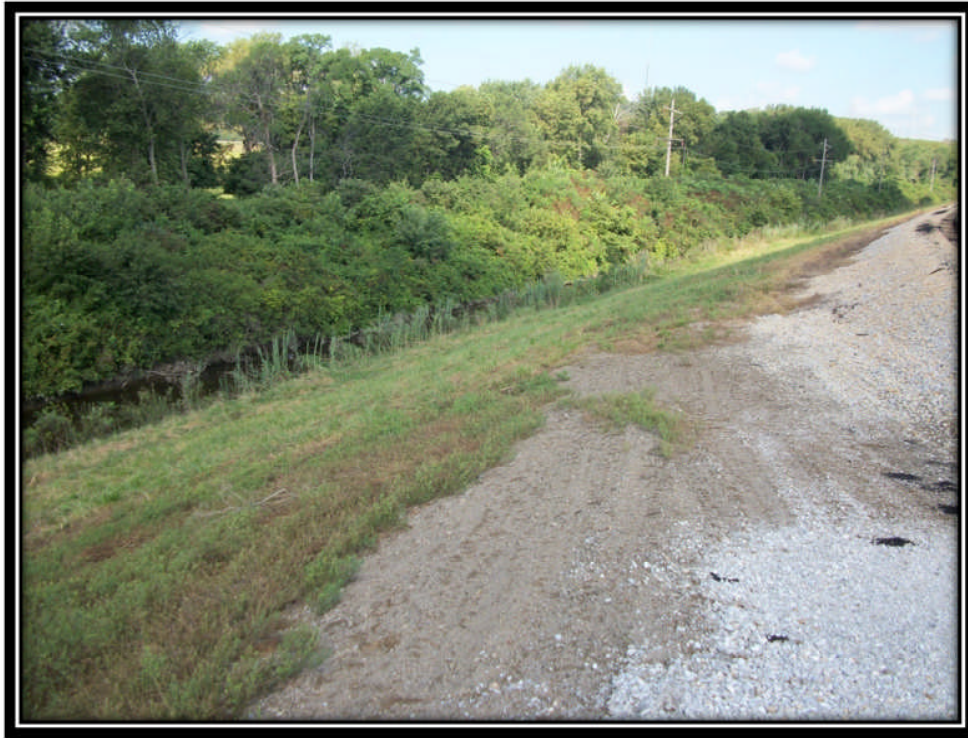
Photo 25 – Typical Western Embankment of Clarification Pond, Clarification Pond Inlet and Pond 1

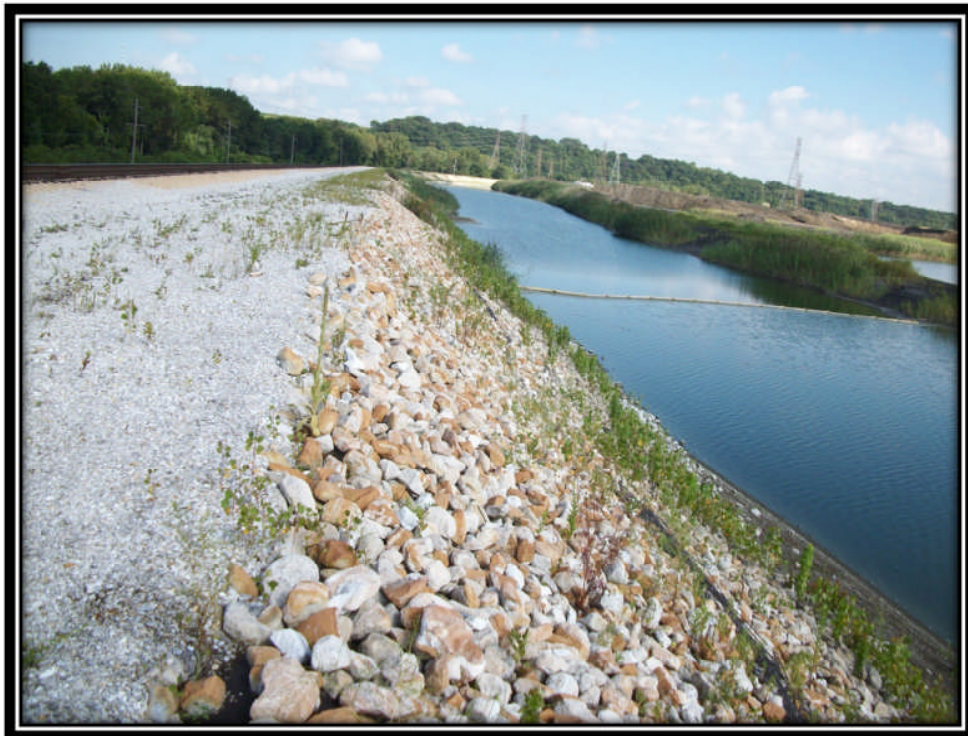
Photo 26 –Clarification Pond Inlet Channel with Riprap (Note Ash Pond Settling Channel Inlets)

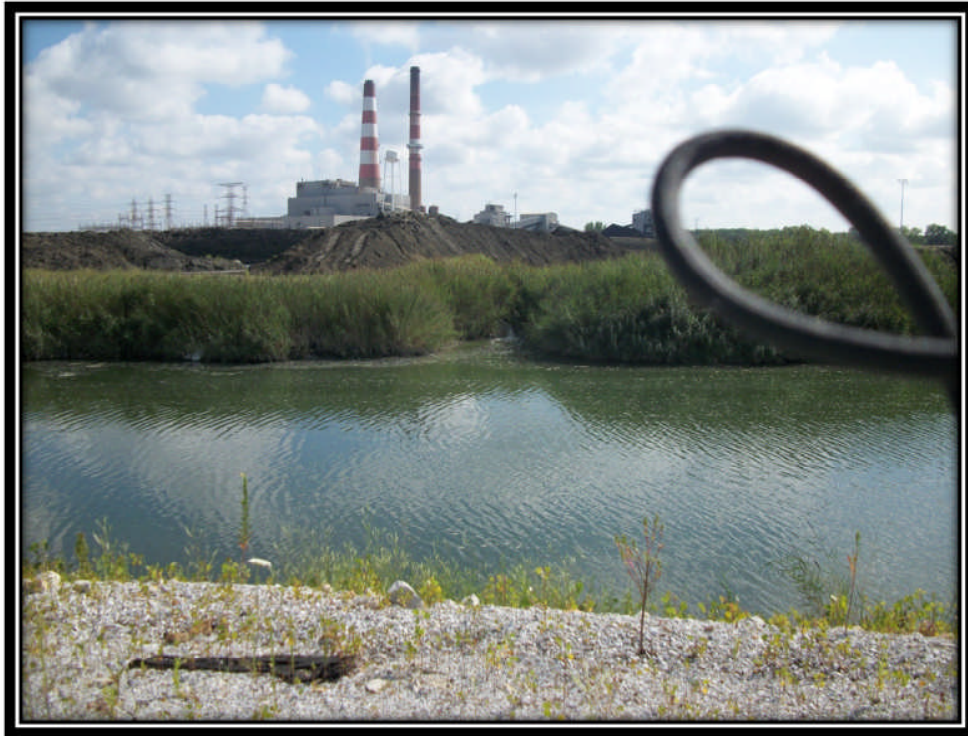
Photo 27 – Outlet of Ash Pond Settling Channel into Clarification Pond Inlet Channel

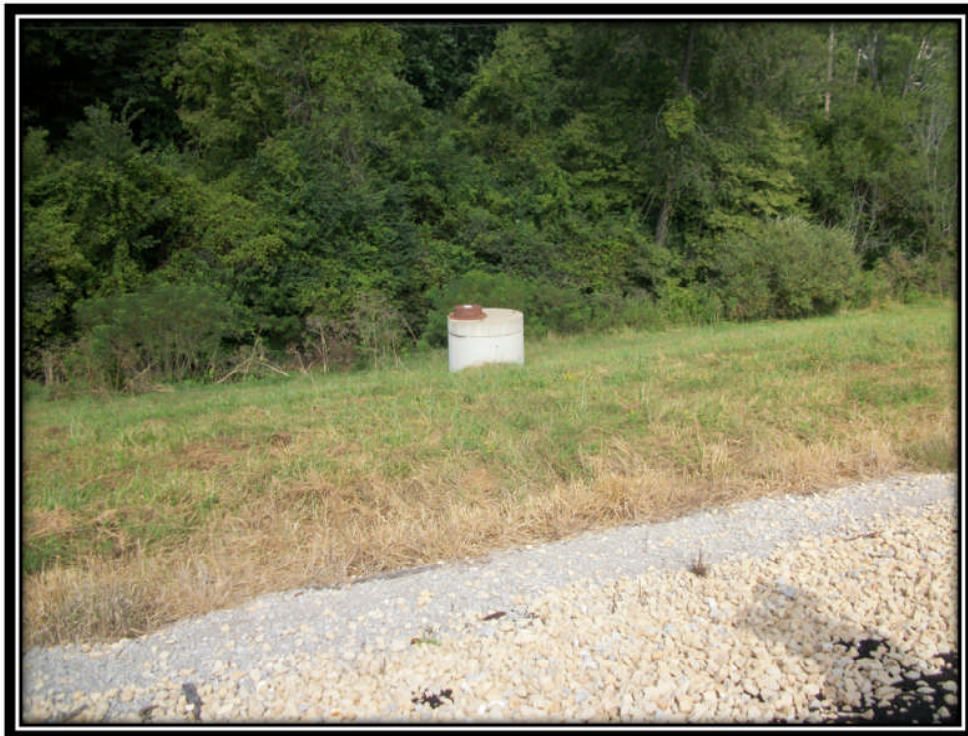
Photo 28 – Waste Water Sewer Line Manhole in Downstream Slope (Near Toe of Original Embankment)

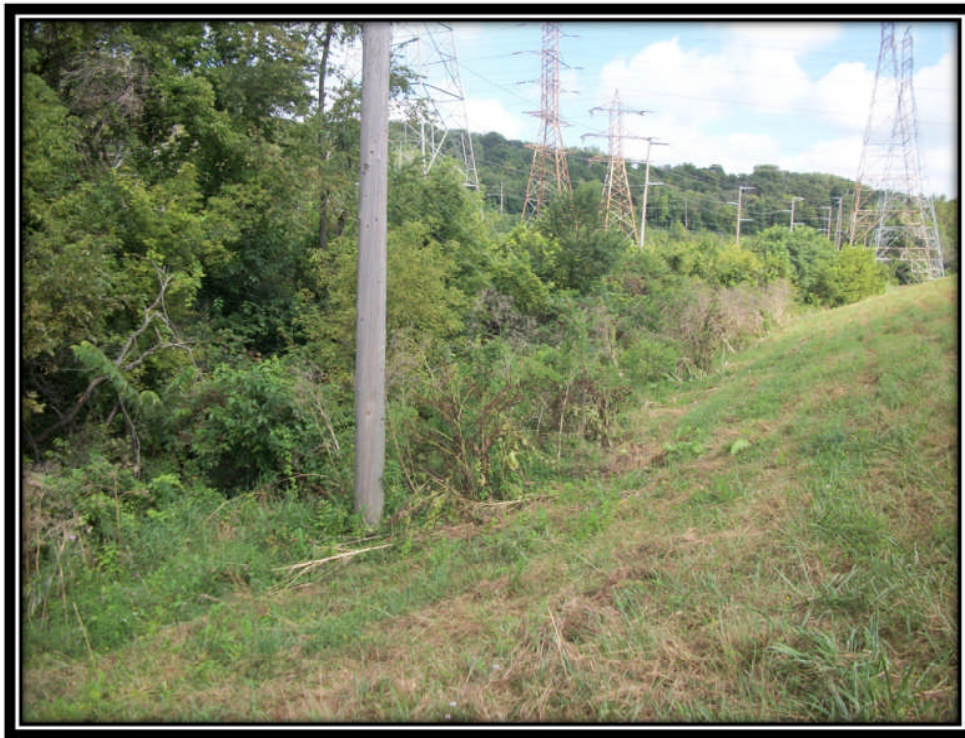
Photo 29 – Electric Line Penetration near Toe of Downstream Embankment

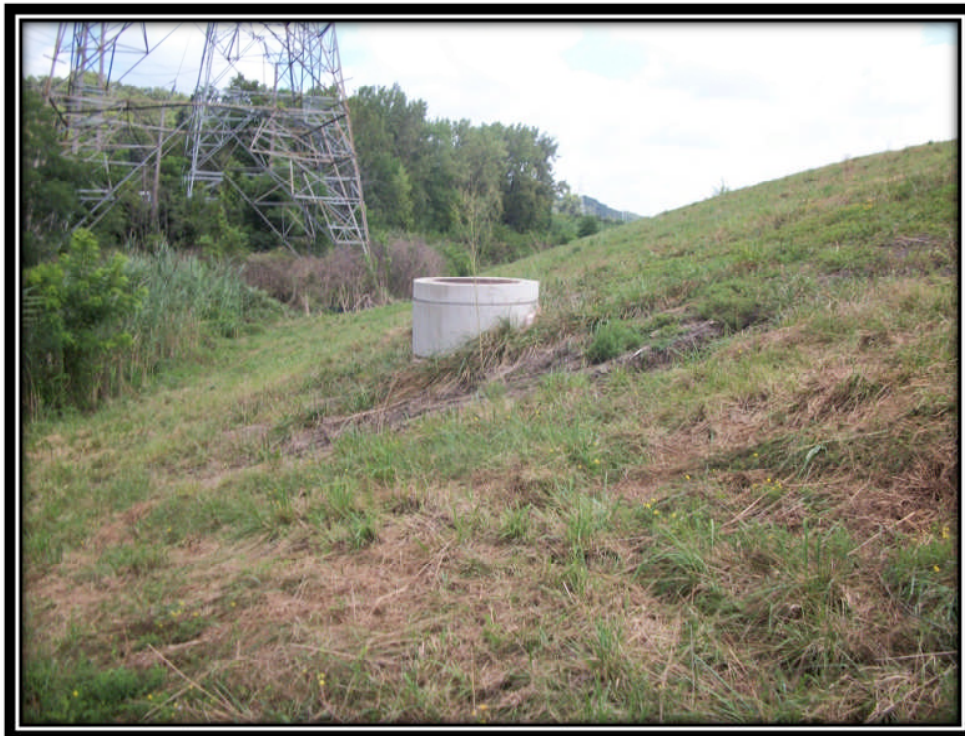
Photo 30 – Waste Water Sewer Line Manhole in Downstream Slope with Erosion Present
