**COAL ASH IMPOUNDMENT
SITE ASSESSMENT FINAL REPORT**

**E.D. Edwards Power Generating Station
Ameren Energy Generating Company
Bartonville, Illinois**

KLEINFELDER PROJECT NUMBER 112618-2

May 10, 2011

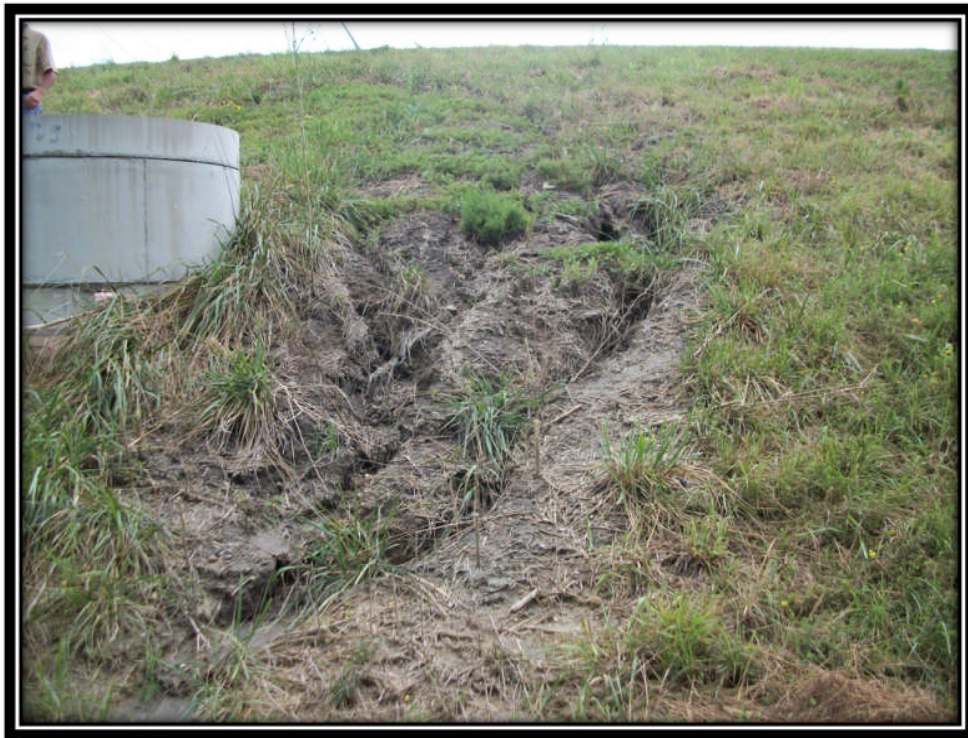
Photo 31 – Erosion Greater Than 12” Present at Sides of Waste Water Sewer Manhole

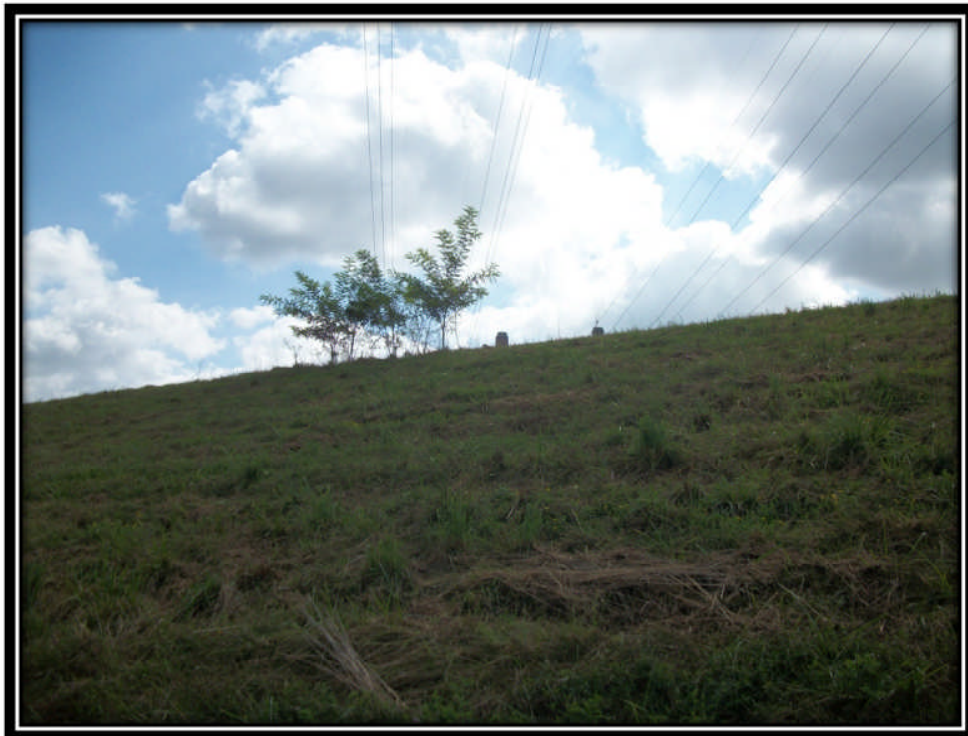
Photo 32 – Small Diameter Vegetation Growing on Crest

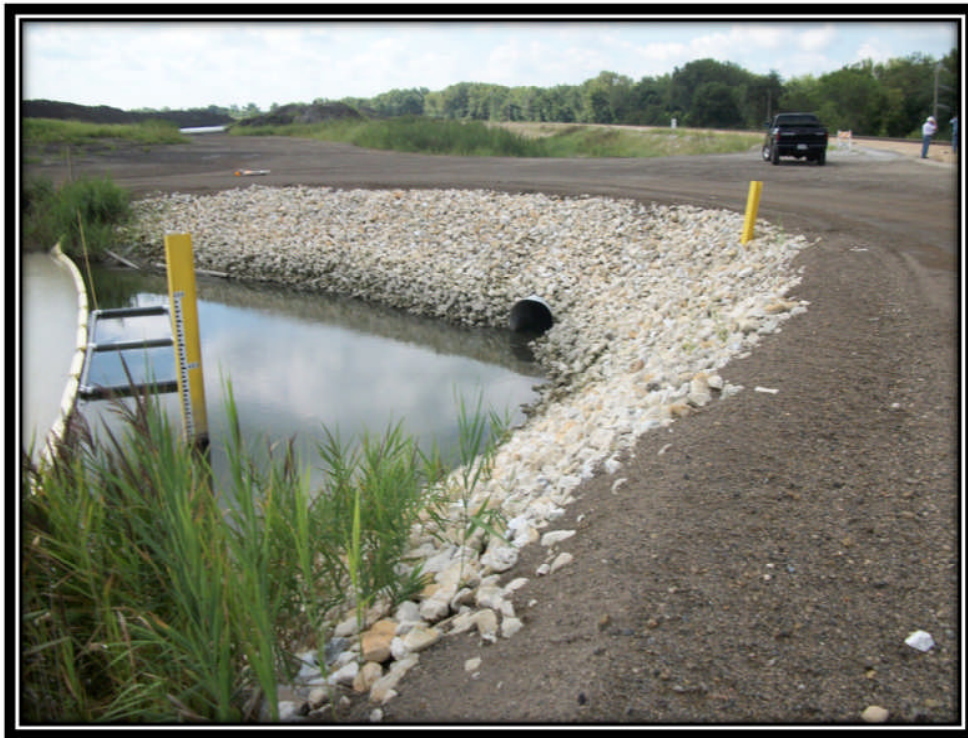
- The upstream slope was laid back at approximately 2H:1V.
- Minor erosion, less than 6 inches, was noted on some of the upstream slopes, especially in areas where new fill had been added to widen haul routes at the north end of the pond.
- Vegetation was present on the majority of the upstream slope. However, vegetation with stem diameters greater than one inch was not noted during the inspection.
- Mowing/vegetation control had not been completed on the majority of the upstream slope.

Photo 33 – Outlet Piping from Pond 1 into Clarification Pond Inlet Channel

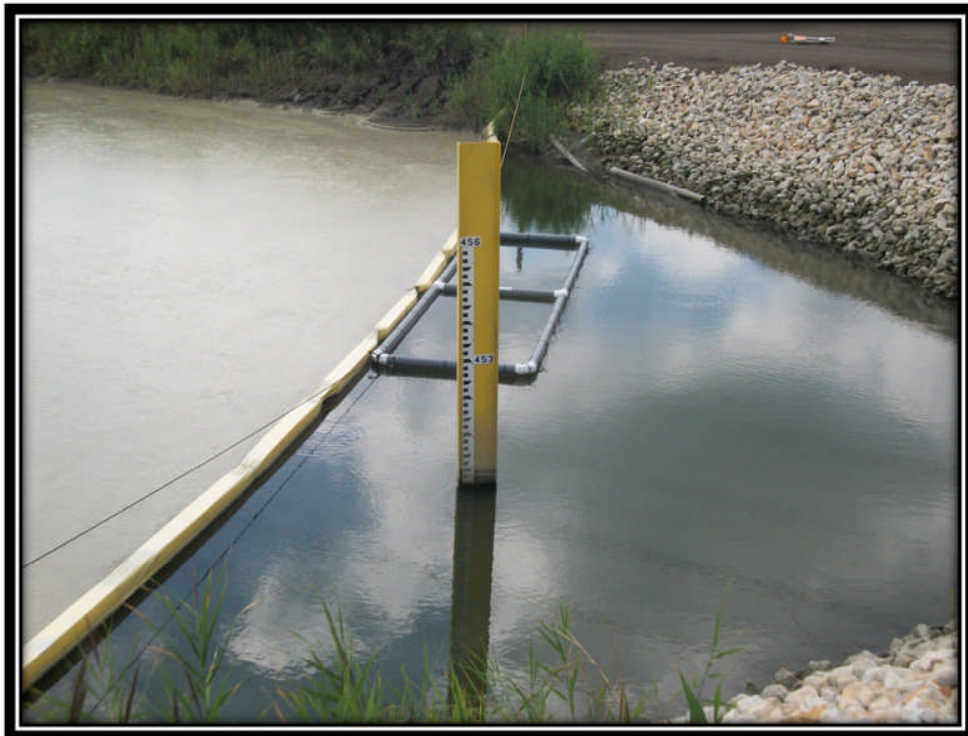
Photo 34 – Pond 1 Pool Elevation Gauge

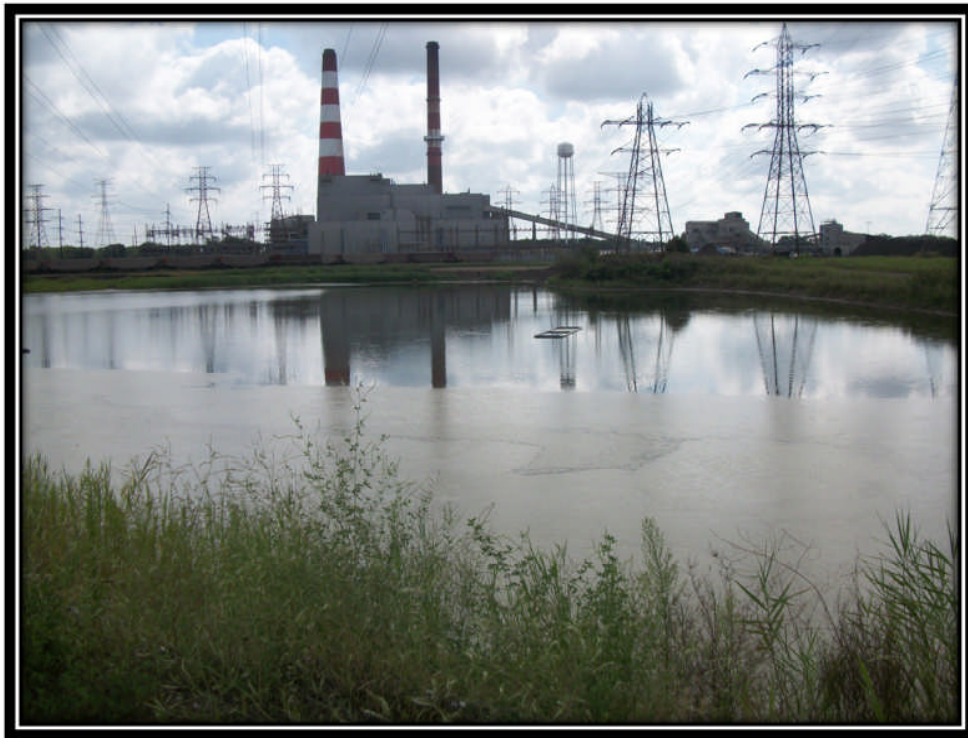
Photo 35 – Pond 1 General Conditions

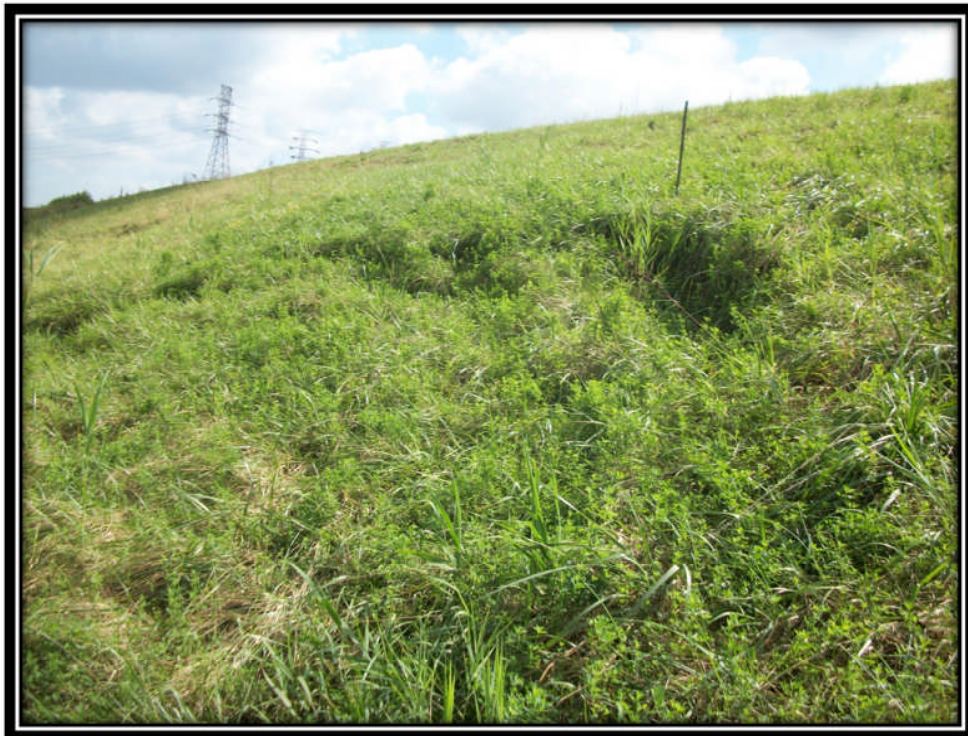
- Erosion, some areas greater than 6 inches, was noted on some of the downstream slope.
- Penetrations into the downstream embankment, including manholes, were present.
- A large scarp, approximately two feet in depth, was present for a significant portion of the western embankment slope.
- Grasses and woody bushes were observed on the downstream slope.

Photo 36 – Scarp on Western Pond 1 Downstream Slope (Note Post for Observational Purposes)

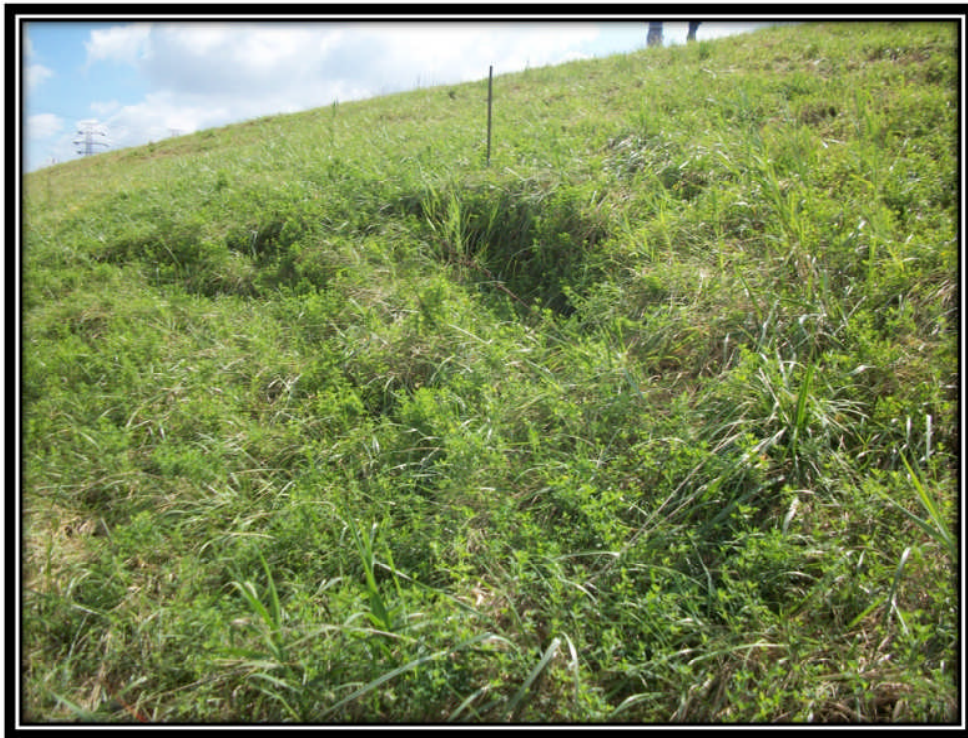
Photo 37 – Scarp on Western Pond 1 Downstream Slope Approximately 18"-24" Deep

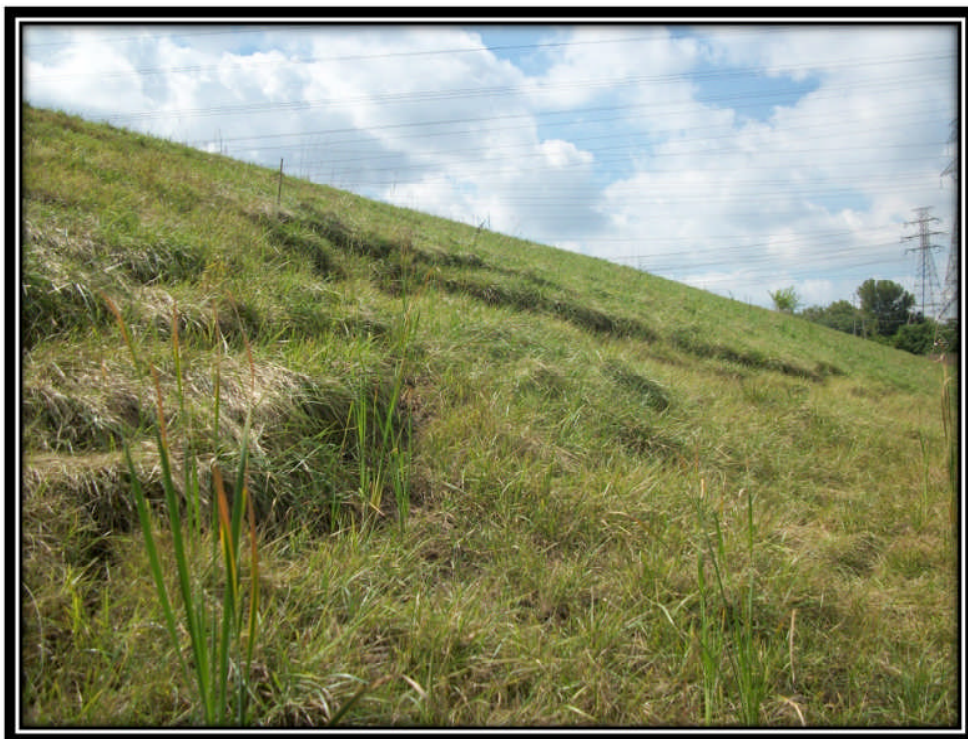
Photo 38 – Scarp on Western Pond 1 Downstream Slope

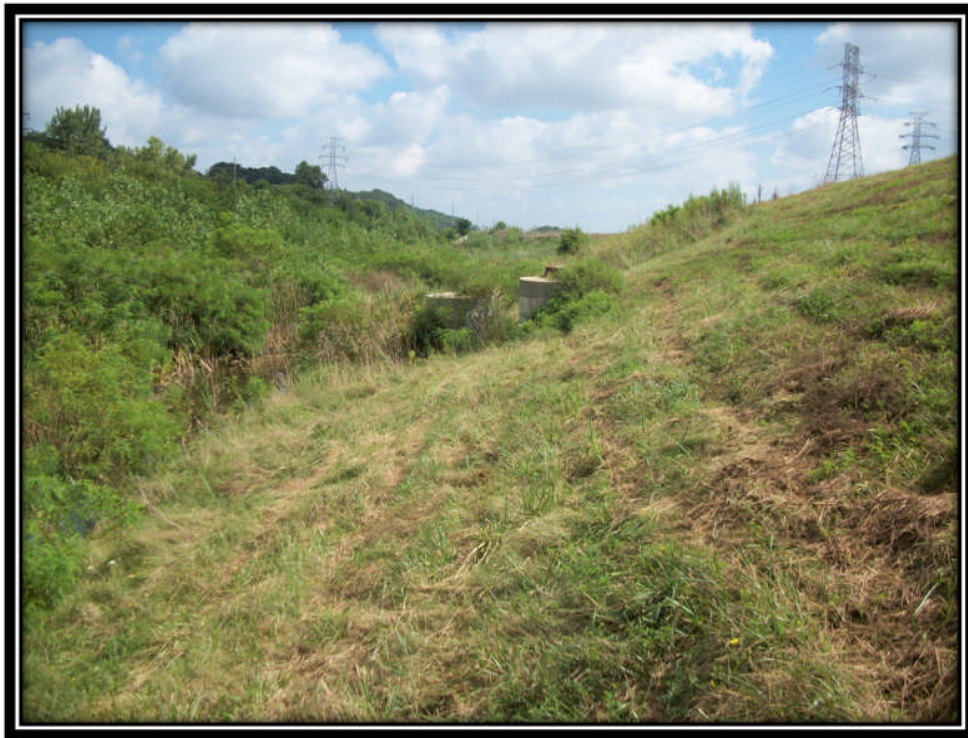
Photo 39 – Waste Water Sewer Manhole on Downstream Slope of Pond 1

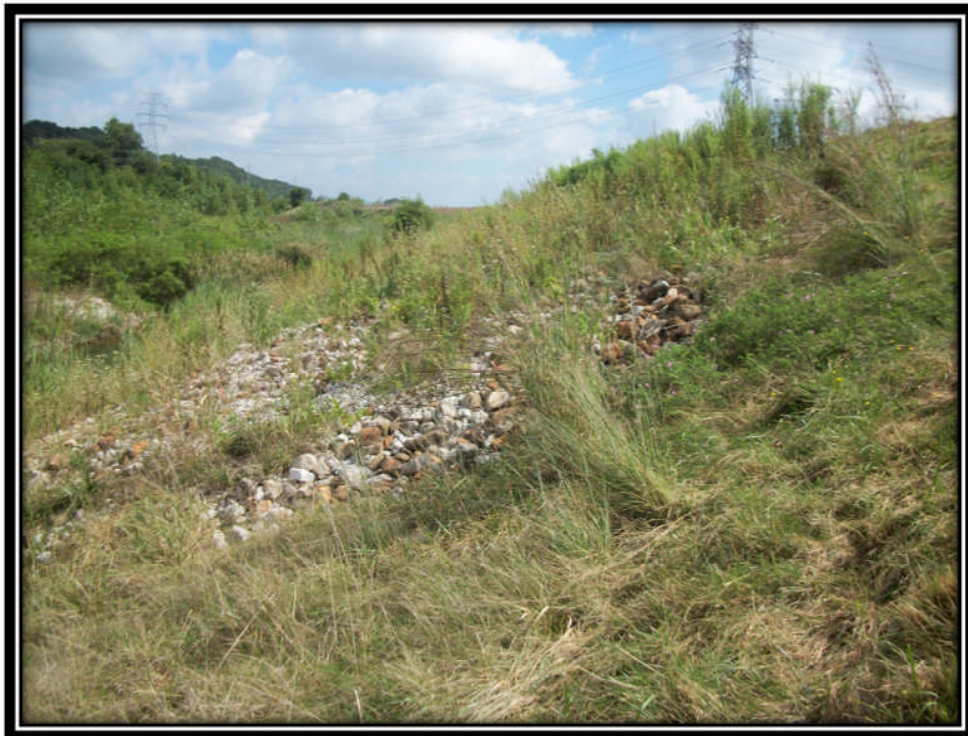
Kleinfelder understands that embankment stability analyses are currently being completed for each of the cells by another consultant retained by Ameren Energy. In addition, two zones of embankment slope instability were reported on the widened western embankment (widened for rail spur construction). Specifically, one zone of surface instability was reported by Ameren Energy near the north end of the west embankment and was apparently stabilized and covered with riprap. Another zone of surface instability was reported by Ameren Energy on the west embankment. We observed the surface scarp and were informed that Ameren continues to monitor the scarp for signs of additional movement. Ameren reported that this slope failure is located in an area where the original embankment was widened with a combination of soil and ash from the plant.

Photo 40 – Scarp that has Been Repaired on Western Pond 1 Downstream Slope

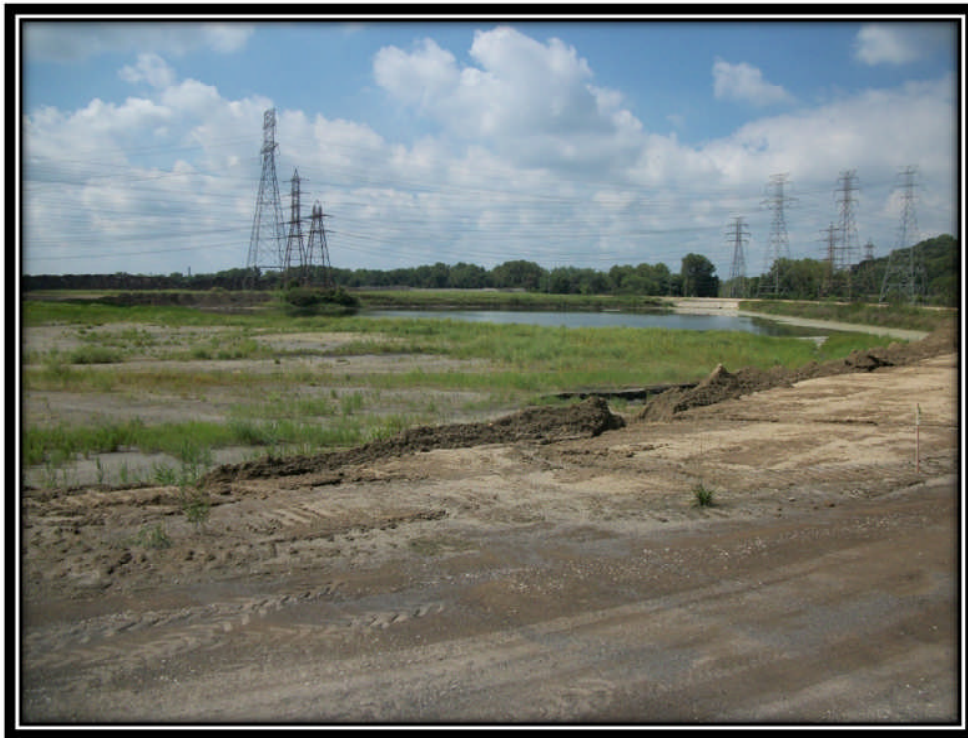
- The impoundment crest consists of a graded fill used as a haul route for plant operations and removal of fly ash, bottom ash, and boiler slag residue. The crest is also used for a railroad line that is utilized in the delivery of coal for the facility.
- Overall, the crest was clear of all vegetation with only some sparse grasses and minimal bushes observed on the crest.
- No major depressions or rutting were noted on the impoundment crest.
- A chain link fence is located on the eastern side of the cooling pond at the crest. The chain link pole penetrations are at least 40 feet away from the upstream slope of the impoundment.
- Minor erosion was noted on crest in limited locations. This erosion was typically less than six inches in depth and typically appeared on the edges of the crest, where grade breaks occurred when transitioning to embankment

Photo 41 – Pond 1 General Conditions (Note Access Road Expansion into Pond)

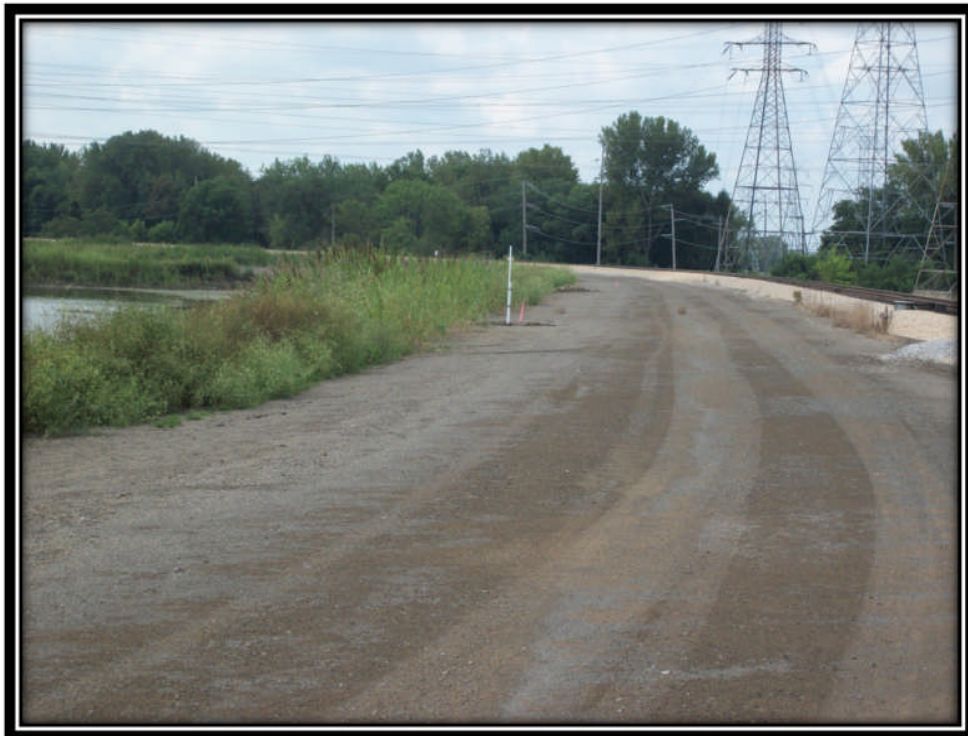
Photo 42 – General Crest Conditions of Pond 1 (Note Piezometer in Crest)

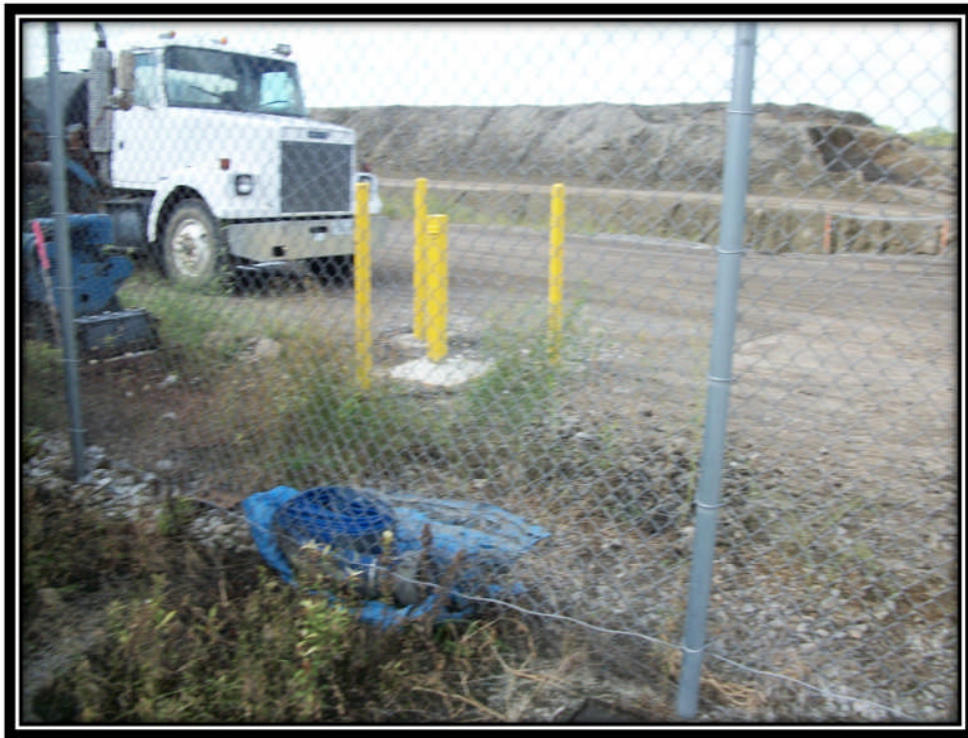
Photo 43 – Typical Newly Installed Monitoring Well

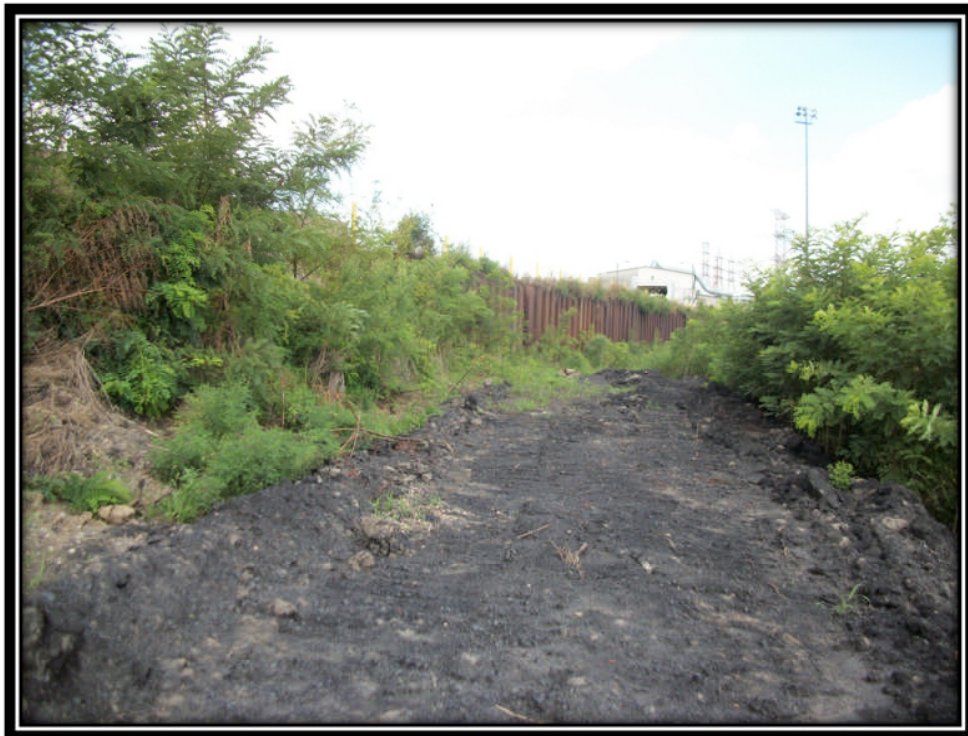
- Grasses and woody bushes were observed on the downstream slope and at the toe of the embankment for a large portion of the impoundment.
- Typically, the embankment was very close to the natural ground elevation and only elevated from the natural ground elevations in some locations.
- Typically, the embankment was well maintained with what appears to be regular mowing and grading operations.

Photo 44 – Floodwall Separating Ash Pond Settling Channels and Coal Pile

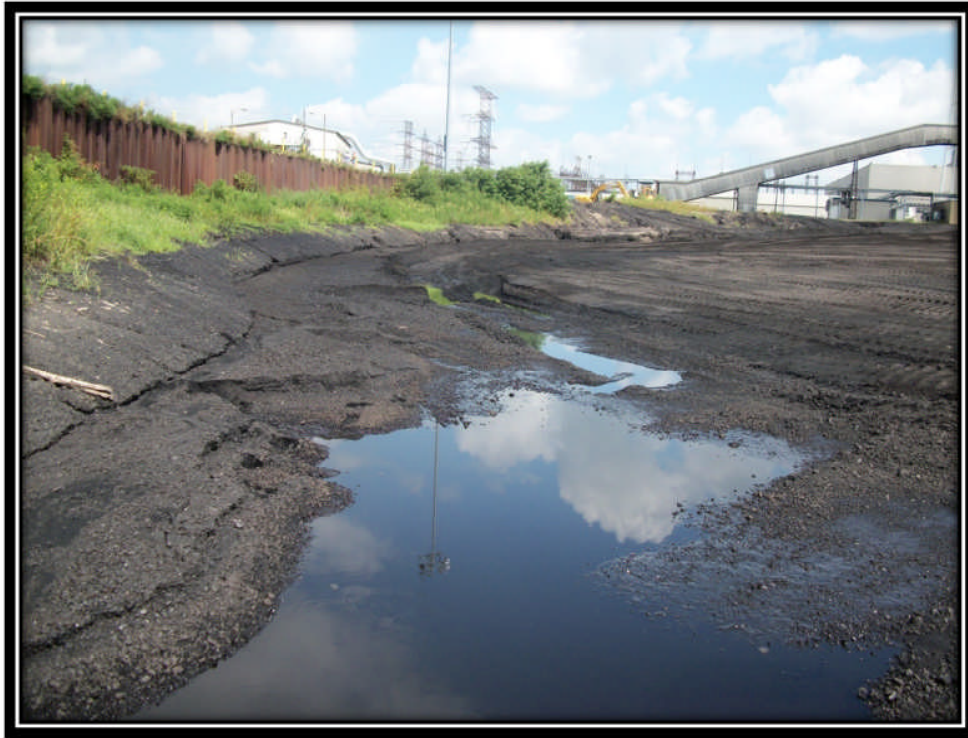
- Minor possible seepage from the impoundment was noted at the base of the sheet pile wall. This seepage could also be surface water runoff seeping through the coal stockpile.
- The toe area had a few locations where vegetation and woody growth were noted.

Photo 45 – Storm Water Channel between Coal Pile and Floodwall (Possible Seep Location)
