**DRAFT REPORT  
ROUND 10 DAM ASSESSMENT – JUNE 2, 2011  
AMEREN ENERGY GENERATING COMPANY – HUTSONVILLE  
POWER STATION  
POND A, POND B, AND POND D  
HUTSONVILLE, ILLINOIS**

RE: Assessment of Dam Safety of Coal Combustion Surface Impoundments at the  
Hutsonville Power Station

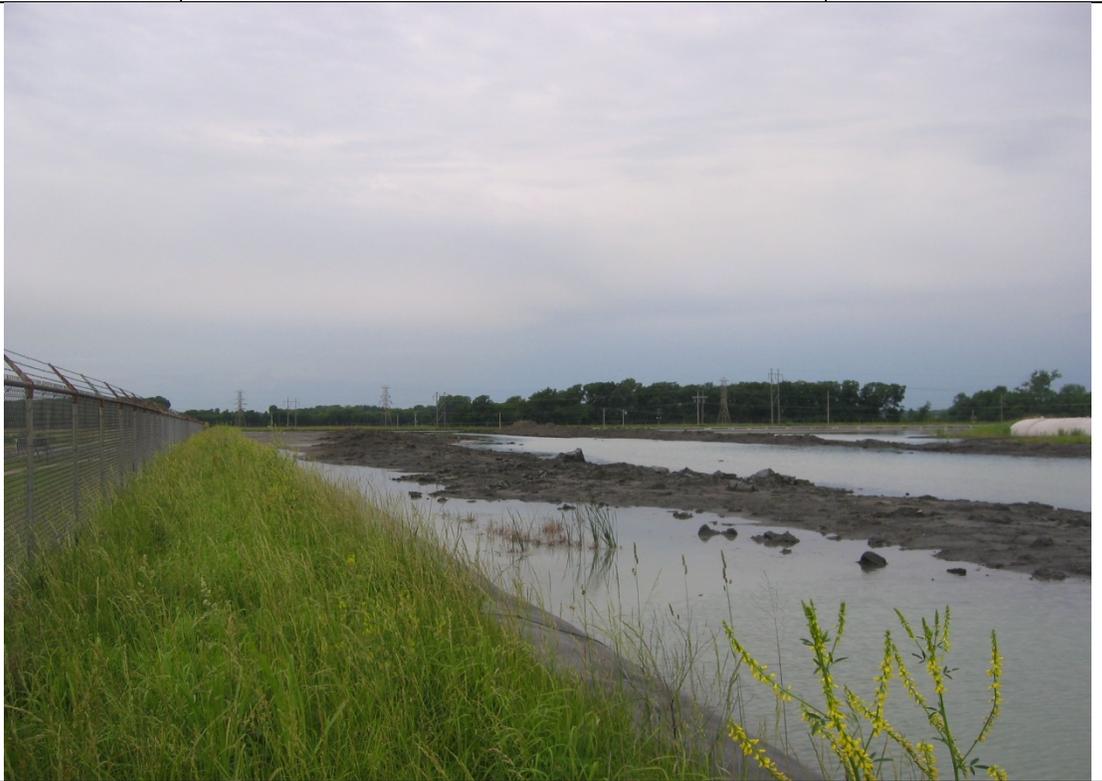
Upstream slope and crest of  
Pond A.

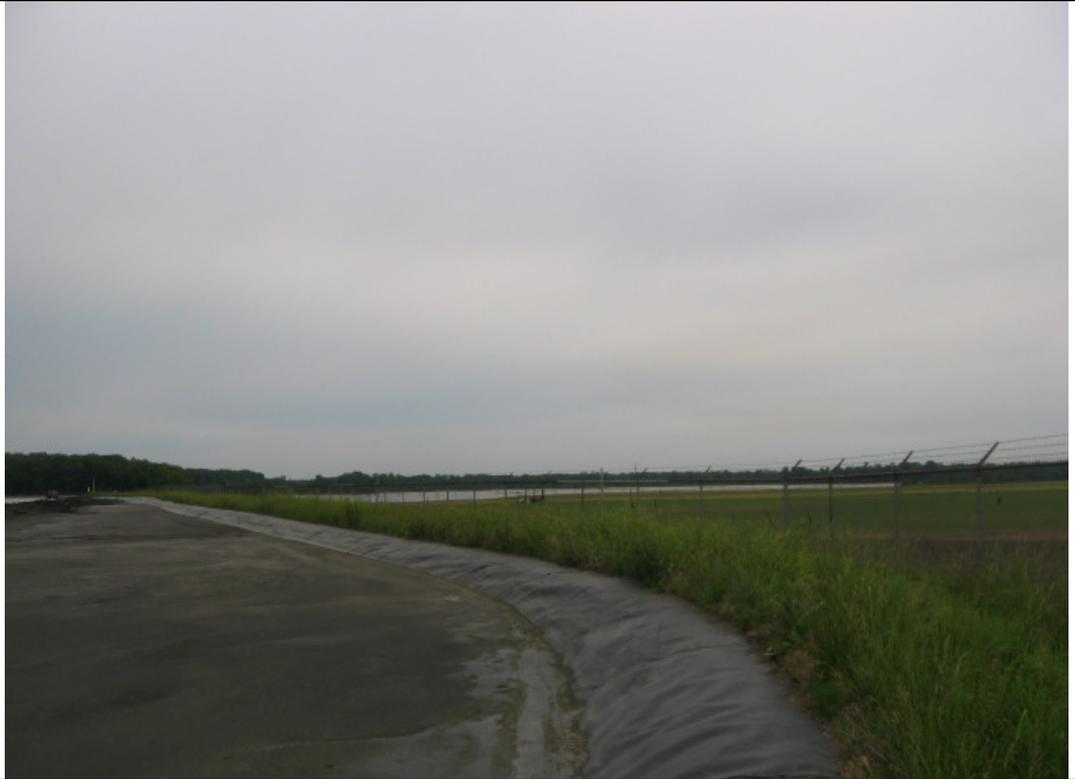
Description:  
Upstream slope and crest of  
Pond A.

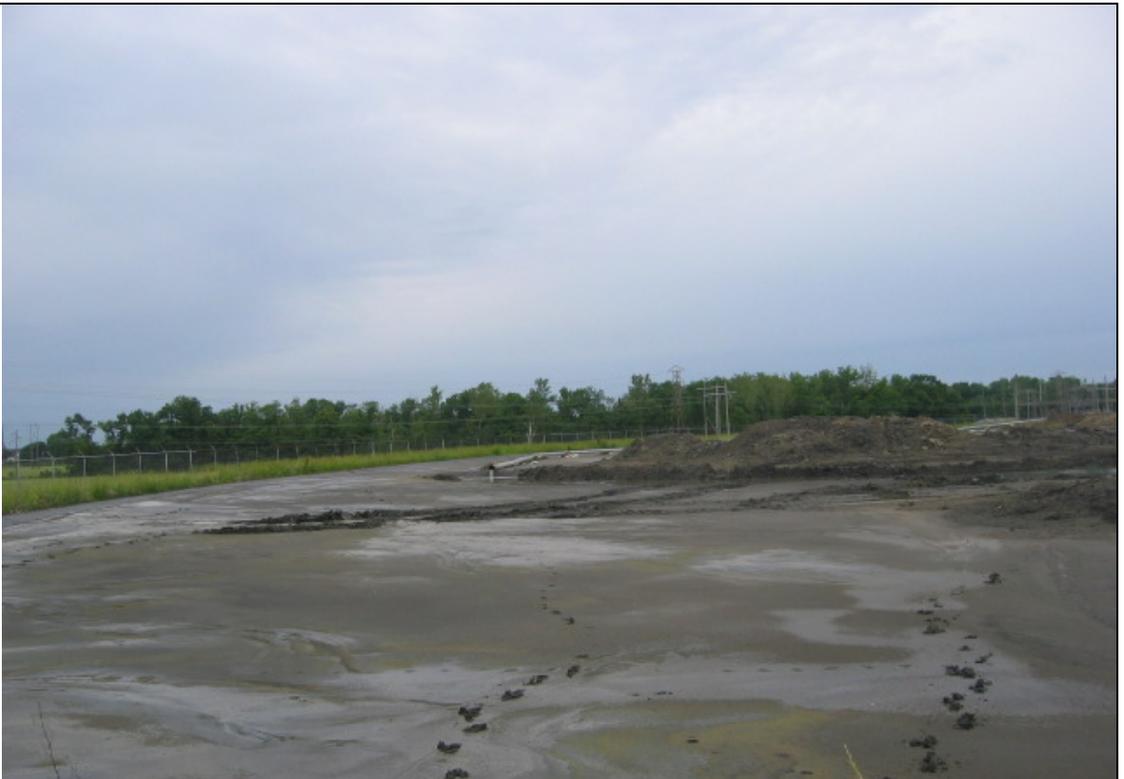
Photo No.  
**4**

Description:  
Upstream slope and  
discharge pipe in Pond A.

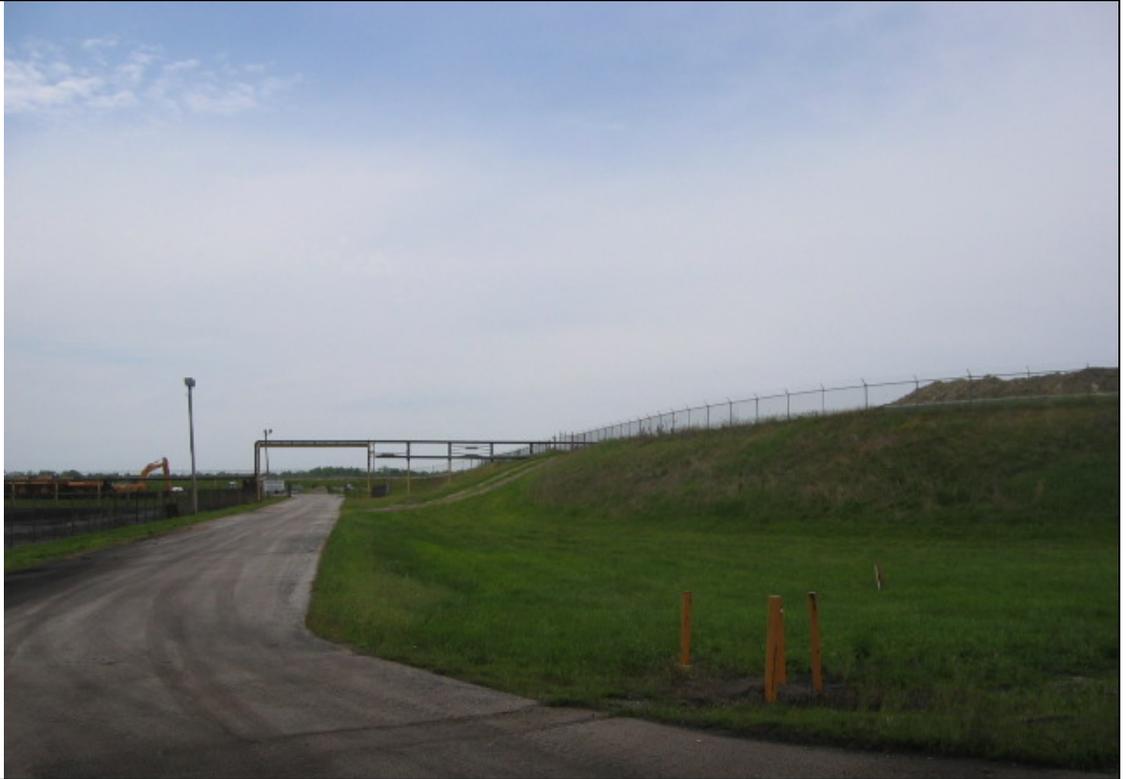
The downstream slope of the impoundment was generally vegetated with grass. No seepage was observed on the downstream slope. Minor localized sloughing of the soils was observed along the downstream slope near the northeast corner of the impoundment.

**Description:**  
Downstream slope of Pond A.

1. Repair sloughing on the downstream slope of Pond A;
2. Fill currently observed animal burrows by injecting grout under low to moderate pressures to ensure the entire limits of the respective burrow is adequately filled;
3. Exercise stoplogs and slide gates; and,
4. Increase frequency of maintenance mowing such that overgrowth of vegetation is minimized.

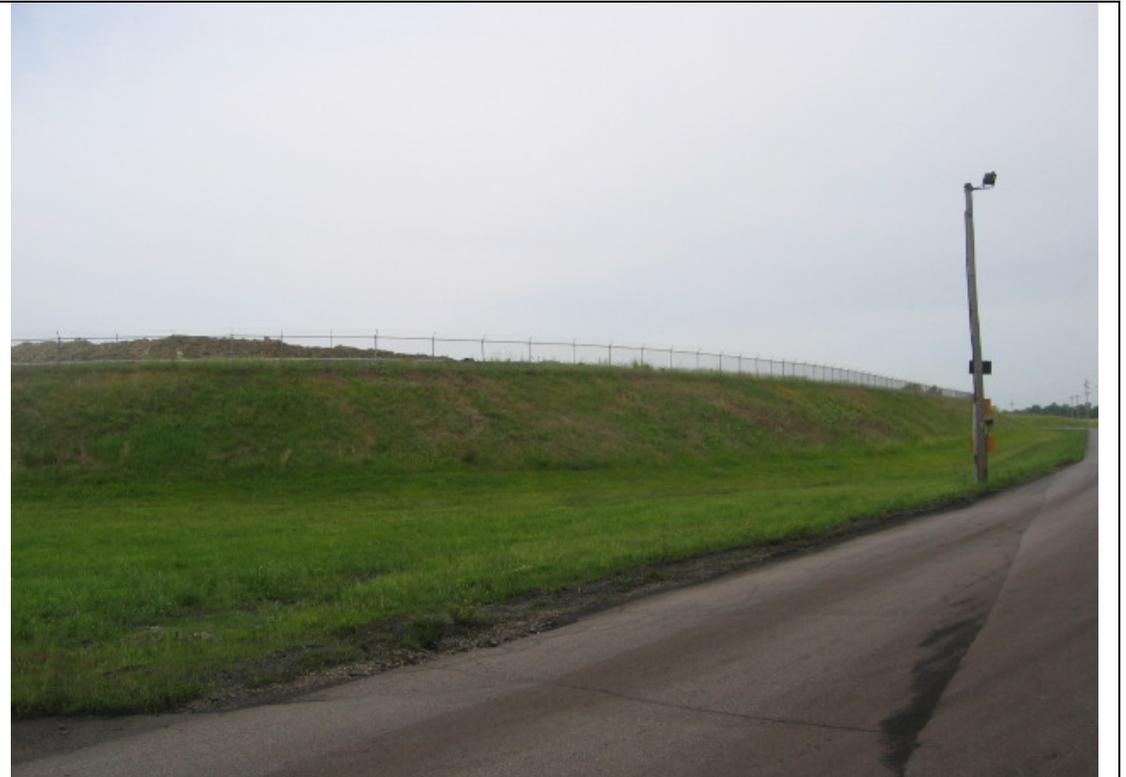
**Photo No.**  
**12**

**Description:**  
Downstream slope of Pond A.

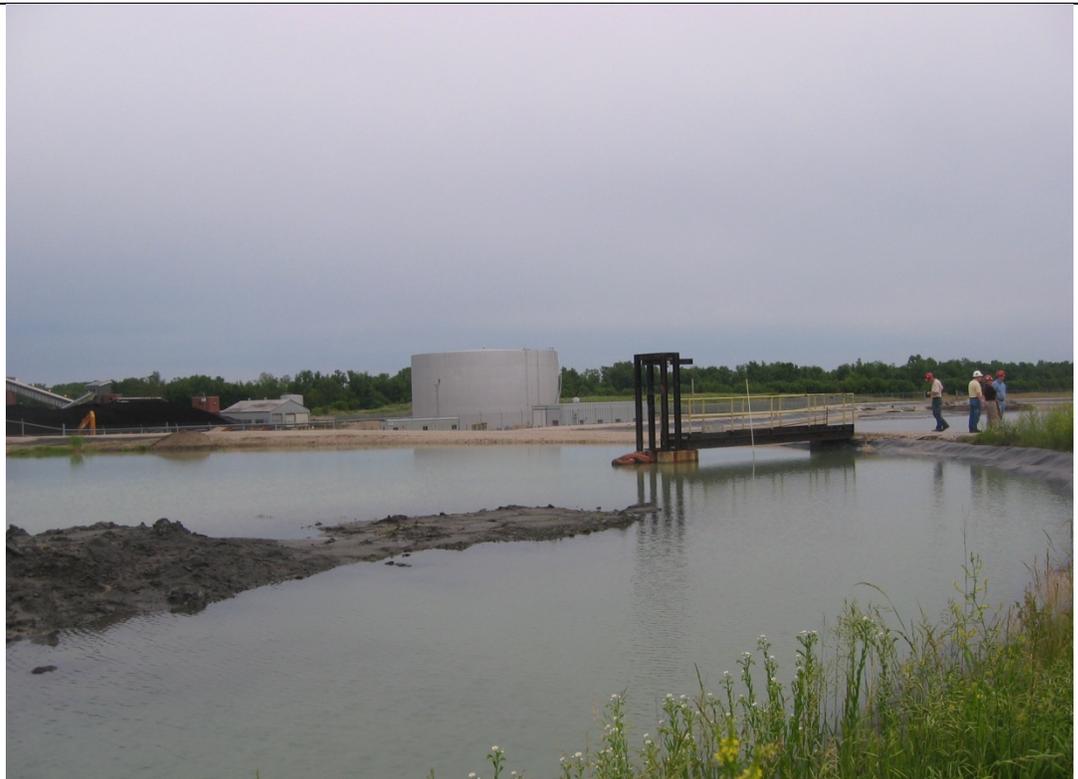
**Description:**  
Decant structure in Pond A.

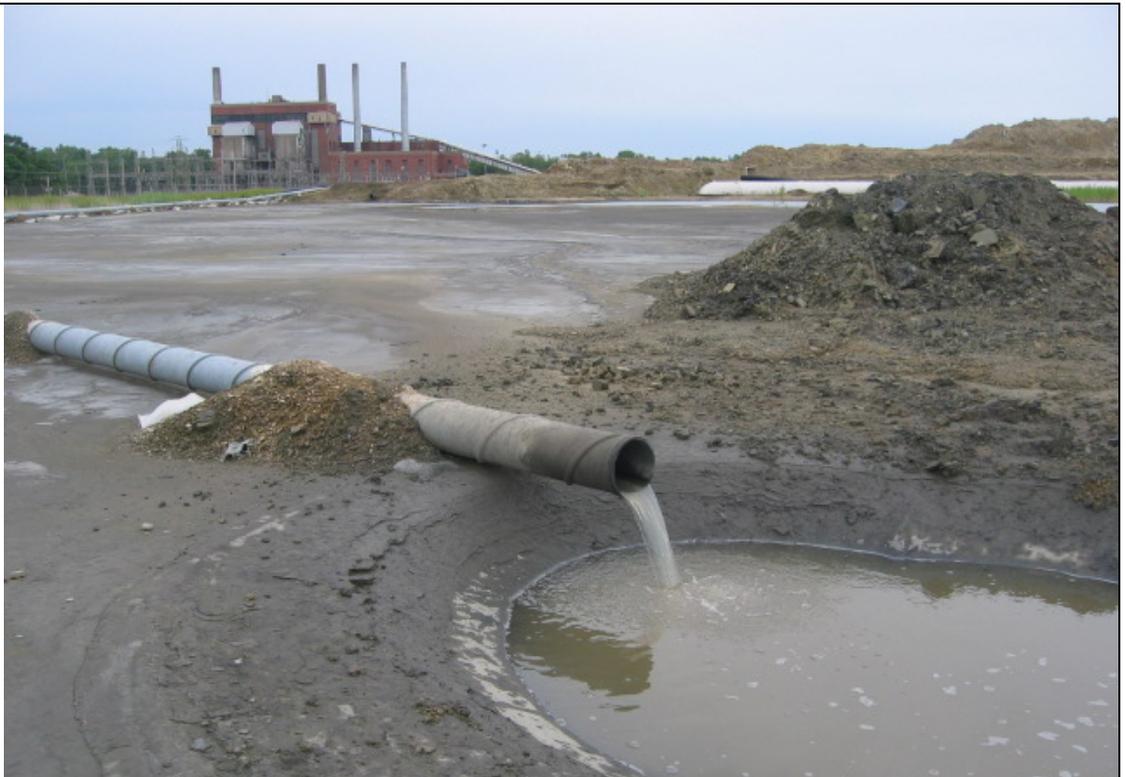
**Description:**  
Discharge pipe in Pond A.

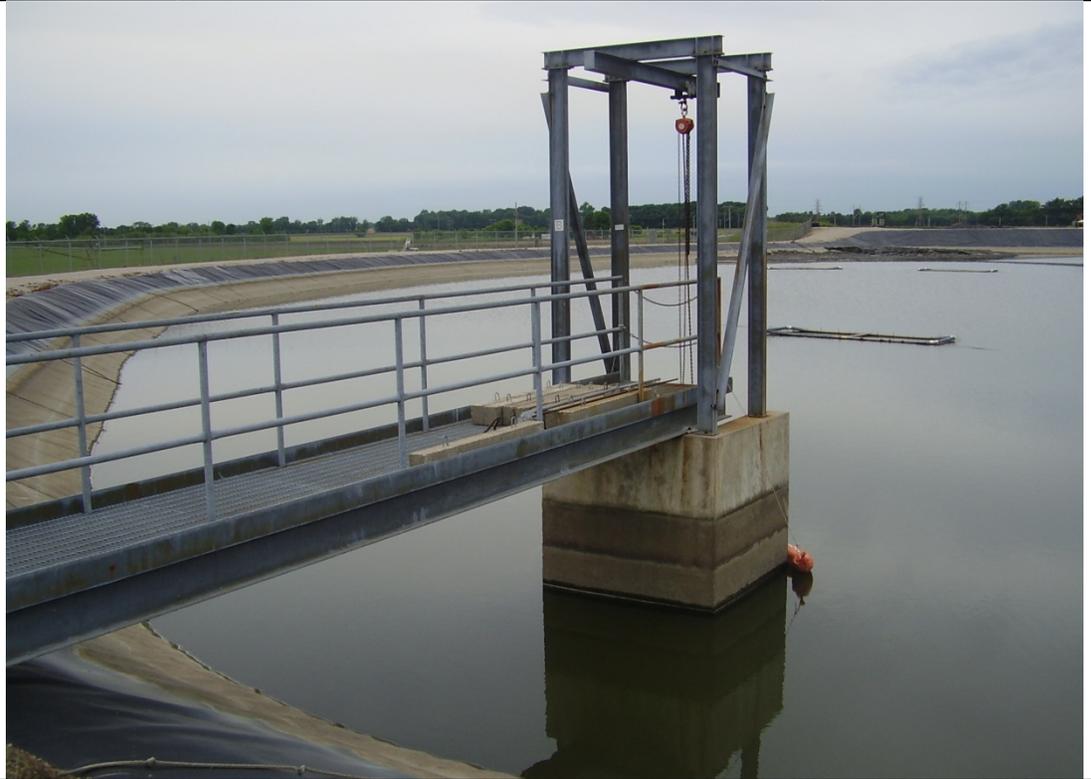
Description:  
Decant structure in Pond B.

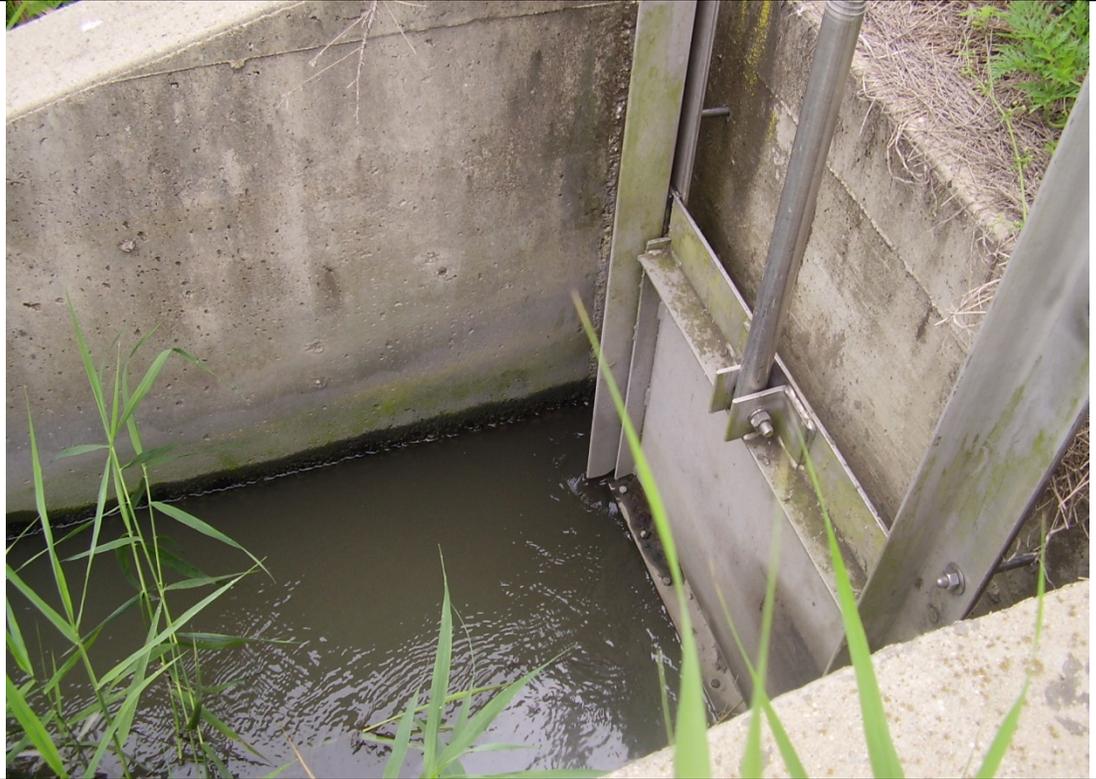
Description:  
Decant structure in the active  
portion of Pond D.

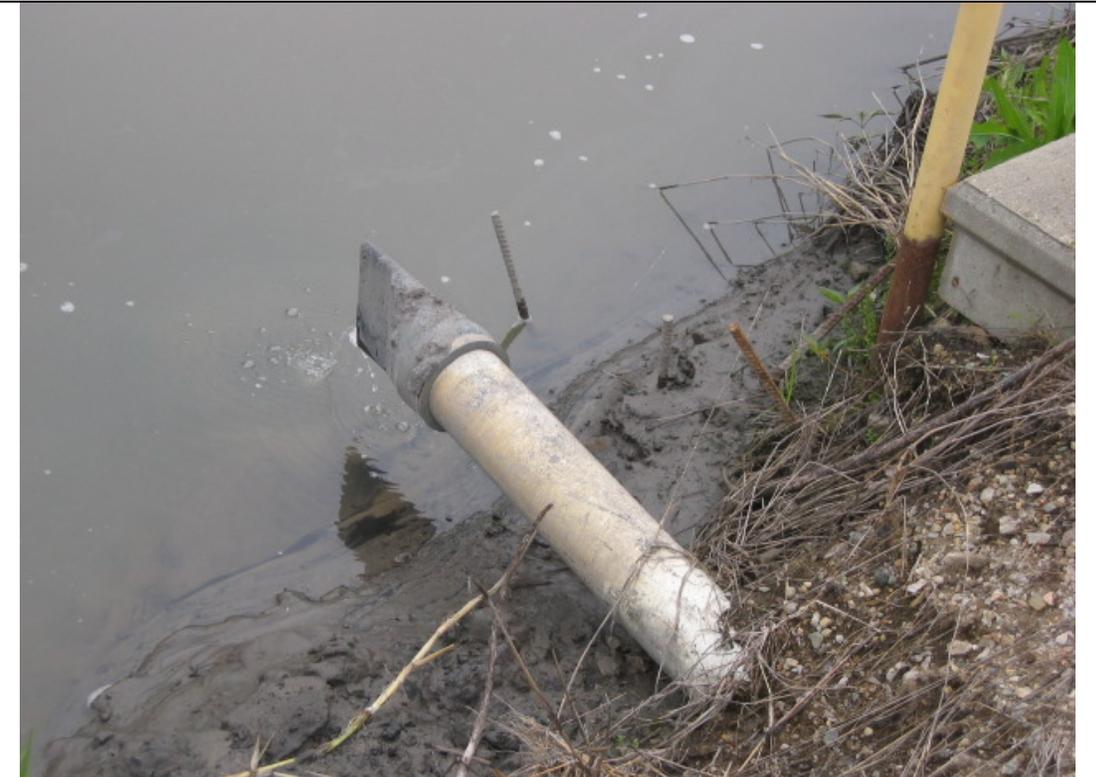
Photo No.  
**54**

Description:  
Discharge pipe in active  
portion of Pond D.
