**FINAL REPORT  
ROUND 10 DAM ASSESSMENT  
AMEREN ENERGY GENERATING COMPANY – HUTSONVILLE POWER  
STATION  
POND A, POND B, POND D  
HUTSONVILLE, ILLINOIS**

October 16, 2012  
GZA File No. 170142.30

RE: Assessment of Dam Safety of Coal Combustion Surface Impoundments at the  
Hutsonville Power Station

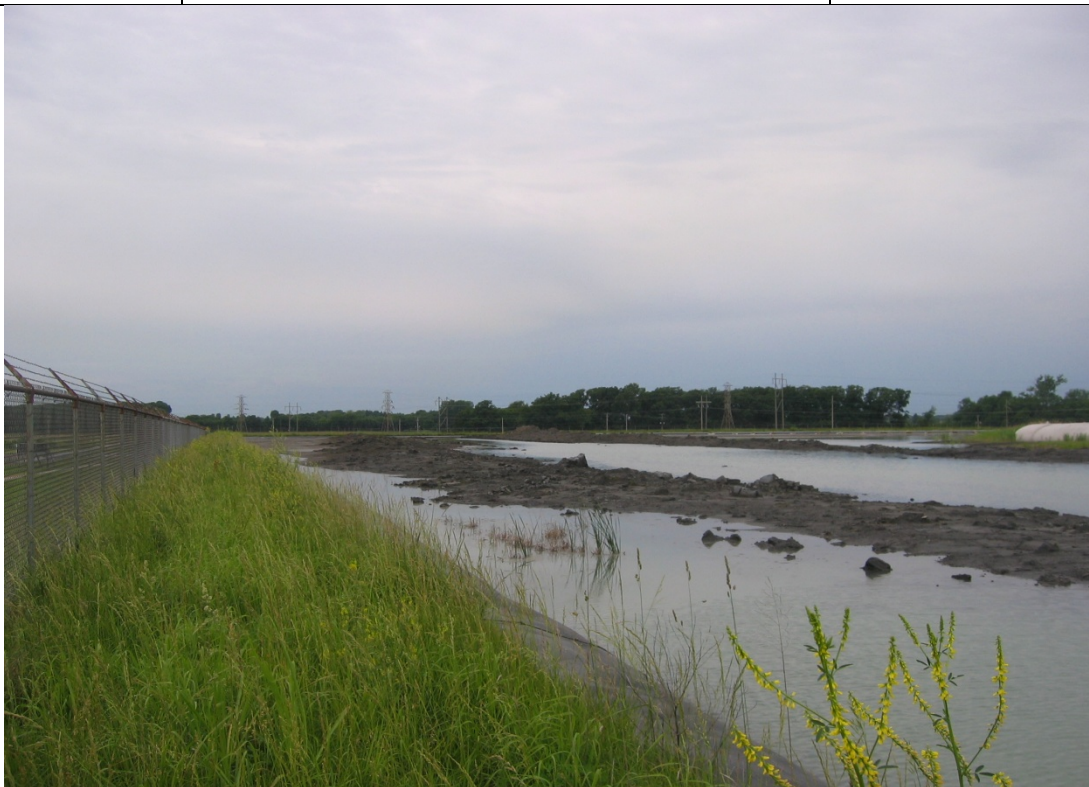
**Photo No.**  
**2**

**Description:**  
Upstream slope and crest of  
Pond A.

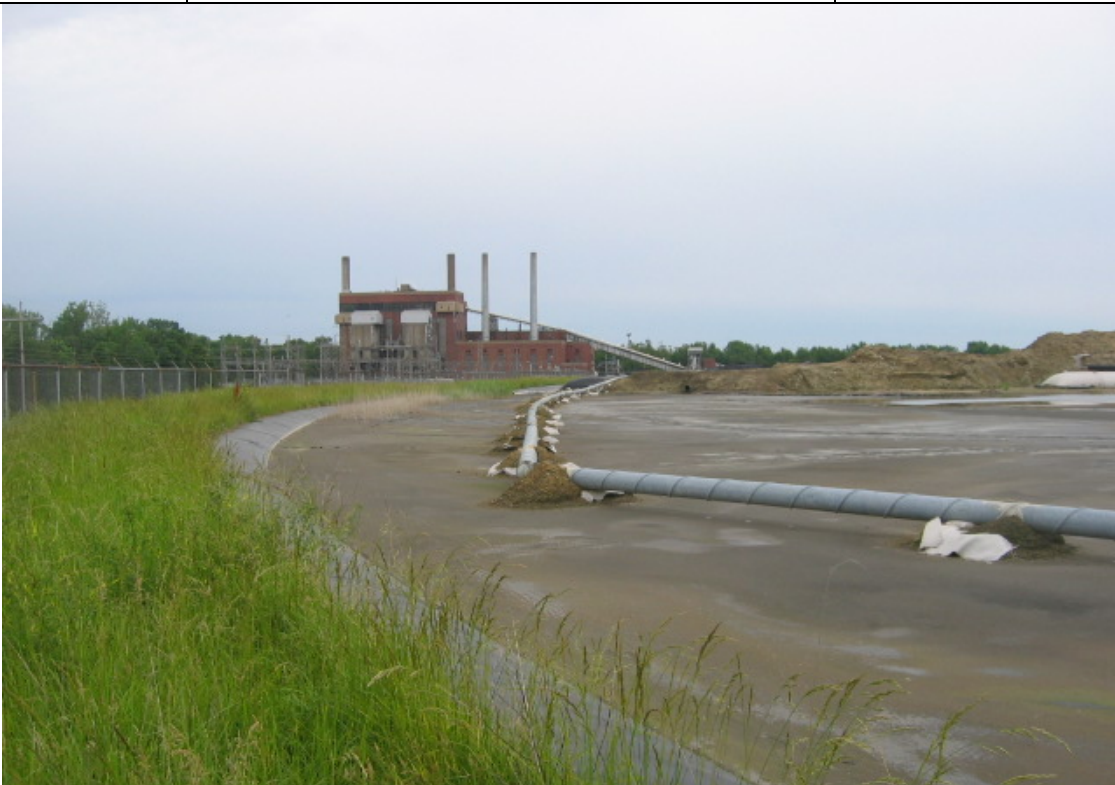
**Photo No.**  
**6**

**Description:**  
Upstream slope and crest of  
Pond A.

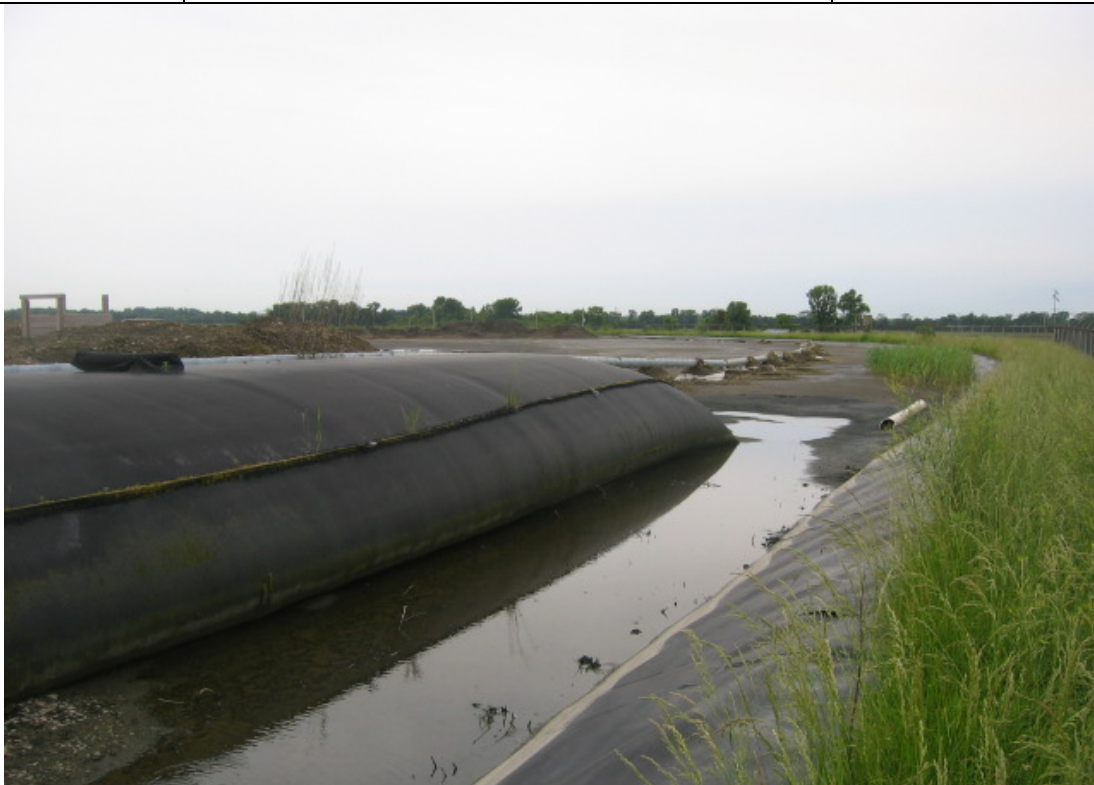
**Photo No.**  
**8**

**Description:**  
Upstream slope and crest of  
Pond A.

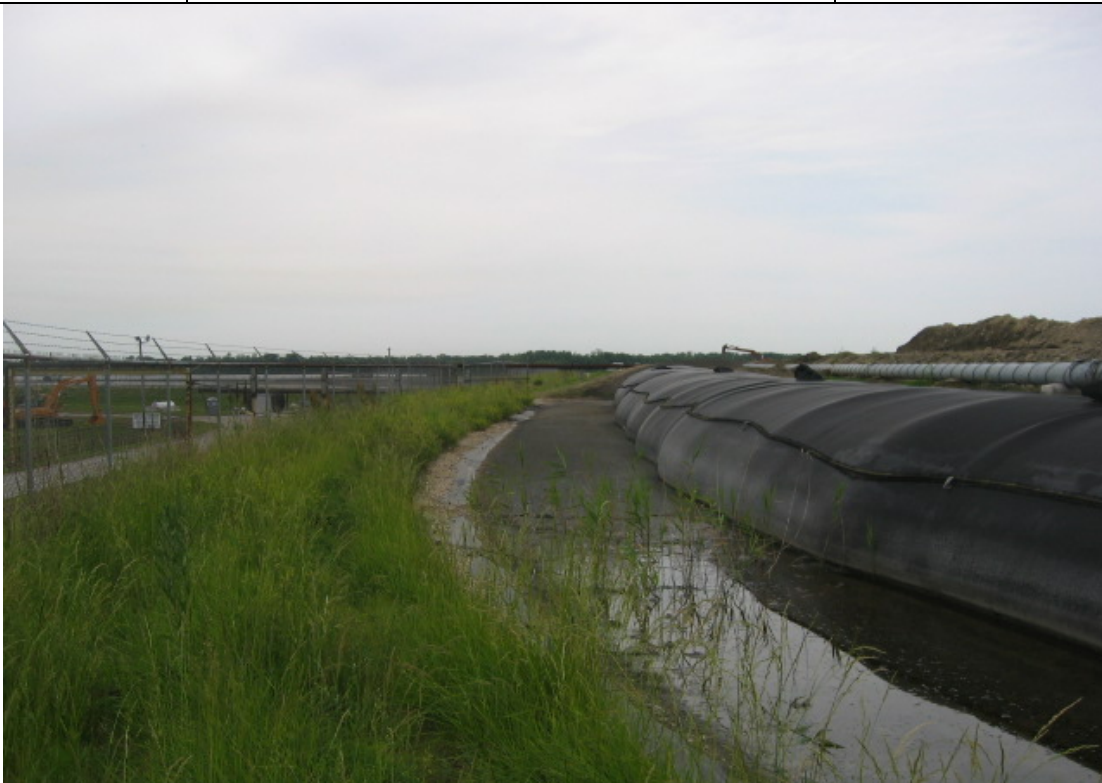
**Photo No.**  
**10**

**Description:**  
Upstream slope and crest of  
Pond A.

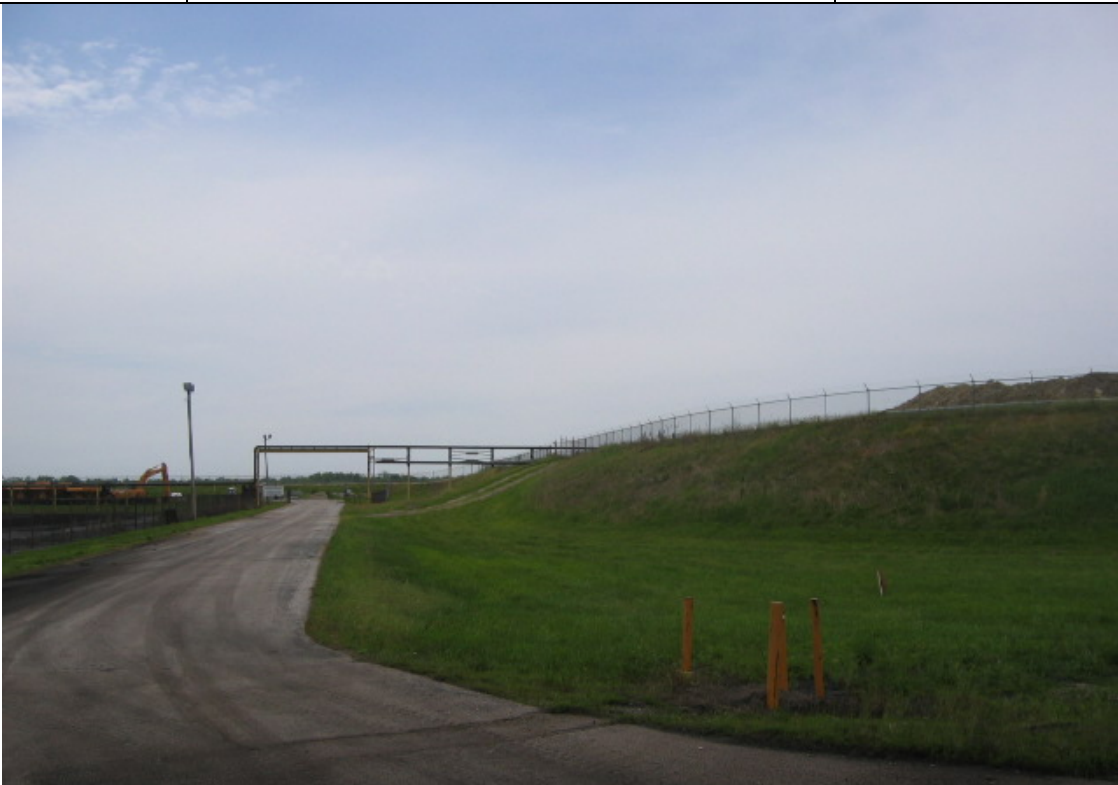
**Photo No.**  
**12**

**Description:**  
Downstream slope of Pond  
A.

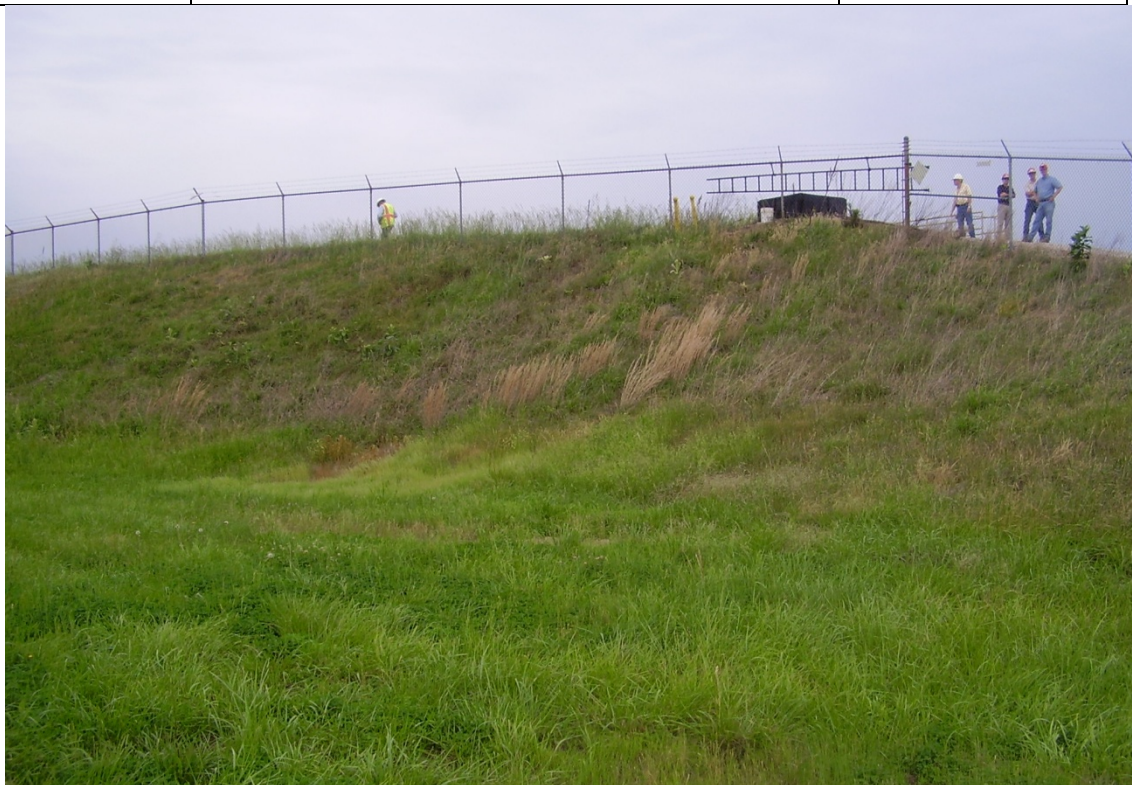
**Photo No.**  
**20**

**Description:**  
Decant structure in Pond A.

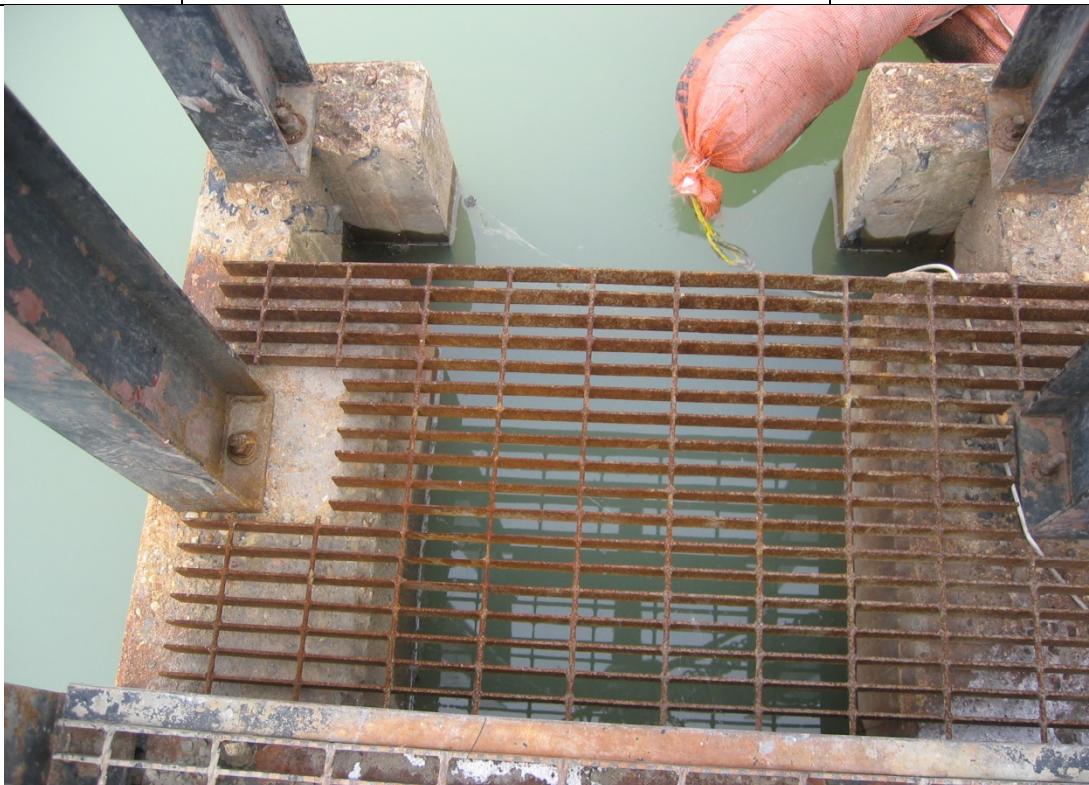
**Photo No.**  
**22**

**Description:**  
Discharge pipe in Pond A.

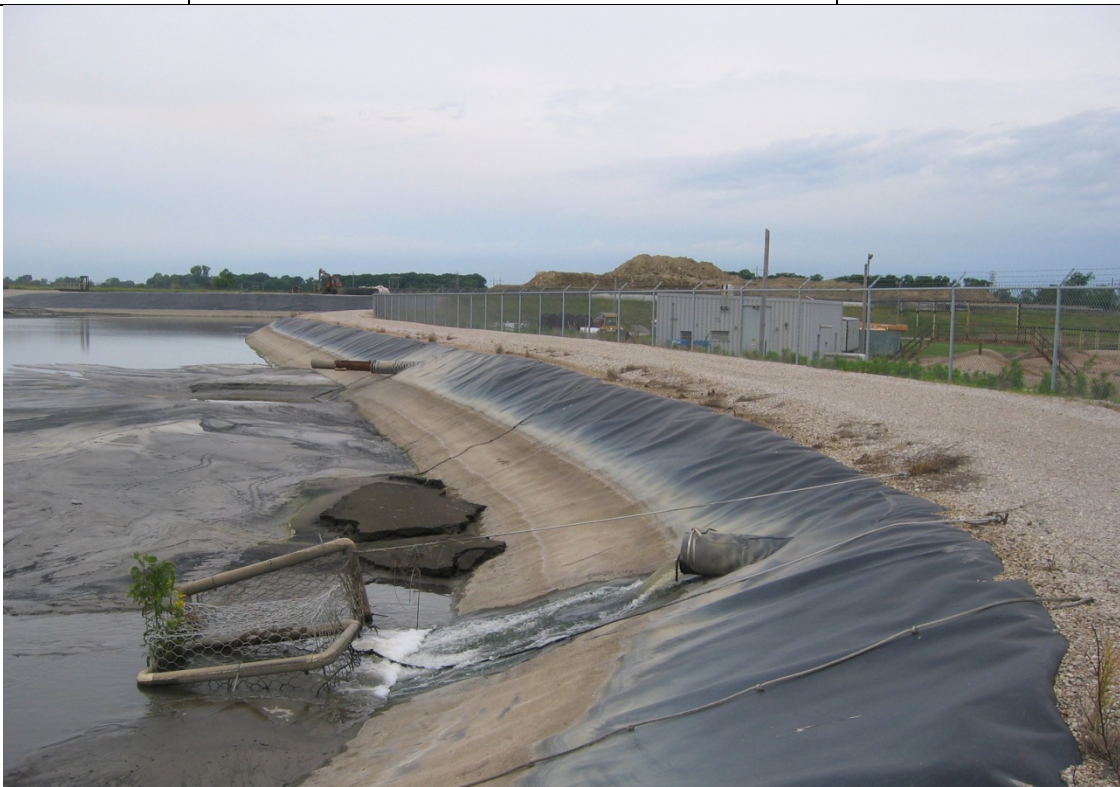
**Photo No.**  
**24**

**Description:**  
Upstream slope and crest of  
Pond B.

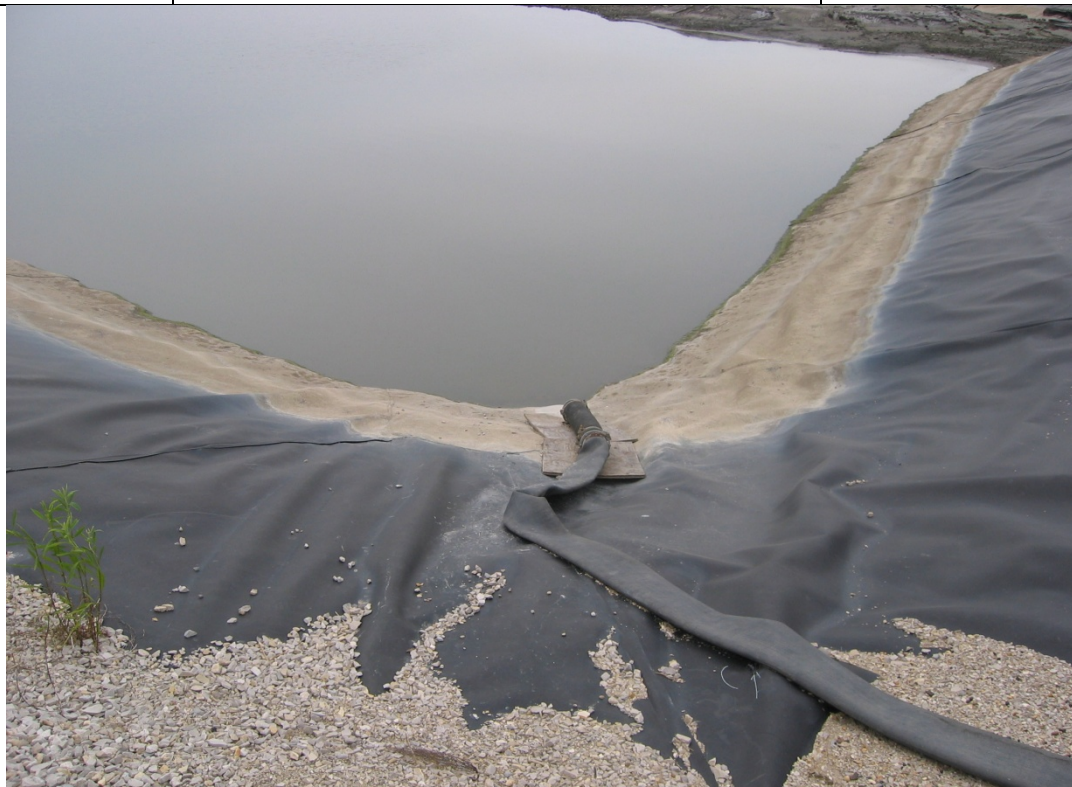
**Photo No.**  
**26**

**Description:**  
Upstream slope and crest of  
Pond B.

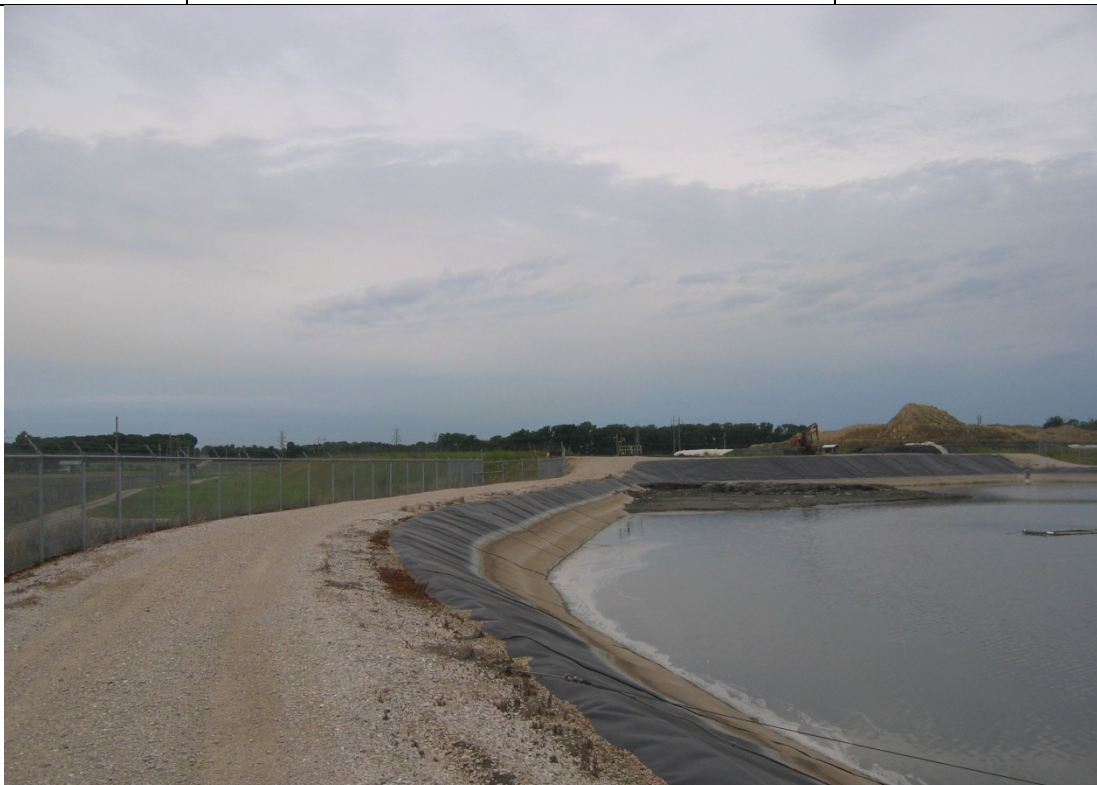
**Photo No.**  
**28**

**Description:**  
Upstream slope and crest of  
Pond B.

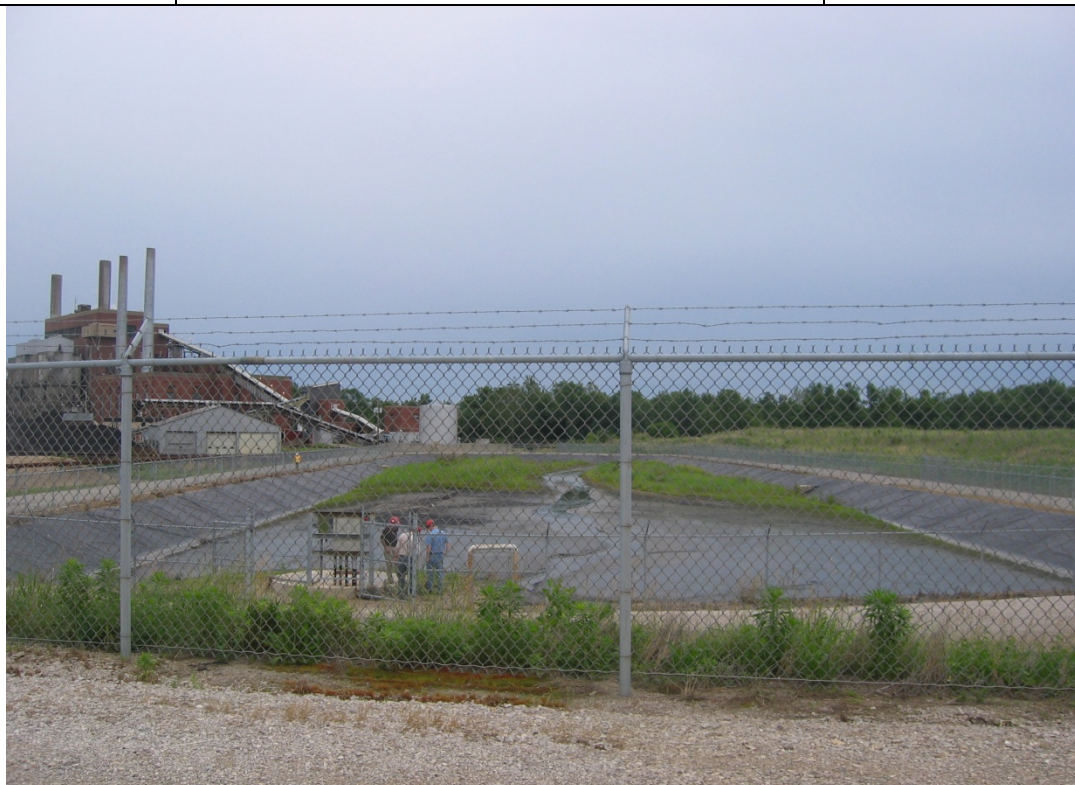
**Photo No.**  
**40**

**Description:**  
Pond C as seen from north.

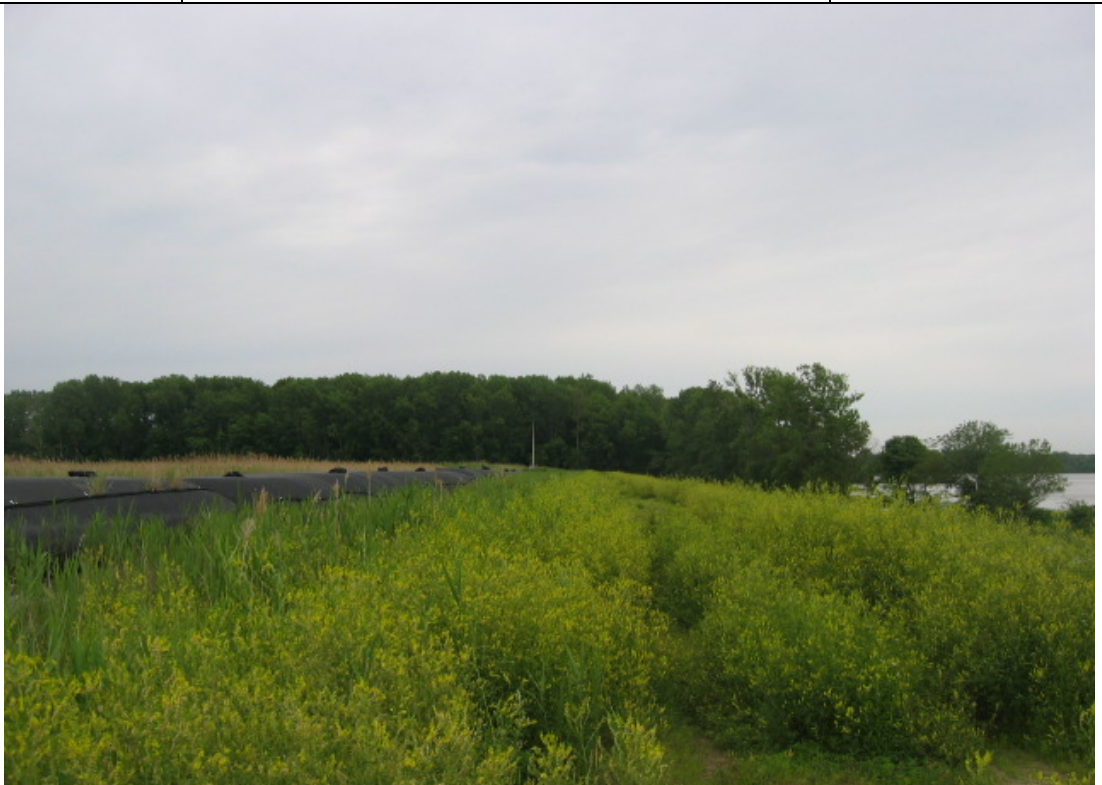
**Photo No.**  
**42**

**Description:**  
Downstream slope of the  
closed portion of Pond D as  
seen from the southeast  
corner.

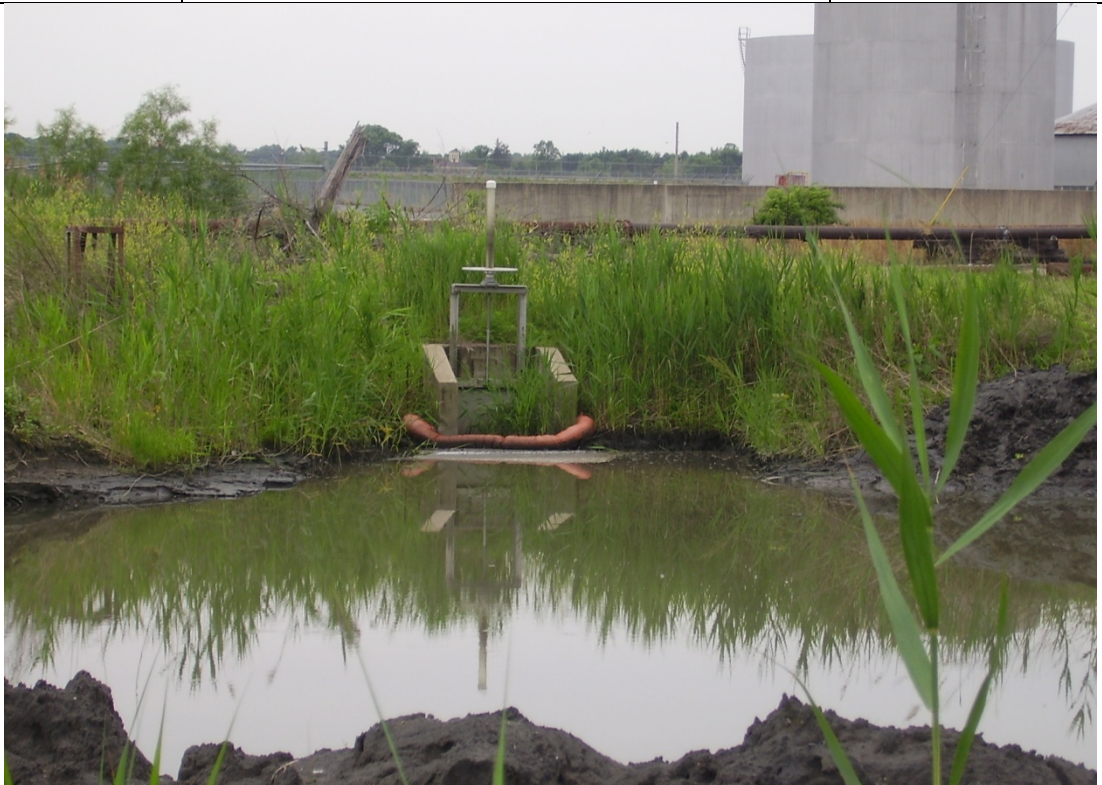
**Photo No.**  
**50**

**Description:**  
Upstream slope in Pond D.

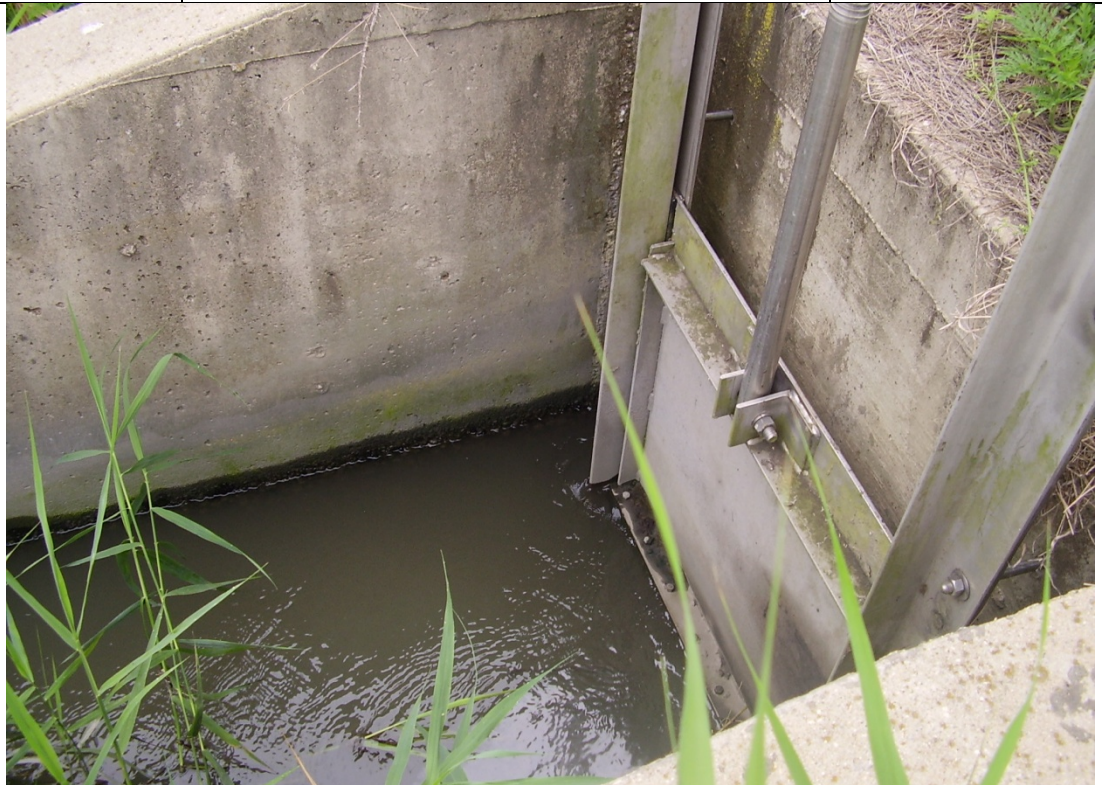
**Photo No.**  
**54**

**Description:**  
Discharge pipe in active  
portion of Pond D.
