# **Dam Safety Assessment of CCW Impoundments**

**Joppa Plant**

**United States Environmental Protection Agency  
Washington, DC**

May 27, 2010

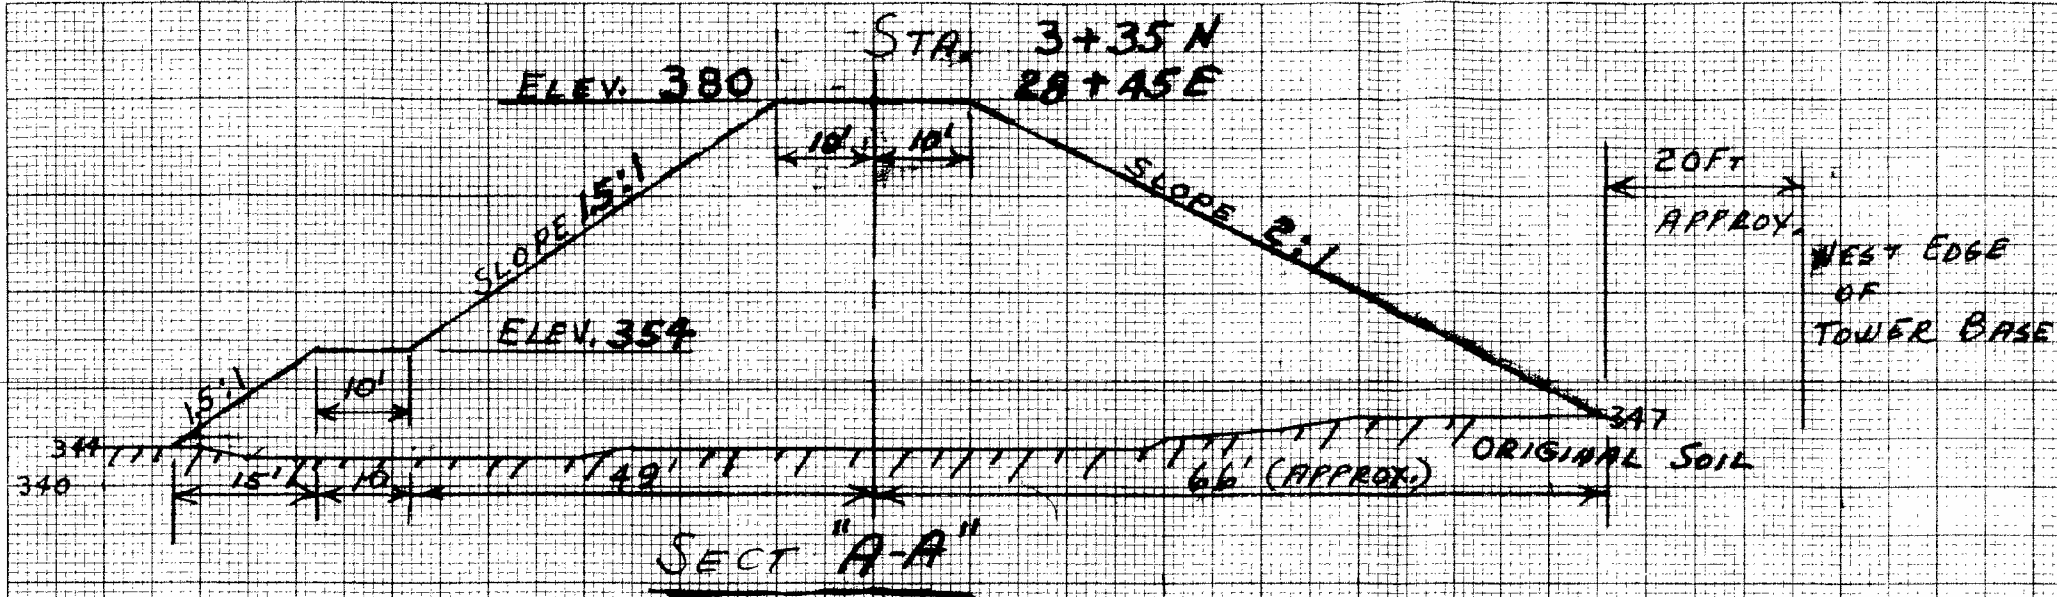
- The outboard slope is steeper than generally recommended for dam and dike construction. The design drawings (See attached EEI Drawing AP-109) indicate the slope should be 2H:1V, but the observed slope appeared to be steeper and matched the 1.5H:1V slope of the Northern Pond.

- Based on Drawing AP-109, Sht. 1 (attached), the Southern Pond embankment was keyed into a suitable foundation through a layer of fly ash for a portion of the embankment. Section A-A, which is indicative of construction in the area near the power lines (Dwg. 4229-8211, Sht. 1), indicates that this section of the embankment was not keyed into the underlying foundation.

- Inboard slopes – keep vegetation under control to allow for visual inspection of the exposed portion of the slope above the waterline.
- Additional studies – perform geotechnical investigation, cross-sectional topographic survey, and slope stability analyses of critical sections. Install piezometers to check phreatic levels within the embankment. Analyze for normal pool with steady state seepage, maximum surcharge pool, and seismic loading conditions and, depending on the results of the analyses, consider alternatives for stabilizing the embankments and control the seepage.

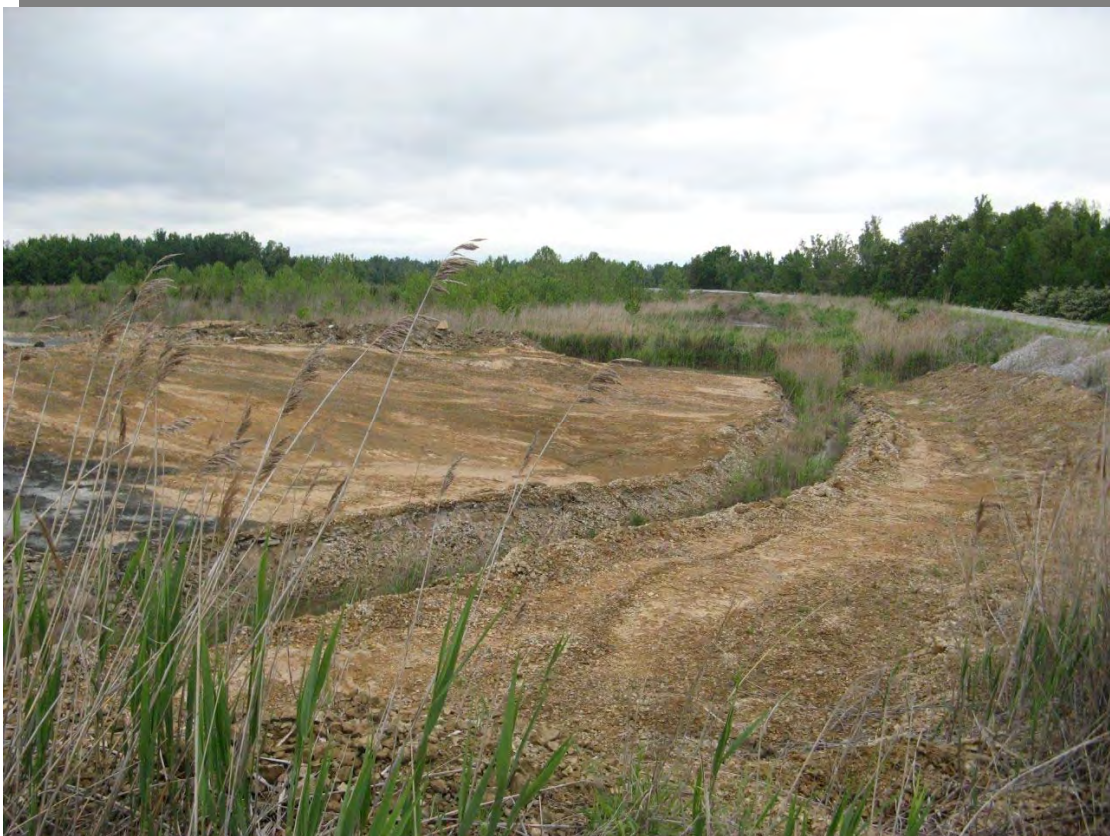
Photo 4 – Interior of Northern Pond, looking north from Central Dike.  
Channel to direct flow from Culvert to Pond outlet structure.

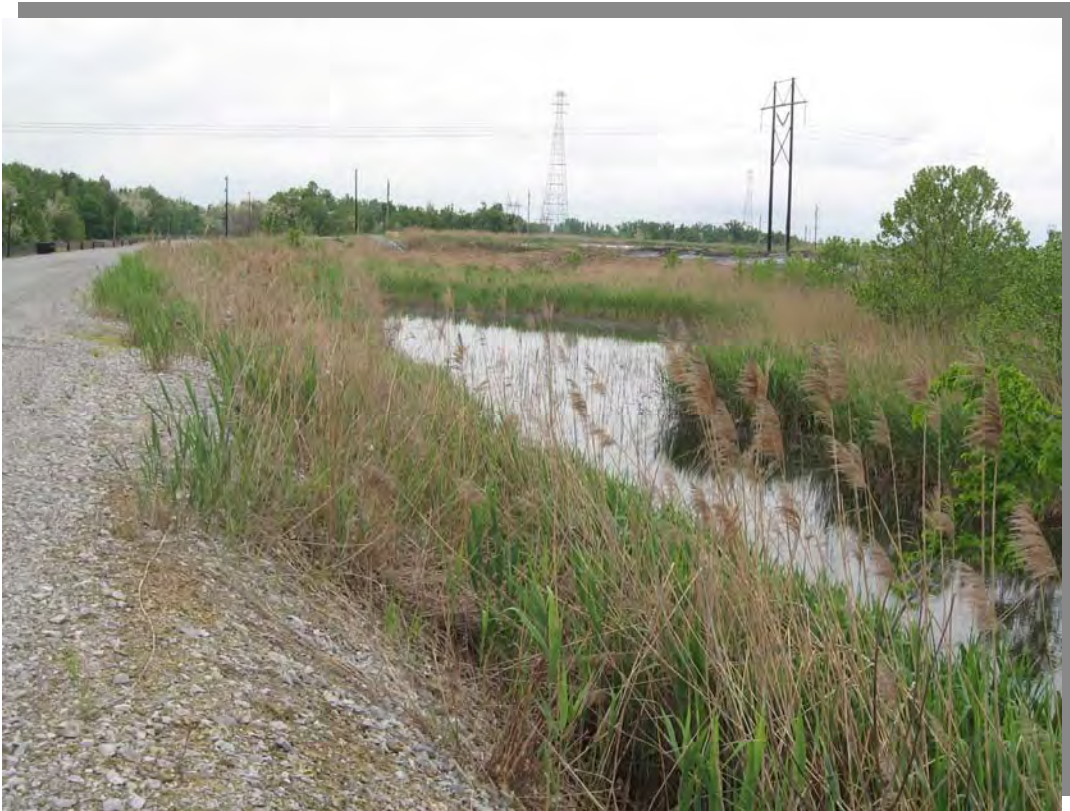
Photo 5 – Interior of Northern Pond, looking south from northern corner.  
Note vegetative growth on inboard slope..

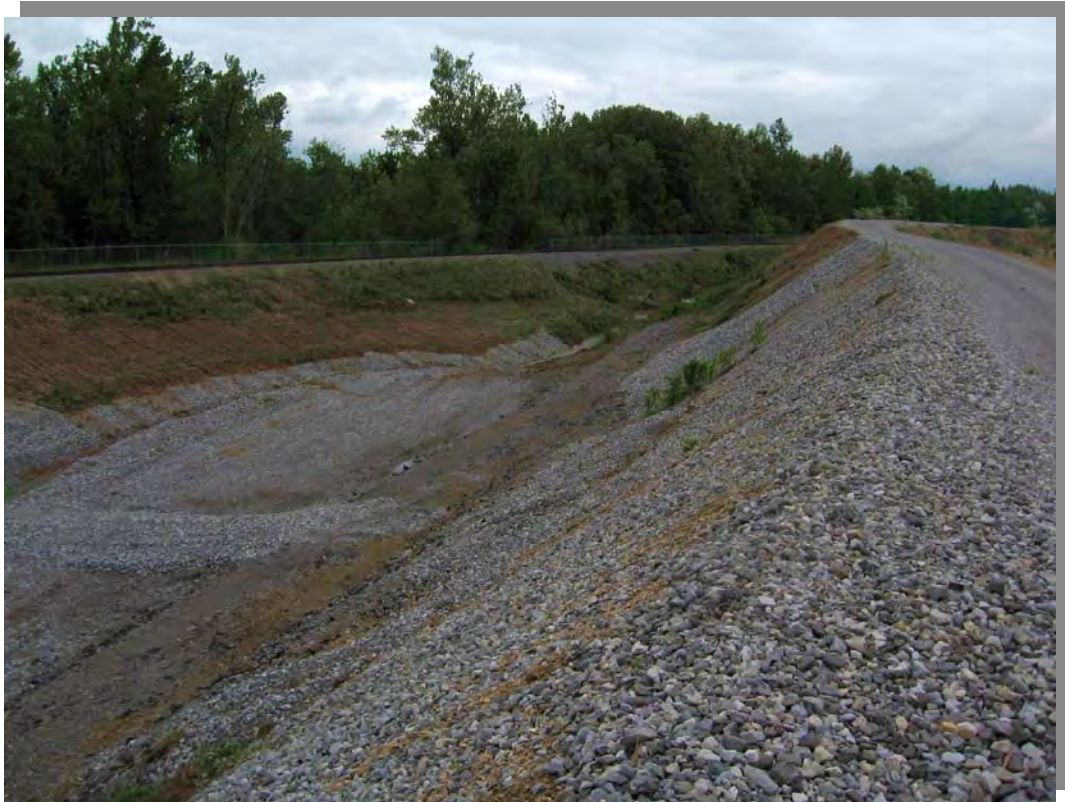
Photo 6 – Outboard slope of Northern Pond near the northern end.

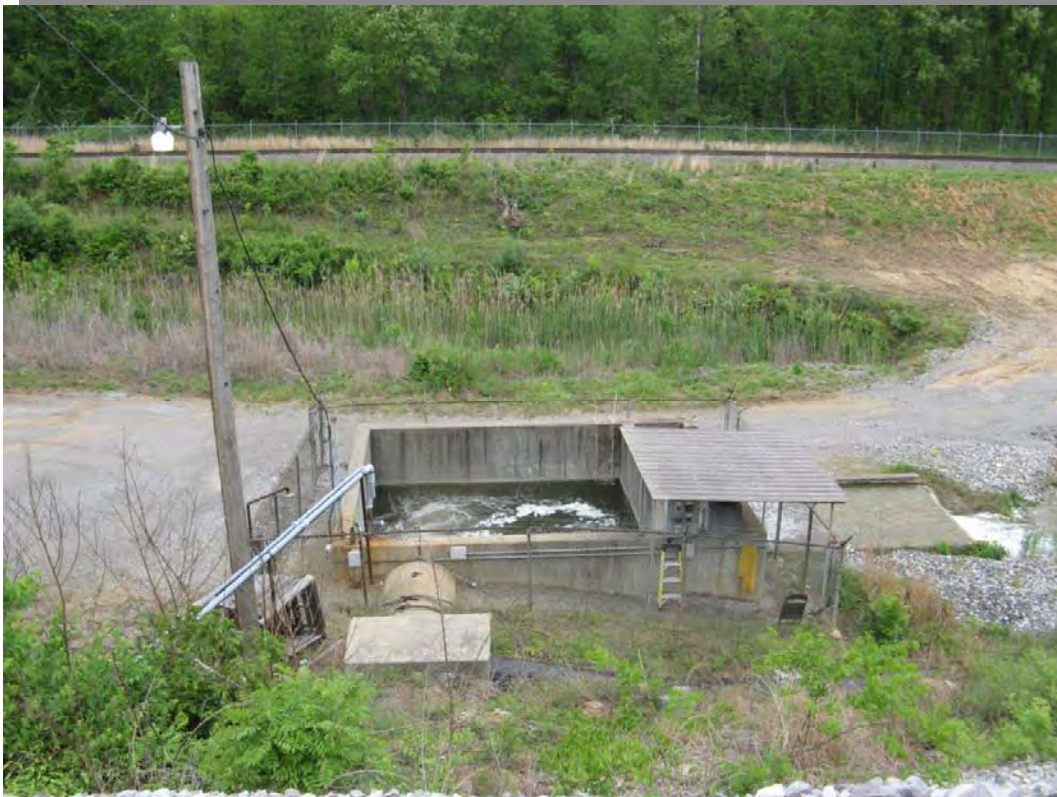
Photo 9 – pH balance outlet structure. Note HDPE pipe running parallel to toe (Southern Pond discharge) joining with concrete pipe (Northern Pond discharge) outside of structure.

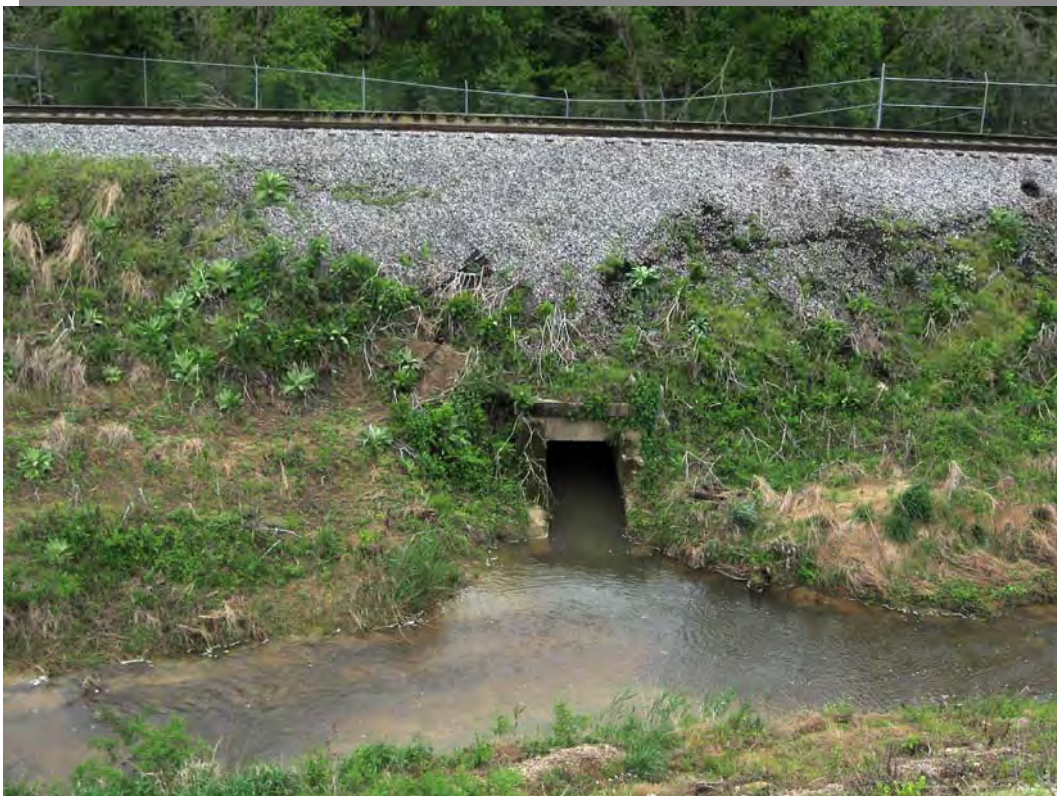
Photo 10 – Runoff from drainage area east of Ash Pond merging with Pond effluent..

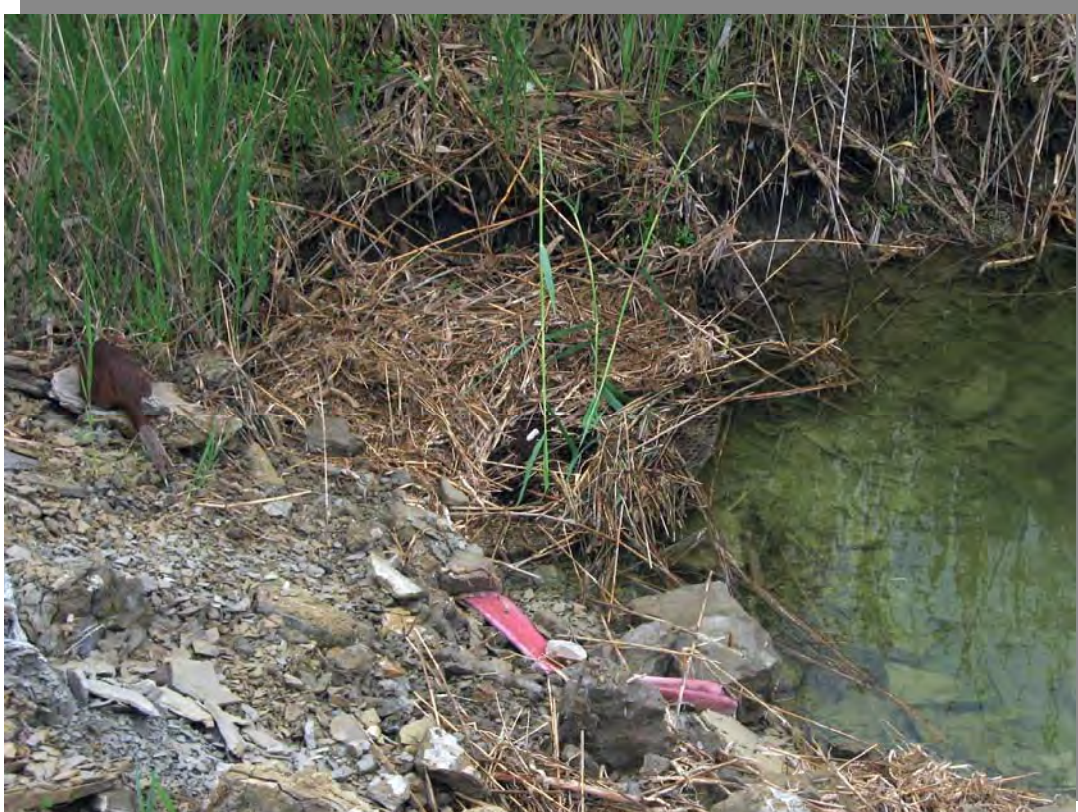
- A crushed-stone access road was constructed over the length of the crest. The road appears to be in good condition with no rutting, erosion or standing water observed.
- The outlet structure was covered with dried reeds but appeared to be in good condition and functioning normally (Photo 12).

Photo 12 – Northern Pond outlet structure, located at northern end of impoundment.

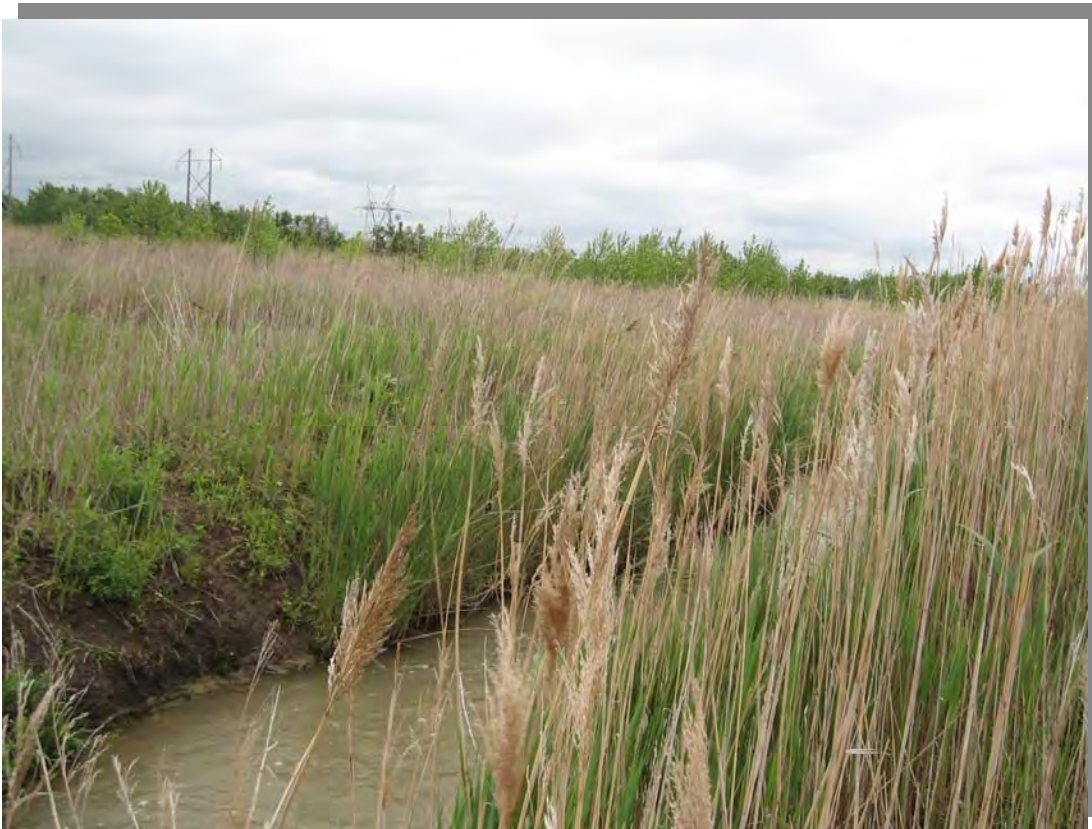
Photo 14 – Channel dredged into CCW that conveys inflow from pipes to eastern side of Southern Pond.

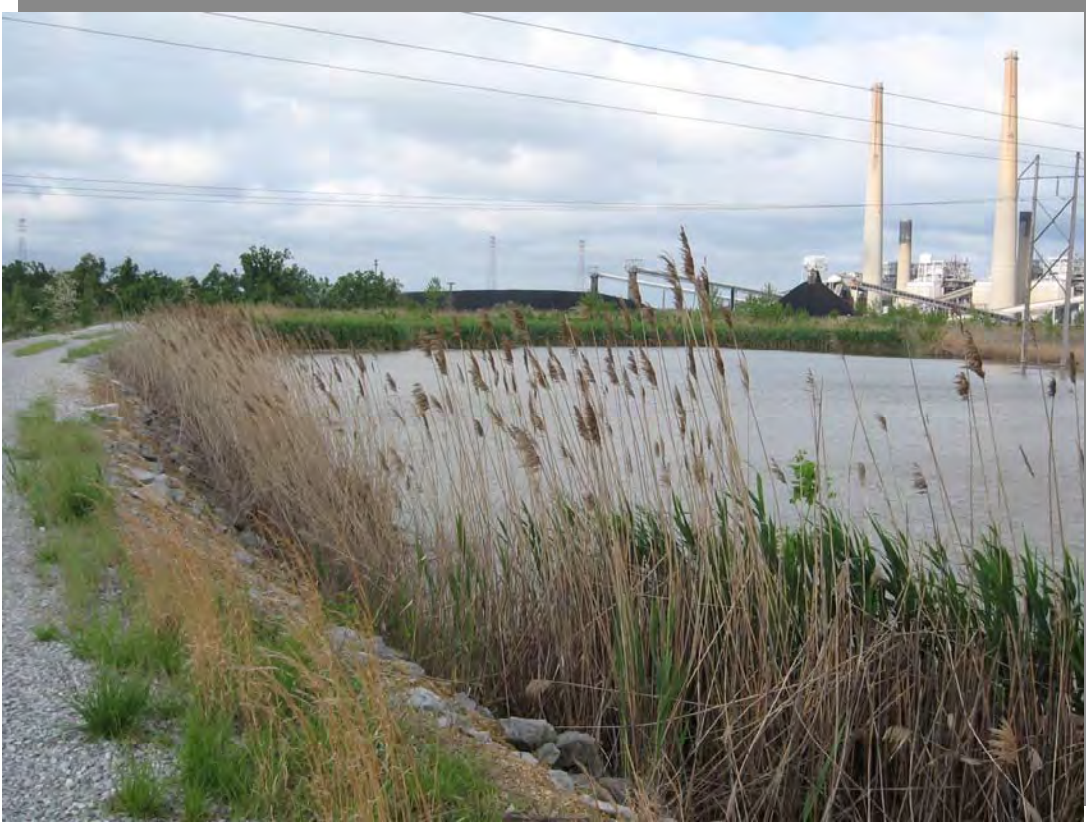
Photo 17 – Interior of Southern Pond, looking south from primary outlet structure.

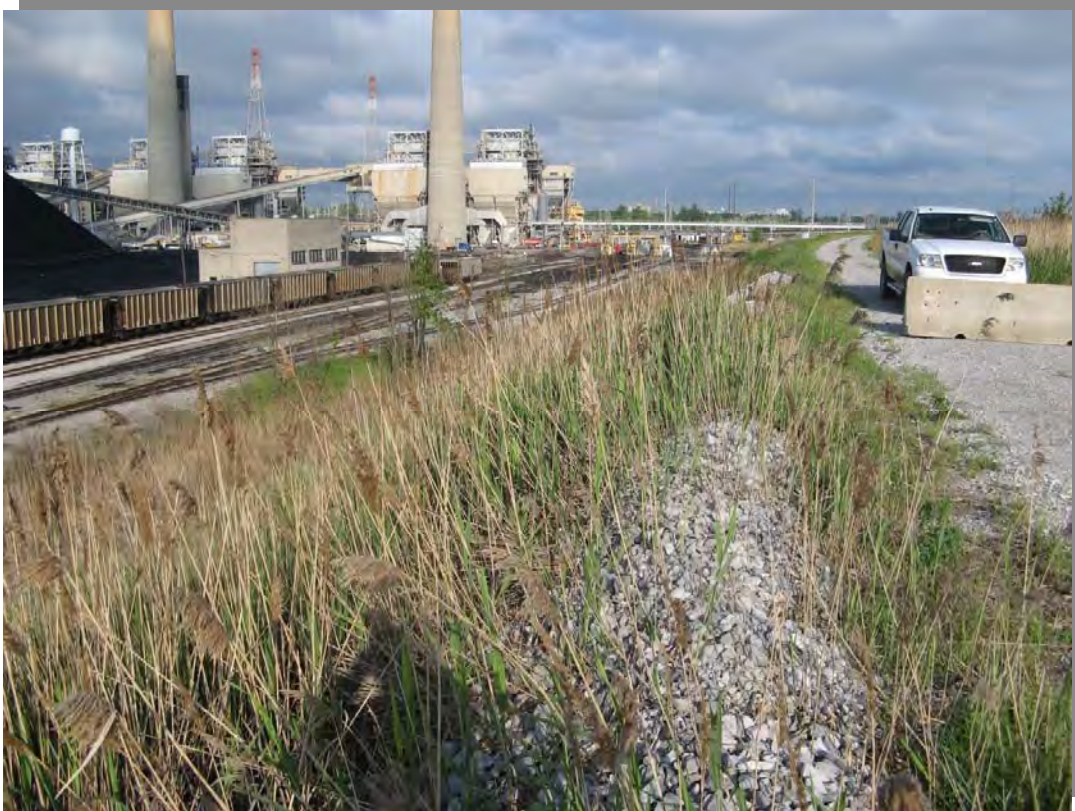
Photo 18 – Outboard slope of southern embankment of Southern Pond.  
Note Jersey barrier blocking vehicular access to eastern embankment.

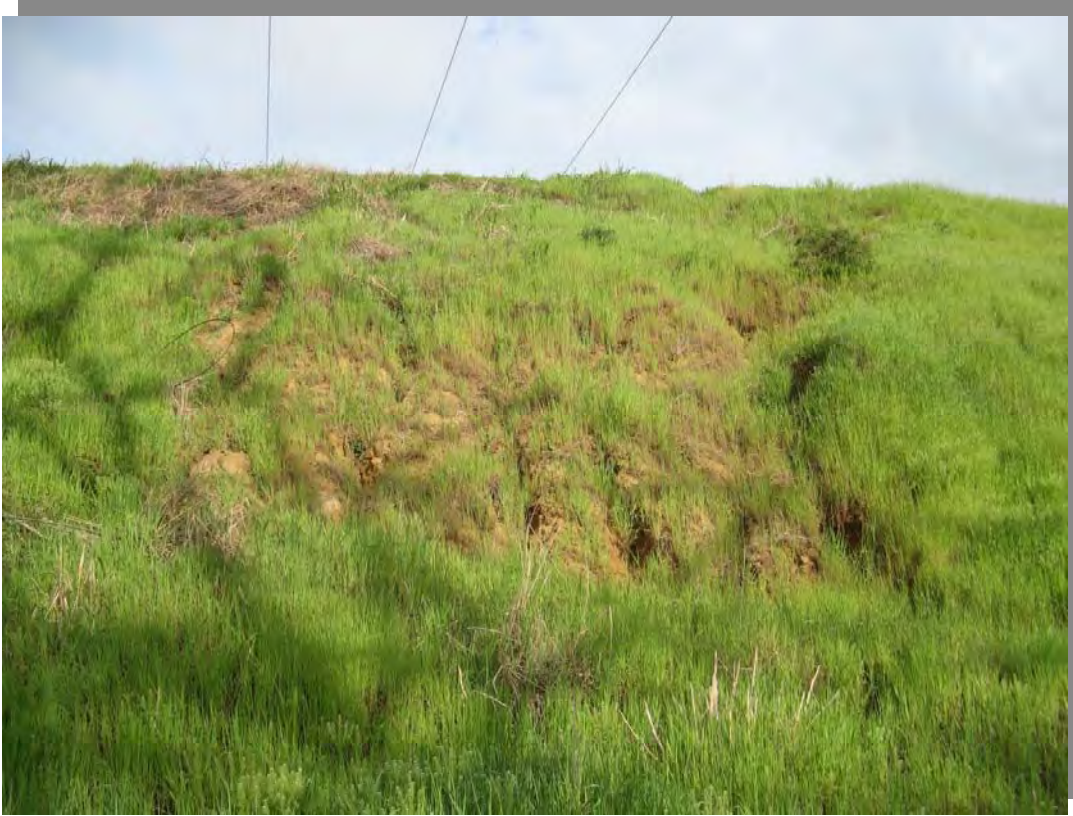
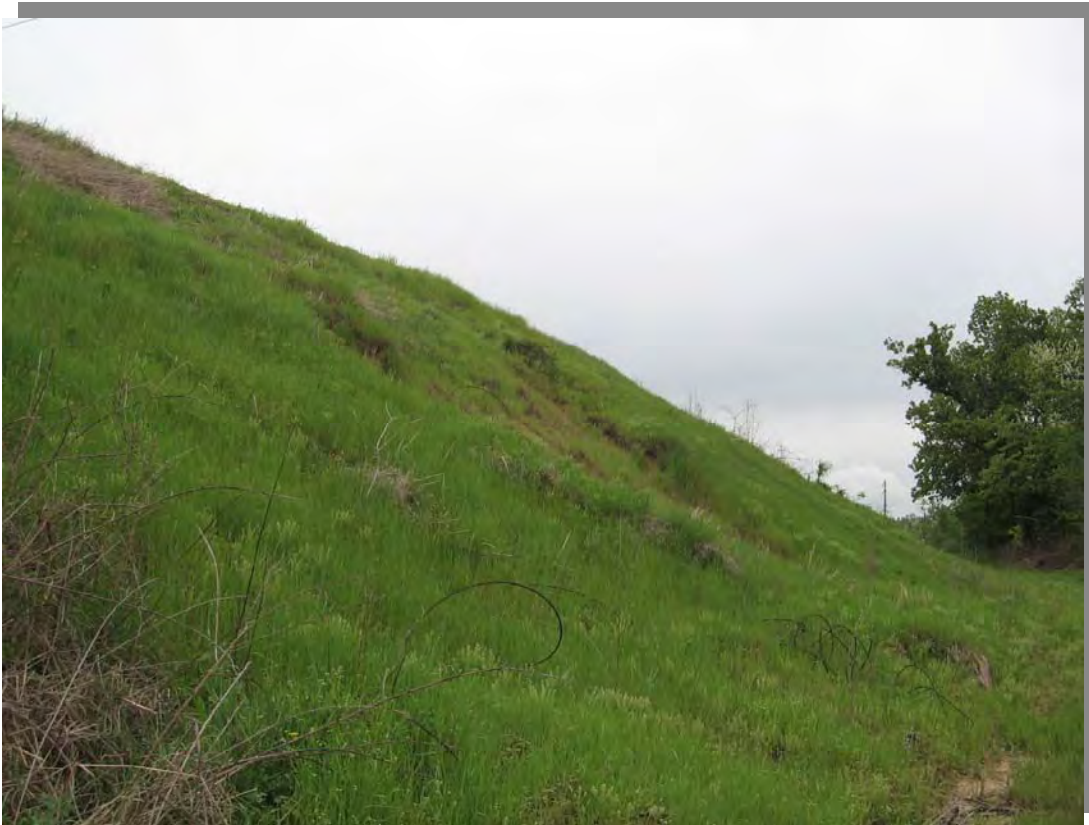
- Surface erosion, sloughs and slides were observed along the outboard slope. The most significant erosion was observed in the area below the power lines that cross the Southern Pond (Photos 20 - 22).

| Inspection Issue # | Comments |
|---|---|
| 17, 18, 19 | Scarps and sloughing of embankment observed in area below power lines that cross the South Pond (Eastern embankment of South Pond). Erosion of lower portion of berm observed approximately 100' south of power lines. |

Photo 20 – Outboard slope of Southern Pond near power lines.

Photo 21 – Erosion on east embankment of Southern Pond below the power lines.

Photo 22 – Slides and sloughs on east embankment of Southern Pond, approximately 200 feet south of power lines.

- Outboard slopes – remove deleterious vegetation and continue regular maintenance of the slopes; repair any areas of sloughs, slides and erosion.
- Outboard toe – investigate the extent of seepage, monitor the seepage on a regular basis, and develop alternatives for treating the deteriorated sections of the embankment.

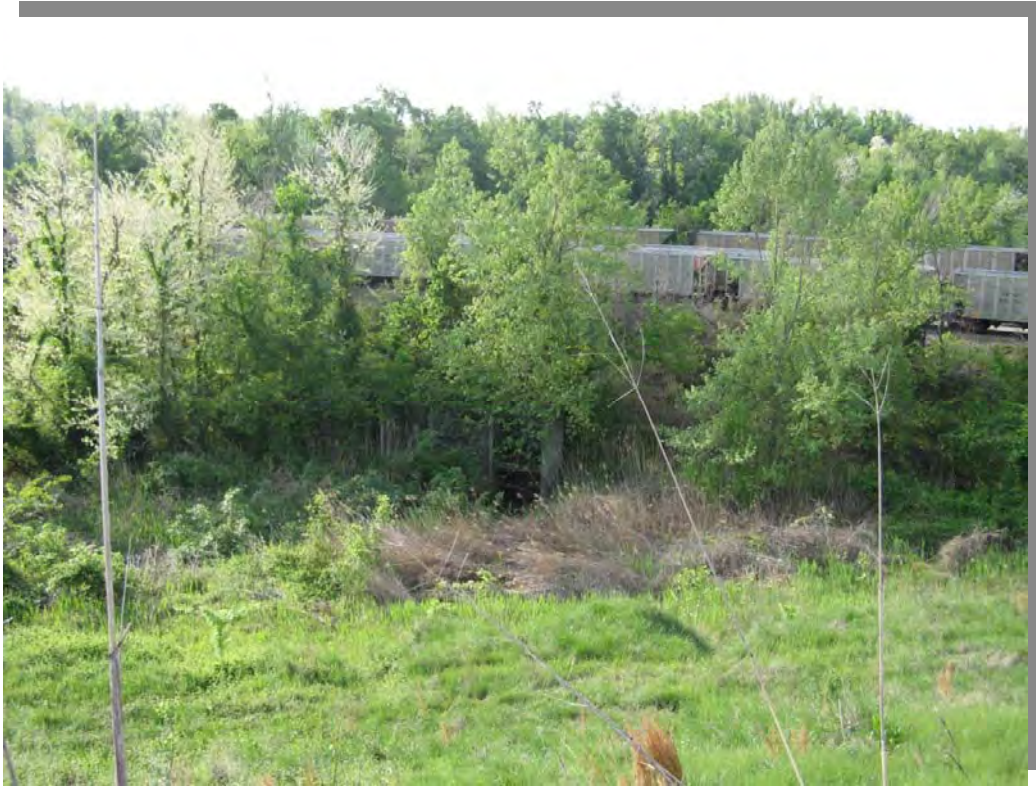
Photo 25 – Ash Pond outlet channel pass-through below EEI railroad siding.
