Dam Safety Assessment of CCW Impoundments

Joppa Plant

United States Environmental Protection Agency
Washington, DC

September 24, 2010

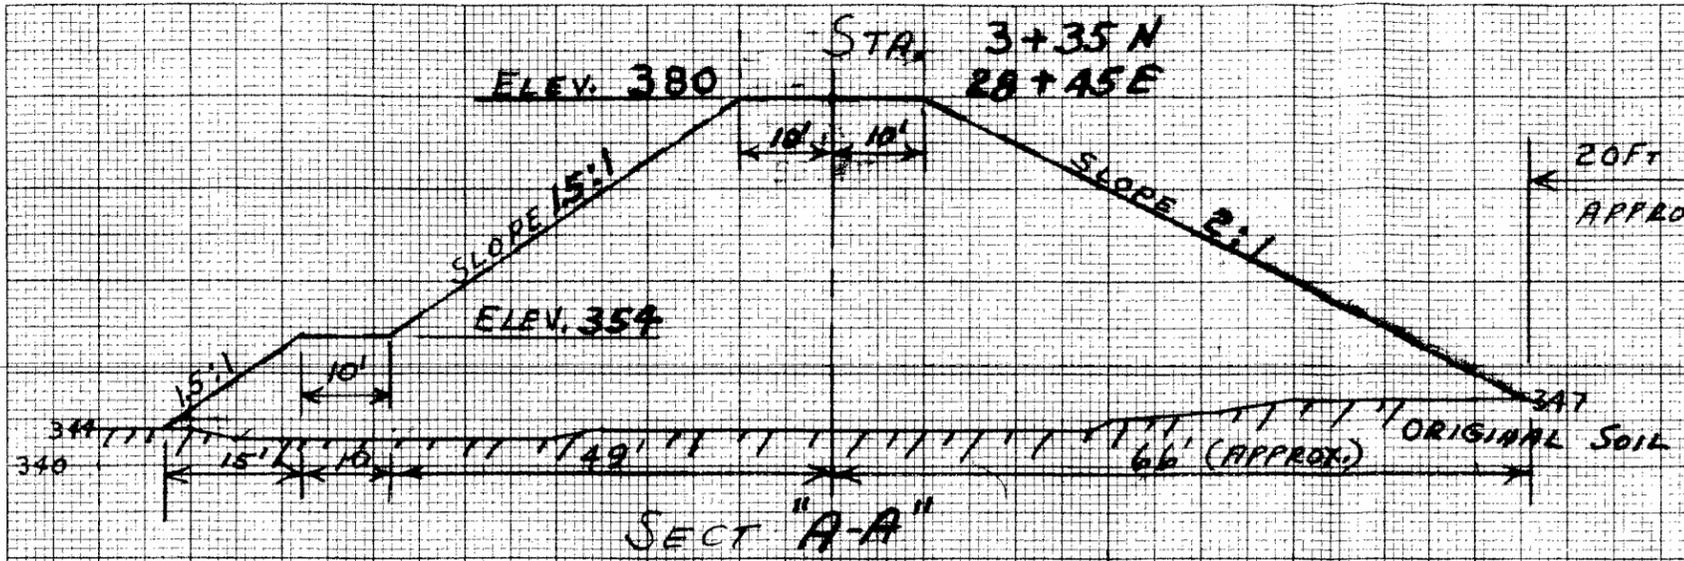
SECT "A-A"

- Based on Drawing AP-109, Sht. 1 (attached), the Southern Pond embankment was keyed into a suitable foundation through a layer of fly ash for a portion of the embankment. Section A-A, which is indicative of construction in the area near the power lines (Dwg. 4229-8211, Sht. 1), indicates that this section of the embankment was not keyed into the underlying foundation.

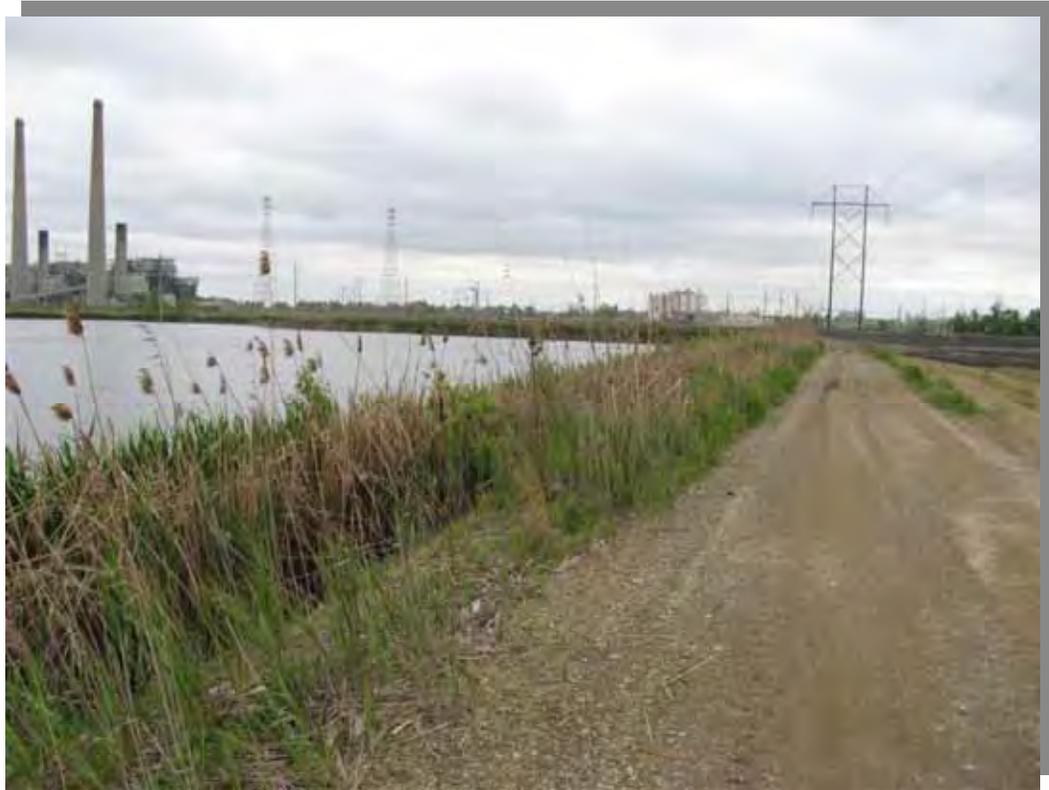
Photo 1 – Central Dike, looking west. Note vegetative growth on inboard slope of Southern Pond.

- Inboard slopes – keep vegetation under control to allow for visual inspection of the exposed portion of the slope above the waterline.
- Additional studies – perform geotechnical investigation, cross-sectional topographic survey, and slope stability analyses of critical sections. Install piezometers to check phreatic levels within the embankment. Analyze for normal pool with steady state seepage, maximum surcharge pool, and seismic loading conditions and, depending on the results of the analyses, consider alternatives for stabilizing the embankments and control the seepage.

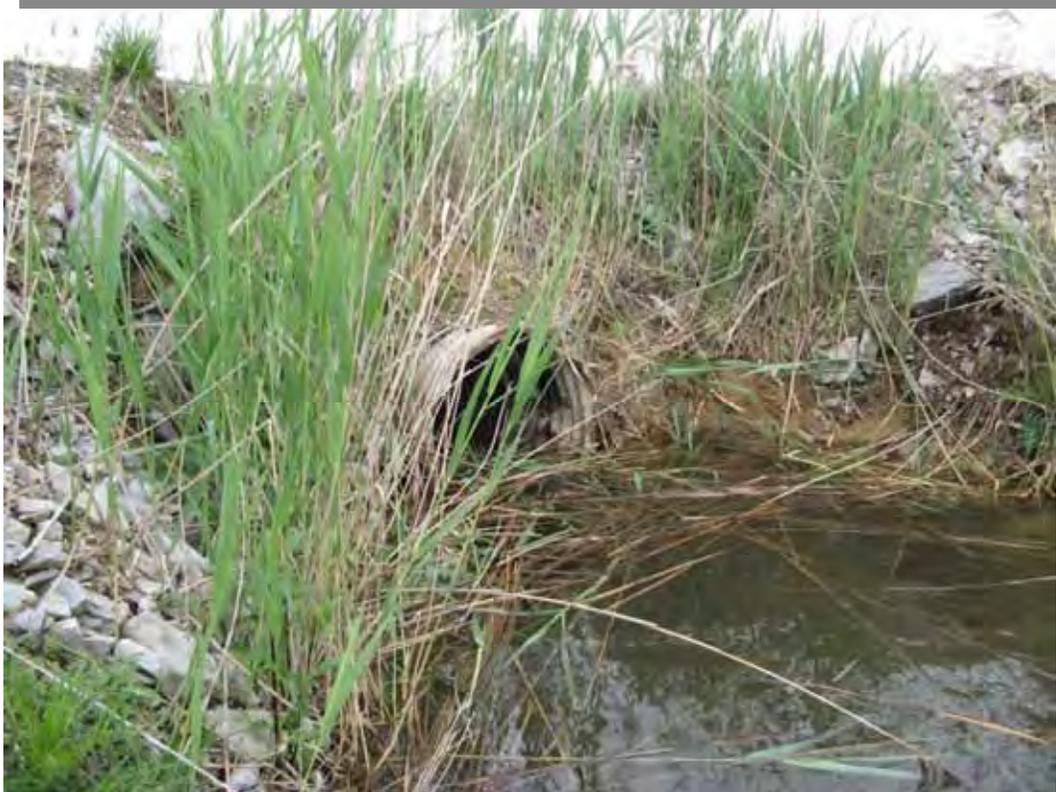
- The 24-inch connecting pipe does not have a control structure (gate, valve, stoplogs, etc.) to regulate the amount of flow between the impoundments. Riprap has been placed, or fallen into, the opening of the pipe and was observed within the pipe, near its midpoint. The riprap limits the capacity of the pipe and may have slightly raised the water surface elevation in the Southern Pond (Photos 2 & 3).

Photo 2 – Central Dike Culvert entrance in Southern Pond.
Note water surface elevation in pond in relation to pipe invert.

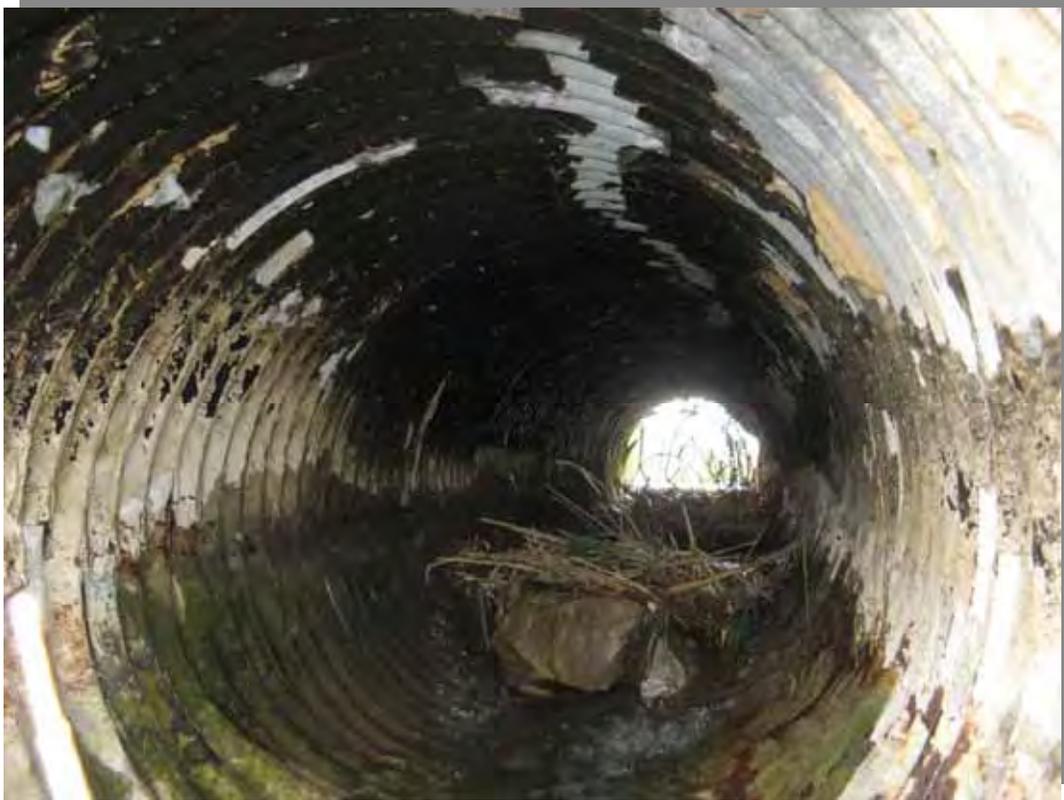
- Sloughs, slides and erosion of the Southern Pond embankment.
- Deleterious vegetation growing along the length of the inboard and outboard slopes of the embankment.
- Riprap in the 24-inch culvert through the Central Dike limiting the pipe capacity.
- Seepage in multiple locations along the outboard toe of the Southern Pond embankment.
- Portions of the Southern Pond embankment constructed on "Fly Ash" foundation, other portions on native soils without a cutoff trench.

Photo 3 – Interior of Central Dike Culvert. Note riprap “dam” limiting pipe’s capacity.

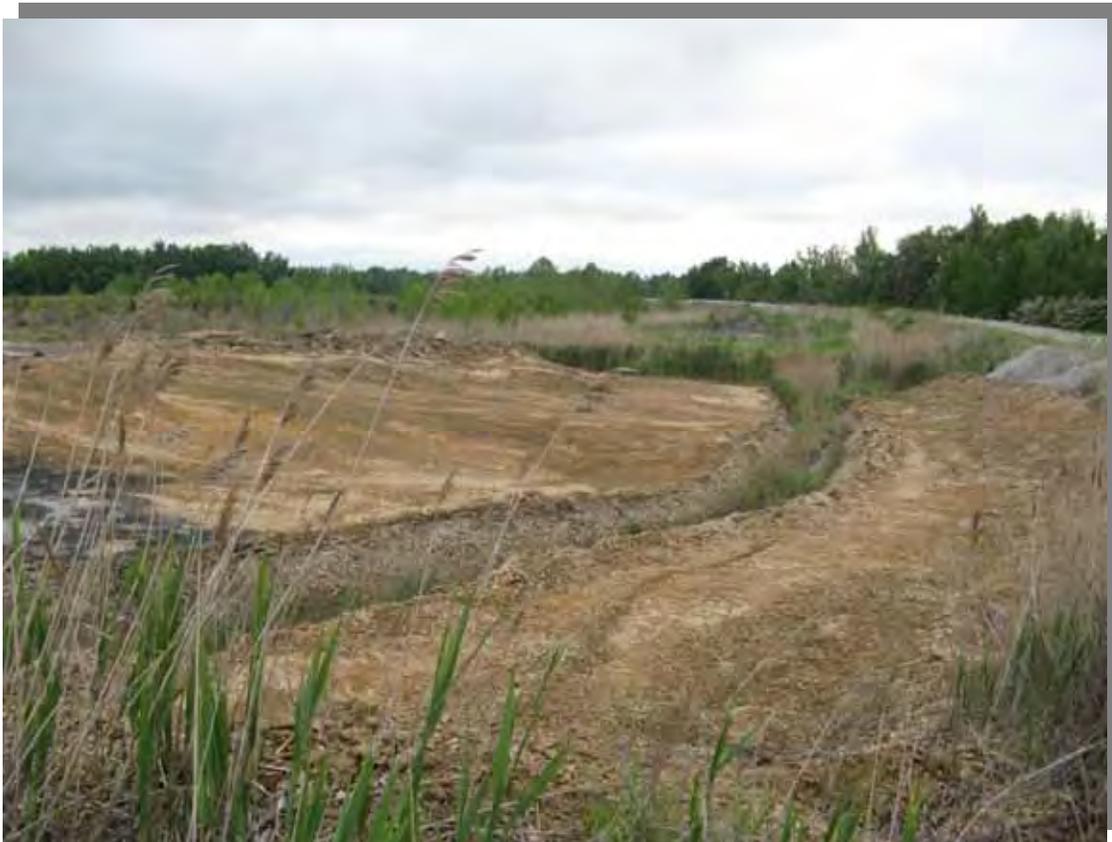
Photo 4 – Interior of Northern Pond, looking north from Central Dike.
Channel to direct flow from Culvert to Pond outlet structure.

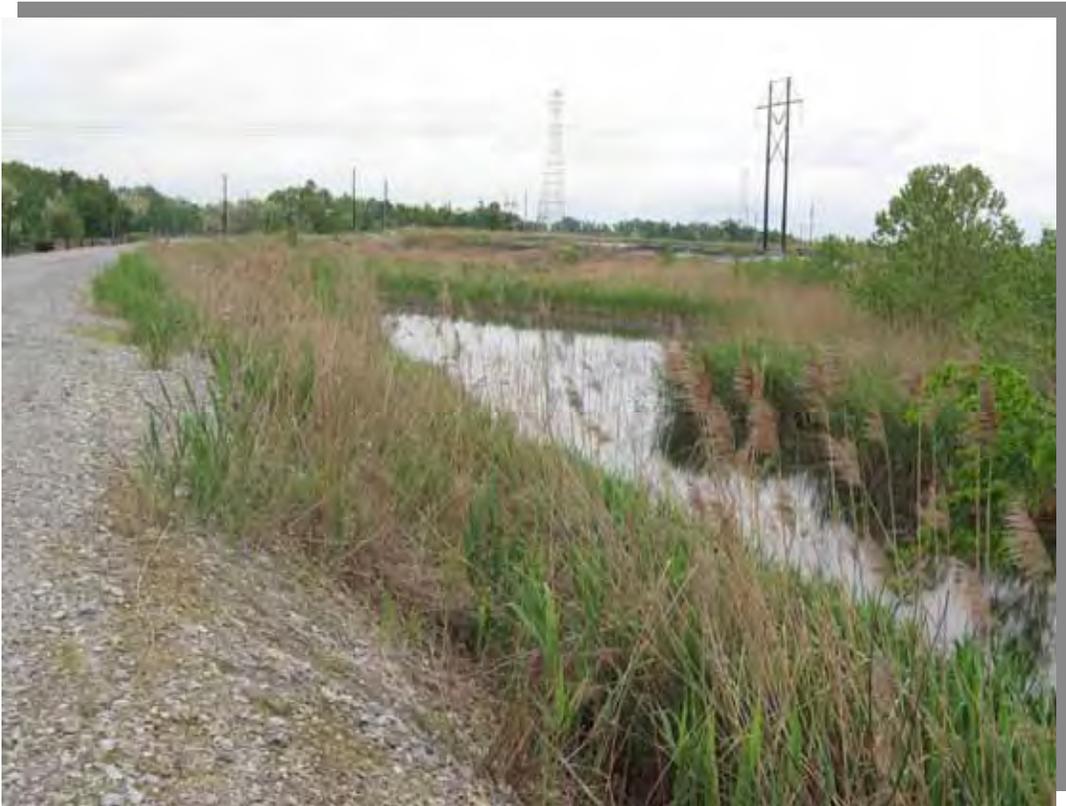
Photo 5 – Interior of Northern Pond, looking south from northern corner.
Note vegetative growth on inboard slope..

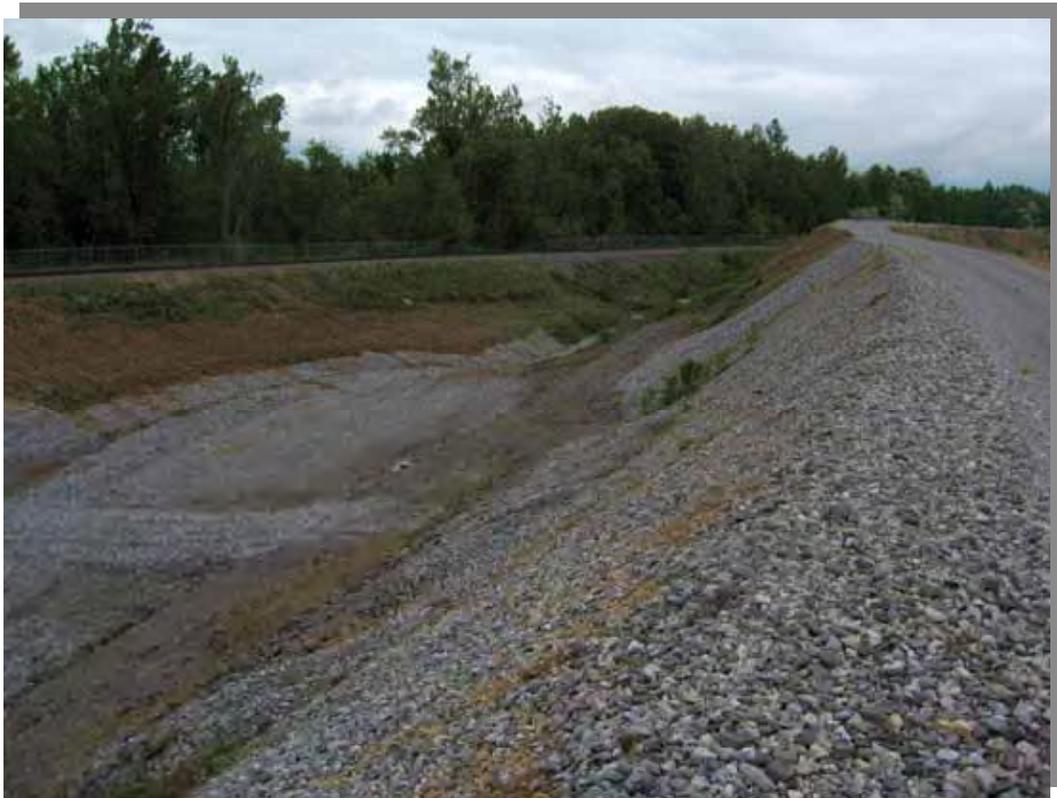
Photo 6 – Outboard slope of Northern Pond near the northern end.

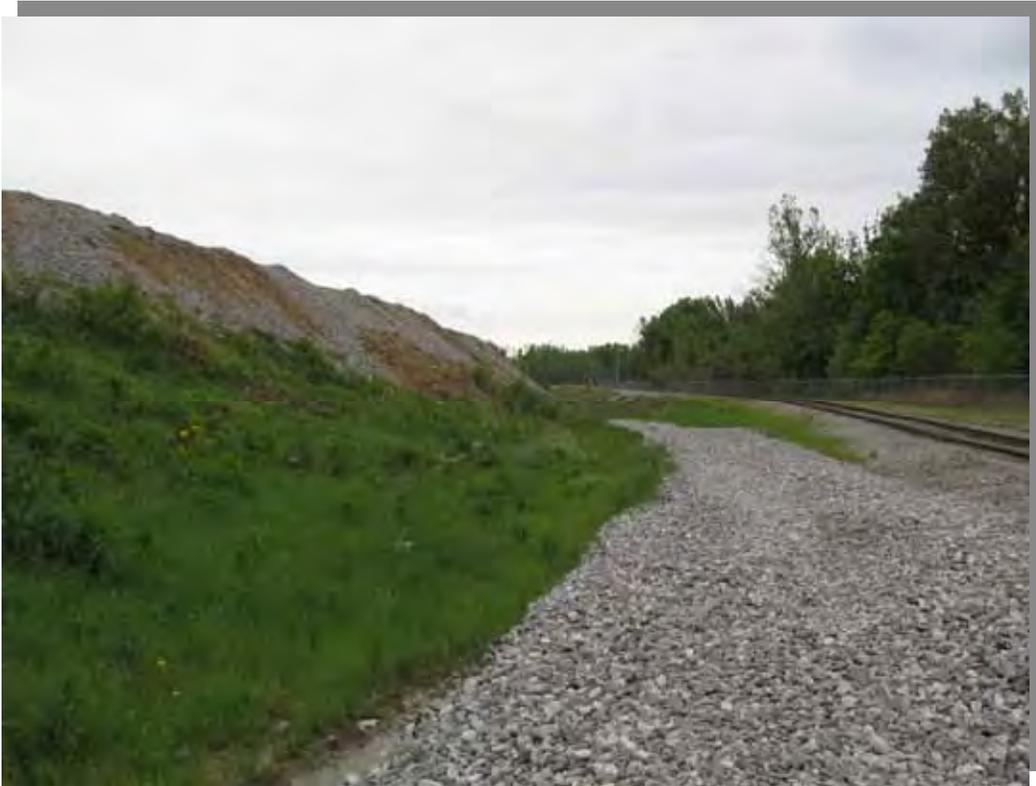
Photo 7 – Outboard slope of Northern Pond near the northern end.
Note repairs near the crest.

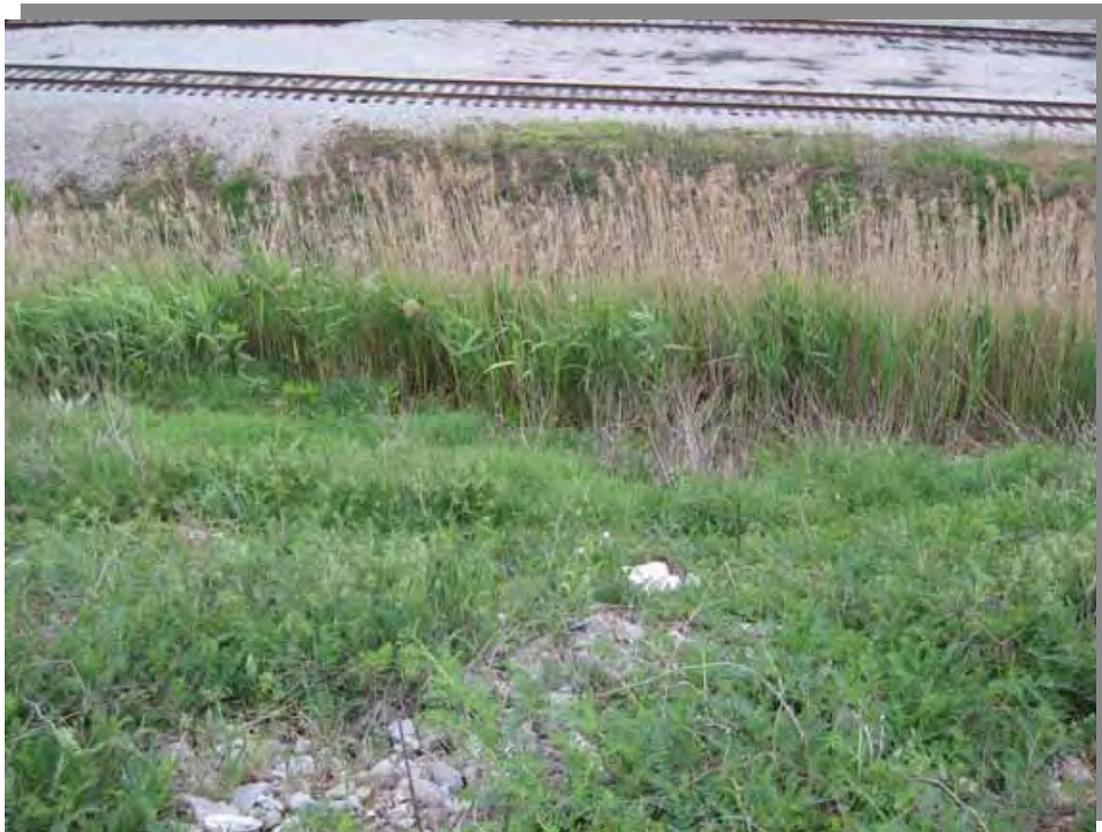
Photo 8 – Outboard slope of Northern Pond near the northern end.
Note reedy grasses at toe.

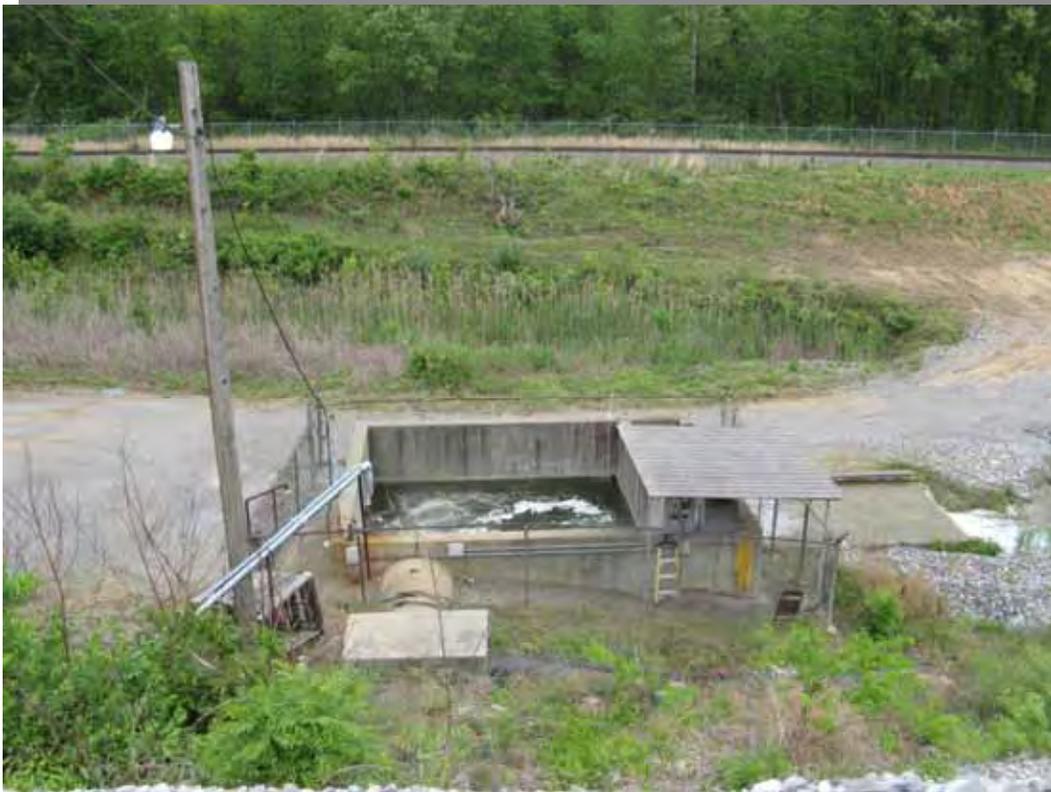
Photo 9 – pH balance outlet structure. Note HDPE pipe running parallel to toe (Southern Pond discharge) joining with concrete pipe (Northern Pond discharge) outside of structure.

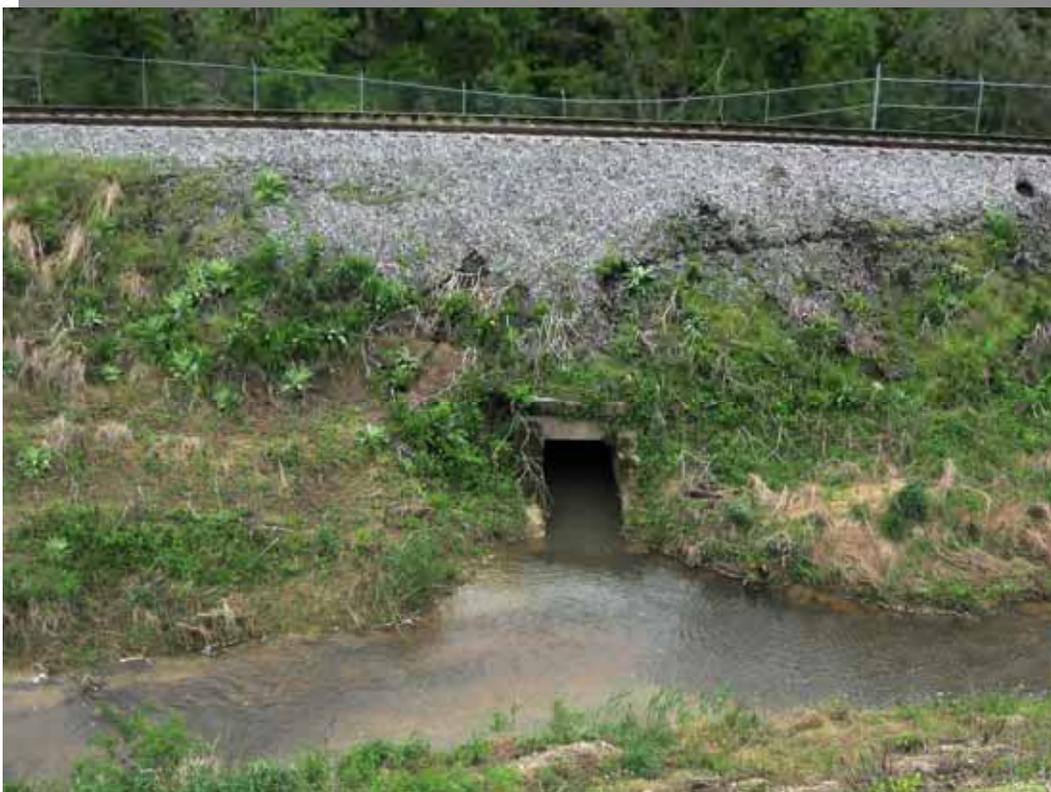
Photo 10 – Runoff from drainage area east of Ash Pond merging with Pond effluent..

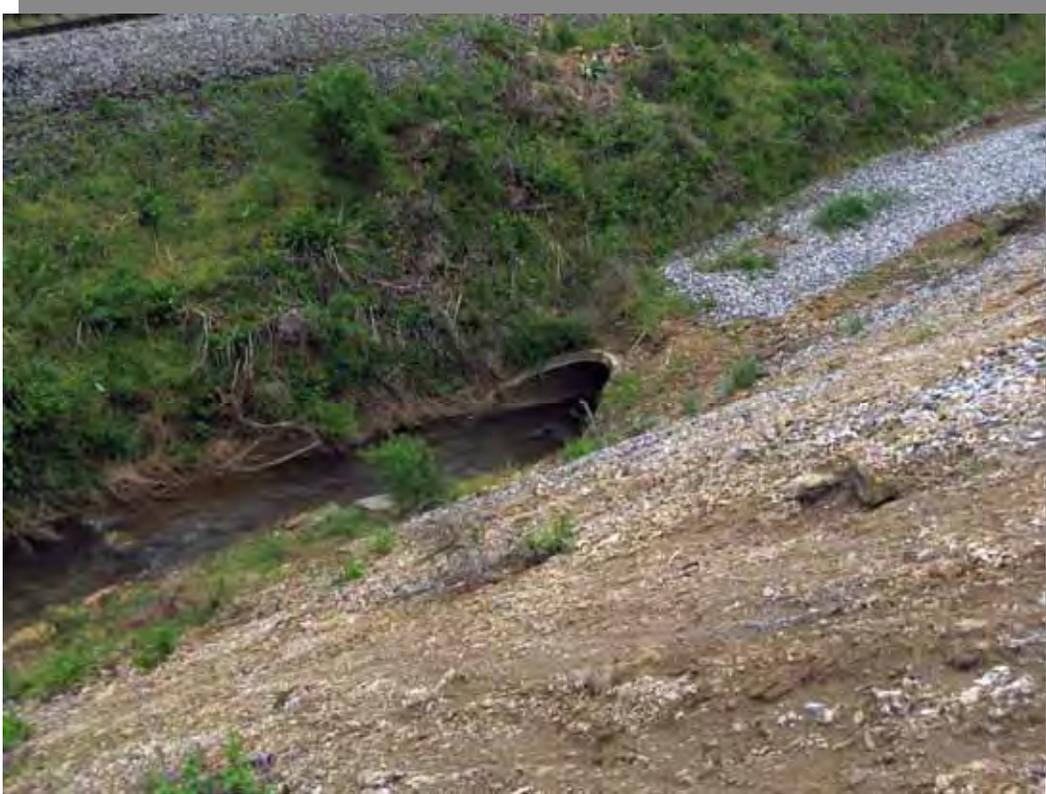
Photo 11 – Ash Pond outlet channel transitioning from open channel to underground culvert.

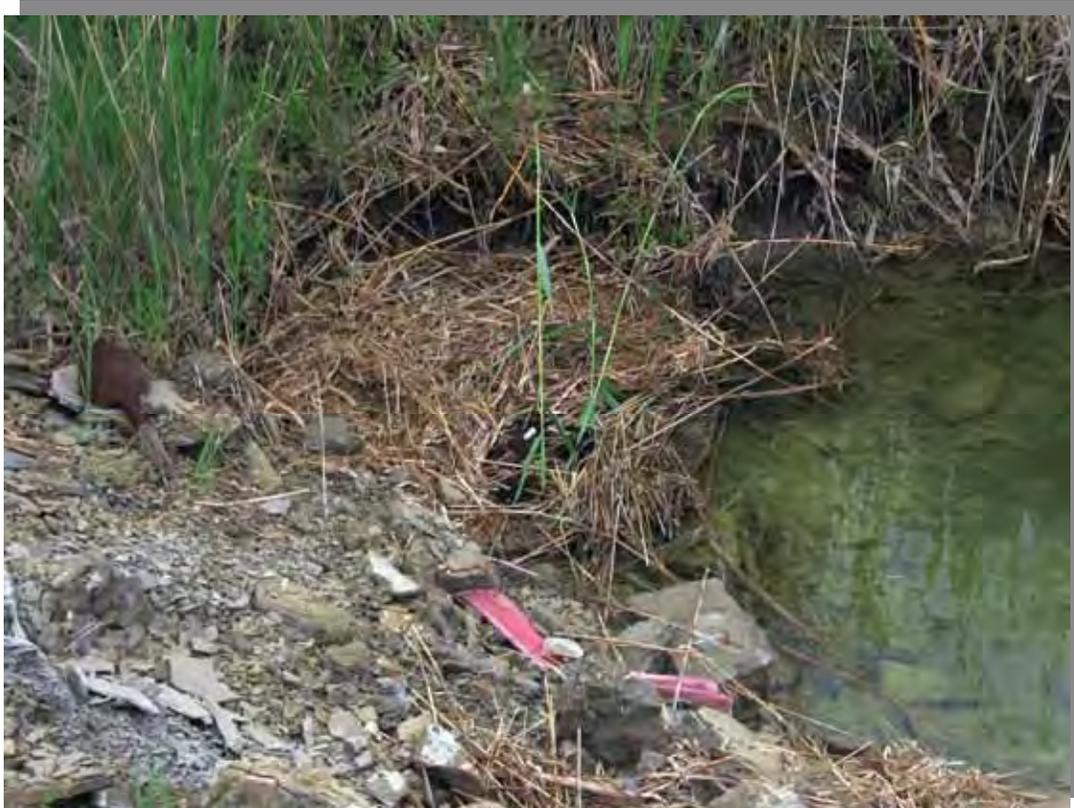
- A crushed-stone access road was constructed over the length of the crest. The road appears to be in good condition with no rutting, erosion or standing water observed.
- The outlet structure was covered with dried reeds but appeared to be in good condition and functioning normally (Photo 12).

Photo 12 – Northern Pond outlet structure, located at northern end of impoundment.

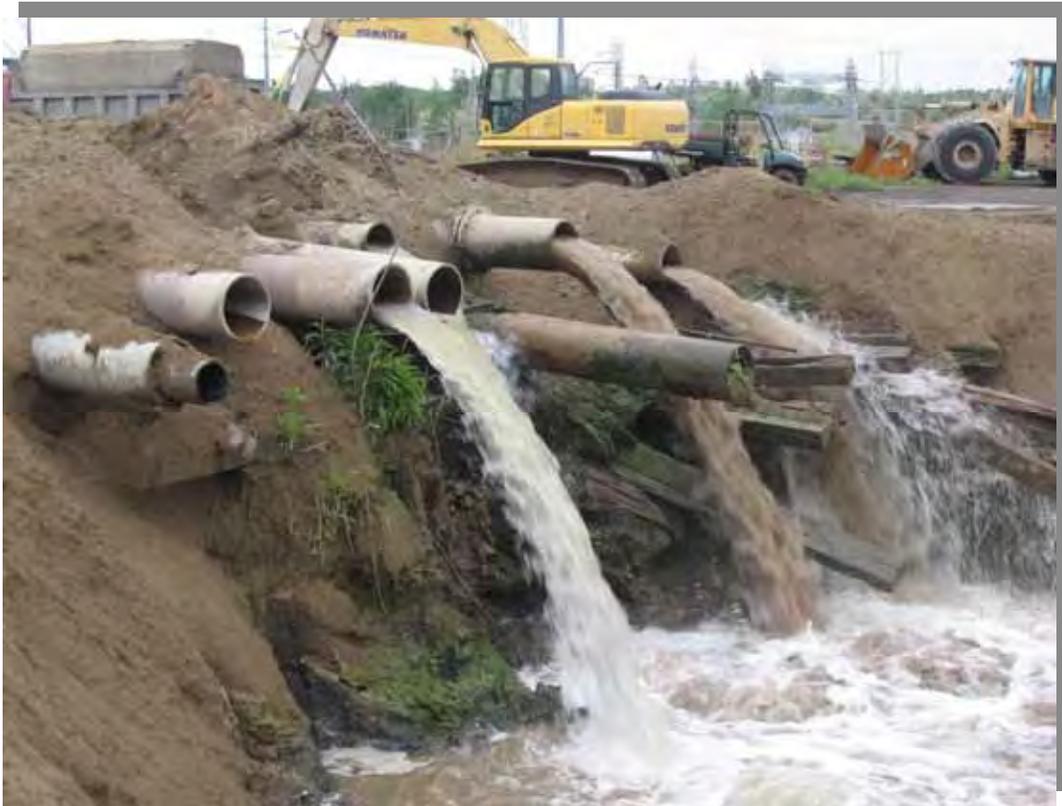
Photo 13 – CCW discharge from Joppa Plant into Ash Pond at southwestern corner of Southern Pond..

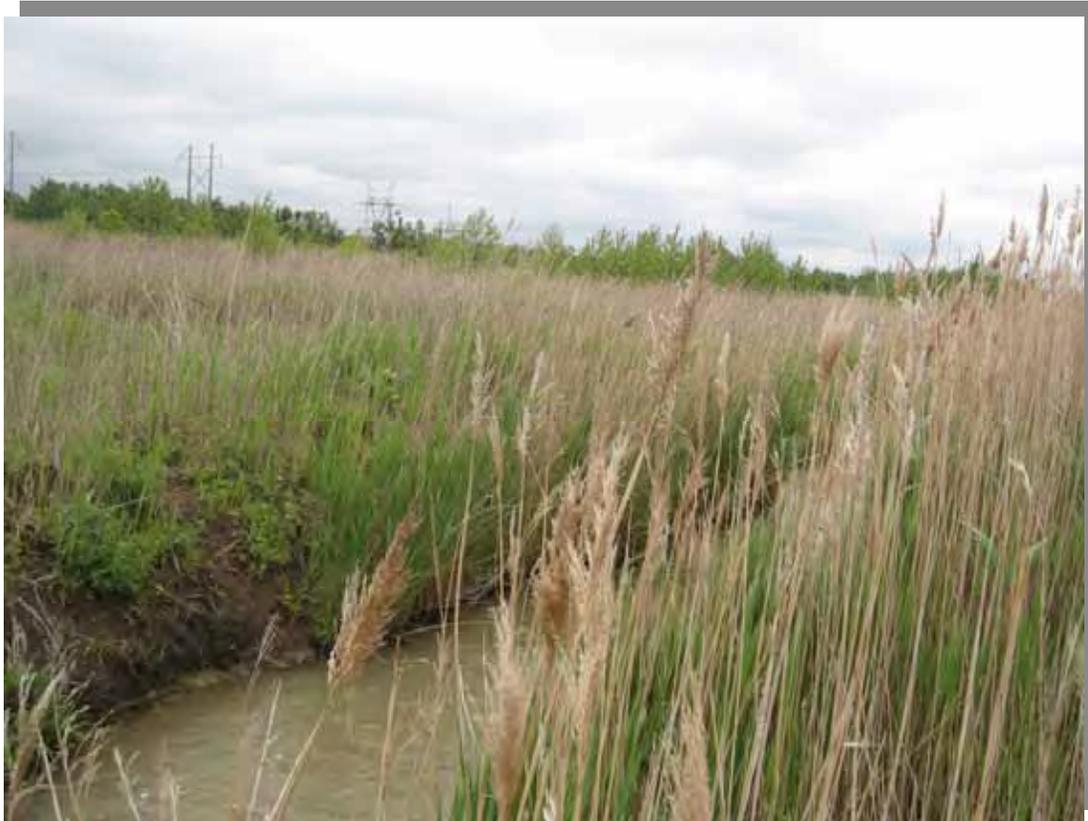
Photo 14 – Channel dredged into CCW that conveys inflow from pipes to eastern side of Southern Pond.

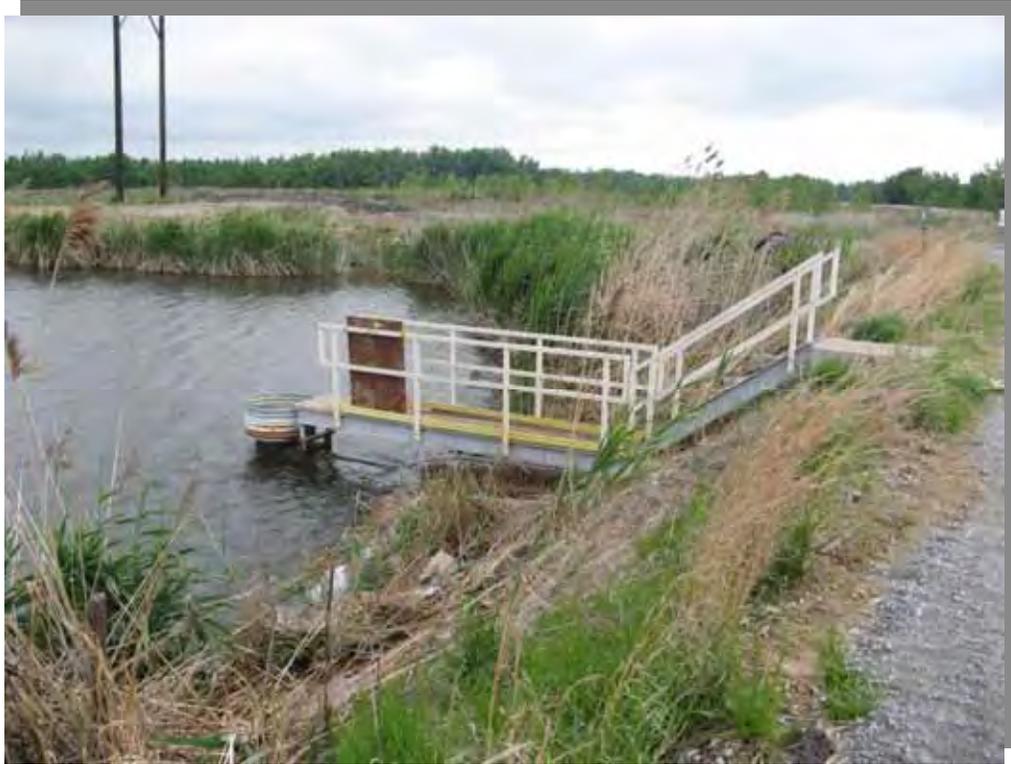
Photo 15 – Southern Pond primary outlet structure.

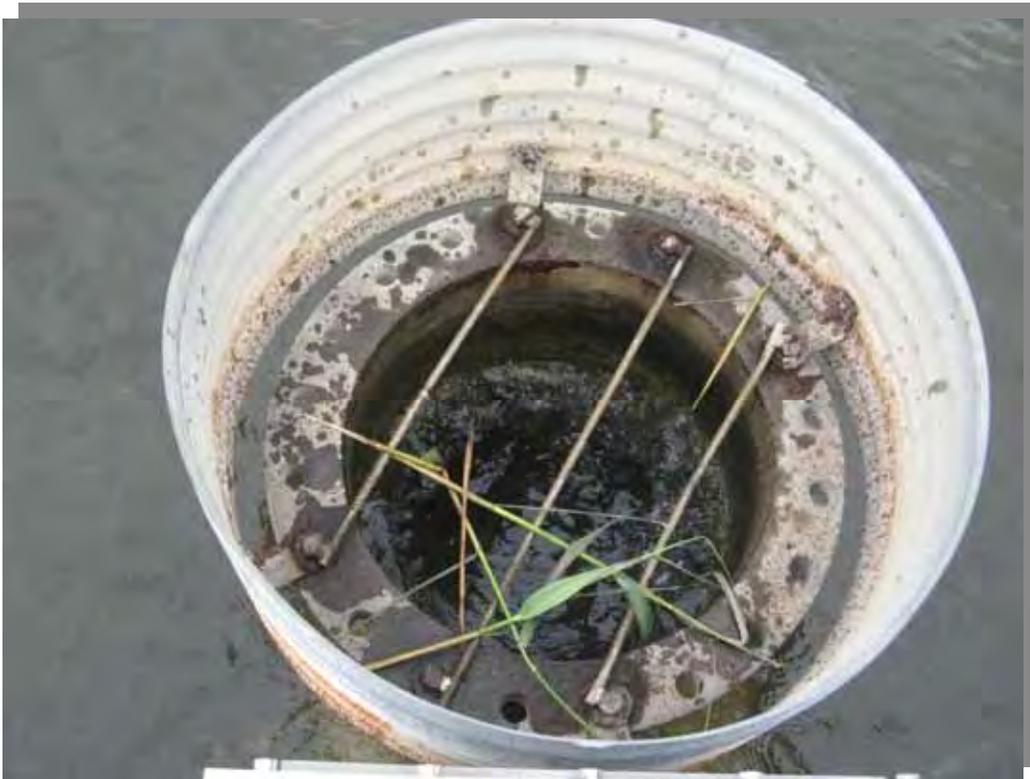
Photo 16 – Interior of Southern Pond primary outlet structure.

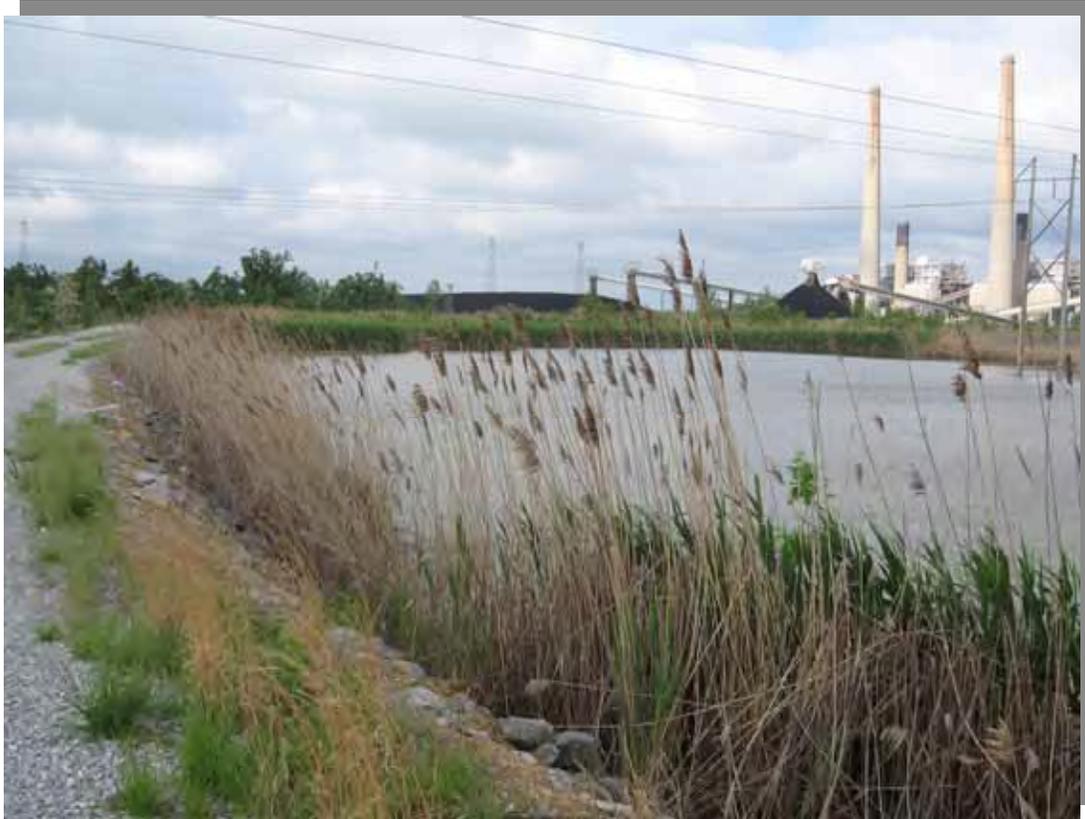
Photo 17 – Interior of Southern Pond, looking south from primary outlet structure.

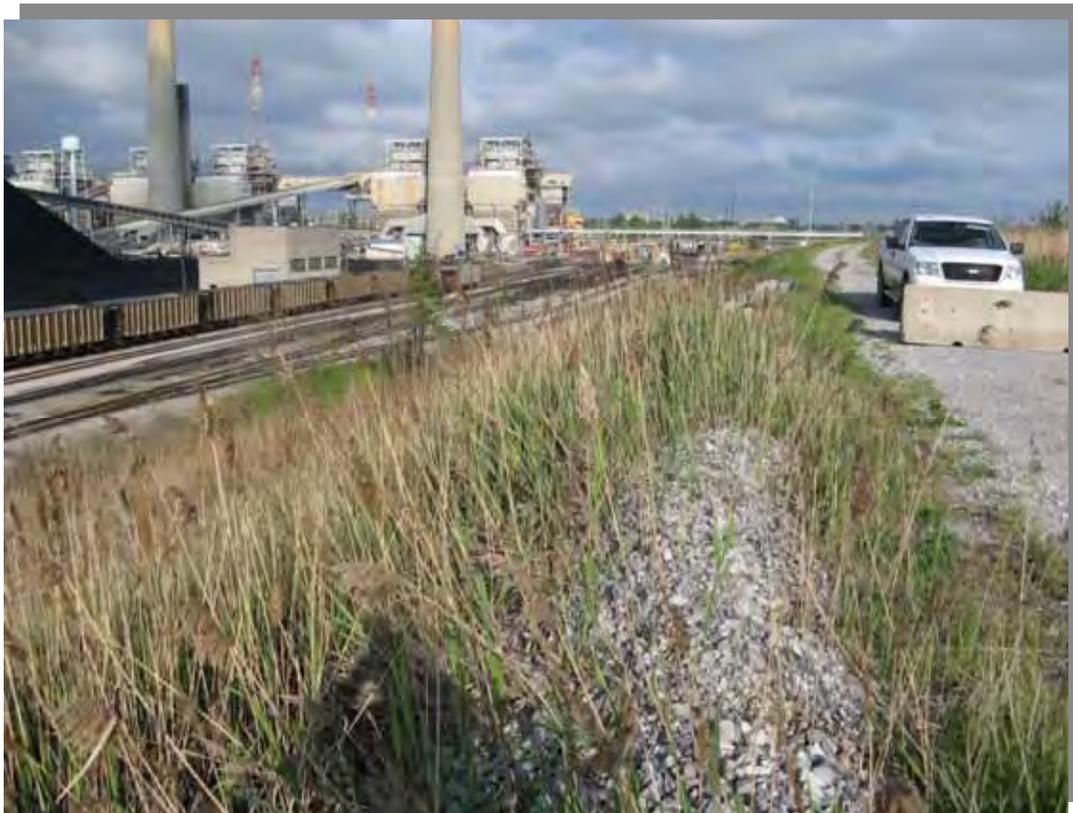
Photo 18 – Outboard slope of southern embankment of Southern Pond.
Note Jersey barrier blocking vehicular access to eastern embankment.

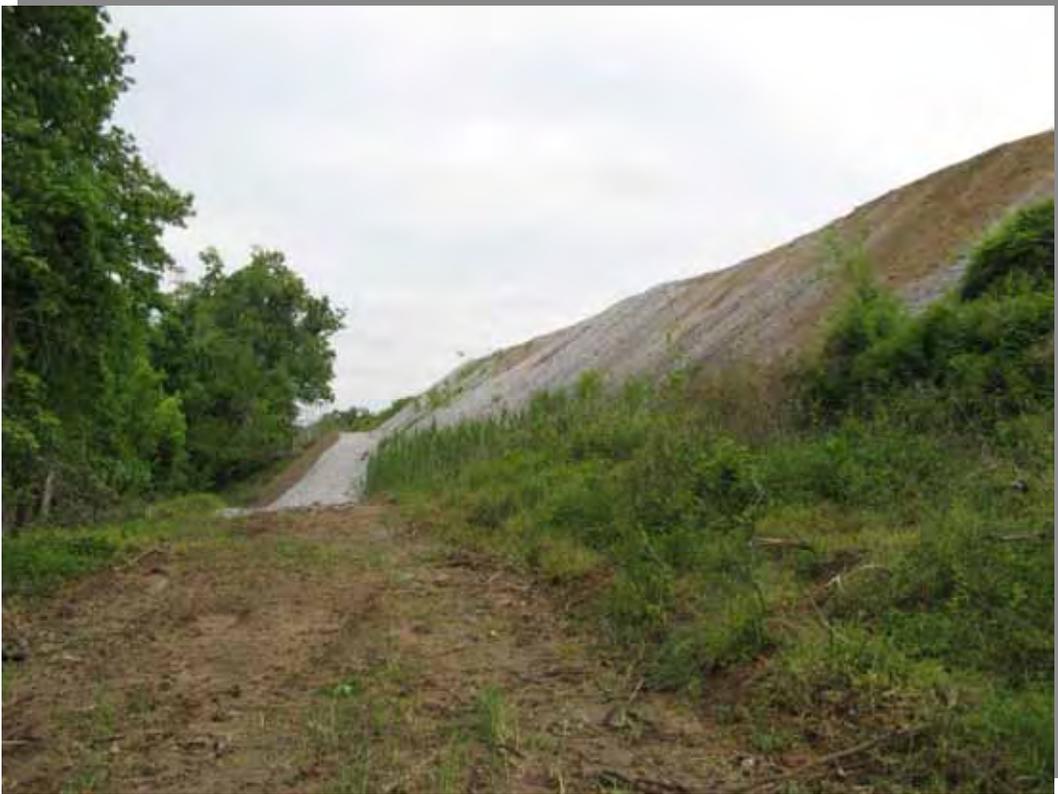
Photo 19 – Outboard slope of eastern embankment of Southern Pond.
Note repairs near crest and partially completed access road along toe.

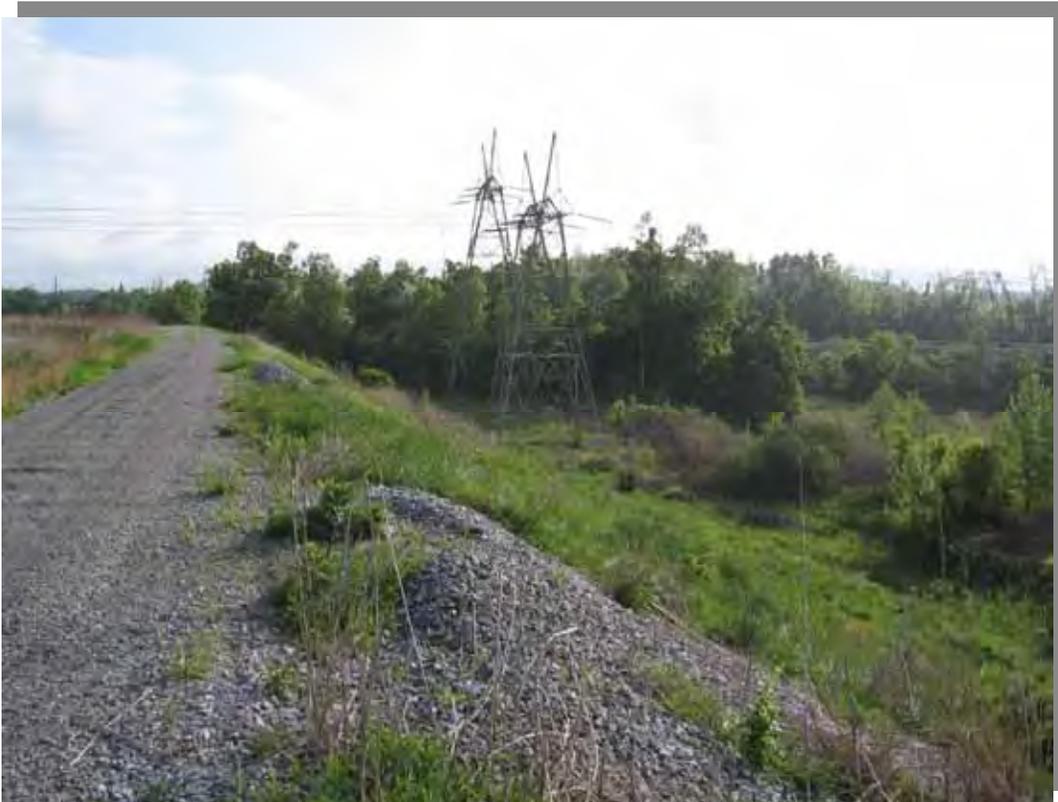
- Surface erosion, sloughs and slides were observed along the outboard slope. The most significant erosion was observed in the area below the power lines that cross the Southern Pond (Photos 20 - 22).

Photo 20 – Outboard slope of Southern Pond near power lines.

- Outboard slopes – remove deleterious vegetation and continue regular maintenance of the slopes; repair any areas of sloughs, slides and erosion.
- Outboard toe – investigate the extent of seepage, monitor the seepage on a regular basis, and develop alternatives for treating the deteriorated sections of the embankment.

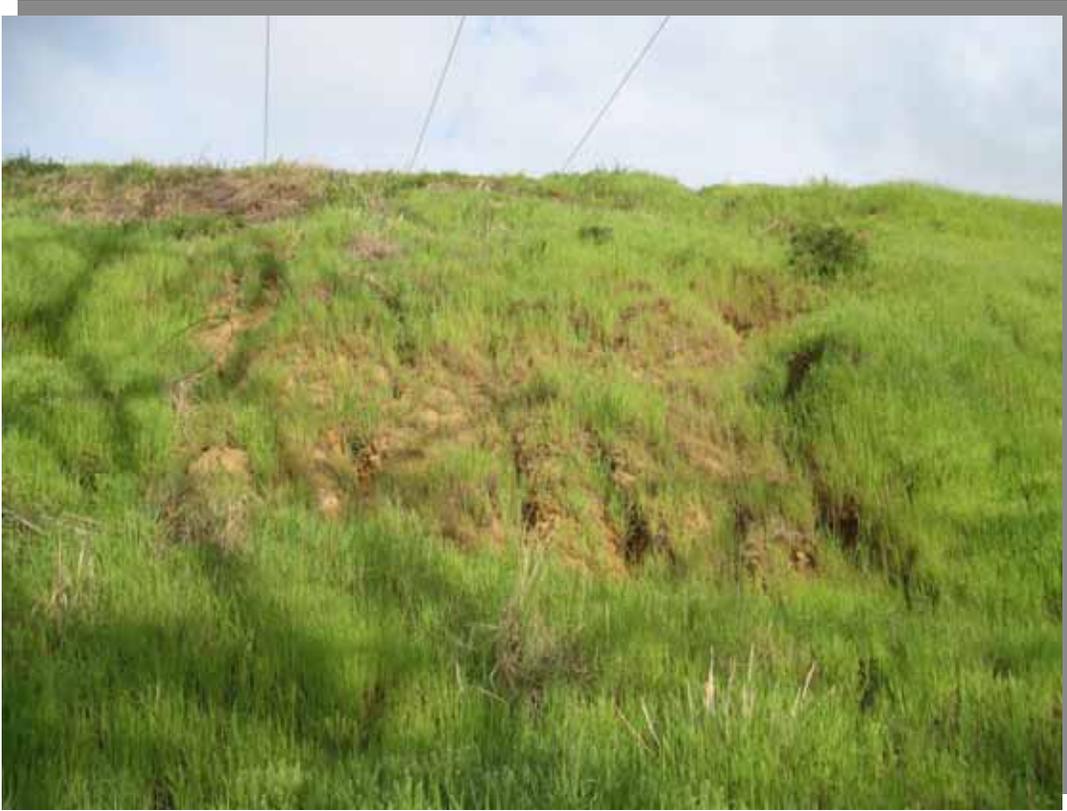
Photo 21 – Erosion on east embankment of Southern Pond below the power lines.

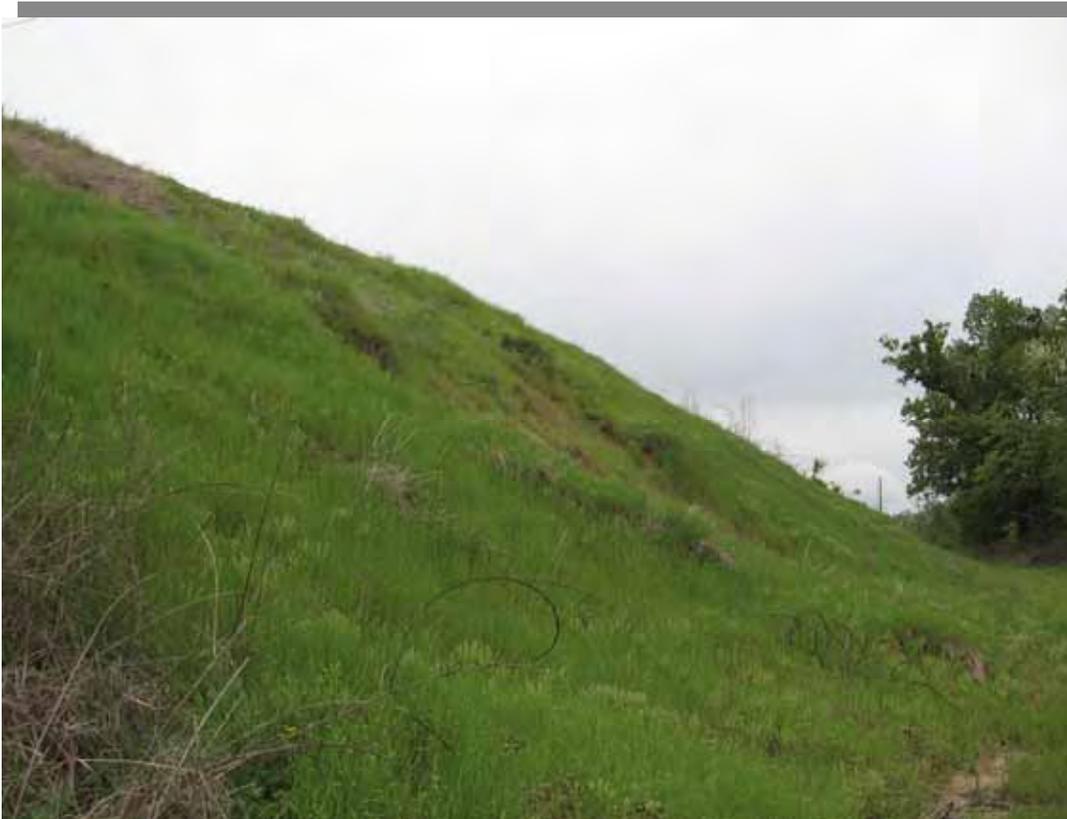
Photo 22 – Slides and sloughs on east embankment of Southern Pond, approximately 200 feet south of power lines.

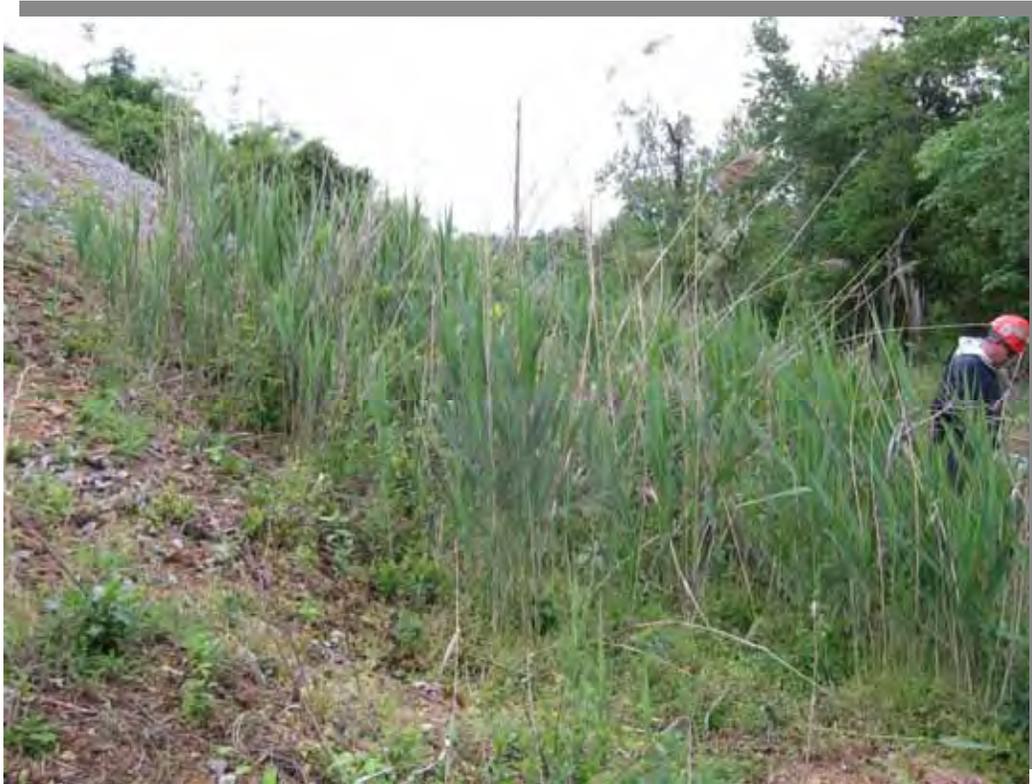
- Seepage was observed in multiple locations along the outboard toe of the embankment. The most significant area of seepage is located approximately 500 feet north of the power lines (Photos 23 & 24). Other areas where seepage was observed include an area approximately 200 feet south of the power lines and along the southern embankment of the Southern Pond. The approximate locations of seepage are identified on Figure 3.

Photo 23 – Outboard toe of Southern Pond eastern embankment approximately 500 feet north of power lines. Note reedy grasses indicating moist conditions, signs of seepage.

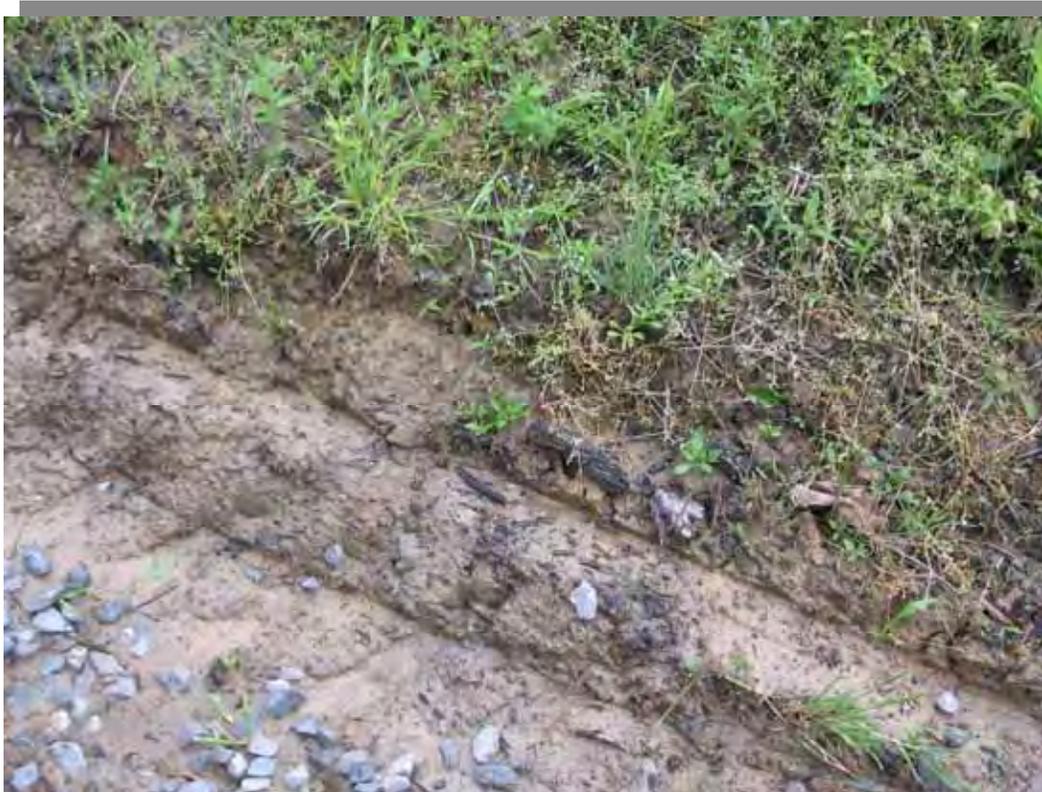
Photo 24 – Seepage at toe of east embankment of Southern Pond, near location indicated in Photo 23 above.
