Dam Safety Assessment of CCW Impoundments

Joppa Plant

United States Environmental Protection Agency
Washington, DC

September 24, 2010

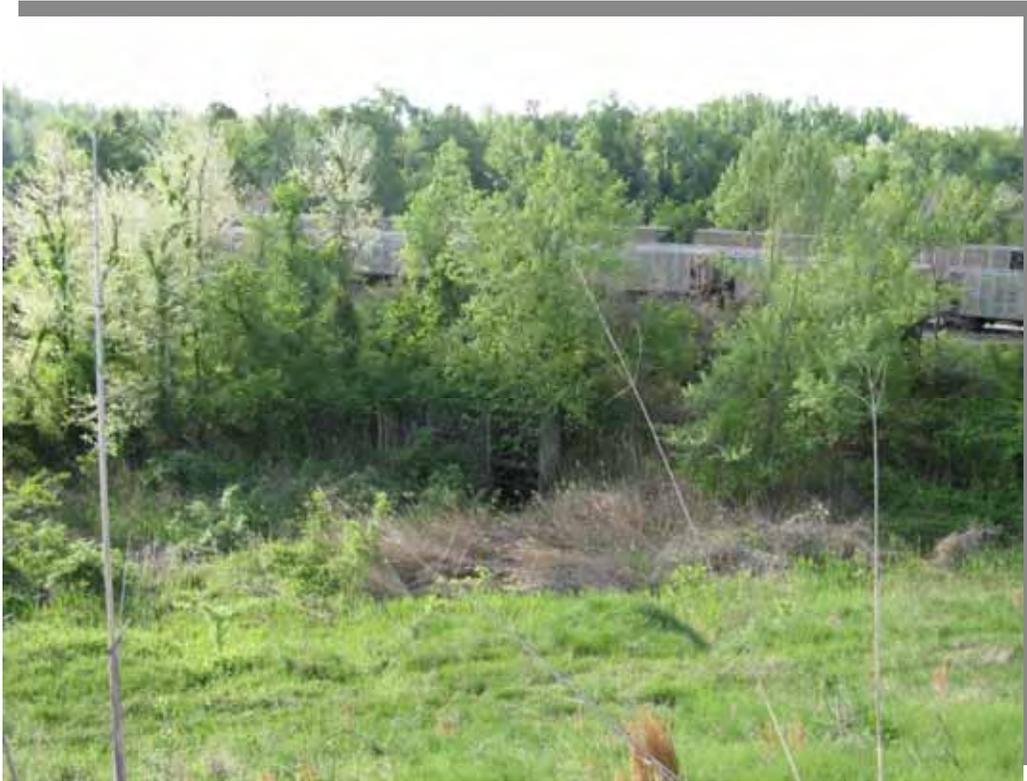
Photo 25 – Ash Pond outlet channel pass-through below EEI railroad siding.
