DRAFT REPORT

Dam Safety Assessment of CCW Impoundments

Labadie Power Station

January 2011

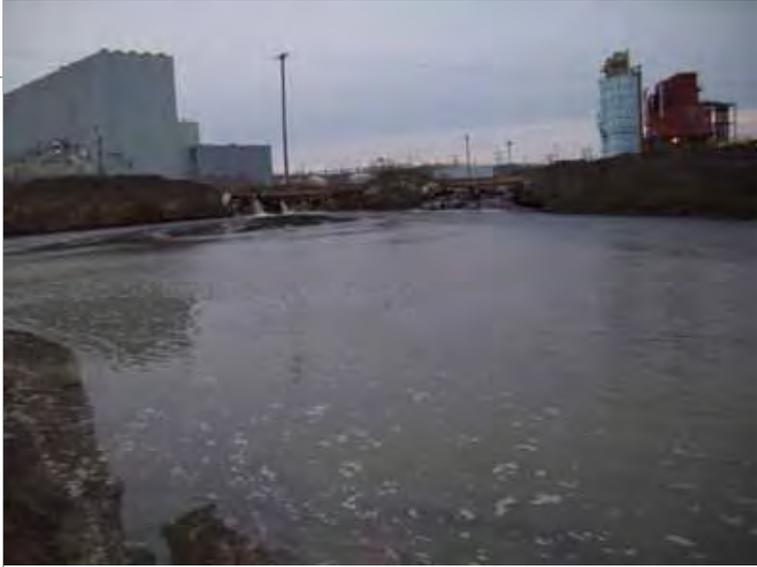
CLIENT NAME: US EPA		SITE LOCATION: Labadie Power Station. Labadie, MO	PROJECT NO. 13489 46122
PHOTO NO. B1	DATE: Nov. 17, 2010

DESCRIPTION Northern corner, note influent of CCW in background.

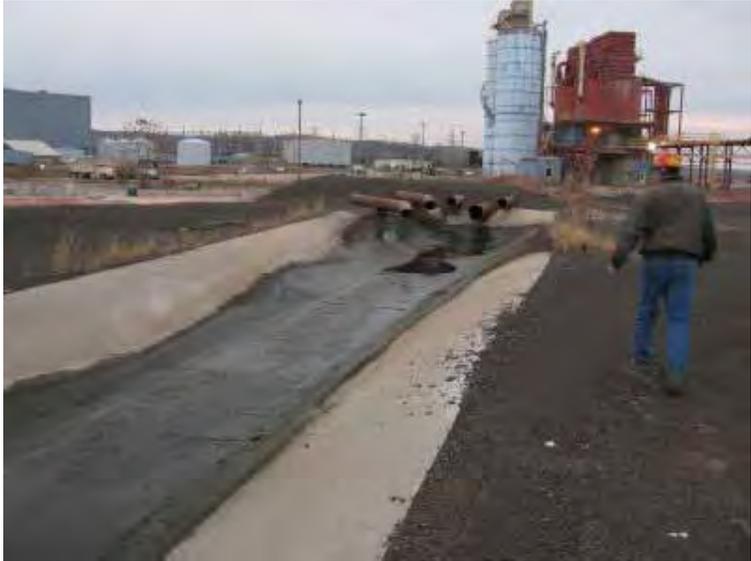
CLIENT NAME: US EPA		SITE LOCATION: Labadie Power Station. Labadie, MO	PROJECT NO. 13489 46122
PHOTO NO. B2	DATE: Nov. 17, 2010

DESCRIPTION Discharge pipes for water pumped from the Combined Drain Sump.

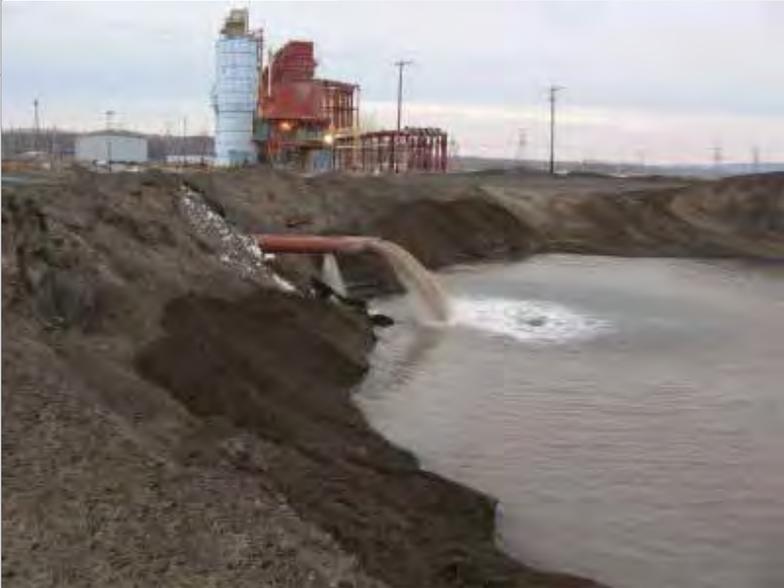
CLIENT NAME: US EPA		SITE LOCATION: Labadie Power Station. Labadie, MO	PROJECT NO. 13489 46122
PHOTO NO. B3	DATE: Nov. 17, 2010

DESCRIPTION CCW discharge into Bottom Ash Pond, northern corner of pond.

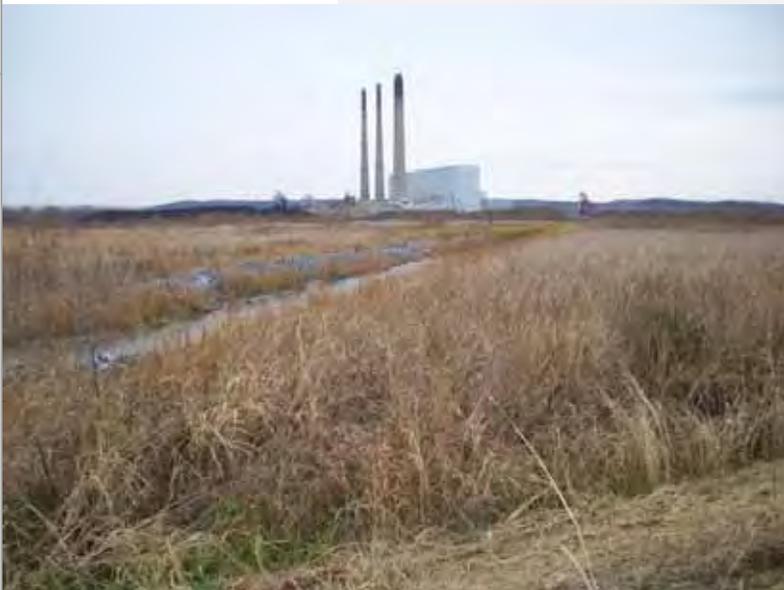
CLIENT NAME: US EPA		SITE LOCATION: Labadie Power Station. Labadie, MO	PROJECT NO. 13489 46122
PHOTO NO. B4	DATE: Nov. 17, 2010

DESCRIPTION Interior of Bottom Ash Pond, looking north. Note channel cut through deposited CCW.

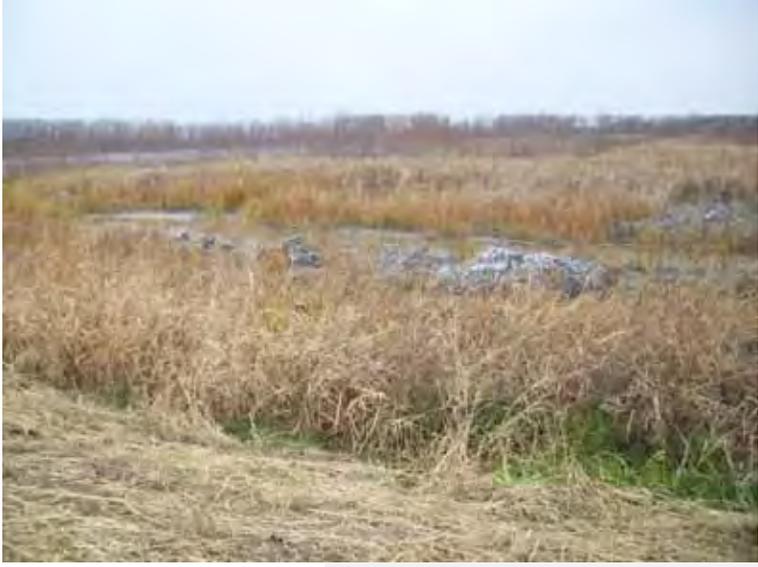
CLIENT NAME: US EPA		SITE LOCATION: Labadie Power Station. Labadie, MO	PROJECT NO. 13489 46122
PHOTO NO. B5	DATE: Nov. 17, 2010

DESCRIPTION Interior of Bottom Ash Pond. Note vegetative growth on CCW.

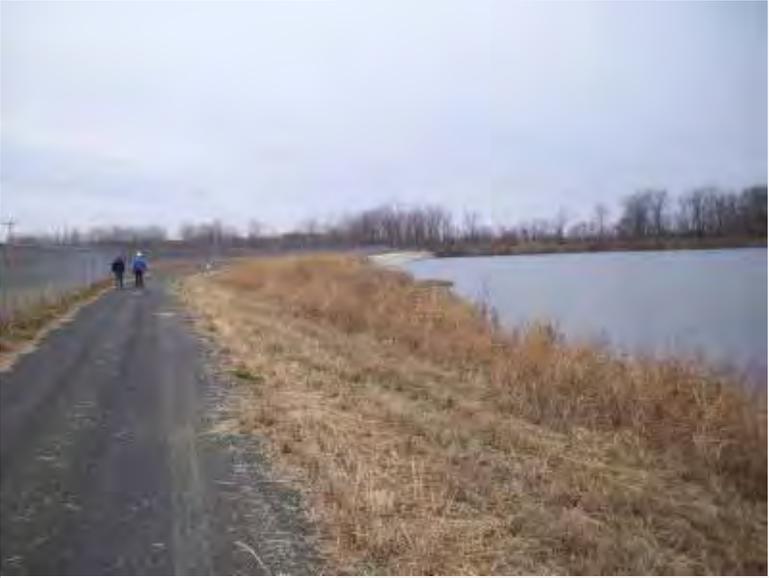
CLIENT NAME: US EPA		SITE LOCATION: Labadie Power Station. Labadie, MO	PROJECT NO. 13489 46122
PHOTO NO. B6	DATE: Nov. 17, 2010

- A crushed-stone access road was constructed over the length of the crest. The road appears to be in good condition with no rutting, erosion or standing water observed (Photos B6 & B16).

DESCRIPTION Southern embankment, looking west. Note riprap on inboard slope, background.

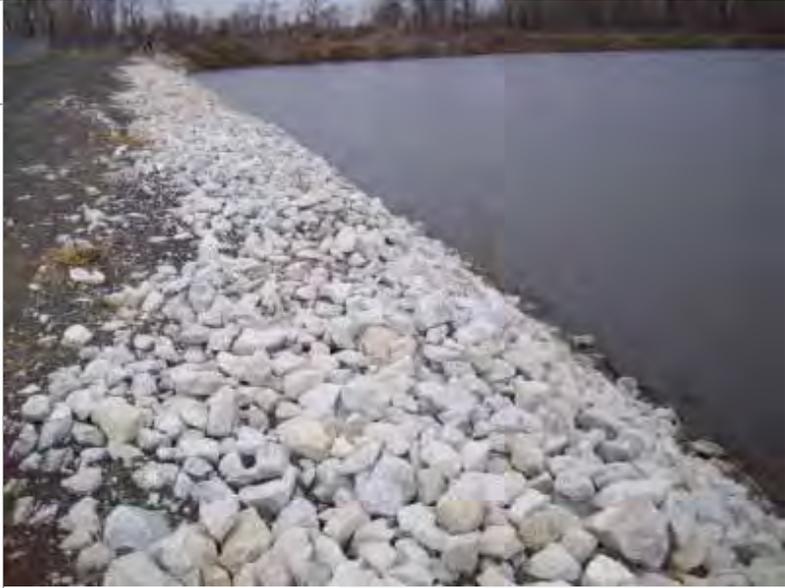
CLIENT NAME: US EPA		SITE LOCATION: Labadie Power Station. Labadie, MO	PROJECT NO. 13489 46122
PHOTO NO. B7	DATE: Nov. 17, 2010

- A portion of the inboard slope was covered with stone riprap (Photo B7), reportedly in response to deficiencies noted during inspections of the structure. The remainder of the inboard slope is either obscured/covered with CCW, or well vegetated.

DESCRIPTION Riprap on portion of inboard slope of southern embankment.

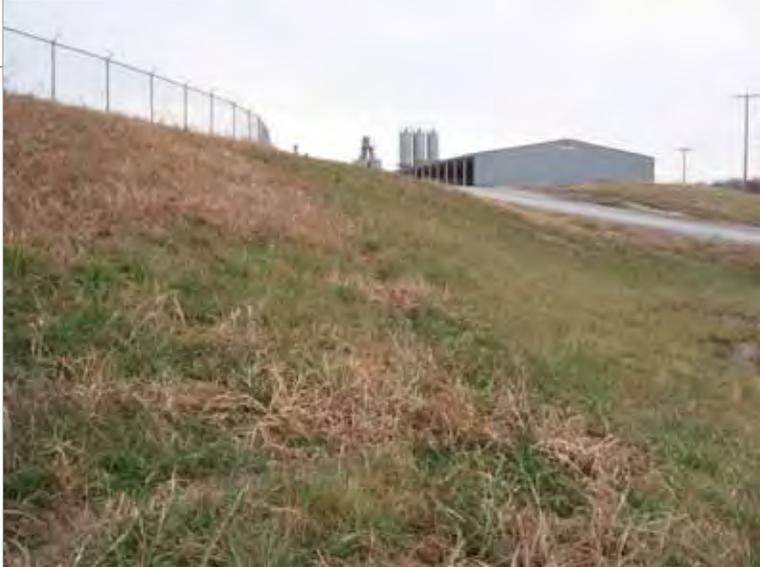
CLIENT NAME: US EPA		SITE LOCATION: Labadie Power Station. Labadie, MO	PROJECT NO. 13489 46122
PHOTO NO. B8	DATE: Nov. 17, 2010

- The outboard slope is generally covered with well maintained grass (Photo B8), though some taller grasses were observed along the western embankment (Photo B9). According to Ameren personnel, the grass is normally maintained along this embankment, but the mowing contractor missed the fall mowing.

- Several animal burrows were observed along the northern, eastern and southern embankments (Photo C-10).
- A Redi-mix concrete plant has been erected on reclaimed material placed outboard of the southern embankment (Photos B8 and C11). The plant uses CCW material obtained from the Labadie Power Station as part of the concrete mix. The plant is currently furloughed due to economic conditions, but will return to service when the demand for Redi-mix concrete increases.

DESCRIPTION Outboard face of southern embankment. Note redi-mix plant.

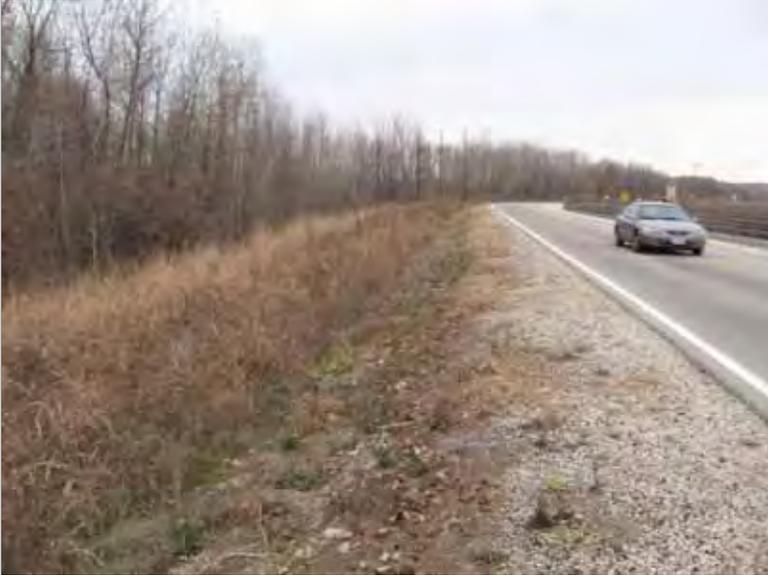
CLIENT NAME: US EPA		SITE LOCATION: Labadie Power Station. Labadie, MO	PROJECT NO. 13489 46122
PHOTO NO. B9	DATE: Nov. 17, 2010

DESCRIPTION Outboard face and toe of western embankment. Note vegetative growth.

- Outboard slopes – remove deleterious vegetation and continue regular maintenance of the slopes.
- Additional studies – no additional studies may be needed. A conclusion will be included in the Final version of this report if the 2010 subsurface investigation and stability analyses is available for review by O'Brien & Gere.
- If the Bottom Ash Pond is not taken out of service and replaced with the dry landfill, a seepage collection and monitoring system should be installed along the outboard slope of the western embankment.

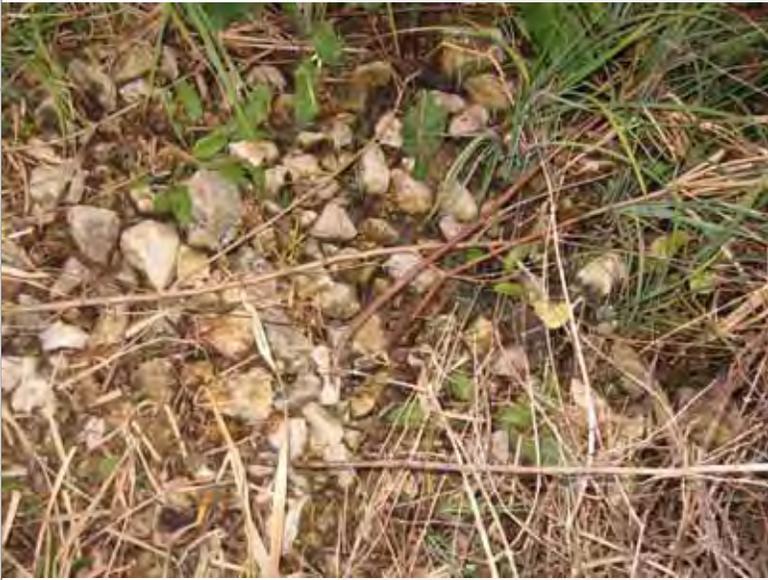
CLIENT NAME: US EPA		SITE LOCATION: Labadie Power Station. Labadie, MO	PROJECT NO. 13489 46122
PHOTO NO. B10	DATE: Nov. 17, 2010

- Several seepage locations were observed along the toe of the western embankment, extending for a distance of approximately 200' starting near the southwestern corner of the pond (typical seep, Photo B10). According to Ameren personnel, the seepage started shortly after the embankment was raised in 1988. The representatives also noted that the rate of seepage has remained relatively steady, although it will fluctuate in response to changes in pool elevation. The seepage was clear.

Based on conversations with Ameren personnel, no releases have occurred from the Bottom Ash Pond impoundment. No patchwork repair on the embankment appears to have been performed. As stated above, the seepage observed along the toe of the western embankment was initially observed shortly after the embankment crest was raised in 1988. Ameren personnel reported that the rate, color and location of seepage does not appear to have changed. Additionally, temporary piezometers were reportedly installed in the western embankment during the 2010 subsurface investigation. Water level readings taken in the piezometers reportedly remained steady through the testing period and appeared appropriate based on the pool water surface elevation and the location of the seepage. Since the subsurface and stability analyses report was not yet available at the time of writing of this report, the testing period and results could not be reviewed.

DESCRIPTION Typical seepage at toe of western embankment.

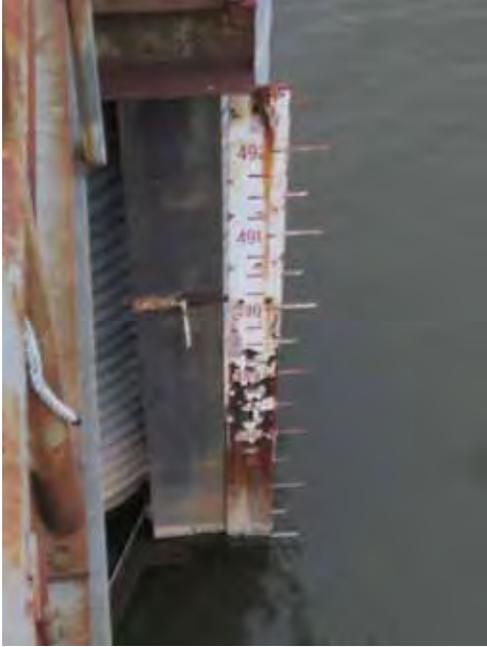
CLIENT NAME: US EPA		SITE LOCATION: Labadie Power Station. Labadie, MO	PROJECT NO. 13489 46122
PHOTO NO. B11	DATE: Nov. 17, 2010

- The outlet structure appeared to be in good condition and functioning normally (Photo B14). A staff gage is housed on the outside of the galvanized CMP but the numbers near normal-pool level have corroded and are not legible (Photo B11). An accurate reading of the pool water surface elevation is presented on a meter (Photo B13) located inside the outlet valve and CO2 control building. CO2 is used to regulate the pH of the discharge, if it falls outside acceptable levels.

DESCRIPTION Staff gage on outlet structure.

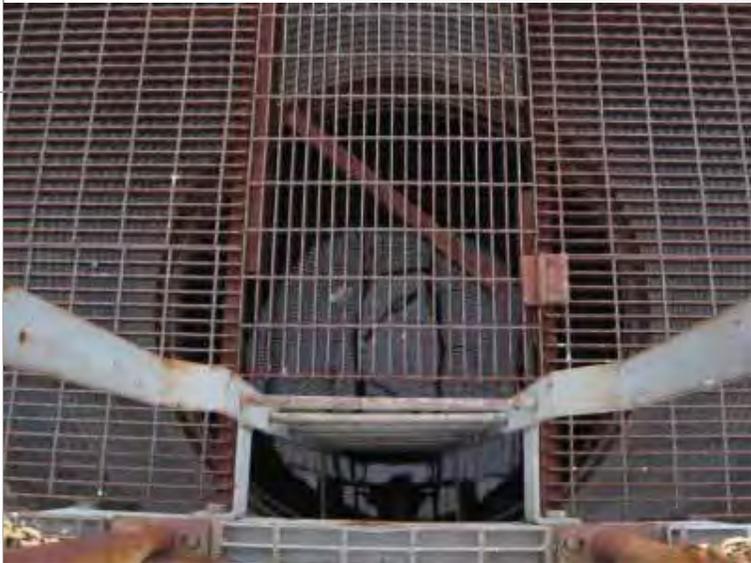
CLIENT NAME: US EPA		SITE LOCATION: Labadie Power Station. Labadie, MO	PROJECT NO. 13489 46122
PHOTO NO. B12	DATE: Nov. 17, 2010

DESCRIPTION Interior of galvanized 8-foot diameter CMP outlet works skimmer.

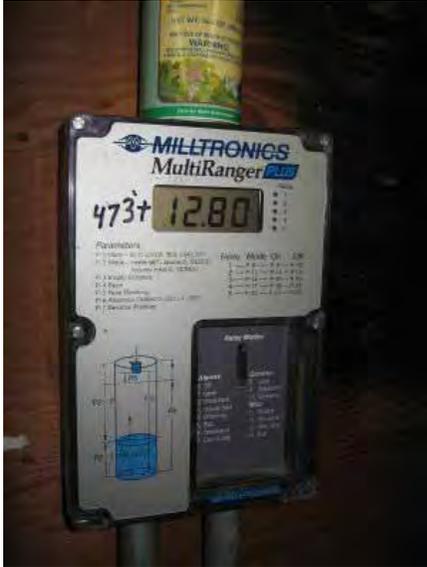
CLIENT NAME: US EPA		SITE LOCATION: Labadie Power Station. Labadie, MO	PROJECT NO. 13489 46122
PHOTO NO. B13	DATE: Nov. 17, 2010

DESCRIPTION Water level readout in valve and CO2 control building.

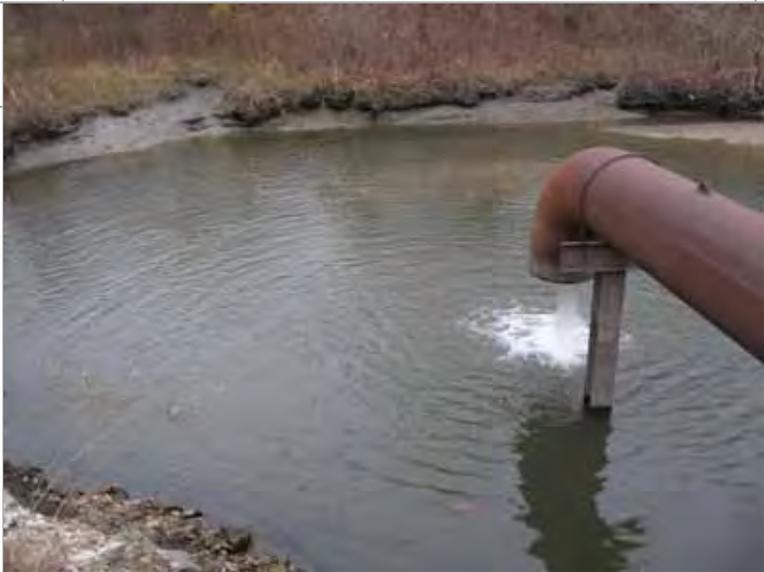
CLIENT NAME: US EPA		SITE LOCATION: Labadie Power Station. Labadie, MO	PROJECT NO. 13489 46122
PHOTO NO. B14	DATE: Nov. 17, 2010

DESCRIPTION Discharge from outlet structure.

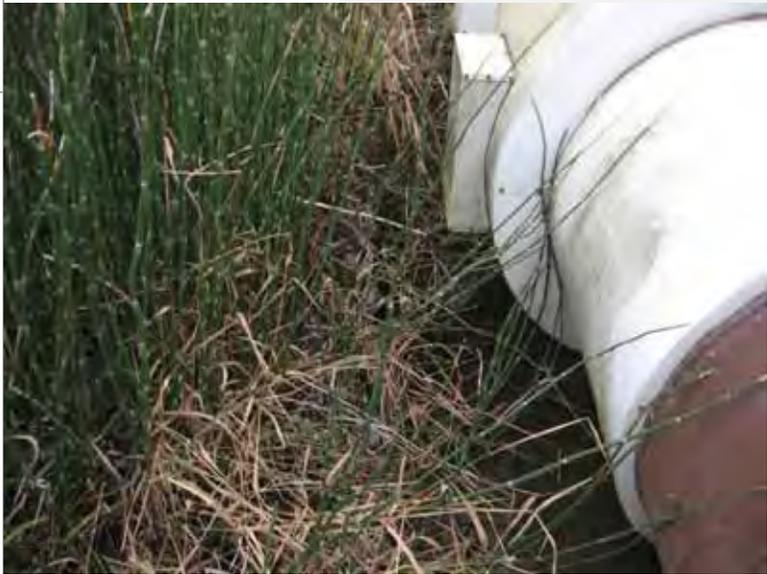
CLIENT NAME: US EPA		SITE LOCATION: Labadie Power Station. Labadie, MO	PROJECT NO. 13489 46122
PHOTO NO. B15	DATE: Nov. 17, 2010

- A small amount of seepage (approx. 5 gpm) was observed around the outside of the outlet pipe (Photo B15).
- Discharge from the outlet structure pools at the toe of the western embankment before flowing north to the Missouri River.

DESCRIPTION Seepage along outlet pipe.

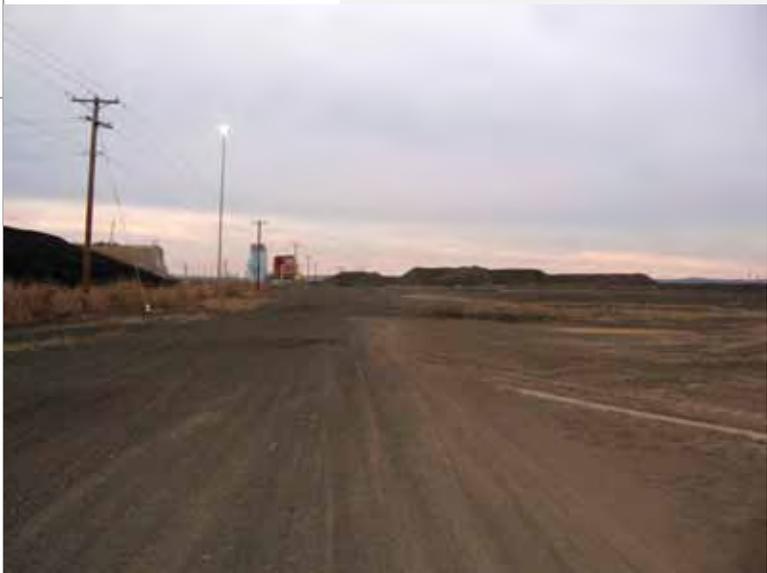
CLIENT NAME: US EPA		SITE LOCATION: Labadie Power Station. Labadie, MO	PROJECT NO. 13489 46122
PHOTO NO. B16	DATE: Nov. 17, 2010

DESCRIPTION Crest of northern embankment. Note width and dried CCW.

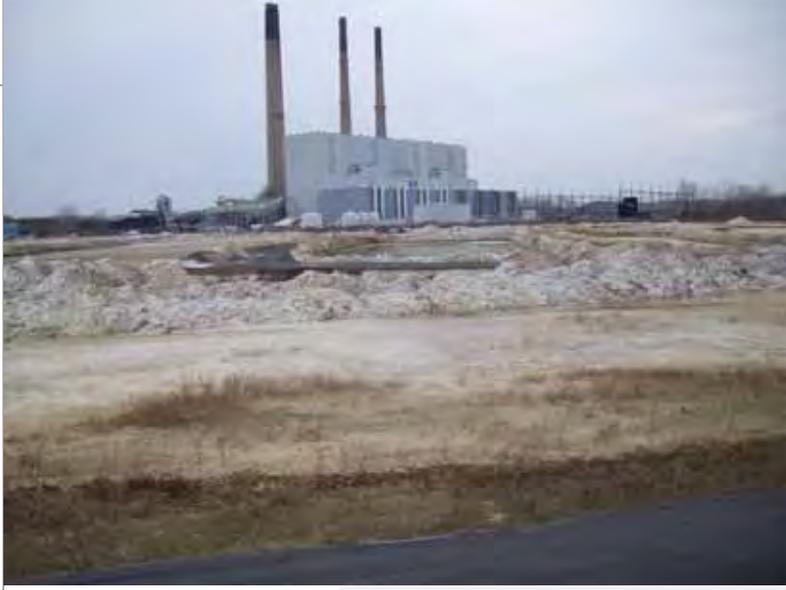
CLIENT NAME: US EPA		SITE LOCATION: Labadie Power Station. Labadie, MO	PROJECT NO. 13489 46122
PHOTO NO. C1	DATE: Nov. 17, 2010

- The 60-mil PVC liner installed on the inboard slope is exposed or covered with CCW (Photos C1 - C5). A small tree was observed growing near the inboard slope of the northern embankment (Photo C-3).

DESCRIPTION Interior of Fly Ash Pond, looking north. Note dried CCW and exposed 60 mil HDPE liner

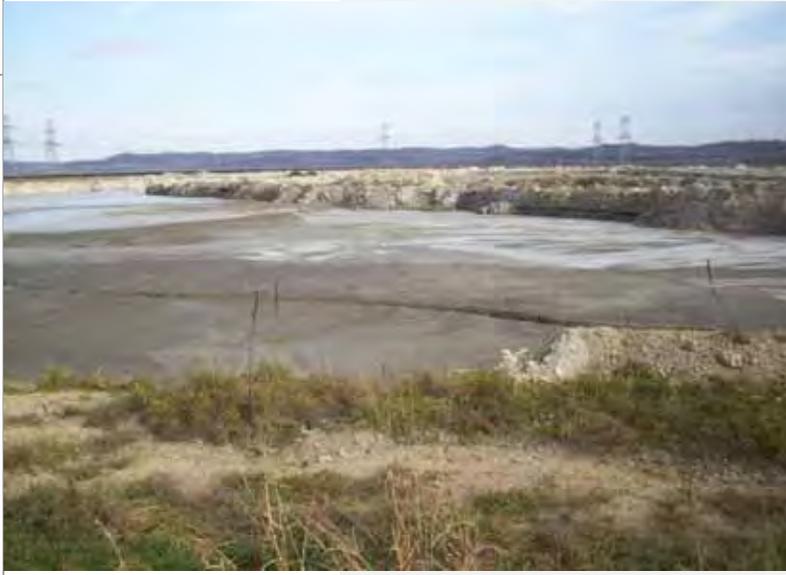
CLIENT NAME: US EPA		SITE LOCATION: Labadie Power Station. Labadie, MO	PROJECT NO. 13489 46122
PHOTO NO. C2	DATE: Nov. 17, 2010

DESCRIPTION Interior of Fly Ash Pond, looking south. Note dried CCW and excavated channel.

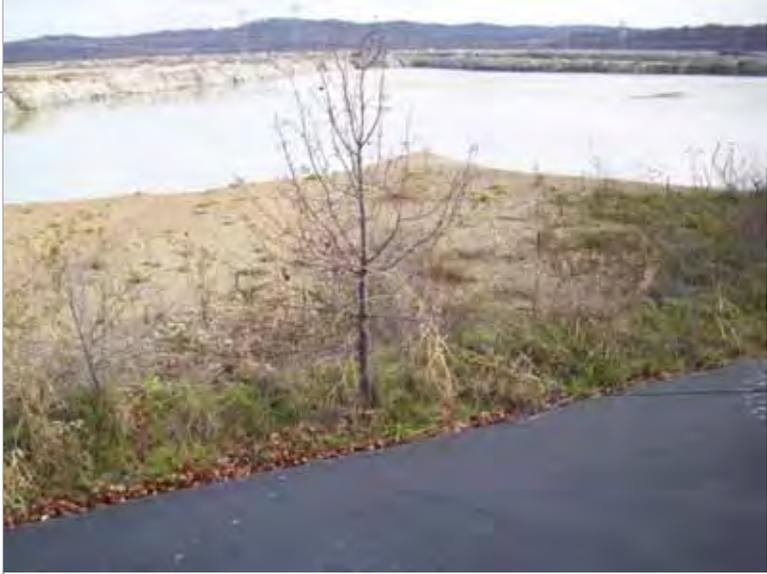
CLIENT NAME: US EPA		SITE LOCATION: Labadie Power Station. Labadie, MO	PROJECT NO. 13489 46122
PHOTO NO. C3	DATE: Nov. 17, 2010

DESCRIPTION Interior of Fly Ash Pond looking south. Note tree and exposed liner.

- Outboard slopes – repair animal burrows.
- Inboard slopes – remove the small tree growing along the northern portion of the embankment.
- Interior crest – repair erosion near discharge end of six-inch diameter PVC pipes.
- Additional studies – no additional studies may be needed, final conclusion will be provided after review of the 2010 subsurface investigation and stability analyses.

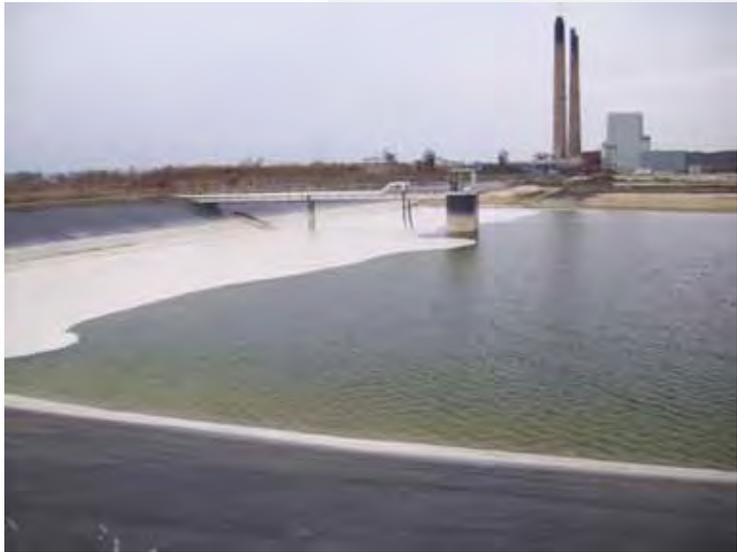
CLIENT NAME: US EPA		SITE LOCATION: Labadie Power Station. Labadie, MO	PROJECT NO. 13489 46122
PHOTO NO. C4	DATE: Nov. 17, 2010

DESCRIPTION Fly Ash Pond outlet structure.

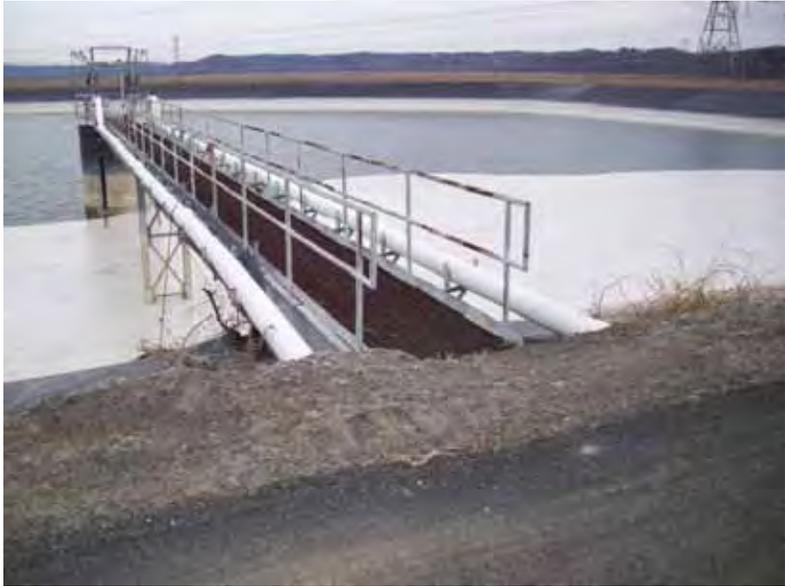
CLIENT NAME: US EPA		SITE LOCATION: Labadie Power Station. Labadie, MO	PROJECT NO. 13489 46122
PHOTO NO. C5	DATE: Nov. 17, 2010

- The crest of the dividing dike between the Fly Ash and Bottom Ash Ponds has eroded at the discharge end of the PVC pipes (Photo C6).
- A crushed-stone access road was constructed over the length of the crest. The road appears to be in good condition with no rutting, erosion or standing water observed (Photo C5).

DESCRIPTION Access bridge to Fly Ash Pond outlet structure. Note six-inch diameter PVC pipes along the bridge.

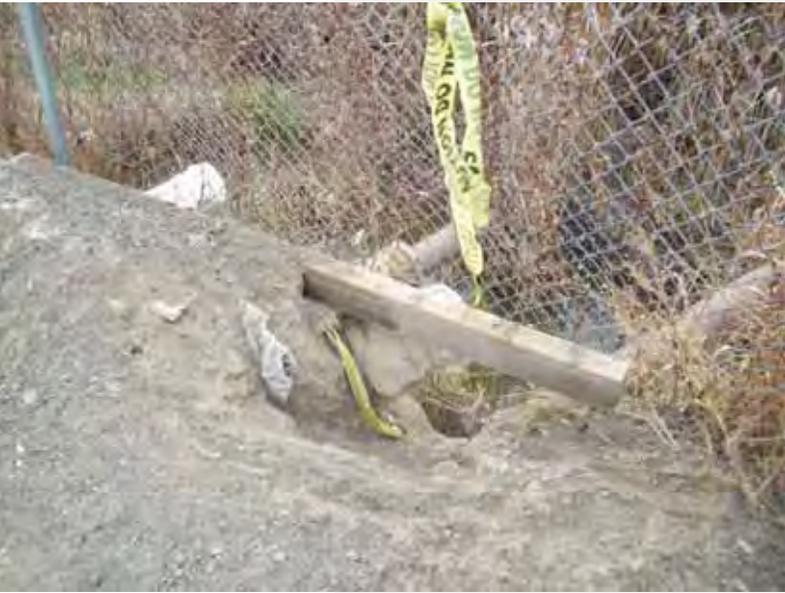
CLIENT NAME: US EPA		SITE LOCATION: Labadie Power Station. Labadie, MO	PROJECT NO. 13489 46122
PHOTO NO. C6	DATE: Nov. 17, 2010

DESCRIPTION Discharge end of PVC pipes from Fly Ash Pond into Bottom Ash Pond. Note erosion of dividing dike crest.

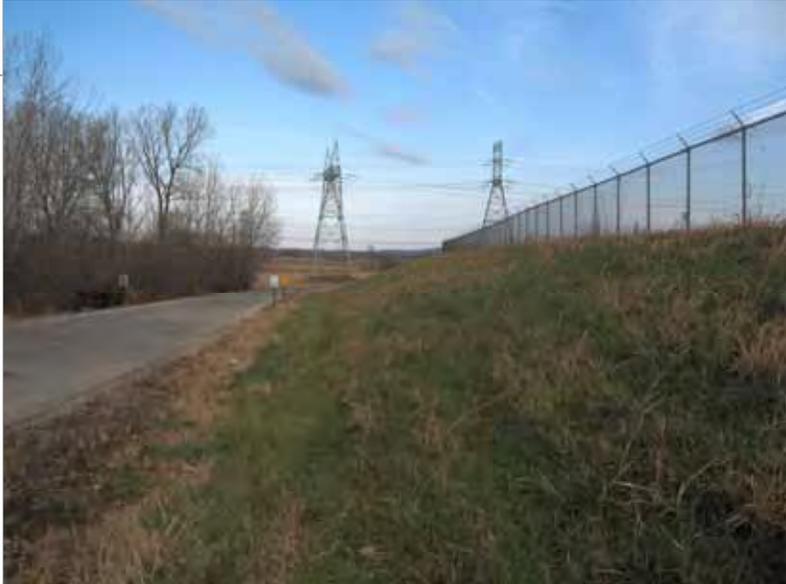
CLIENT NAME: US EPA		SITE LOCATION: Labadie Power Station. Labadie, MO		PROJECT NO. 13489 46122
PHOTO NO. C7	DATE: Nov. 17, 2010

- The outboard slope is generally covered with well-maintained grass (Photos C7 - C9).
- A change in the slope of the outboard face was observed for approximately ¼-mile along the toe of the eastern embankment. The change in slope did not appear to be the result of a slough of the embankment. It is not known if this section of the embankment was constructed with a change from the design slope of 3H:1V.

DESCRIPTION Northern embankment, looking east.

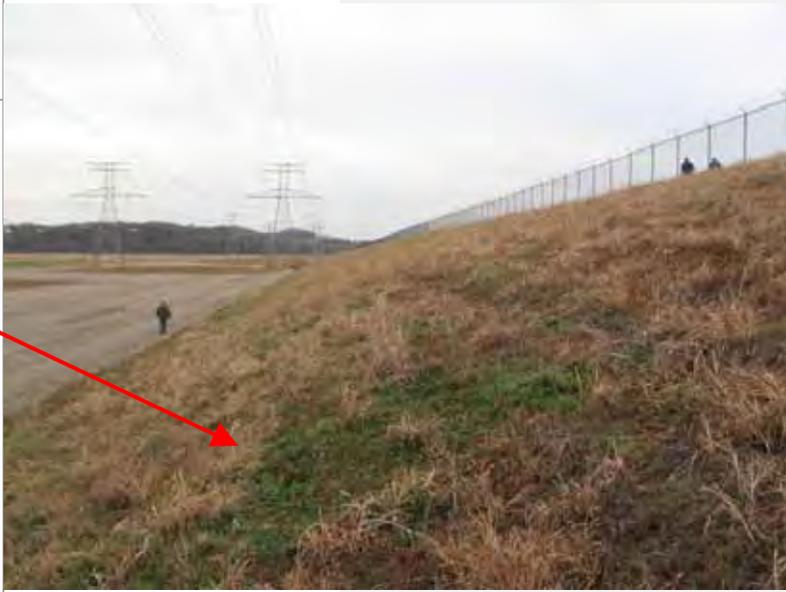
CLIENT NAME: US EPA		SITE LOCATION: Labadie Power Station. Labadie, MO		PROJECT NO. 13489 46122
PHOTO NO. C8	DATE: Nov. 17, 2010

DESCRIPTION Eastern embankment looking south. Note change in slope near the toe.

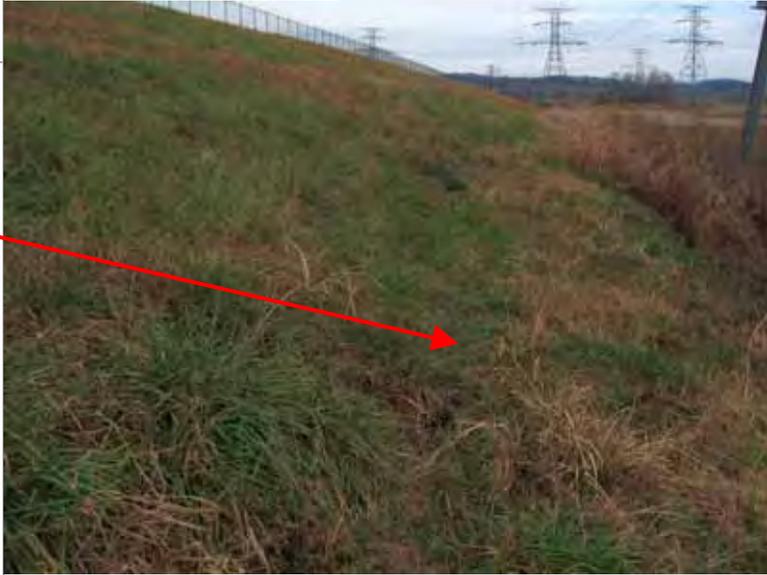
CLIENT NAME: US EPA		SITE LOCATION: Labadie Power Station. Labadie, MO	PROJECT NO. 13489 46122
PHOTO NO. C9	DATE: Nov. 17, 2010

DESCRIPTION Eastern embankment looking north. Note change in slope near the toe.

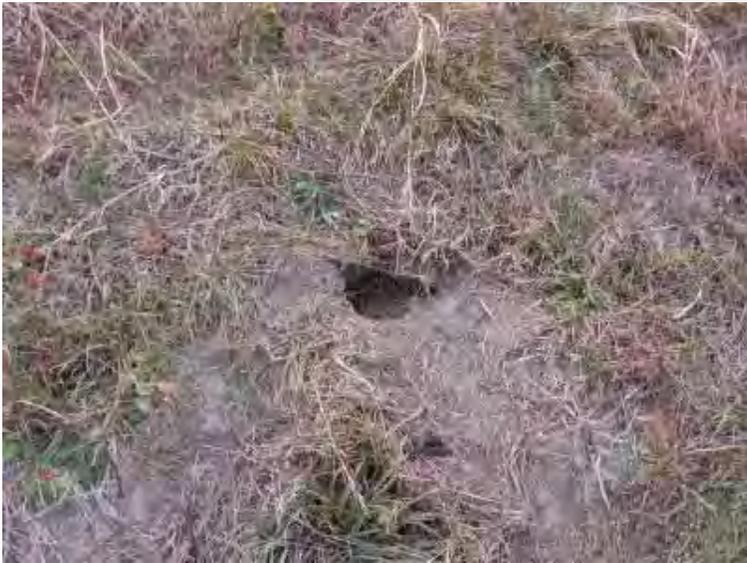
CLIENT NAME: US EPA		SITE LOCATION: Labadie Power Station. Labadie, MO	PROJECT NO. 13489 46122
PHOTO NO. C10	DATE: Nov. 17, 2010

DESCRIPTION Typical animal burrow.

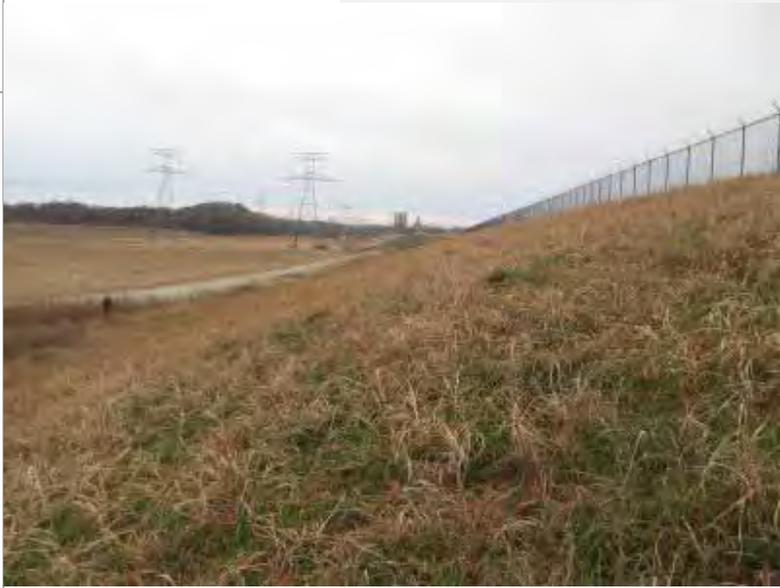
CLIENT NAME: US EPA		SITE LOCATION: Labadie Power Station. Labadie, MO	PROJECT NO. 13489 46122
PHOTO NO. C11	DATE: Nov. 17, 2010

DESCRIPTION Southern embankment looking west.

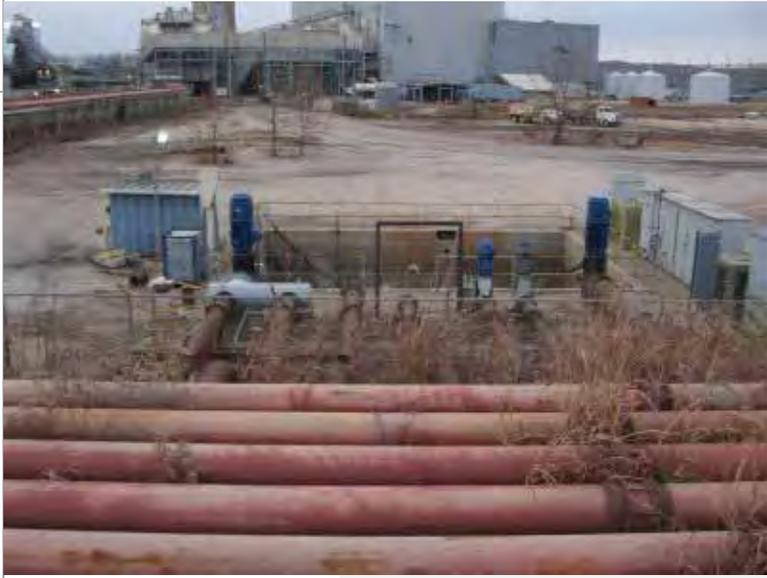
CLIENT NAME: US EPA		SITE LOCATION: Labadie Power Station. Labadie, MO	PROJECT NO. 13489 46122
PHOTO NO. C12	DATE: Nov. 17, 2010

DESCRIPTION Combined Drain Sump.
