# **Dam Safety Assessment of CCW Impoundments**

## **Labadie Power Station**

# Dam Safety Assessment of CCW Impoundments

Labadie Power Station

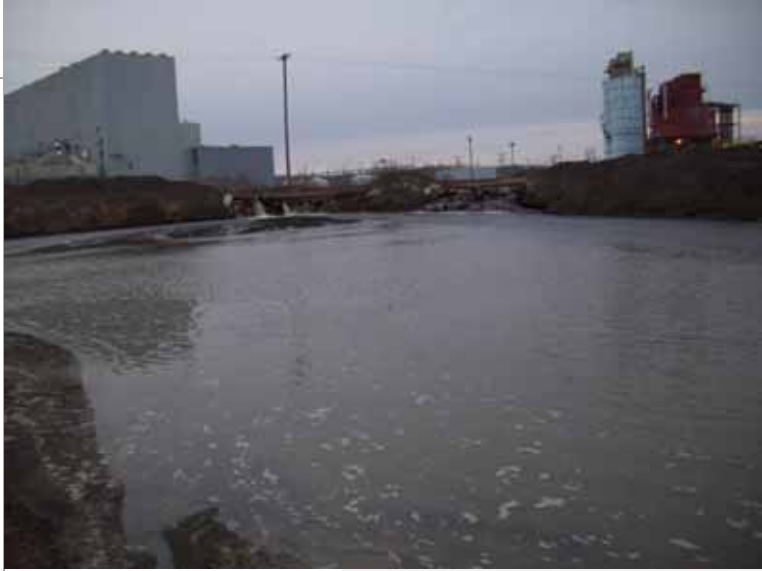
| <b>PHOTO NO.</b><br>B1 | <b>DATE:</b><br>Nov. 17, 2010 | | |

| <b>DESCRIPTION</b><br>Northern corner, note influent of CCW in background. | | | |

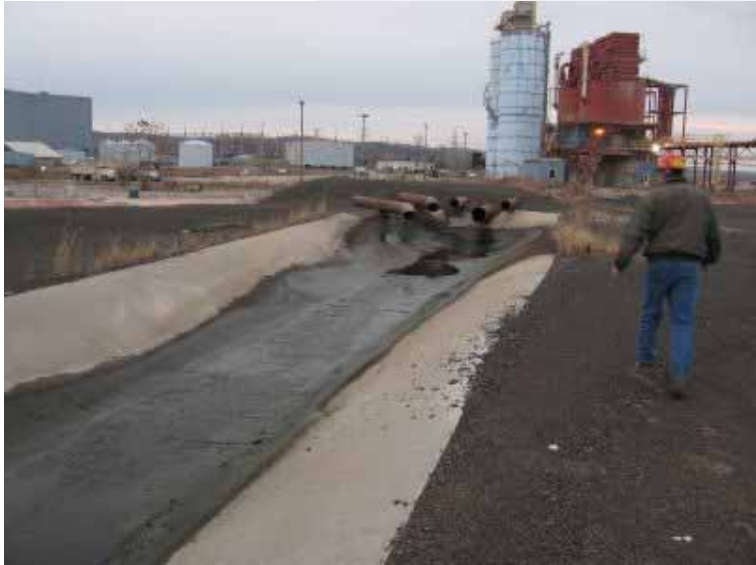
| <b>PHOTO NO.</b><br>B2 | <b>DATE:</b><br>Nov. 17, 2010 | | |

| <b>DESCRIPTION</b><br>Discharge pipes for water pumped from the Combined Drain Sump. | | | |

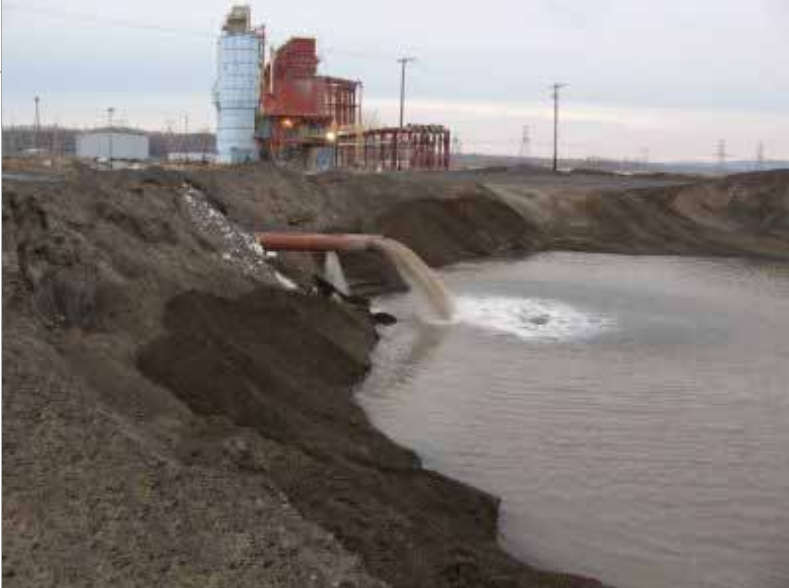
| <b>PHOTO NO.</b><br>B3 | <b>DATE:</b><br>Nov. 17, 2010 | | |

| <b>DESCRIPTION</b><br>CCW discharge into Bottom Ash Pond, northern corner of pond. | | | |

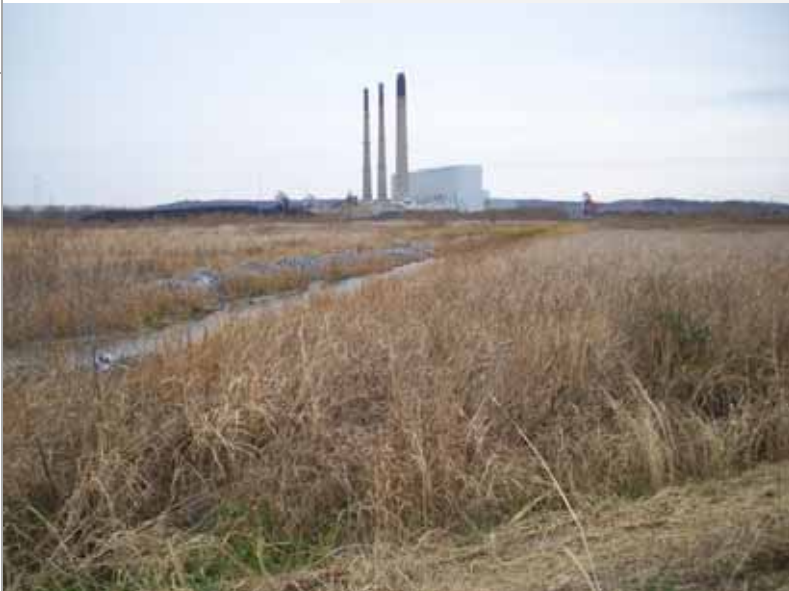
| <b>PHOTO NO.</b><br>B4 | <b>DATE:</b><br>Nov. 17, 2010 | | |

| <b>DESCRIPTION</b><br>Interior of Bottom Ash Pond, looking north. Note channel cut through deposited CCW. | | | |

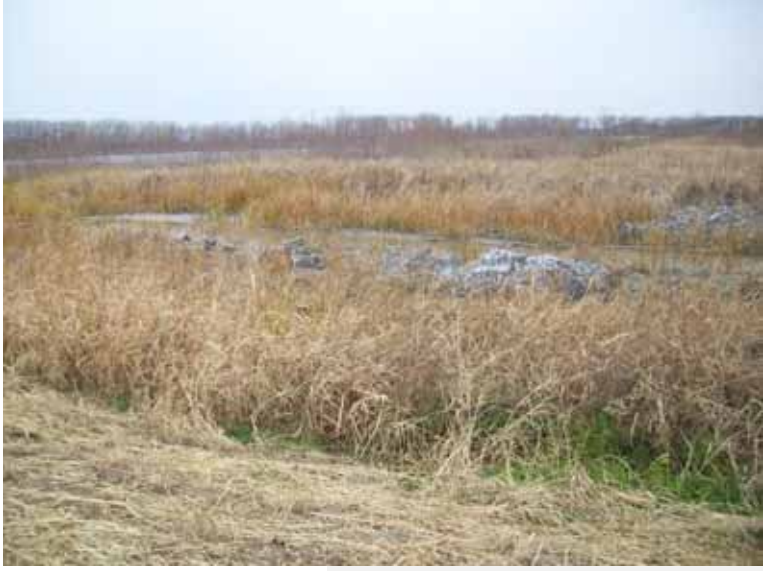
| <b>PHOTO NO.</b><br>B5 | <b>DATE:</b><br>Nov. 17, 2010 | | |

| <b>DESCRIPTION</b><br>Interior of Bottom Ash Pond.<br>Note vegetative growth on CCW. | | | |

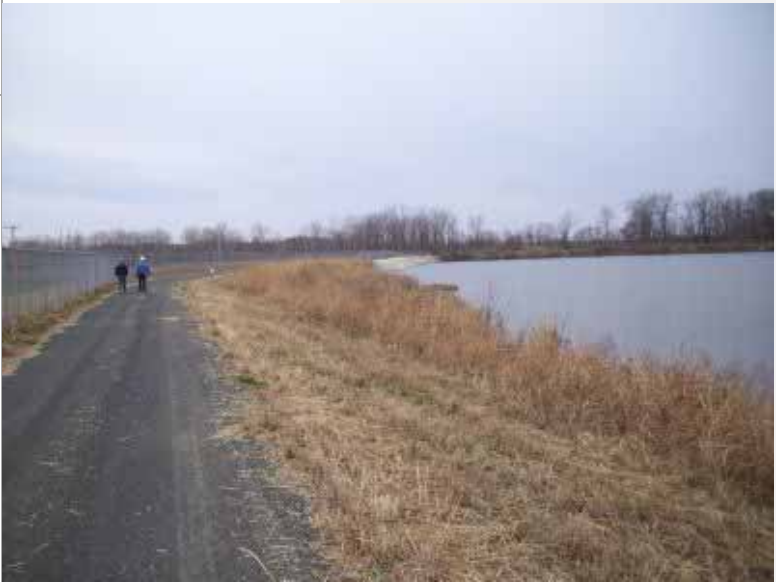
| <b>PHOTO NO.</b><br>B6 | <b>DATE:</b><br>Nov. 17, 2010 | | |

- A crushed-stone access road was constructed over the length of the crest. The road appears to be in good condition with no rutting, erosion or standing water observed (Photos B6 & B16).

| <b>DESCRIPTION</b><br>Southern embankment,<br>looking west. Note riprap on<br>inboard slope, background. | | | |

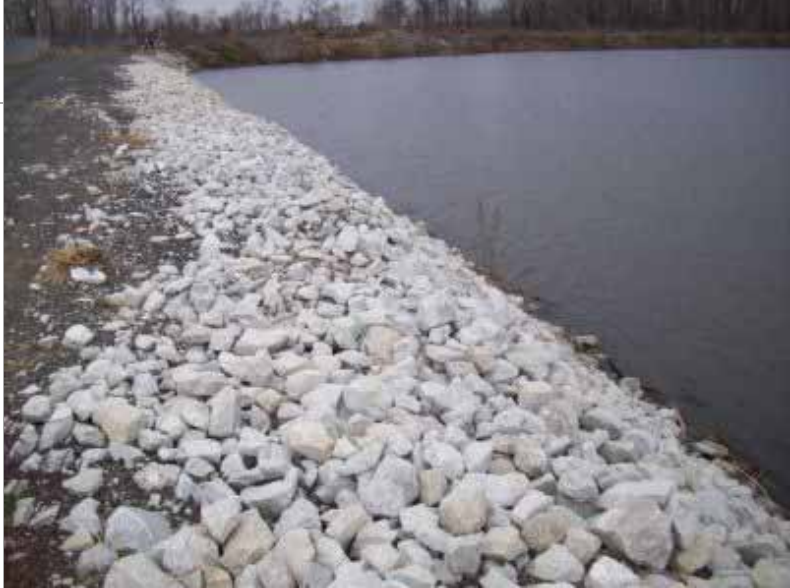
| <b>PHOTO NO.</b><br>B7 | <b>DATE:</b><br>Nov. 17, 2010 | | |

- A portion of the inboard slope was covered with stone riprap (Photo B7), reportedly in response to deficiencies noted during inspections of the structure. The remainder of the inboard slope is either obscured/covered with CCW, or well vegetated.

| <b>DESCRIPTION</b><br>Riprap on portion of inboard slope of southern embankment. | | | |

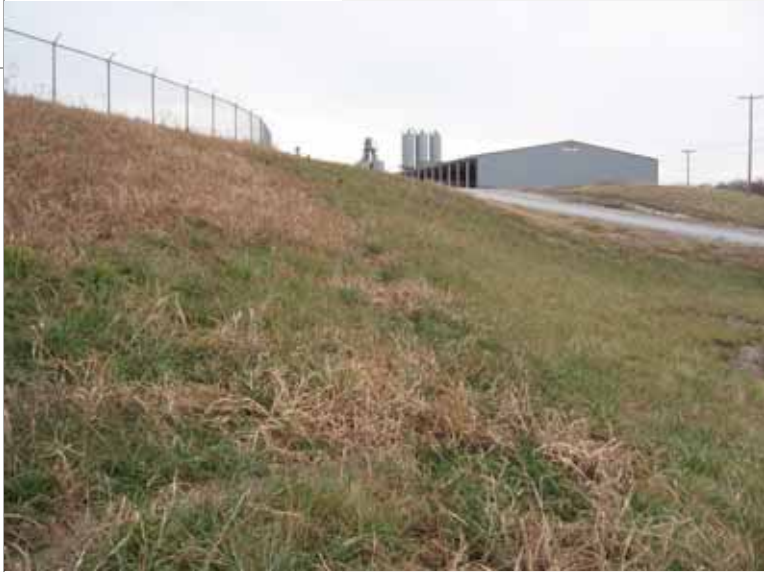
| <b>PHOTO NO.</b><br>B8 | <b>DATE:</b><br>Nov. 17, 2010 | | |

- The outboard slope is generally covered with well maintained grass (Photo B8), though some taller grasses were observed along the western embankment (Photo B9). According to Ameren personnel, the grass is normally maintained along this embankment, but the mowing contractor missed the fall mowing.

- Several animal burrows were observed along the northern, eastern and southern embankments (Photo C-10).
- A Redi-mix concrete plant has been erected on reclaimed material placed outboard of the southern embankment (Photos B8 and C11). The plant uses CCW material obtained from the Labadie Power Station as part of the concrete mix. The plant is currently furloughed due to economic conditions, but will return to service when the demand for Redi-mix concrete increases.

| <b>DESCRIPTION</b><br>Outboard face of southern embankment. Note redi-mix plant. | | | |

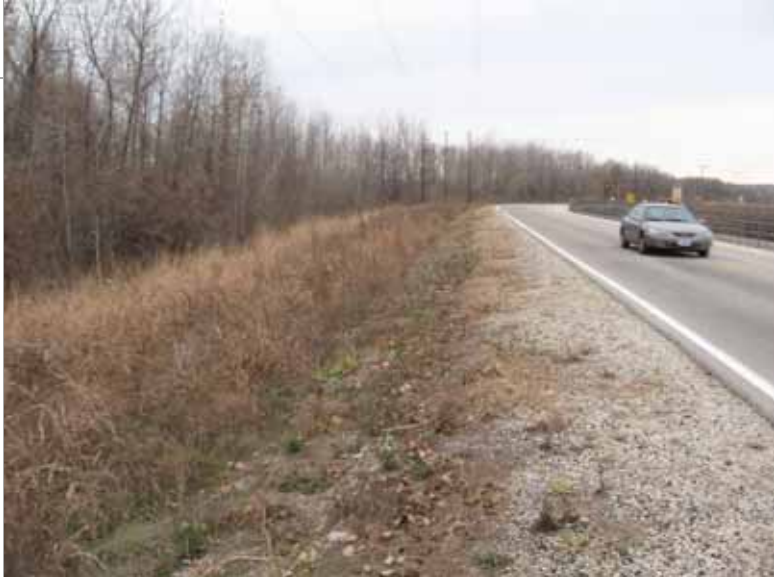
| <b>PHOTO NO.</b><br>B9 | <b>DATE:</b><br>Nov. 17, 2010 | | |

| <b>DESCRIPTION</b><br>Outboard face and toe of western embankment. Note vegetative growth. | | | |

- Outboard slopes – remove deleterious vegetation and continue regular maintenance of the slopes.
- Additional studies – no additional studies may be needed. The input for cross section 5 should be provided.
- If the Bottom Ash Pond is not taken out of service and replaced with the dry landfill, a seepage collection and monitoring system installed along the outboard slope of the western embankment if changes in the color, rate or location of seepage are observed.

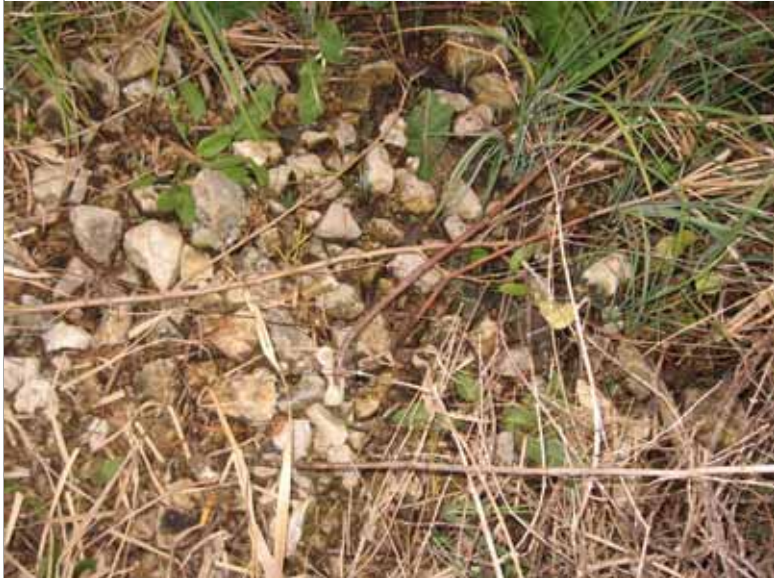
| <b>PHOTO NO.</b><br>B10 | <b>DATE:</b><br>Nov. 17, 2010 | | |

- Several seepage locations were observed along the toe of the western embankment, extending for a distance of approximately 200' starting near the southwestern corner of the pond (typical seep, Photo B10). According to Ameren personnel, the seepage started shortly after the embankment was raised in 1988. The representatives also noted that the rate of seepage has remained relatively steady, although it will fluctuate in response to changes in pool elevation. The seepage was clear.

| <b>DESCRIPTION</b><br>Typical seepage at toe of western embankment. | | | |

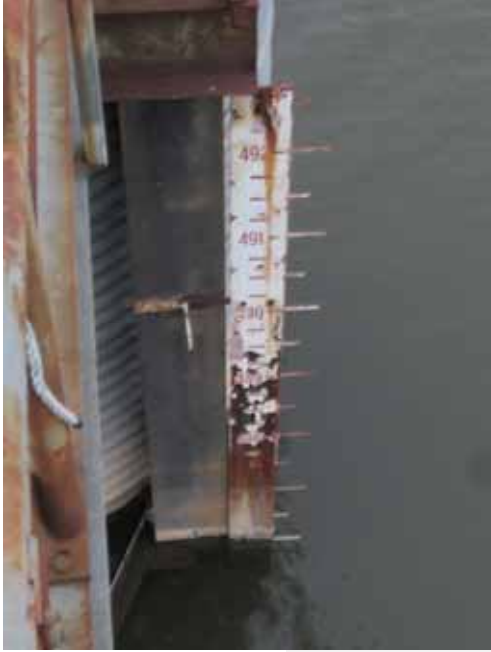
| <b>PHOTO NO.</b><br>B11 | <b>DATE:</b><br>Nov. 17, 2010 | | |

- The outlet structure appeared to be in good condition and functioning normally (Photo B14). A staff gage is housed on the outside of the galvanized CMP but the numbers near normal-pool level have corroded and are not legible (Photo B11). An accurate reading of the pool water surface elevation is presented on a meter (Photo B13) located inside the outlet valve and CO2 control building. CO2 is used to regulate the pH of the discharge, if it falls outside acceptable levels.

| <b>DESCRIPTION</b><br>Staff gage on outlet structure. | | | |

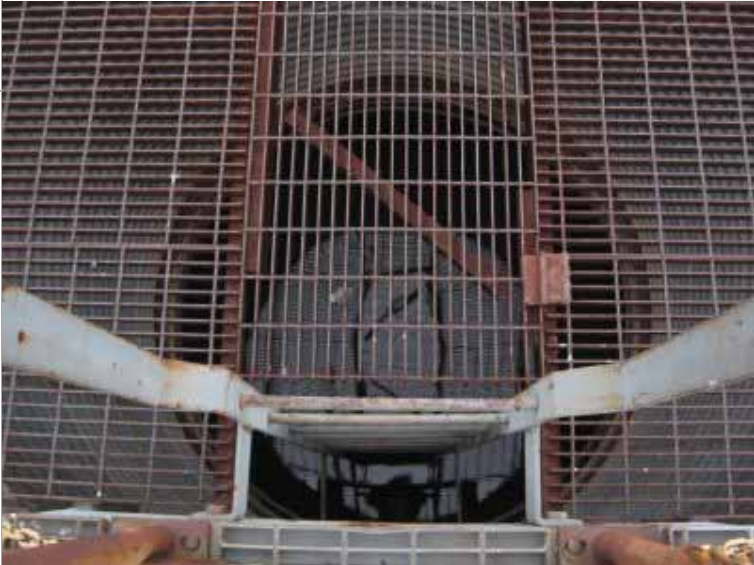
| <b>PHOTO NO.</b><br>B12 | <b>DATE:</b><br>Nov. 17, 2010 | | |

| <b>DESCRIPTION</b><br>Interior of galvanized 8-foot diameter CMP outlet works skimmer. | | | |

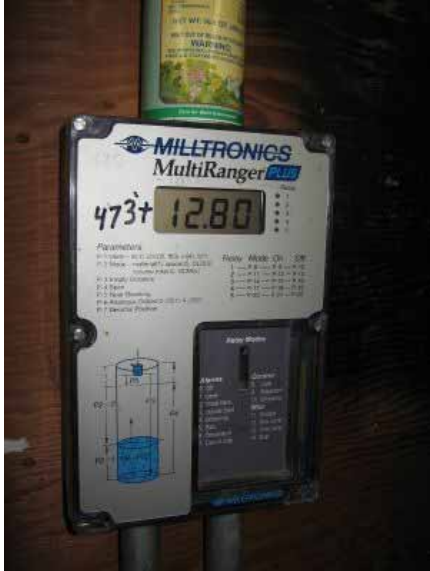
| <b>PHOTO NO.</b><br>B13 | <b>DATE:</b><br>Nov. 17, 2010 | | |

| <b>DESCRIPTION</b><br>Water level readout in valve and CO2 control building. | | | |

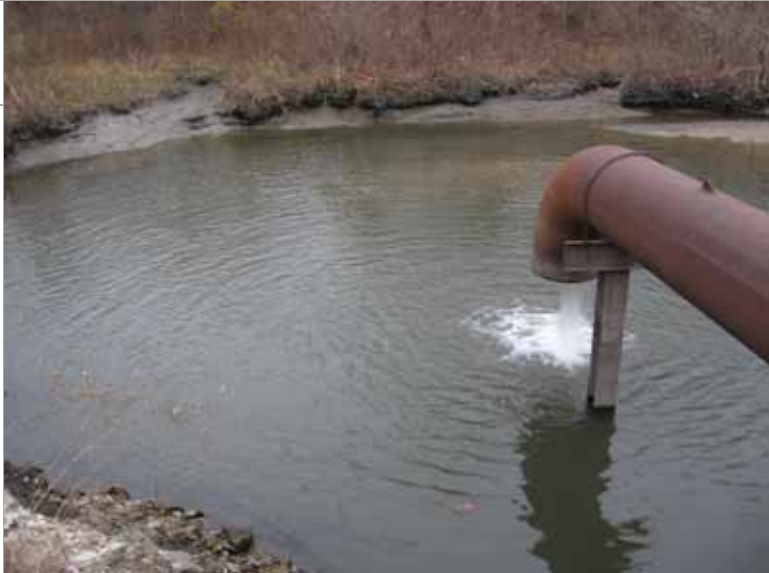
| <b>PHOTO NO.</b><br>B14 | <b>DATE:</b><br>Nov. 17, 2010 | | |

| <b>DESCRIPTION</b><br>Discharge from outlet structure. | | | |

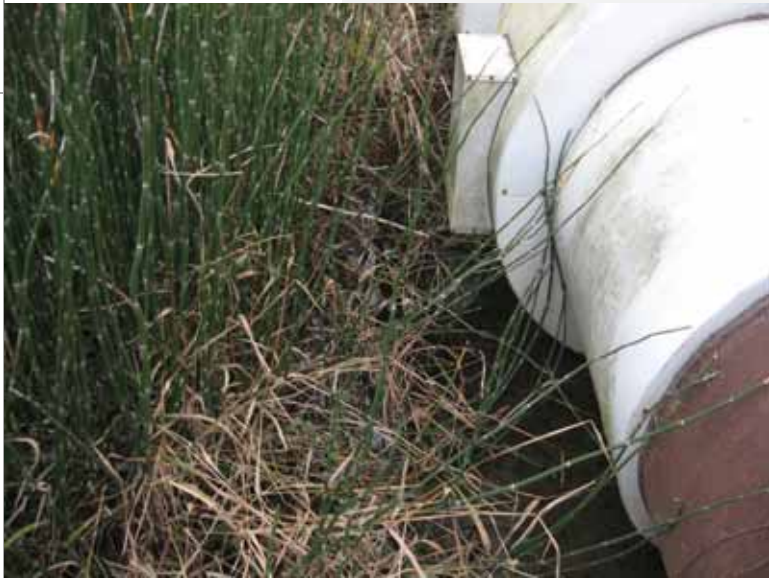
| <b>PHOTO NO.</b><br>B15 | <b>DATE:</b><br>Nov. 17, 2010 | | |

- A small amount of seepage (approx. 5 gpm) was observed around the outside of the outlet pipe (Photo B15).
- Discharge from the outlet structure pools at the toe of the western embankment before flowing north to the Missouri River.

| <b>DESCRIPTION</b><br>Seepage along outlet pipe. | | | |

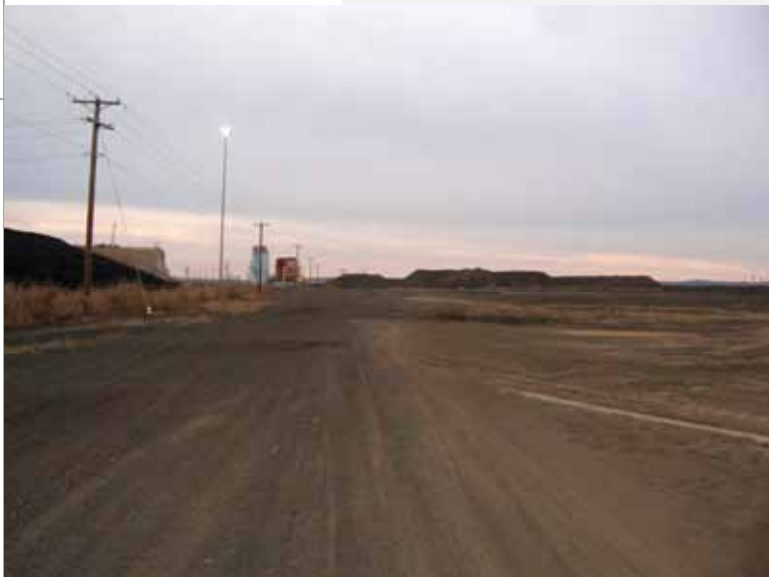
| <b>PHOTO NO.</b><br>B16 | <b>DATE:</b><br>Nov. 17, 2010 | | |

| <b>DESCRIPTION</b><br>Crest of northern embankment. Note width and dried CCW. | | | |

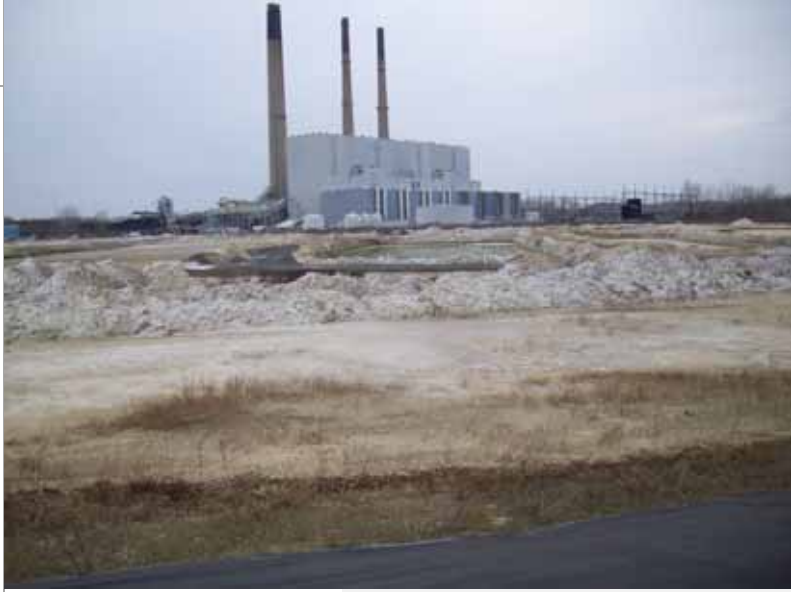
| <b>PHOTO NO.</b><br>C1 | <b>DATE:</b><br>Nov. 17, 2010 | | |

- The 60-mil HDPE liner installed on the inboard slope is exposed or covered with CCW (Photos C1 - C5). A small tree was observed growing near the inboard slope of the northern embankment (Photo C-3).

| <b>DESCRIPTION</b><br>Interior of Fly Ash Pond, looking north. Note dried CCW and exposed 60 mil HDPE liner | | | |

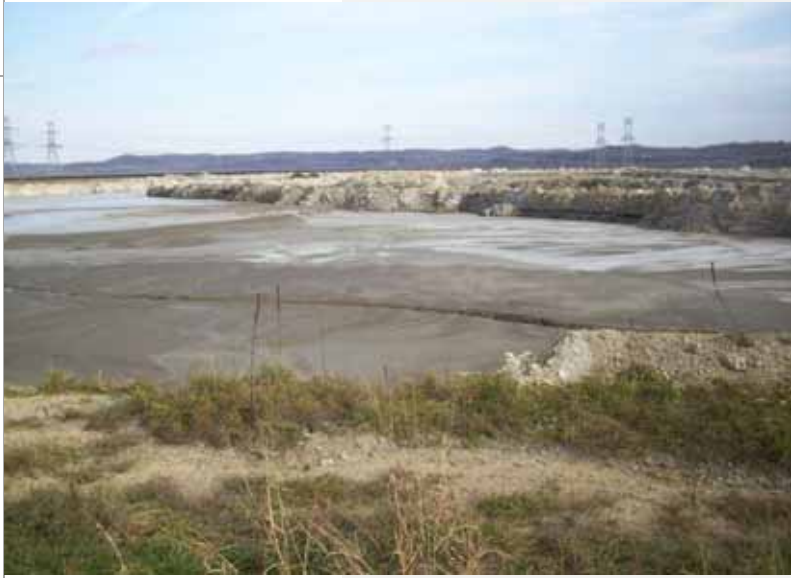
| <b>PHOTO NO.</b><br>C2 | <b>DATE:</b><br>Nov. 17, 2010 | | |

| <b>DESCRIPTION</b><br>Interior of Fly Ash Pond, looking south. Note dried CCW and excavated channel. | | | |

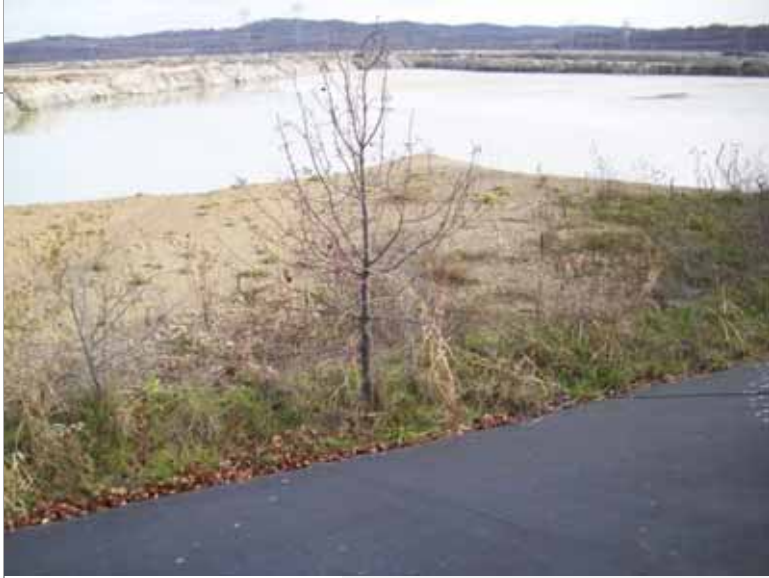
| <b>PHOTO NO.</b><br>C3 | <b>DATE:</b><br>Nov. 17, 2010 | | |

| <b>DESCRIPTION</b><br>Interior of Fly Ash Pond looking south. Note tree and exposed liner. | | | |

- Outboard slopes – repair animal burrows.
- Inboard slopes – remove the small tree growing along the northern portion of the embankment.
- Interior crest – repair erosion near discharge end of six-inch diameter PVC pipes.
- Additional studies – no additional studies may be needed. However, an explanation as to why the water level readings in Soundings P-3 and P-4 were not used in the analyses should be provided, and/or the slope stability analyses should be re-run using the data from Sounding P-4 (apparent worst-case scenario).

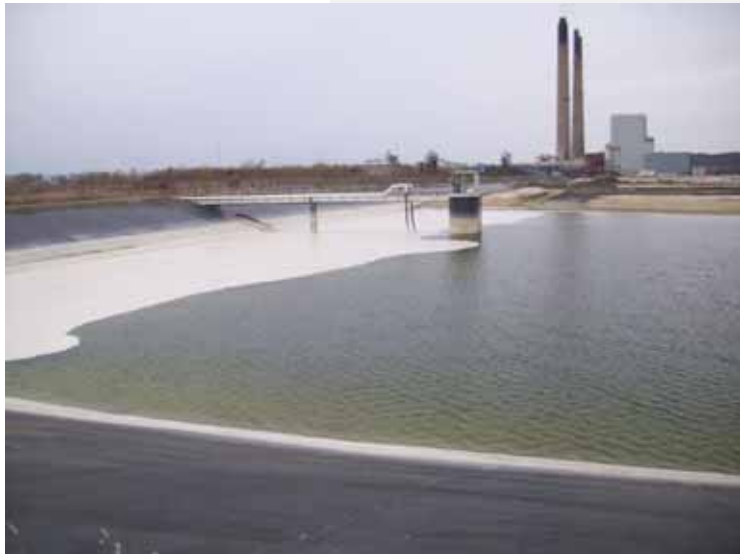
| <b>PHOTO NO.</b><br>C4 | <b>DATE:</b><br>Nov. 17, 2010 | | |

| <b>DESCRIPTION</b><br>Fly Ash Pond outlet structure. | | | |

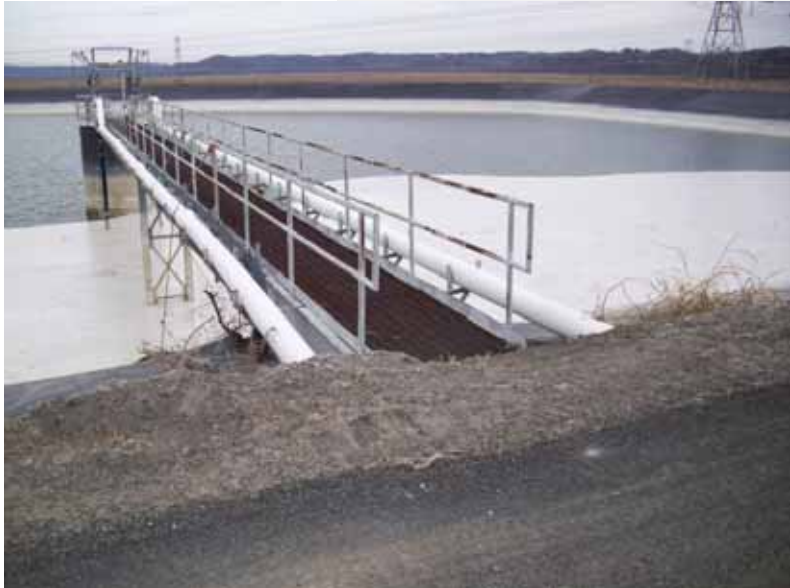
| <b>PHOTO NO.</b><br>C5 | <b>DATE:</b><br>Nov. 17, 2010 | | |

- The crest of the dividing dike between the Fly Ash and Bottom Ash Ponds has eroded at the discharge end of the PVC pipes (Photo C6).
- A crushed-stone access road was constructed over the length of the crest. The road appears to be in good condition with no rutting, erosion or standing water observed (Photo C5).

| <b>DESCRIPTION</b><br>Access bridge to Fly Ash Pond outlet structure. Note six-inch diameter PVC pipes along the bridge. | | | |

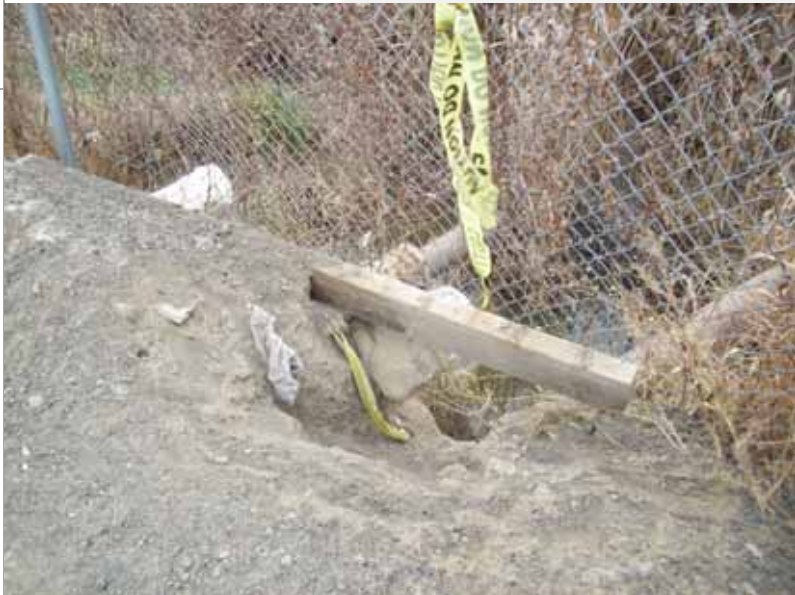
| <b>PHOTO NO.</b><br>C6 | <b>DATE:</b><br>Nov. 17, 2010 | | |

| <b>DESCRIPTION</b><br>Discharge end of PVC pipes from Fly Ash Pond into Bottom Ash Pond. Note erosion of dividing dike crest. | | | |

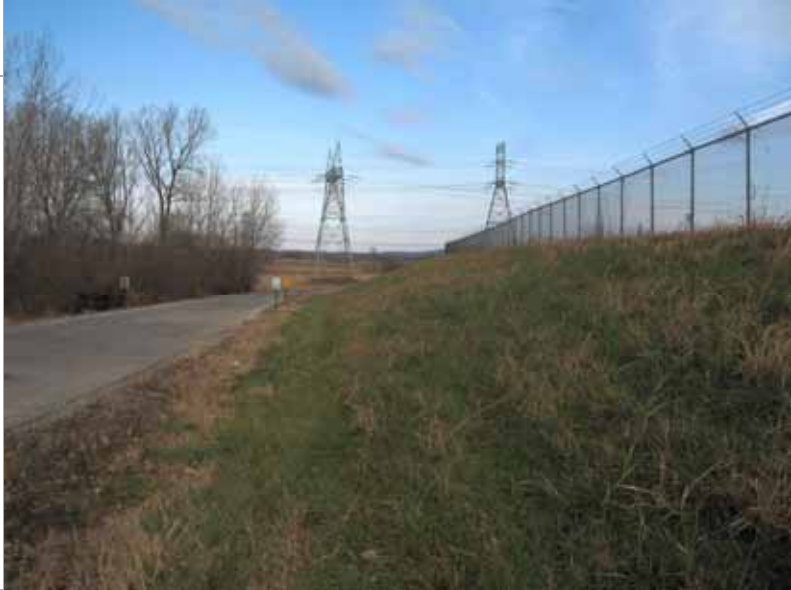
| <b>PHOTO NO.</b><br>C7 | <b>DATE:</b><br>Nov. 17, 2010 | | |

- The outboard slope is generally covered with well-maintained grass (Photos C7 - C9).
- A change in the slope of the outboard face was observed for approximately ¼-mile along the toe of the eastern embankment. The change in slope did not appear to be the result of a slough of the embankment. It is not known if this section of the embankment was constructed with a change from the design slope of 3H:1V.

| <b>DESCRIPTION</b><br>Northern embankment, looking east. | | | |

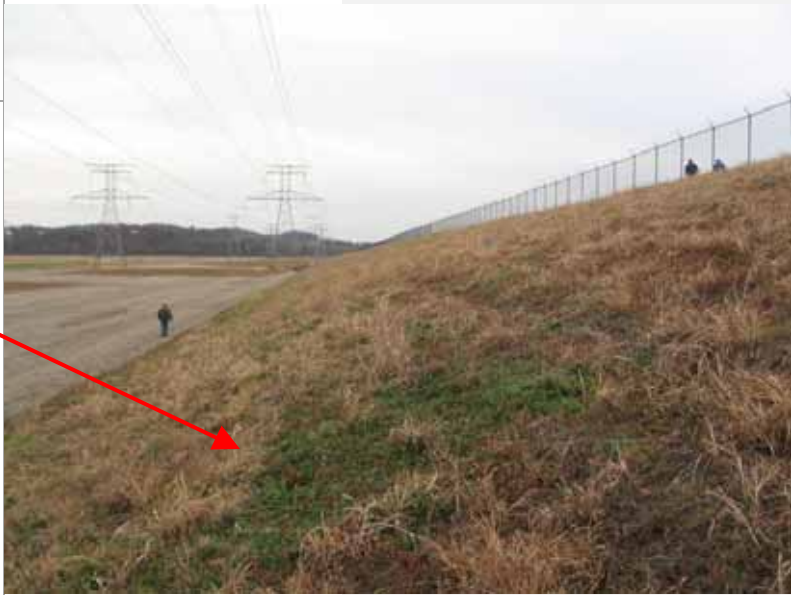
| <b>PHOTO NO.</b><br>C8 | <b>DATE:</b><br>Nov. 17, 2010 | | |

| <b>DESCRIPTION</b><br>Eastern embankment looking south. Note change in slope near the toe. | | | |

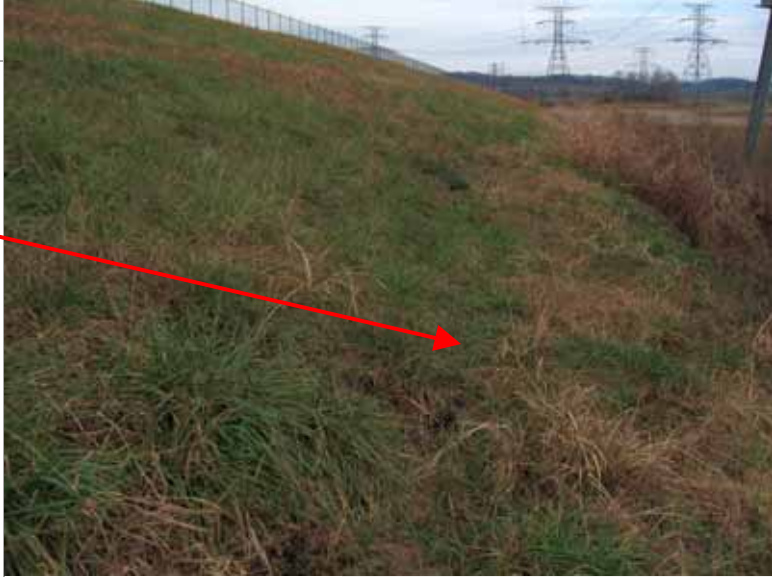
| <b>PHOTO NO.</b><br>C9 | <b>DATE:</b><br>Nov. 17, 2010 | | |

| <b>DESCRIPTION</b><br>Eastern embankment looking north. Note change in slope near the toe. | | | |

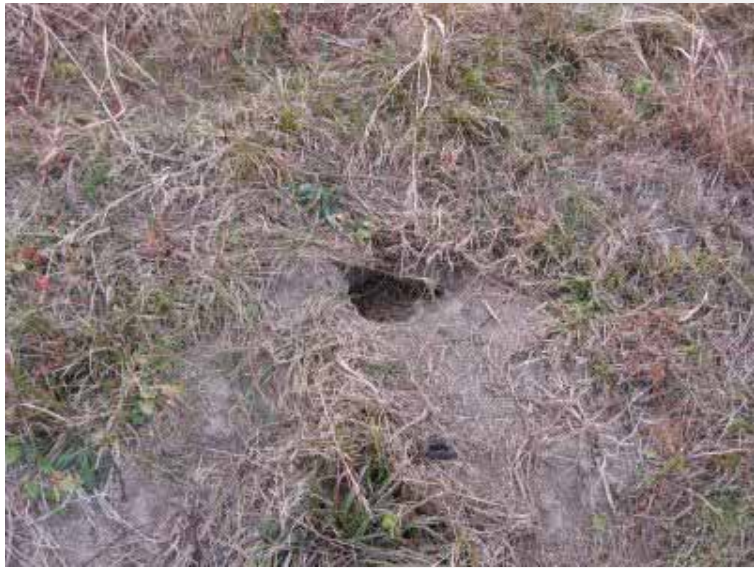
| <b>PHOTO NO.</b><br>C10 | <b>DATE:</b><br>Nov. 17, 2010 | | |

| <b>DESCRIPTION</b><br>Typical animal burrow. | | | |

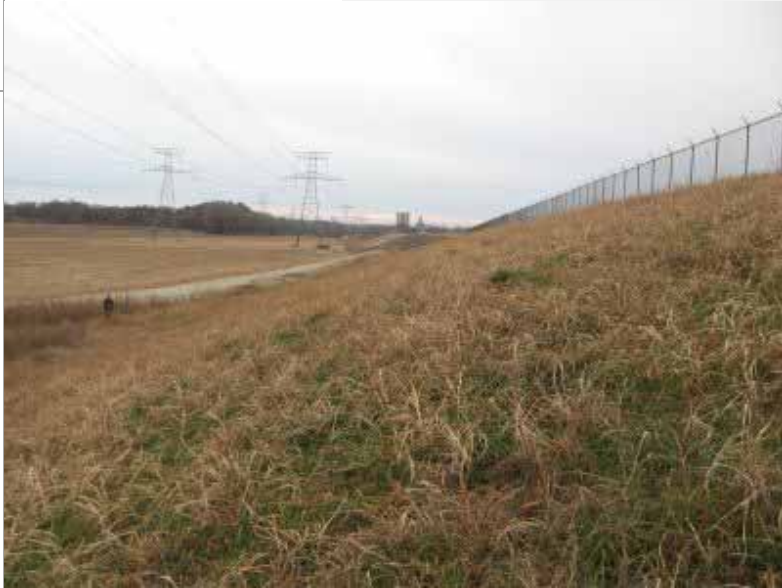
| <b>PHOTO NO.</b><br>C11 | <b>DATE:</b><br>Nov. 17, 2010 | | |

| <b>DESCRIPTION</b><br>Southern embankment looking west. | | | |

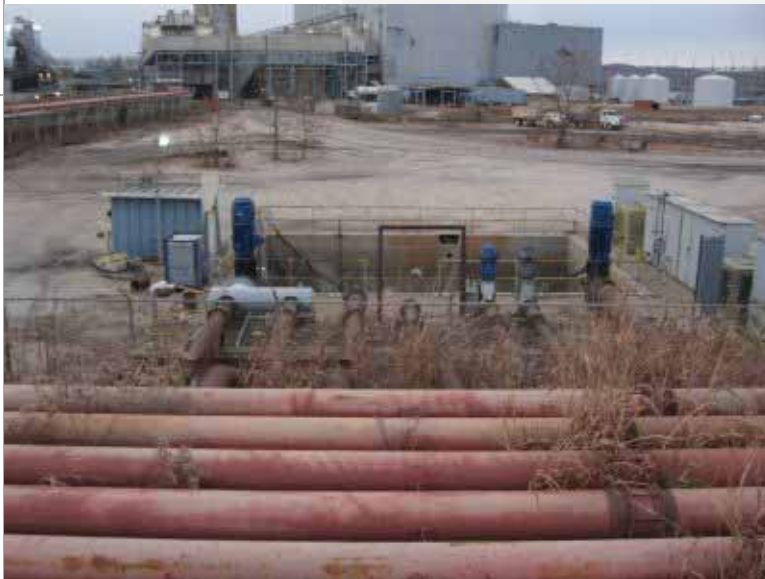
| <b>PHOTO NO.</b><br>C12 | <b>DATE:</b><br>Nov. 17, 2010 | | |

| <b>DESCRIPTION</b><br>Combined Drain Sump. | | | |
