Subject: EPA Comments on Ameren UE, Meramec Power Station, St. Louis, MO

Meramec Power Station

Round 7 - Dam Assessment Report

Ash Pond Dam Stability Analysis

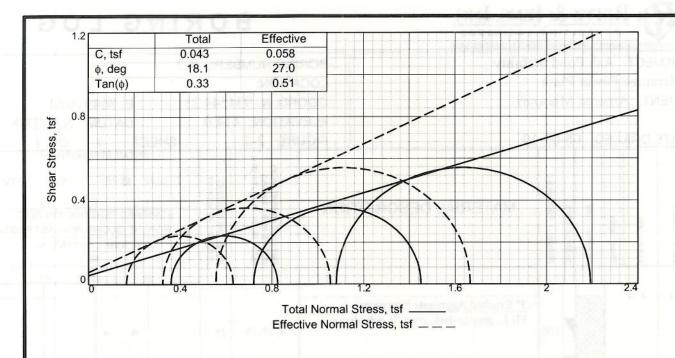
Figure 2-3

Type of Test:
CU with Pore Pressures
Sample Type: Shelby Tube

Description: Silty clay FILL (CL), grey and brownish grey, with pockets of very silty clay and high plastic clay, trace rock

Source of Sample: PZ-1 Depth: 19

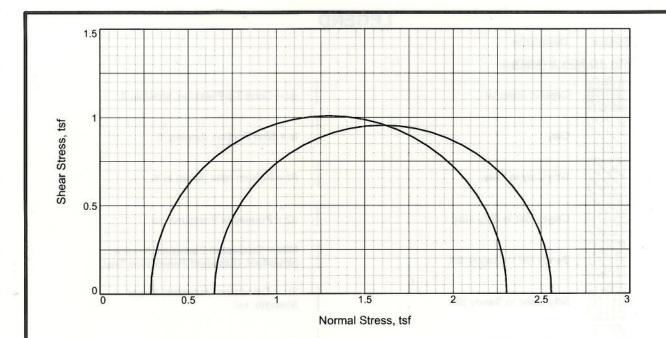
Figure 2-4

Unconsolidated Undrained **Sample Type:** Shelby Tube

Description: Clay Fill (CH), mottled gray and dark gray, with trace organics, high plasticity

Source of Sample: B-2

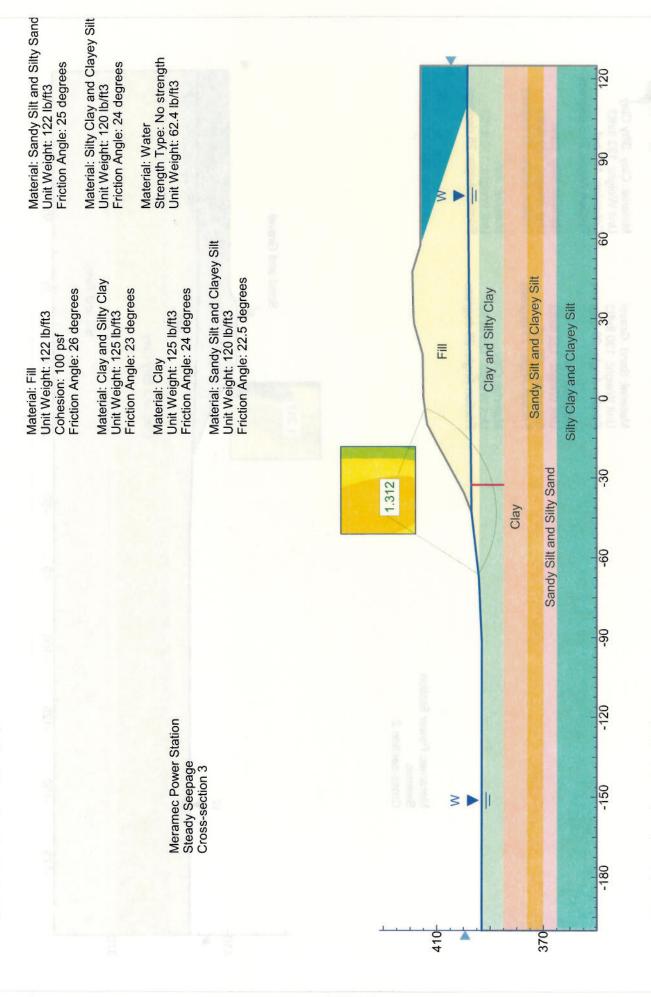
Figure B-6

Material: Fill

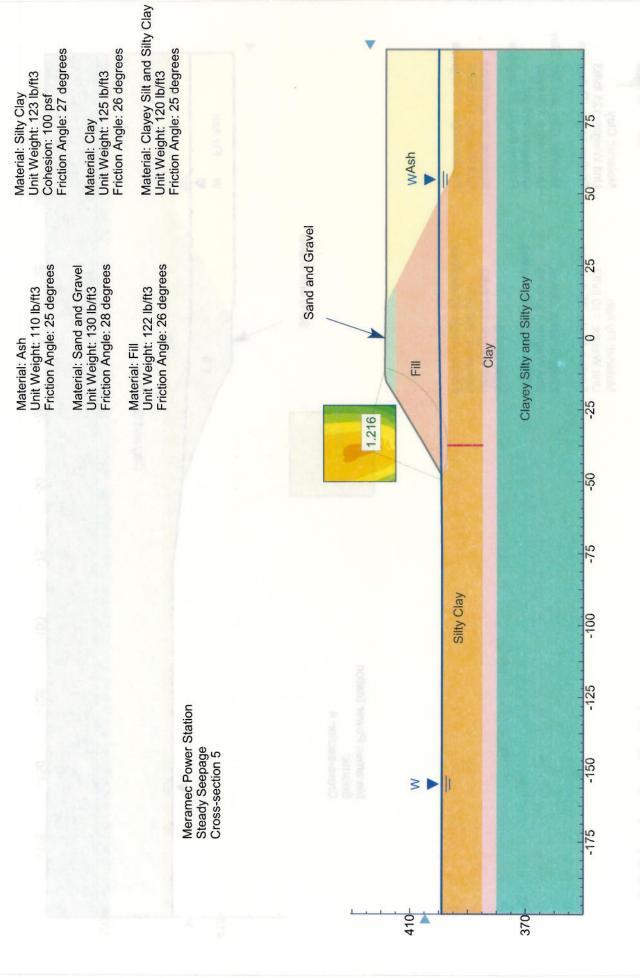
Unit Weight: 110 lb/ft3 Friction Angle: 25 degrees Material: Ash

Material: Sand and Gravel Unit Weight: 130 lb/ft3 Friction Angle: 28 degrees

Unit Weight: 122 lb/ft3 Friction Angle: 26 degrees Material: Fill

Meramec Power Station Seismic

Cross-section 5

Material: Silty Clay Unit Weight: 123 lb/ft3 Cohesion: 100 psf Friction Angle: 27 degrees

Material: Clay Unit Weight: 125 lb/ft3 Friction Angle: 26 degrees

Material: Clayey Silt and Silty Clay Unit Weight: 120 lb/ft3 Friction Angle: 25 degrees
