**Coal Combustion Waste Impoundment  
Round 7 - Dam Assessment Report**

*Meramec Power Station*

*Ameren Missouri*  
**St. Louis, Missouri**

**June 2011**

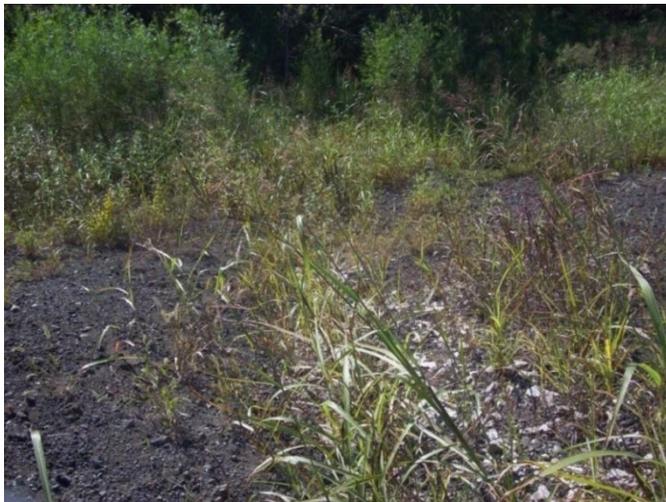
No evidence of major repairs to the embankments or prior releases was observed during the field assessment. Evidence of slope repair due to erosion on the outside slope of the perimeter levee was observed. Maintenance and methods of operation are adequate.

5. Repaired erosion area along levee embankment at Pond 8.

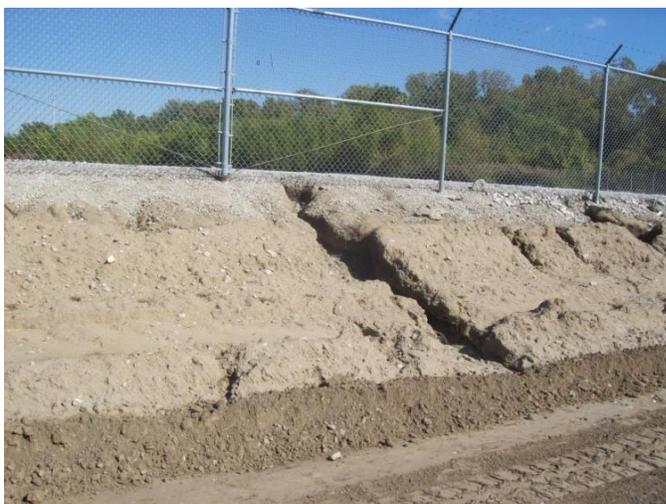
6. Looking at runoff erosion along top of levee embankment from runoff at Pond 2.

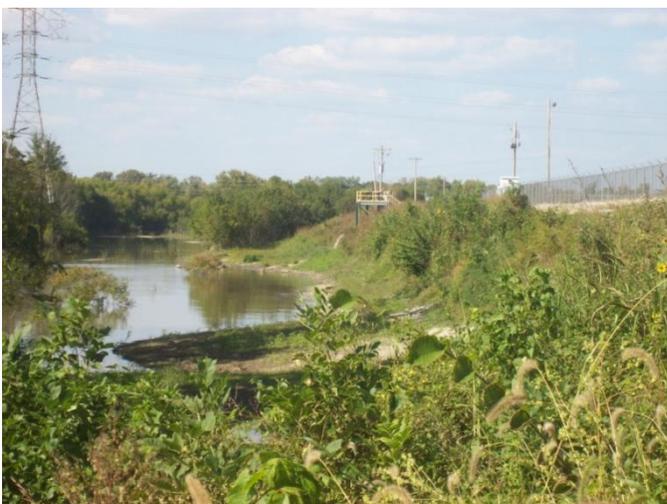
9. Looking northwest at outside slope of Pond 2 levee embankment. Note – High water was observed in the Meramec River during site visit. Perimeter access road was submerged.

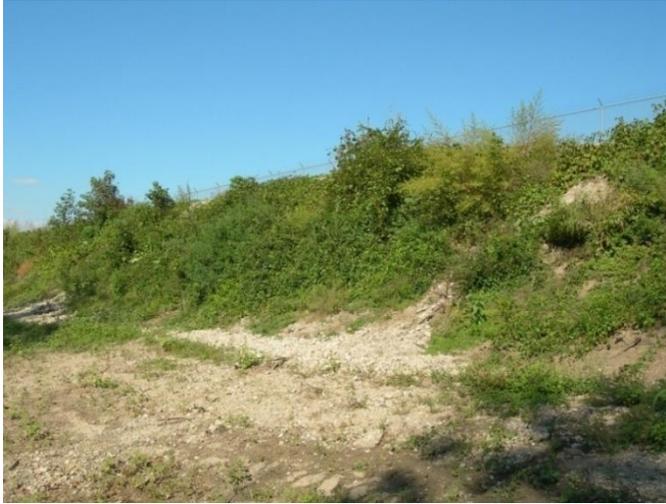
10. Outside slope of levee embankment at Pond 2. An unknown pipe was observed at the location, see Photo 14.

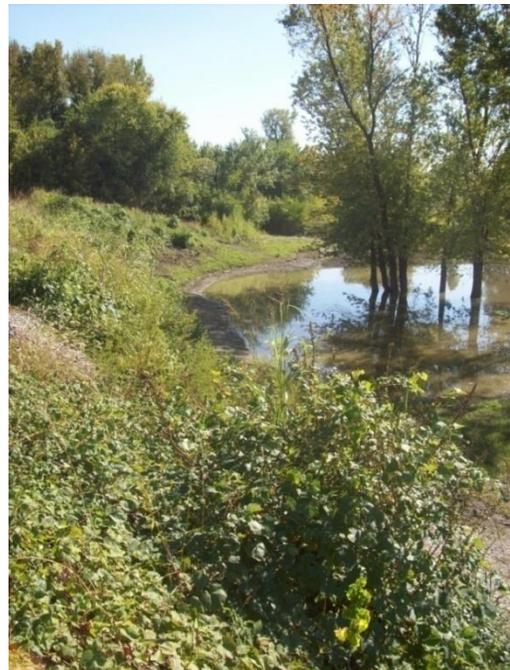
11. Looking southeast along outside slope of levee embankment of Pond 2. Note - High water was observed in the Meramec River during site visit.

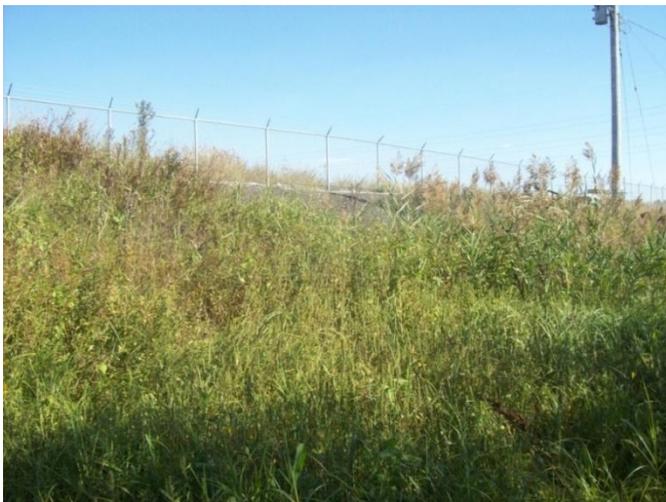
12. Looking at outside slope of levee embankment at Pond 8. Note - Repaired erosion area at edge of crest.

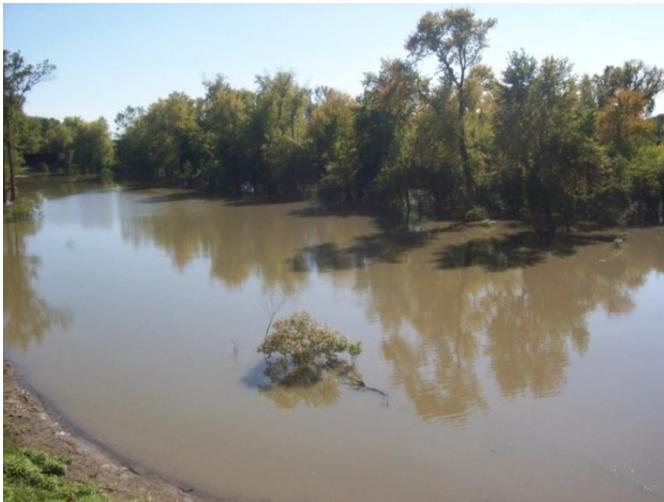
17. Looking southeast at tree line adjacent to submerged perimeter access road.

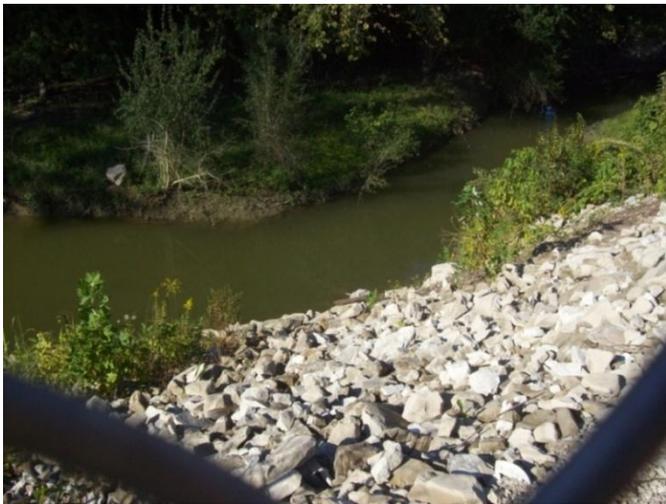
26. Evidence of repair to outside slope of levee embankment due to erosion.

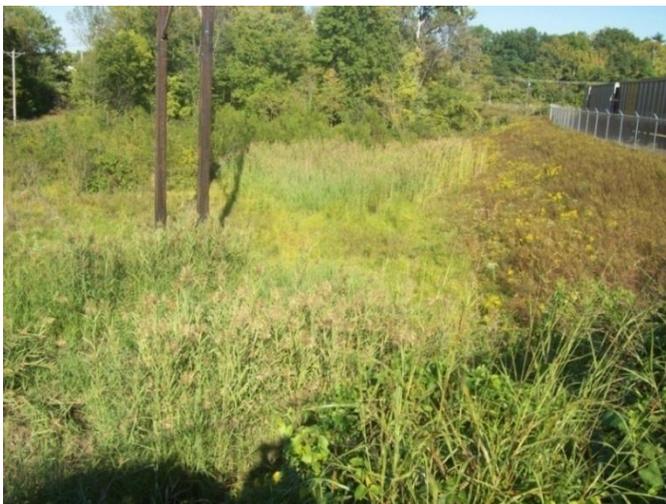
It is recommended to continue to monitor the seepage area observed at the outside toe of Pond 4 for changed conditions.

27. Looking towards Pond 4 (Bottom Ash Pond) at outside toe and slope of levee embankment. Note - Cat tails.
