**COAL ASH IMPOUNDMENT
SITE ASSESSMENT FINAL REPORT**

**Meredosia Power Station
Ameren Energy Generating Company
Meredosia, Illinois**

KLEINFELDER PROJECT NUMBER 112618-7

May 10, 2011

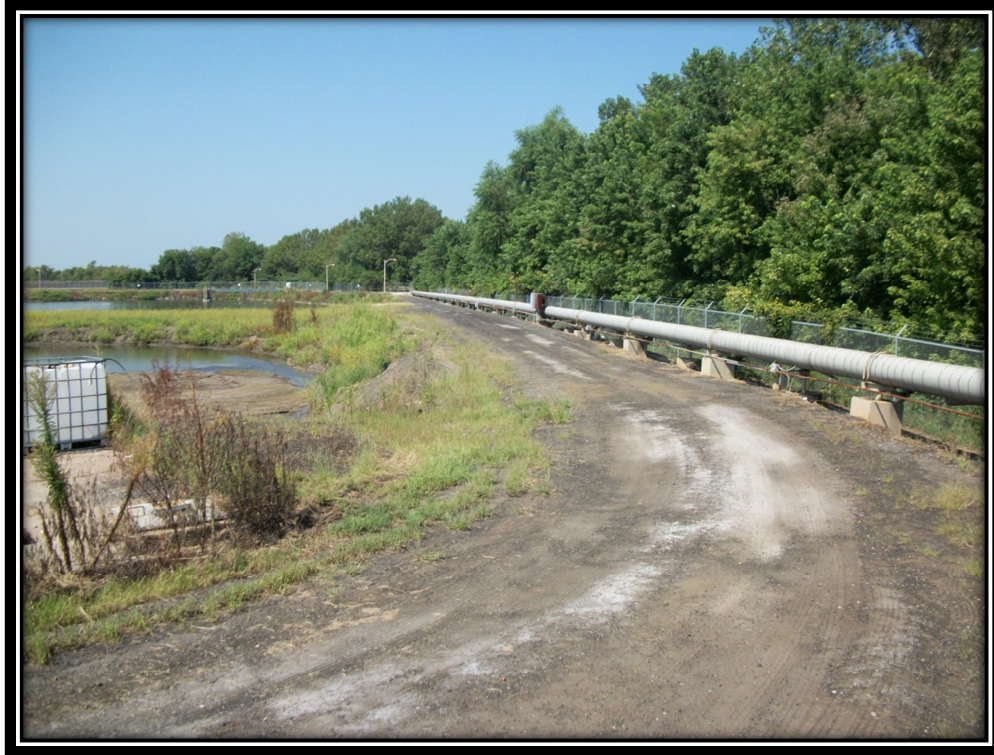
Overall, the crest of the impoundment was in satisfactory condition. Photos 1 through 3 show the condition of the crest. Specific observations include:

- The impoundment crest is a gravel road.
- Sparse grasses and bushes were observed on the crest.
- No major depressions or rutting was noted on the impoundment crest.
- Transecting the crest with minimal cover are two Fly Ash sluice lines. Photo 24 in Appendix B shows these sluice lines.
- A chain link fence is located around the majority of the Bottom Ash Pond at the crest.
- Multiple light poles penetrate the crest of the levee. These light poles can be seen in Appendix B photos 23 and 28.
- Minor erosion was noted on crest in multiple locations. This erosion was typically less than six inches in depth and typically appeared on the edges of the crest where grade breaks occurred when transitioning to embankment slopes.

- Foundations for the pipeline that runs along the crest of northern embankment penetrate the crest in multiple locations.

Photo 1 – Bottom Ash Pond Embankment Looking Southwest (Note Pipeline, Foundations and Fence)

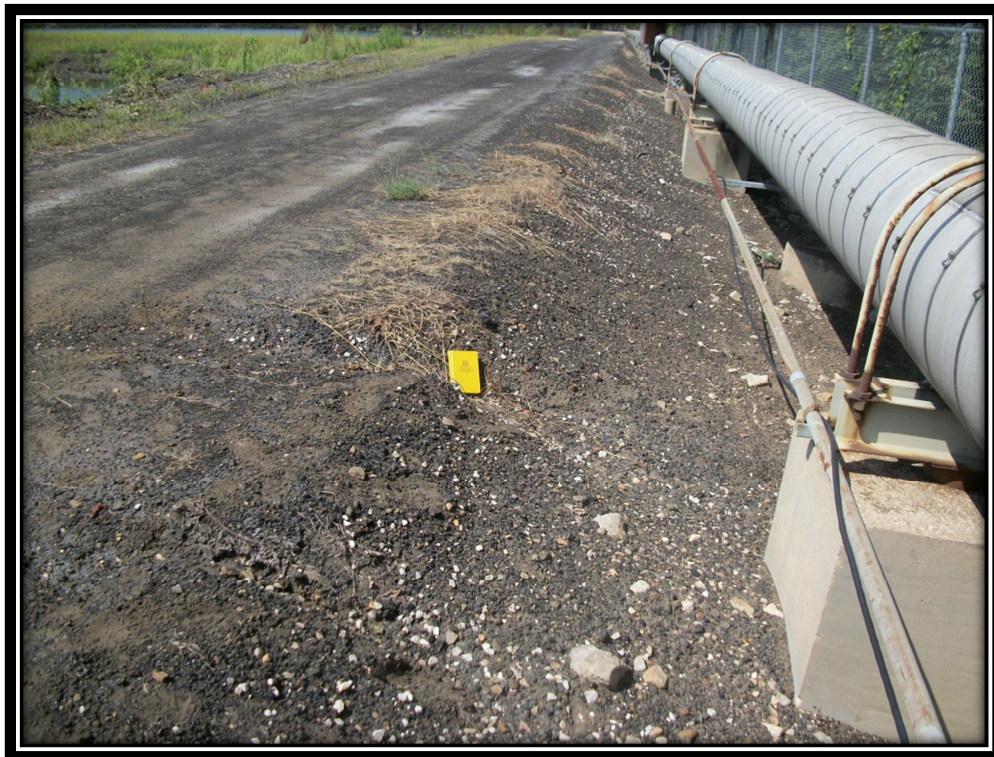
Photo 2 – Minor Surface Erosion of Bottom Ash Pond Crest (Note Typical Crest Condition and Pipeline)

1. **Repair erosion of embankment.** Minor surface erosion was noted at both the Bottom Ash Pond and Fly Ash Pond. Areas where erosion has occurred should be filled in and re-dressed with appropriate fill in order to prevent erosion from cutting further into the embankments.

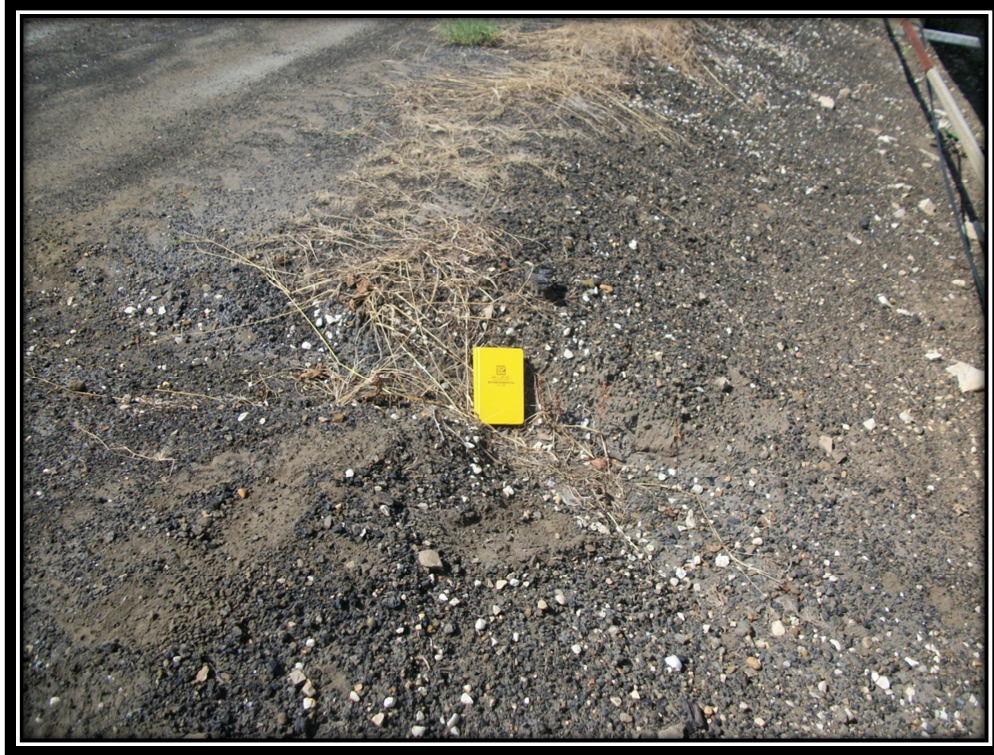
Photo 3 – Minor Surface Erosion of Crest and Downstream Slope of the Bottom Ash Pond (Typical)

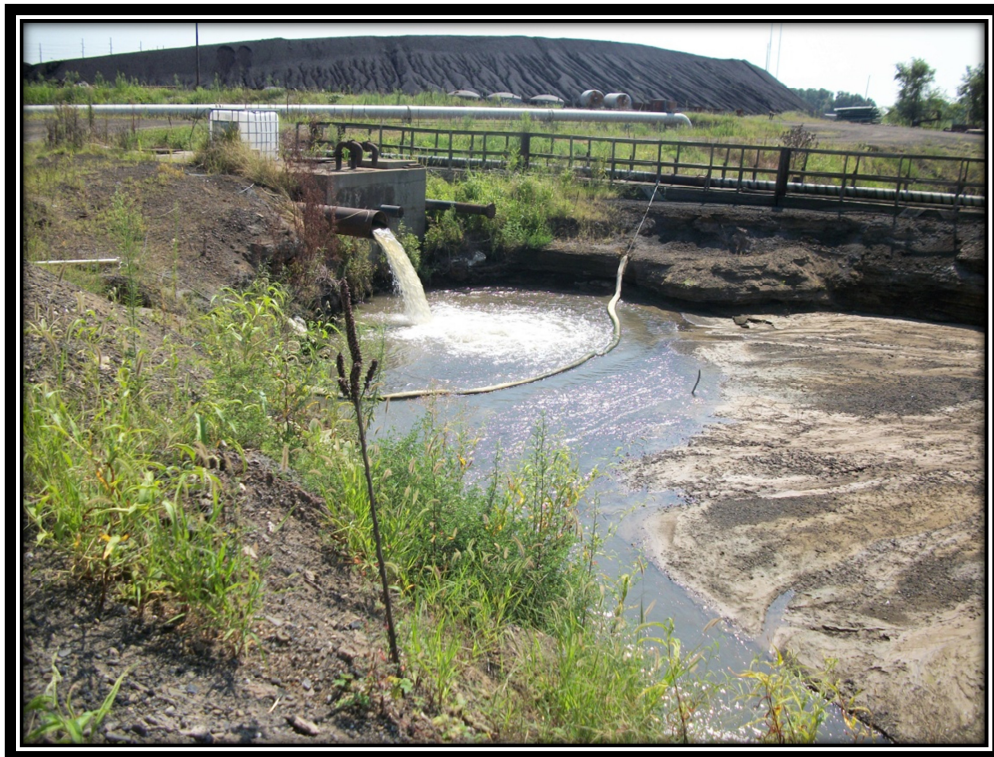
Inflow into the Bottom Ash Pond is via metal piping on the northeastern corner of the impoundment, as well as storm water runoff that flows naturally into the pond. The inlet pipe can be seen in photo 4 of Appendix B. From this inlet location the ash and water slurry then flows through an interior settling channel and into the larger storage pool of the impoundment. The inlet pipe appears to be in satisfactory condition.

Photo 4 – Bottom Ash Pond Inlet Piping (Note Coal Stockpile in Background)

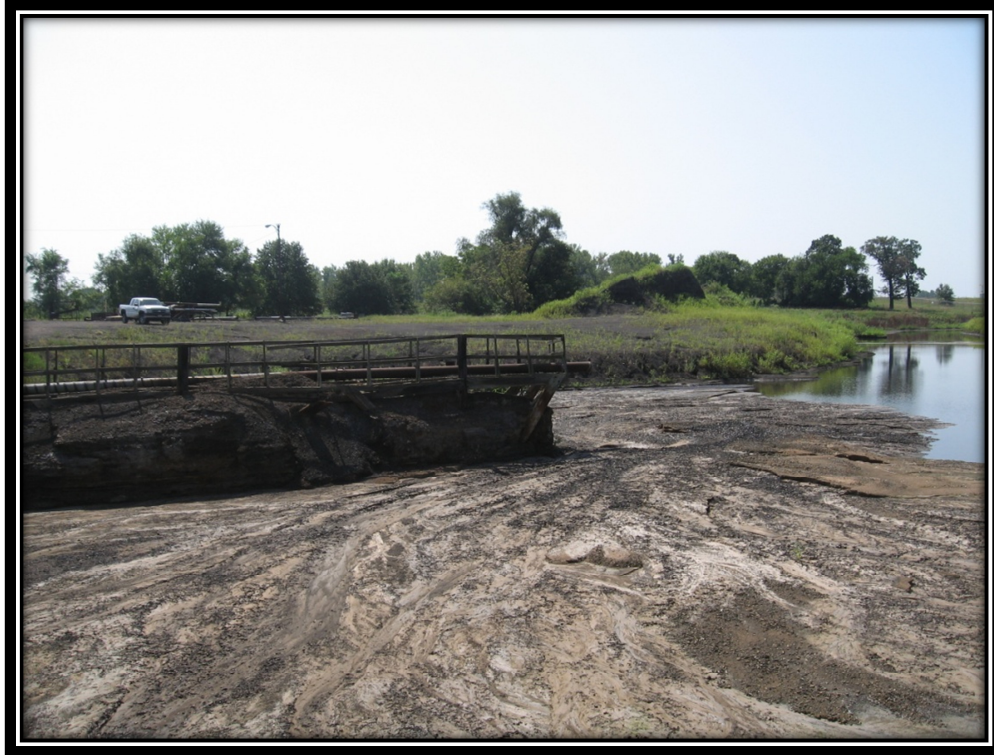
The bottom ash pond inlet pipe appears to be supported on wood supports. The supports appeared to be weathered, although not to the point of structural failure. Due to the age of the facility, a structural engineering evaluation is merited to determine the condition of the supports.

Photo 5 – Bottom Ash Pond Inlet Piping

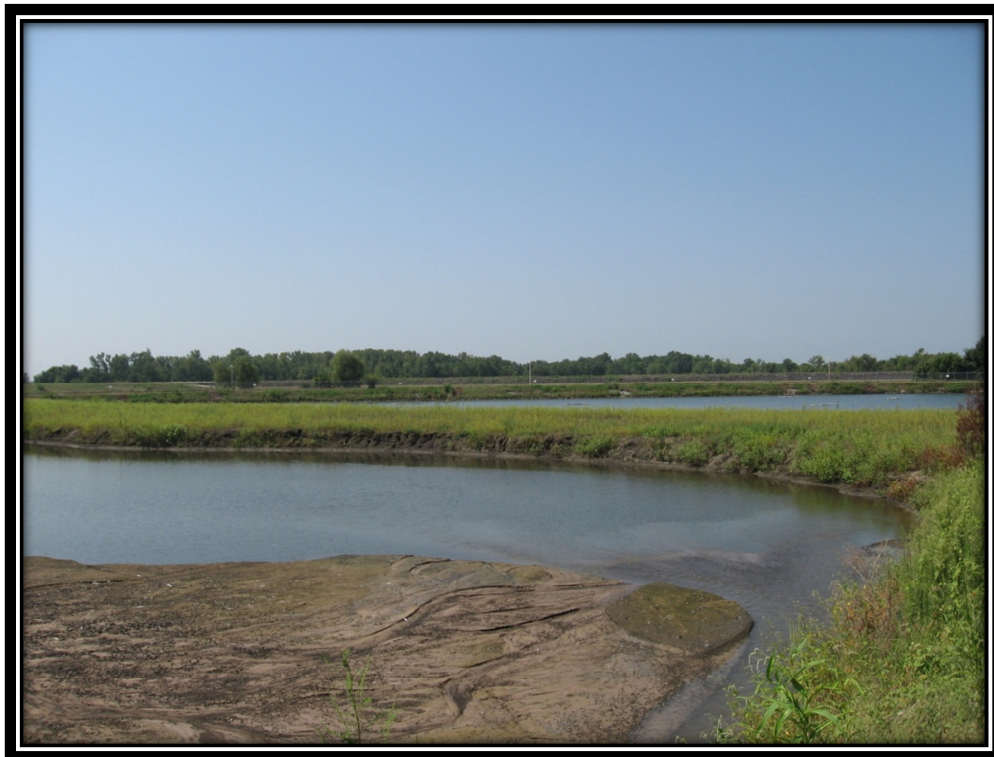
Overall, the upstream slope of the impoundment was in fair condition. Photos 1, 6 and 23 in Appendix B show the conditions of the upstream slope. Specific observations include:

- The upstream slope was laid back at approximately 1.5H:1V, based on visual observations. This varies from the construction documents provided by Ameren, probably due to the build-up of bottom ash on the embankment. However, it is possible that cleanout operation at the Bottom Ash Pond could have cut into the embankment and steepened it over time.
- Minor erosion rills, less than 6 inches deep, were noted on some of the upstream slopes.
- Grasses and woody bushes were observed on the upstream slope for the majority of the impoundment.
- Mowing/Vegetation control had not been completed on the majority of the upstream slope.

Photo 6 – Settling Channel of Bottom Ash Pond near Inlet

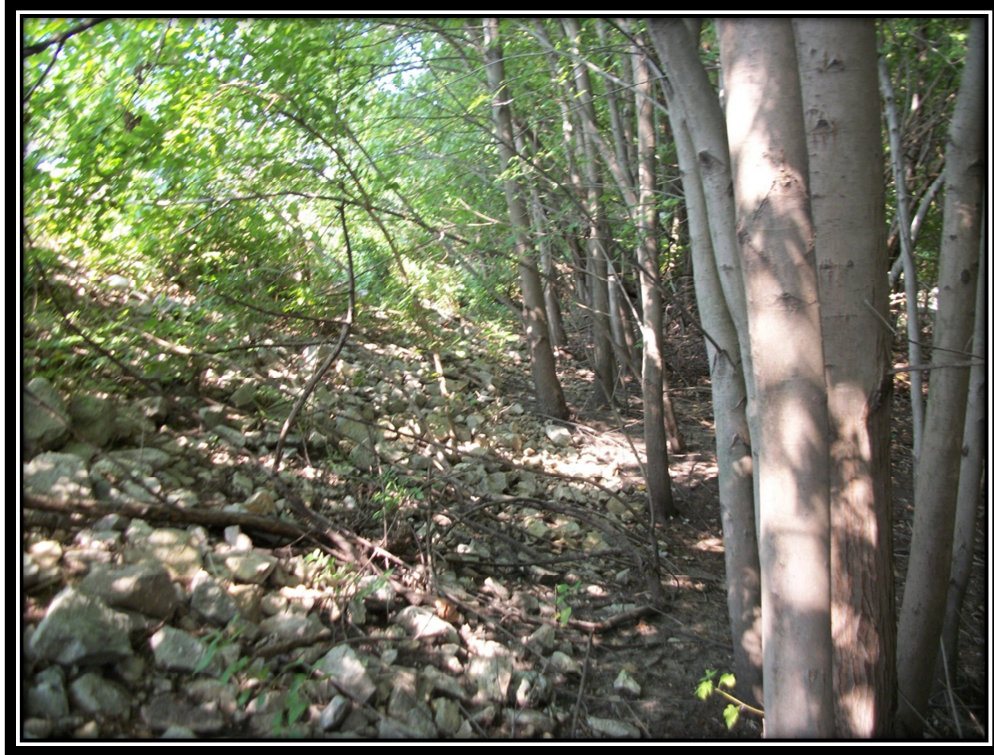
Overall, the downstream slope was in fair to poor condition. Photos 7, 8, 9, 18 and 20 show the conditions of the downstream slope. Specific observations include:

- There was slope protection on the downstream slope adjacent to the Illinois River. It was comprised of riprap that ranged greatly in size. Riprap armoring was sparse in some areas of the downstream slope.
- Minor erosion rills, less than 6 inches deep, were noted on some of the downstream slope.
- Grasses, woody bushes and large mature trees were observed on the downstream slope and at the toe of the embankment for the majority of the impoundment.
- Driven sheet pile used to form an access to the oil delivery area intersects the downstream slope of the Bottom Ash Pond as shown in Photos 12 and 13.

Photo 7 – Riprap and Mature Trees on the Downstream Slope of the Bottom Ash Pond (Typical)

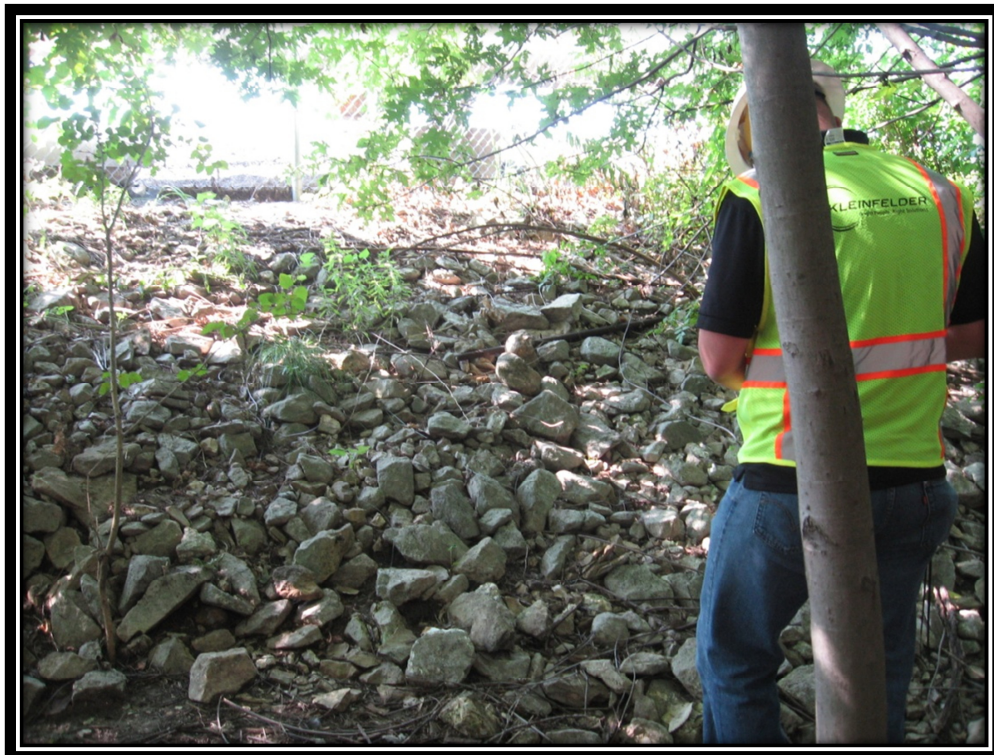
Photo 8 – Riprap on Downstream Slope of Bottom Ash Pond (Typical)

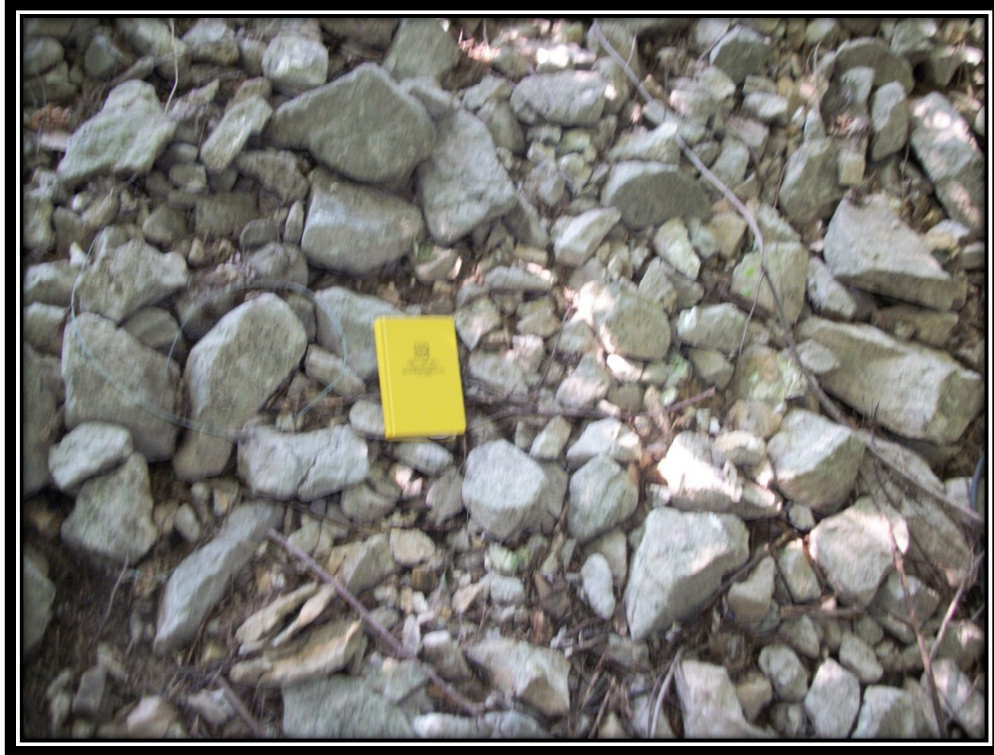
Photo 9 – Undersized Riprap on Downstream Embankment of the Bottom Ash Pond

1. Repair erosion of embankment.
2. Review the condition of riprap at the downstream toe of the bottom ash embankment and upgrade the riprap, if needed, to meet typical requirements for riprap size and placement.
3. Maintain a log of maintenance and other activities at the fly ash impoundments and supporting facilities.
4. Develop an Operation and Maintenance (O&M) manual for the impoundments and the facility.

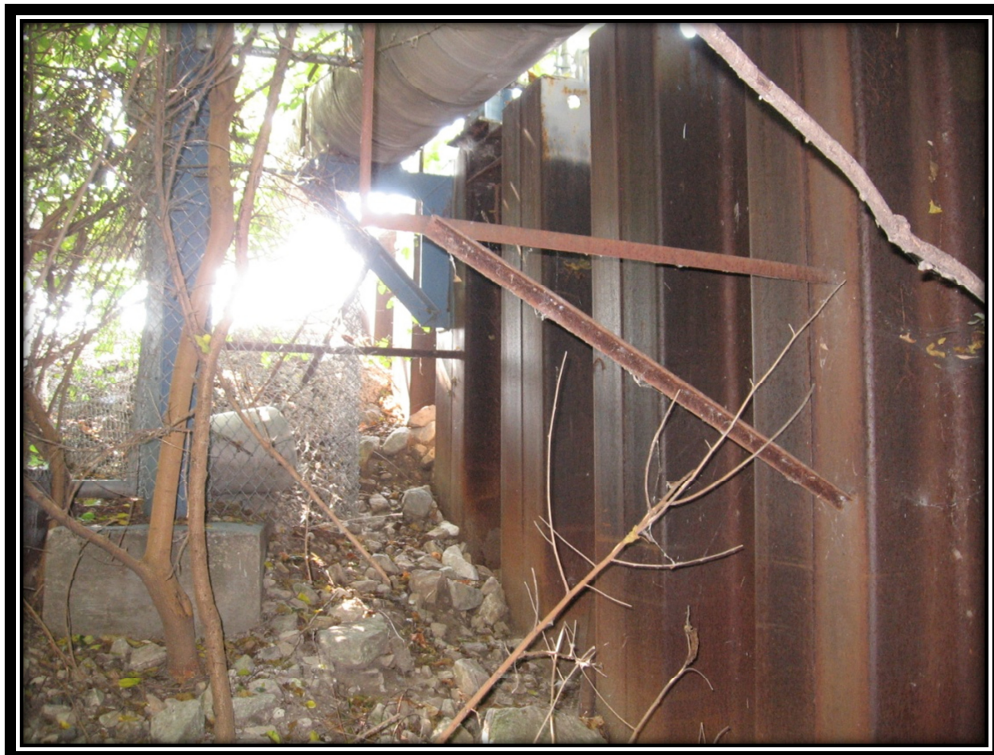
Photo 12 – North Side of the Oil Delivery Sheet Pile Platform (Note Penetration into Embankment)

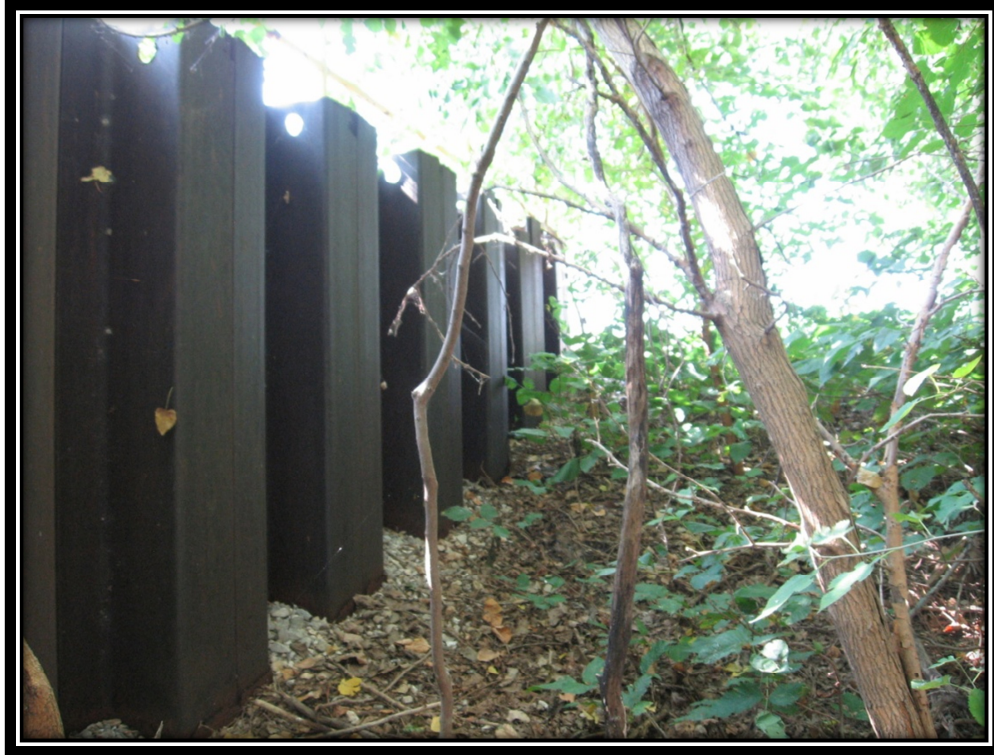
Photo 13 – South Side of the Oil Delivery Sheet Pile Platform (Note Penetration into Embankment)

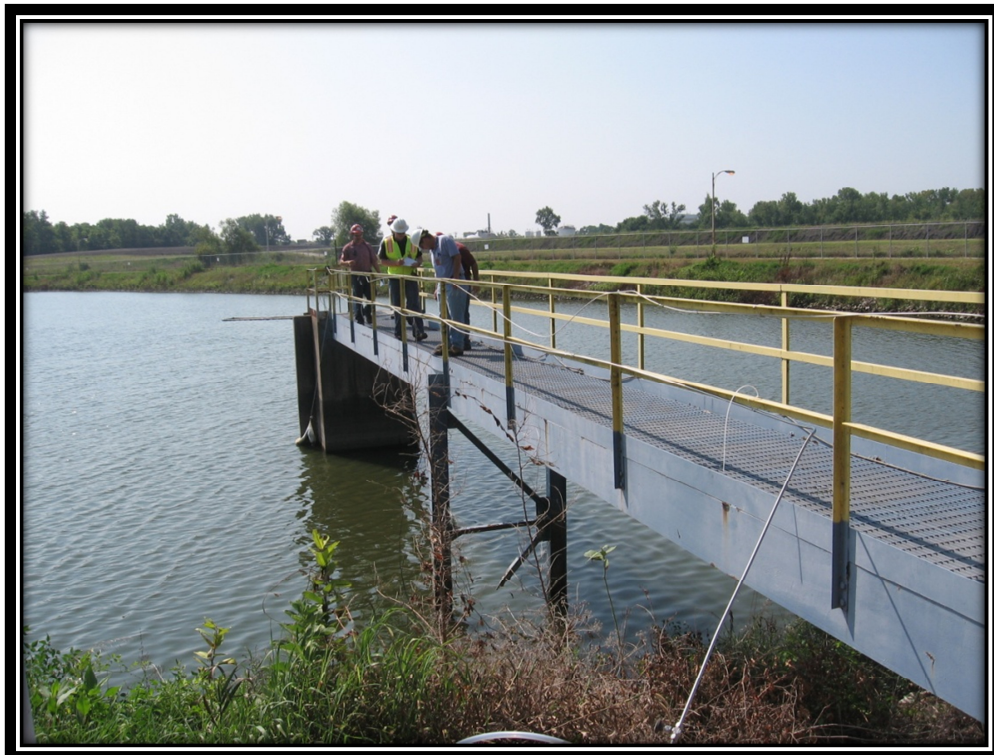
According to the inspection conducted in July, 2009, a fractured cross brace was noted in the middle support of the catwalk at the bottom ash pond. The assessment conducted in 2010 by Kleinfelder shows that the same fractured cross member is not repaired (see Photo 14 in Appendix B). The catwalk bridge access portion appears to be in satisfactory condition and the superstructure appears to be intact with minor corrosion. The catwalk substructure concrete foundations appear to be in satisfactory condition as well with little to no concrete spalling or scaling.

- One cross brace of the catwalk used to access the weir box has rusted through.
- No video monitoring of the clay pipe was available at the time of assessment
- Overall, the outlet works system appears to be functioning as intended at this time.

Photo 14 – Outlet Works for the Bottom Ash Pond (Note Broken Support of Walkway)

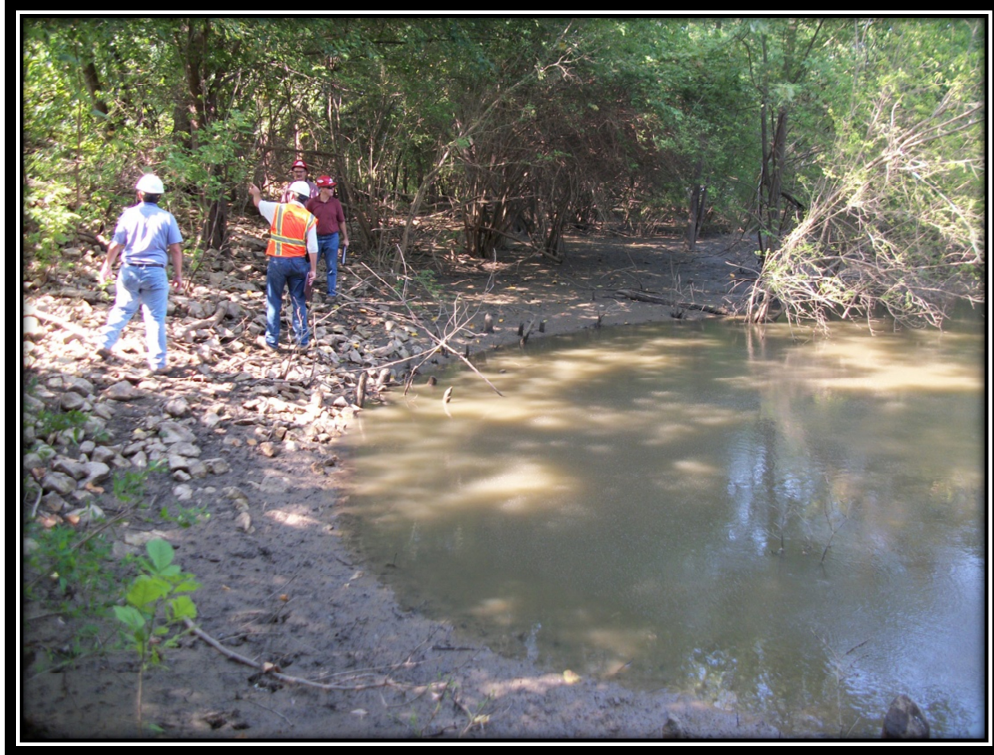
The toe areas of the embankment were in fair to poor condition. See photos 15 and 17 for the condition of these areas. Key features and observations of these areas include:

- The discharge location of the outlet pipe was not able to be observed as it was inundated at the time of assessment

Photo 15 – Bottom Ash Pond Outlet Piping Outfall (Submerged)

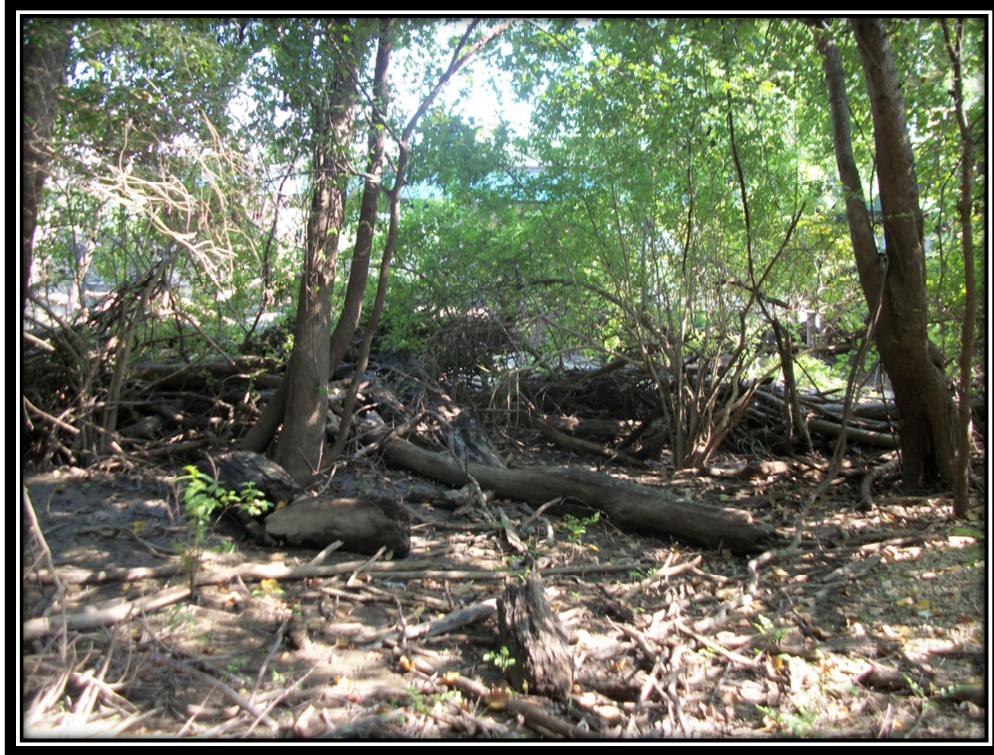
Photo 17 – Debris Pile and Heavy Vegetation at the Downstream Toe of the Bottom Ash Pond (Typical)

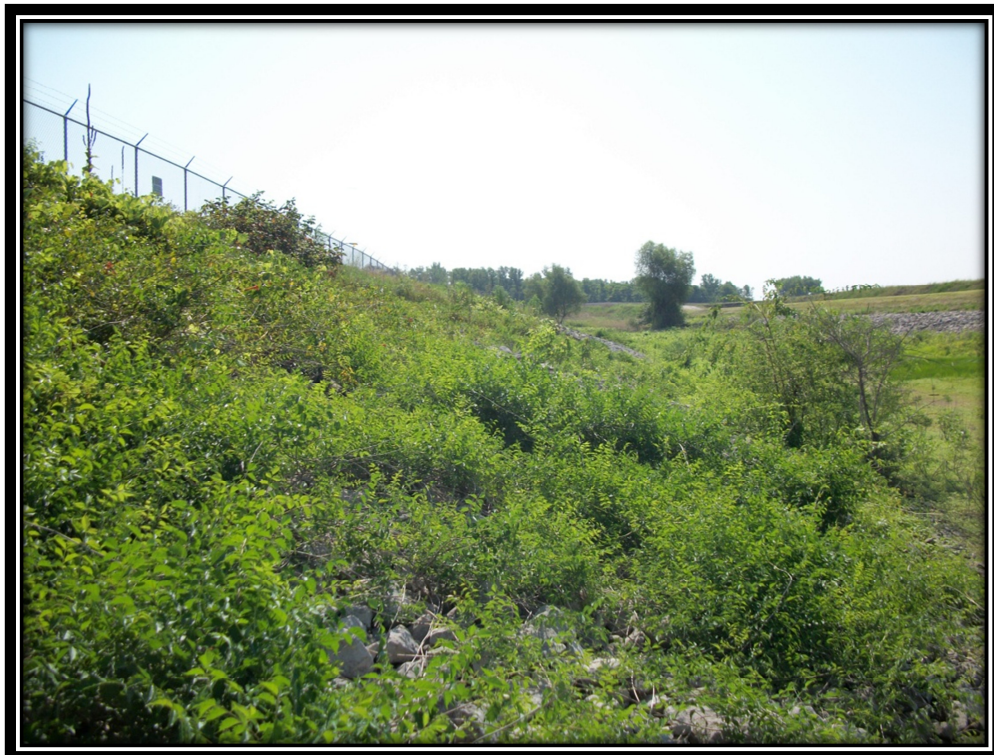
Photo 18 – Vegetated Riprap on the Bottom Ash Pond Southwest Embankment

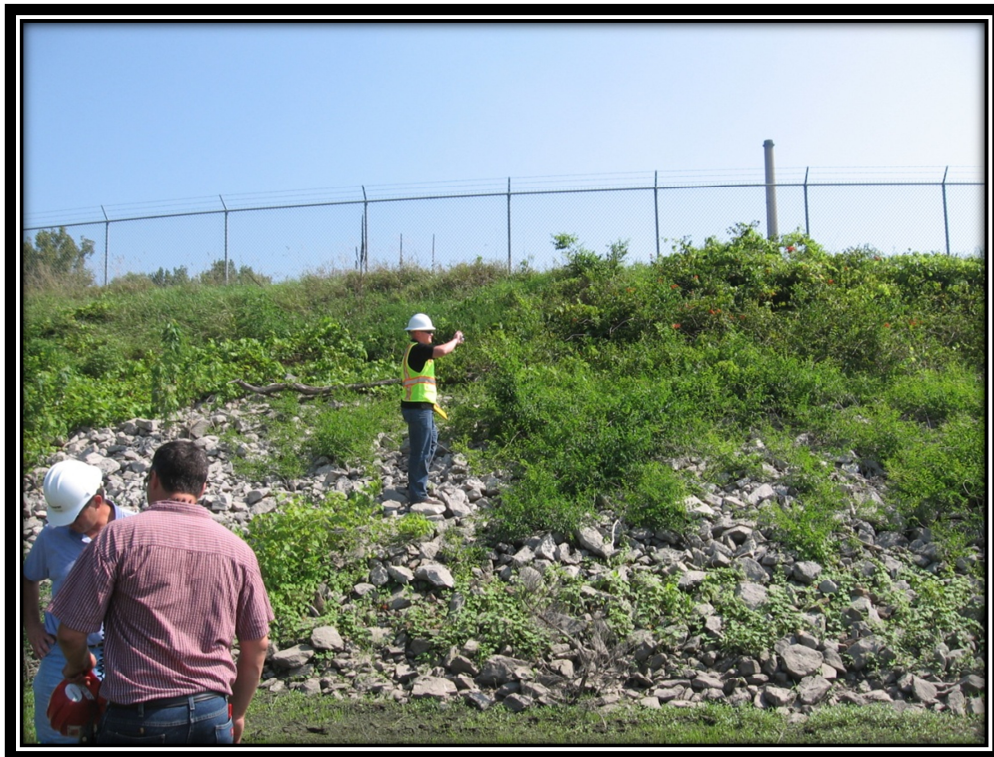
Photo 20 – Riprap on Downstream Slope of Bottom Ash Pond (Note Fence at Crest)

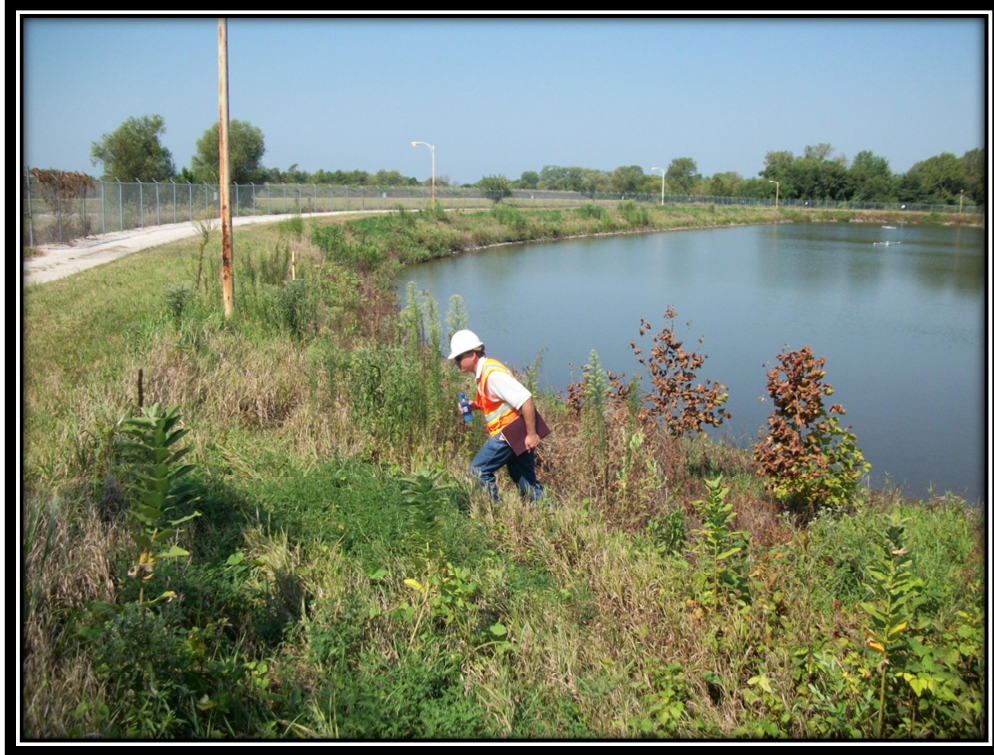
Photo 23 – Upstream Slope of the Bottom Ash Pond (Note Steep Slopes and Light Pole Penetrations)

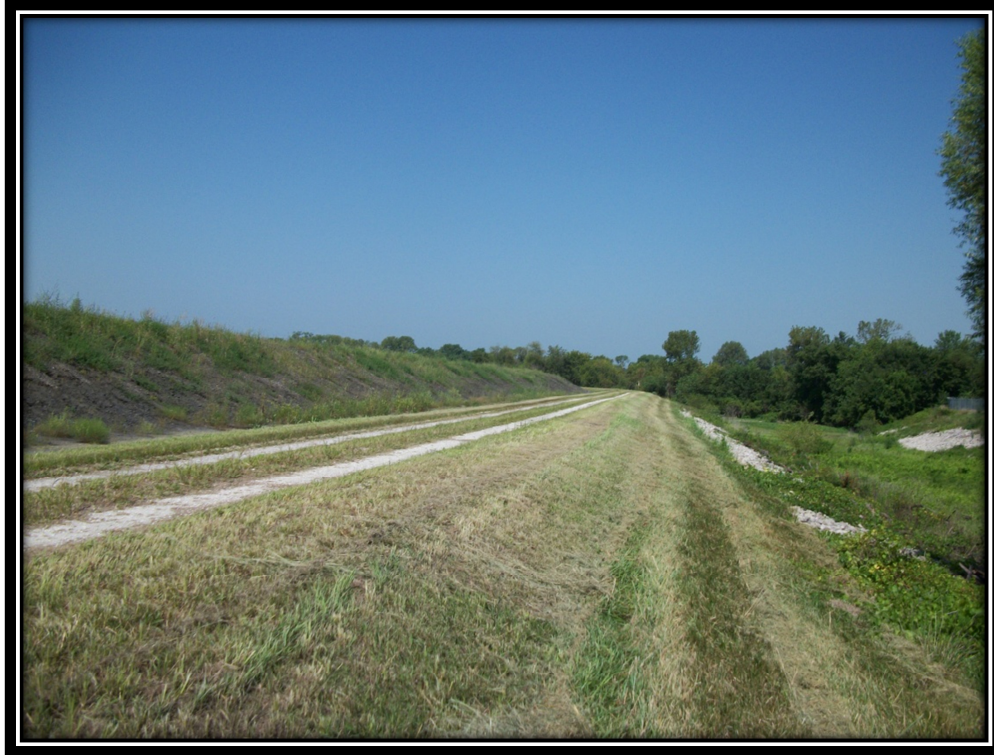
Overall, the crest of the impoundment was in satisfactory condition. Photos 29 and 31 show the condition of the crest. Specific observations include:

- The impoundment crest is a gravel road.
- Sparse grasses and bushes were observed on the crest.
- No major depressions or rutting was noted on the impoundment crest.
- Minor erosion was noted on crest in multiple locations. This erosion was typically less than six inches in depth and typically appeared on the edges of the crest where grade breaks occurred when transitioning to embankment slopes.

Photo 29 – Typical Embankment of Fly Ash Pond (Note Fly Ash Cell Divider Embankment to Left in Photo)

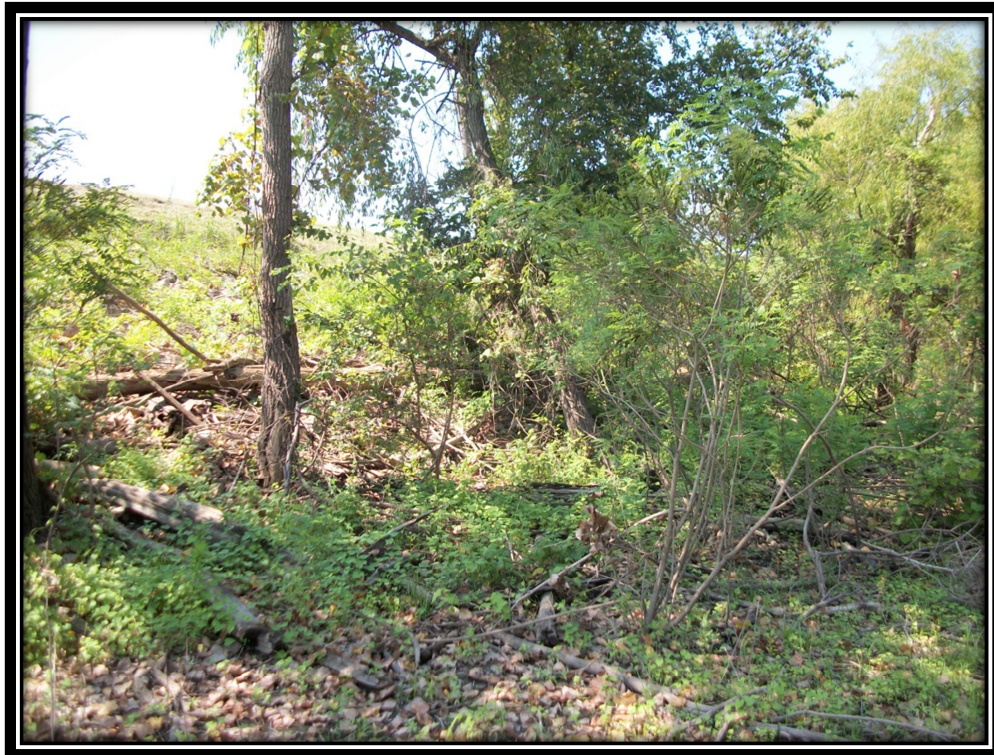
Overall, the downstream slope was in fair condition. Photos 30 and 31 show the conditions of the downstream slope. Specific observations include:

- Grasses, woody bushes and large mature trees were observed on the downstream slope and at the toe of the embankment for a large portion of the impoundment.

The toe areas of the embankment were in fair to poor condition. See photos 30 and 33 for the condition of these areas. Key features and observations of these areas include:

Photo 30 – Vegetation on the Downstream Slope and Toe of the Fly Ash Pond

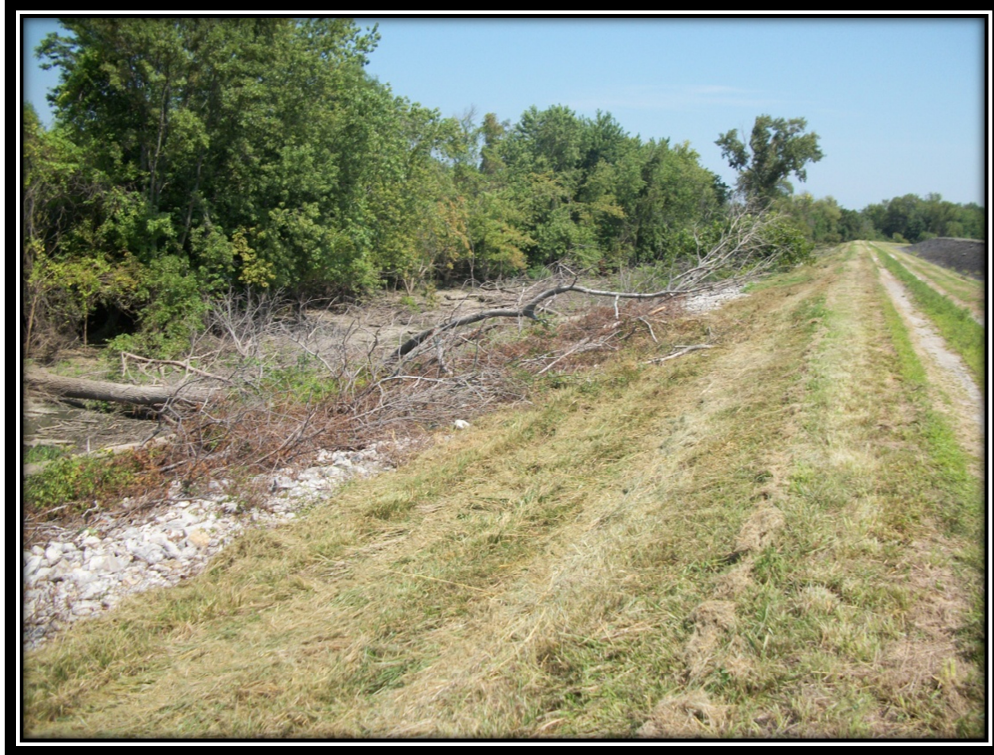
Photo 31 – Fly Ash Pond Embankment (Note Riprap and Felled Tree Debris near Toe)

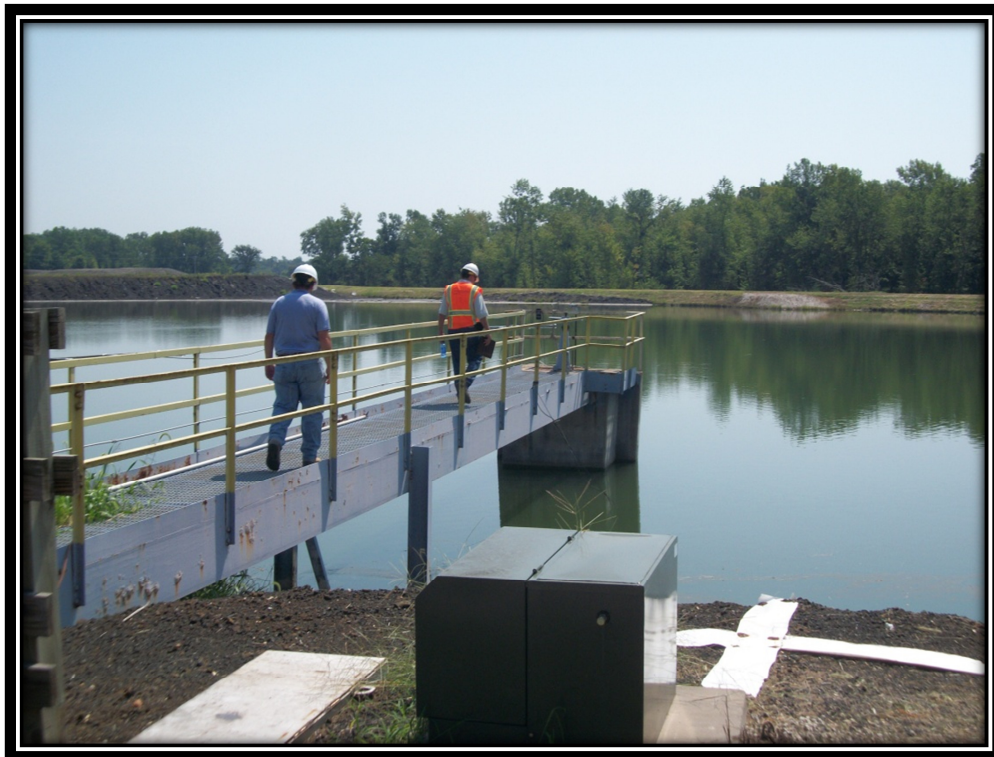
Overall, the upstream slope of the impoundment was in satisfactory condition. Photo 32 in Appendix B shows the conditions of the upstream slope. Specific observations include:

- The upstream slope was laid back at approximately 3H:1V
- Mowing had not been completed on the majority of the upstream slope.
- Grasses, bushes and woody debris were observed on the slope.

The outlet works of the Fly Ash Pond are almost identical to that of the Bottom Ash Pond. The outlet works intake weir box is located in cell 4 near the western embankment, approximately 75 feet toward the center of the pond. The weir box is accessible via a metal catwalk. The weir box has stop logs and a v-notch weir that can adjust the height of intake for the outlet structure. A sluice gate separates the weir box from a 12 inch vitrified clay pipe leading to the discharge location on the Illinois River. Operation of this sluice gate in flood conditions is possible by one person without any mechanized equipment. According to Ameren Energy personnel and the provided design drawings, the discharge location of the outlet pipe has a concrete slab to protect against slope erosion during discharge. However, this slab could not be observed during the assessment as it was inundated.

Photo 32 – Fly Ash Pond Outlet Works

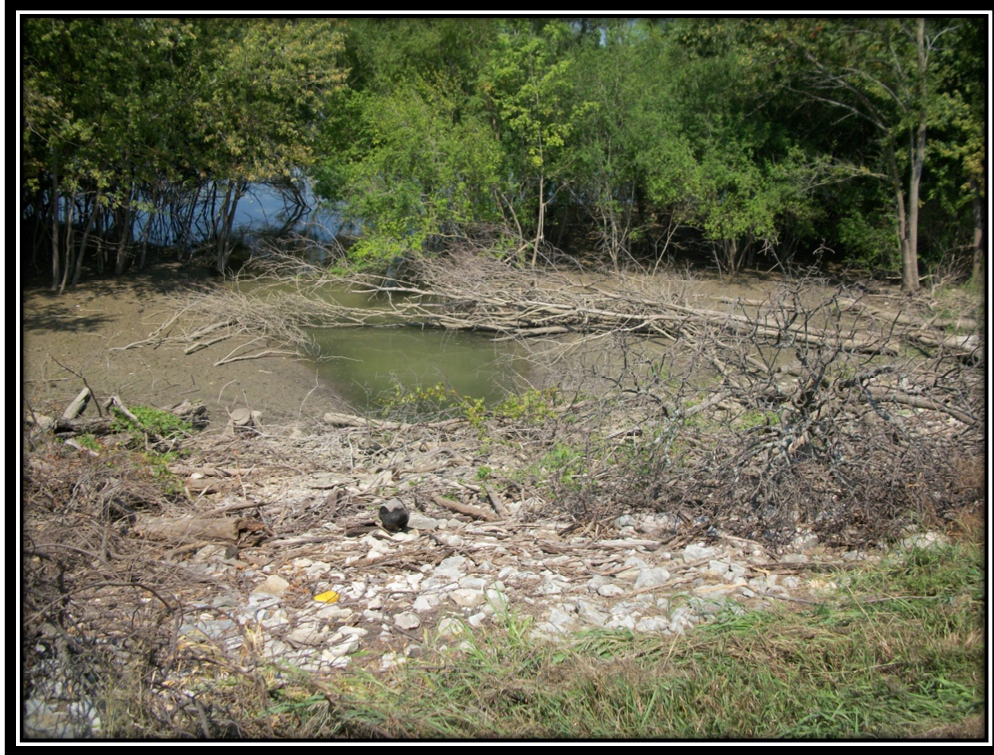
- The discharge location of the outlet pipe was not able to be observed as it was inundated at the time of assessment
- No video monitoring of the clay pipe was available at the time of assessment
- Overall, the outlet works system appears to be functioning as intended at this time.

Photo 33 – Fly Ash Pond Outlet Works Pipe Outfall (Submerged)

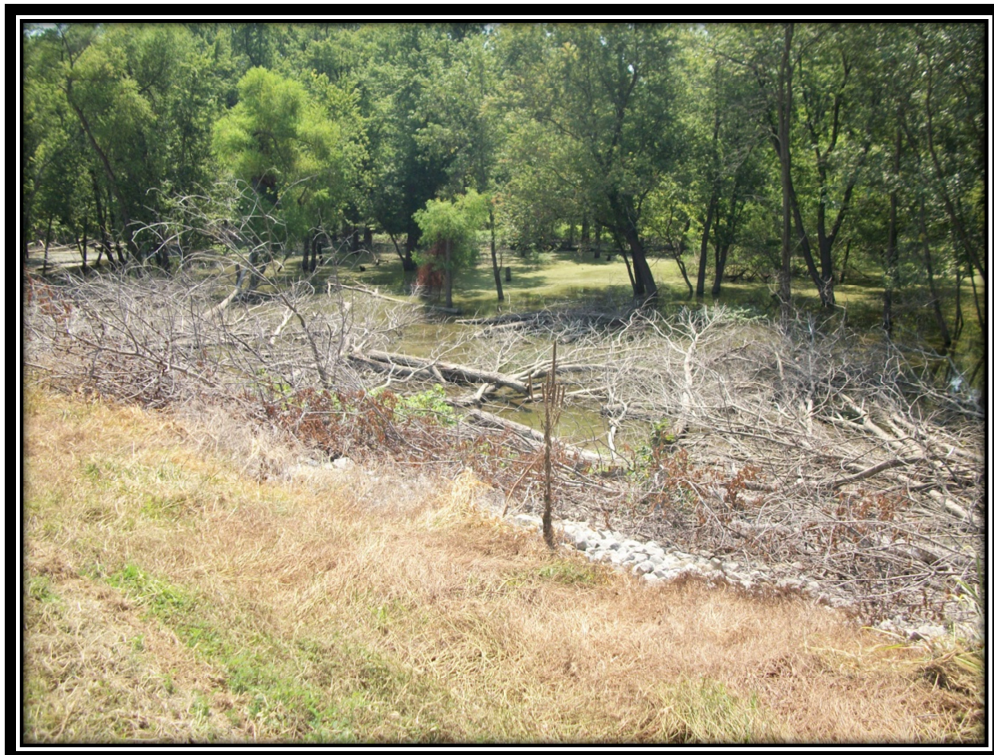
Photo 34 – Flooded Timber and Felled Tree Debris at the Toe of the Fly Ash Pond

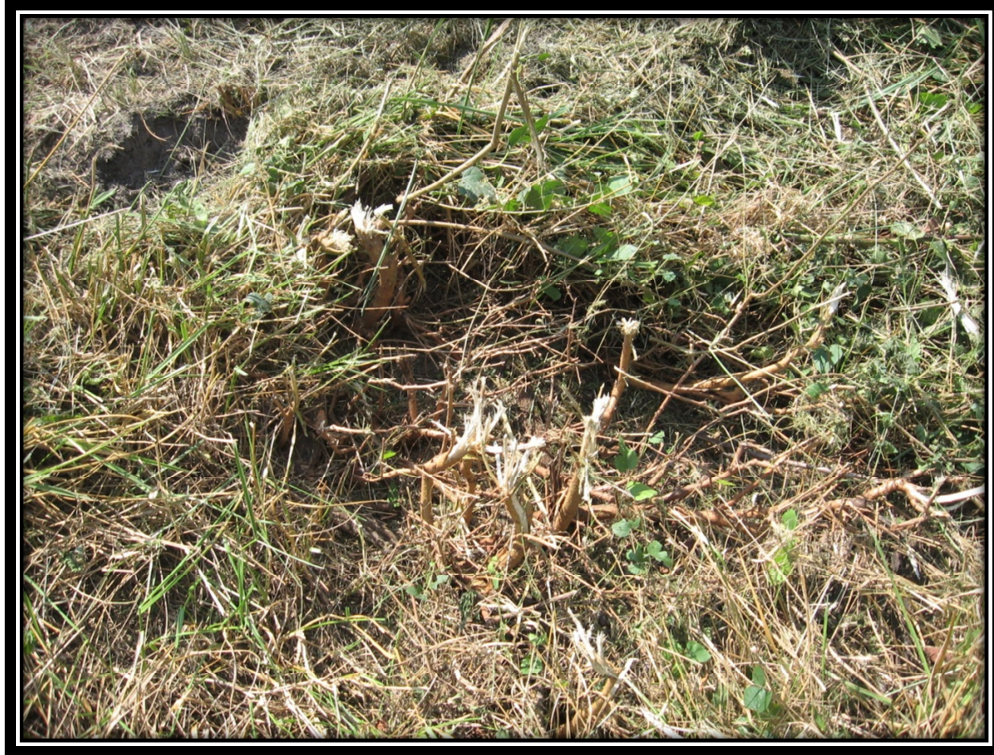
Photo 35 – Mowed Woody Vegetation on Downstream Slope of Fly Ash Pond (Note Intact Root System)
