COAL ASH IMPOUNDMENT SITE ASSESSMENT REPORT

**Newton Power Station
Ameren Energy Generating Company
Newton, Illinois**

KLEINFELDER PROJECT NUMBER 112618-4

April 2011

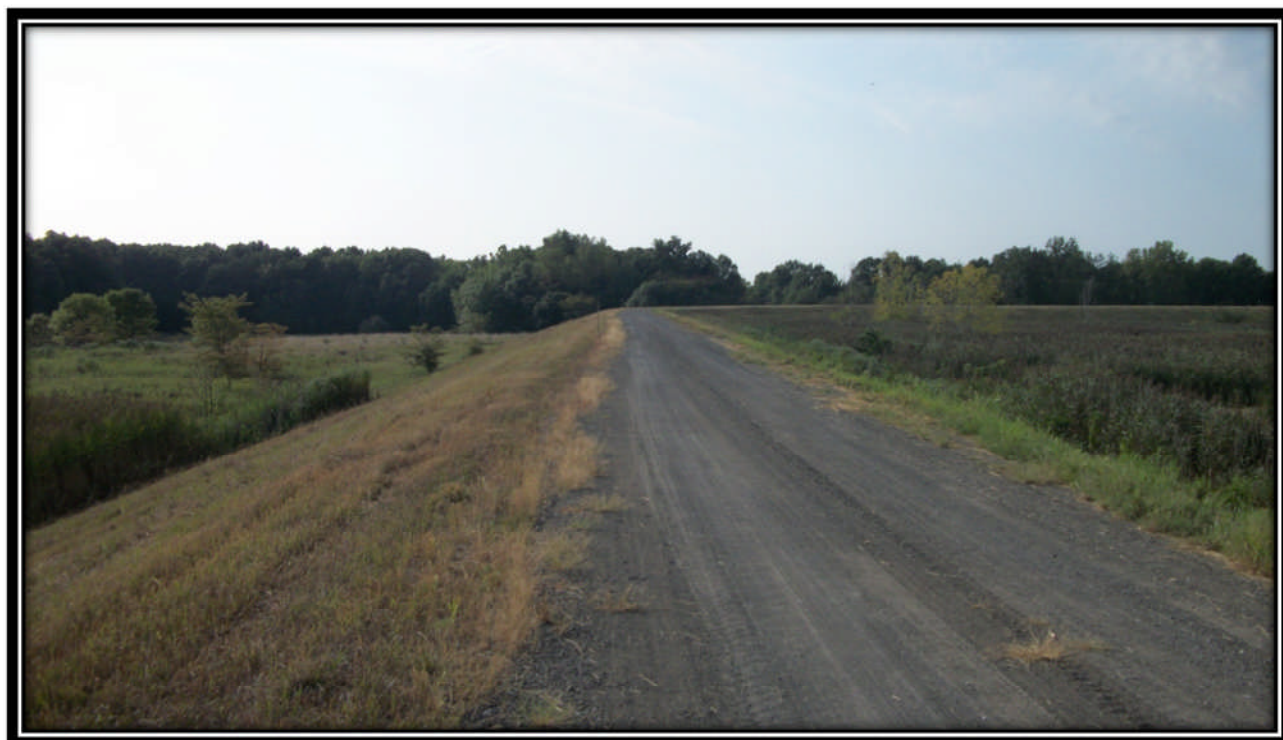
Photo 1 – Looking East along North embankment

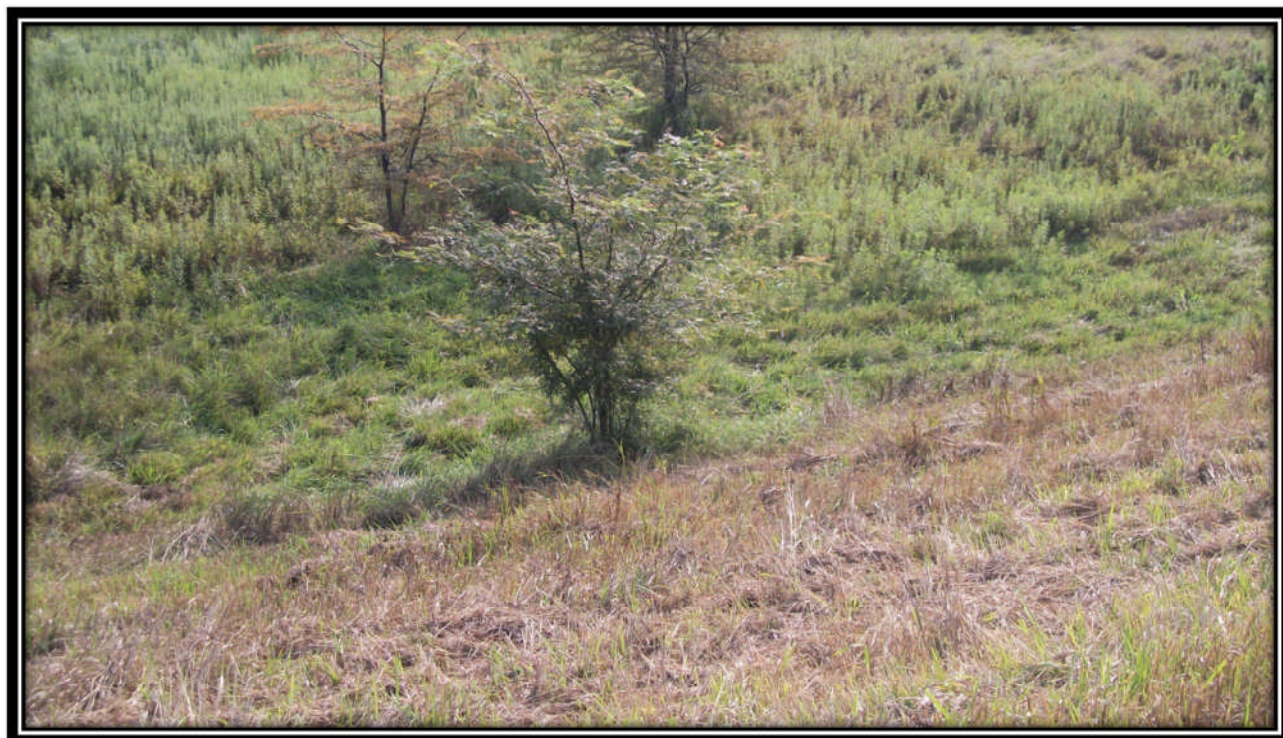
Photo 2 – Shrubs at downstream toe

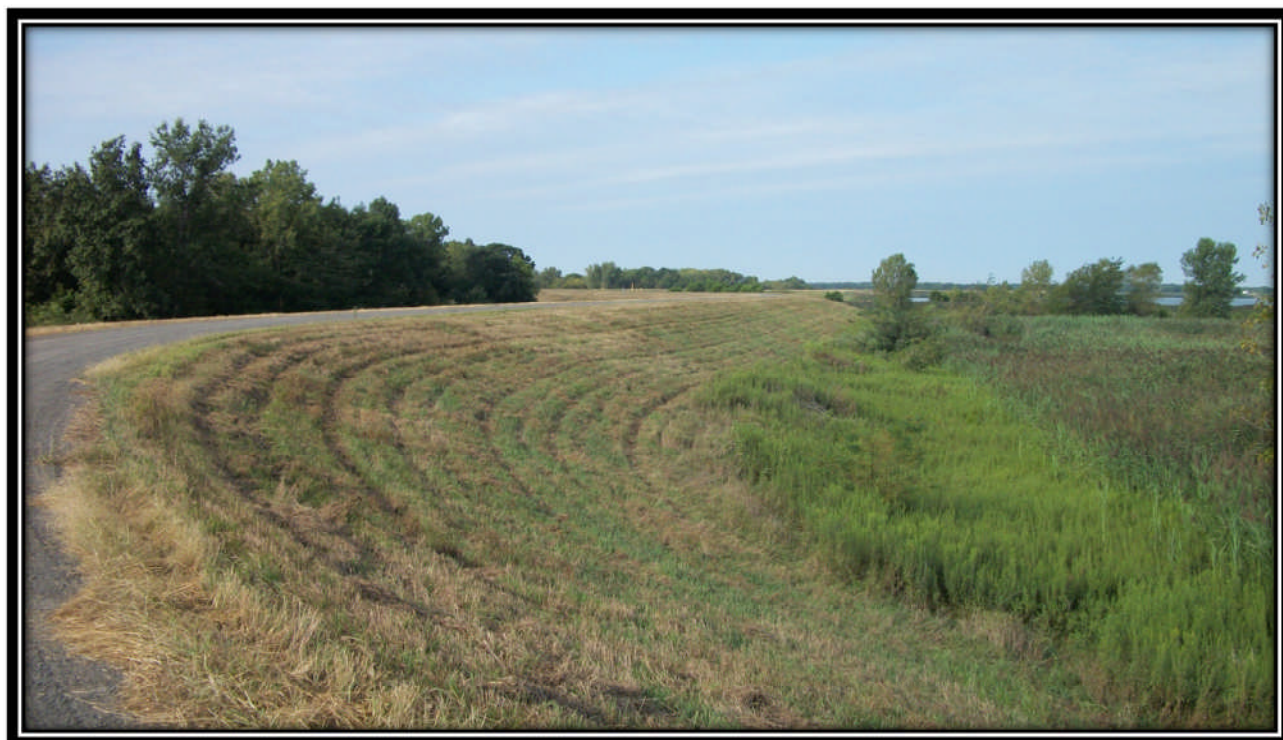
Overall, the upstream slope was in satisfactory condition. Photograph 3 in Appendix B shows typical conditions of the upstream slope. Specific observations include:

- The upstream slope was laid back at approximately 3H:1V, based on visual observations.
- Minor erosion rills, less than 6 inches deep, were noted on some of the upstream slopes.
- A few woody bushes were observed on the upstream slope, and a few trees were observed near the upstream toe of the embankment of the impoundment.
- Mowing/Vegetation control had been completed on the majority of the upstream slope.

Photo 3 – Looking South along East embankment, vegetation on upstream slope

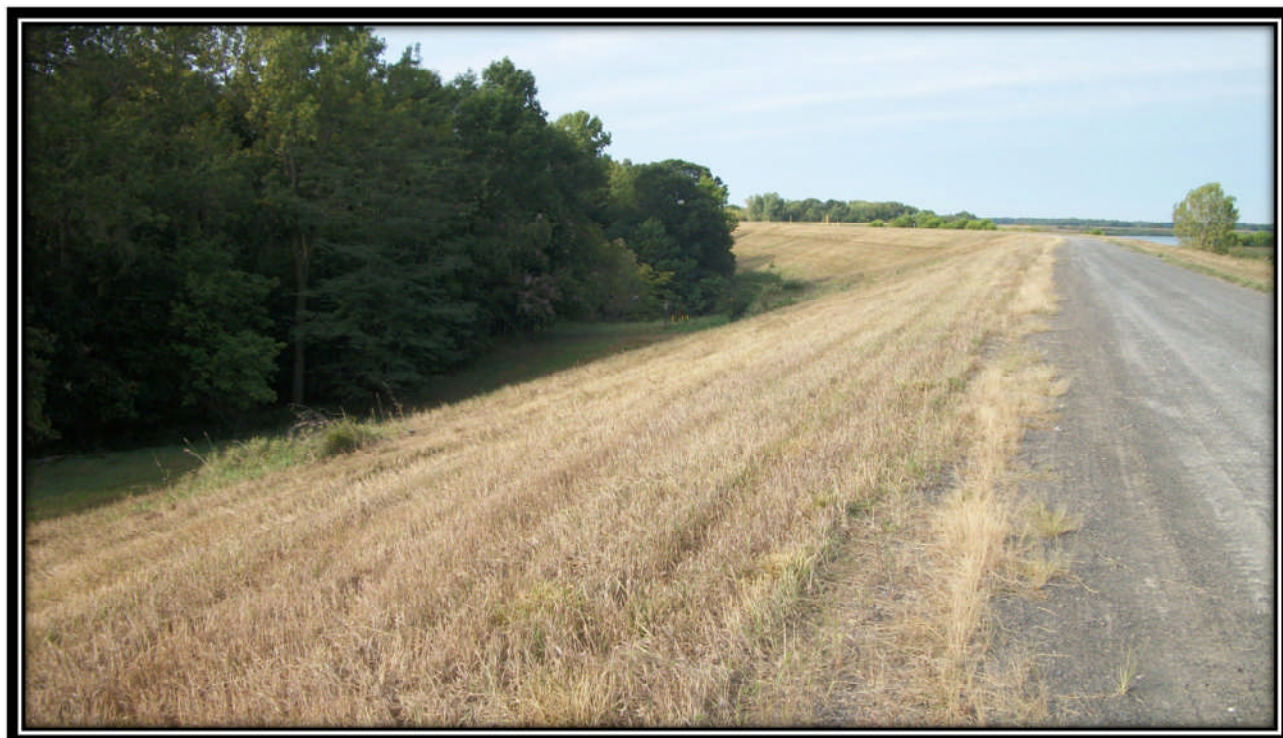
Overall, the downstream slope was in satisfactory condition. Photograph 4 shows typical conditions of the downstream slope. Specific observations include:

- Erosion rills up to 6 inches deep were noted on some downstream slopes.
- Grasses were observed on the downstream slope.

Photo 4 – Looking South along East embankment, vegetation on downstream slope

1. **Repair erosion of embankment by 08/01/2011.** Minor surface erosion was noted at both the Primary and Secondary Ash Ponds. Areas where erosion has occurred should be filled in and re-dressed with appropriate fill to prevent erosion from cutting further into the embankments.

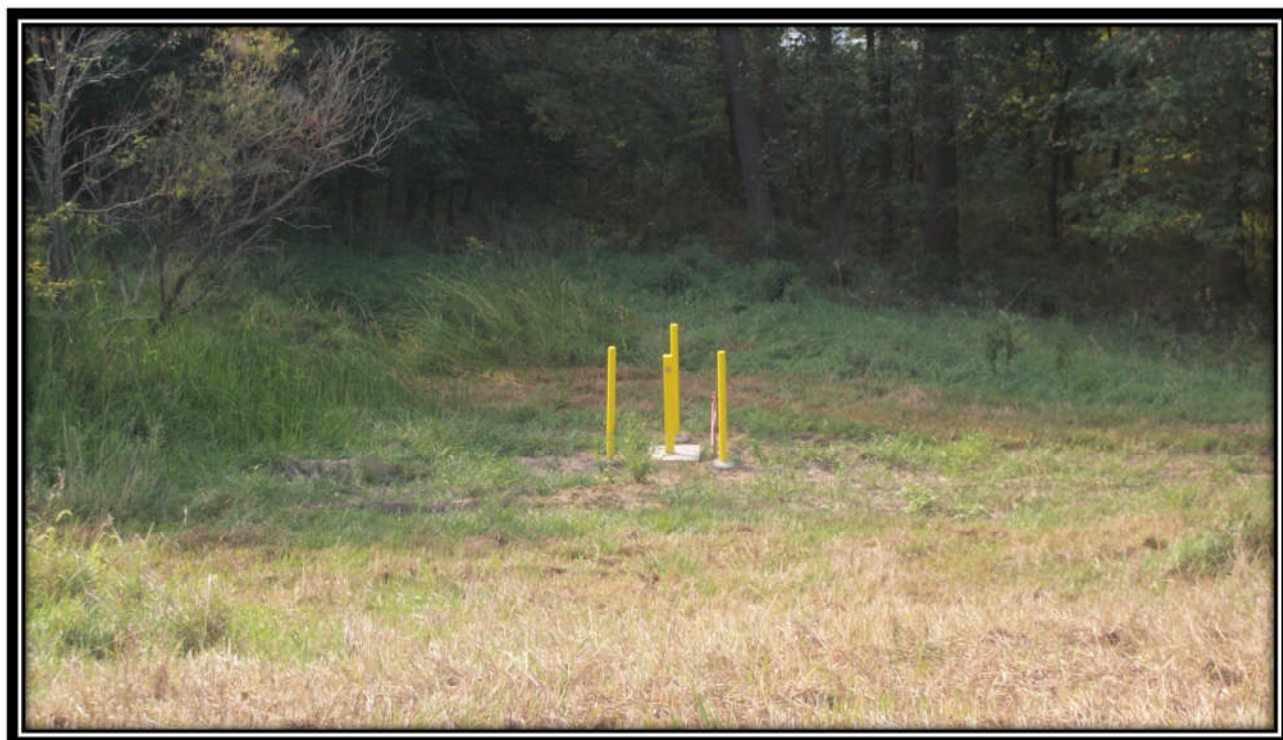
Photo 5 – Monitoring well at toe

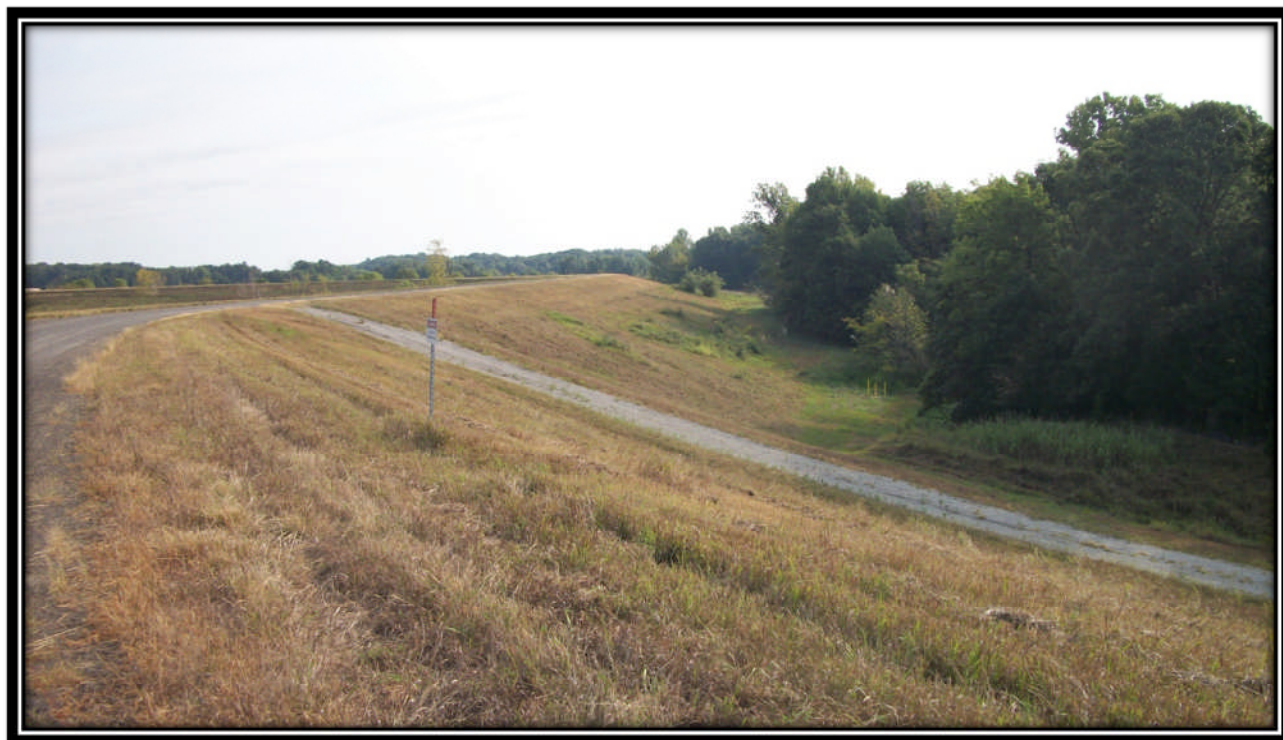
The toe areas of the embankment were in satisfactory condition. Photograph 6 shows typical conditions of these areas. Key features and observations of these areas include:

- Except for a few small bushes and trees, vegetation has been cut back at least 20 feet from the toe, leaving primarily grasses.
- Some hydrophilic vegetation was observed at seepage locations, but ponded water was not observed.

Photo 6 – Road up downstream slope to pump house

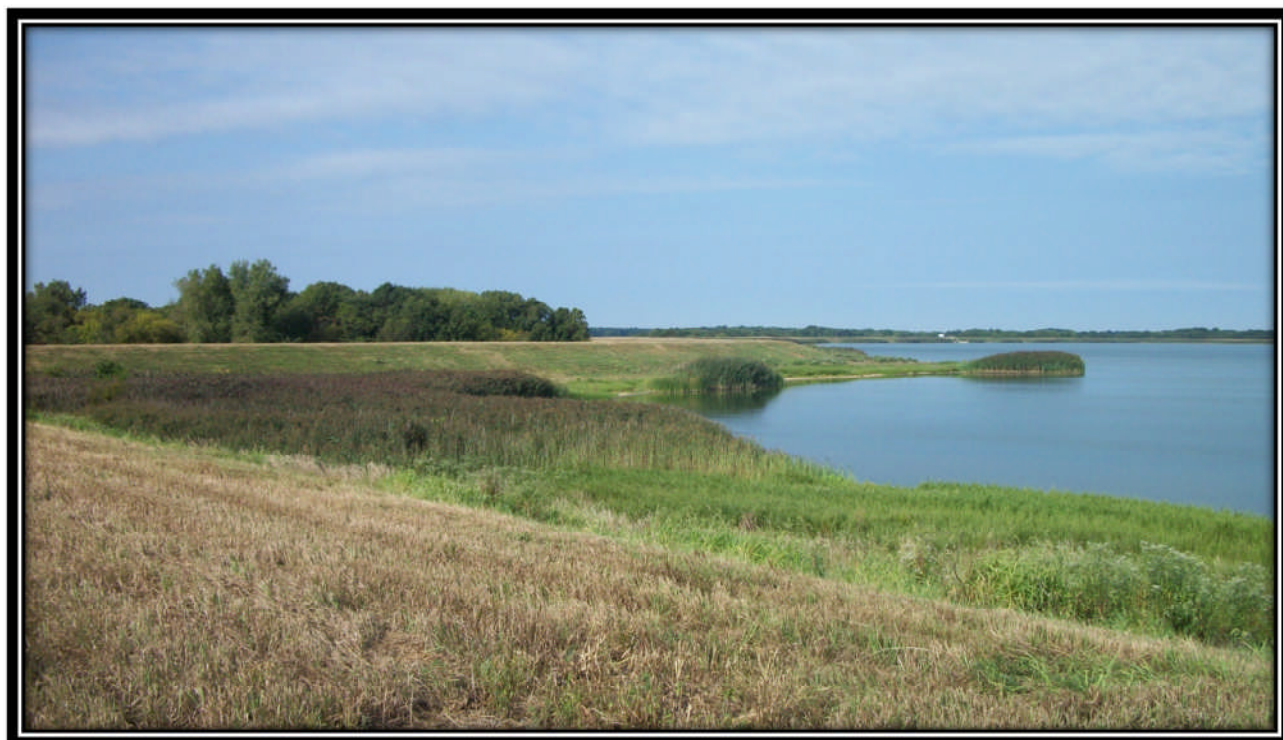
Photo 7 – Looking South along East embankment

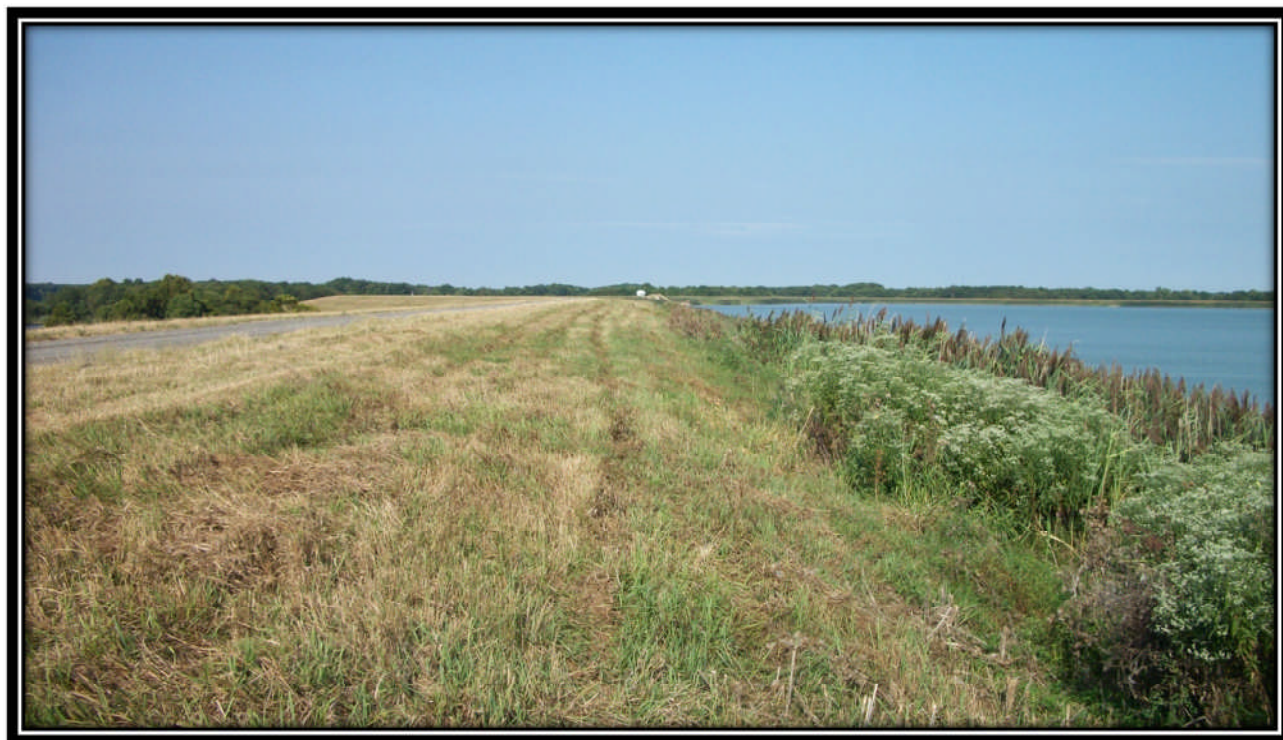
Photo 8 – Vegetation on upstream slope looking Southwest along East embankment

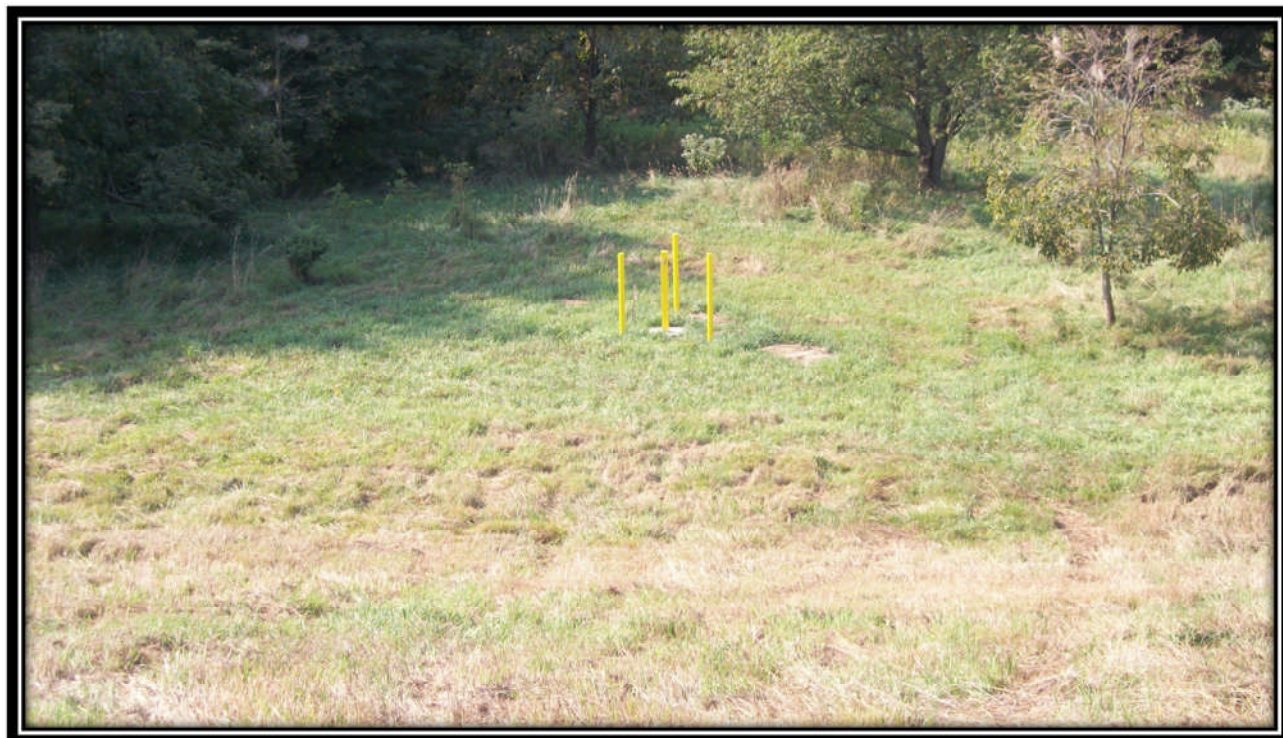
Photo 9 – Monitoring well

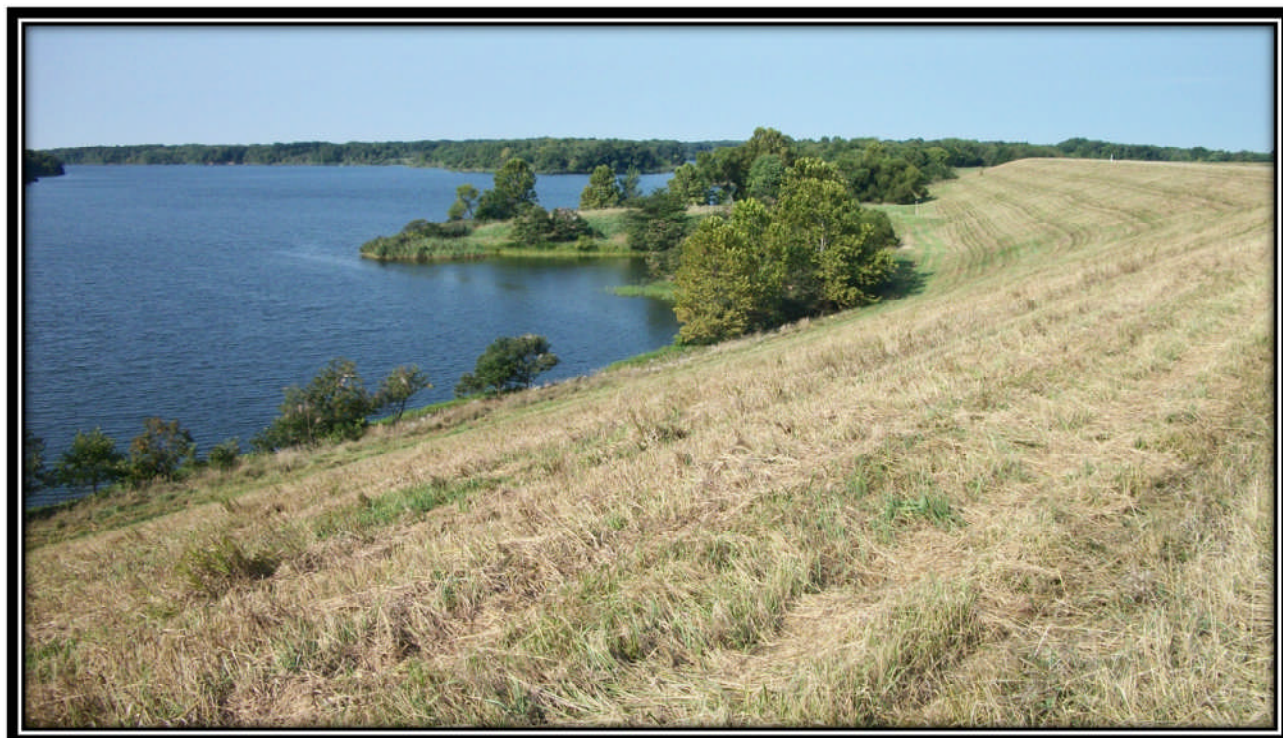
Photo 10 – Max section, downstream

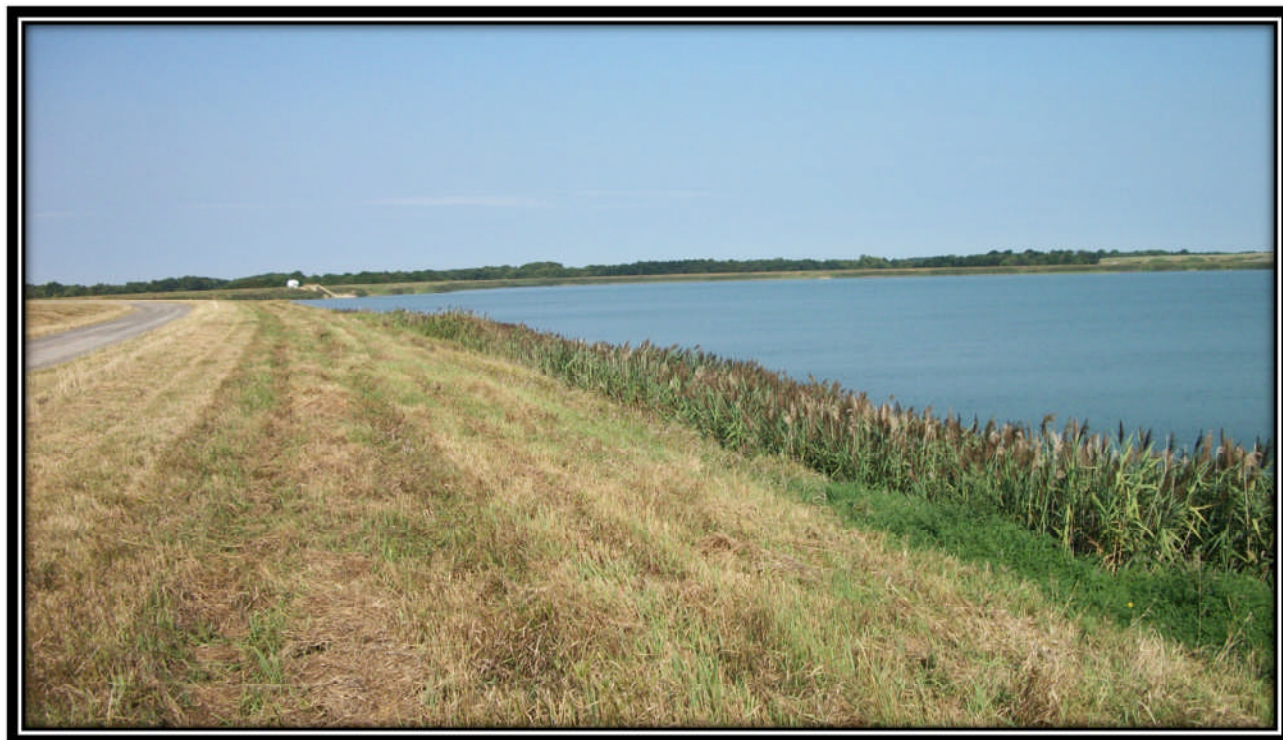
Photo 11 – Max section, upstream

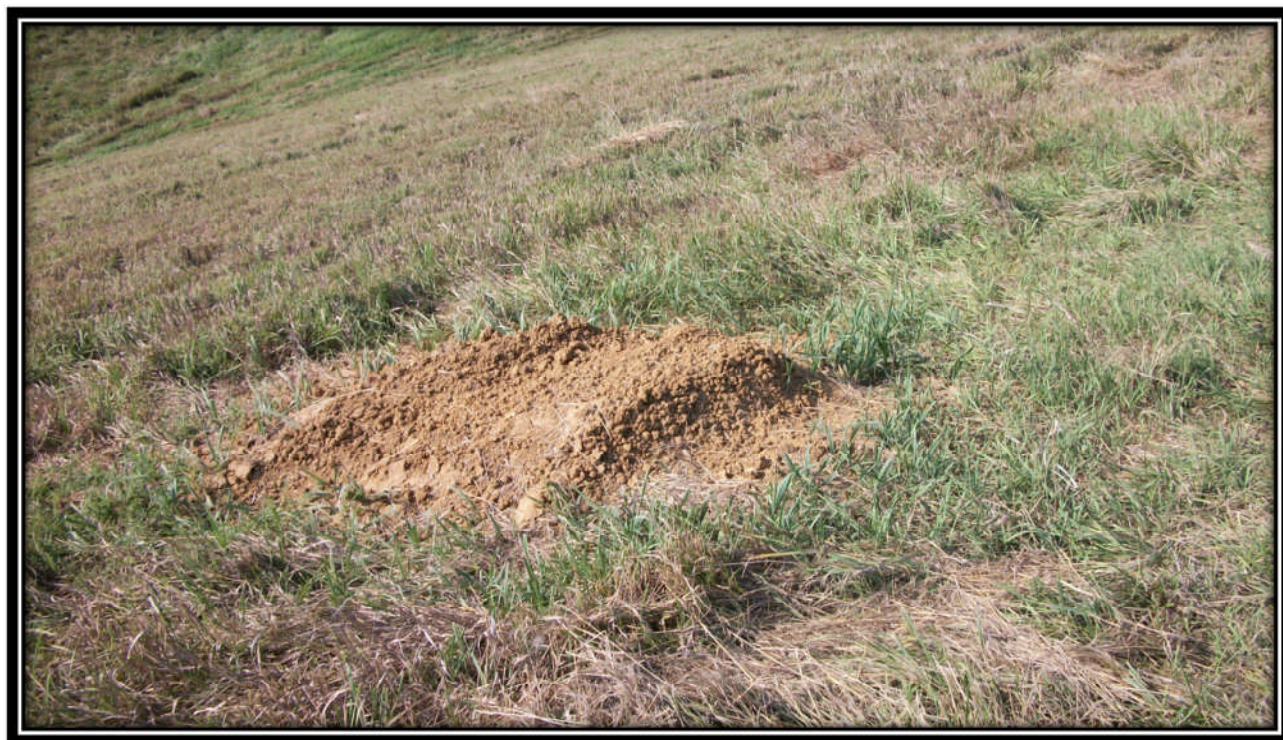
Photo 12 – Boring on the downstream slope

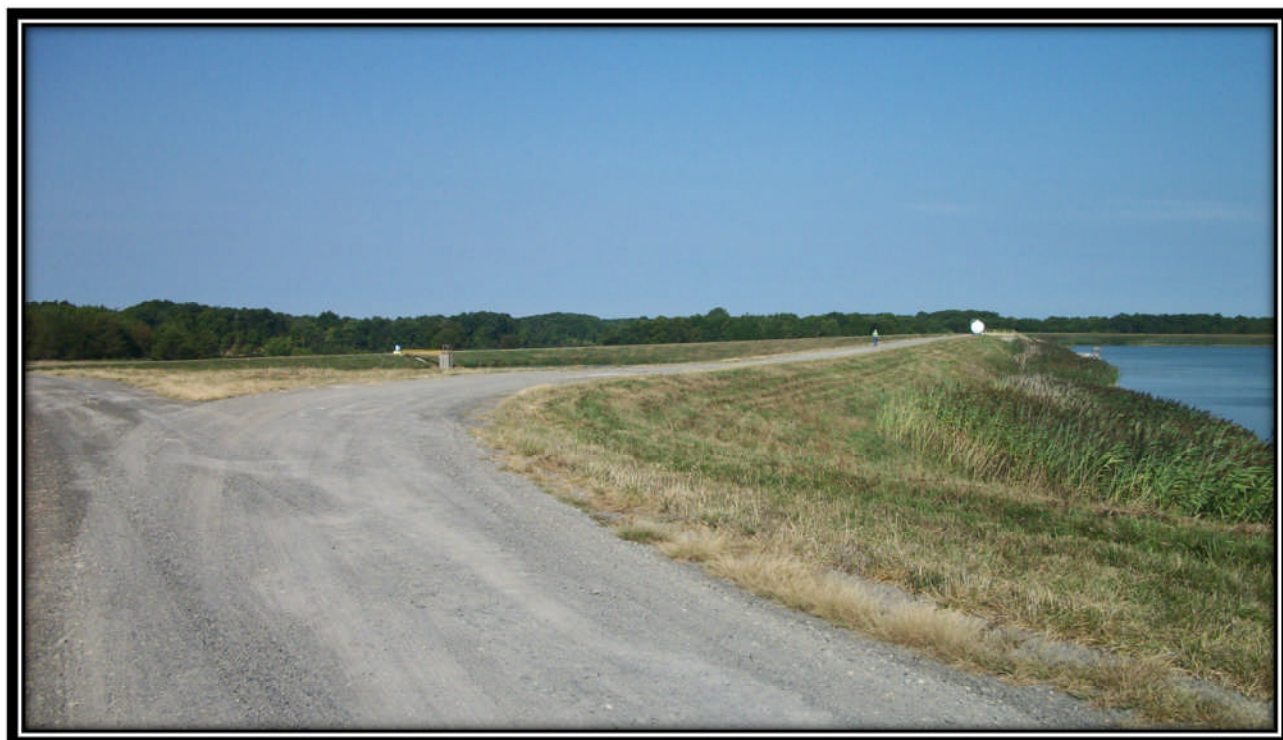
Photo 13 – Junction of separating dike

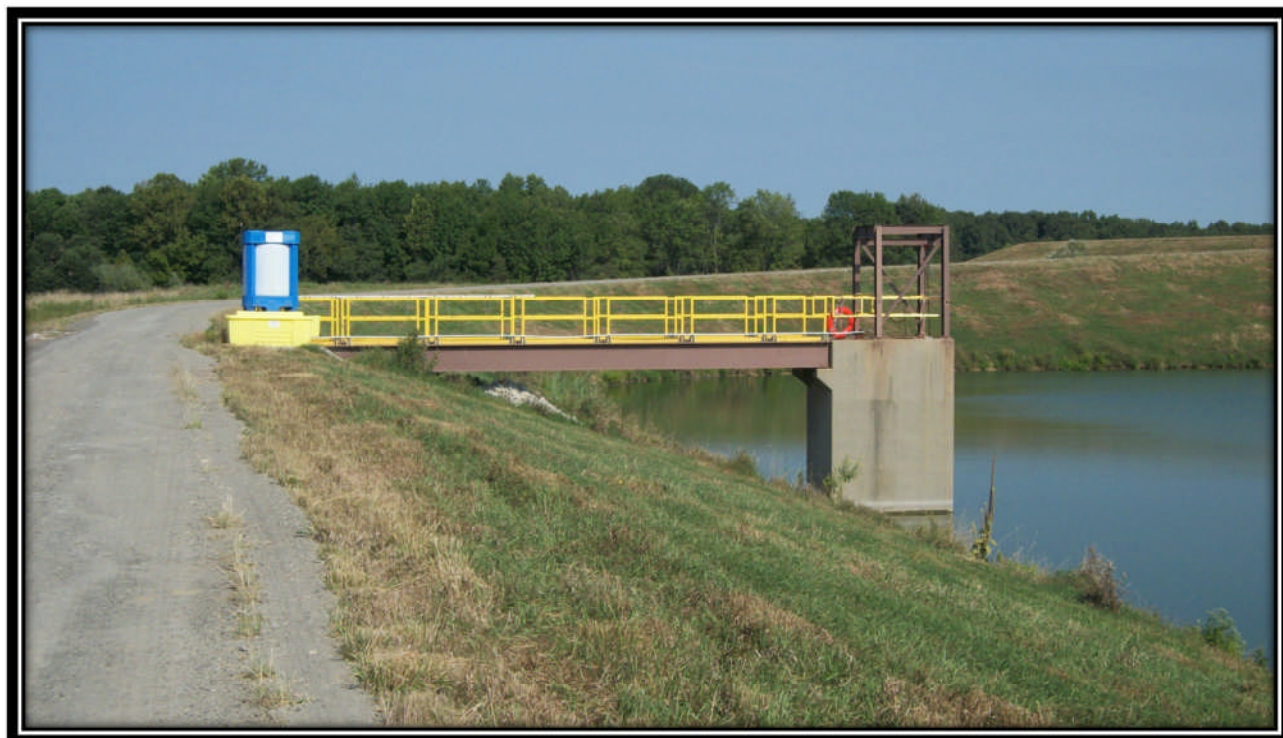
girders, handrail, and stairs appeared to be in satisfactory condition. Refer to Photographs 14, 15 and 16 in Appendix B for further clarification.

Overall, the upstream slope of the impoundment was in satisfactory condition. Photograph 14 in Appendix B shows the typical condition of the upstream slope. Specific observations include:

Overall, the crest of the impoundment was in satisfactory condition. Photograph 14 shows the typical condition of the crest. Specific observations include:

- The impoundment crest is a gravel road.
- Very sparse grasses were observed on the upstream side of the crest.
- No major depressions or rutting were noted on the impoundment crest.

Photo 14 – Secondary pond outlet

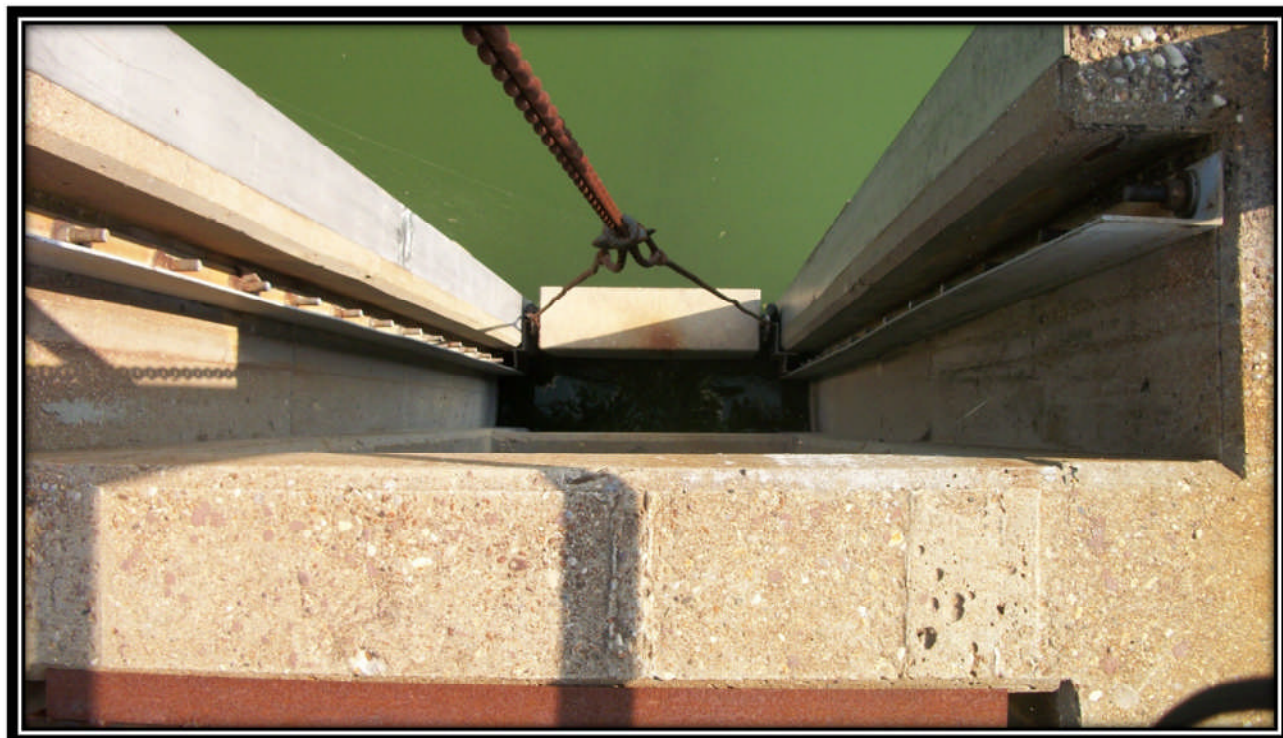
Photo 15 – Secondary pond outlet

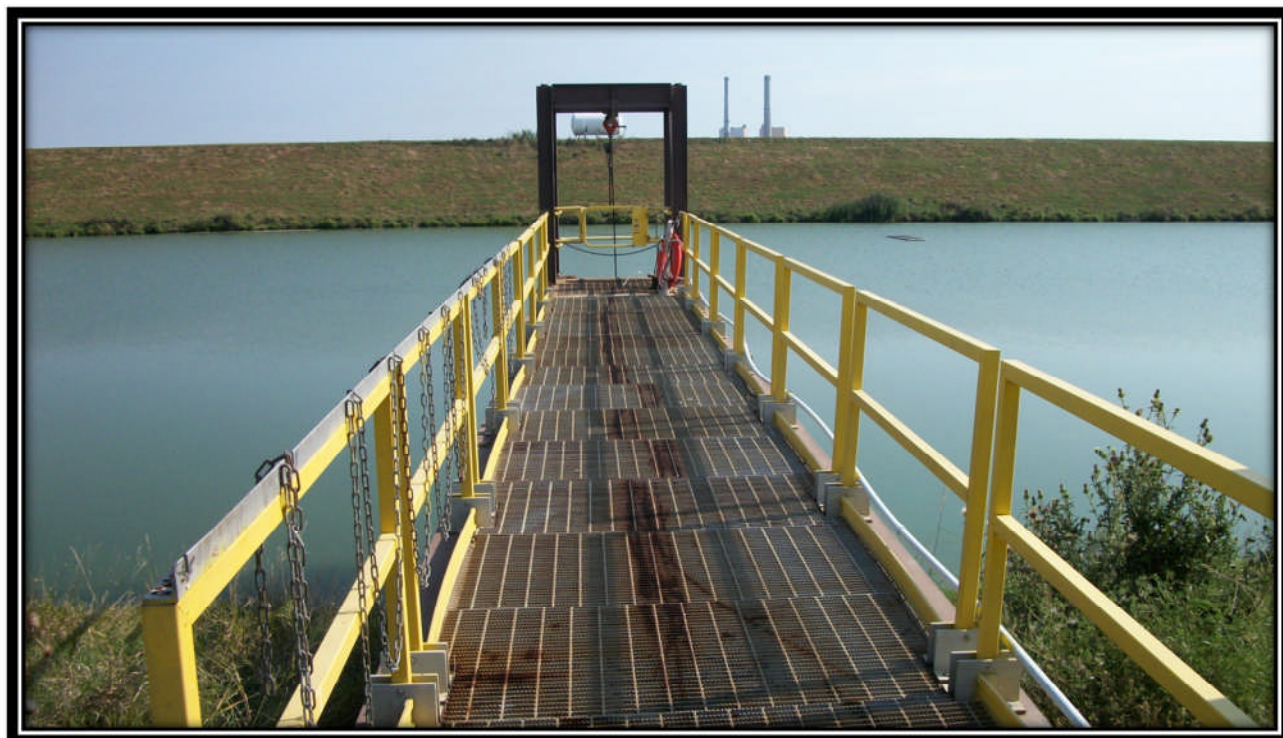
Photo 16 – Secondary pond outlet

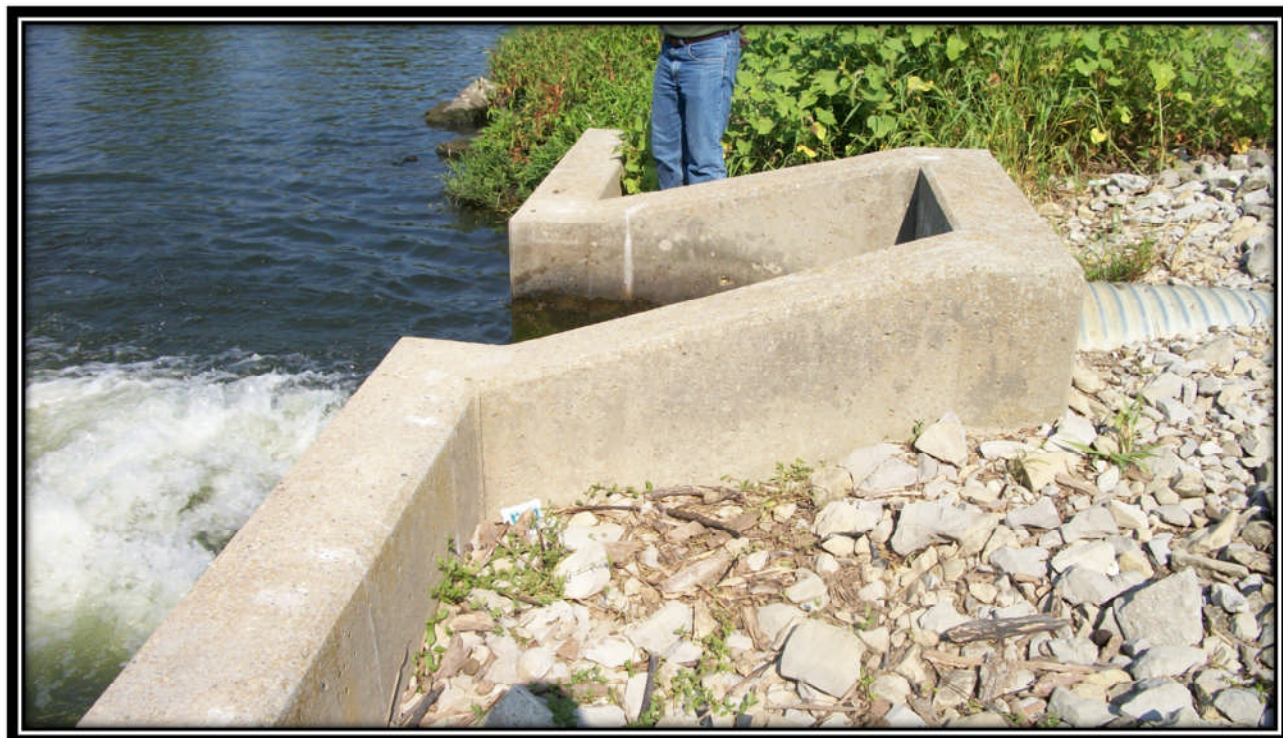
Photo 17 – CIPP lining slipped into CMP, discharging into Lake Newton

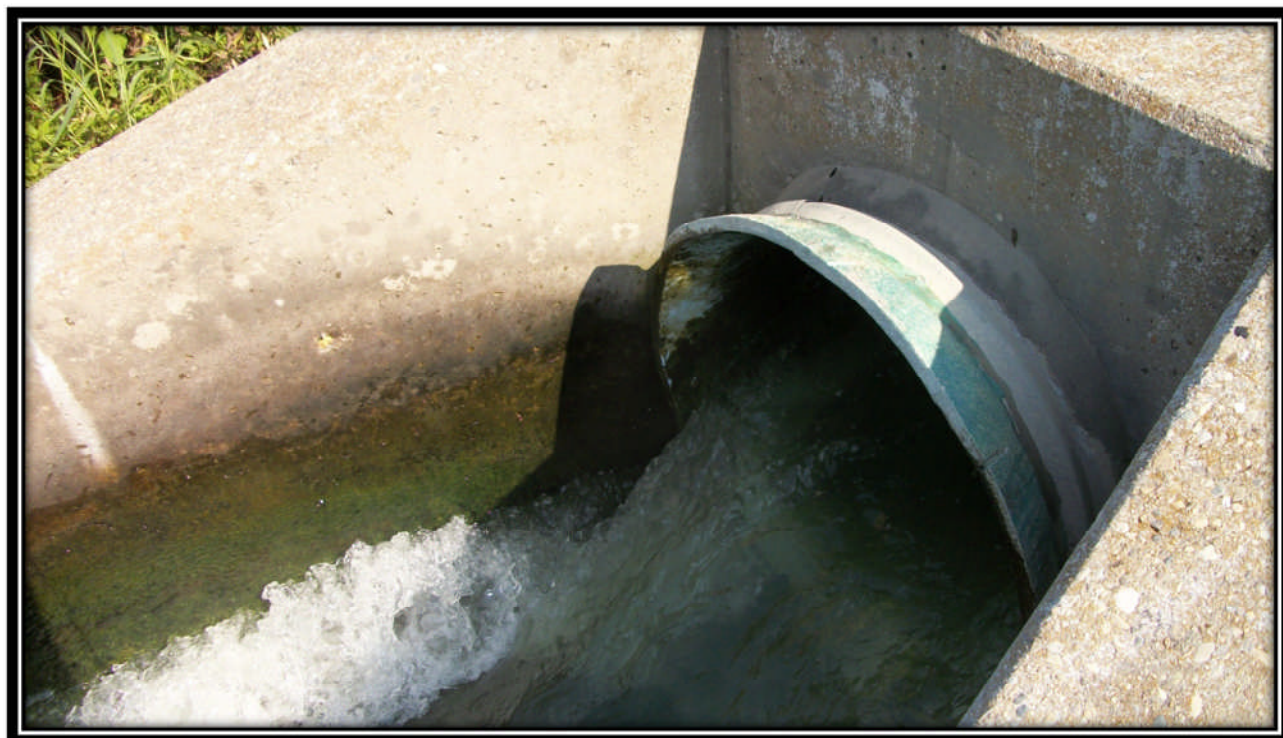
Photo 18 – CIPP lining slipped into CMP

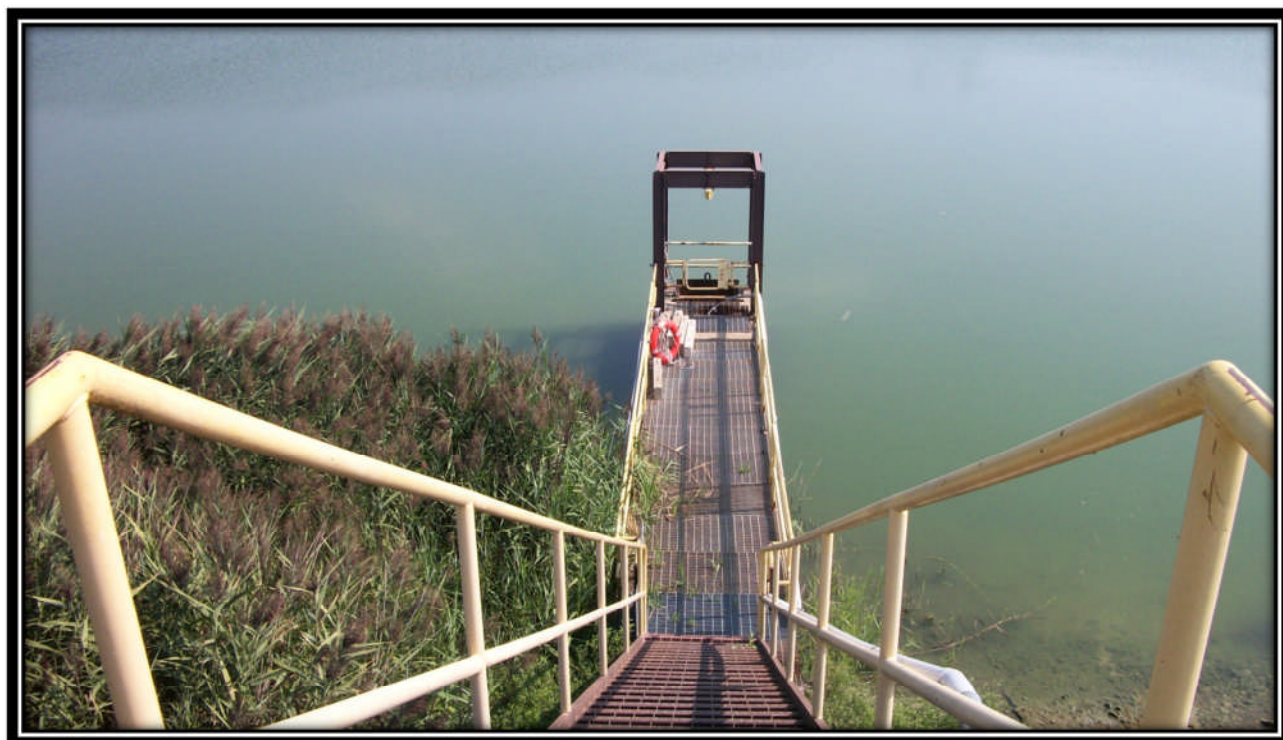
Photo 19 – Primary pond outlet

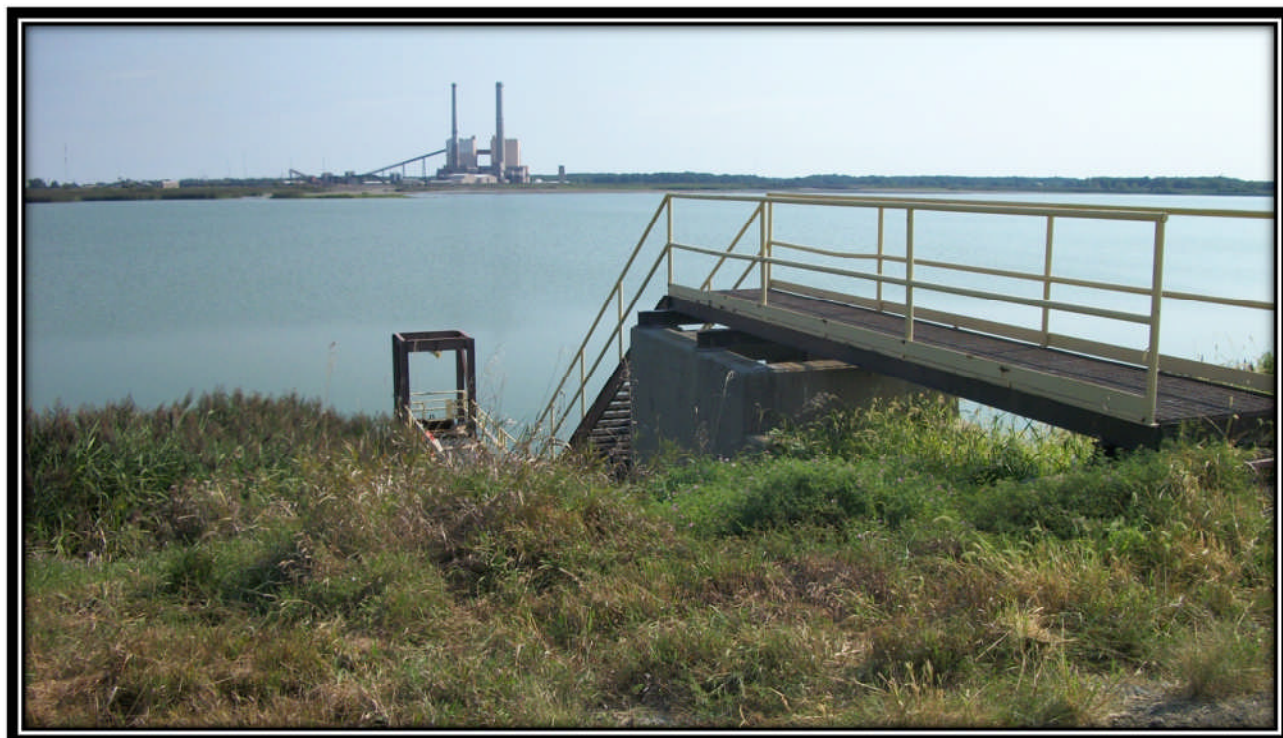
Photo 20 – Primary pond outlet

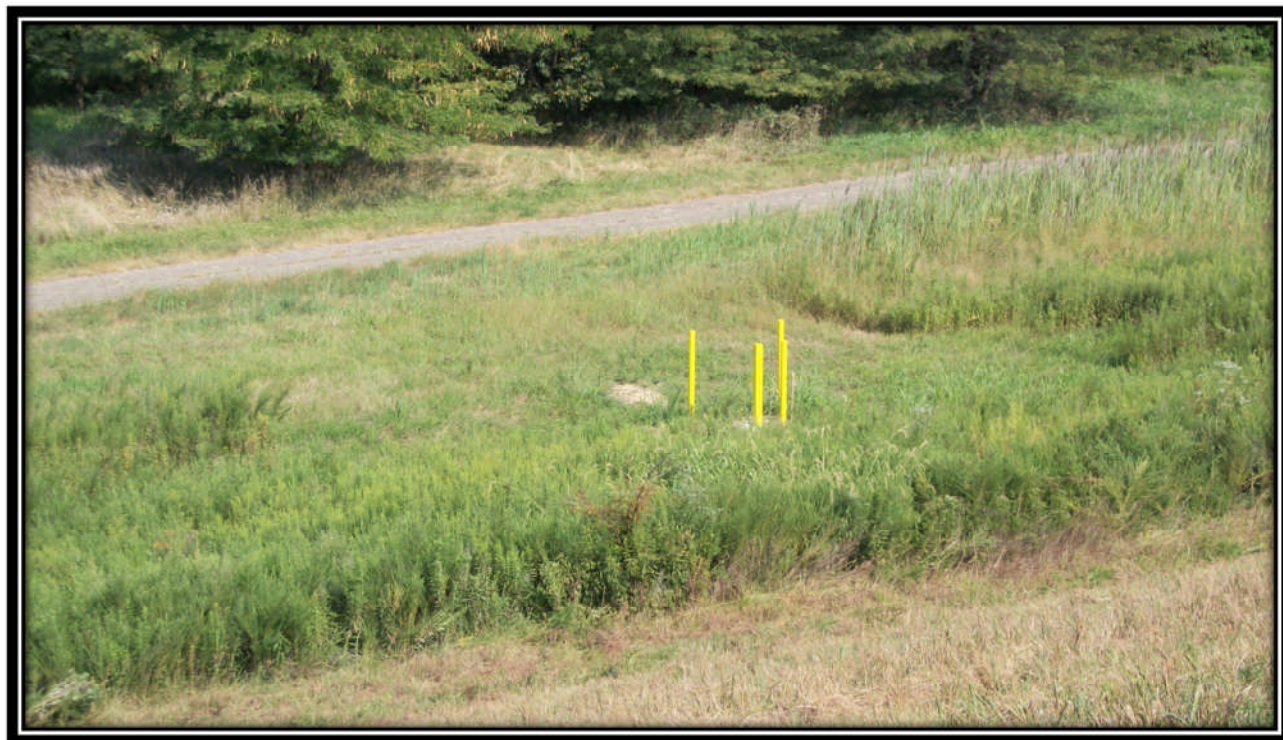
Photo 21 – Monitoring well on downstream toe

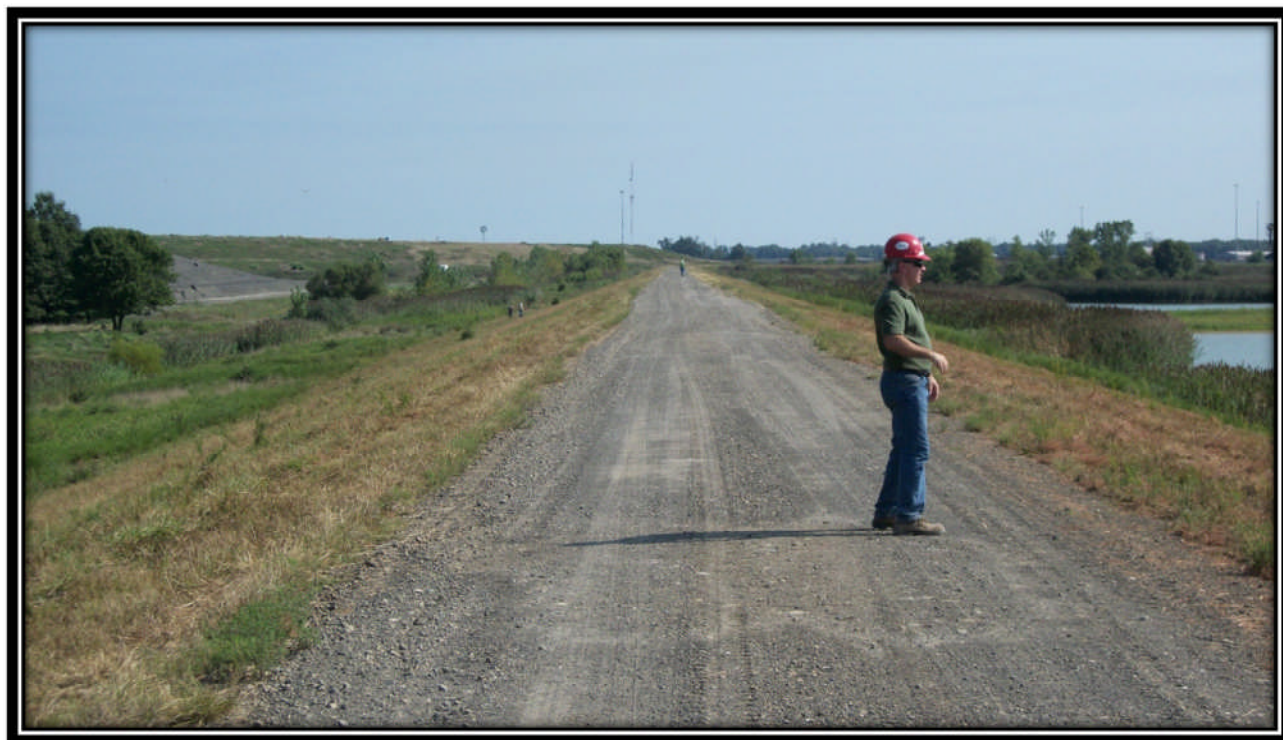
Overall, the crest of the impoundment was in satisfactory condition. Photograph 22 shows the typical condition of the crest. Specific observations include:

- The impoundment crest is a gravel road.
- Almost no grasses were observed on the crest.
- No major depressions or rutting were noted on the impoundment crest.

Photo 22 – Looking North along West embankment

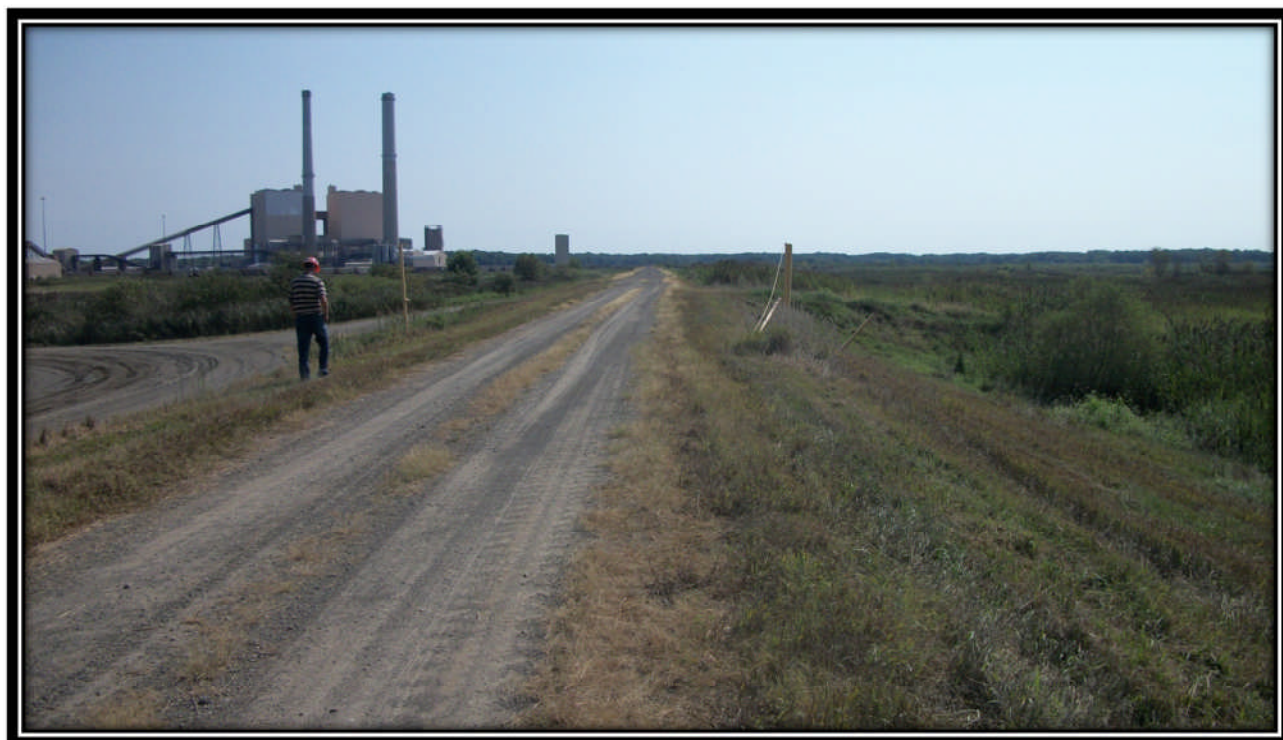
Photo 23 – Looking East along North embankment
