COAL ASH IMPOUNDMENT SITE ASSESSMENT REPORT

**Newton Power Station
Ameren Energy Generating Company
Newton, Illinois**

KLEINFELDER PROJECT NUMBER 112618-4

April 2011

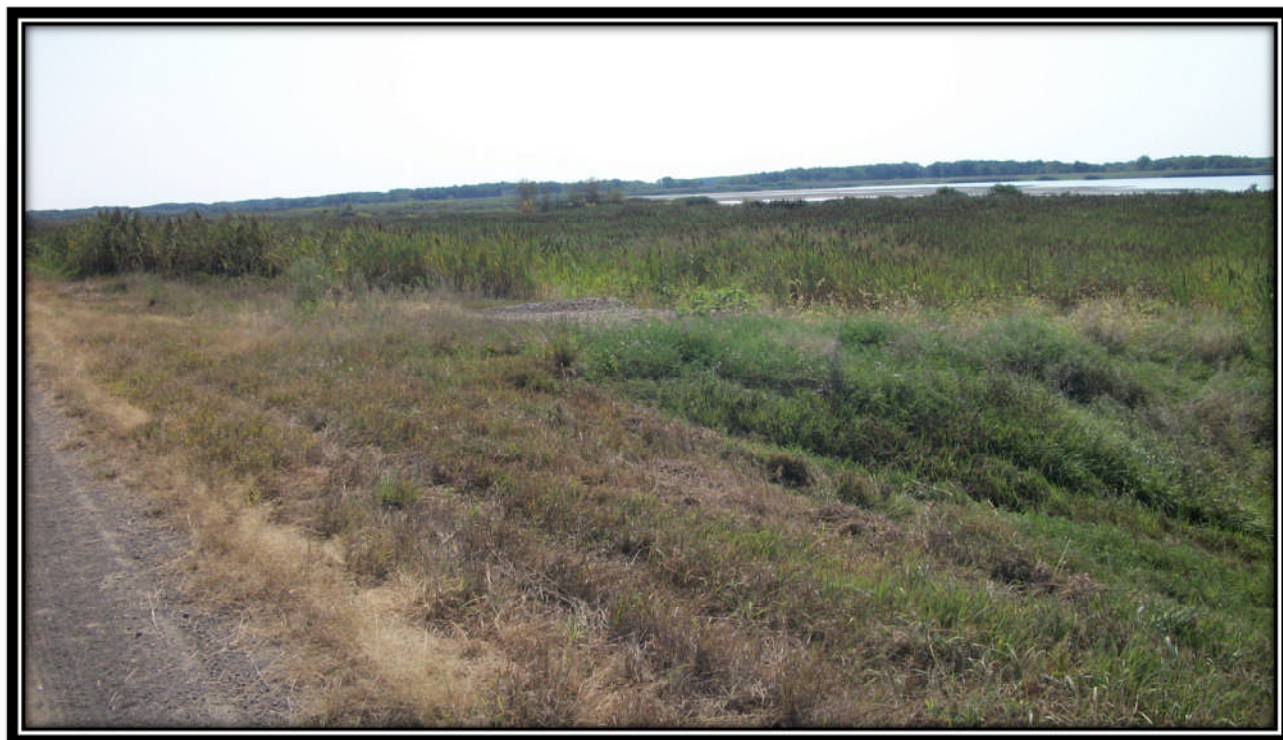
Photo 24 – Road on upstream slope

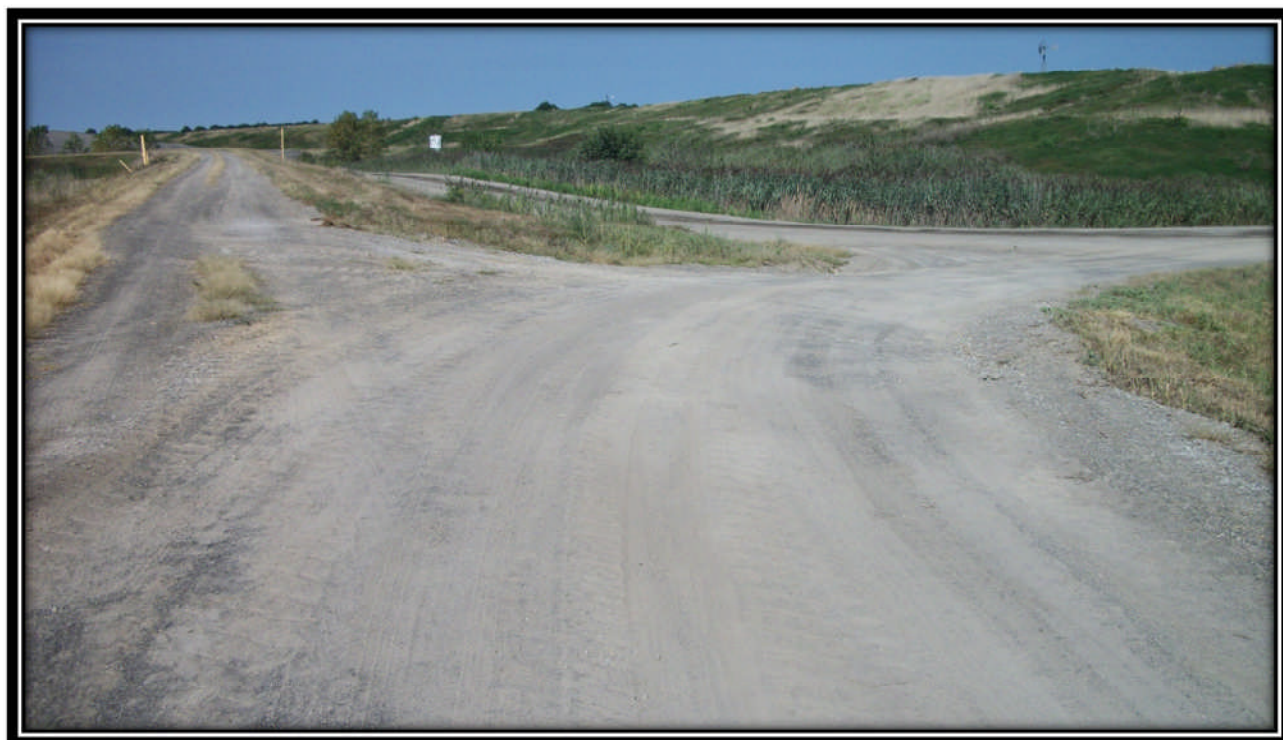
Photo 25 – Road on downstream slope

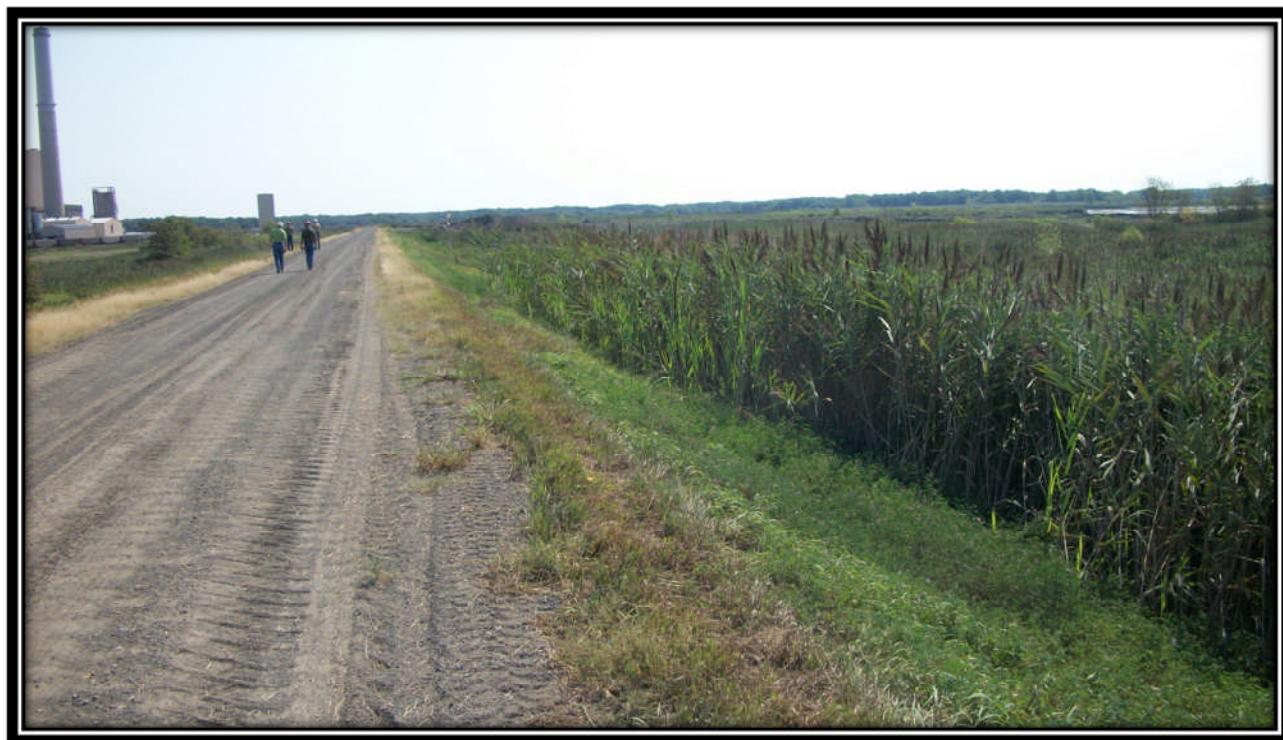
Photo 26 – Minor vegetation on upstream slope

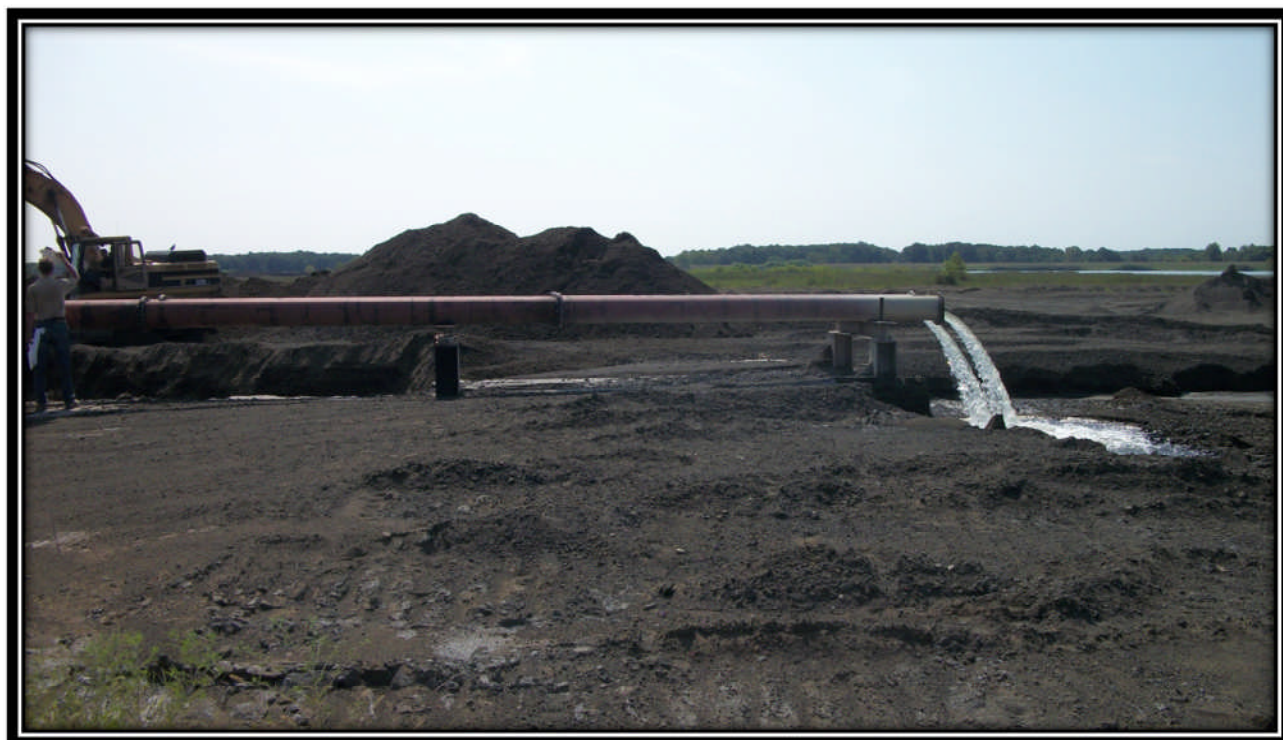
Inflow into the Primary Ash Pond includes metal pipes on the north side of the impoundment, as well as precipitation that falls directly onto the pond. Inlet pipes can be seen in Photograph 27 in Appendix B. The inlet pipes appeared to be in satisfactory condition.

Photo 27 – Discharge pipes

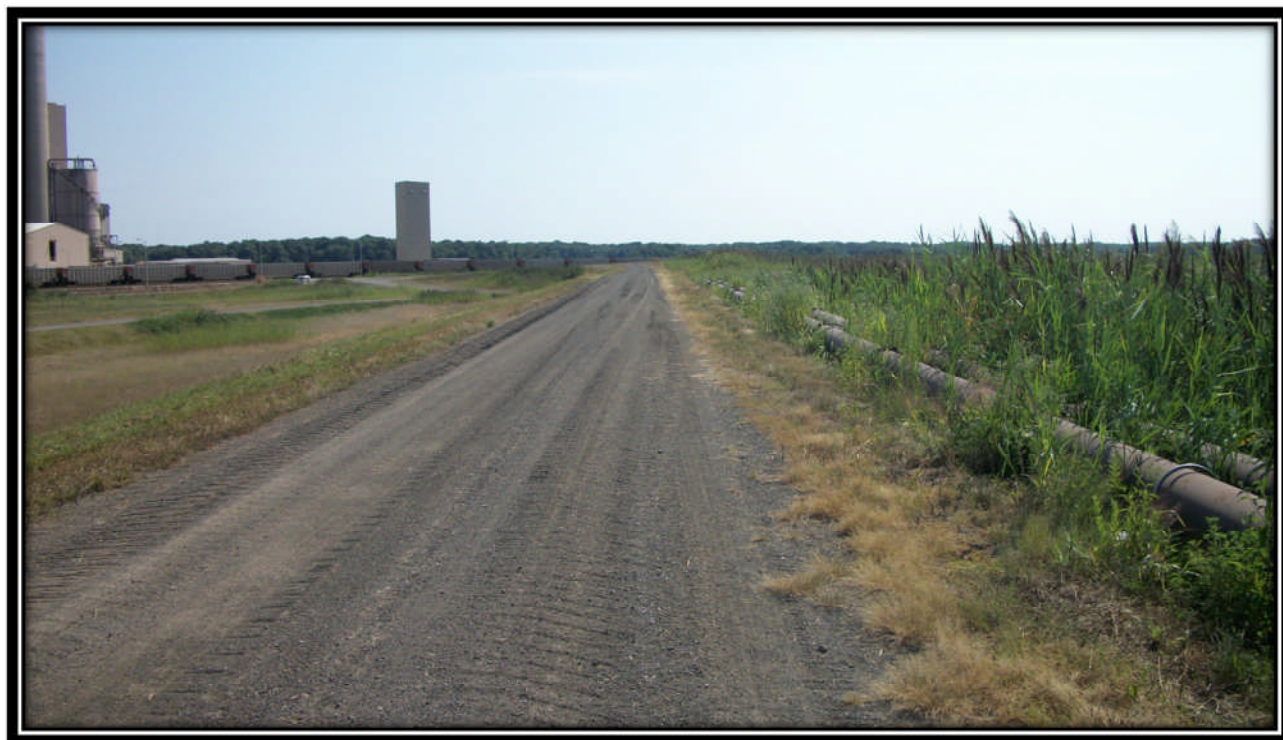
Photo 28 – Looking East along North embankment

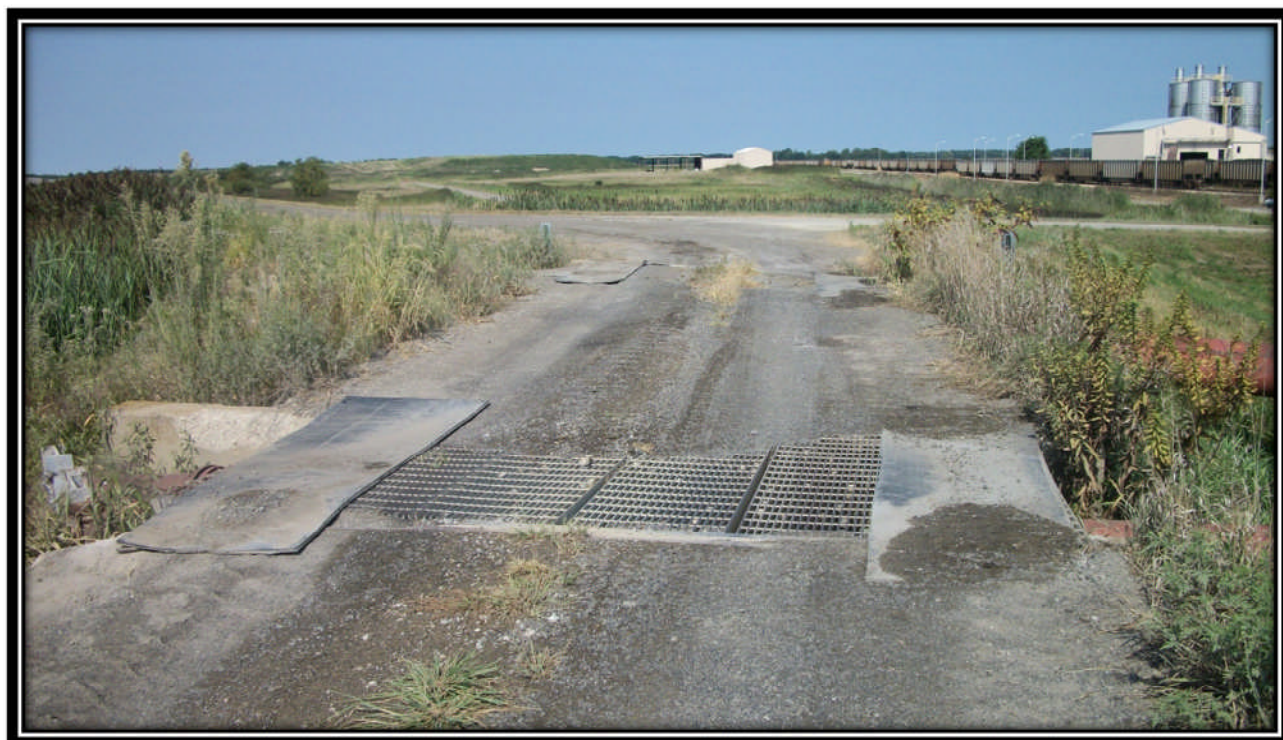
Photo 29 – Pipe crossing approximately 2 feet below grade

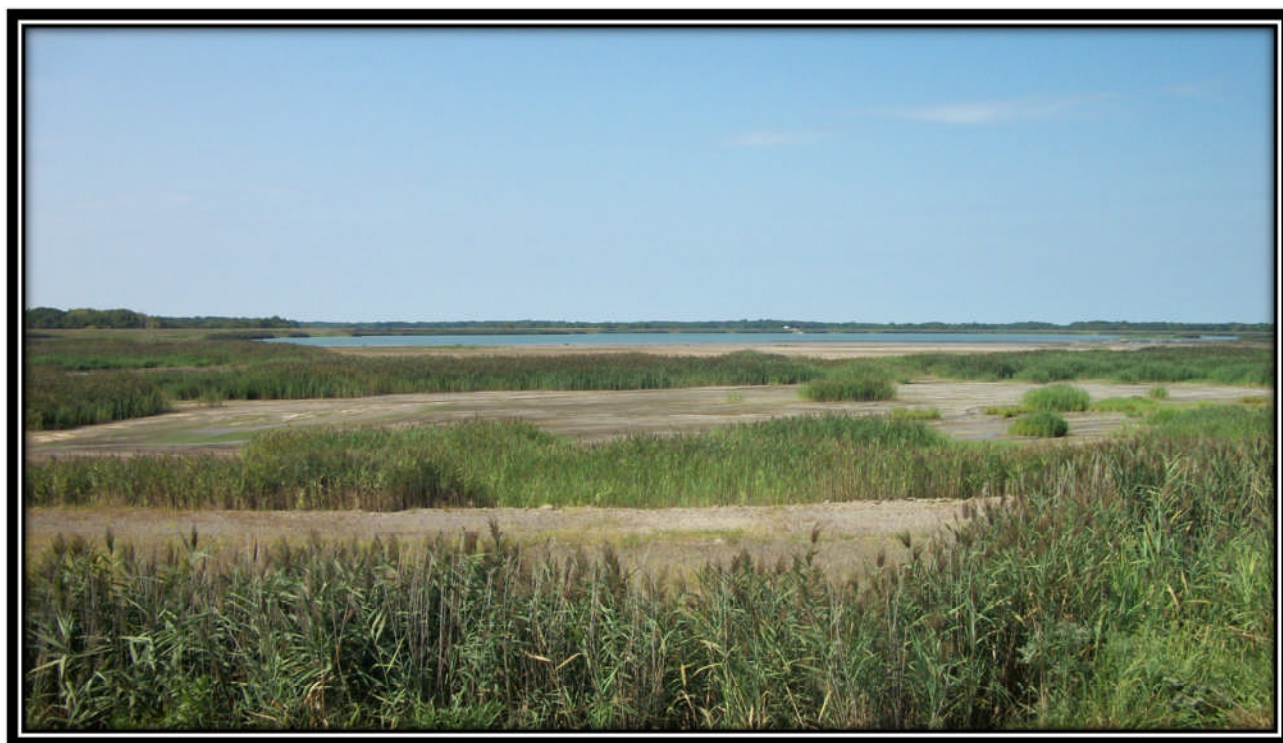
Photo 30 – Primary pond looking South from North embankment

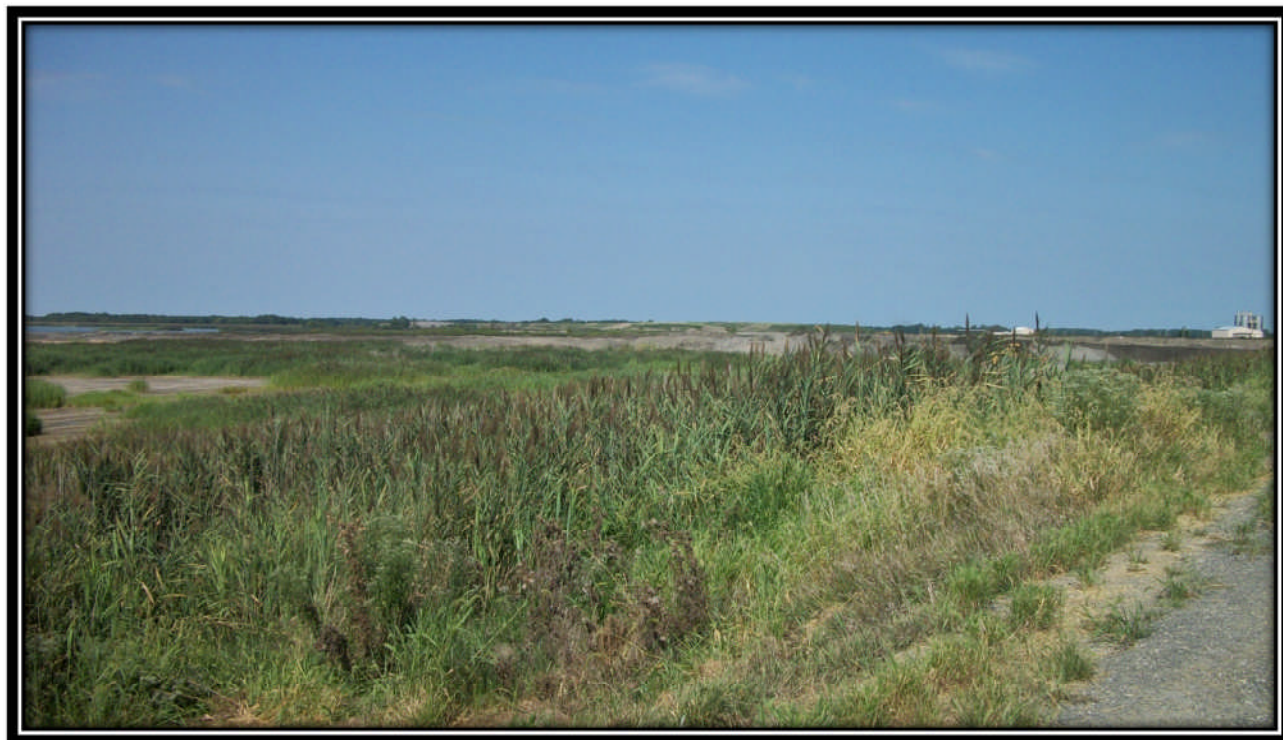
Photo 31 – Primary pond looking South from North embankment

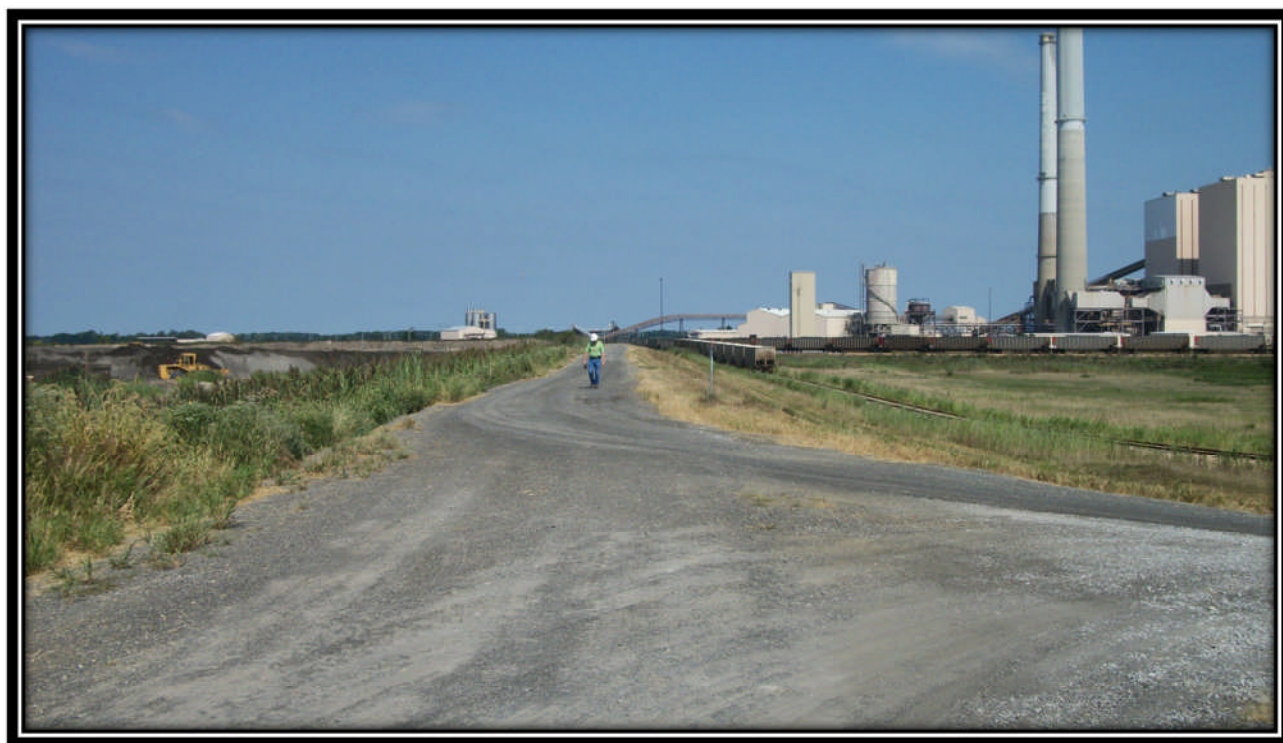
Photo 32 – Looking West along North embankment
