## Coal Combustion Waste Impoundment Round 7 - Dam Assessment Report

Rush Island Power Station Ameren Missouri Festus, Missouri

Dewberry & Davis, LLC Fairfax, Virginia

Under Contract Number: EP-09W001727 June 2011

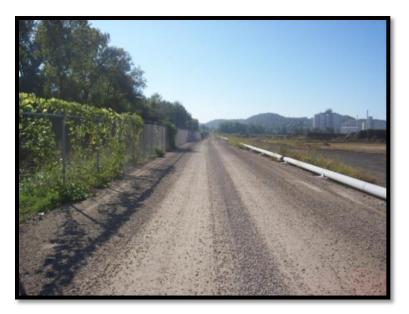
The crest of the ash pond showed no signs of significant depressions, tension cracks or other indications of settlement or shear failure. Figure 5.2.1-1 shows the typical crest condition of the embankment.

Figure 5.2.1-1: Typical crest condition of embankment, South.

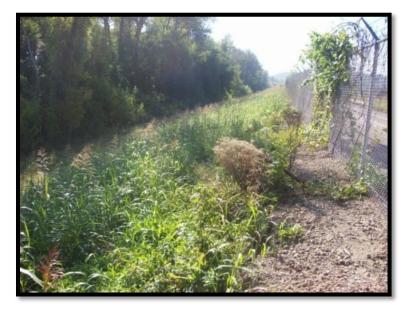
The external embankment has medium to heavy vegetative cover ranging from tall grass to trees. Some areas along the embankment were observed to have minimal grass cover and signs of minor erosion due to roadway runoff or the use of maintenance equipment. There were no scarps, sloughs, bulging, cracks or depressions observed along the embankment indicating slope instability. No evidence of spills, release or performance related problems could be found through field observations. The pond borders the Isle du Boise Creek on the southern portions of its embankment. A five foot bench between the banks of the creek and the toe of the pond embankment exists. This area was covered by medium to heavy vegetation. Figure 5.2.3-1 shows the conditions of the external embankment.

Figure 5.2.3-1: Ash pond external embankment with medium to heavy vegetative cover, Southeast.

A need for slope maintenance for the external embankment is necessary to limit the growth of vegetation and facilitate visual dam inspection. It should be noted that in 2006, the Corps of Engineers armored with rip-rap the entire length of the Isle du Boise Creek bank adjoining the ash pond. Careful consideration should be taken in monitoring signs of erosion of the ash pond external embankment due to flood waters of either the Isle du Bois Creek or the Mississippi River.

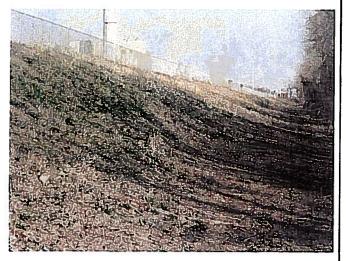
In the vicinity of station 30+00 the toe of the levee embankment slope has been eroded away to form a steep slope about 5 feet high. The surface has no erosion protection. This is shown in the photo to the right. In the event of a Mississippi river flood continued erosion could occur that would not be able to be observed through the flood waters, and the slope could fail. This eroded area needs to be rebuilt and rip-rapped. A similar section occurs about 80 feet south of the discharge platform bridge that also needs to be reshaped and rip-rapped. The rock rip-rap should be placed on either a bedding layer, or a separation layer of non-woven filter fabric. The finish face of the entire slope should be built to

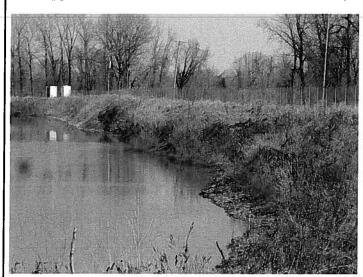
Wave action style erosion has steepened the internal slopes of the east and south sides of the polish pond from approximately stations 33+00 to 50+00. In many cases the erosion has created slopes as steep as

1H:1V, and along the east shore the erosion is within 10 feet of the edge of the roadway. A photo is shown on the left of this discussion.

The slope stability study has shown that the steady seepage condition is the most critical for the existing external slopes. The internal slopes have to be re-built with soils to a minimum 2H:1V slope to meet the seepage analysis assumptions. These slopes should also be rip-rapped after rebuilding to protect against recurrence of the wave erosion.

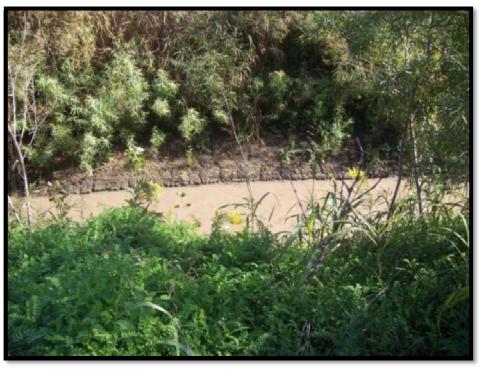
**Figure 15:** Downstream embankment of ash pond at Isle du Bois Creek. (High water noted during assessment. There is a 5' bench from toe of embankment to creek.)

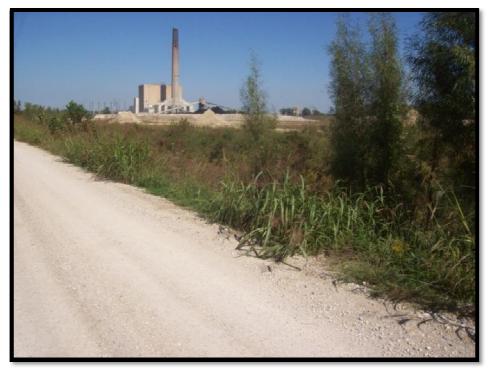
**Figure 16:** Vegetative growth adjacent to top of ash pond embankment, North. (A contract is in place to clear trees.)
