**Re: Ameren Missouri  
Sioux Power Station  
Response to Dewberry & Davis Final Coal Combustion Waste Impoundments  
Round 7 – Dam Assessment Report**

July 29, 2011

RE: Ash Pond Stability Recommendations  
Sioux Power Station

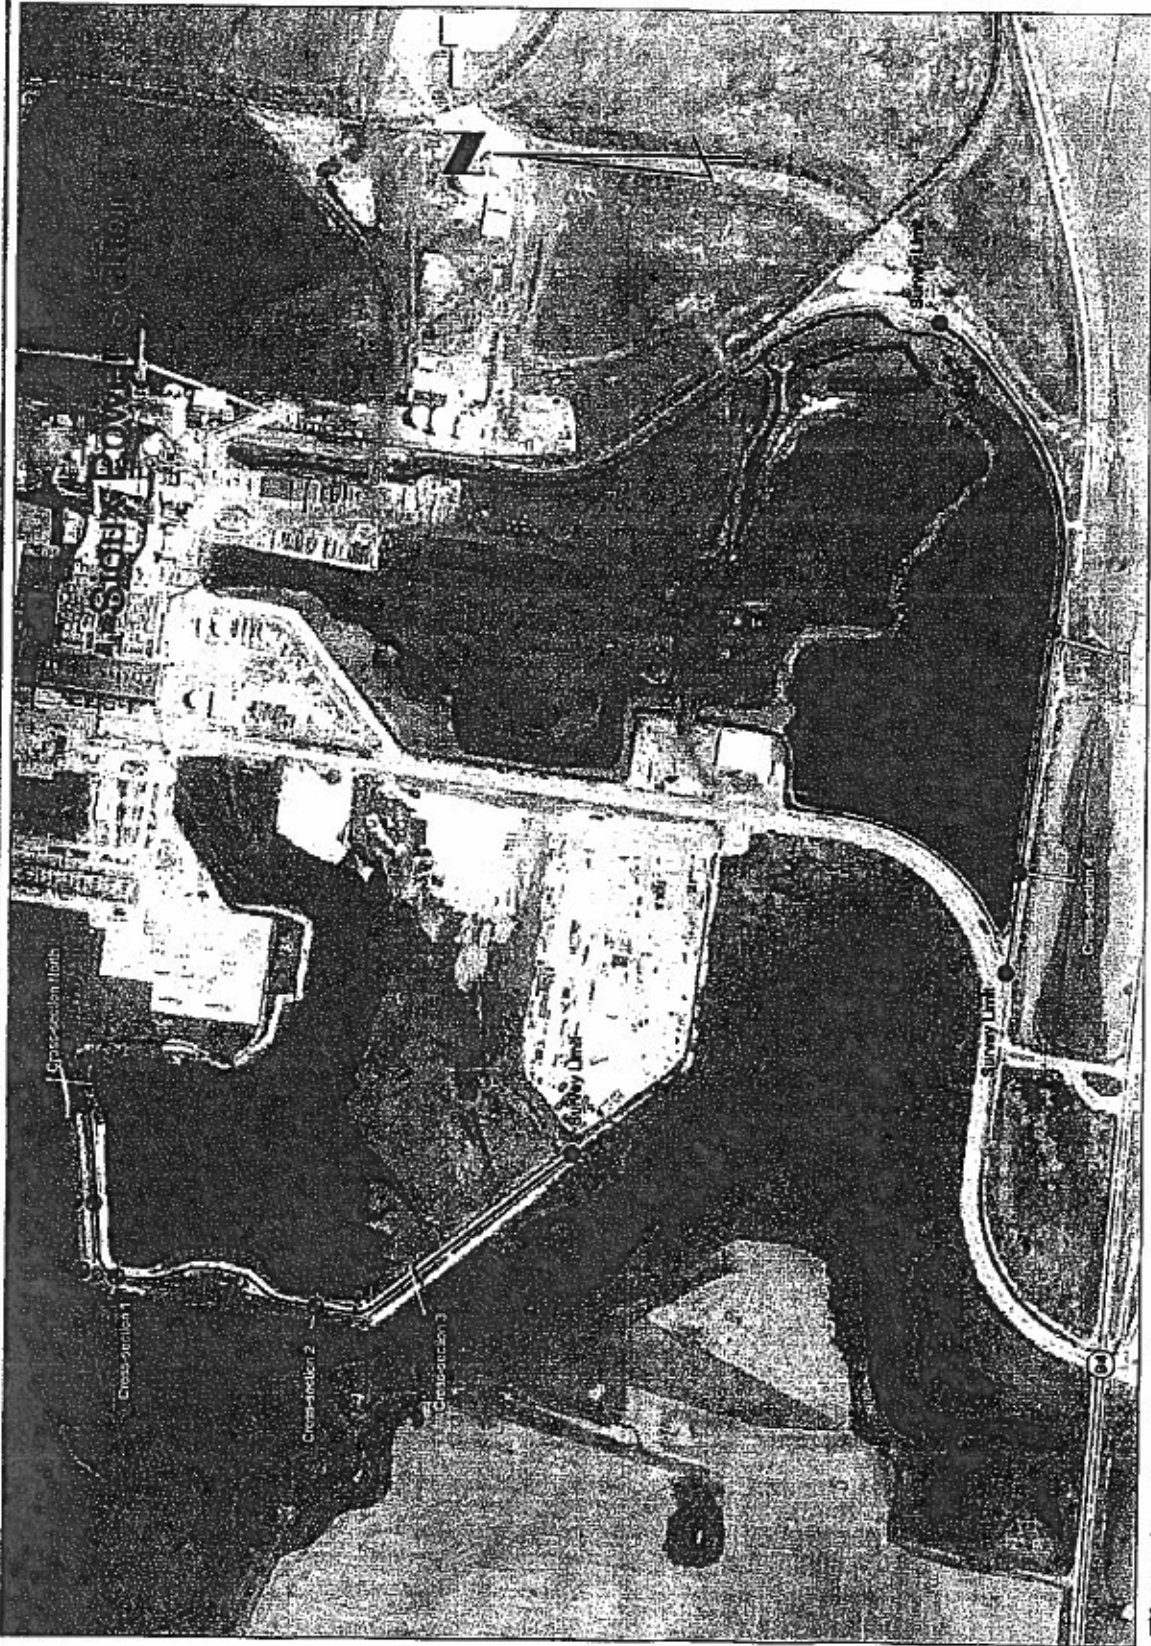
Figure 1

Attached to this letter are graphical depictions and summaries of slope stability analyses for three cross-sections. The attached stability analyses results show the FS for the existing exterior slopes of the embankment cross-sections and, if applicable, for the modified cross-sections. The full pool was assumed to be at el. 434.5 in our analyses, with a linear phreatic surface through the embankments. The locations of the cross-sections are shown in Figure 1.

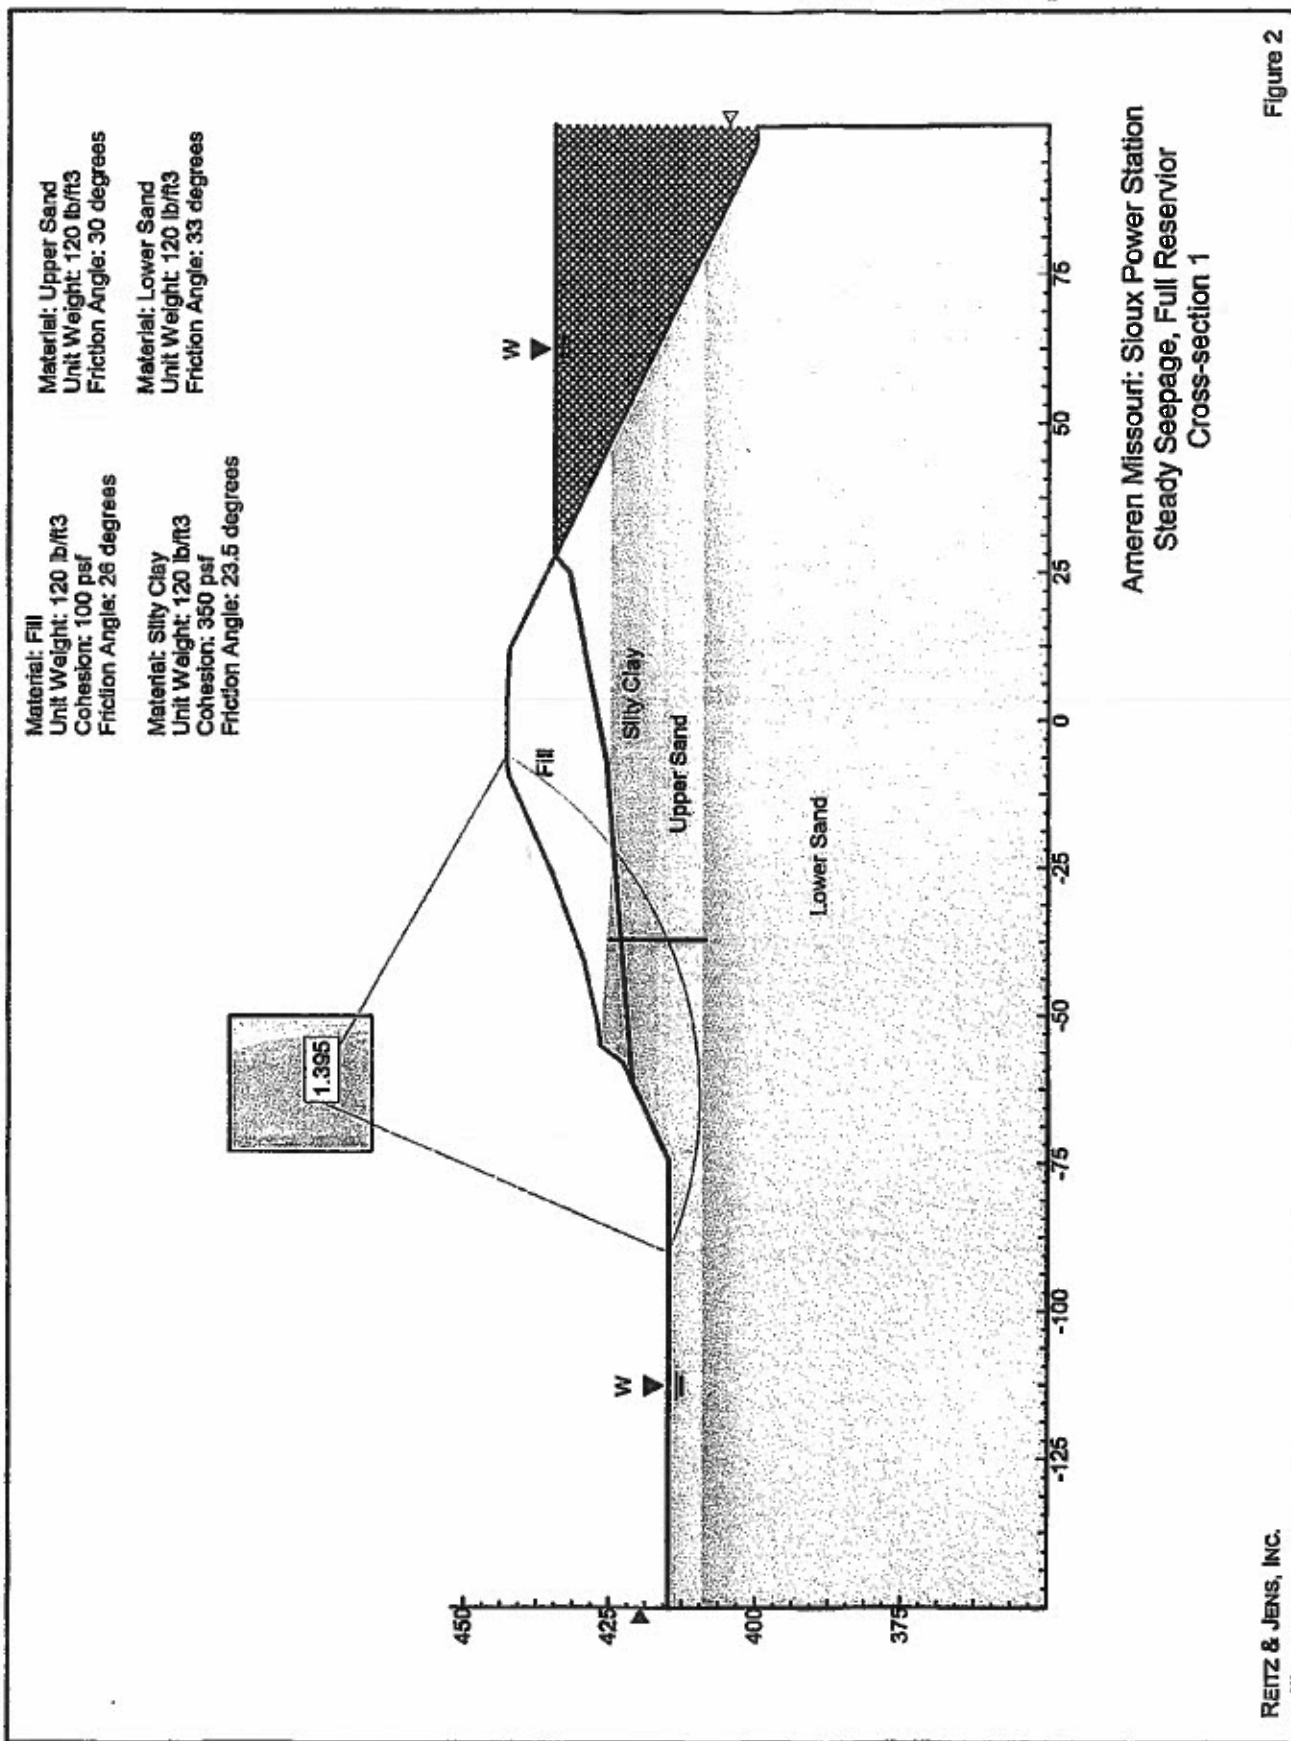
Ameren Missouri: Sioux Power Station  
Steady Seepage, Full Reservoir  
Cross-section 1

Reitz & Jens performed analyses of the Sioux Power Station ash pond embankments in November 2010, and found two areas of the Bottom Ash Pond which had factors of safety (FS) less than 1.5 for full pond (“reservoir”), steady-state seepage, and long-term (drained) shear strength properties. Ameren Missouri asked Reitz & Jens to re-analyze these areas and to provide recommendations for increasing the FS to 1.5 or greater for those areas where the FS is now less than 1.5.

Cross-section	Factor of Safety	
	Existing Long-term	Improved Long-term
1 (Northwest)	1.40	1.64
North (Northeast)	1.32	1.52
2 (West)	1.51	N/A

For cross-section 1, we recommend constructing a rock wedge along the adjacent slope of the drainage channel slope to increase the FS to 1.5. The rock wedge should be a minimum of 3 feet thick and built to a maximum 2H:1V slope where the slopes of the drainage channel are higher or steeper than the drainage channel slope shown in cross-section 2. A 17-foot wide by 4-foot thick stability berm is recommended for the north cross-section to achieve a minimum FS of 1.5. The extent of these stabilization measures should be determined by a topographic survey of the area.
