Subject: EPA Comments on Ameren UE, Sioux Power Station, West Alton, MO
Round 7 Draft Assessment Report

**Re: Ameren Missouri
Sioux Power Station
Response to Dewberry & Davis Draft Coal Combustion Waste Impoundments
Round 7 – Dam Assessment Report**

RE: Ash Pond Dam Stability Analysis
Sioux Power Station

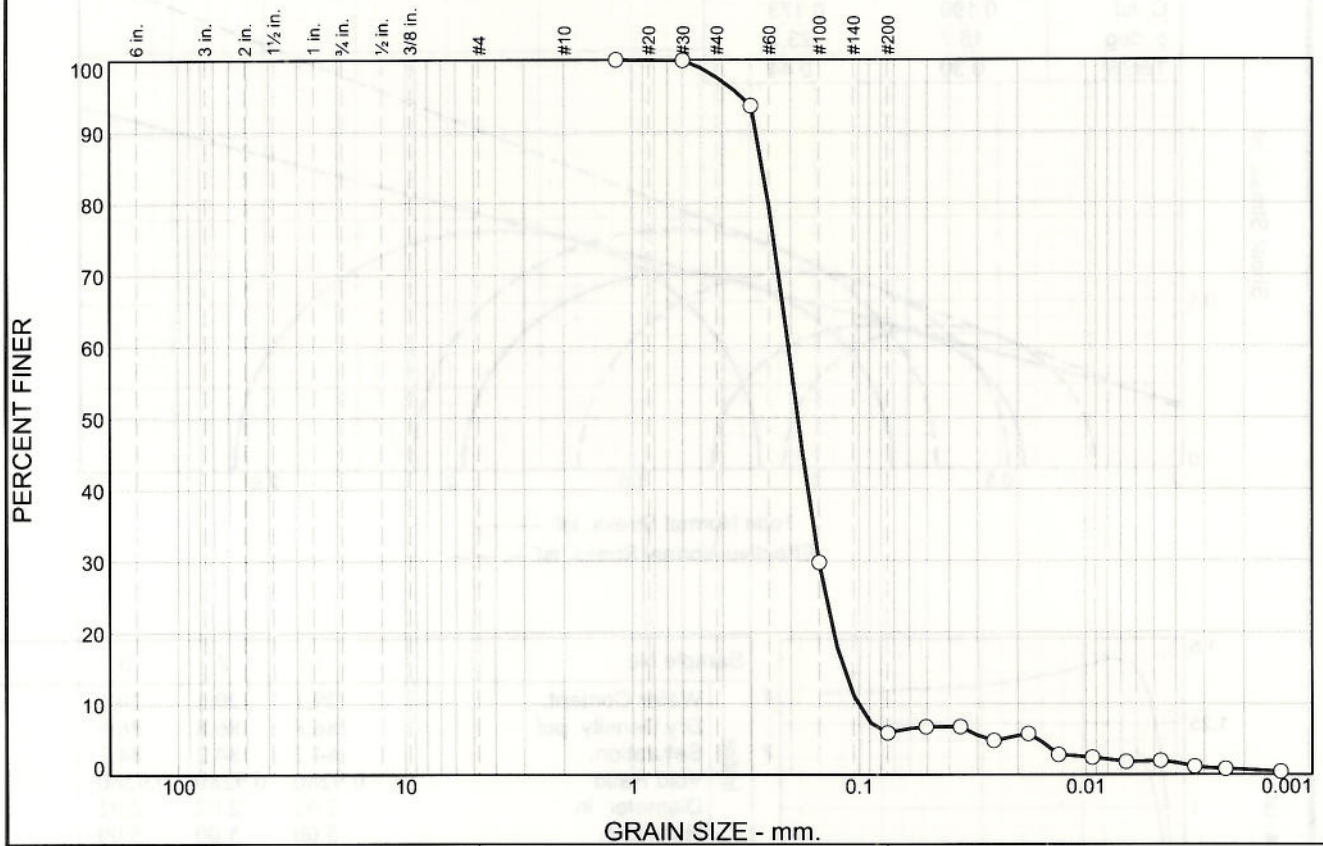
Figure 2-7

The seepage area with concentrated flow was observed making sediment and a sample of the sediment yielded was obtained. The grain size of the sediment was quantified and is provided in Figures 2-7 to 2-10. A sandbag ring was constructed around the area with concentrated flow to provide estimates of flow rate, qualitatively estimate the sediment yield and slow the transport of sediment. The flow rate was measured with a 90° v-notched weir at 3 stages of the sandbag construction, or three different ponding levels above the seep. The bottom ash pond level was at approximately elevation 434 feet (roughly 1 to 2 feet lower than normal because of a plant outage) or 15 feet the elevation of the seep. The flow measurements are approximate due to seepage through and under the sandbags, but are a reasonable

Observations of the seep show that the sediment yield is intermittent. The history of the seepage area is unknown. We recommend constructing an inverted filter over the bank of the seepage area to help stop the migration of fines from within the embankment. The details of the filter are presented in Appendix C. The filter should generally consist of a two foot thick base layer of coarse sand above the existing ground surface. The coarse sand should be overlain with a two foot intermediate layer consisting of gravel. Four feet of rip rap is recommended at the surface of the filter to protect against wave and current erosion. The recommended gradations for the coarse sand, and gravel and rip rap are presented in Appendix C. A sketch of the approximate location, limits of the filter and a typical cross-section of the filter are also presented in this appendix.

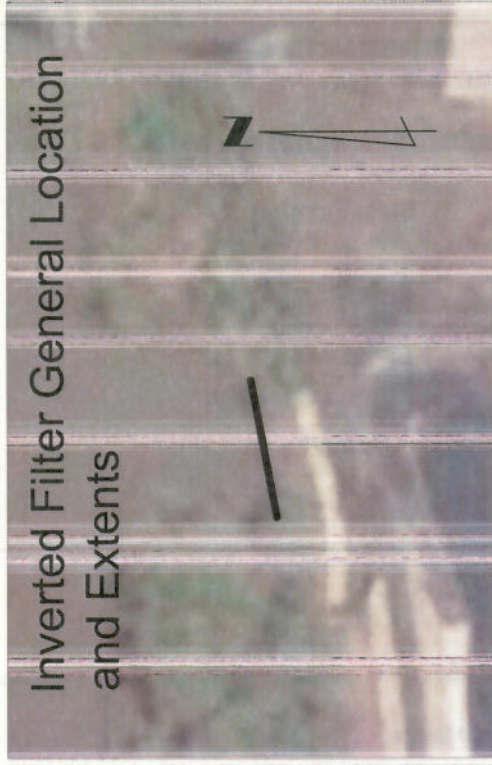
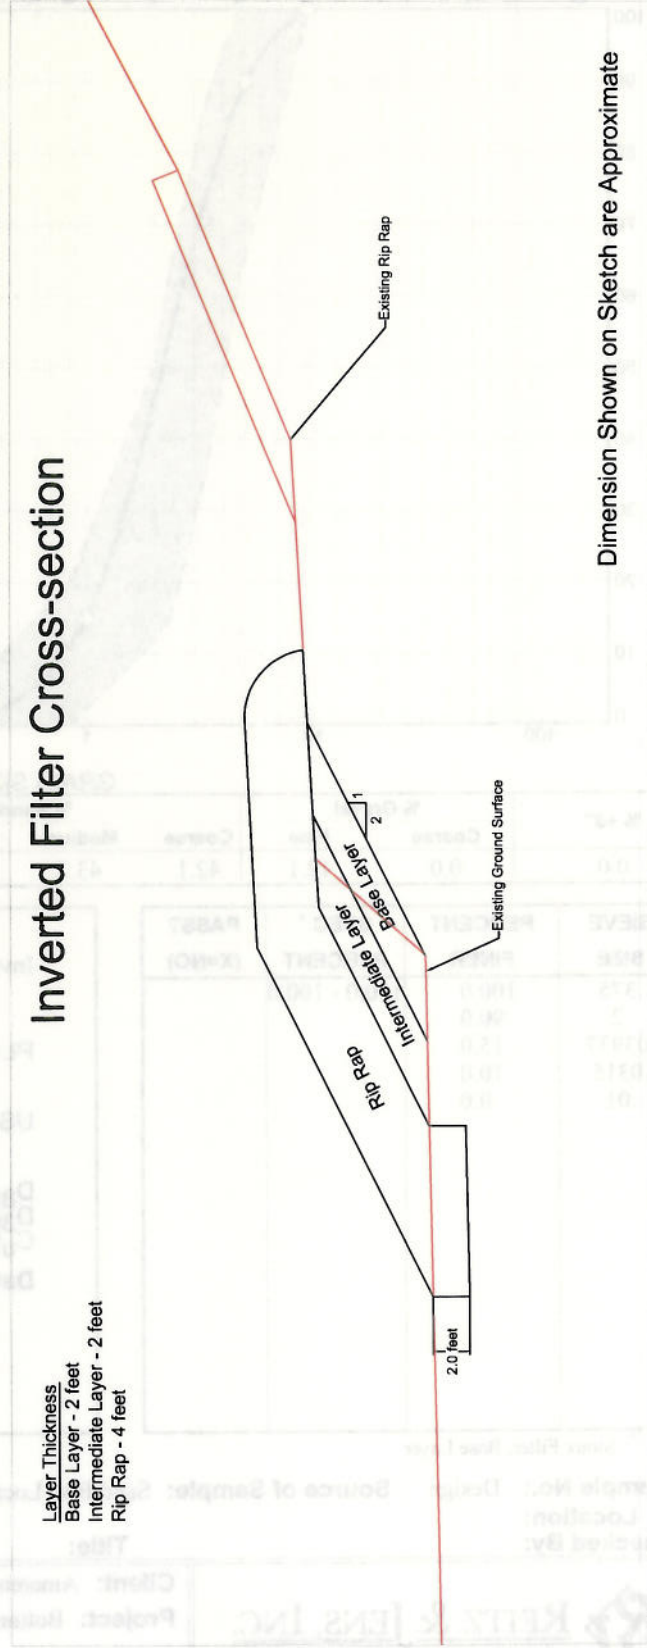
Sioux Power Station Inverted Filter General Location and Extents Cross-section

During the initial stages of this project RJ was made aware of a seepage area near the toe of the embankment close to the northeast corner of the bottom ash pond. The scope of this project was expanded to analyze and monitor the seepage, and provide recommendations for the remediation of this area. The seepage area consisted of one area with concentrated or “piping” type flow. In the same area, several “pin” type seeps were also observed flowing at the same time as the larger seep.

An inverted filter should be constructed over the downstream bank were seepage has been observed. The details of the inverted filter are provided in Appendix C. Monitoring of the seepage area should be continued. A densification program is recommended to remediate any potential voids caused by the transport of fines.

- Layer Thickness
- Base Layer - 2 feet
- Intermediate Layer - 2 feet
- Rip Rap - 4 feet
