Coal Combustion Waste Impoundment

Round 7 - Dam Assessment Report

Sioux Power Station (Site #001)

AmerenUE

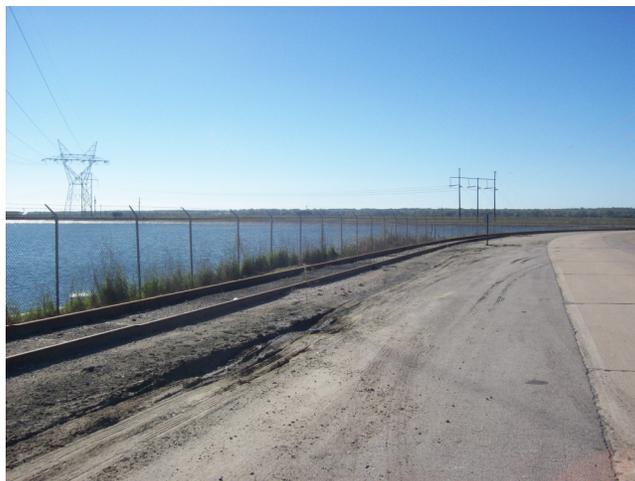
Figure 5.2.1-1: Photograph of Fly Ash Embankment, View to the South

The crest of the embankment had no signs of significant depressions, tension cracks, or other indications of settlement or shear failure. Figure 5.2.1-1 shows the crest along its western boundary. The railroad and access road to the plant form the embankment. In this area the embankment is quite wide, approximately 75 feet in width.

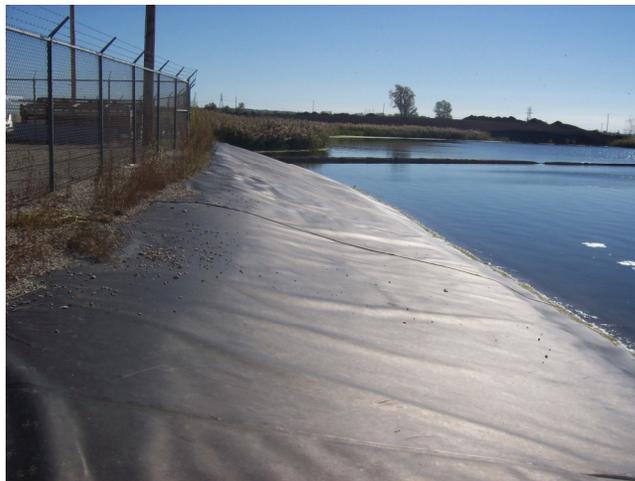
Figure 5.2.2-1: Photograph of Upstream/Inside Slope of Fly Ash Pond, View Looking East

According to the Reitz & Jens, Inc. 2007 Phase I Sioux Plant Report provided by AmerenUE, the Fly Ash Pond was lined with a 60-mm thick HDPE liner in 1993. There were no observed scarps, sloughs, bulging, cracks, depressions or other indications of slope stability problems. Figure 5.2.2-1 shows a representative section of the upstream/inside slope of the embankment.

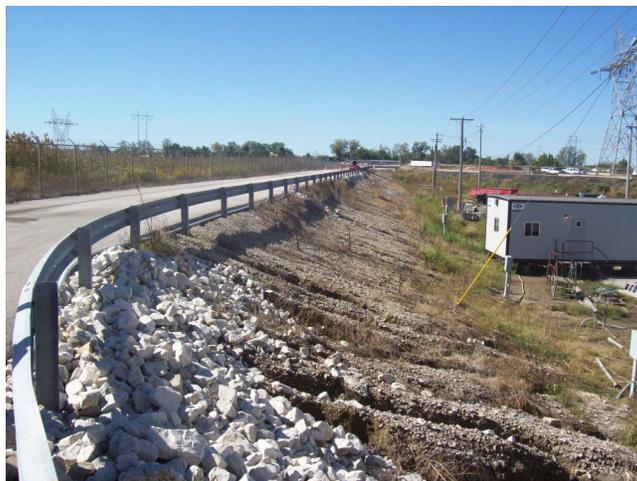
Figure 5.2.3-1: Photograph of Fly Ash Dam Downstream/Outside Slope, View to the South

Areas of surface runoff erosion were observed on the downstream/outside slope of the Fly Ash embankment in parts. Rip-rap has been added to those areas to minimize future erosion and they are monitored for stability on a weekly basis. Figure 5.2.3-1 shows one of the eroded areas near the northwest corner of the embankment.

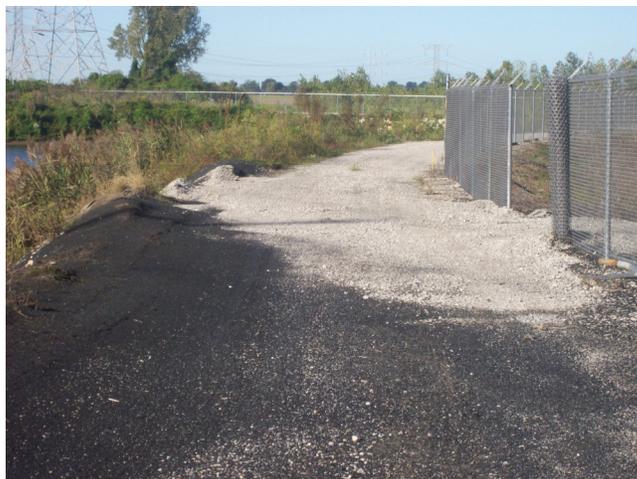
Figure 5.3.1-1: Photograph of Bottom Ash Pond with ash on crest, View Looking West

The crest of the embankment had no signs of significant depressions, tension cracks, or other indications of settlement or failure. There were some areas of erosion which have been overlain with rip-rap to enhance stability. One area of the embankment had obvious signs of ash along the inside slope and crest (Fig. 5.3.1-1).

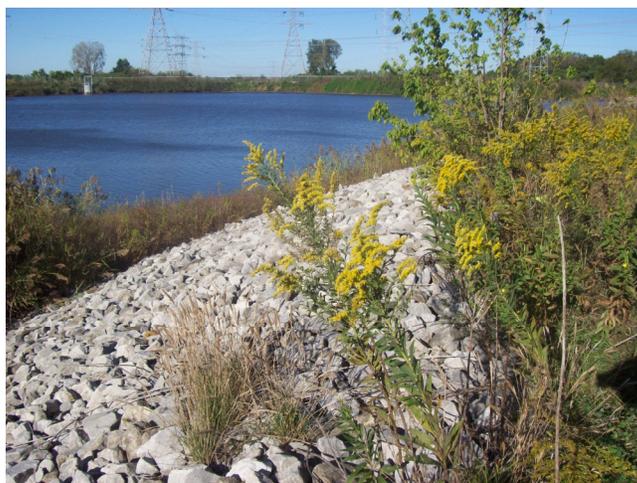
Figure 5.3.2-1: Photograph of Bottom Ash Pond Upstream/Inside Slope, View Looking West

The upstream/inside slope is vegetated with various scrub/shrub species and tall grasses and wildflowers. There were no observed scarps, sloughs, bulging, cracks, depressions, or other signs of slope instability. Rip-rap had been placed along the interior slopes of the northern and northwestern portions of the embankment to enhance stability.

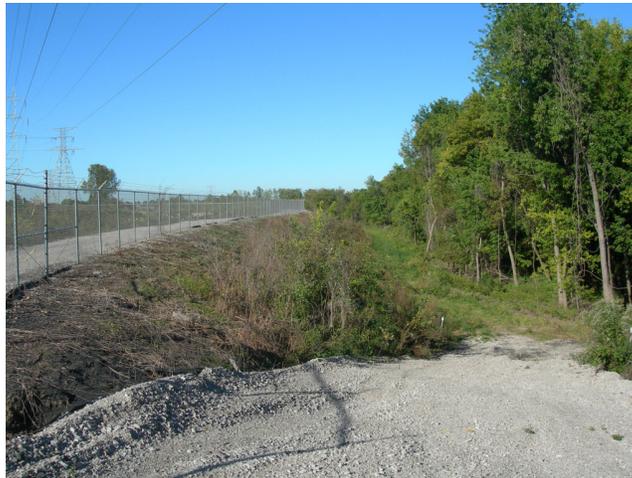
Figure 5.3.3-1: Photograph of Bottom Ash Pond Downstream/Outside Embankment, View Looking North

The downstream/outside slope and toe of the Bottom Ash Pond embankment are covered in various plant species; along the slope are various scrub/shrub plant species and tall grasses and wildflowers, while some larger trees are located at the toe of the slope.

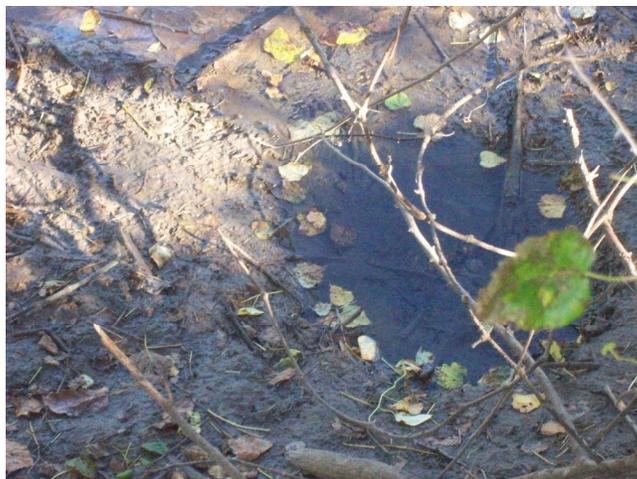
A small seep was observed (Fig. 5.3.3-2) in the northwestern corner of the pond embankment, approximately 75' from the toe of the embankment. The situation is monitored weekly by AmerenUE personnel.

Figure 5.3.3-2: Photograph of clearwater seep emerging 75' from toe of embankment.

- There were no indications of scarps, sloughs, depressions or bulging anywhere along the dam;
- Boils or sinks were not observed along the slopes, groins or toe;
- A small seepage located 75' from the toe of the embankment in the northeast corner of the Bottom Ash Pond embankment was observed, AmerenUE is monitoring the area on a weekly basis, and
- The crest appeared free of major depressions and no significant vertical or horizontal alignment variations were observed.

Continue weekly monitoring of western portion of Bottom Ash Pond embankment for signs of erosion or wave action by adjacent channel as well as monitoring the clear water seep observed in the northeastern corner of the embankment. It is also recommended that removal of the woody vegetation along the bottom ash pond, southeast side, should continue if the filled area is planned to be removed and used as an embankment in the future.

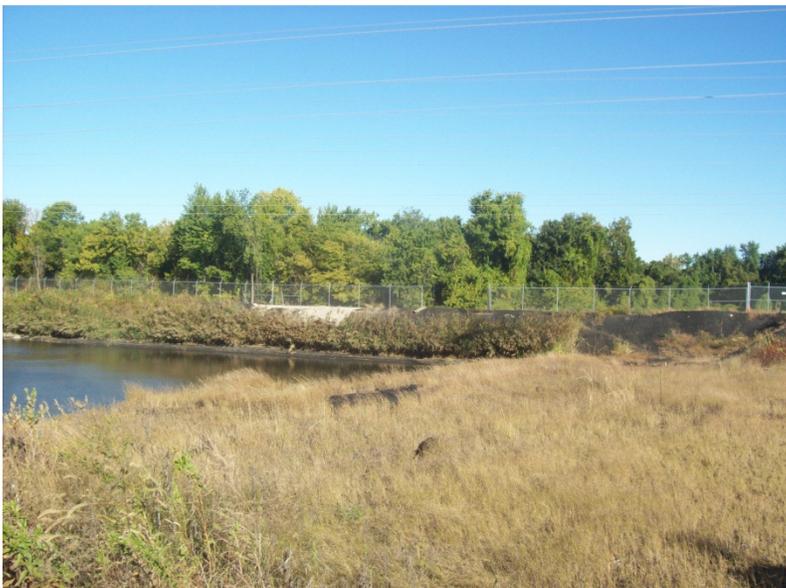
7. Looking at North side and Northeast corner of Bottom Ash Pond.

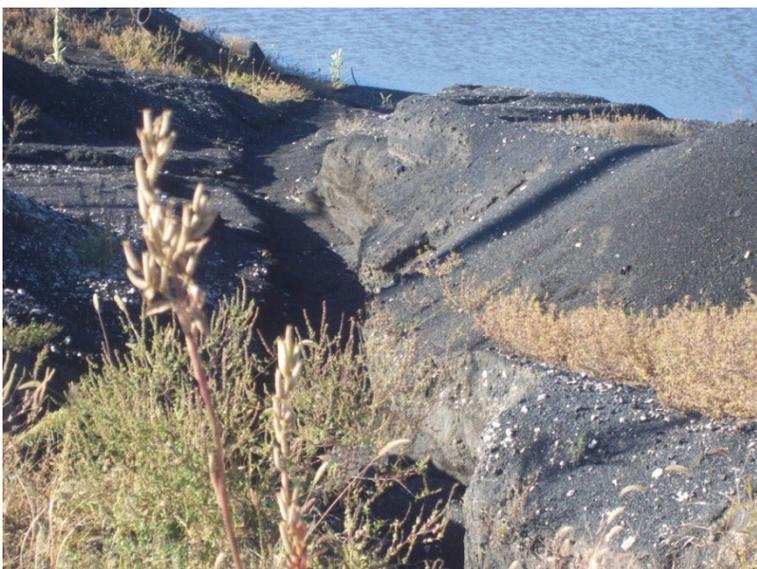
8. Runoff erosion in Bottom Ash Pond.

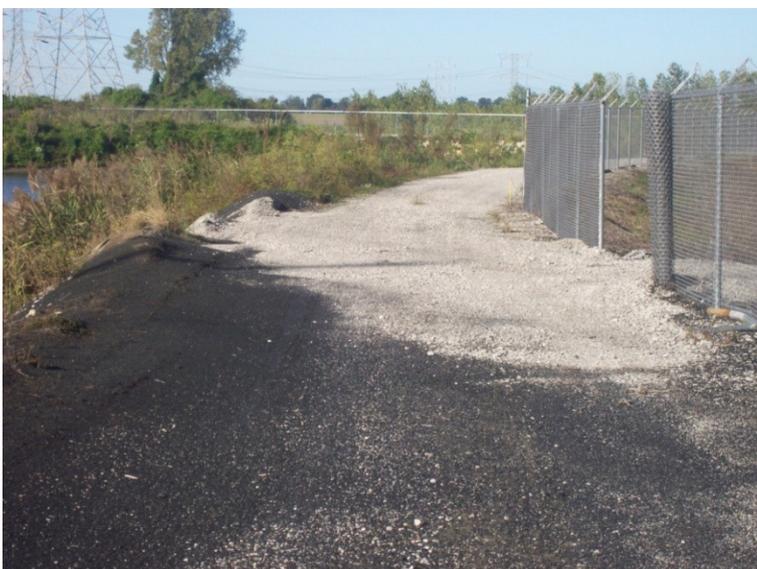
9. Top of embankment looking West.
Note - Bottom Ash along embankment.

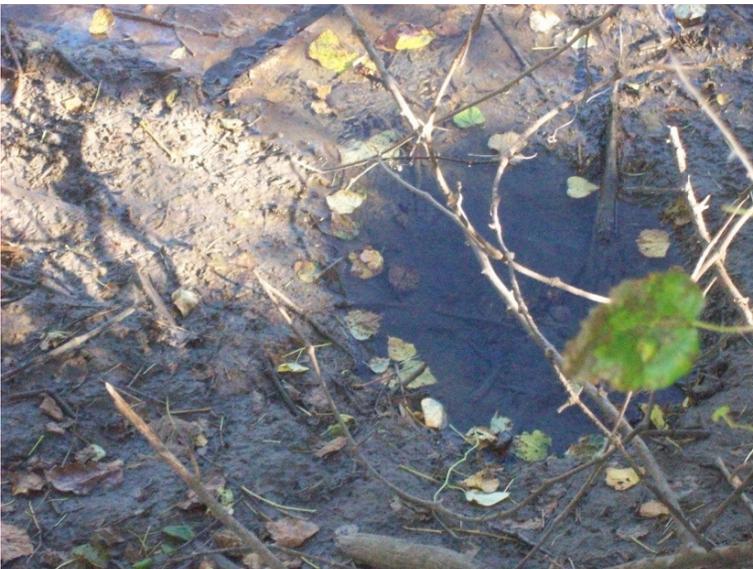
11. Seep location approximately 75' from toe of embankment and flows to the Mississippi River. Note – seep water is clear and being monitored by weekly inspection team.

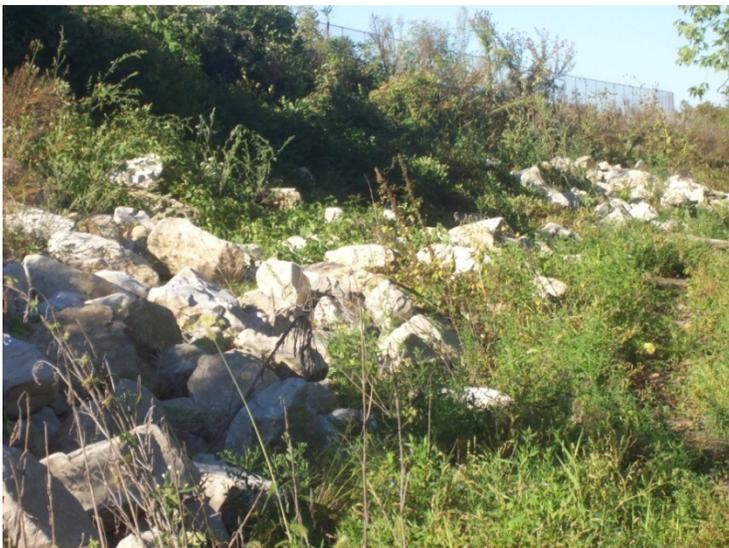
12. Riprap on slope – repair of eroded area.

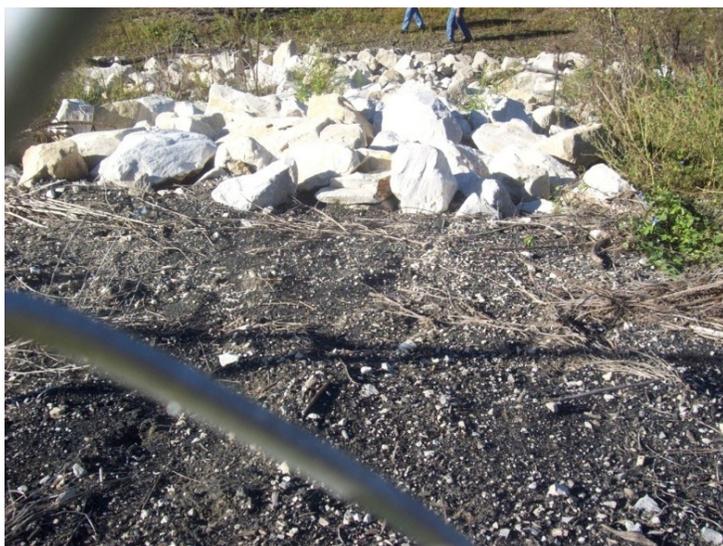
31. Repair of eroded area lined with riprap.

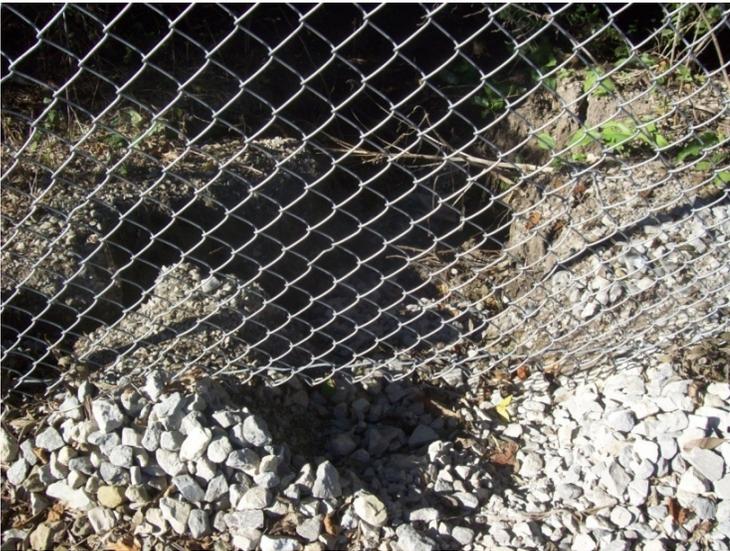
35. Erosion area caused by surface runoff.

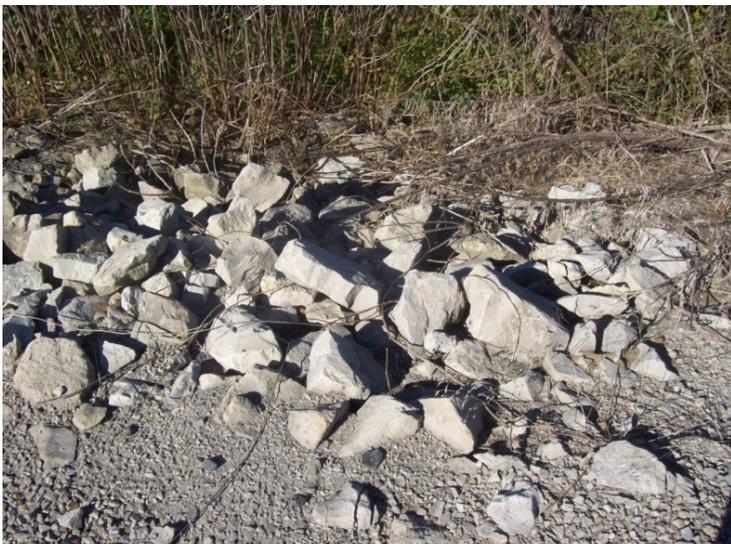
49. Looking at riprap that is used to repair surface runoff erosion.

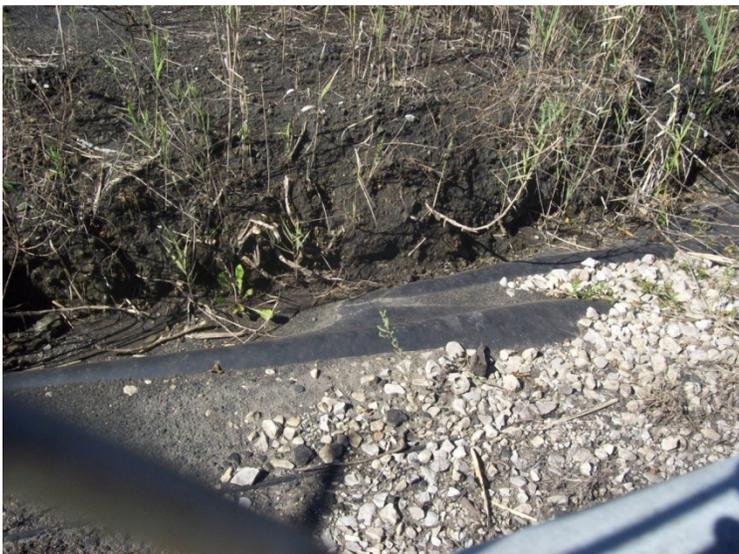
64. Looking at liner under fill material (Fly Ash).

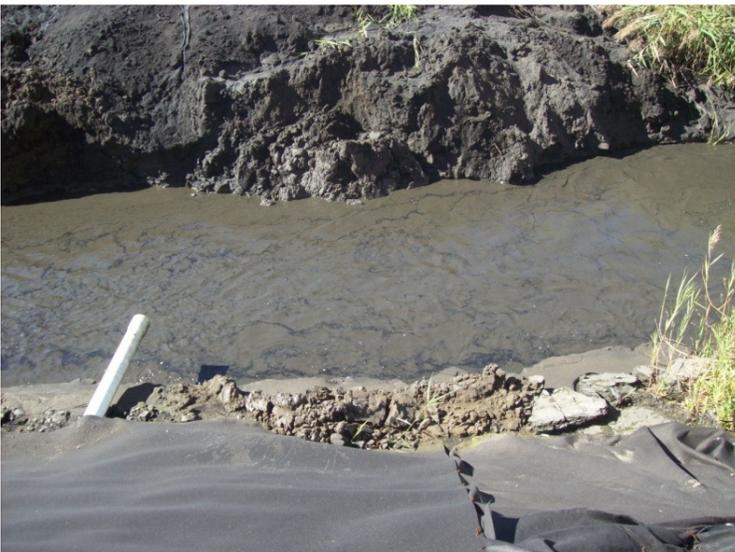
69. Outfall channel – Note - heavy Fly Ash in channel.

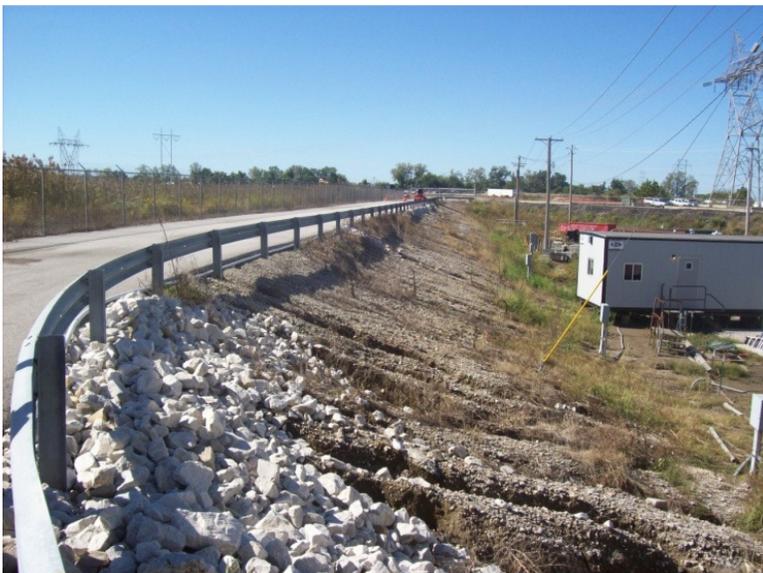
70. Looking along embankment and repair measures addressing runoff erosion.

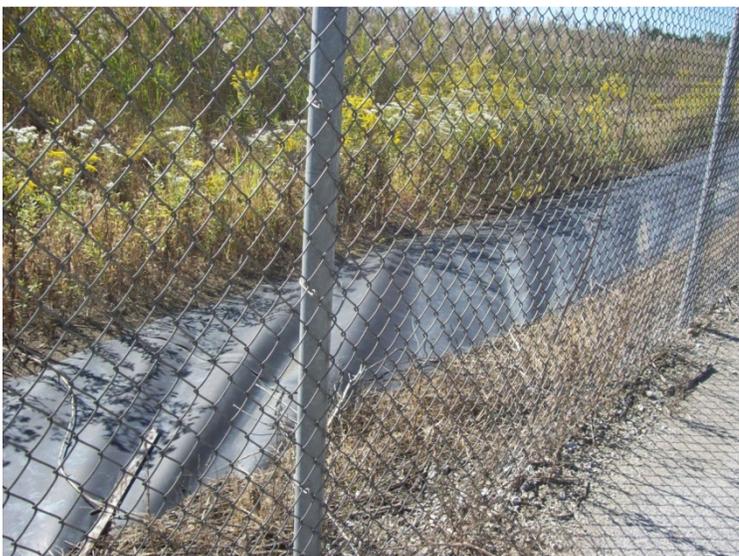
71. Looking at pond embankment and liner. Note - fill material (Fly Ash) over liner.
