FINAL REPORT

Dam Safety Assessment of CCW Impoundments

James M. Barry Electric Generating Plant

December 8, 2010

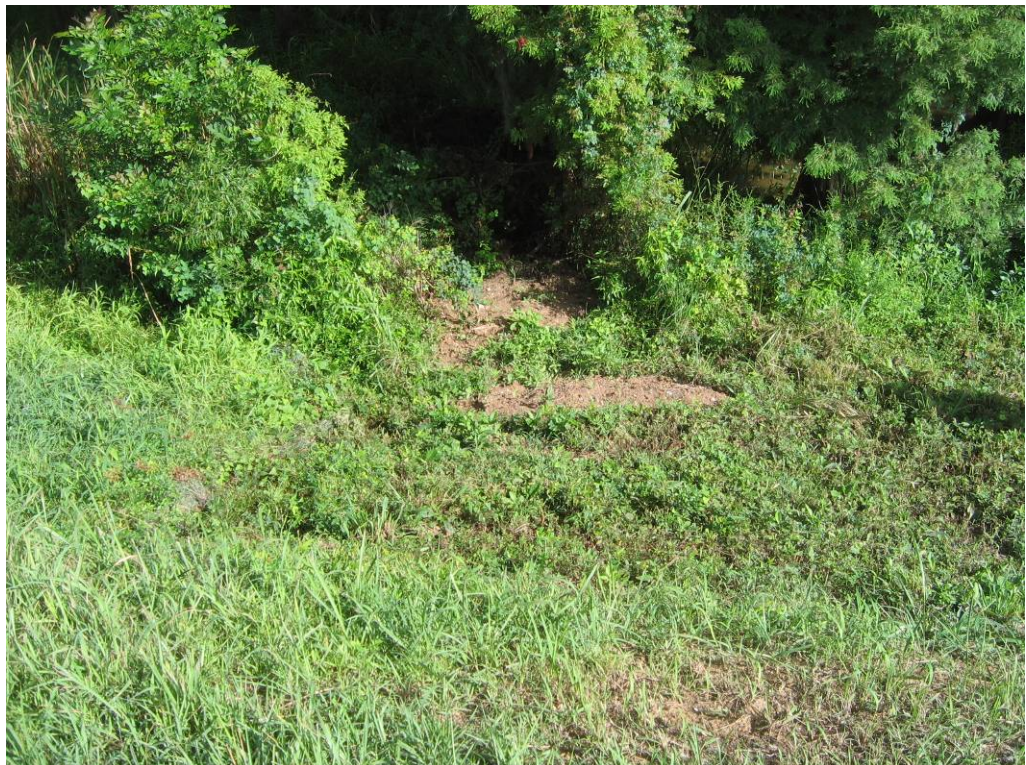
Photo Number:
B2

Mound built up for drill rig to take soil borings. During January 1998 soils investigation for proposed ash pond dike modifications

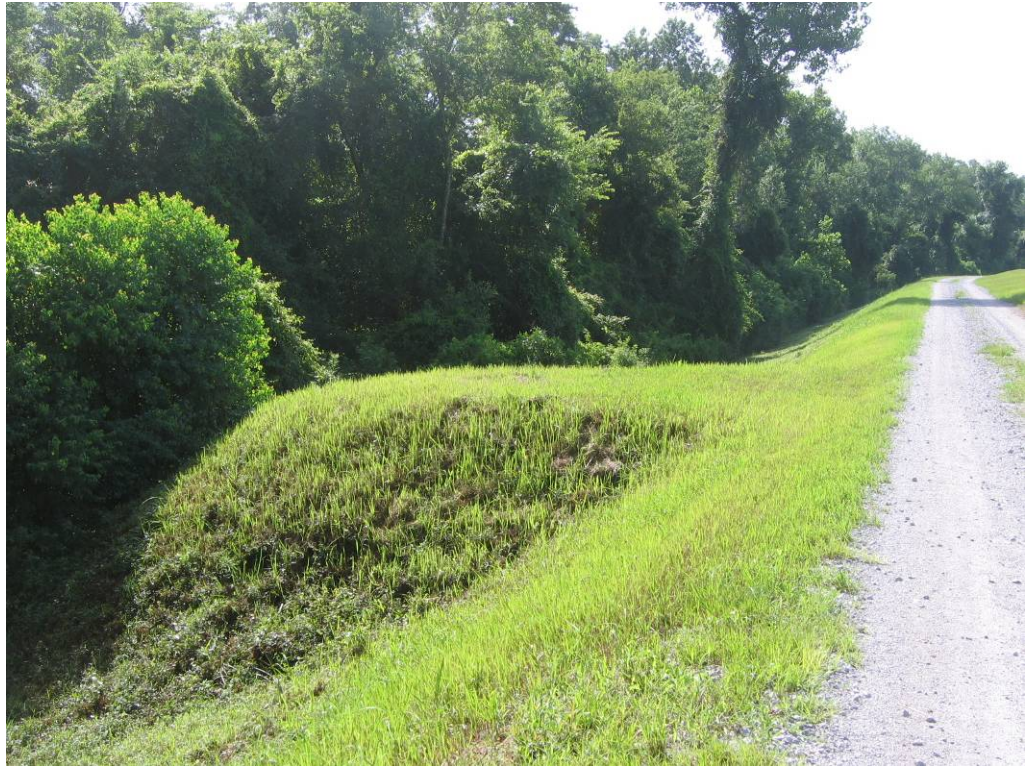
Photo Number:
B3

- A few small animal burrows were noted on the outboard slopes of the eastern embankments due mainly to feral hogs and nutria swamp rats (Appendix B – Photo B3)

Looking southeast along top of east embankment on north side of CCW Management Unit – Note where top of embankment was raised on right side of photo resulting from 1998 Study

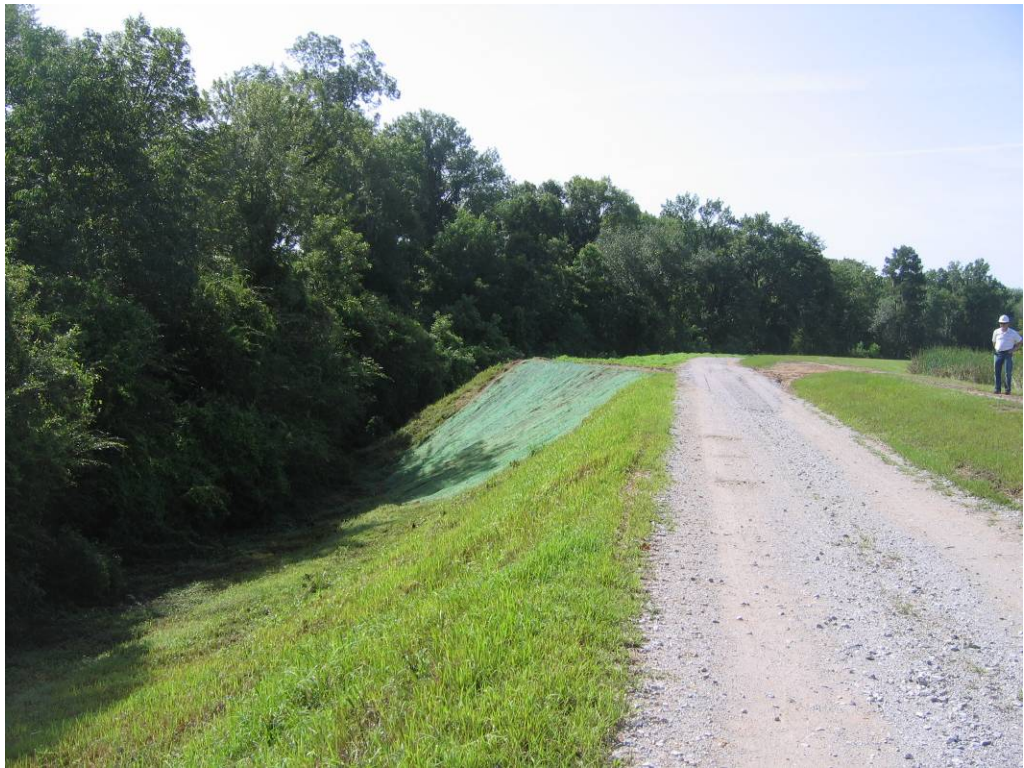
Photo Number:
B5

- There is some minor surficial sloughing at numerous locations and some bulging at locations where recent embankment raising meets previous embankment, but no cracks or scarps were observed in these areas (Appendix B – Photo B5).
- Approximately 5-7 trees on downstream embankment just up from toe of slope near stabilized portion of pond on Northwest end (Appendix B – Photo B23).
- The outlet structure appeared to be in good condition and functioning normally (Appendix B – Photos B12 and B16). Flow over the discharge weirs appeared clear.

Description:
Repair area near outward toe of east embankment slope on east side of CCW Management Unit

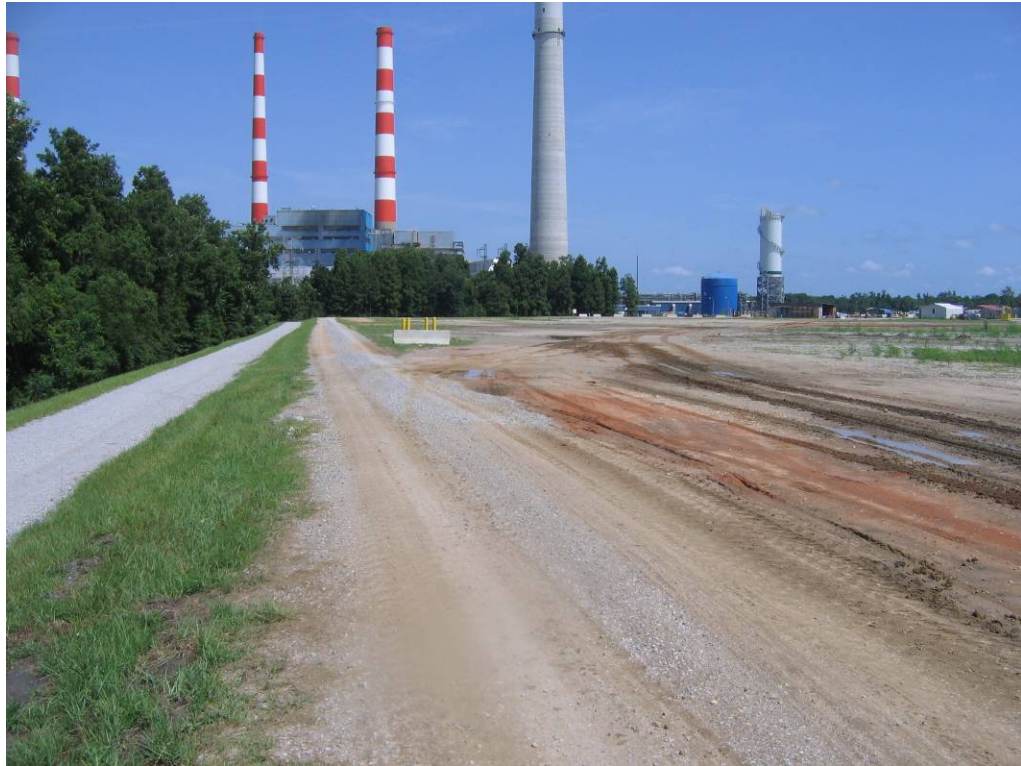
Trees near toe of outward slope of south embankment. This portion of embankment is in area where CCW Management Unit has been closed and stabilized

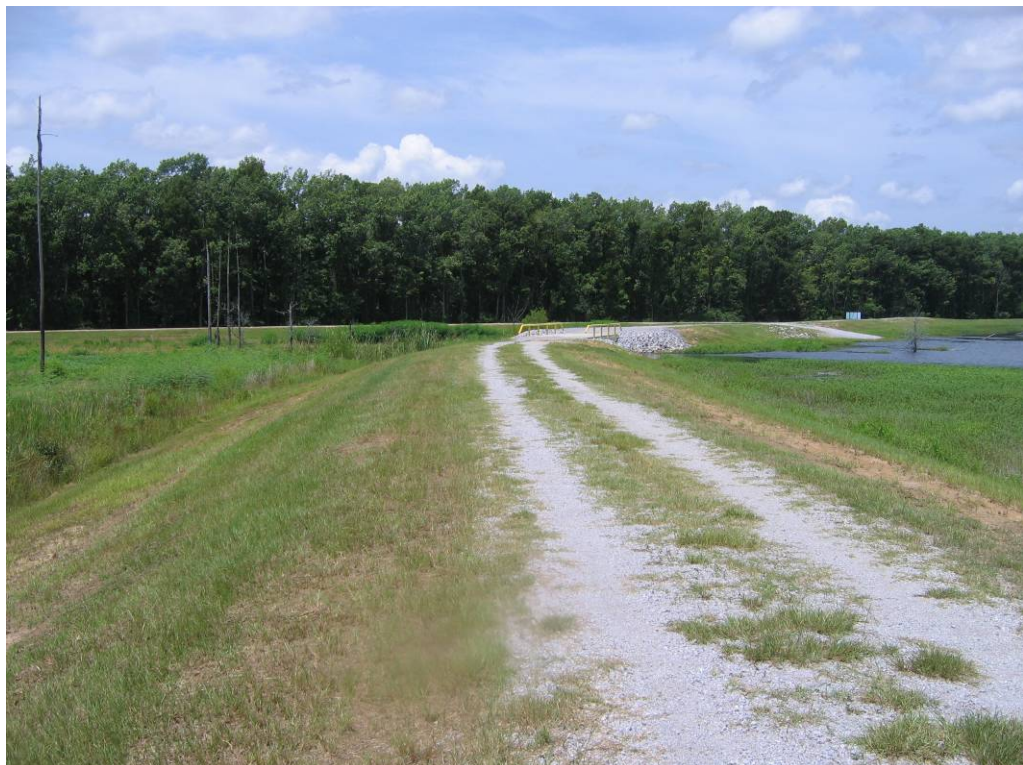
Looking east
along Diversion
Dike from
Primary
Diversion Dike
Outfall – Note
rutting from
machinery on
right side of
photo
