**Coal Combustion Residue Impoundment  
Round 9 - Dam Assessment Report**

*Plant Gadsden*

*Fly Ash Dike*

*Alabama Power Company*  
**Gadsden, Alabama**

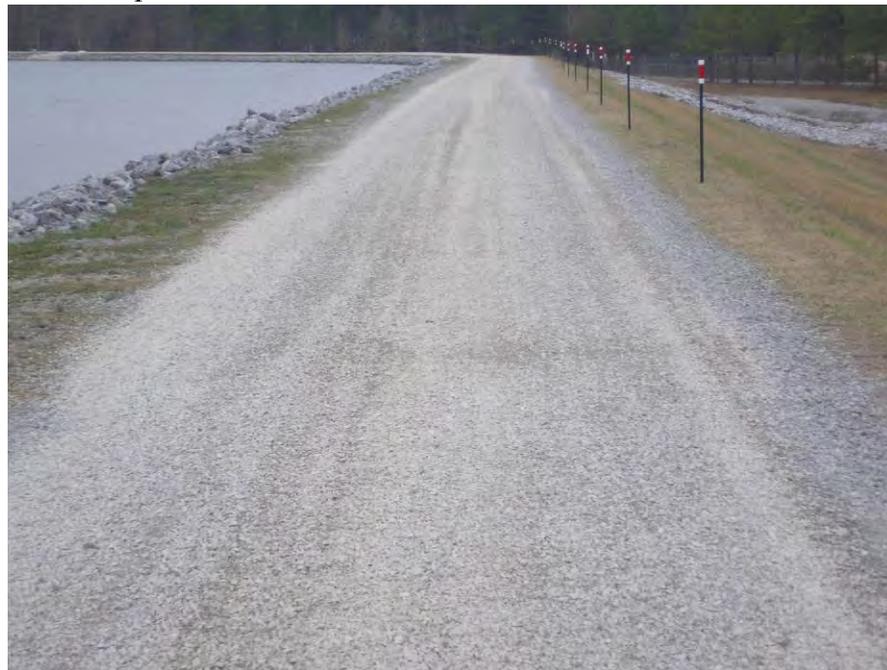
The crest of the impoundment embankment has no signs of depressions, tension cracks, or other indications of settlement or shear failure. Previous inspection reports reviewed by Dewberry did not indicate issues concerning the embankment crest. Figure 5.2.1-1 shows the condition of the lower pond crest.

Figure 5.2.1-1: Lower Pond Crest West End of North Dike

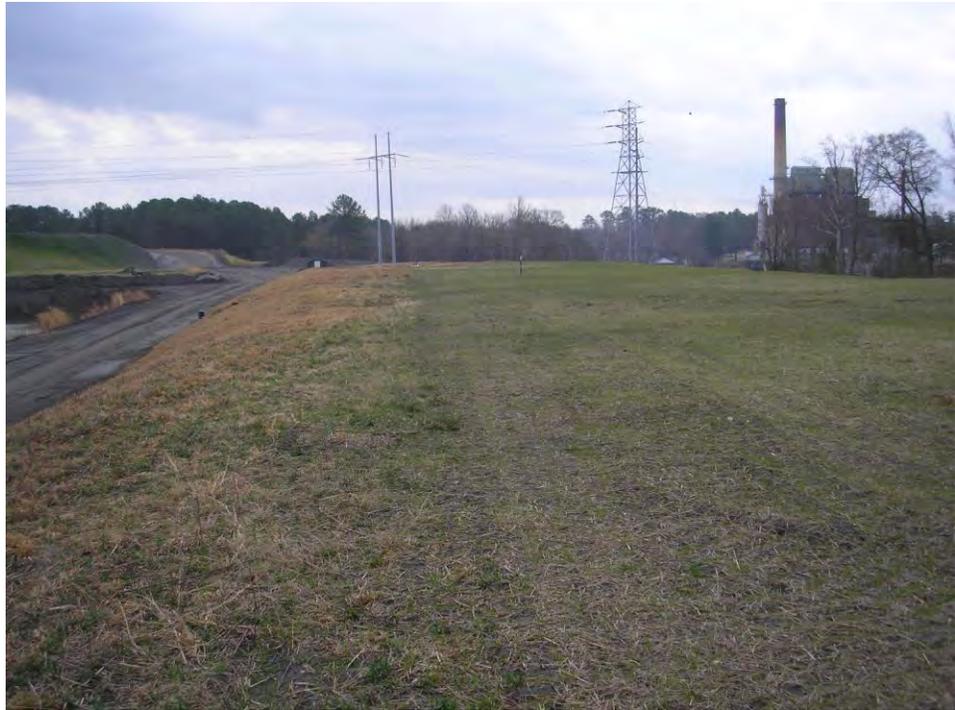
Filling the east end and both sides of the upper ash pond to support storage and handling of dry ash has resulted in there being no water stored against the upper pond embankment. Figure 5.2.1-2 shows the upper pond south embankment crest and inside slope.

Figure 5.2.1-2: Upper Pond Crest and Inside Slope with Ash Fill along Foreground Inside Slope and Stockpiled in Background.

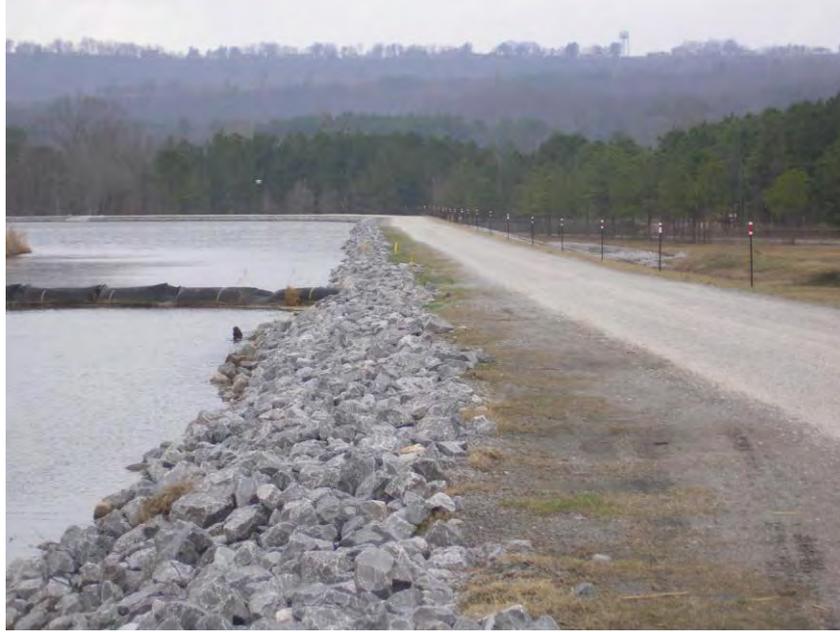
The inside slope of the CCR impoundment lower pond is armored with riprap to protect against wind generated waves. There were no observed scarps, sloughs, bulging, cracks, depressions, or other indications of slope instability or signs of erosion. Figure 5.2.2-1 shows a section of the inside slope of the lower pond.

Figure 5.2.2-1: Lower Pond Interior Slope

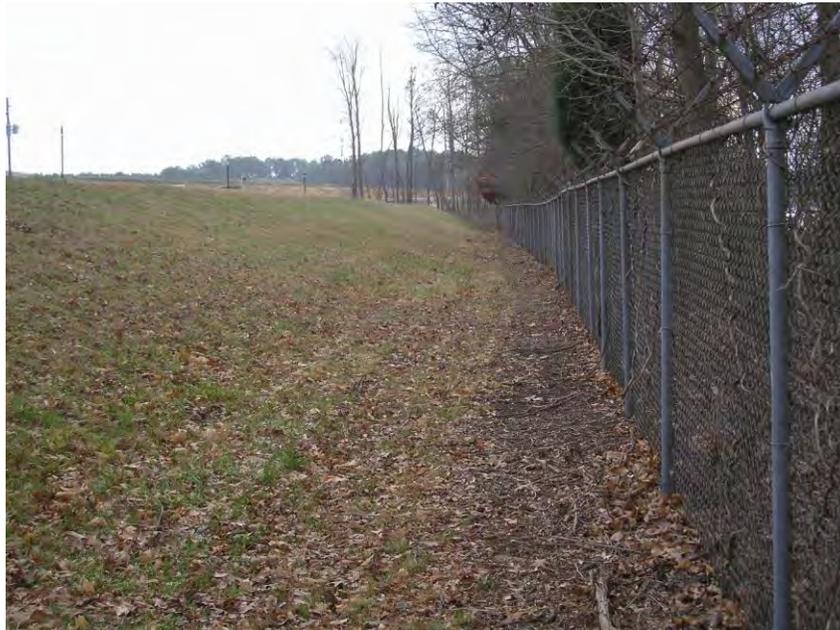
## 5.2.3 Downstream/Outside Slope and Toe

Figure 5.2.3-1: Lower Pond Exterior Slope

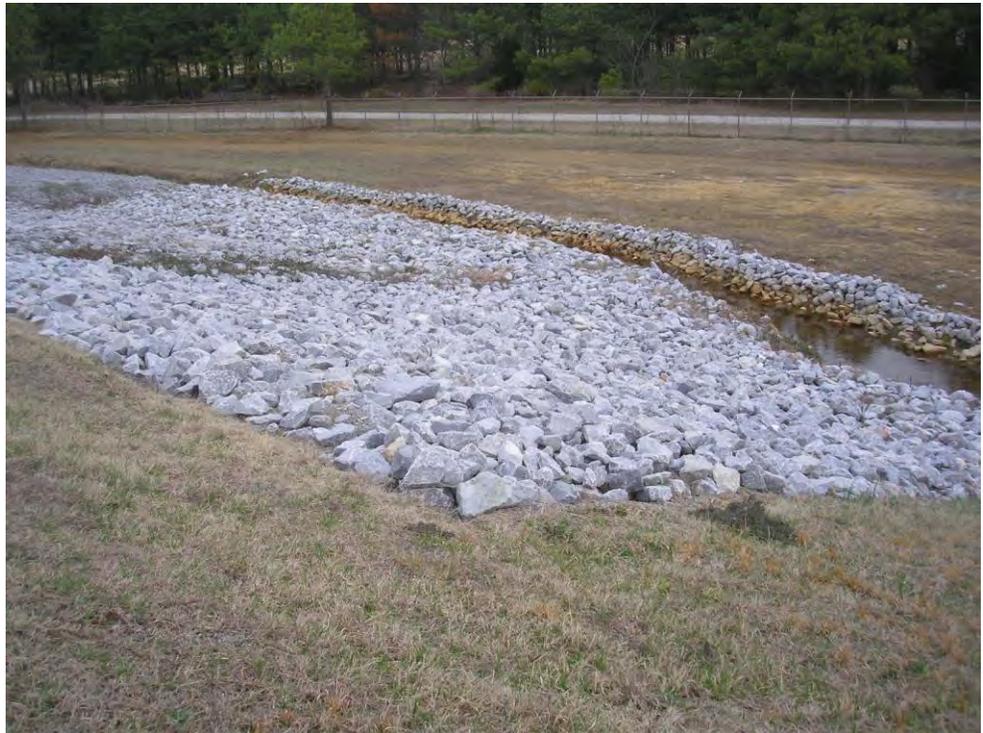
To address an area of potential embankment seepage and poor surface drainage near the toe area at the west end of the lower pond north dike, a riprap filter blanket and riprap lined toe ditch were constructed. Figure 5.2.3-2 shows the slope filter blanket and toe drain ditch. The filter blanket design consisted of a course riprap at the east end and finer riprap to the west as shown in Figure 5.2.3-2.

Water observed in the toe drain ditch was observed to be coming from up-gradient of the filter blanket and appeared to be surface runoff from recent storms in the area.

Figure 5.2.3-2: Lower Pond Exterior Slope Filter Blanket and Riprap Lined Toe Drain

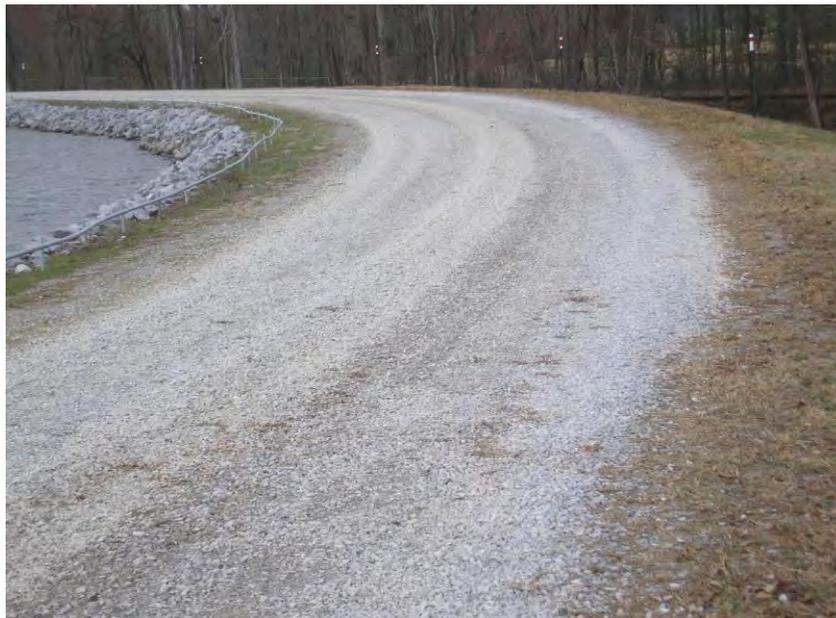
Erosion or uncontrolled seepage was not observed along embankment groins and abutments. Figure 5.2.4-1 shows the interior groin in the northwest corner of the lower pond north embankment. Figure 5.2.4-2 shows the area of the upper pond east abutment of the south dike.

Figure 5.2.4-1: Lower Pond East Embankment Interior North Groin

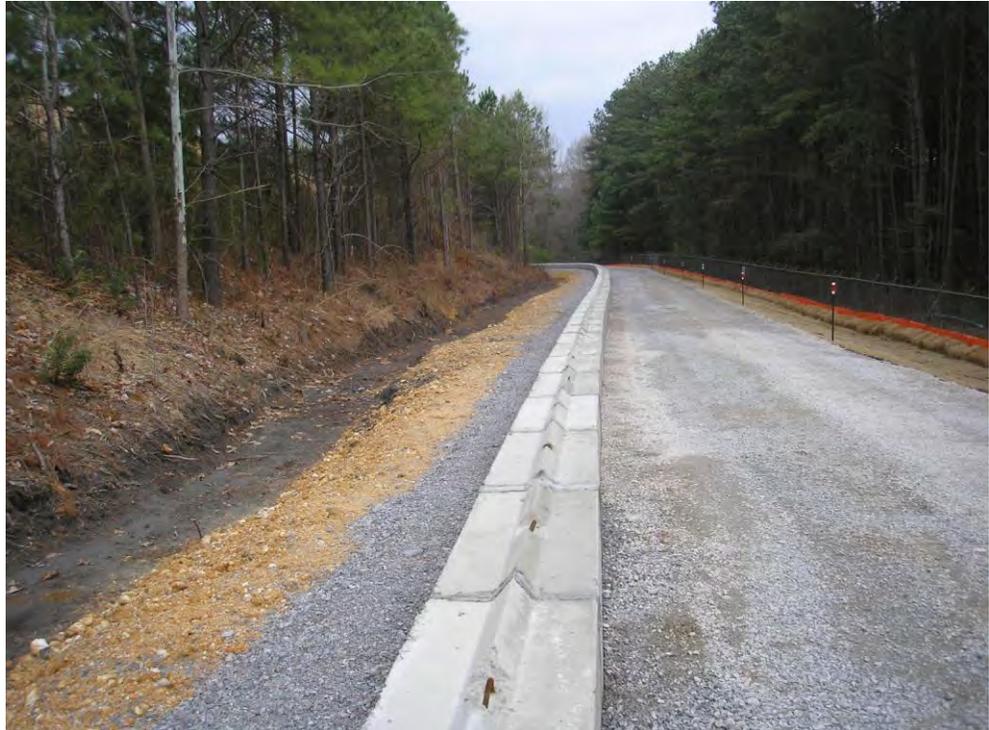
Figure 5.2.4-4: Upper Pond South Embankment Abutment Area

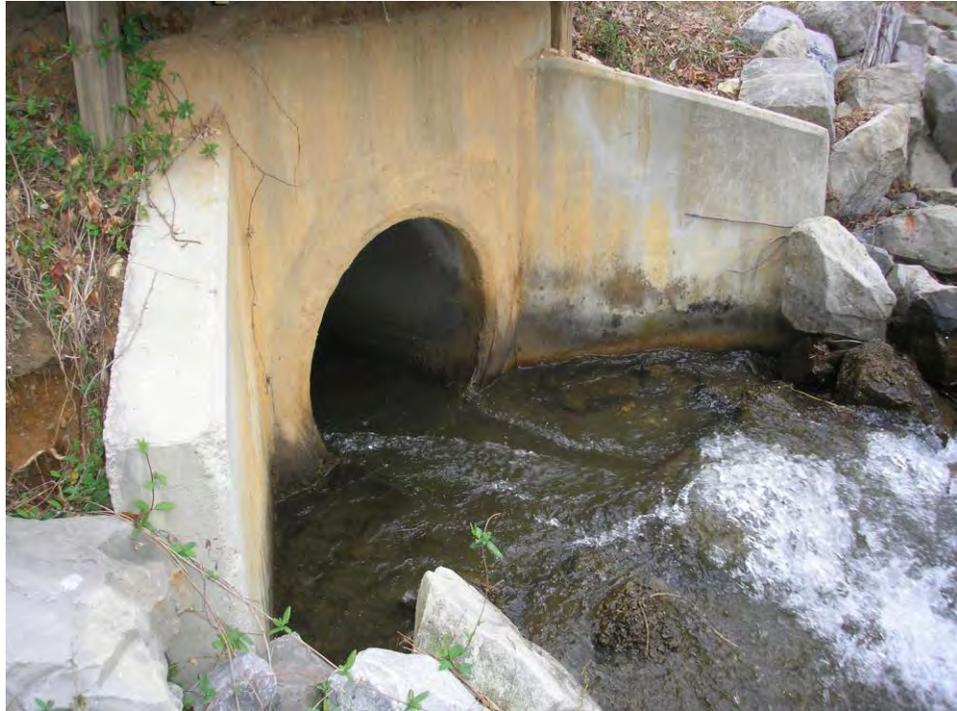
The outlet conduit appeared to be in good condition and operating normally with no signs of clogging. Water flowing from the outlet was clear. Figure 5.3.2-1 shows water discharging from the outlet conduit.

Figure 5.3.2-1: Gadsden Plant CCR Impoundment Primary Spillway Outlet Conduit Discharge

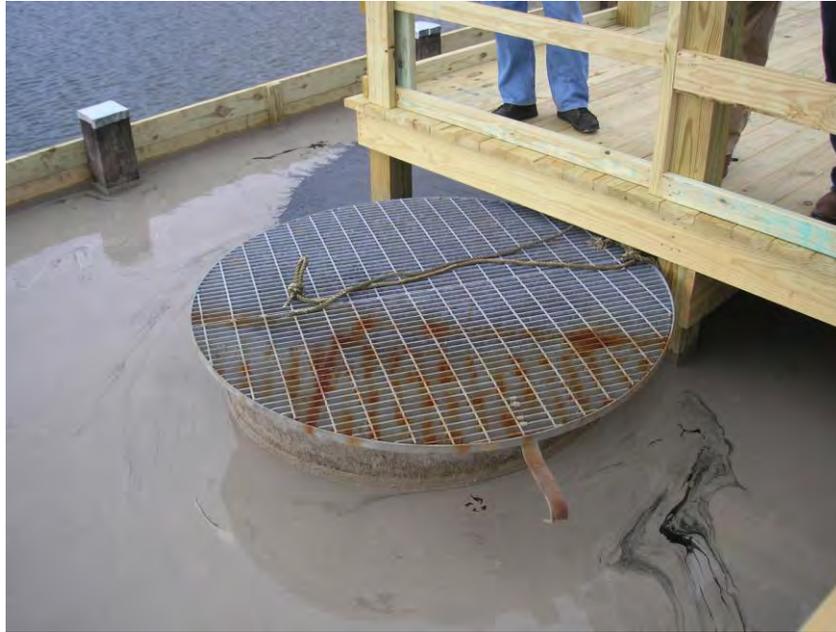
The spillway constructed in conjunction with the lower pond was converted to an emergency spillway around 2001 when the new primary spillway was constructed. The emergency spillway consists of a 48-inch diameter concrete pipe with an overflow elevation of 524.5 ft. and an invert elevation of about 510 ft. The spillway outlet conduit is a 36-inch diameter concrete pipe. No water was observed entering the riser or leaving the spillway outlet during the Dewberry site inspection visit. The outlet conduit was covered by riprap which had to be moved to observe the end of the pipe. Figure 5.3.3-1 shows the emergency spillway riser and Figure 5.3.3-2 shows the outlet conduit.

Figure 5.3.3-1 Gadsden Plant CCR Impoundment Emergency Spillway Riser

Based on observations made during Dewberry's site visit, it is recommended that riprap blocking the outlet conduit of the emergency spillway be removed and that the outlet be kept free of obstructions.

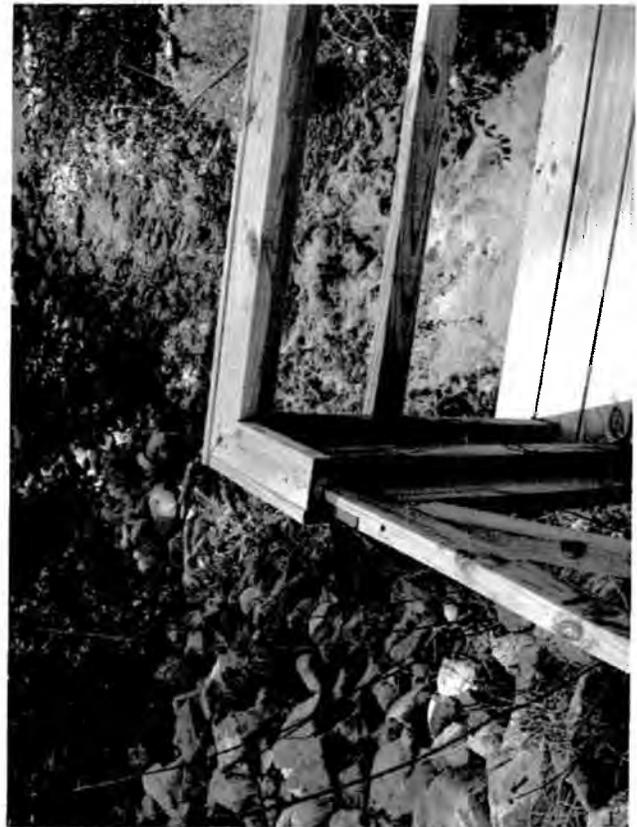
Photo 7: Pond Discharge Point to the Coosa River / Lake Henry

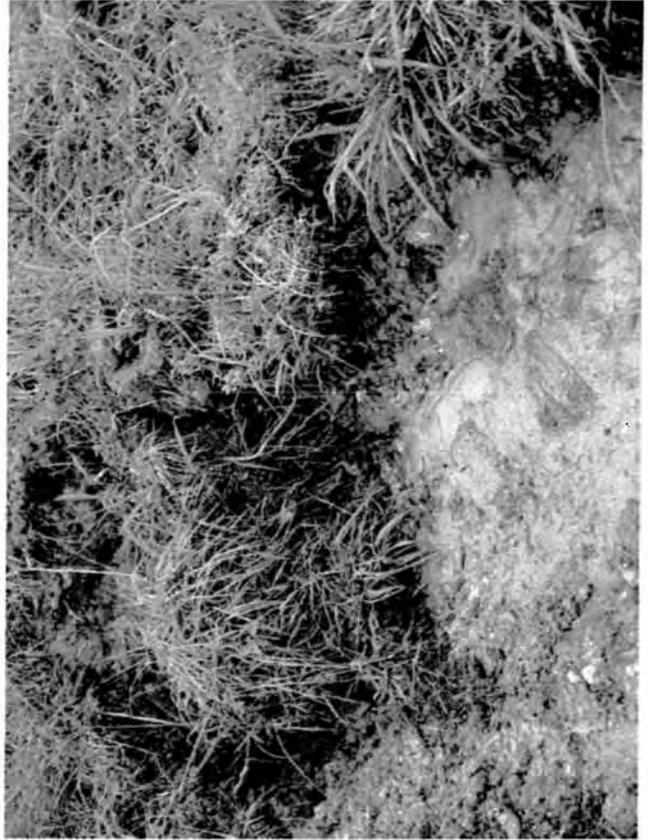
Photo 4: Damage to Embankment by Tracked Equipment

<b>No.</b>	<b>Description</b>	<b>Location</b>
1	Treat ant mounds on the embankments using pesticides.	1979 Extension Embankment
2	Armor the upstream side of the crest of the embankment structures to protect against wave action induced erosion. The armoring can be achieved using riprap.	1979 Extension Embankment (Photo 6)
3	Clear vegetation and trees to a distance up to 20 feet (depending on available APC property) beyond the downstream toe of water-retaining embankments.	1979 Extension Embankment (Photos 3 and 7)
4	Repair portion of 1979 extension dike that was damaged by tracked equipment, and considering extending the weighted filter to this area for protective measures.	1979 Extension Embankment (Photo 4)

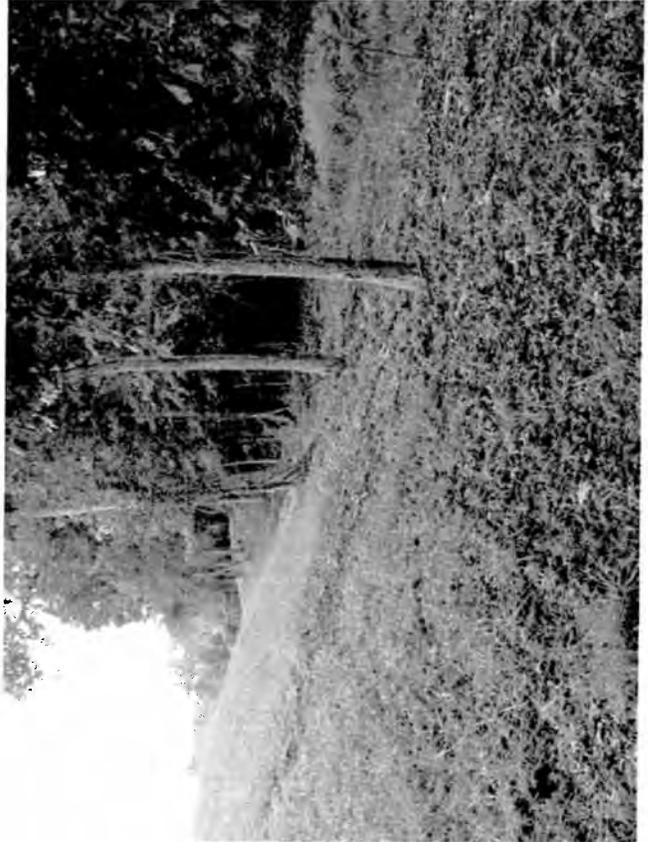
Photo 7: Trees along Toe of Embankment left after Brush Clearing

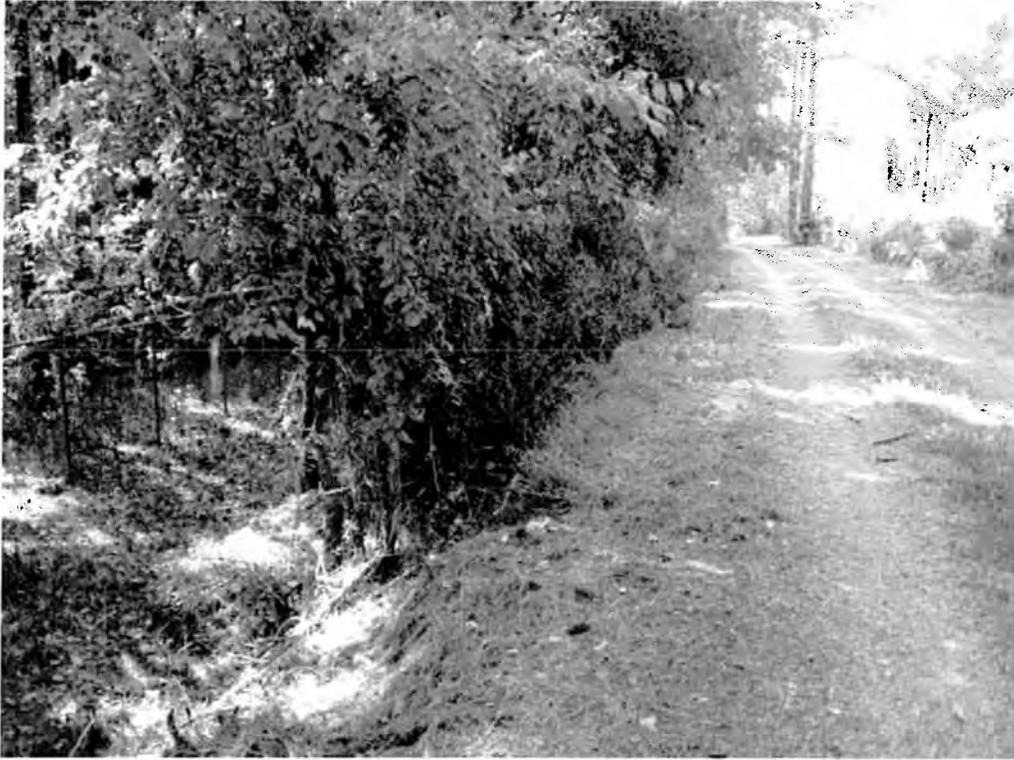
**Photo 1 – Trees on Downstream Face of Original Dike, Typical**

<b>No.</b>	<b>Description</b>	<b>Location</b>
1	The trees along the original ash pond embankment (upstream and downstream) should be removed. The trees on the downstream face should be removed to a distance of 20 feet downstream of the toe where practical.	Original Dike (see Photos 1, 2, and 3)
2	Drainage in the drainage ditch along the upstream face of the original ash pond embankment should be improved. As plans progress, the plant should continue to keep SCG Hydro Services informed.	Original Dike (see Photo 4)
3	The woody debris noted beneath the transmission line should be cleared to provide an unobstructed view of the embankment downstream face.	Original Dike (see Photo 5)
4	It is recommended that the level of maintenance observed along the 1979 Extension dike structure be continued for all ash handling structures at Gadsden SP.	All Structures
5	Stumps observed along the western edge of the 1979 Extension dike should be removed.	1979 Extension Dike (see Photo 9)

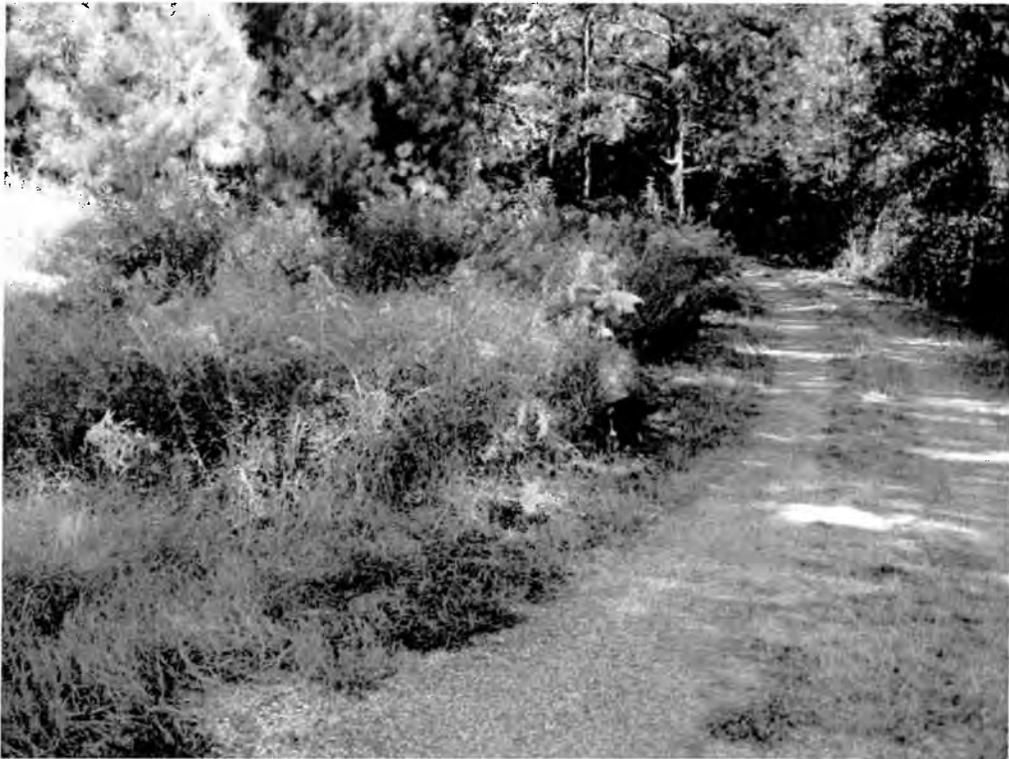
**Photo 2 – Brush on Upstream Face of Original Dike, Typical**

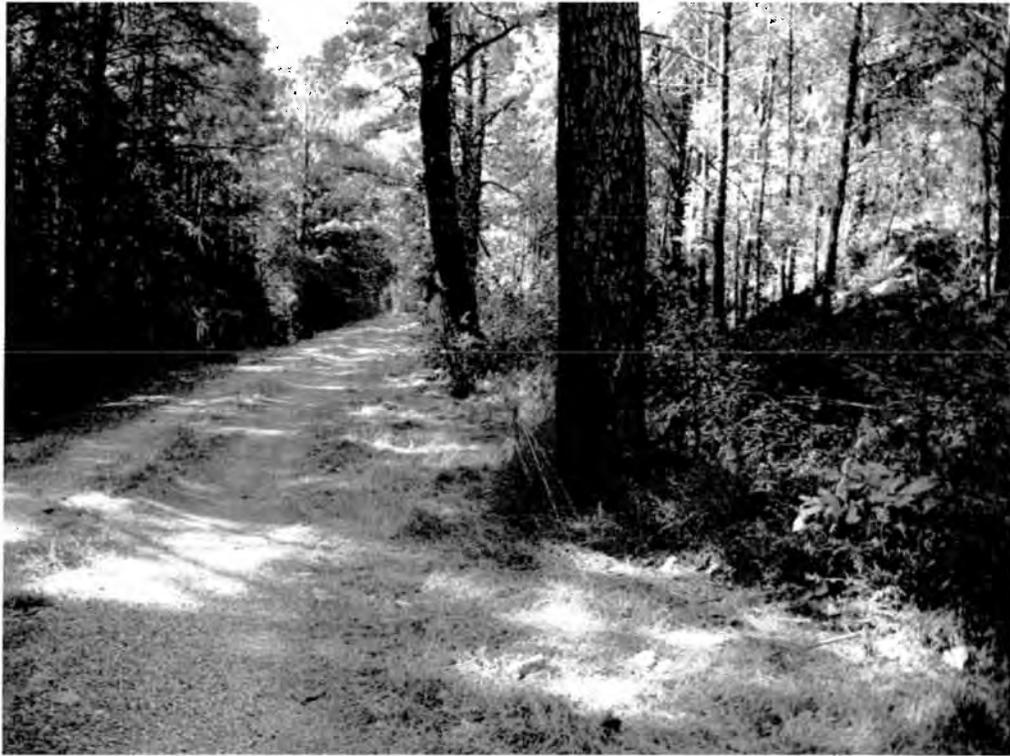
**Photo 3 – Large Tree on Upstream Face of Original Dike**

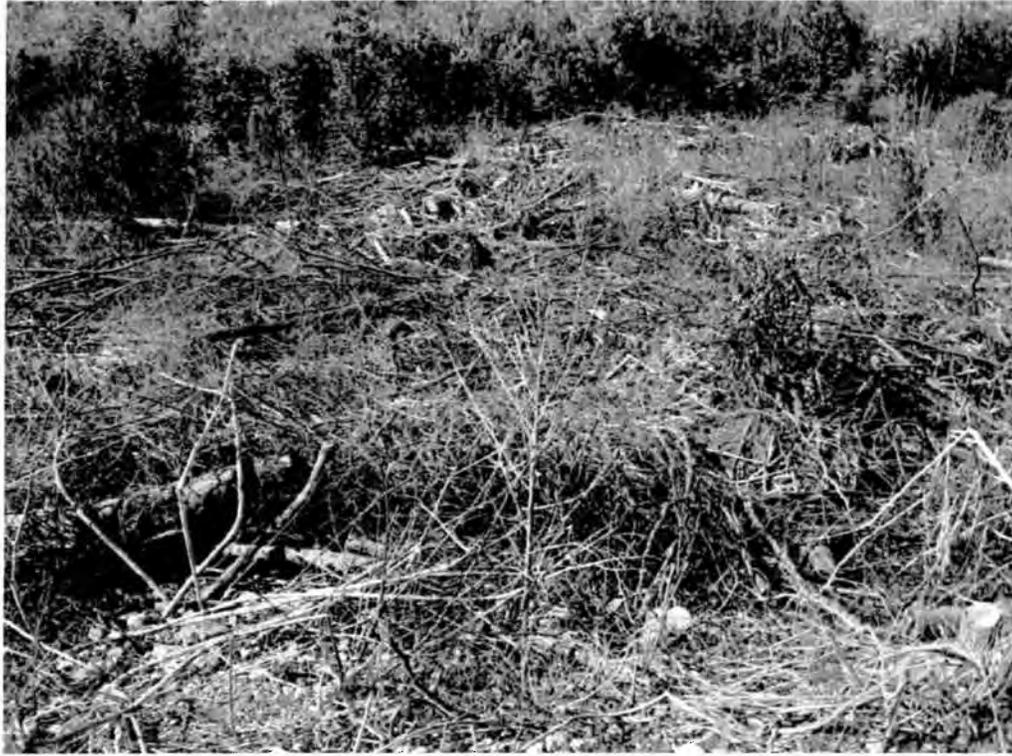
**Photo 5 – Woody Debris Beneath Transmission Lines, Original Dike**

- Clear woody debris from the transmission line to provide unobstructed view of downstream face
- Continue a level of maintenance observed along the 1979 Extension dike structure to all ash impoundment structures at the plant
- Remove stumps observed along the western edge of the 1979 Extension dike.

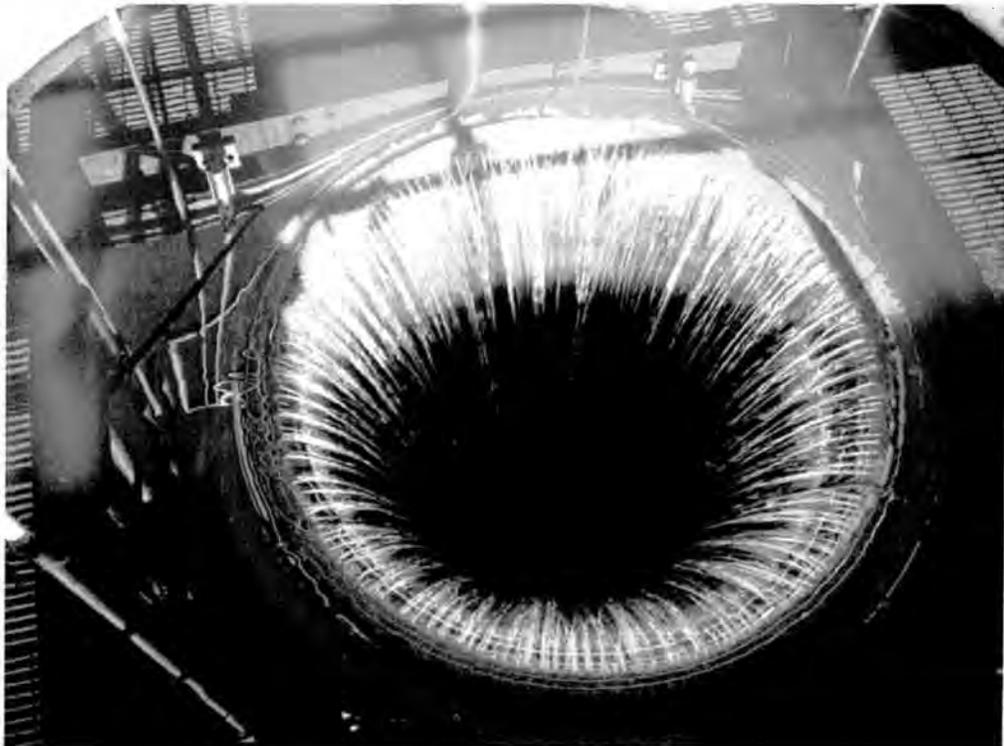
**Photo 6 – Condition of Discharge Structure Intake**

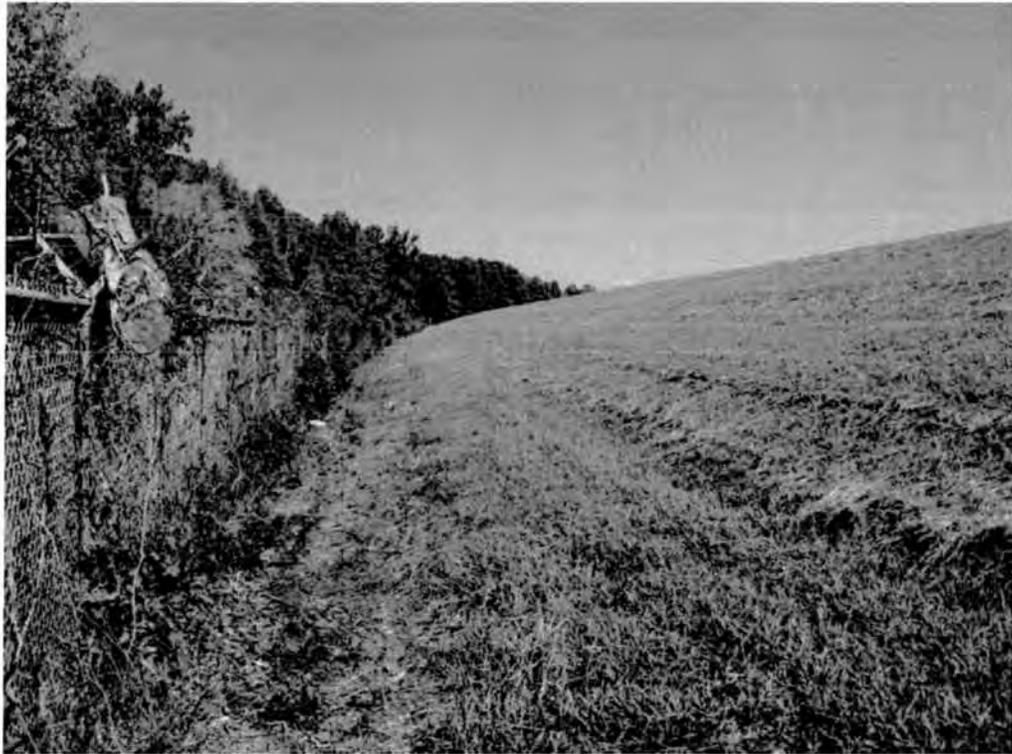
**Photo 7 – Condition of Downstream Face of 1979 Extension Embankment, Typical**

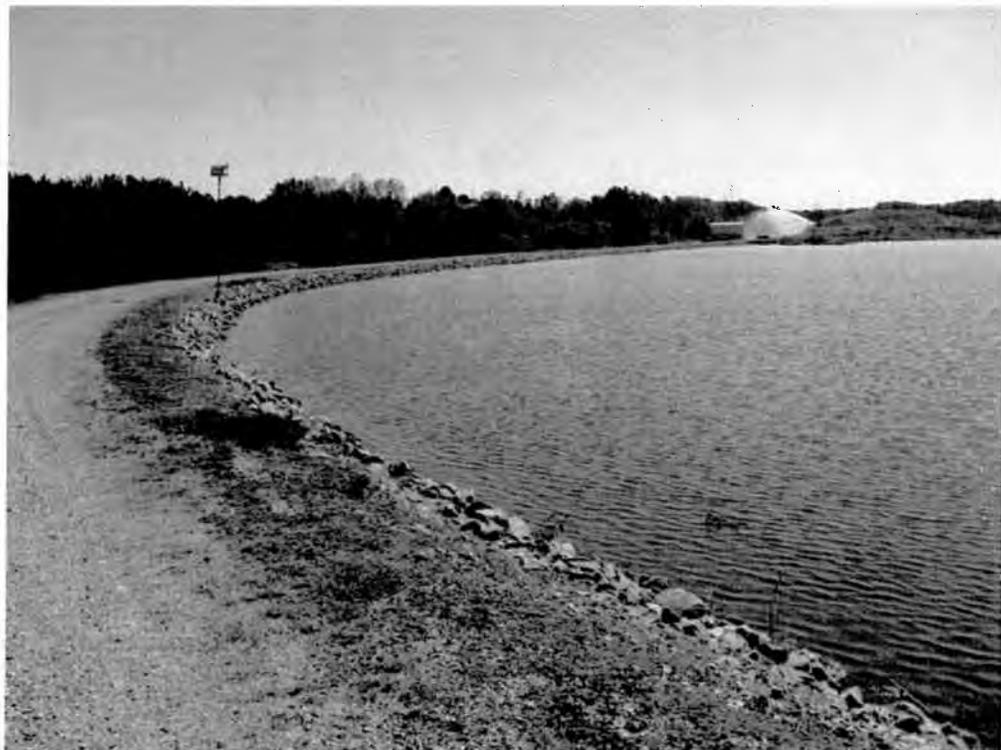
**Photo 8 – Riprap Armoring on Upstream Face of 1979 Extension Embankment**

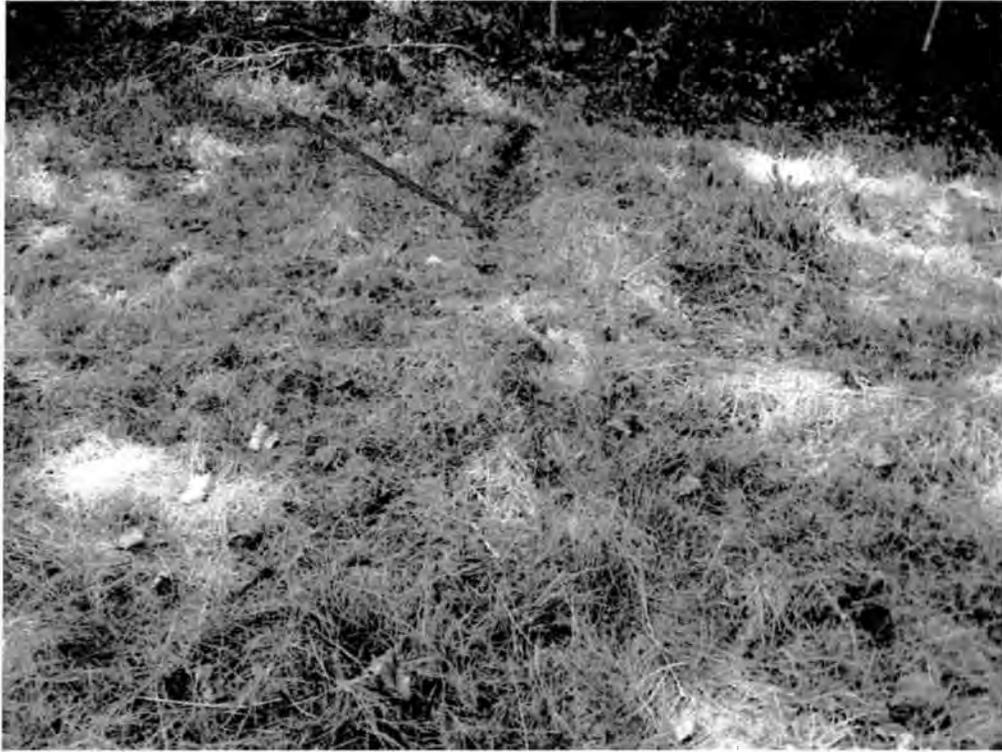
**Photo 9 – Beaver Activity (Trail) at 1979 Extension Embankment**

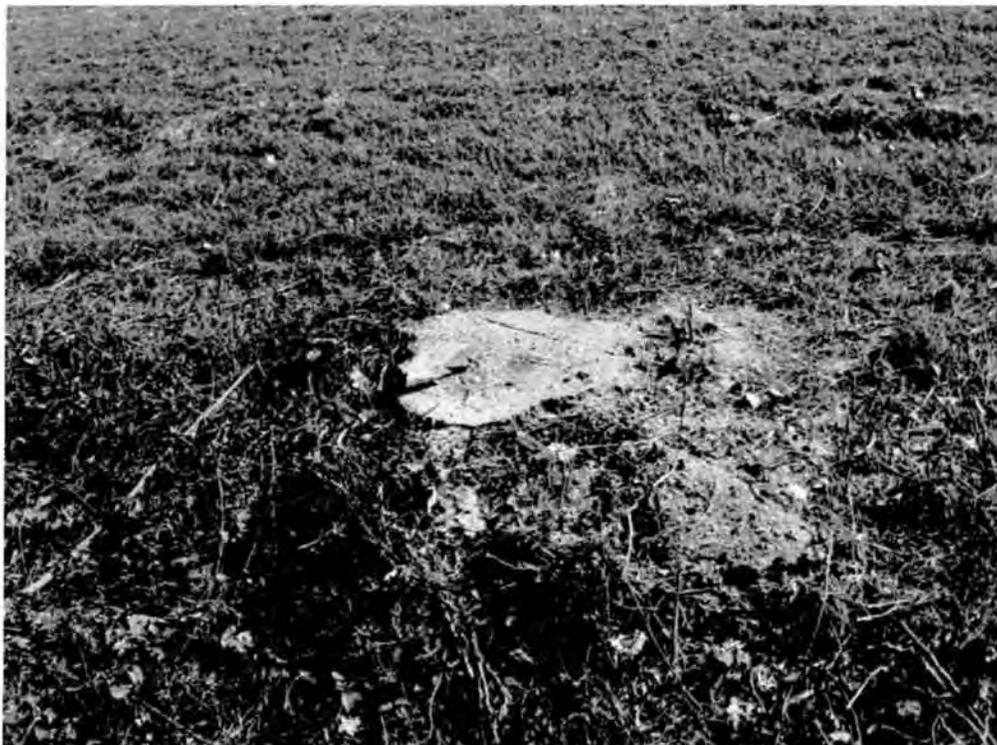
**Photo 10 – Stump Along West End of 1979 Extension Embankment, Typical**

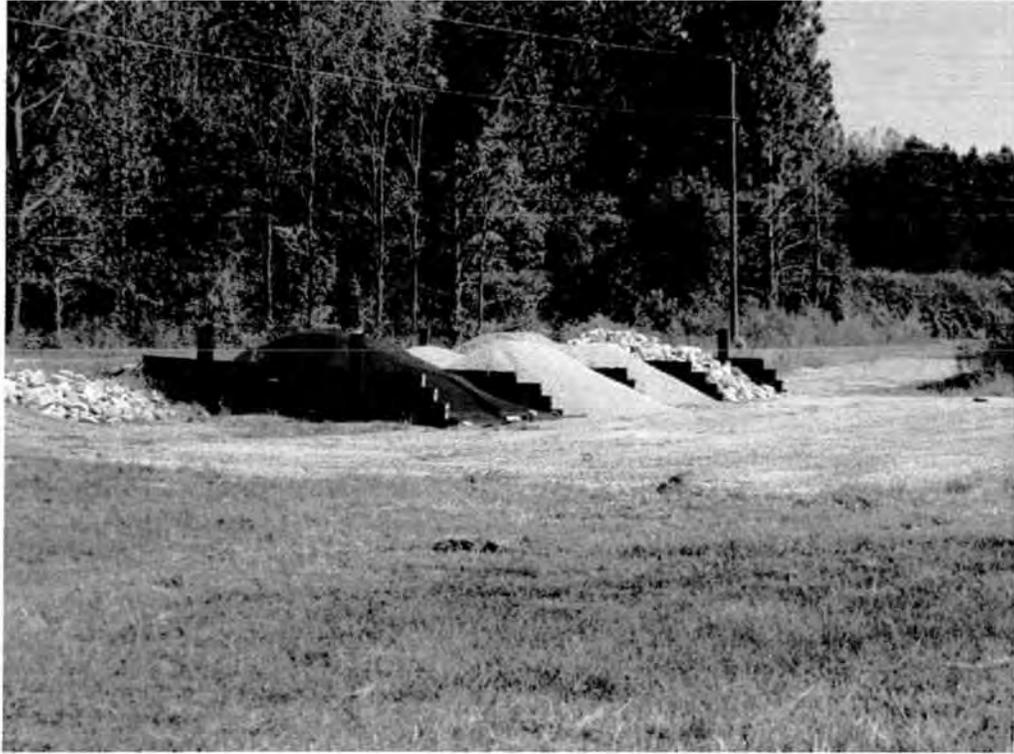
**Photo 11 – Condition of Emergency Filter Stockpiles**
