**Coal Combustion Residue Impoundment
Round 9 - Dam Assessment Report**

Plant Gadsden

Fly Ash Dike

Alabama Power Company
Gadsden, Alabama

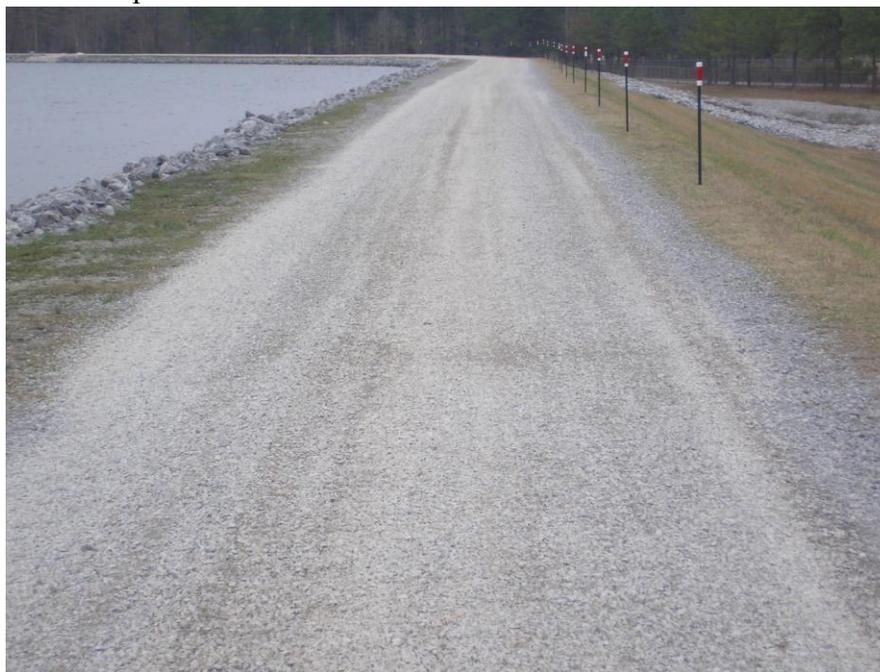
Figure 5.2.1-1: Lower Pond Crest West End of North Dike

The crest of the impoundment embankment has no signs of depressions, tension cracks, or other indications of settlement or shear failure. Previous inspection reports reviewed by Dewberry did not indicate issues concerning the embankment crest. Figure 5.2.1-1 shows the condition of the lower pond crest.

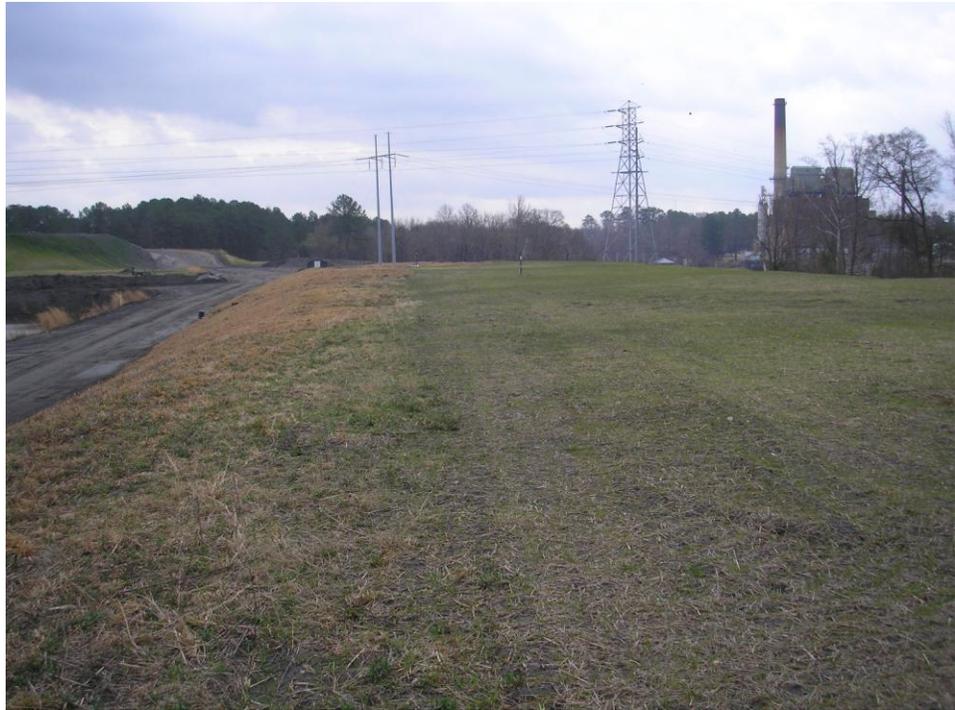
Figure 5.2.1-2: Upper Pond Crest and Inside Slope with Ash Fill along Foreground Inside Slope and Stockpiled in Background.

Filling the east end and both sides of the upper ash pond to support storage and handling of dry ash has resulted in there being no water stored against the upper pond embankment. Figure 5.2.1-2 shows the upper pond south embankment crest and inside slope.

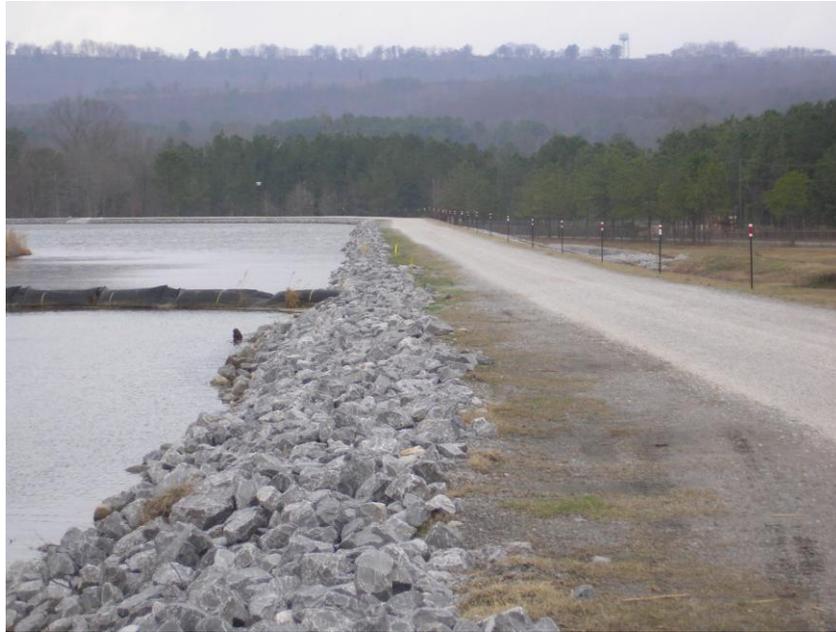
Figure 5.2.2-1: Lower Pond Interior Slope

The inside slope of the CCR impoundment lower pond is armored with riprap to protect against wind generated waves. There were no observed scarps, sloughs, bulging, cracks, depressions, or other indications of slope instability or signs of erosion. Figure 5.2.2-1 shows a section of the inside slope of the lower pond.

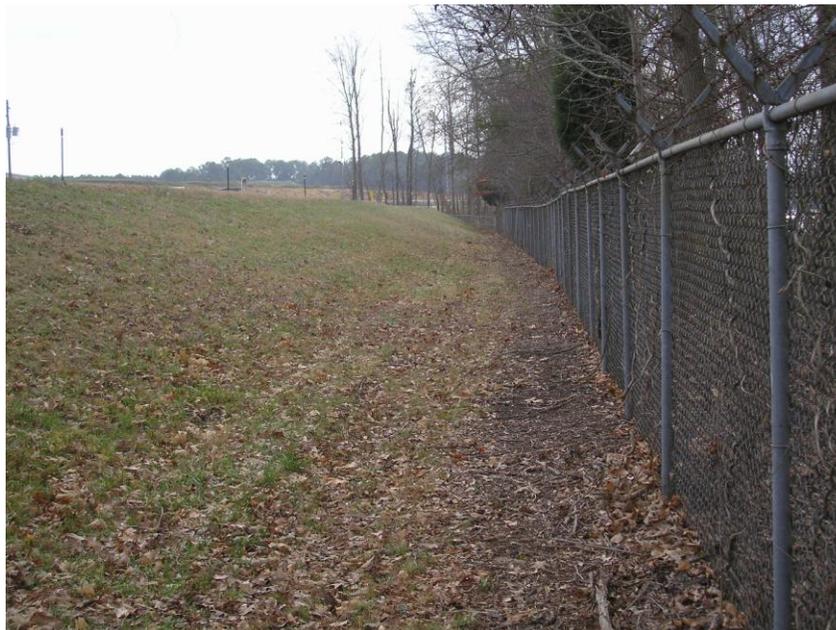
Figure 5.2.3-1: Lower Pond Exterior Slope

The downstream or outside slope of the CCR impoundment lower pond is generally protected by several species of grass and weeds. There were no observed scarps, sloughs, bulging, cracks, depressions or other indications of slope instability or slope erosion. Figure 5.2.3-1 shows a section of the outside slope of the lower pond embankment.

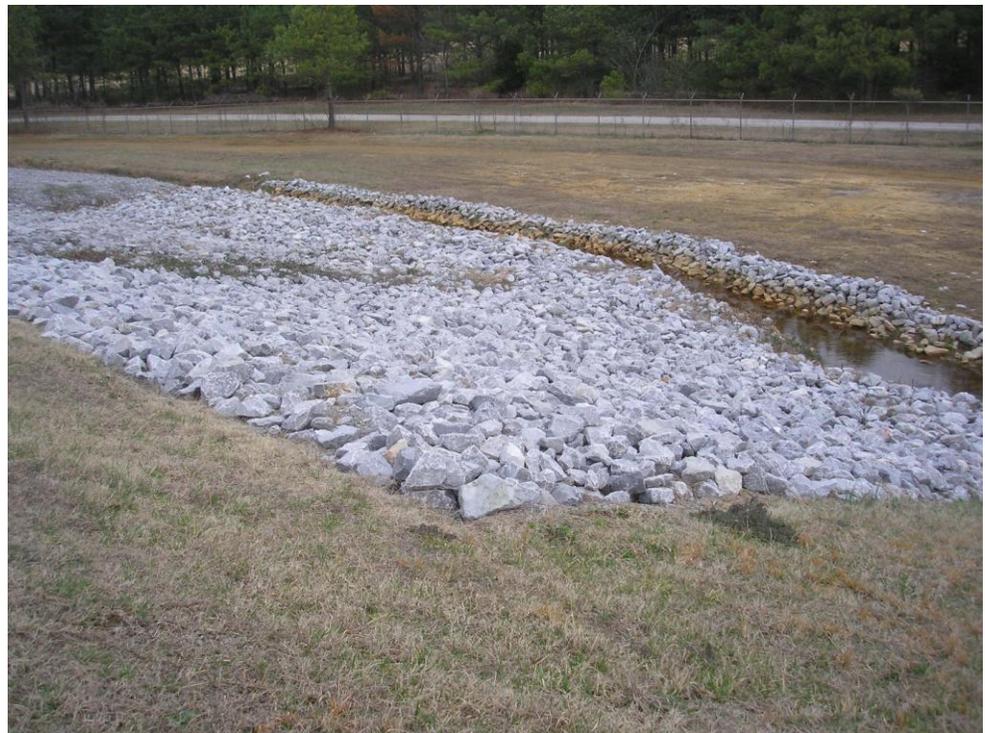
Figure 5.2.3-2: Lower Pond Exterior Slope Filter Blanket and Riprap Lined Toe Drain

To address an area of potential embankment seepage and poor surface drainage near the toe area at the west end of the lower pond north dike, a riprap filter blanket and riprap lined toe ditch were constructed. Figure 5.2.3-2 shows the slope filter blanket and toe drain ditch. The filter blanket design consisted of a course riprap at the east end and finer riprap to the west as shown in Figure 5.2.3-2.

Water observed in the toe drain ditch was observed to be coming from up-gradient of the filter blanket and appeared to be surface runoff from recent storms in the area.

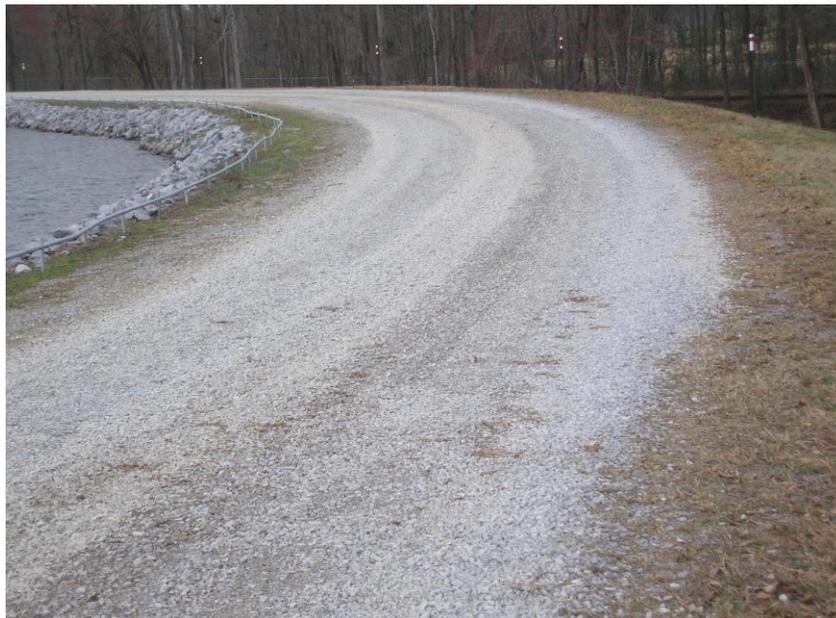
Figure 5.2.4-1: Lower Pond East Embankment Interior North Groin

Erosion or uncontrolled seepage was not observed along embankment groins and abutments. Figure 5.2.4-1 shows the interior groin in the northwest corner of the lower pond north embankment. Figure 5.2.4-2 shows the area of the upper pond east abutment of the south dike.

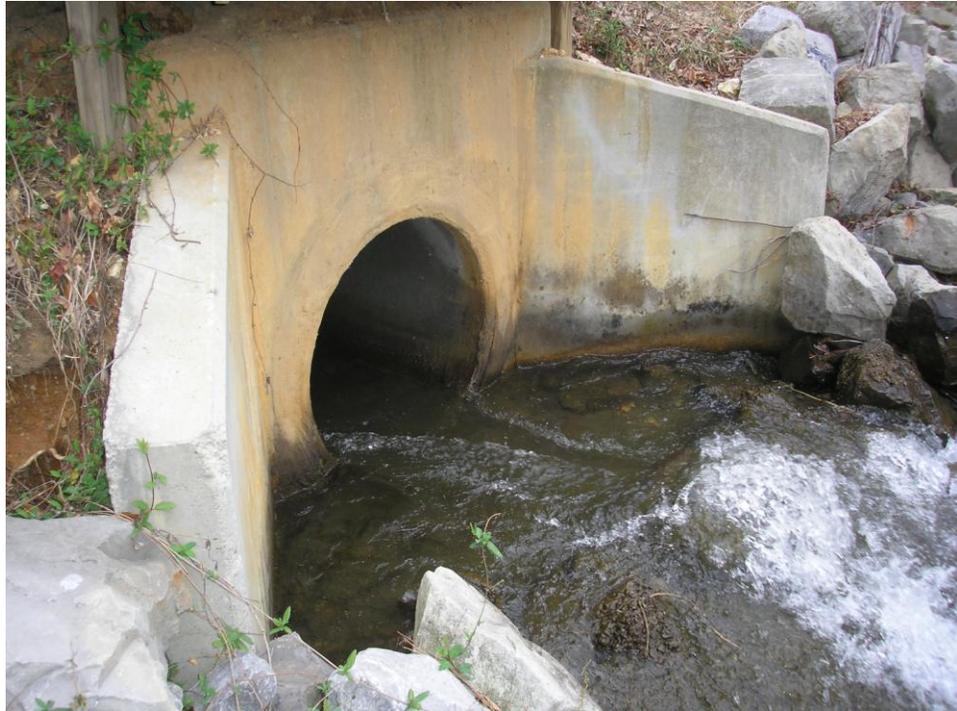
Figure 5.3.2-1: Gadsden Plant CCR Impoundment Primary Spillway Outlet Conduit Discharge

The outlet conduit appeared to be in good condition and operating normally with no signs of clogging. Water flowing from the outlet was clear. Figure 5.3.2-1 shows water discharging from the outlet conduit.

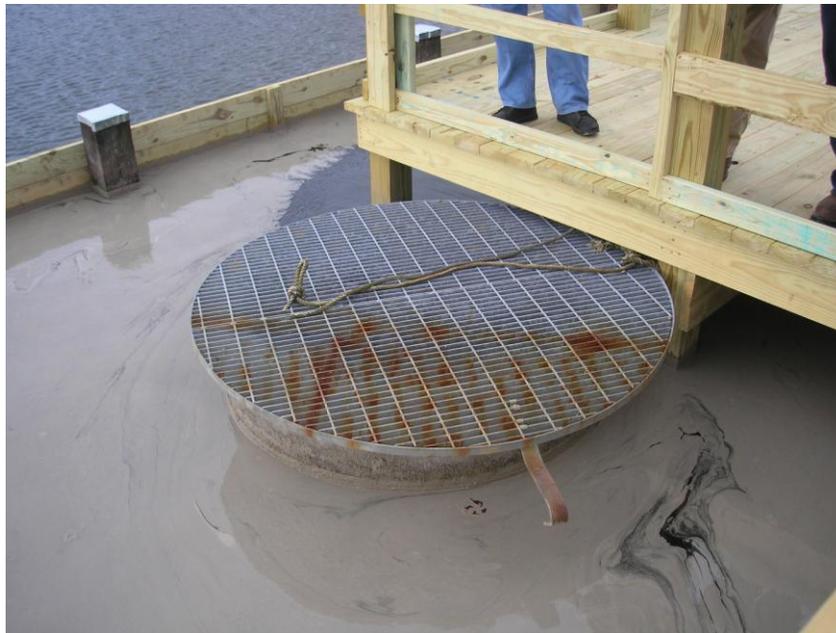
Figure 5.3.3-1 Gadsden Plant CCR Impoundment Emergency Spillway Riser

The spillway constructed in conjunction with the lower pond was converted to an emergency spillway around 2001 when the new primary spillway was constructed. The emergency spillway consists of a 48-inch diameter concrete pipe with an overflow elevation of 524.5 ft. and an invert elevation of about 510 ft. The spillway outlet conduit is a 36-inch diameter concrete pipe. No water was observed entering the riser or leaving the spillway outlet during the Dewberry site inspection visit. The outlet conduit was covered by riprap which had to be moved to observe the end of the pipe. Figure 5.3.3-1 shows the emergency spillway riser and Figure 5.3.3-2 shows the outlet conduit.

Based on observations made during Dewberry's site visit, it is recommended that riprap blocking the outlet conduit of the emergency spillway be removed and that the outlet be kept free of obstructions.

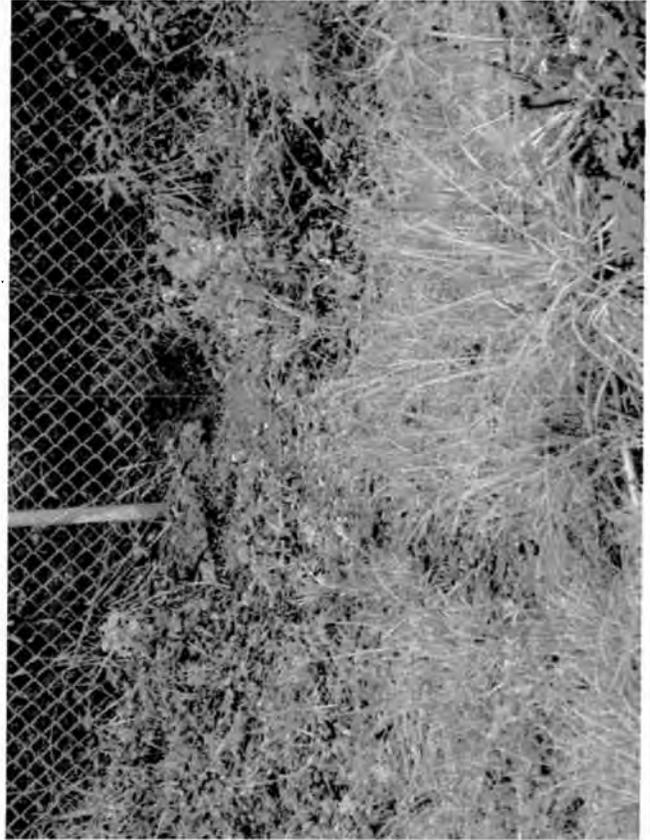
Photo 8: Evidence of Beaver Activity in the Dam Area

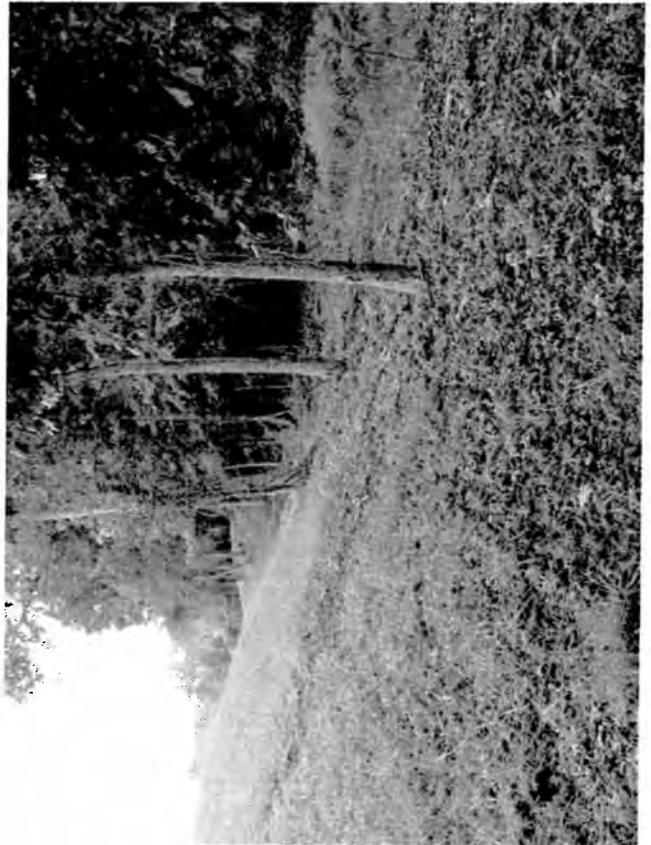
Photo 7: Trees along Toe of Embankment left after Brush Clearing

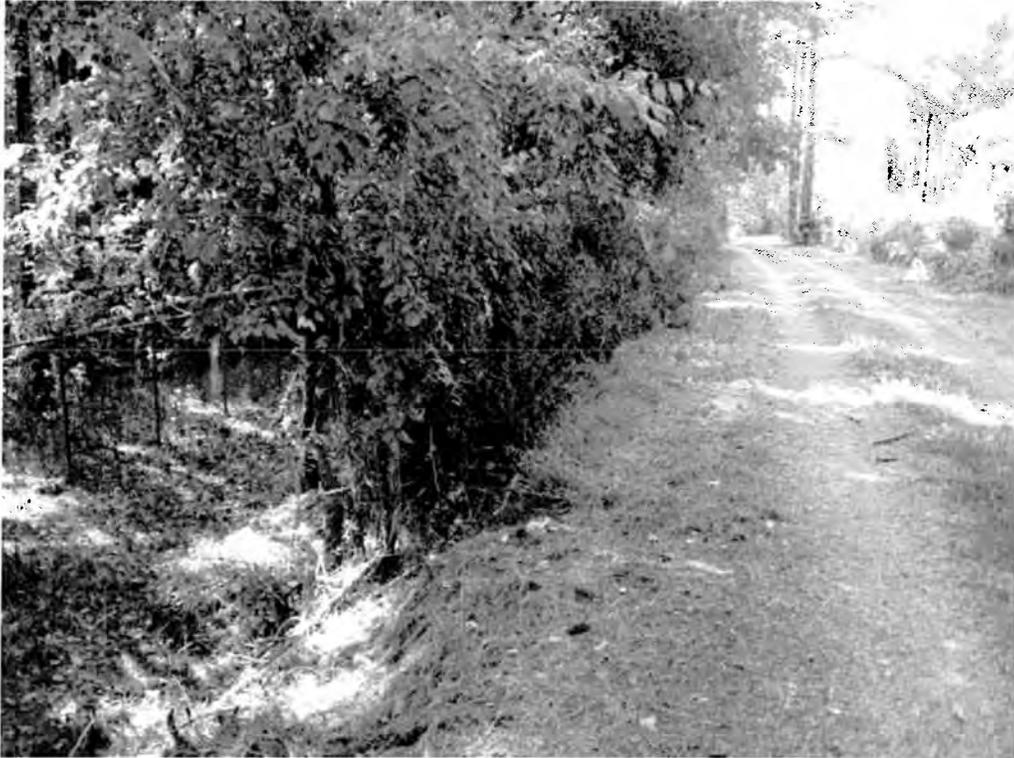
Photo 1 – Trees on Downstream Face of Original Dike, Typical

No.	Description	Location
1	The trees along the original ash pond embankment (upstream and downstream) should be removed. The trees on the downstream face should be removed to a distance of 20 feet downstream of the toe where practical.	Original Dike (see Photos 1, 2, and 3)
2	Drainage in the drainage ditch along the upstream face of the original ash pond embankment should be improved. As plans progress, the plant should continue to keep SCG Hydro Services informed.	Original Dike (see Photo 4)
3	The woody debris noted beneath the transmission line should be cleared to provide an unobstructed view of the embankment downstream face.	Original Dike (see Photo 5)
4	It is recommended that the level of maintenance observed along the 1979 Extension dike structure be continued for all ash handling structures at Gadsden SP.	All Structures
5	Stumps observed along the western edge of the 1979 Extension dike should be removed.	1979 Extension Dike (see Photo 9)

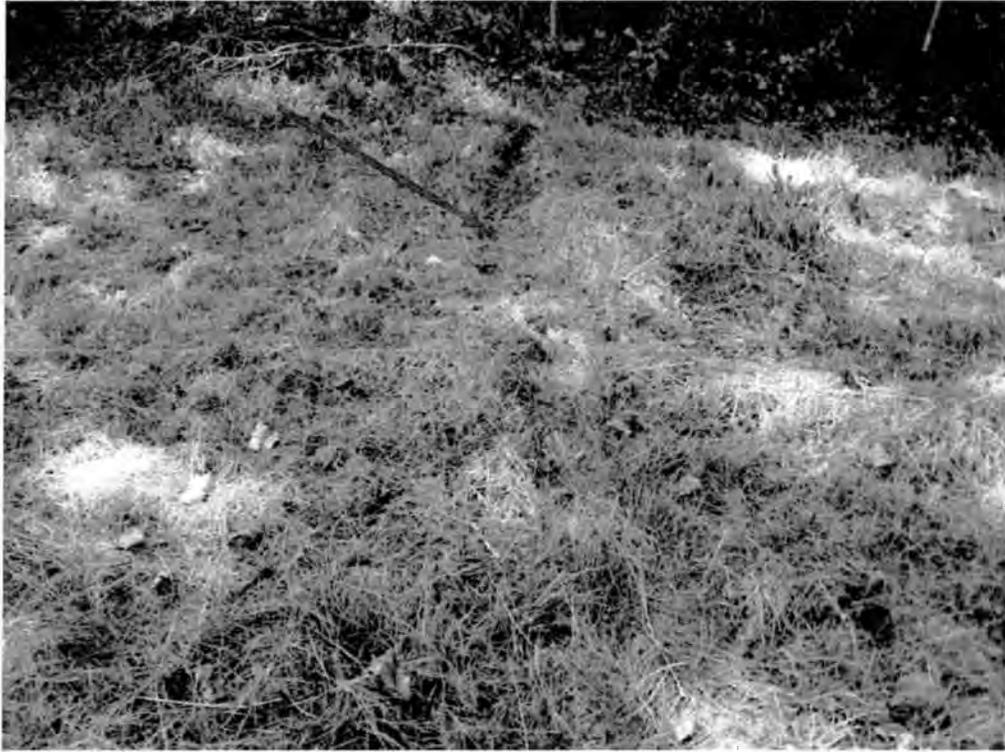
Photo 9 – Beaver Activity (Trail) at 1979 Extension Embankment

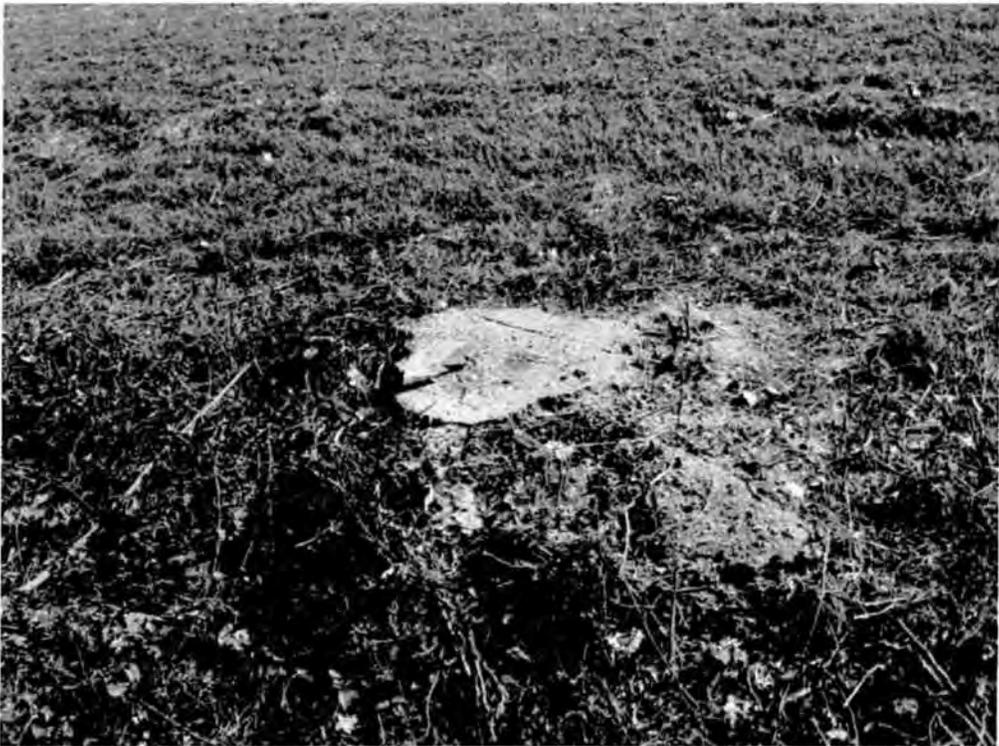
Photo 10 – Stump Along West End of 1979 Extension Embankment, Typical

- Clear woody debris from the transmission line to provide unobstructed view of downstream face
- Continue a level of maintenance observed along the 1979 Extension dike structure to all ash impoundment structures at the plant
- Remove stumps observed along the western edge of the 1979 Extension dike.
