US EPA ARCHIVE DOCUMENT

FINAL REPORT

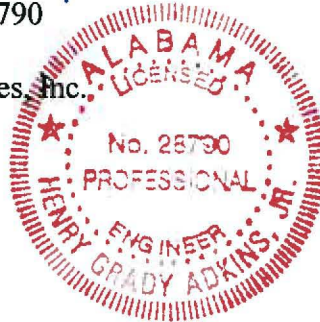
2.0 PROJECT DESCRIPTION

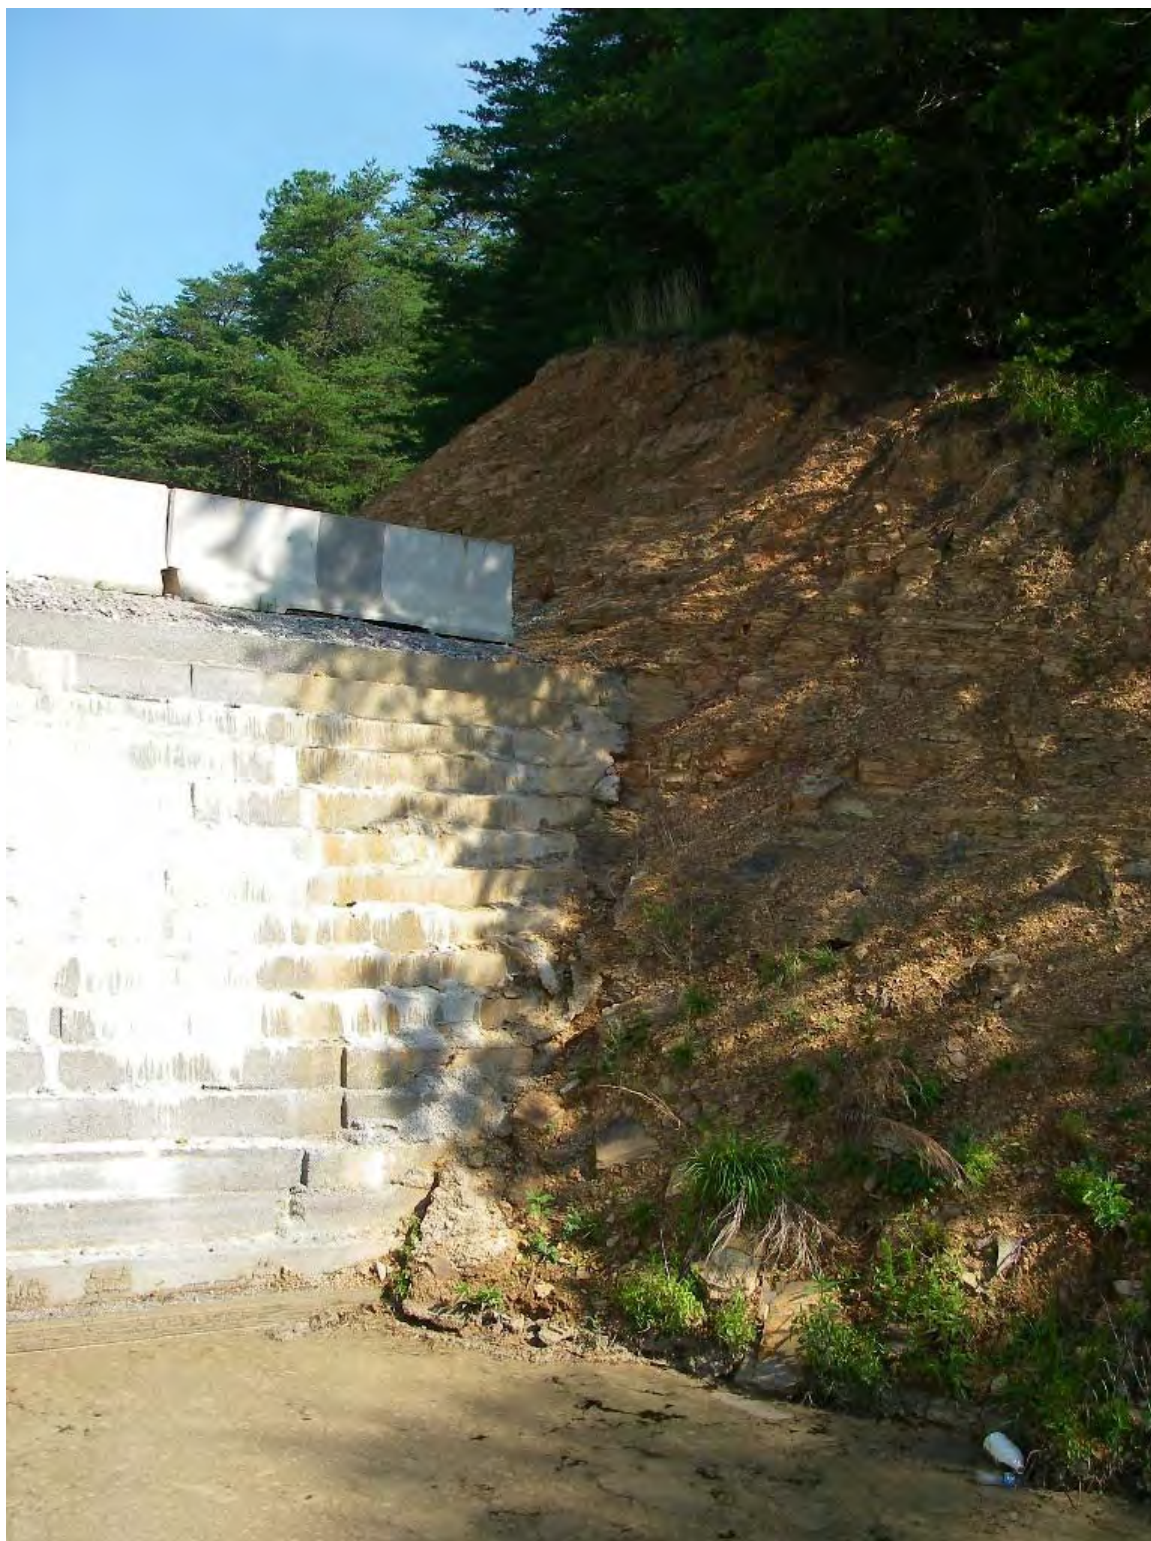
**PHOTO 6: VERTICAL CRACKING IN RCC FACING BLOCK LEFT OF
INTAKE STRUCTURE**

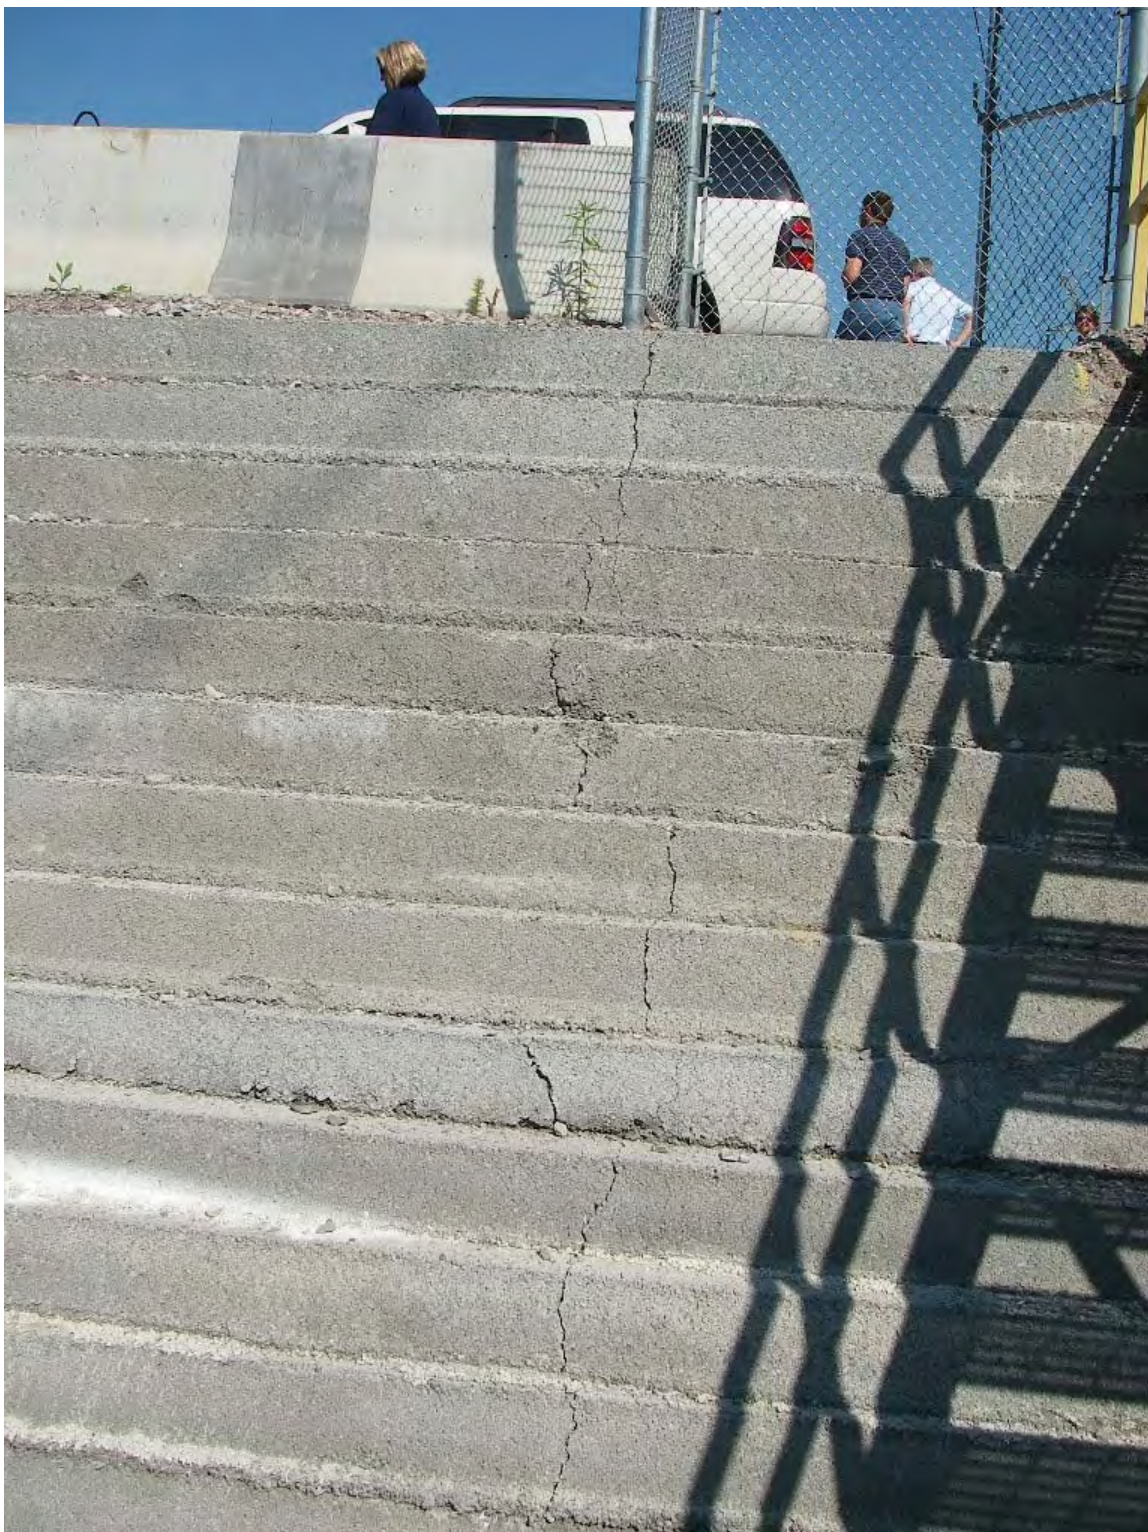
**PHOTO 7: RCC FACING ON UPSTREAM SIDE OF RATTLESNAKE DAM
(LOOKING SW)**

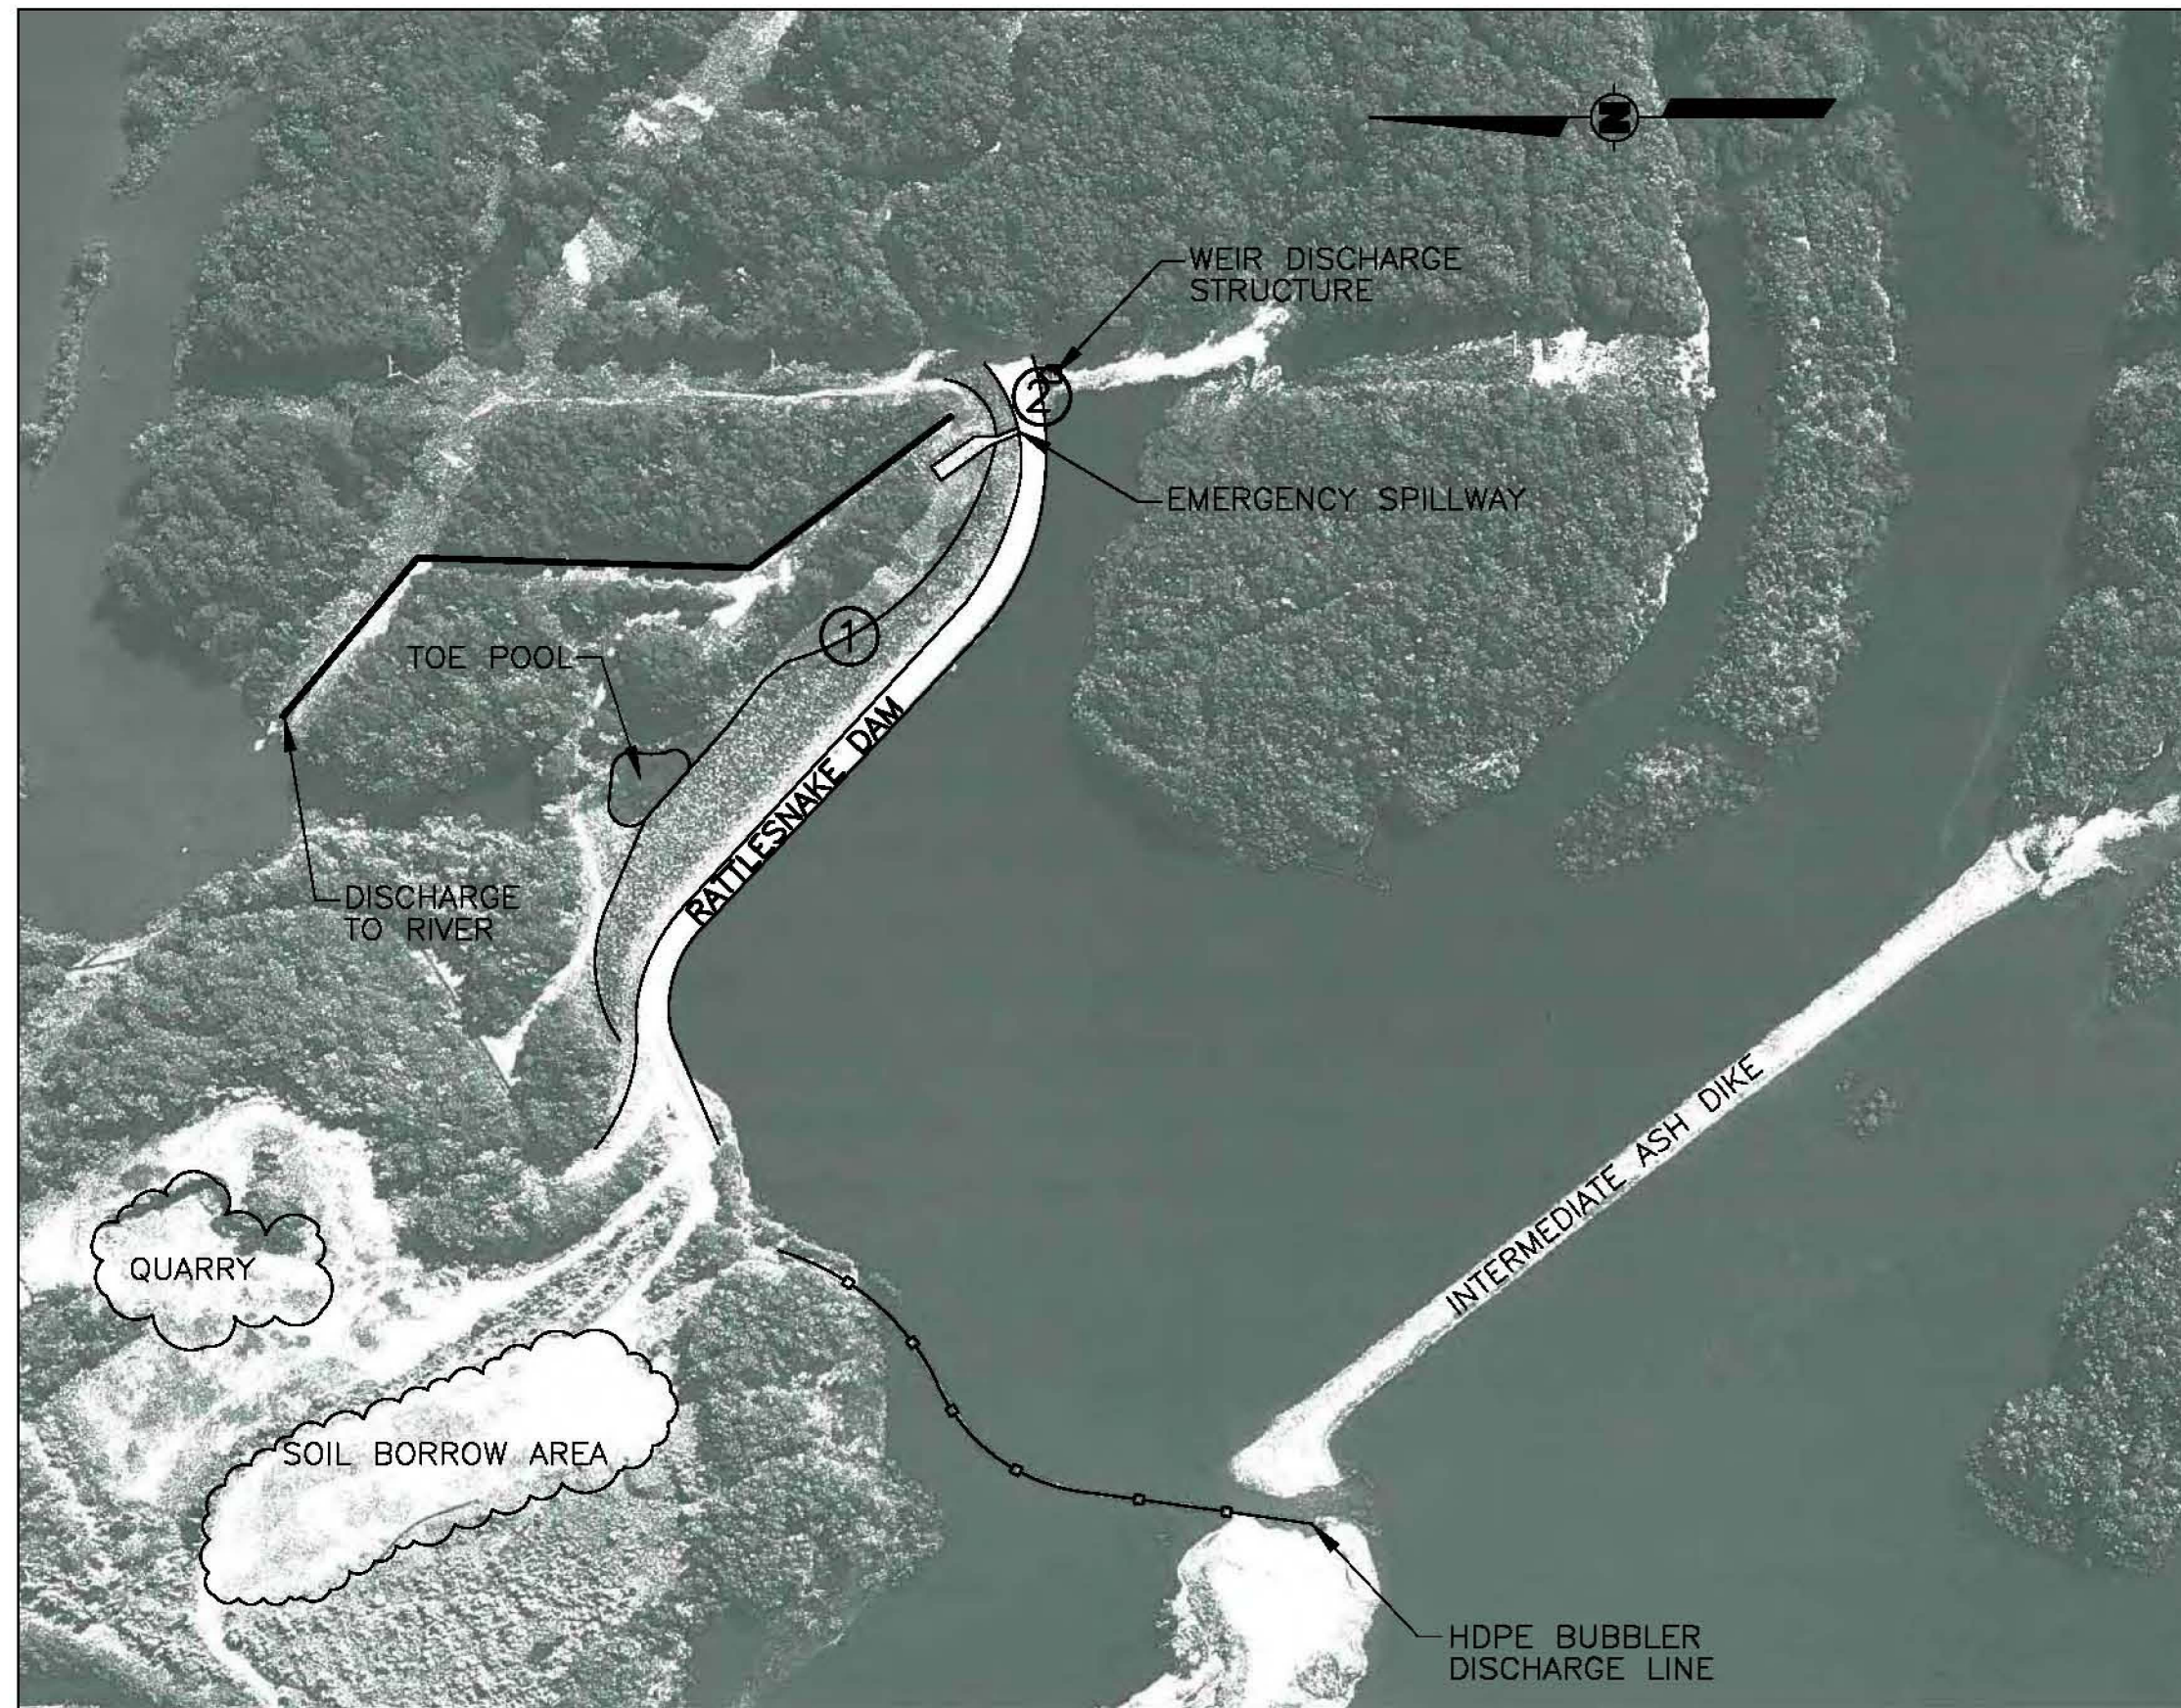
NOTE: DRAWING DIGITIZED FROM HARD COPY FIGURES. NTS.

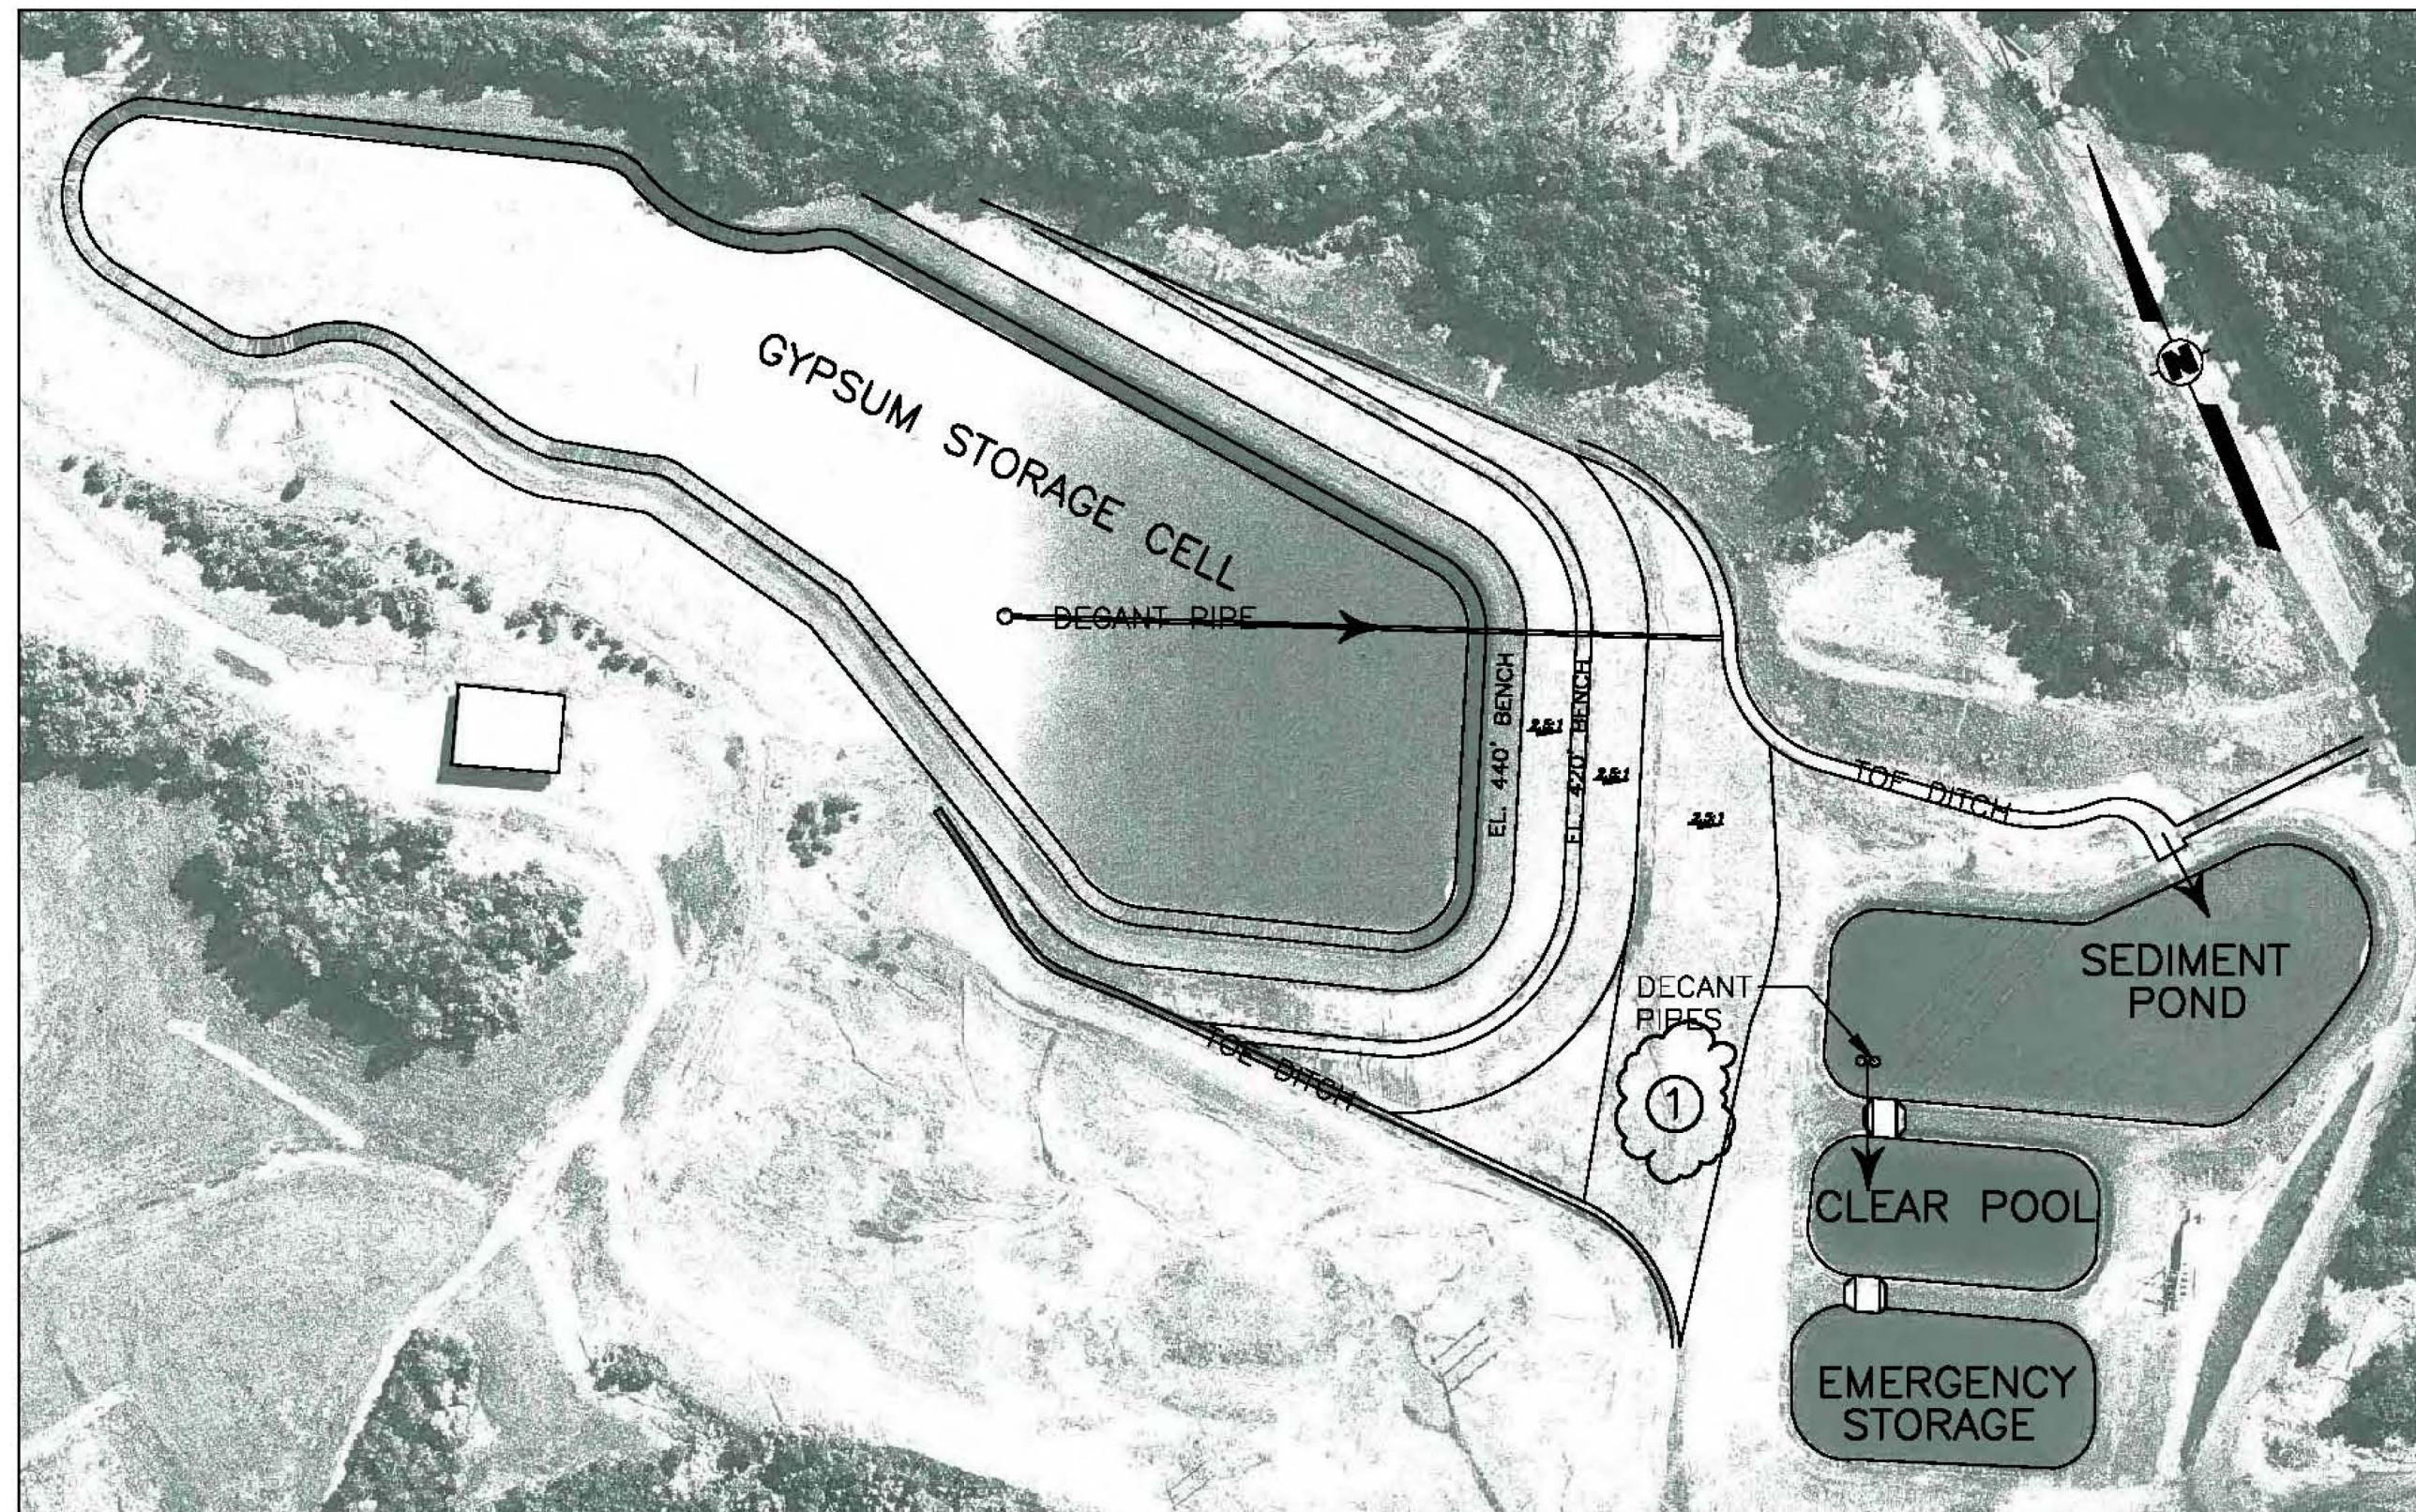
NOTE: DRAWING DIGITIZED FROM HARD COPY FIGURES. NTS.

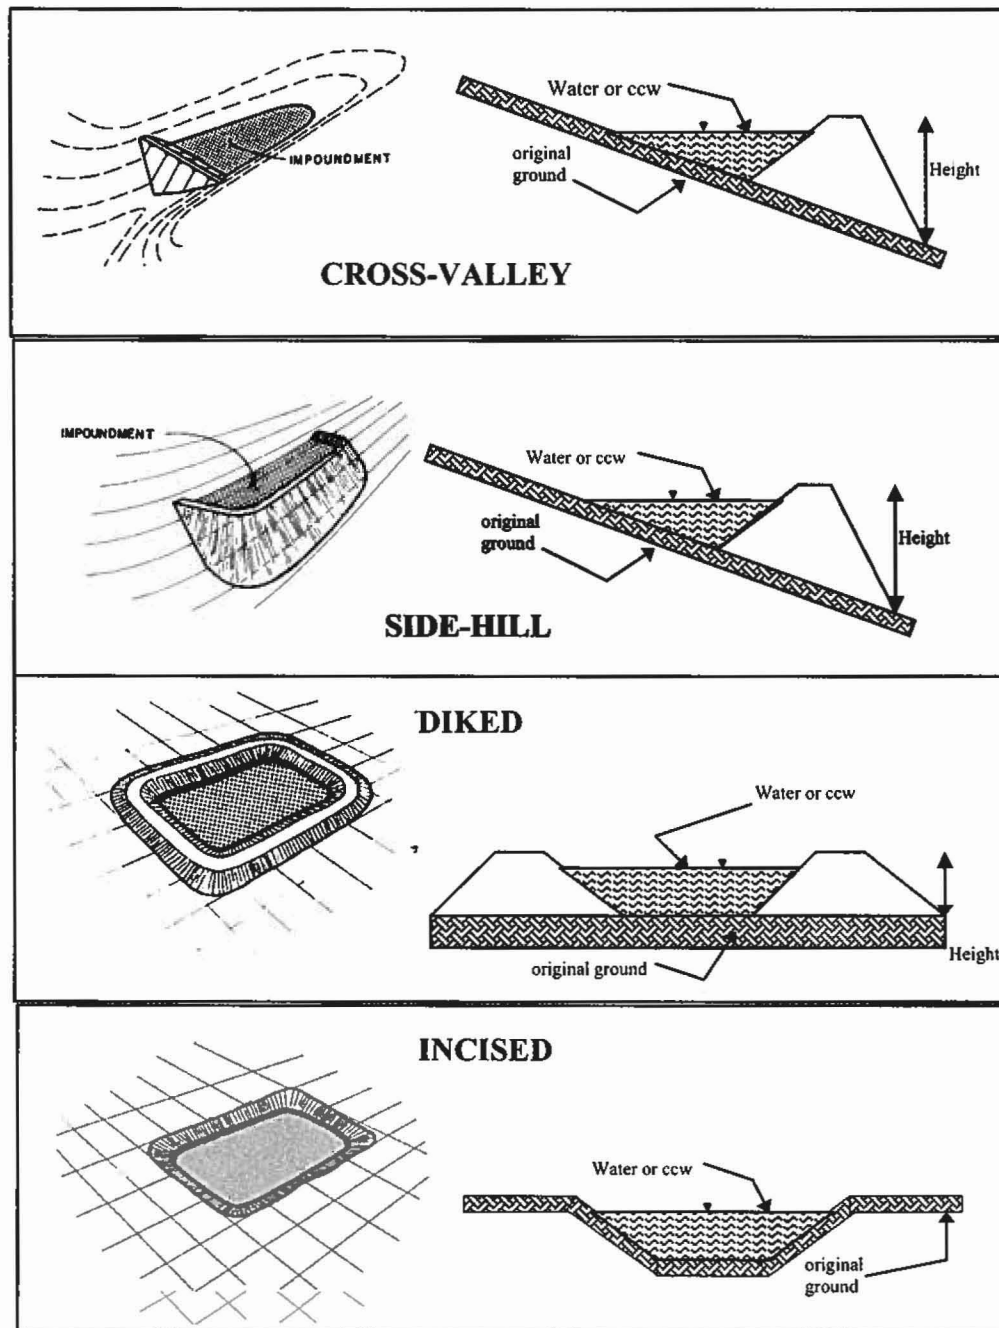
- ☐ Cross-Valley
- ☐ Side-Hill
- ☐ Diked
- ☐ Incised (form completion optional)
- ☒ Combination Incised/Diked

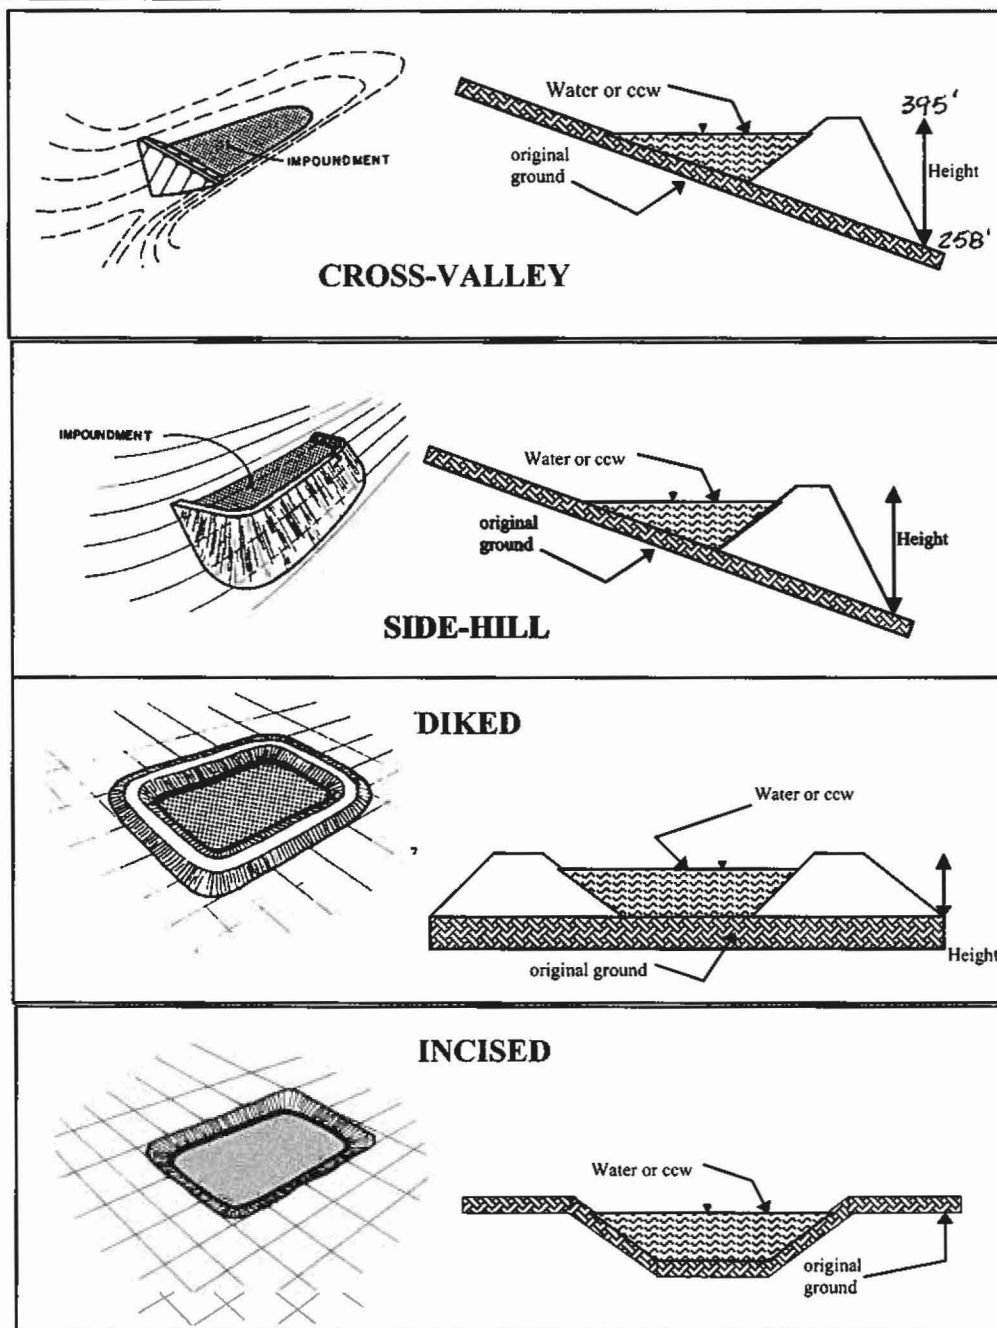
- ☒ Cross-Valley
- ☐ Side-Hill
- ☐ Diked
- ☐ Incised (form completion optional)
- ☐ Combination Incised/Diked
