**Coal Combustion Residue Impoundment
Round 9 - Dam Assessment Report**

Miller Steam Plant

*Coal Combustion Residue Impoundment Dike
Alabama Power Company
West Jefferson, Alabama*

Dewberry & Davis, LLC
Fairfax, Virginia

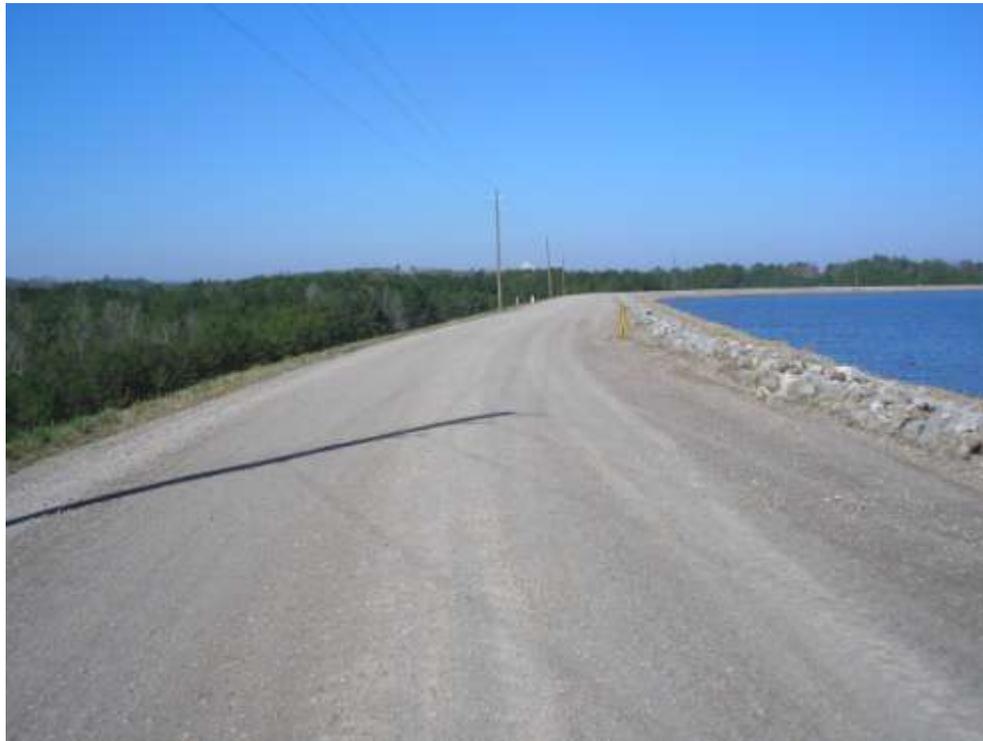
Figure 5.2.1-1: Crest of Main Dam

The crest of the CCR impoundment main dam had no signs of depressions, tension cracks, or other indications of settlement or shear failure. Previous inspection reports reviewed by Dewberry did not indicate issues concerning the crest of the main dam. Figure 5.2.1-1 shows the condition of the main dam crest.

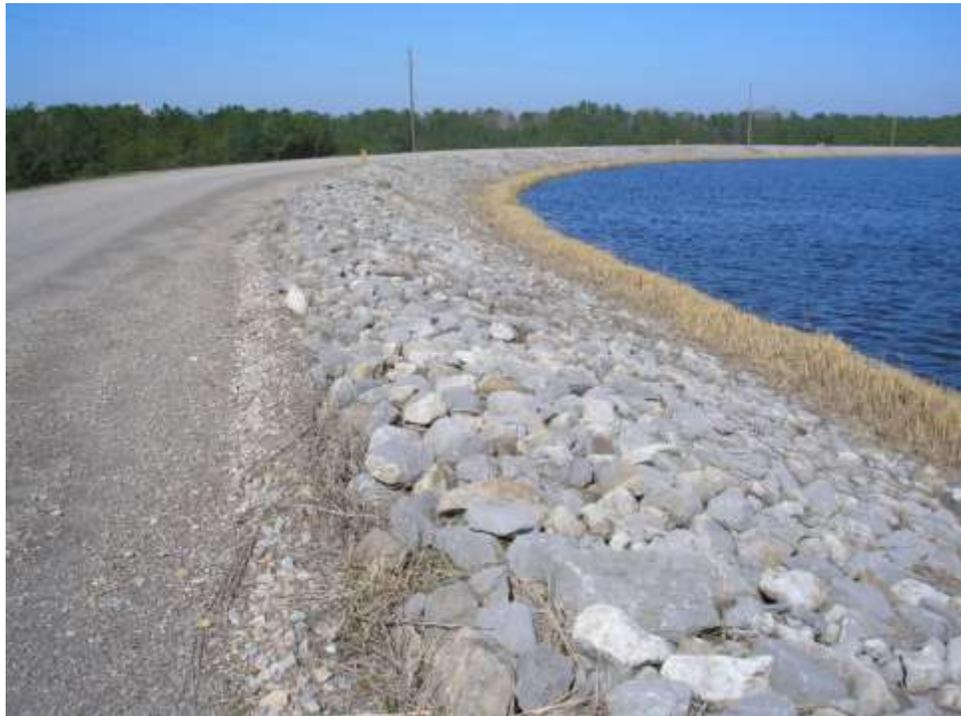
Figure 5.2.2-1 Main Dam Inside Slope

The inside slope of the CCR impoundment main dam is armored with rip-rap to protect the slope from erosion caused by wind generated waves. Grass was observed growing in the rip-rap along the water line. There were no observed scarps, sloughs, bulging, cracks, depressions, or other indications of slope instability or signs of erosion. Figure 5.2.2-1 shows a section of the upstream slope of the main dam.

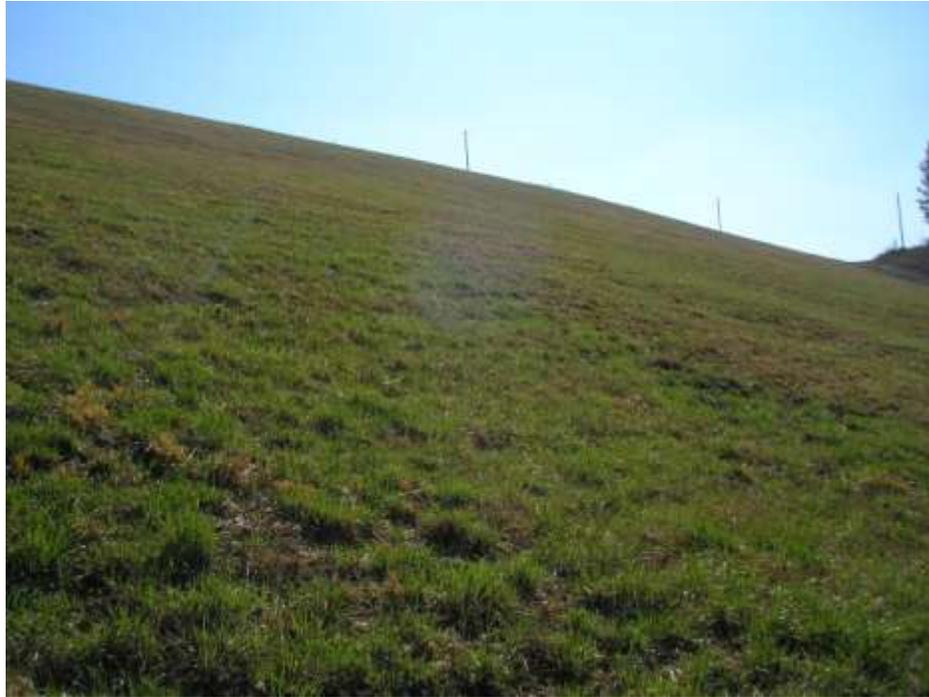
Figure 5.2.3-1 Main Dam Outside Slope

The downstream or outside slope of the CCR impoundment main dam is protected by several species of grass and weeds. There were no observed scarps, sloughs, bulging, cracks, depressions, or other indications of slope instability or signs of erosion. Figure 5.2.3-1 shows a section of the downstream slope of the main dam.

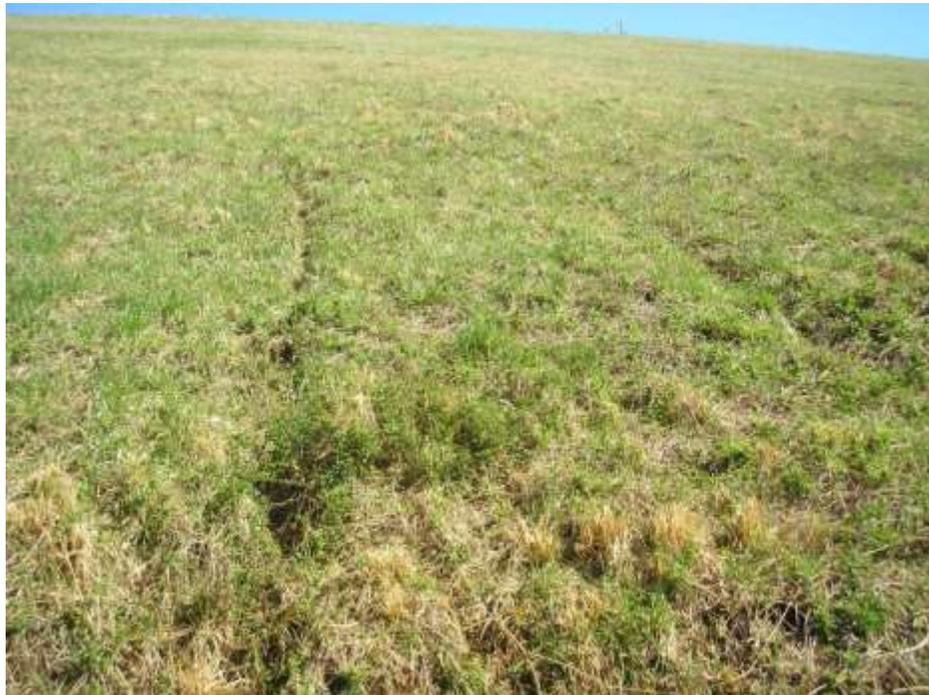
Widely scattered, small erosion rills were observed in the downstream slope. Figure 5.2.3-2 shows an erosion rill.

Figure 5.2.3-2 Main Dam Outside Slope Small Erosion Rill

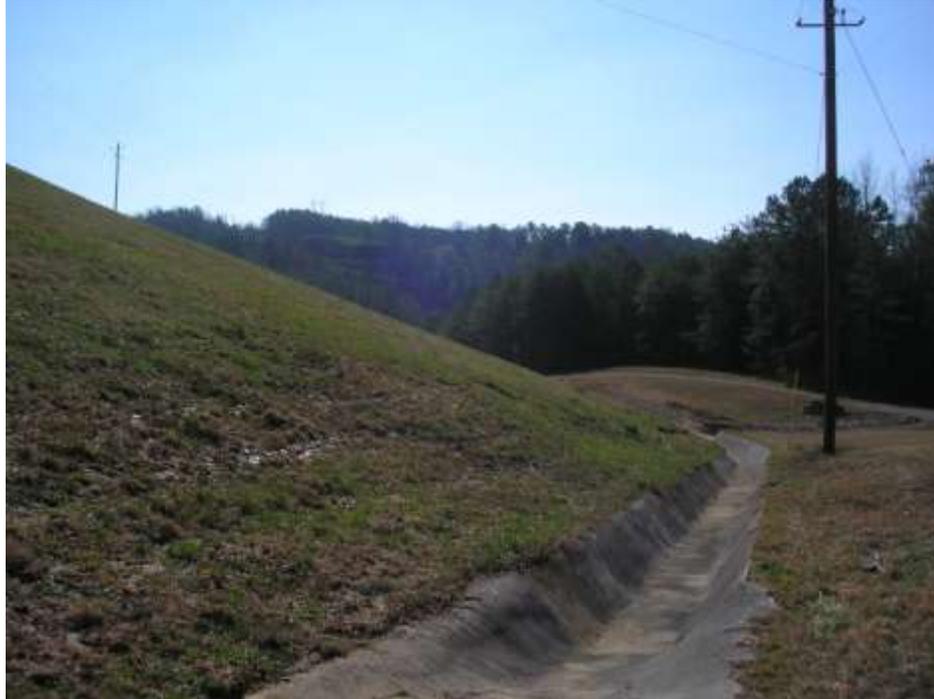
A few isolated wet areas were observed near the outside toe of the dam (see Figure 5.2.3-5). No evidence of flowing water was observed. It could not be determined if the source of water was minor seepage through the embankment or residual precipitation from recent storms.

Figure 5.2.3-5 Wet Area Outside Slope of Main Dam Toe

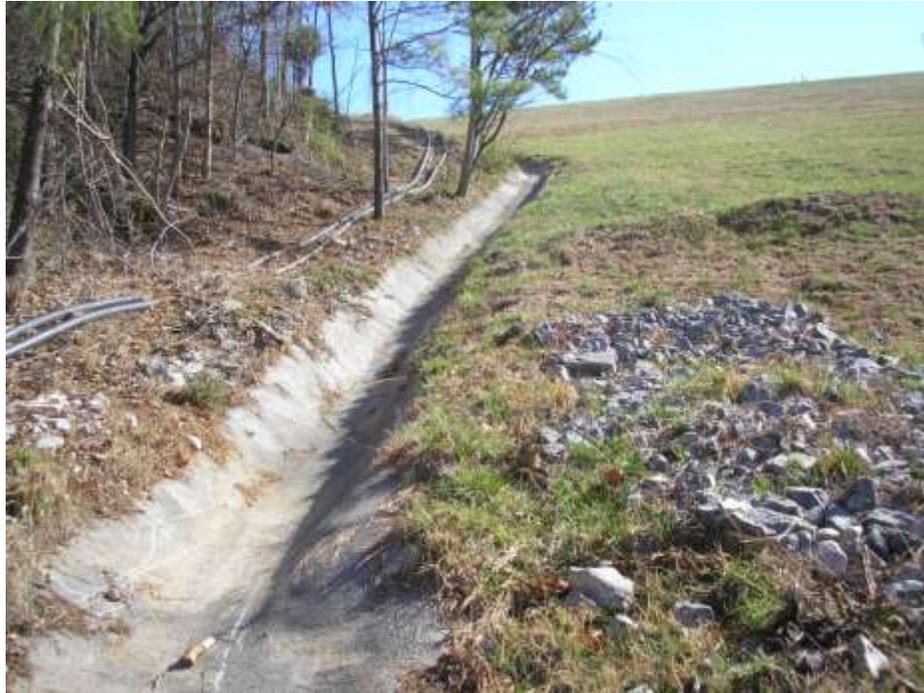
Figure 5.2.4-1 Main Dam North Abutment

Erosion or uncontrolled seepage was not observed along the abutments. The abutments appeared to be in good condition. Figures 5.2.4-1 and 5.2.4-2 show the north and south abutments, respectively.

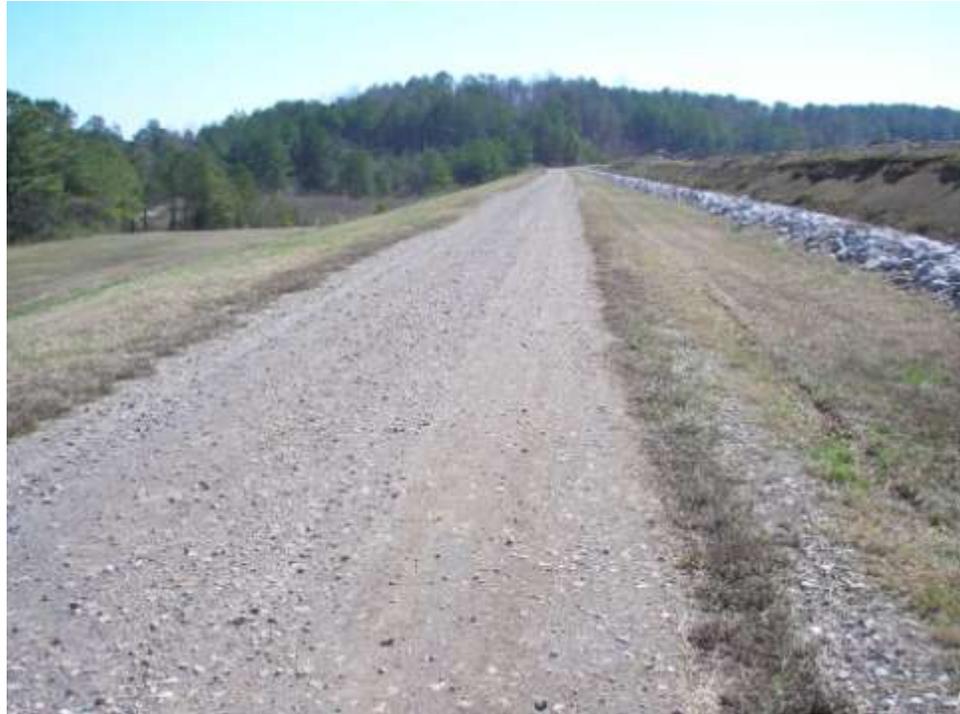
Figure 5.3.1-1 Crest of Saddle Dike

The crest of the CCR impoundment saddle dike had no signs of depressions, tension cracks, or other signs of settlement or shear failure. Previous inspection reports reviewed by Dewberry did not indicate issues concerning the crest of the main dam. Figure 5.3.1-1 shows the condition of the saddle dike crest.

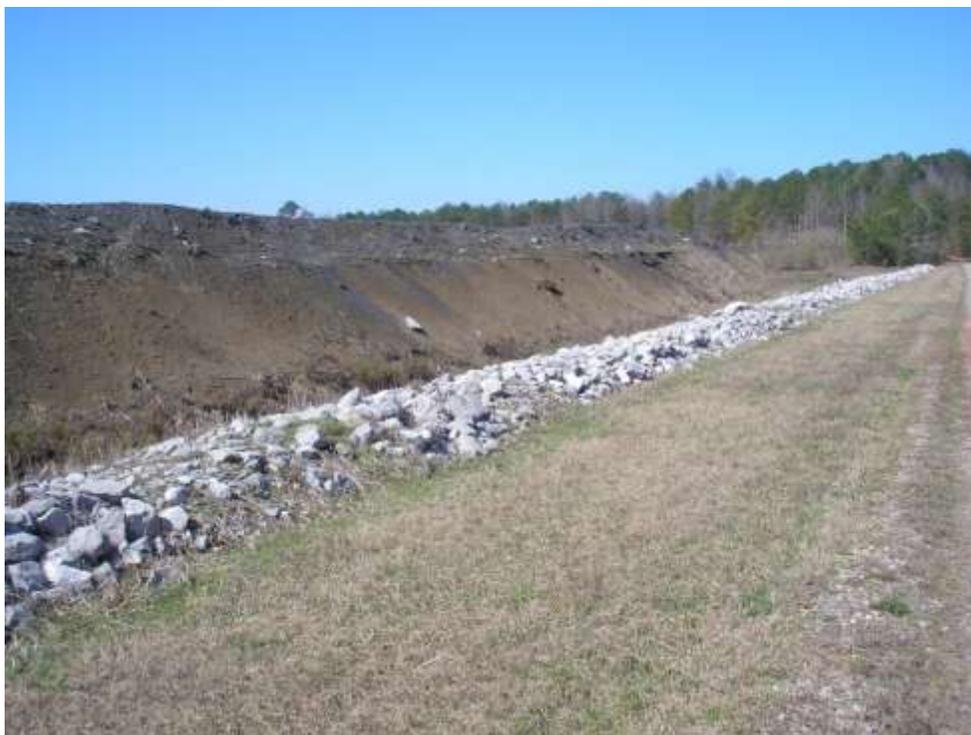
The upstream slope of the CCR impoundment saddle dike is armored with rip-rap, originally to protect the slope from erosion caused by wind generated waves. The impoundment in the area of the saddle dike has been filled with ash such that the embankment inside slope is no longer exposed to wave action. There were no observed scarps, sloughs, bulging, cracks, depressions, or other indications of slope instability or signs of erosion. Figure 5.3.2-1 shows a section of the upstream slope of the saddle dike.

Figure 5.3.2-1 Saddle Dike Inside Slope on Right and Impoundment Ash Fill on Left.

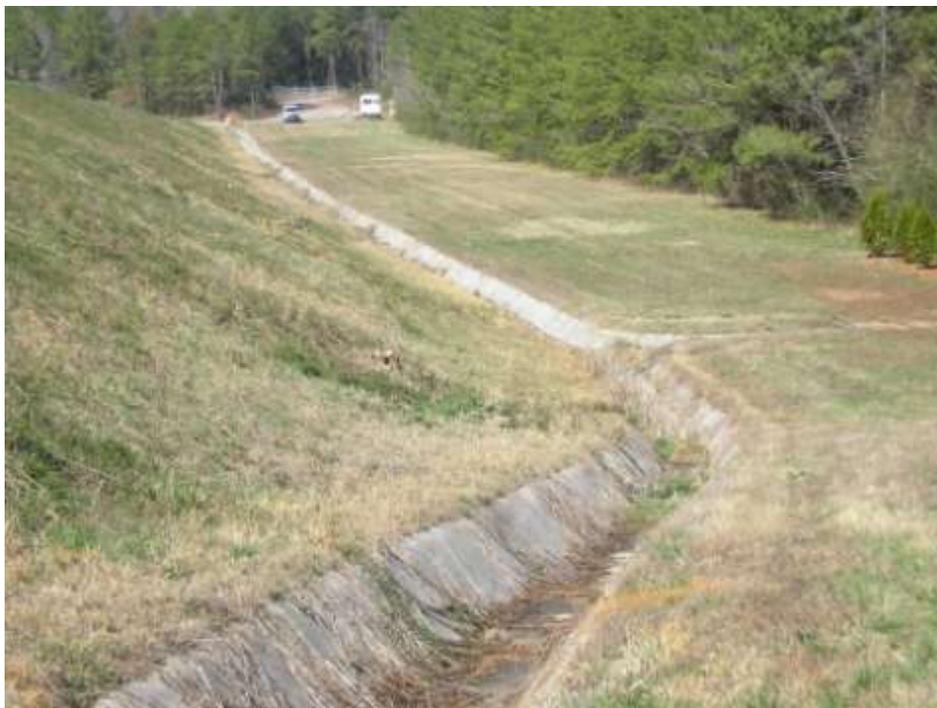
Figure 5.3.3-1 Saddle Dike Outside Slope

The downstream or outside slope of the CCR impoundment saddle is protected by several species of grass and weeds. There were no observed scarps, sloughs, bulging, cracks, depressions, or other indications of slope instability or signs of erosion. Figure 5.3.3-1 shows a section of the outside slope of the main dam.

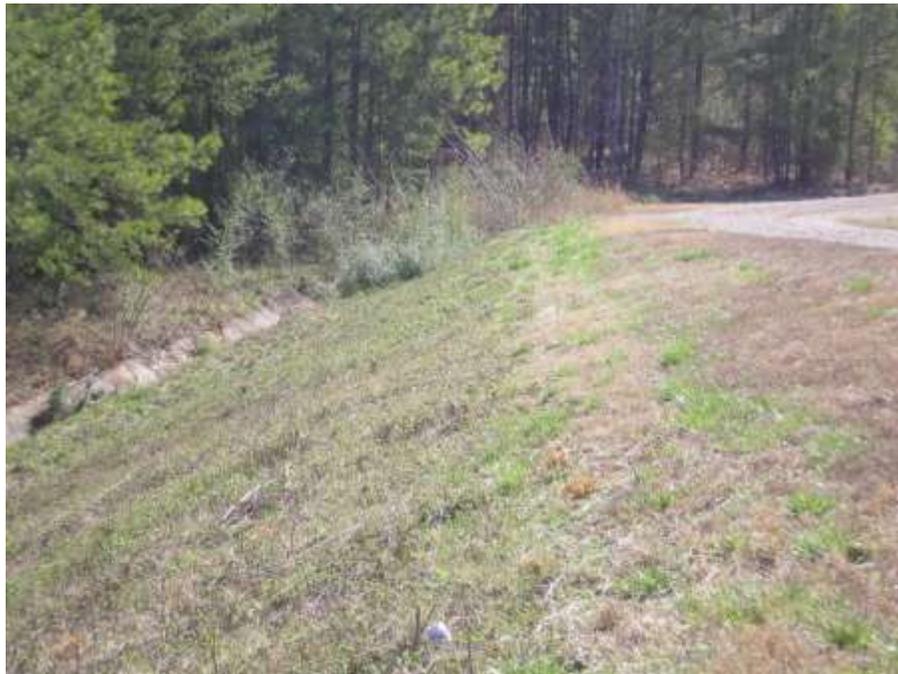
Figure 5.3.4-1 Saddle Dike South Abutment

Erosion or uncontrolled seepage was not observed along the abutments. The abutments appeared to be in good condition. Figure 5.3.4-1 shows the south abutment.

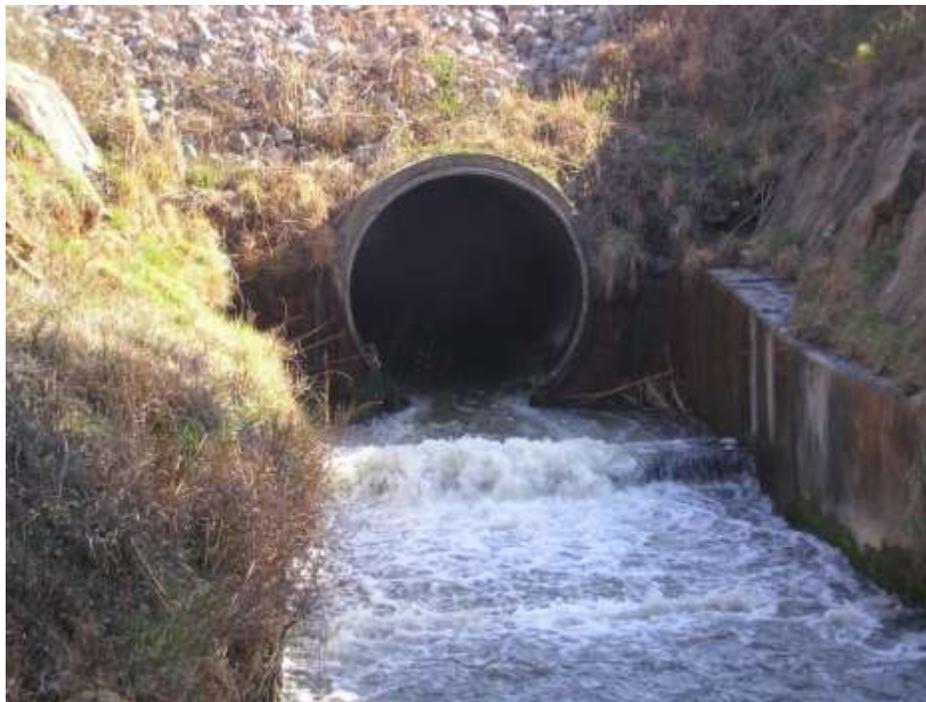
The outlet conduit appeared to be in good conditions and operating normally with no sign of clogging. Water flowing from the outlet was clear. Figure 5.4.2-1 shows the water discharging from the outlet conduit.

Figure 5.4.2-1 Water Flowing from Impoundment Overflow Discharge Conduit

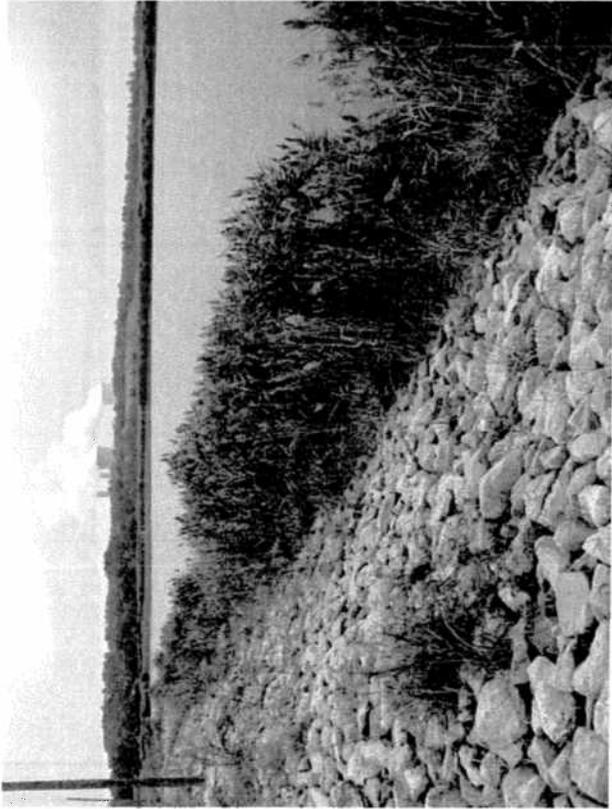
Photo 9: Typical Condition of Upstream Slope of Ash Pond Embankment

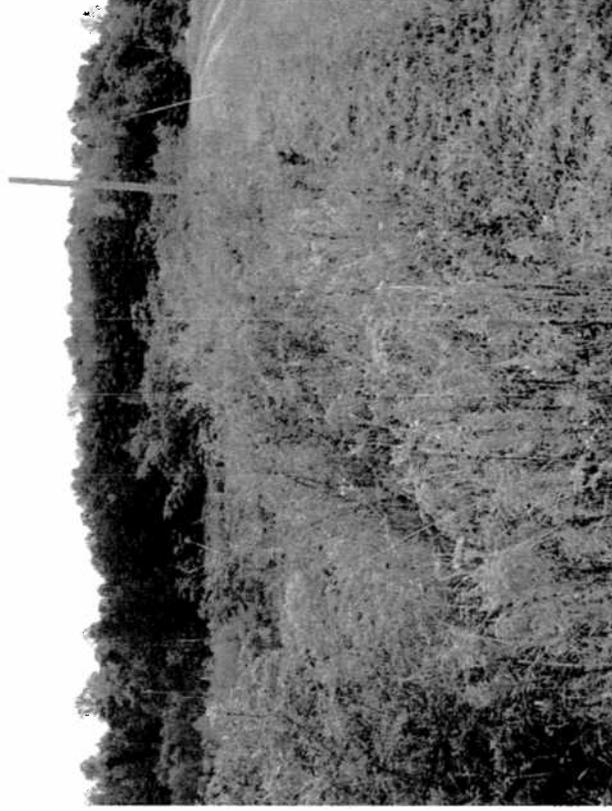
Photo 10: Vegetation on Downstream Slope of Saddle Dike 1

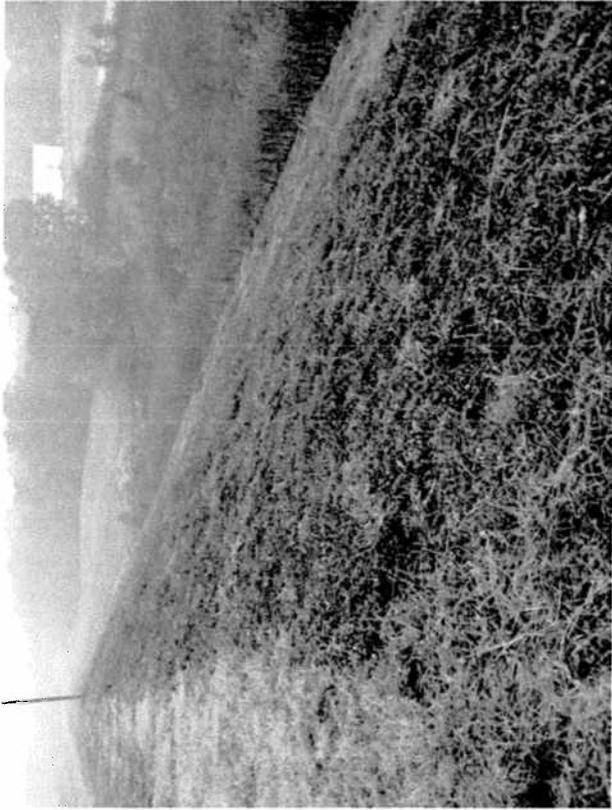
Photo 2: Condition of Saddle Dike Embankment, SE End Looking NW

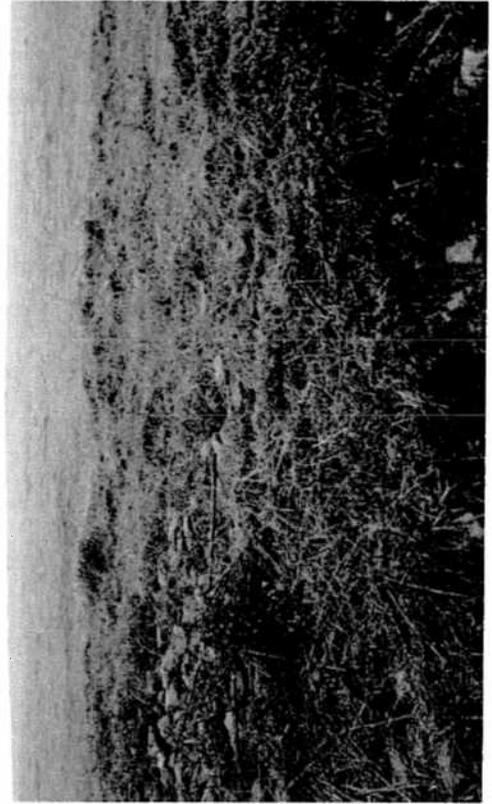
Photo 4: Condition of Main Ash Pond Dam Near Maximum Section

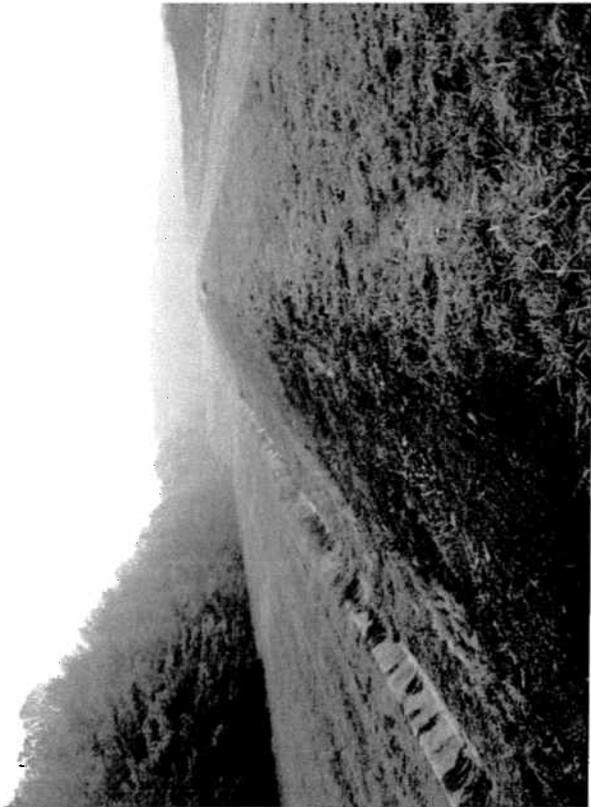
Photo 1: Condition of Saddle Dike Embankment, NW End Looking SE

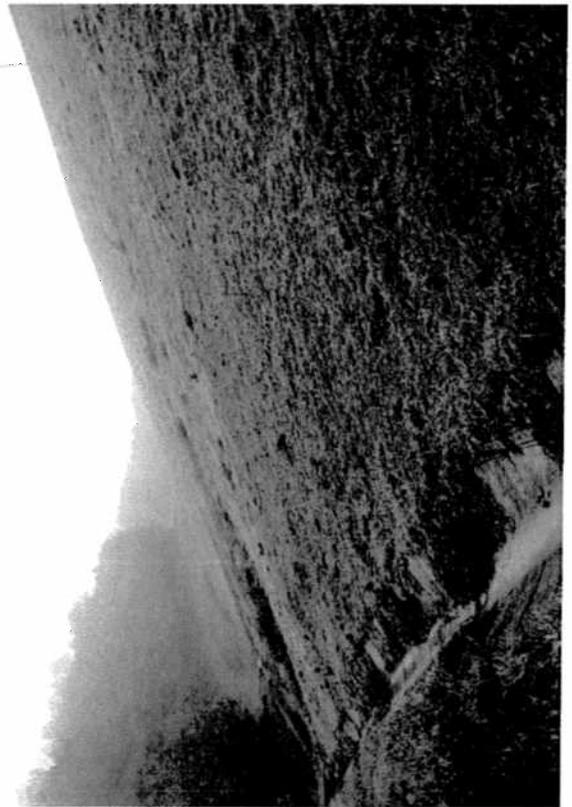
Photo 3: Condition of Main Ash Pond Dike, Near S End Looking N

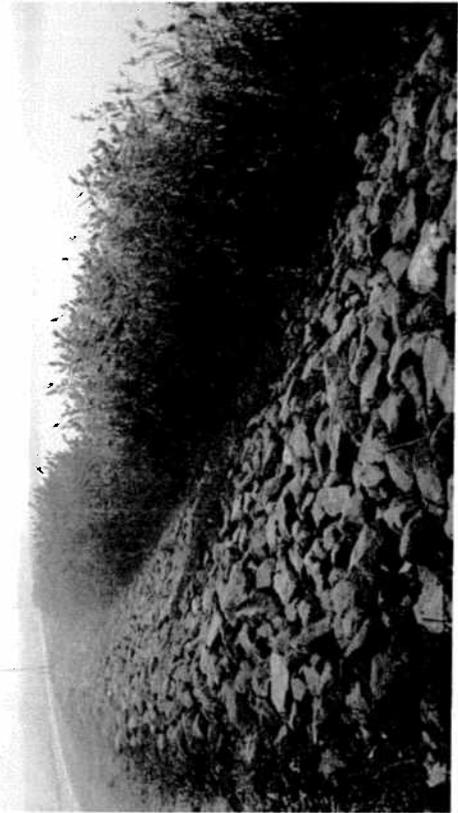
Photo 11: Typical Condition of Upstream Slope of Ash Pond Embankment

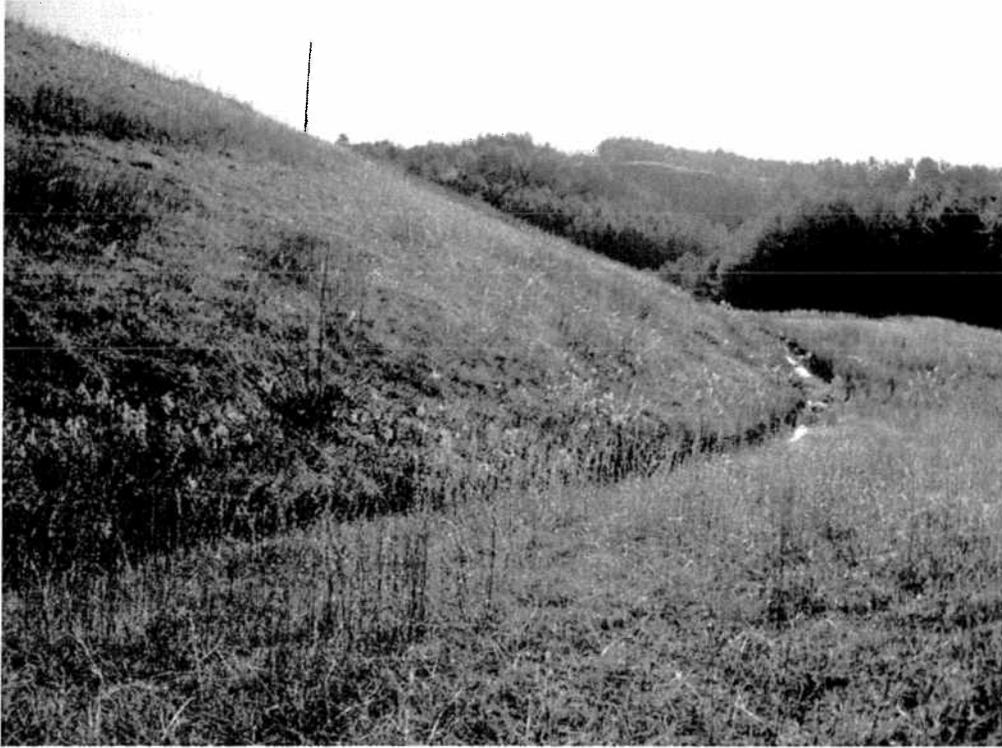
Photo 3: Typical Condition of Downstream Toe of Main Ash Pond Dam

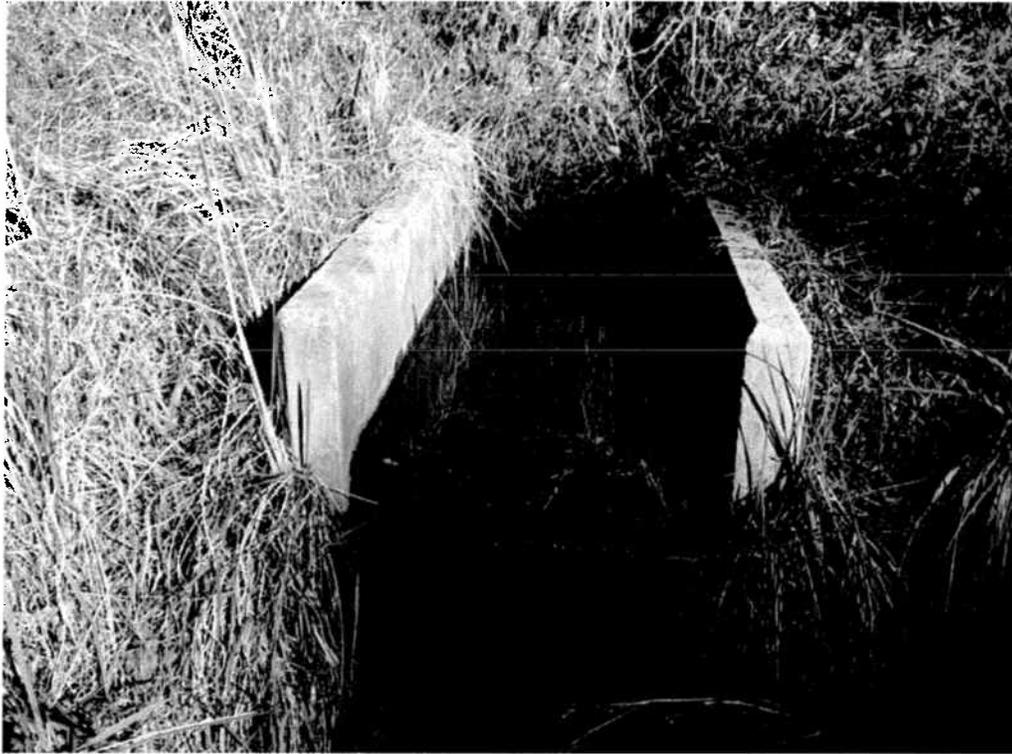
Photo 7: Condition of Weir 1

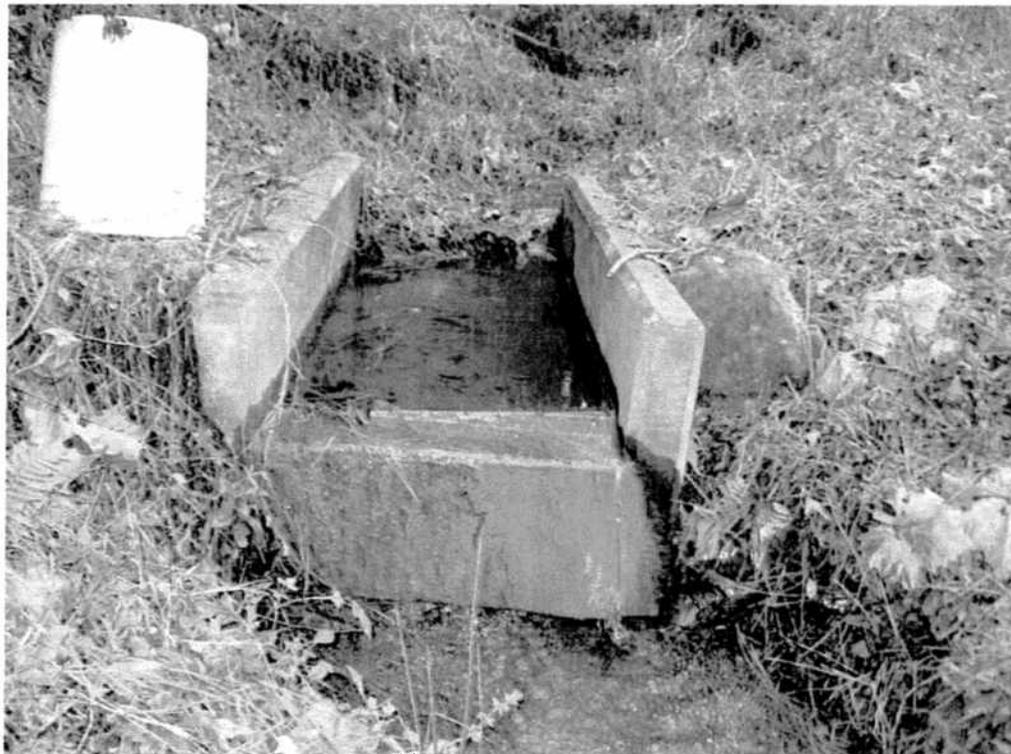
Photo 8: Condition of Weir 2

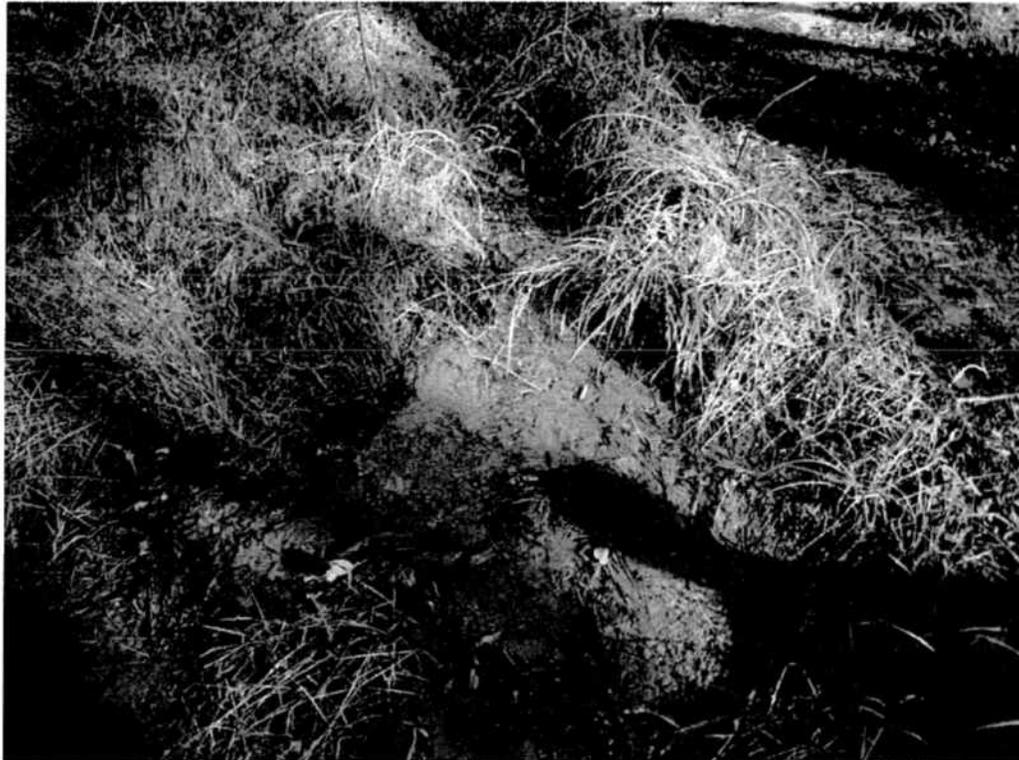
Photo 9: Seepage Along Access Roadway

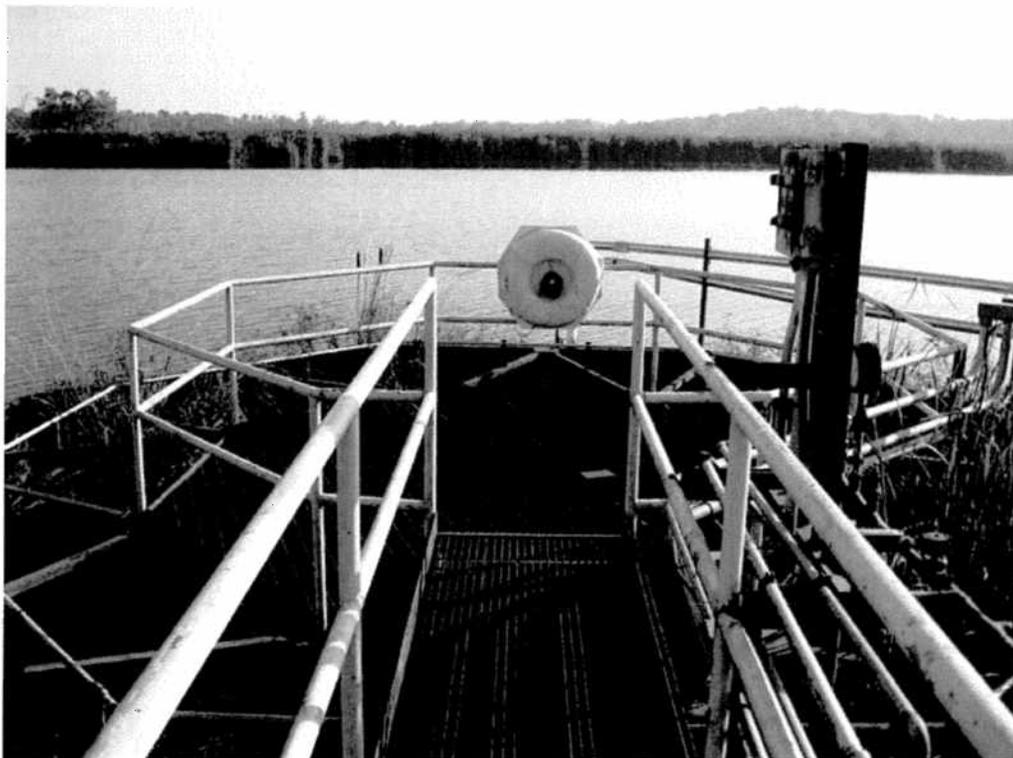
Photo 2: General Condition of Discharge Intake Structure

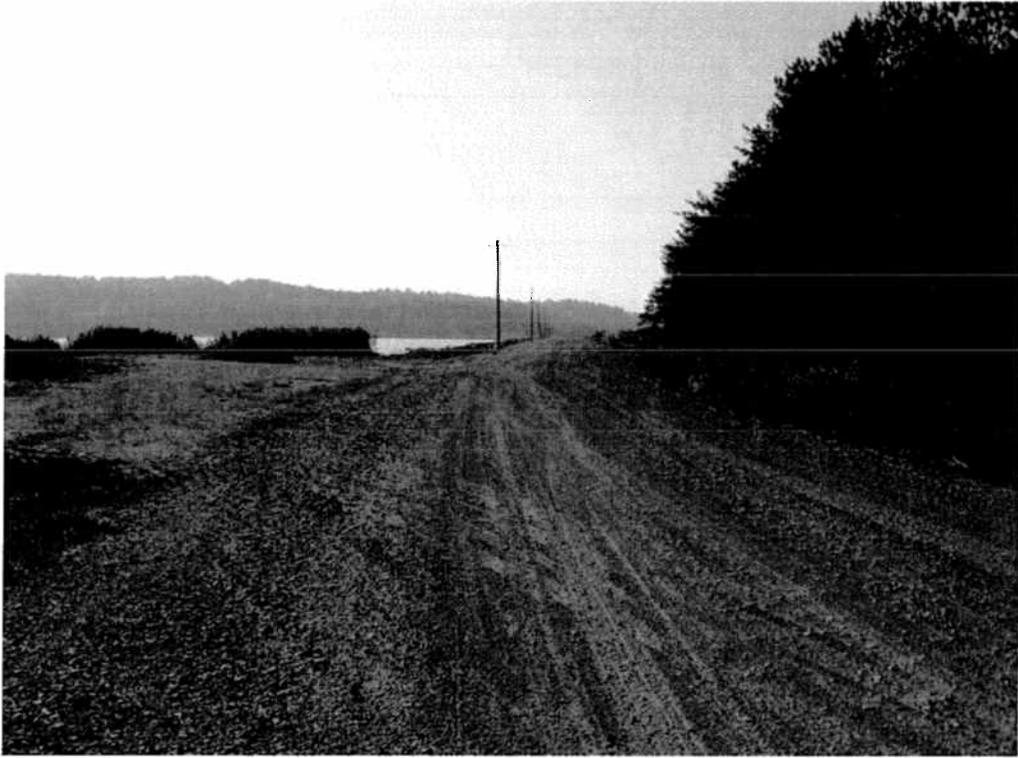
Photo 3: Condition of Main Ash Pond Dam Crest, Typical

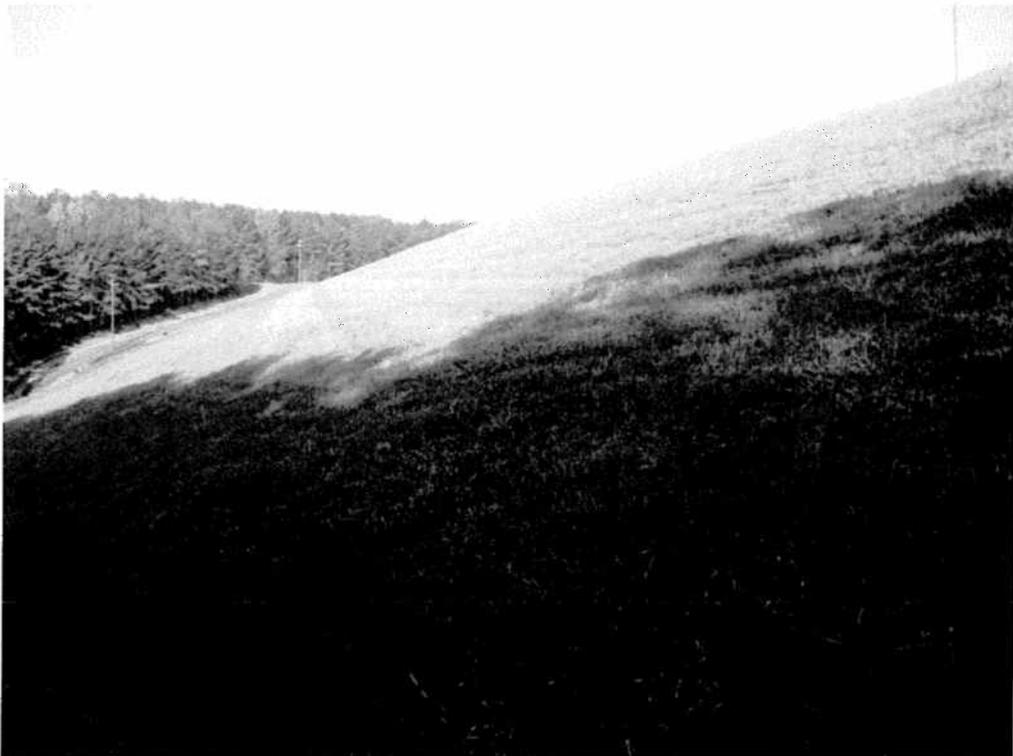
Photo 4: Condition of Main Ash Pond Dam Embankment Downstream Slope, Typical

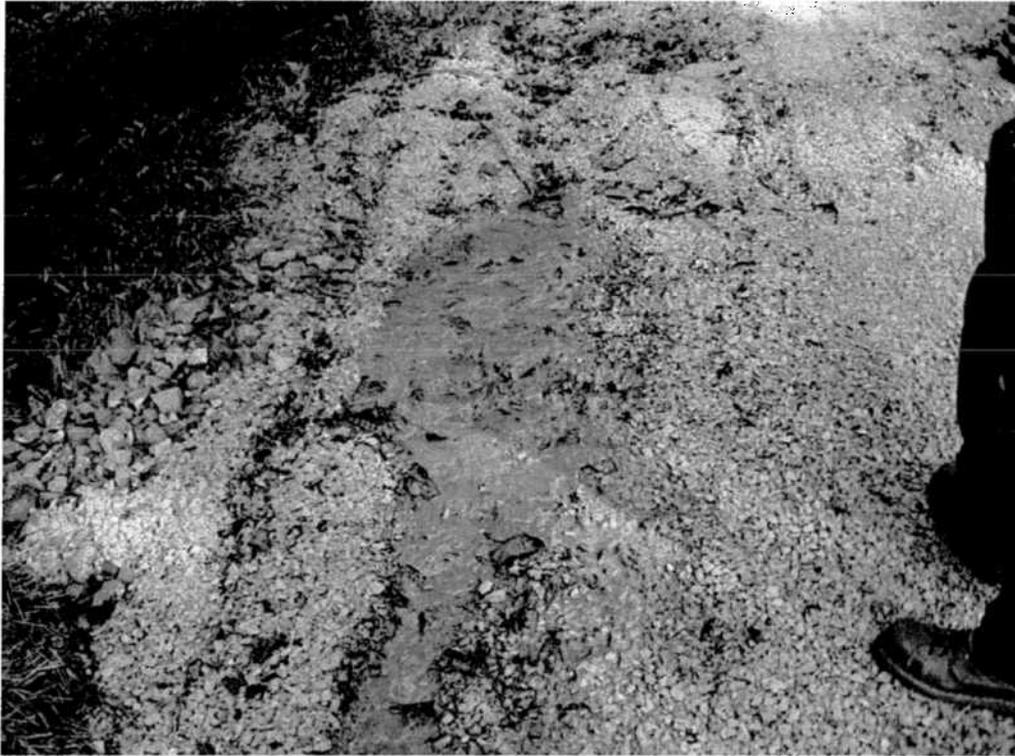
Photo 5: Small Seep Along Access Roadway

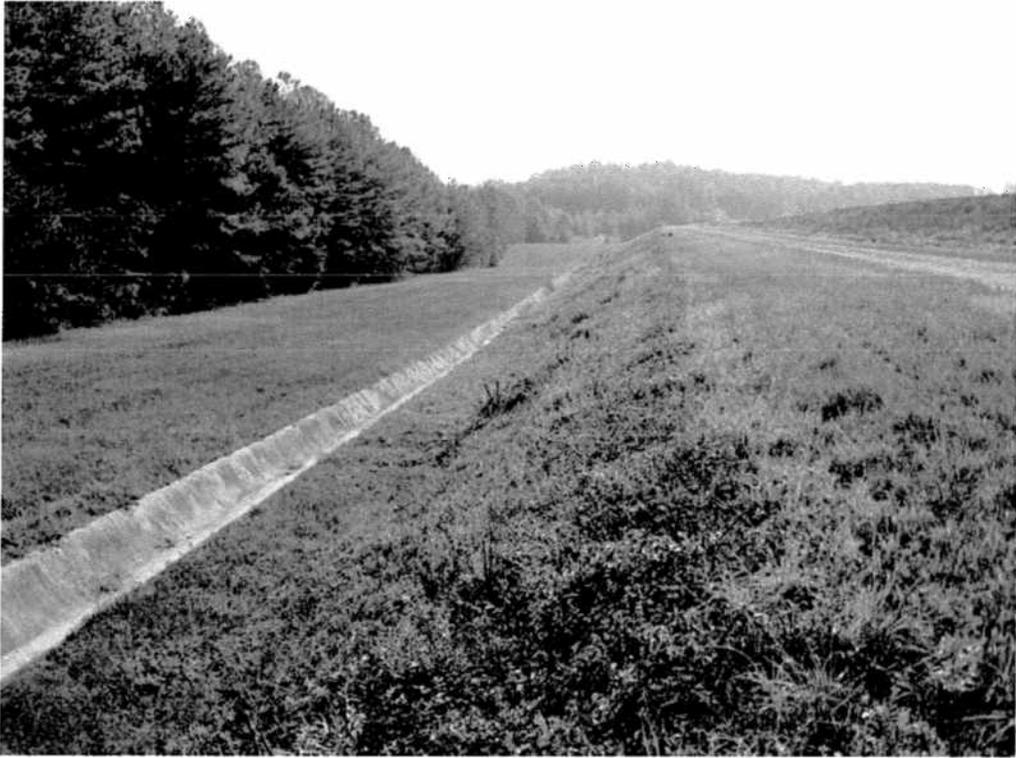
Photo 7: Condition of Saddle Dam, Typical

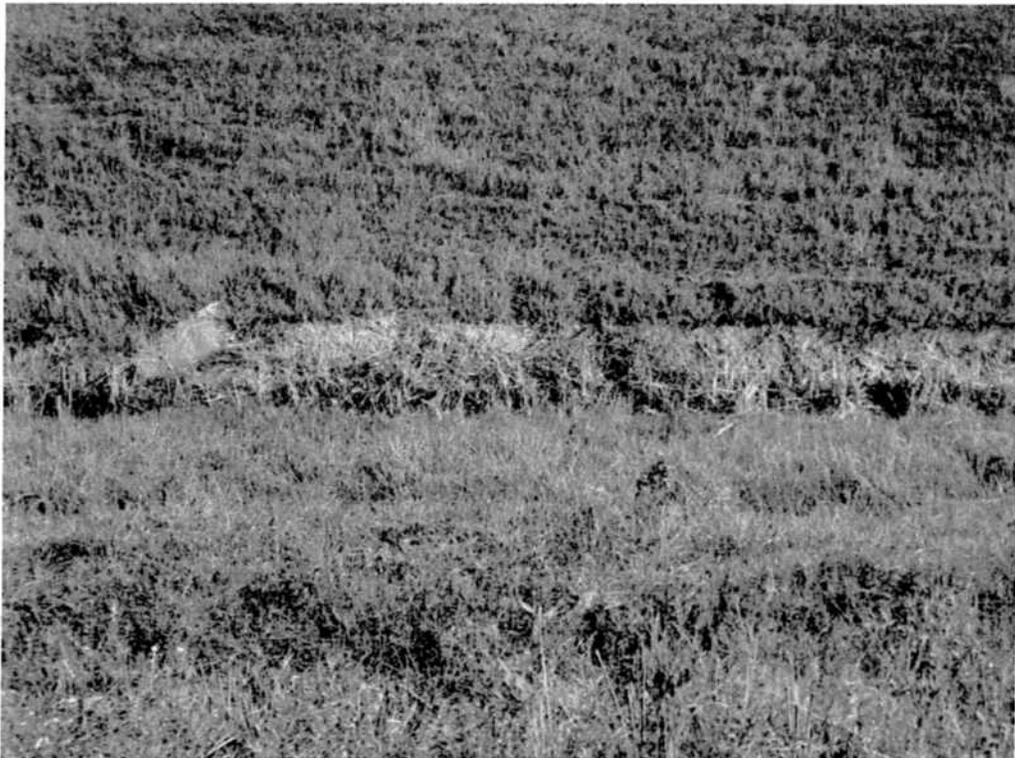
Photo 8: Debris in Concrete Lined Drainage Ditch Along Saddle Dam Toe

No.	Description	Location
1	It is recommended that the current level of embankment maintenance at the main ash pond dam (on both the upstream and downstream slopes) be continued.	Main Ash Pond Dike (see Photo #4)
2	It is recommended that the plant staff clear the debris from the drainage ditches along the main ash pond dam embankment toe so that they are allowed to flow freely, and future maintenance efforts should include provisions to keep them clear.	Main Ash Pond Dike
3	It is recommended that the current level of embankment maintenance be maintained at the saddle dike.	Saddle Dike (see Photo #7)
4	It is recommended that the plant clear the debris from the drainage ditch along the saddle dike embankment toe so that it flows freely.	Saddle Dike (see Photo #8)
