**FINAL**  
**Coal Ash Impoundment -**  
**Specific Site Assessment Report**  
**Arizona Public Service**  
Four Corners Power Plant

Submitted by:  
**GEI Consultants, Inc.**  
6950 South Potomac Street, Suite 300  
Centennial, CO 80112

September 2009  
Project 091330

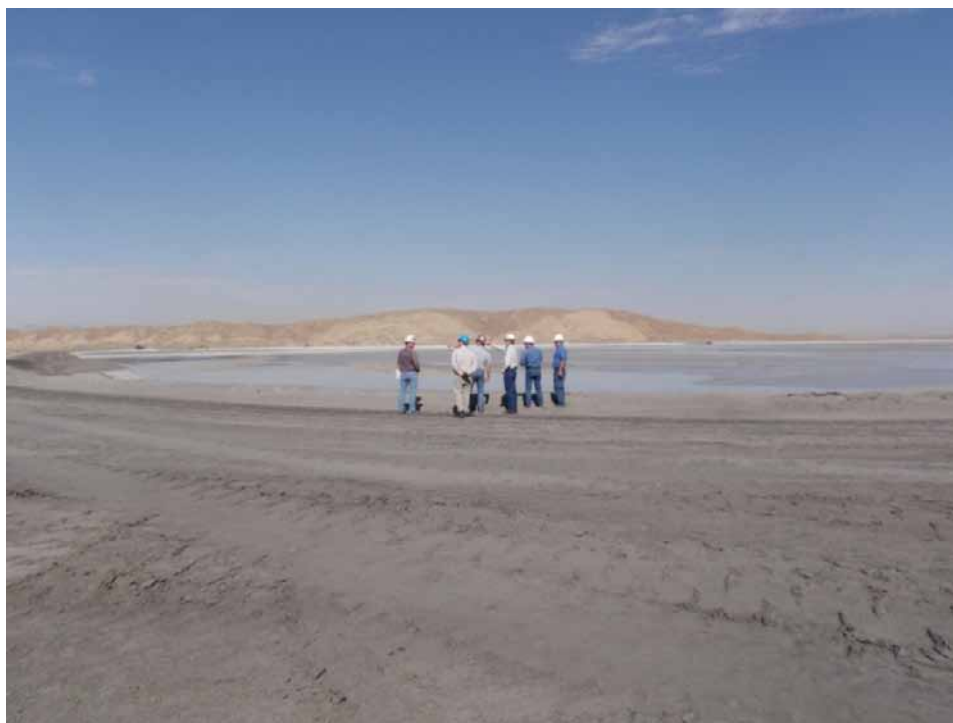
**Photo 1 – LAI General view from SE corner, looking west to Hogback in distance.**

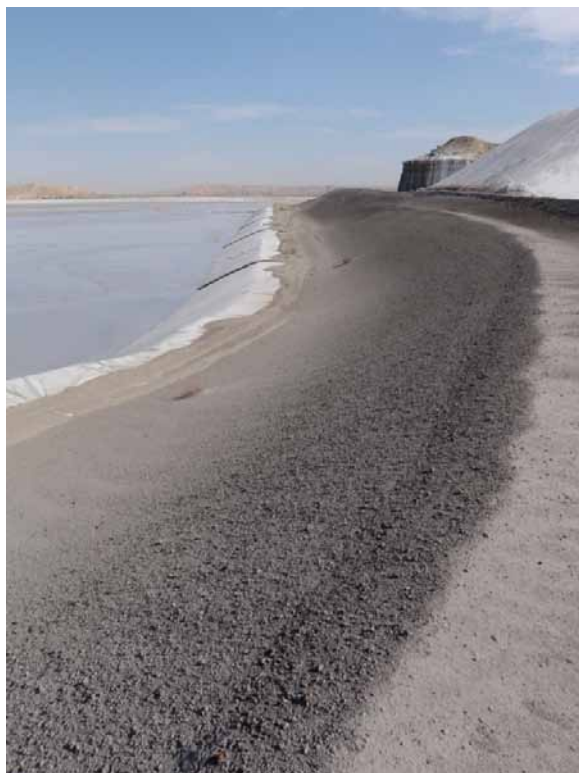
**Photo 3 – LAI Upstream slope of east dam. East dam includes a rockfill zone. Note natural bluffs forming upslope side to east.**

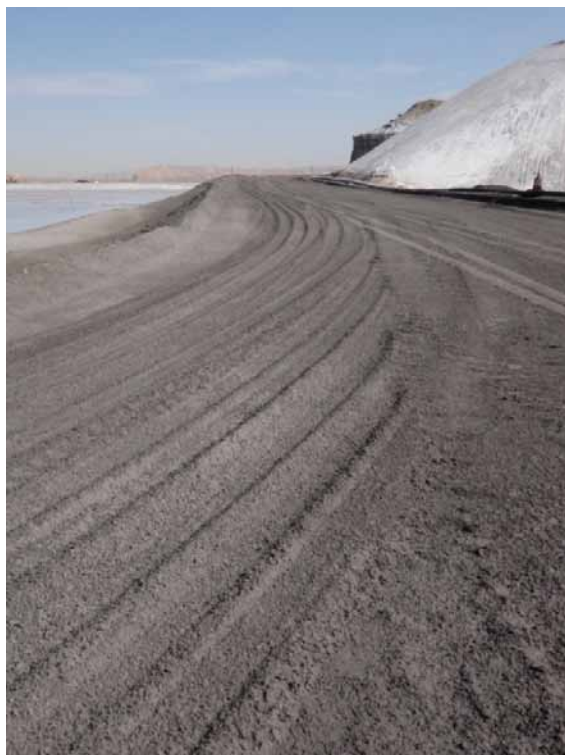
**Photo 4 – LAI Dam crest on east dam.**

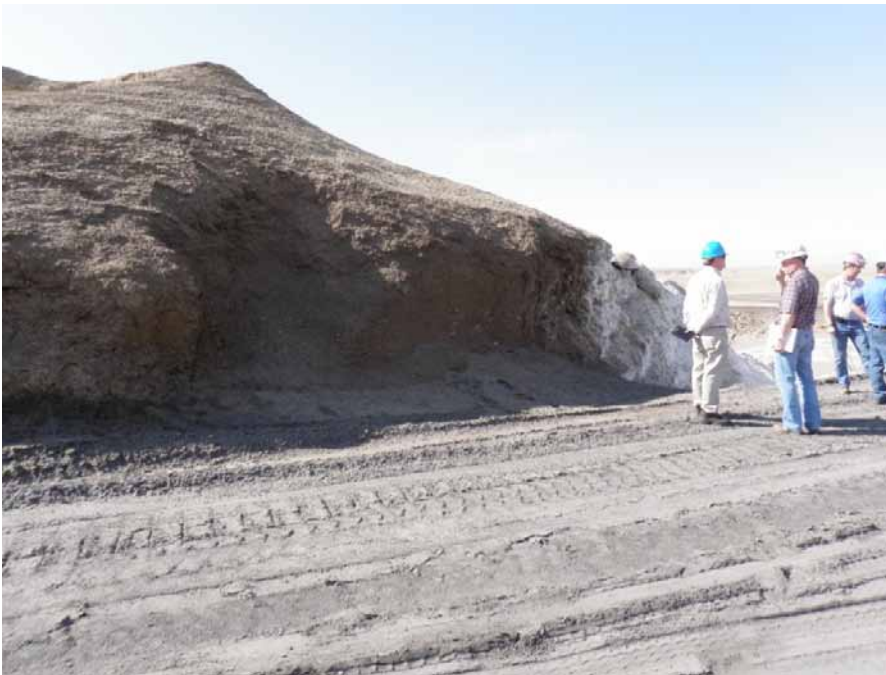
**Photo 6 – LAI Exposed part of natural weathered shale that the south and east berm clay cores tie into for seepage control.**

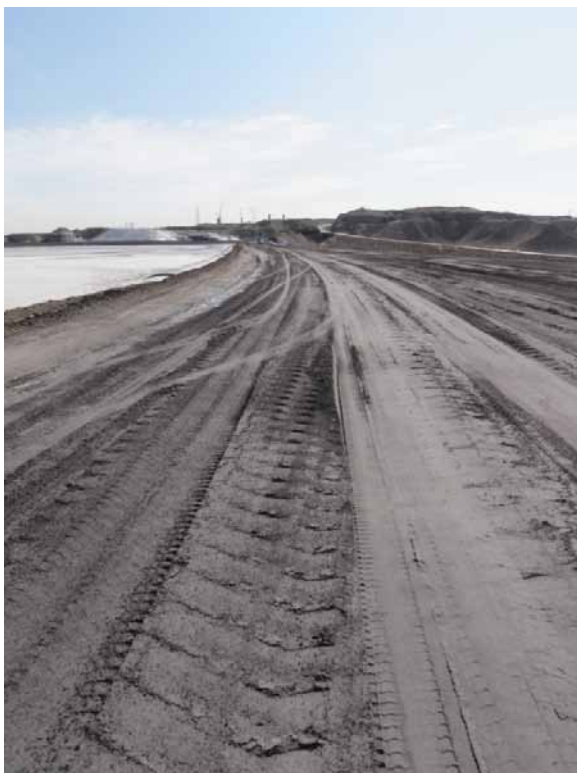
**Photo 7 – LAI Dam crest on south dam, looking to the right and toward natural high ground and power plant in background.**

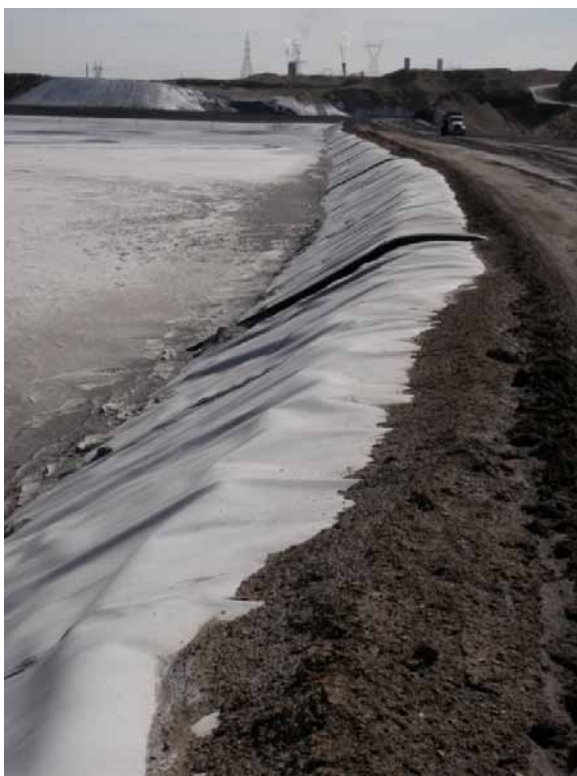
**Photo 8 – LAI Upstream slope on south dam.**

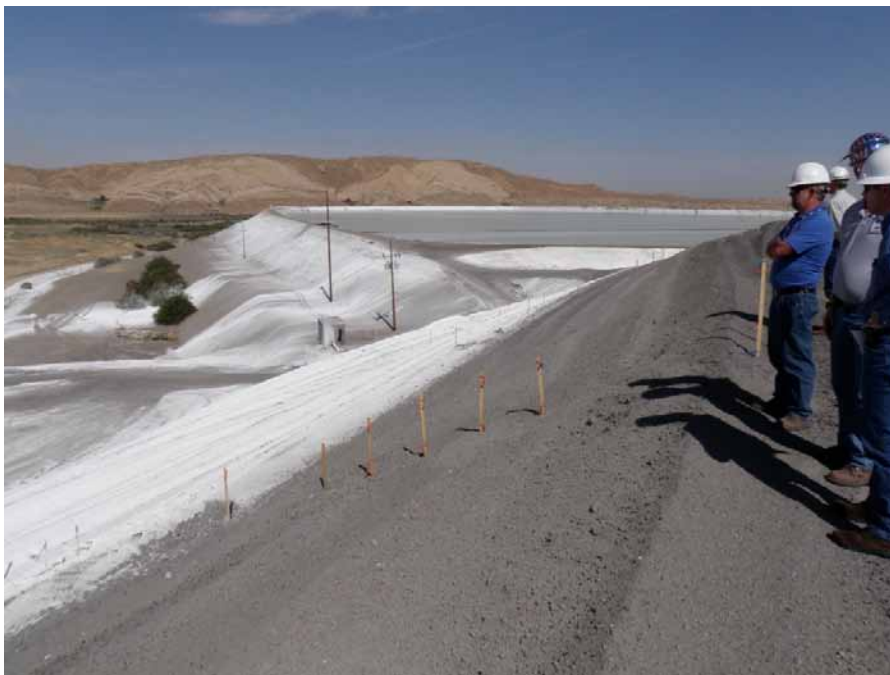
**Photo 11 – LAI Downstream slope at southwest corner. Note LDWI at lower elevation in background and small pump station structure for decant water.**

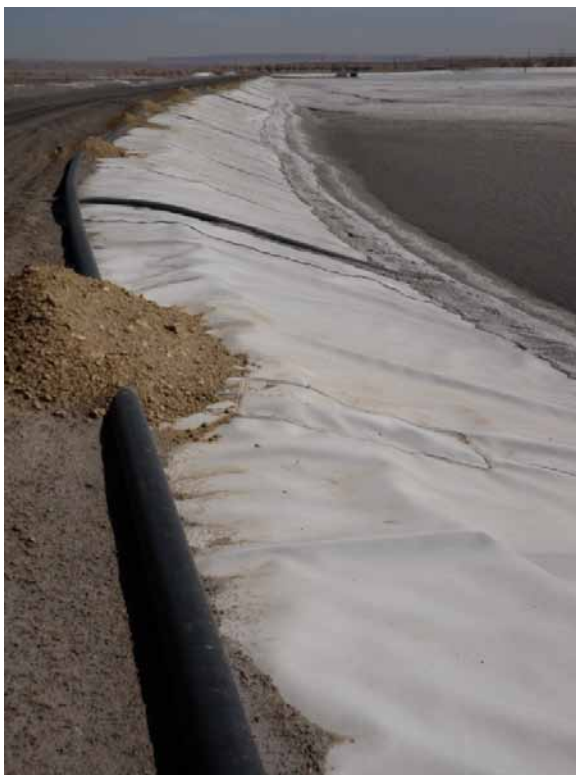
**Photo 12 – LAI Upstream slope on west dam. HDPE pipe is to supply water for construction.**

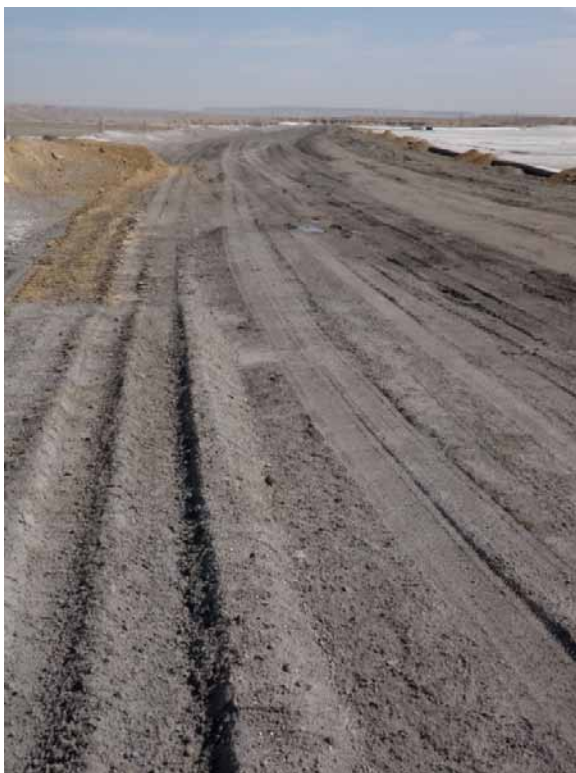
**Photo 13 – LAI Crest of west dam. Note small construction material stockpile for dam raise.**

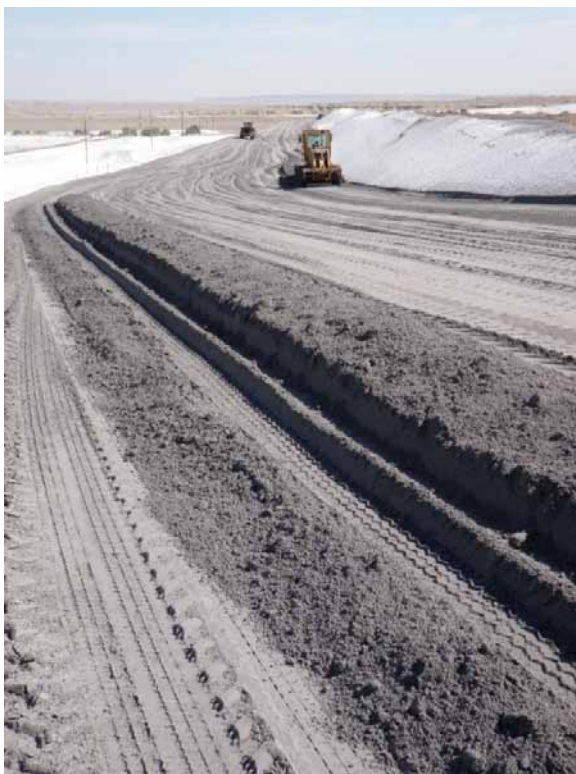
**Photo 14 – LAI Widening the west dam in preparation for dam raise construction.**

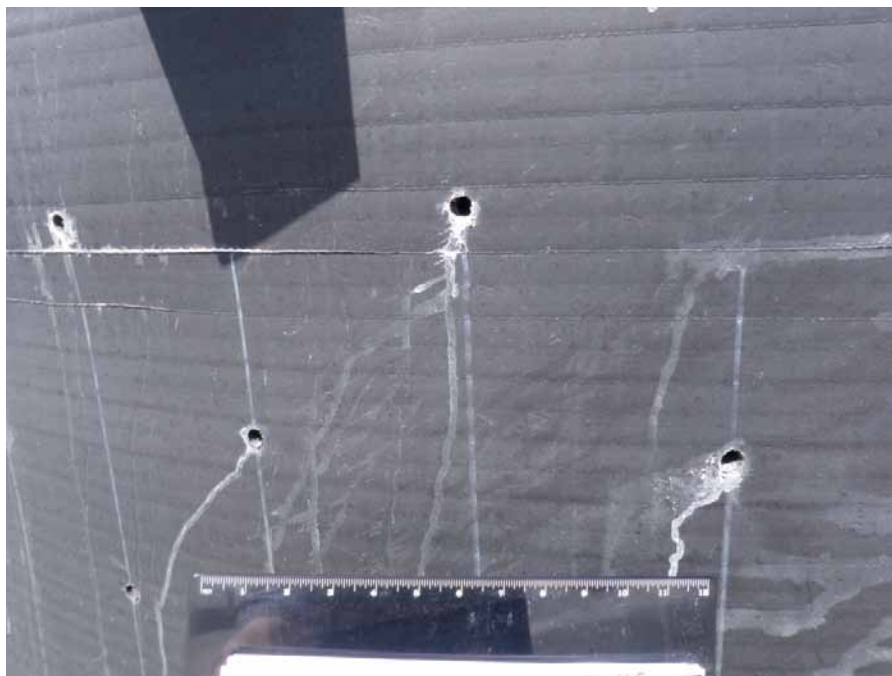
**Photo 18 – LAI Close up view of 1/2" dia perforations in decant drop inlet.**

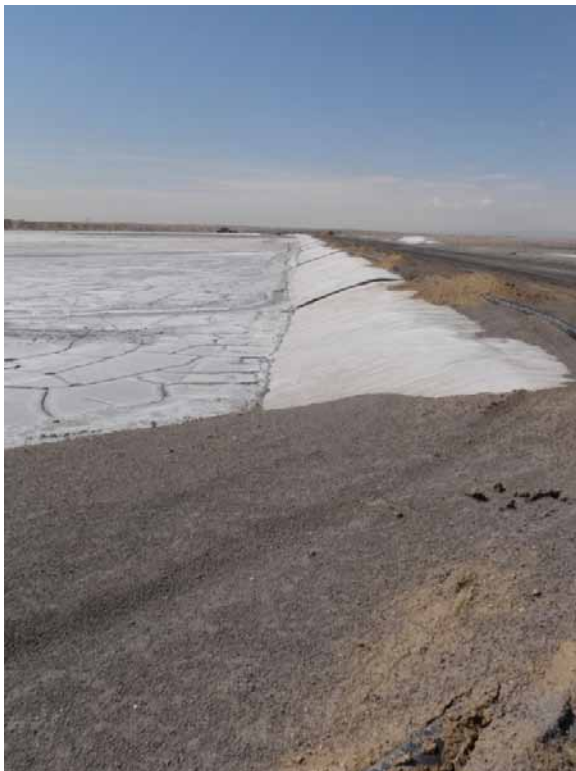
**Photo 19 – LAI Upstream slope of west dam, looking right.**

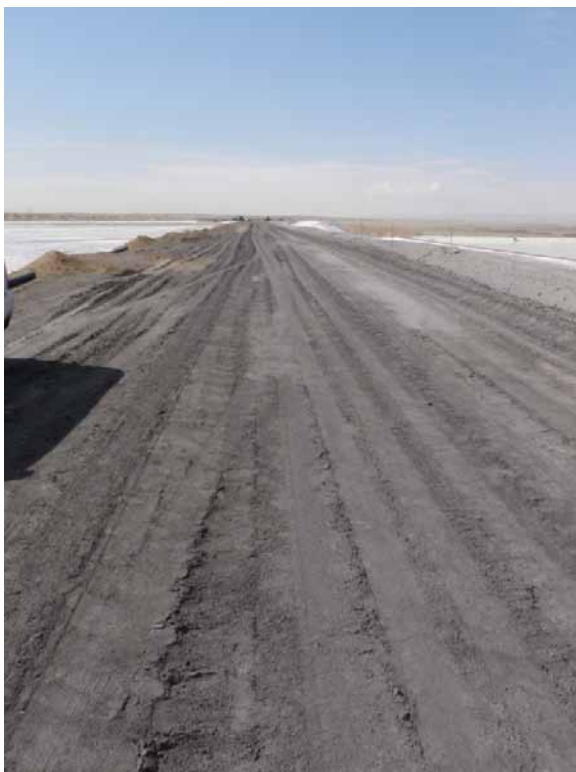
**Photo 20 – LAI Crest of west dam, looking right.**

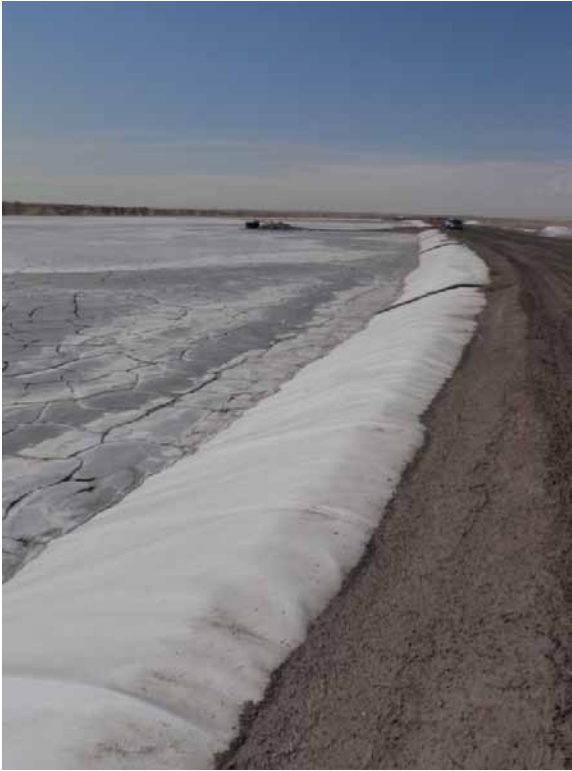
**Photo 21 – LAI Upstream slope of west dam, looking right. Note berm to access decant drop inlet structure.**

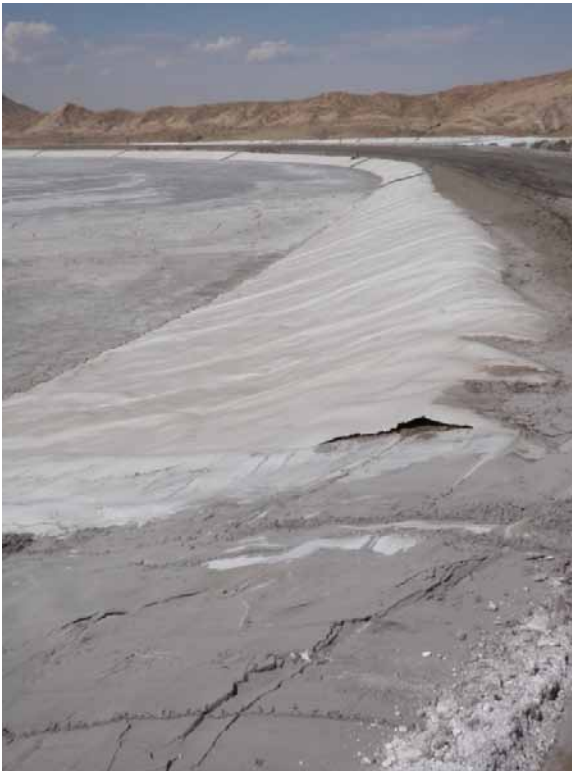
**Photo 22 – LAI Upstream slope of north dam. Note tear in HDPE lining caused by construction equipment. APS has noted and plans immediate repair.**

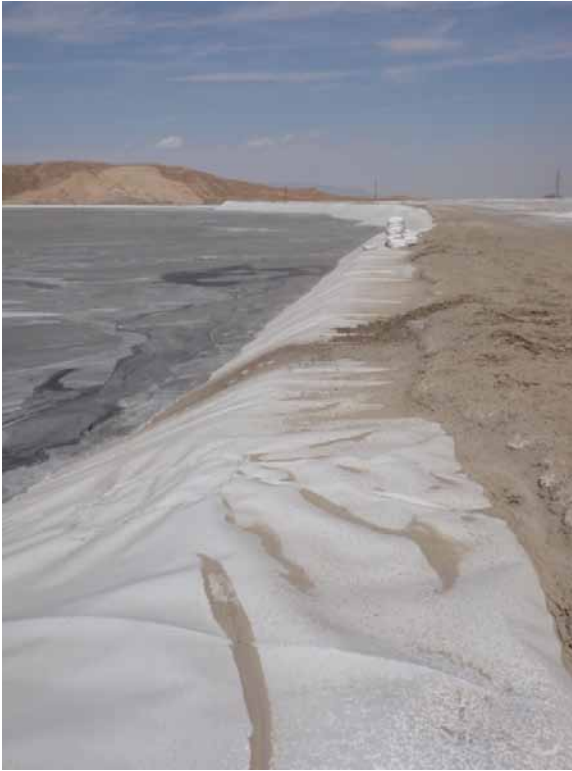
**Photo 23 – LAI Upstream slope of north dam, looking left from near northeast corner of impoundment.**

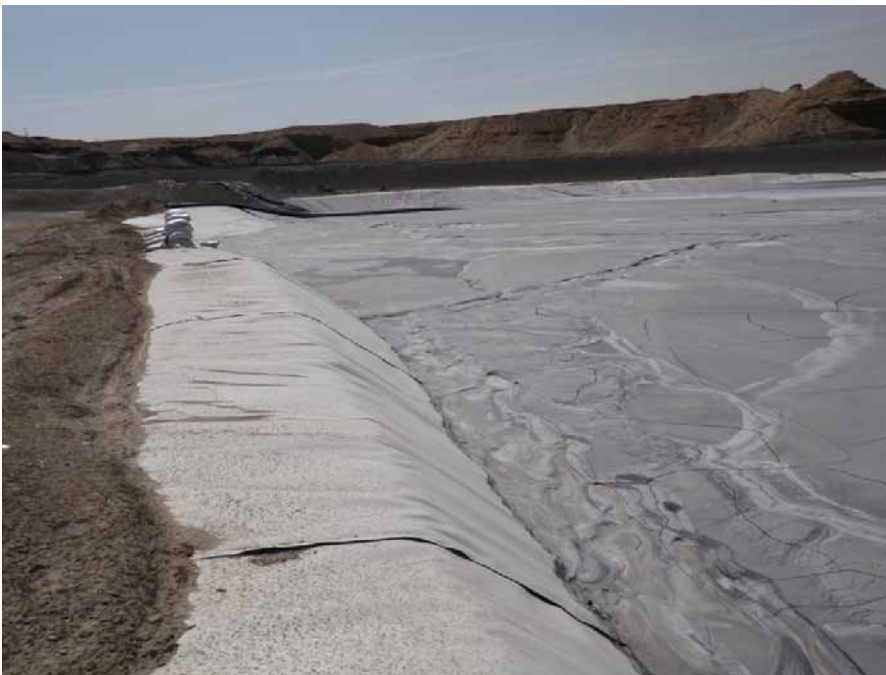
**Photo 24 – LAI Upstream slope of north dam, looking right from near northeast corner of impoundment towards the ash slurry discharge into pond and natural high ground to east.**

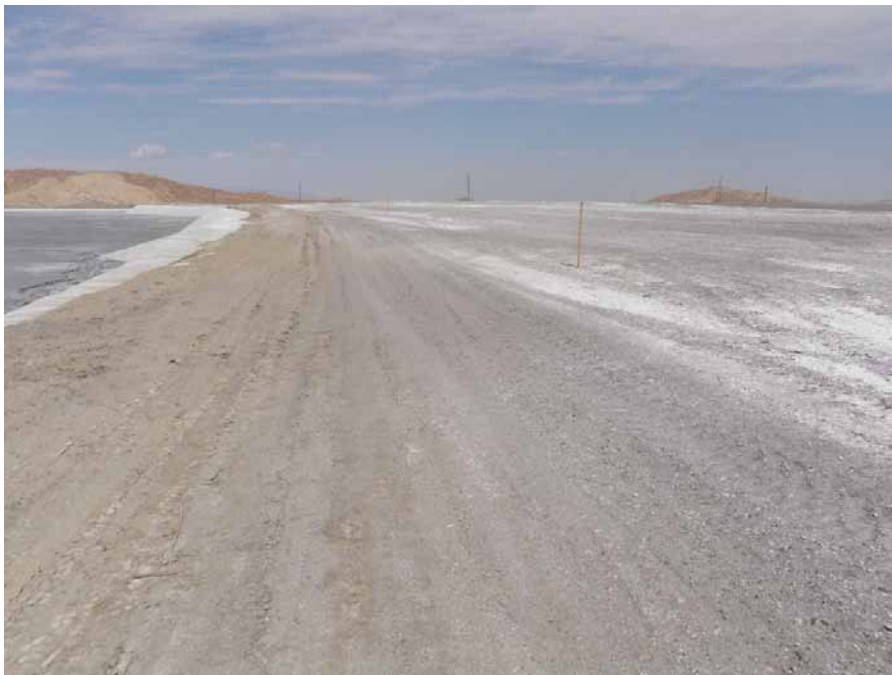
**Photo 25 – LAI Crest of north dam. Note gradually sloping fill between impoundment and Pond #6 to right (out of service).**

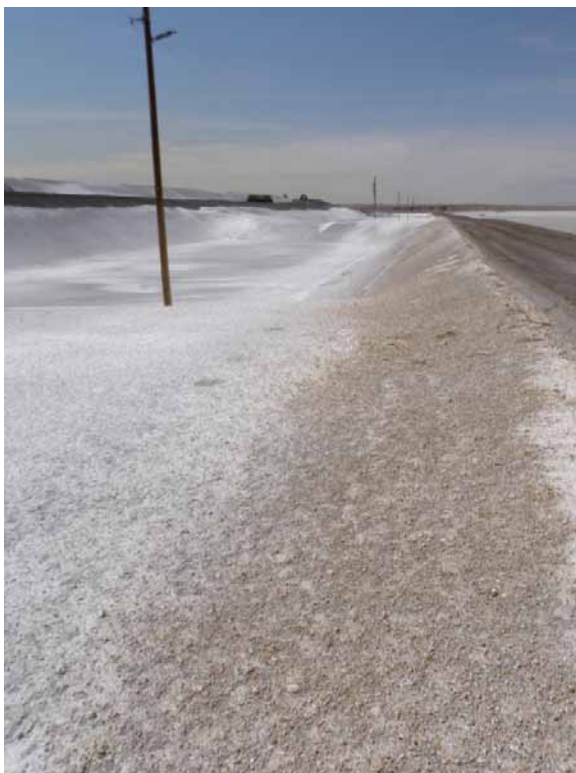
**Photo 27 – LAI Downstream slope and toe of west dam on left, adjacent LDWI dam is on right.**

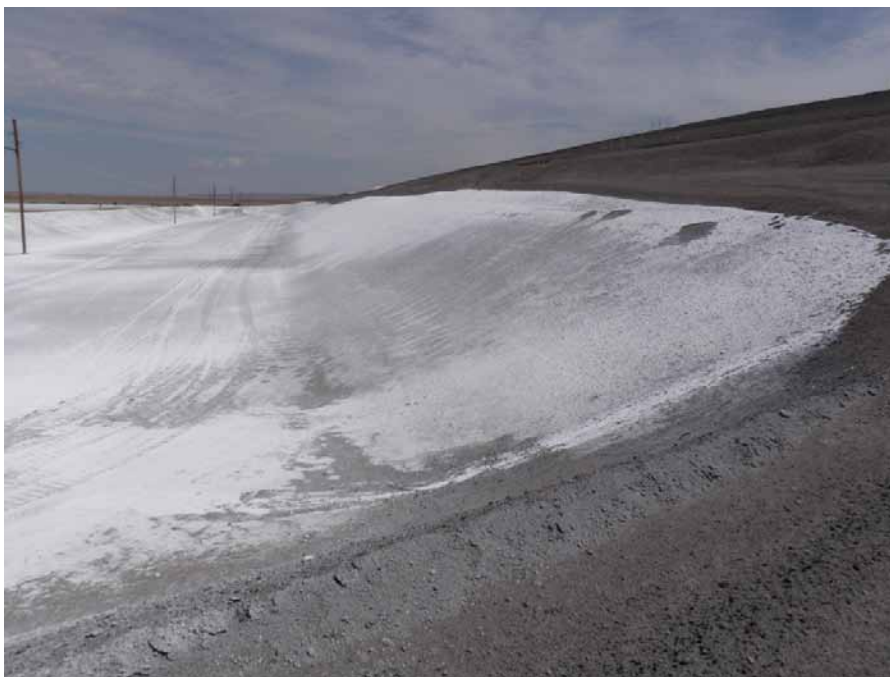
**Photo 28 – LAI Downstream slope and toe of west dam looking right from southeast corner of LAI. Note adjacent LDWI dam on left.**

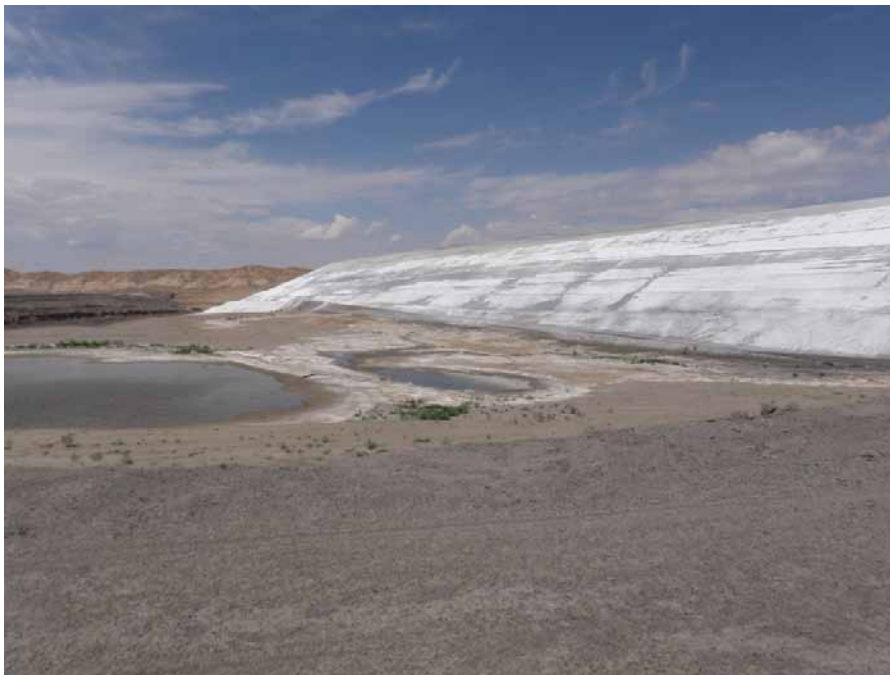
The downstream slope of the dam, which consists of compacted bottom ash, does not have additional erosion protection. Ponded water was observed at the downstream toe of the south embankment of the underlying Pond 3 & 4 embankment (see Photo 29). The seep occurs at a low point in the foundation topography and has been active for many years without significant change. The seep runs clear at a slow rate and there is no evidence of internal erosion of dam materials. There is no toe drain to collect and convey the water away from the embankment. The seepage is expected to reduce as the available water in the Pond 3 & 4 impoundment slowly drains. APS believes that the source of the seepage observed at the downstream toe is construction water that drains from the bottom ash placed to construct the LAI embankment and has found the seepage dries up within a few weeks of stopping construction of the embankment. The downstream slope was observed to be in generally good condition. No seepage was observed at the downstream toe in the northwest corner, where the cutoff trench does not tie in to the underlying 3-4 embankment.

No evidence of significant seepage through the LAI or LDWI dam embankments. Evidence of seepage was observed at the downstream toe (old Pond #4) of the south embankment of the LAI. This has been an area of ongoing seepage according to APS and has not been associated with instability of the surrounding embankment. APS believes that the source of the seepage observed at the downstream toe is construction water that drains from the bottom ash placed to construct the LAI embankment and has found the seepage dries up within a few weeks of stopping construction of the embankment. Tamarisk trees growing at the downstream toe (old Pond #3) of the west embankment of the LDWI may be indicative of local seepage, but likely spread to the embankment slope from an adjacent grove of tamarisk that first became established on the banks of the nearby Pond #6 seepage ditch.

**Photo 29 – LAI Downstream slope and toe of south dam, looking to right. Note ponded water near toe that results from seepage from old Pond #4 that underlies the LAI.**

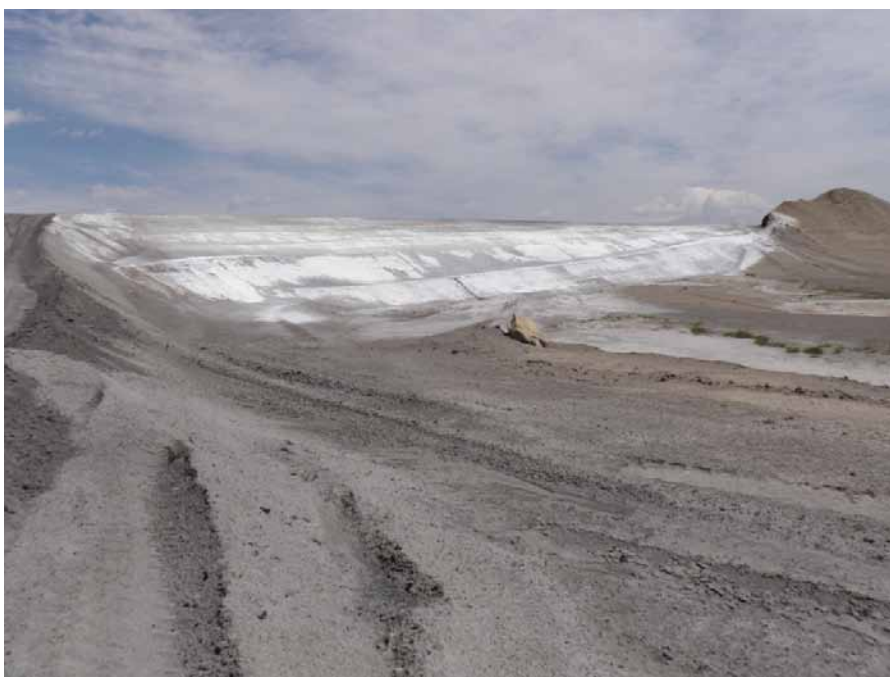
**Photo 30 – LAI Downstream slope and toe of south dam, looking left toward the tie-in with natural weathered shale high ground.**

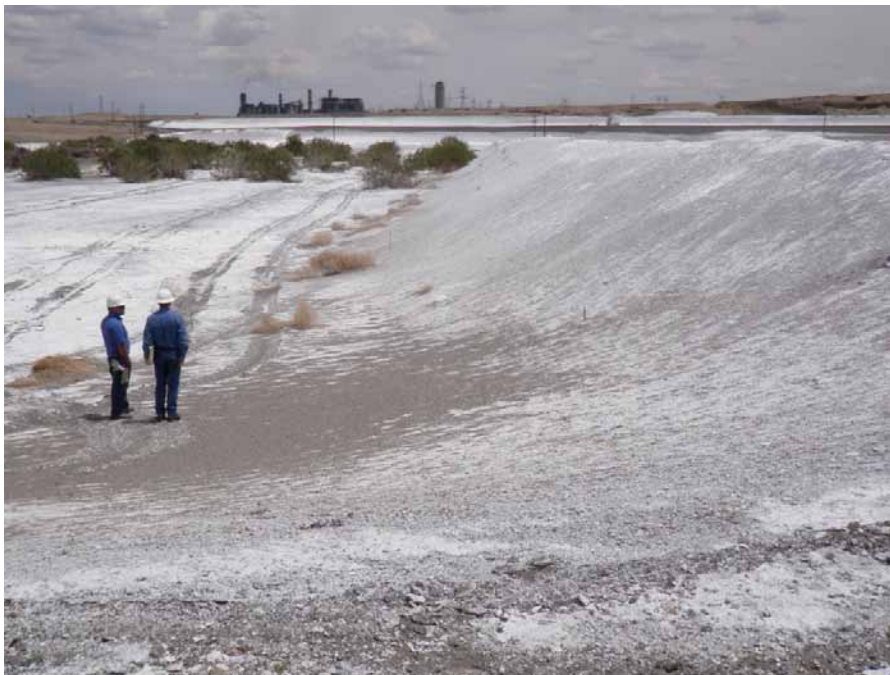
**Photo 31 – LDWI Downstream slope of north dam, looking east to power plant.**

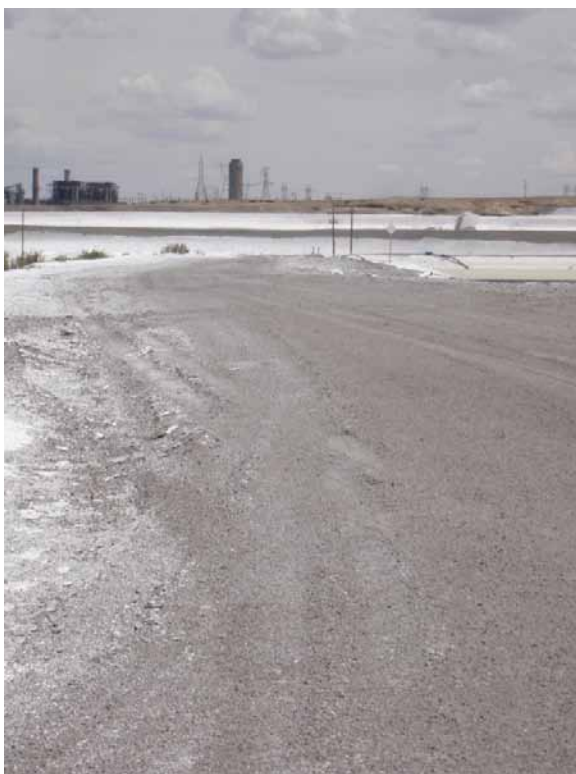
**Photo 32 – LDWI crest of north dam.**

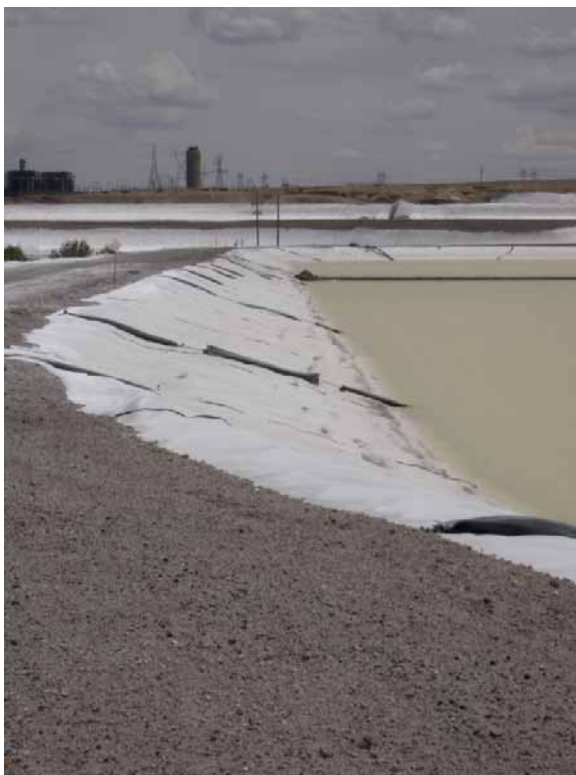
**Photo 33 – LDWI upstream slope of north dam. Note dual HDPE lining.**

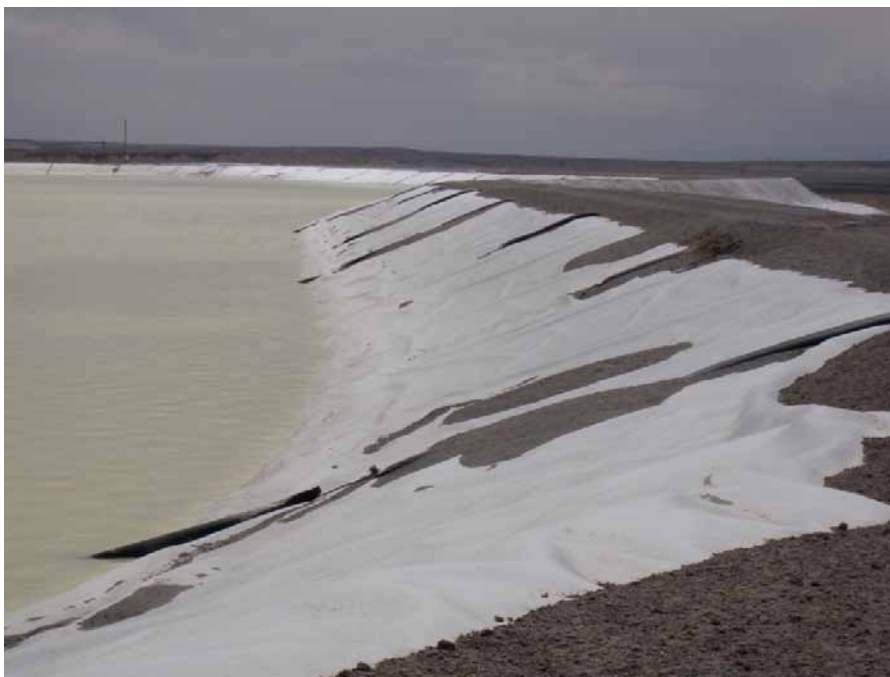
**Photo 34 – LDWI upstream slope of west dam.**

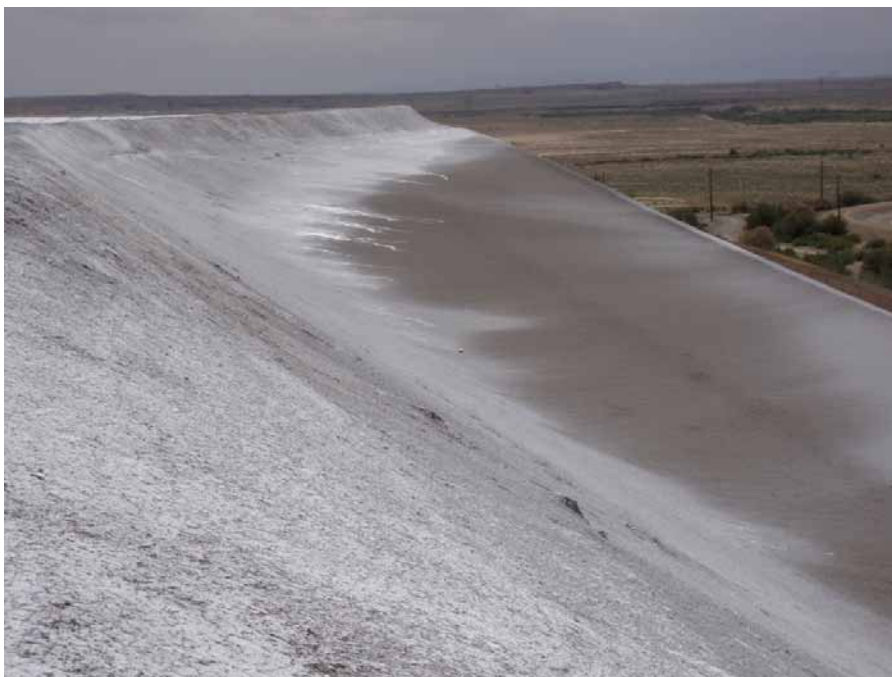
**Photo 35 – LDWI downstream slope of west dam.**

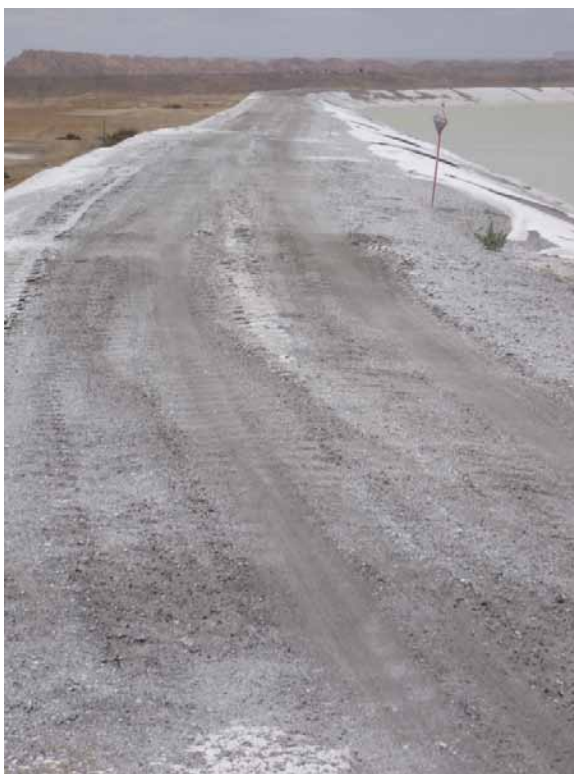
**Photo 36 – LDWI Crest of west dam. Note areas of eroded crest material due to wind.**

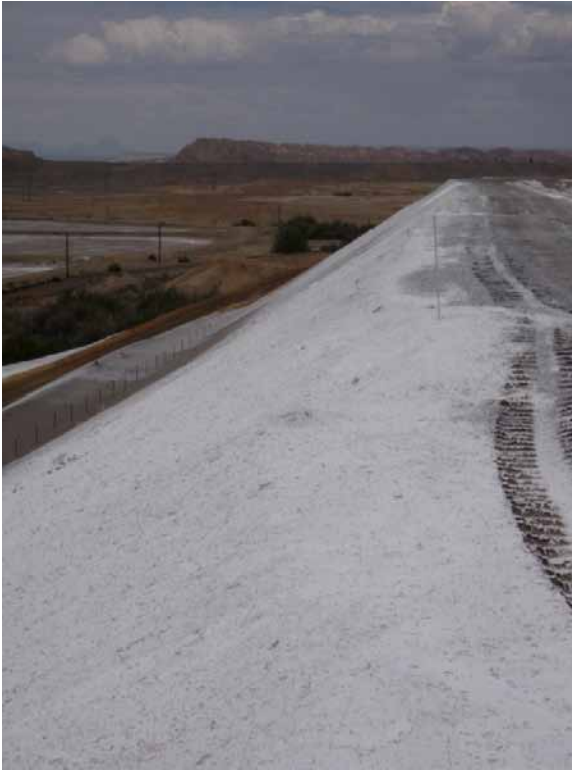
**Photo 37 – LDWI downstream slope of west dam, looking north.**

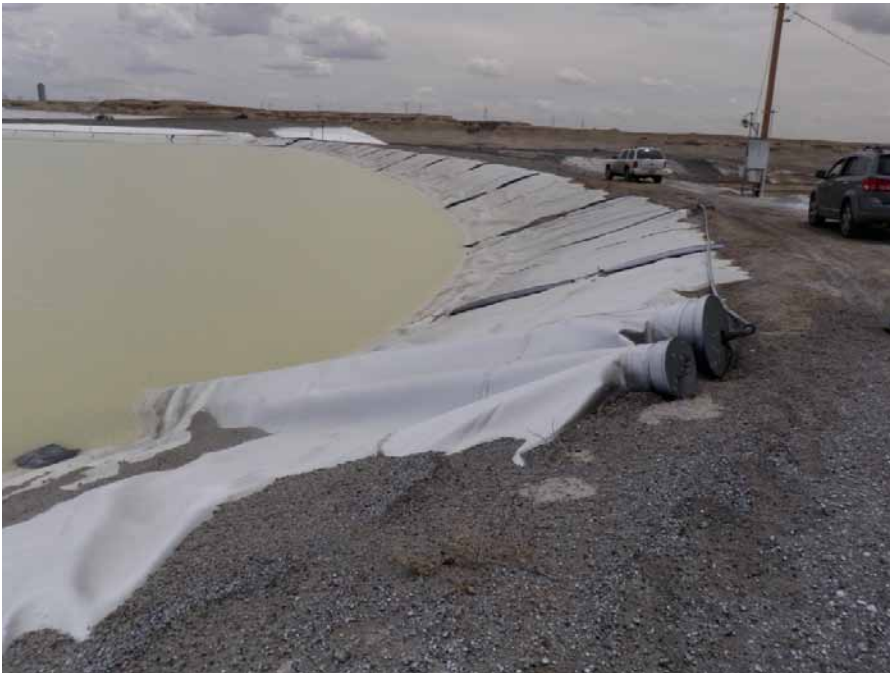
The upstream slope of the dam, which consists of a clay embankment on three sides and a 15-foot-wide clay zone on the west side, is protected with a dual HDPE lining with leak detection system (Photo 38). The upstream slope is mostly obscured by the HDPE lining. There was no visual evidence of slumps or bulges beneath the lining that would be indicative of stability issues. On this basis, the upstream slope was observed to be in good condition.

**Photo 38 – LDWI southwest corner of impoundment. Note HDPE pipes used to monitor leak detection system between layers of HDPE lining. Power supply on pole is for automatic leak detection pump system.**

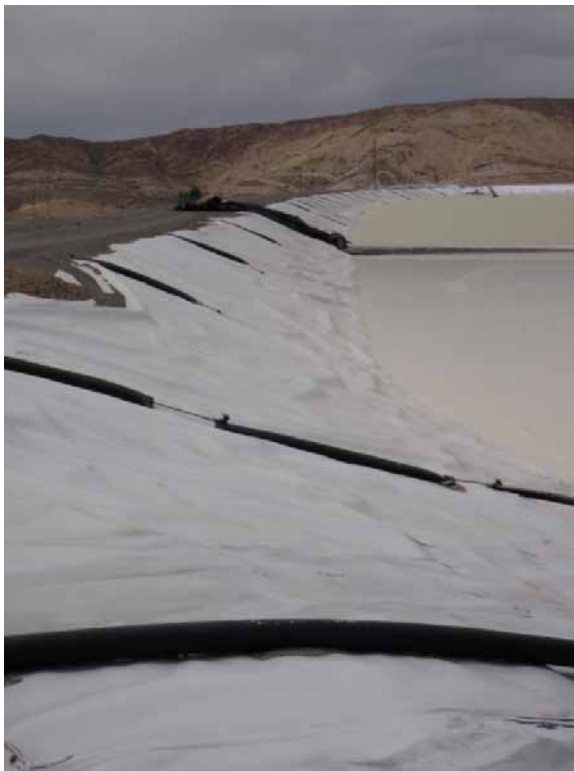
**Photo 39 – LDWI Upstream slope of south dam. Note bladder dam used to divide reservoir to maintain depth of water over pumping system to convey water to power plant.**

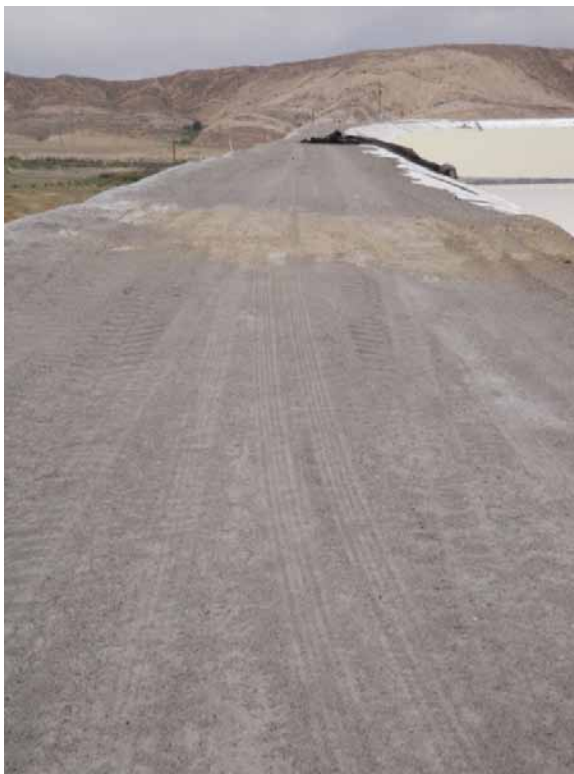
**Photo 40 – LDWI Crest of south dam.**

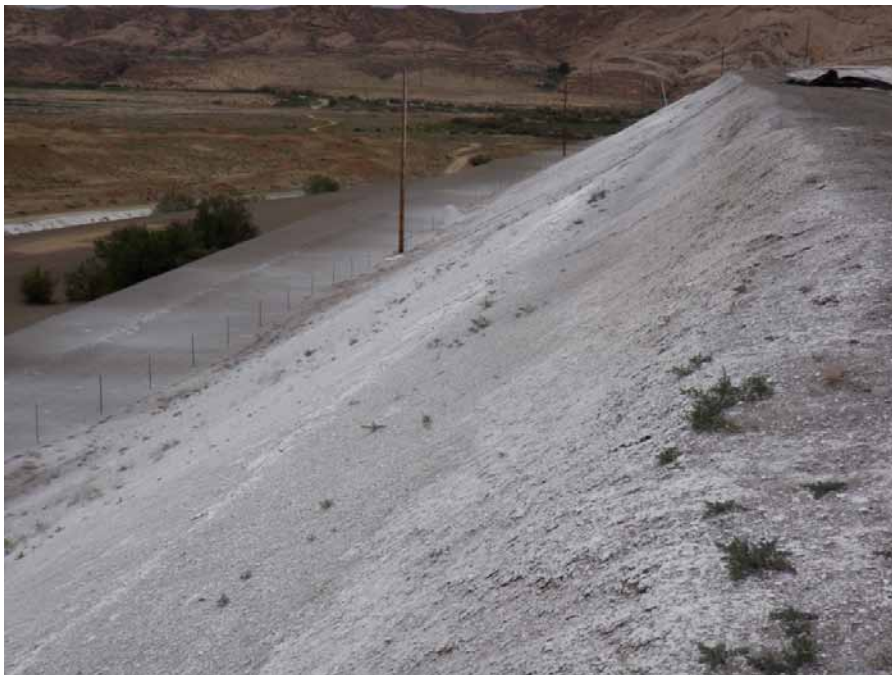
**Photo 41 – LDWI Downstream slope of south dam.**

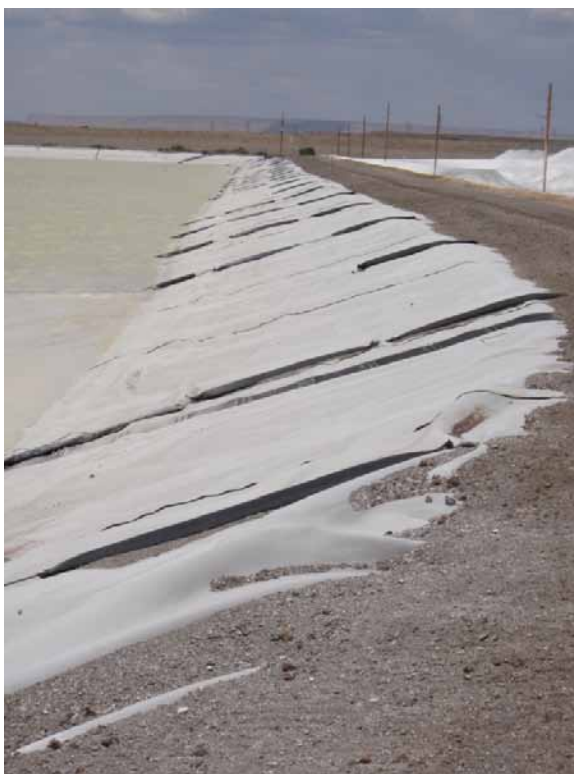
**Photo 42 – LDWI Upstream slope of east dam, looking north.**

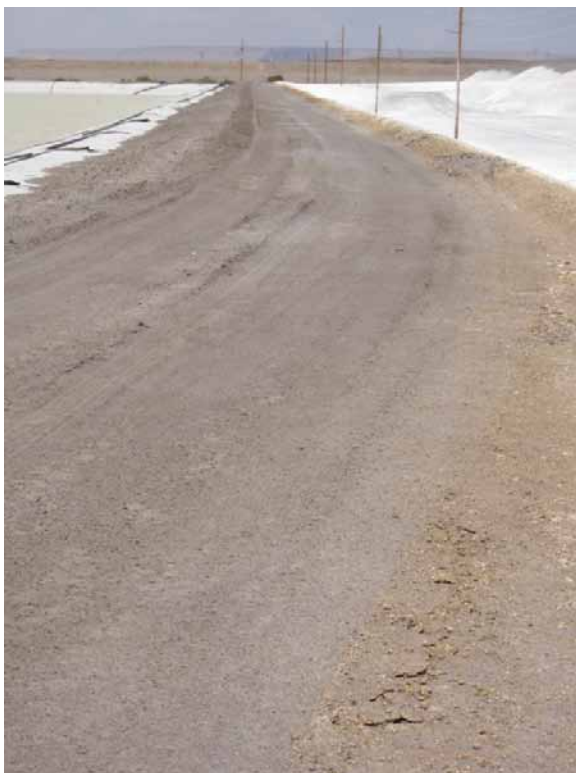
**Photo 43 – LDWI Crest of east dam, looking north.**

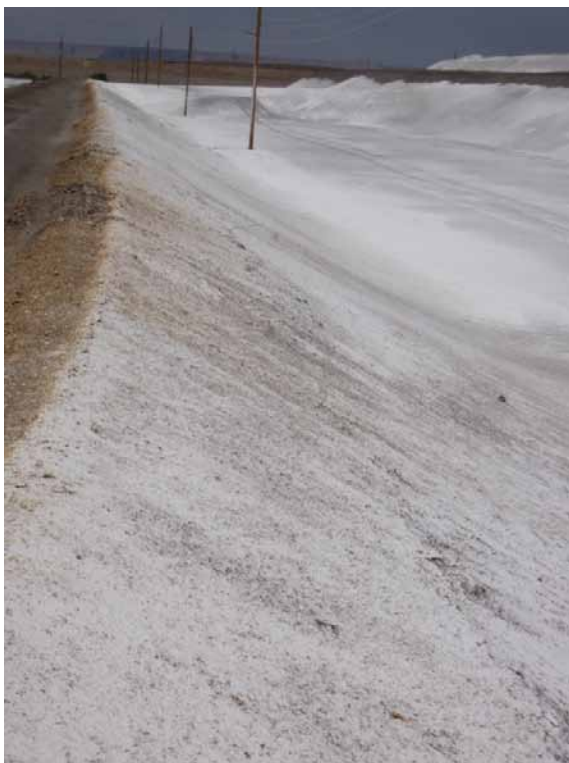
**Photo 44 – LDWI Downstream slope of east dam, looking north. White material is lime applied as a dust control measure.**

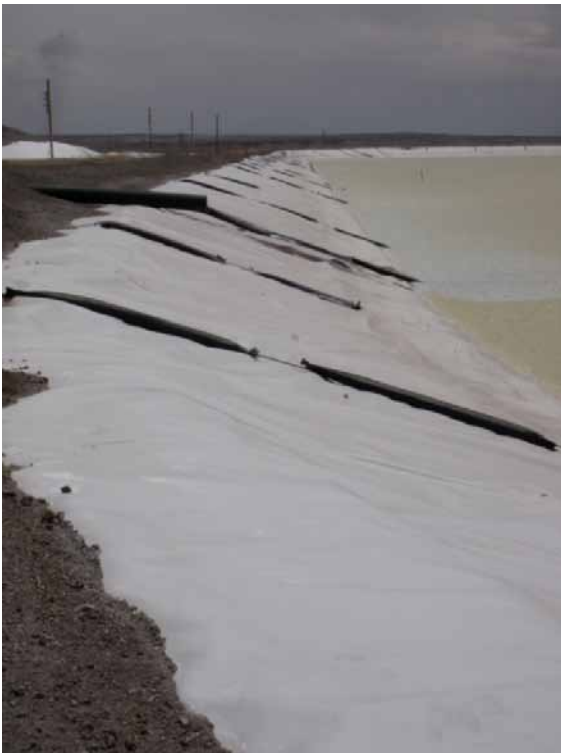
**Photo 46 – LDWI Upstream slope of east dam, looking south. Note the 16 inch and 8 inch discharge pipes from the LAI decant intake that are routed across the top of the LDWI dam.**

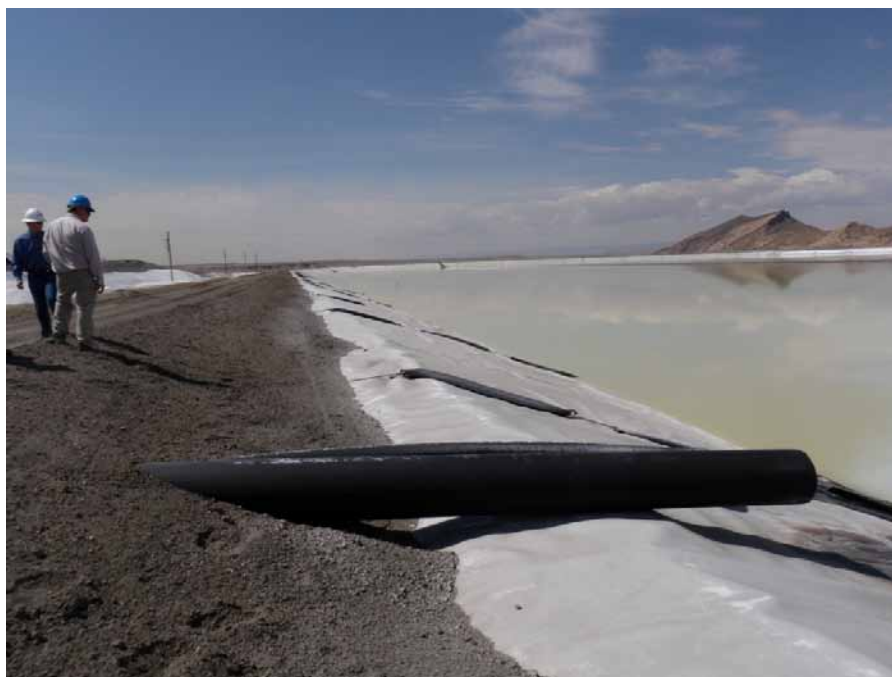
**Photo 47 – LDWI Discharge end of 16" and adjacent 8" pipes with decant water from LAI.**

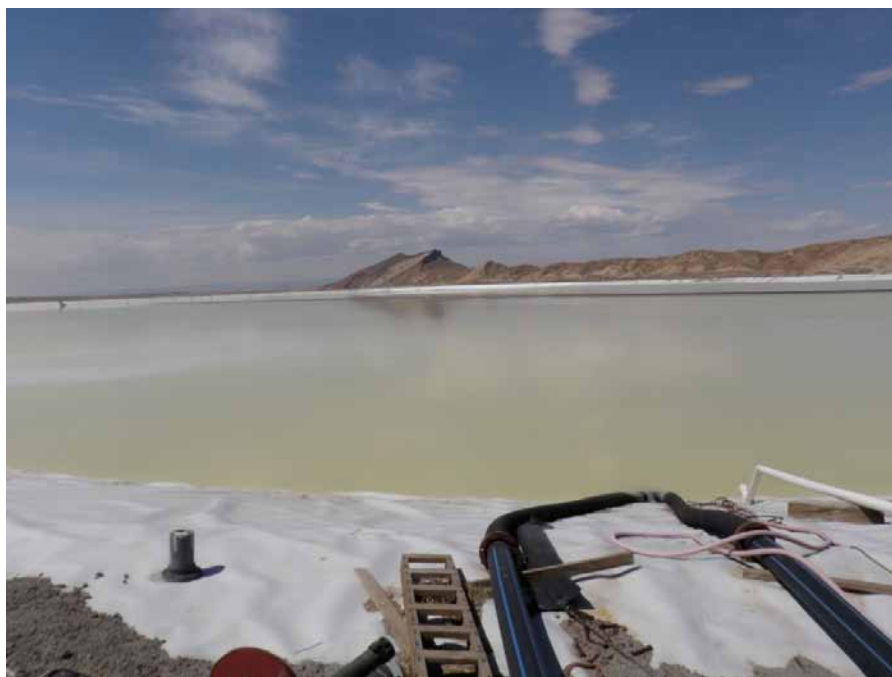
**Photo 48 – LDWI Suction pipes for pumps recirculating water from LDWI back to power plant.**
