FINAL
Coal Ash Impoundment Specific
Site Assessment Report
Arizona Public Service
Cholla Power Plant

Submitted to:
Lockheed-Martin Corporation
2890 Wood Bridge Avenue
Building 209 BAYF
Edison, NJ 08837

Submitted by:
GEI Consultants, Inc.
6950 South Potomac Street, Suite 300
Centennial, CO 80112

December 2009
Project 091330

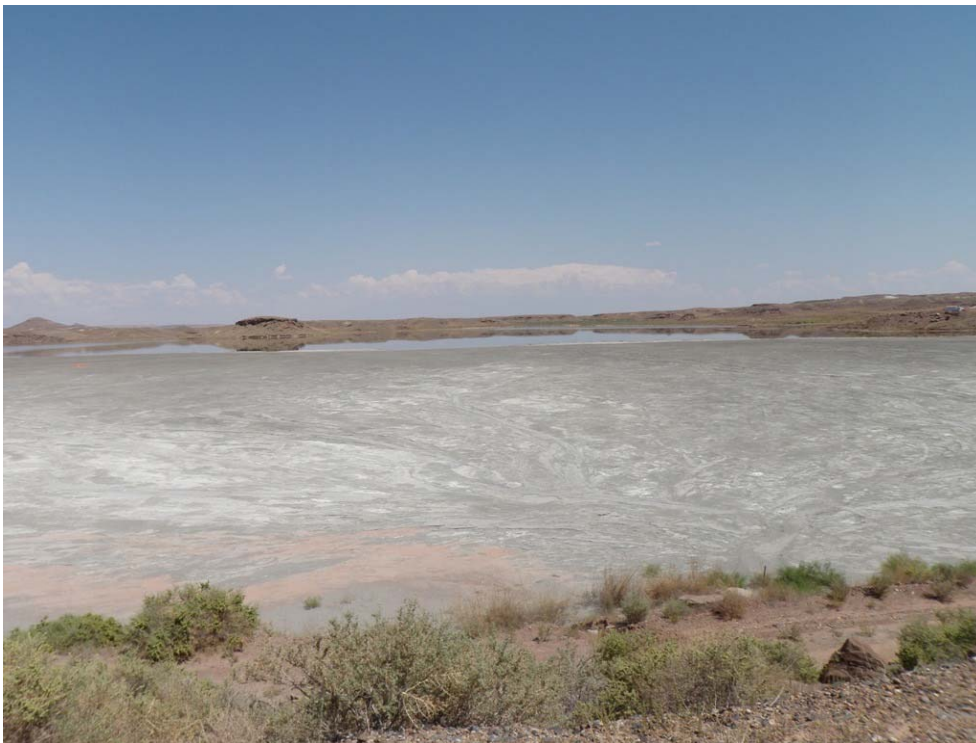
Field assessment of the Fly Ash Pond included driving around the pond and along the entire length of the embankment crest and toe, walking representative sections and closely investigating areas of interest. We saw no obvious signs of settlement or displacement. Several seepage locations were observed at and beyond the downstream toe of the dam. These are closely monitored by APS and are discussed further in Section 6.4.4. A general photo of the Fly Ash Pond is shown in Photo 1.

Photo 1: Fly Ash Pond - Overview looking north from embankment. Note downstream fly ash beach.

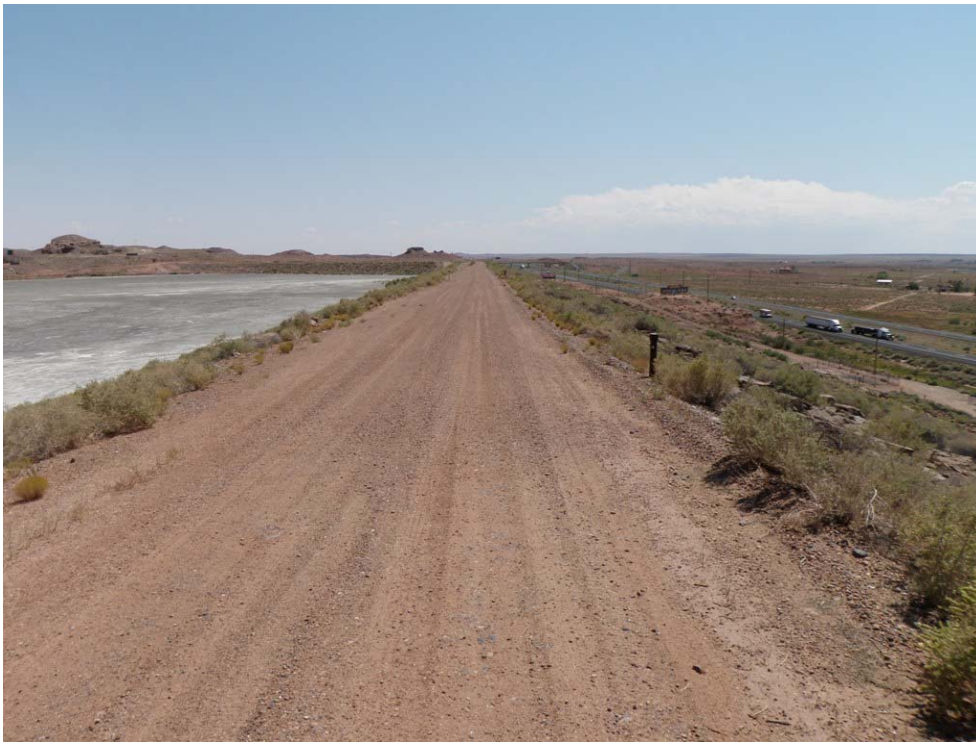
The embankment crest appeared to be in good condition (Photo 2). No signs of cracks or settlement were observed during the assessment. Occasional vegetation (brush) was present on the dam crest. This vegetation should be cleared in routine maintenance. Settlement monitoring points (Photo 3) and piezometers (Photo 4) are present along the dam crest.

Photo 2: Fly Ash Pond Dam - Crest of embankment with dirt road, looking east.

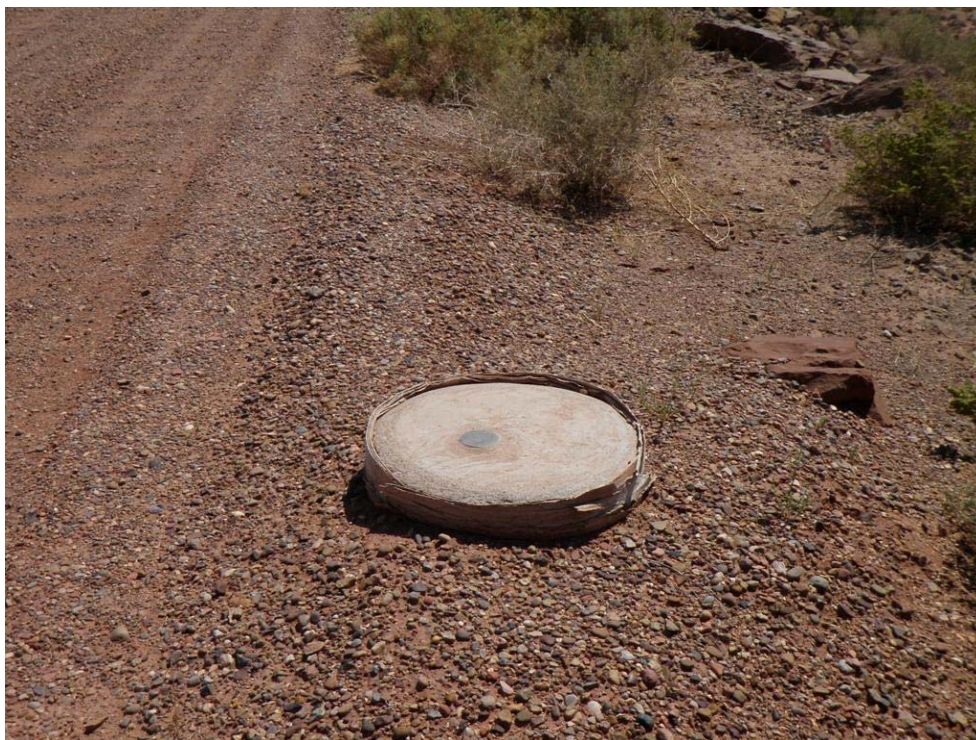
Photo 3: Movement monument on Fly Ash Pond Dam.

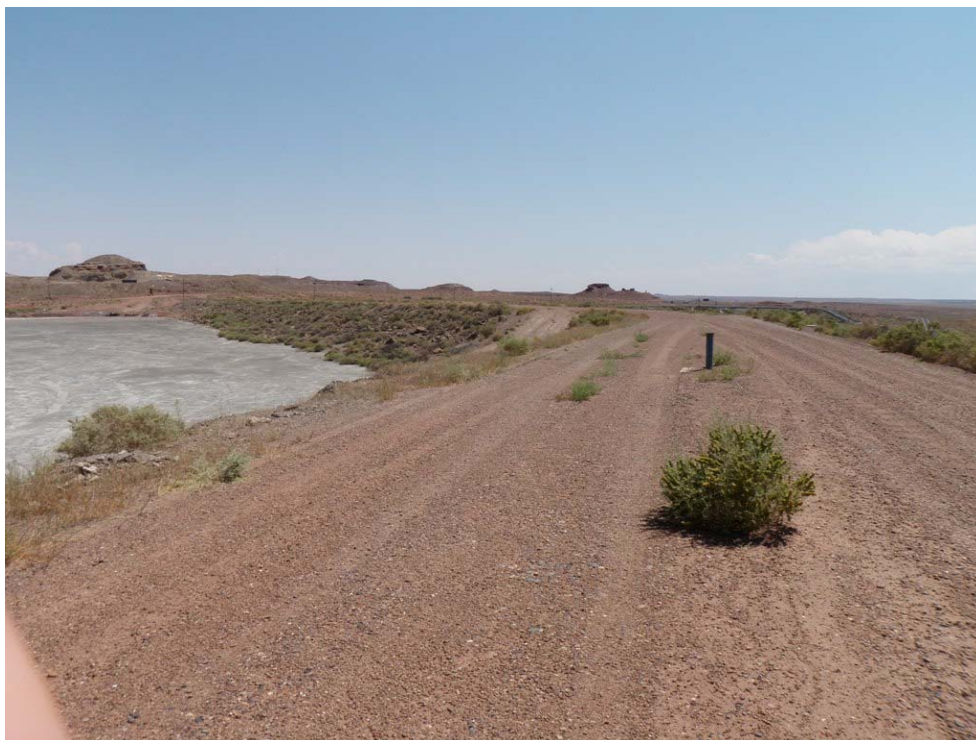
Photo 4: Crest of Fly Ash Pond Dam with piezometer, looking east at bend in embankment.

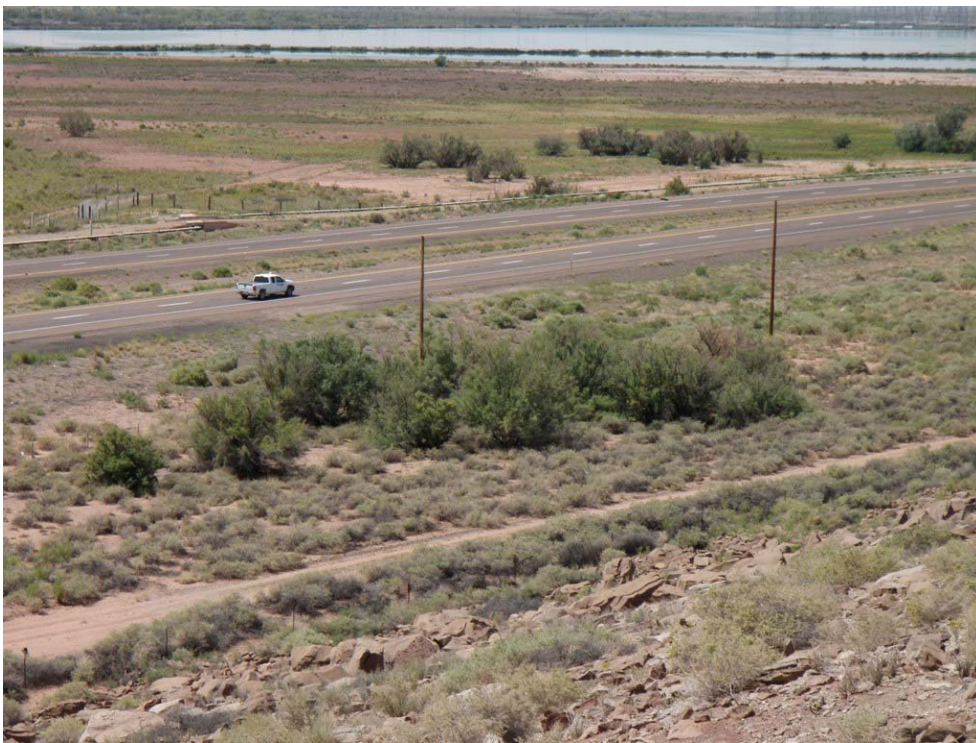
Photo 20: Fly Ash Pond - Tamarisks near downstream toe indicating seepage.

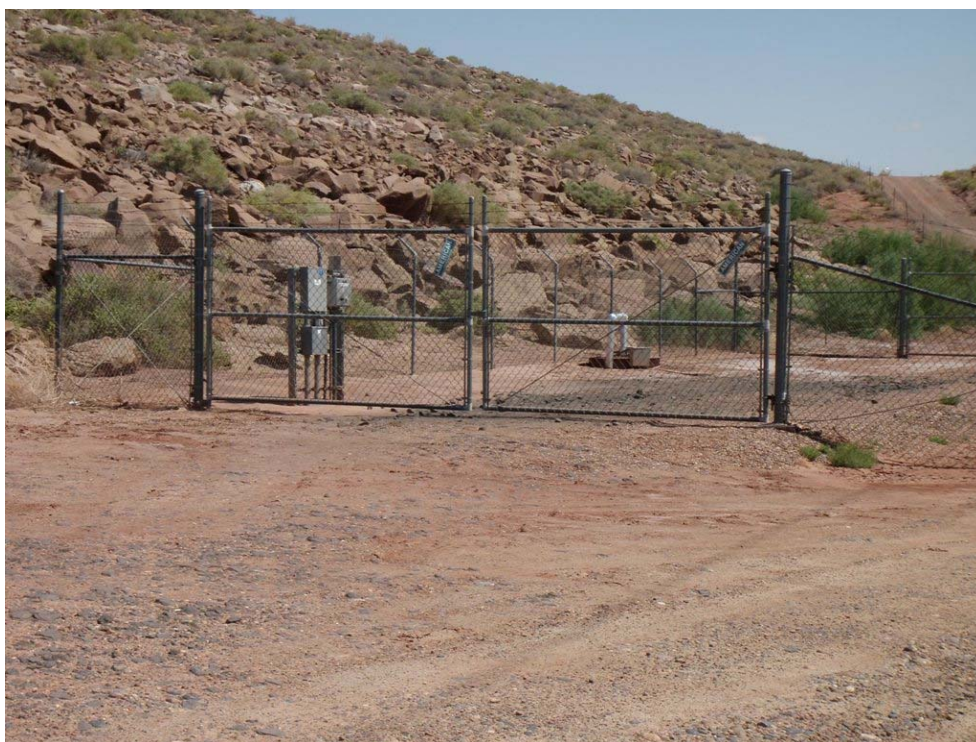
Photo 22: Fly Ash Pond - Seepage collection system for Geronimo Seep.

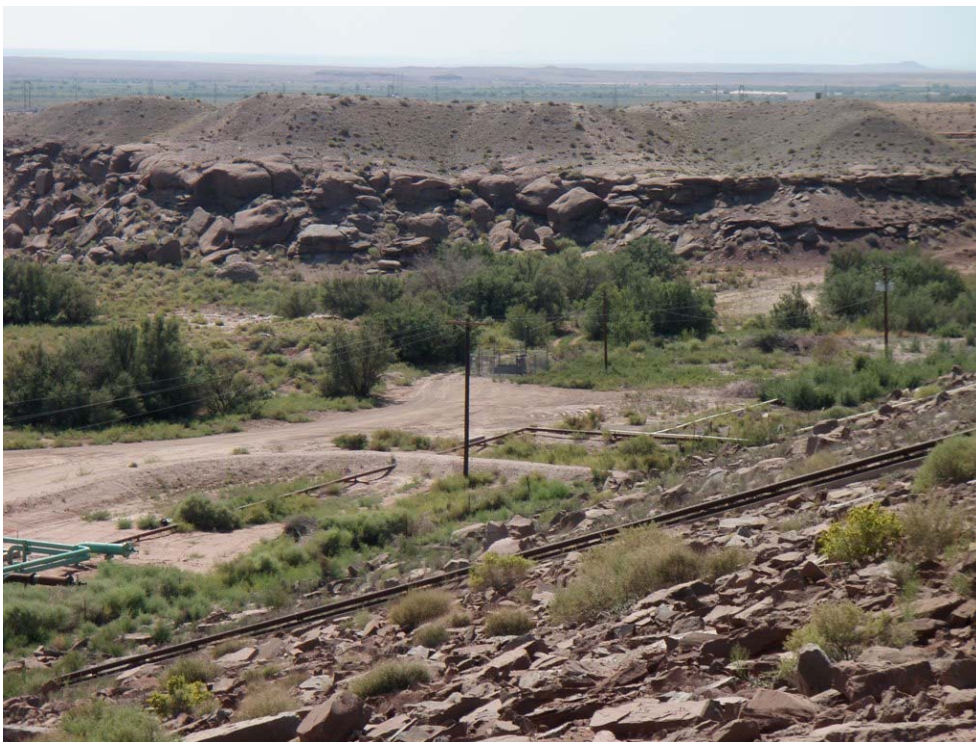
Photo 25: Bottom Ash Pond - West Abutment Seep from embankment crest. Siphon pipes (center) and siphon collection system (lower left) are also visible.

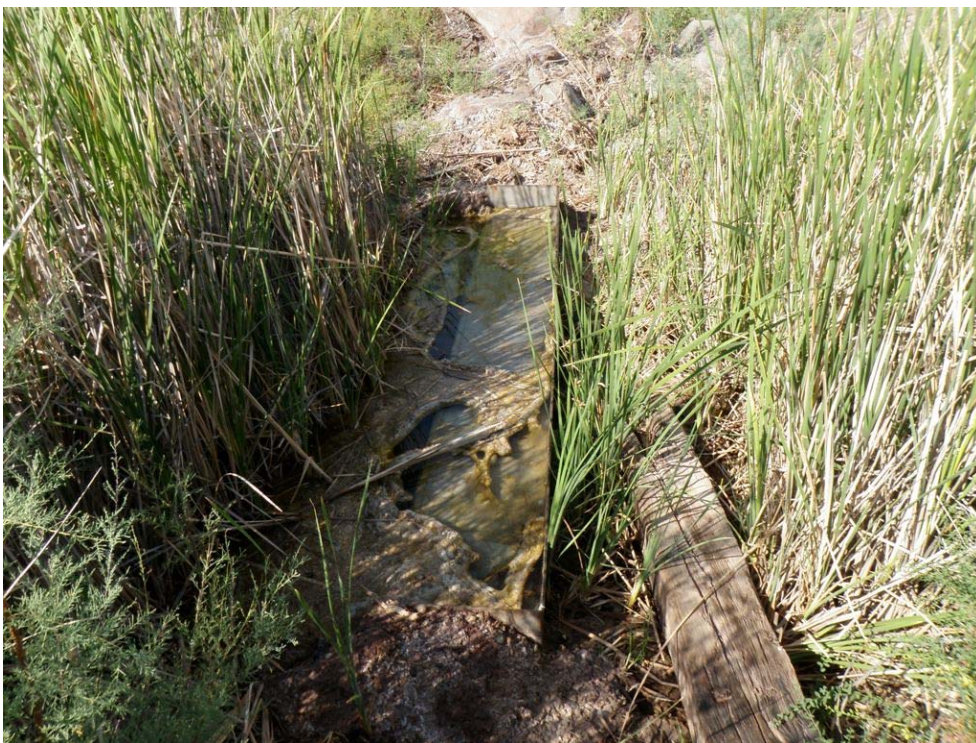
Photo 26: Bottom Ash Pond - Weir at West Abutment Seep.

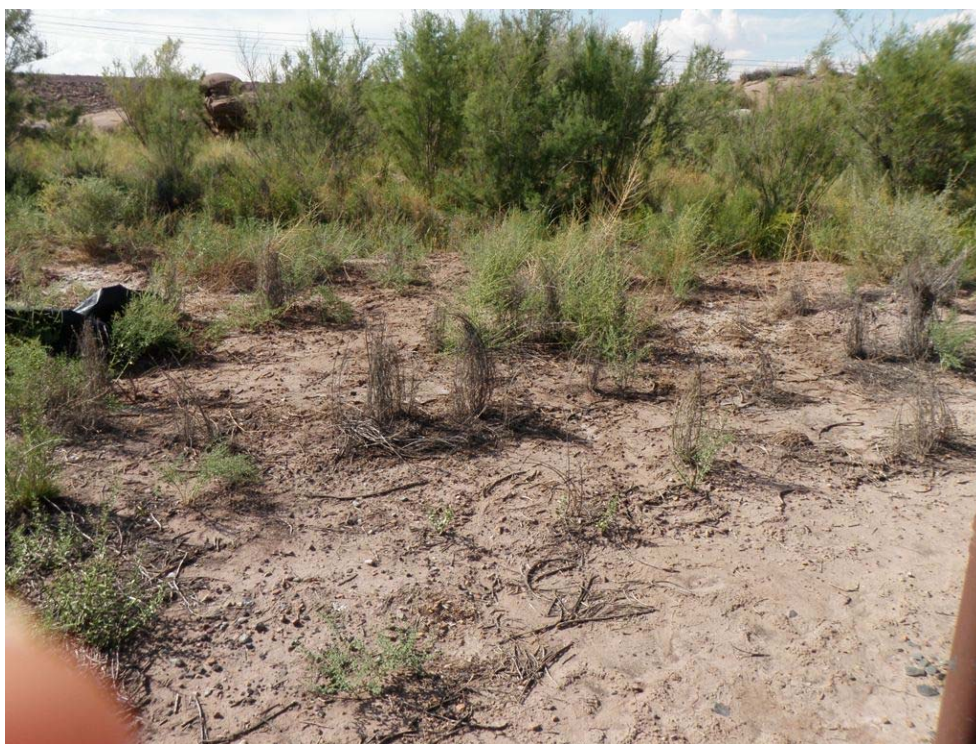
Photo 30: Bottom Ash Pond - Salt patches at Tanner Wash Seep.
