FINAL
Coal Ash Impoundment -
Specific Site Assessment Report
Arizona Public Service
Four Corners Power Plant

Submitted by:
GEI Consultants, Inc.
6950 South Potomac Street, Suite 300
Centennial, CO 80112

September 2009
Project 091330

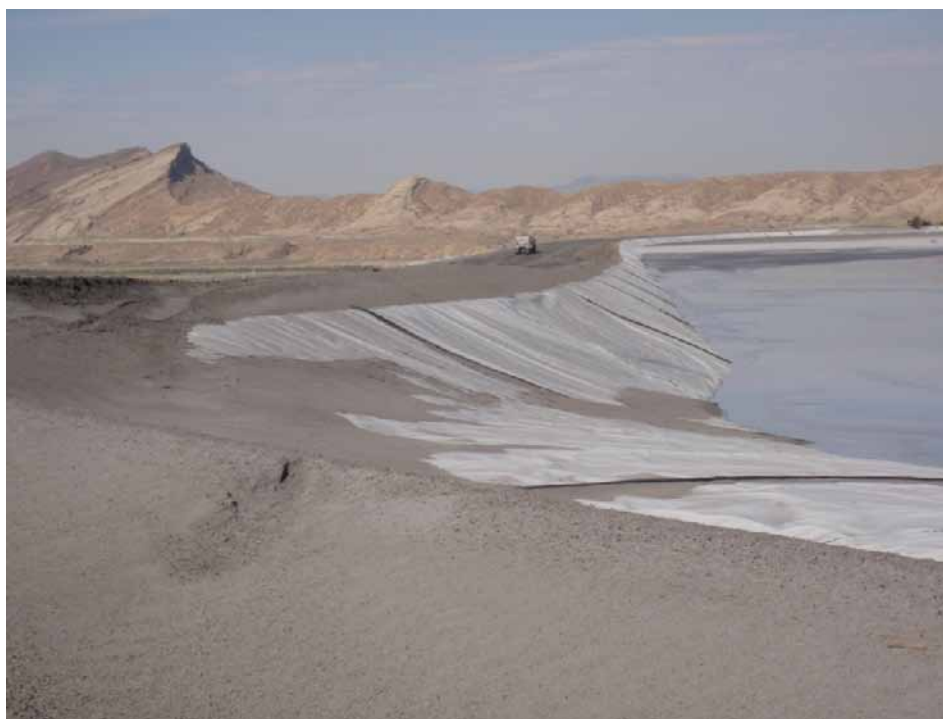
The upstream slope of the dam, which consists of a 15 foot wide clay zone, is protected with an HDPE lining (Photo 2 in Appendix C). The upstream slope is mostly obscured by the HDPE lining. There was no visual evidence of slumps or bulges beneath the lining that would be indicative of stability issues. On this basis, the upstream slope was observed to be in good condition.

Photo 2 – LAI Upstream slope of south dam, looking to left. Note HDPE lining. Note lowest dam crest is on west side.

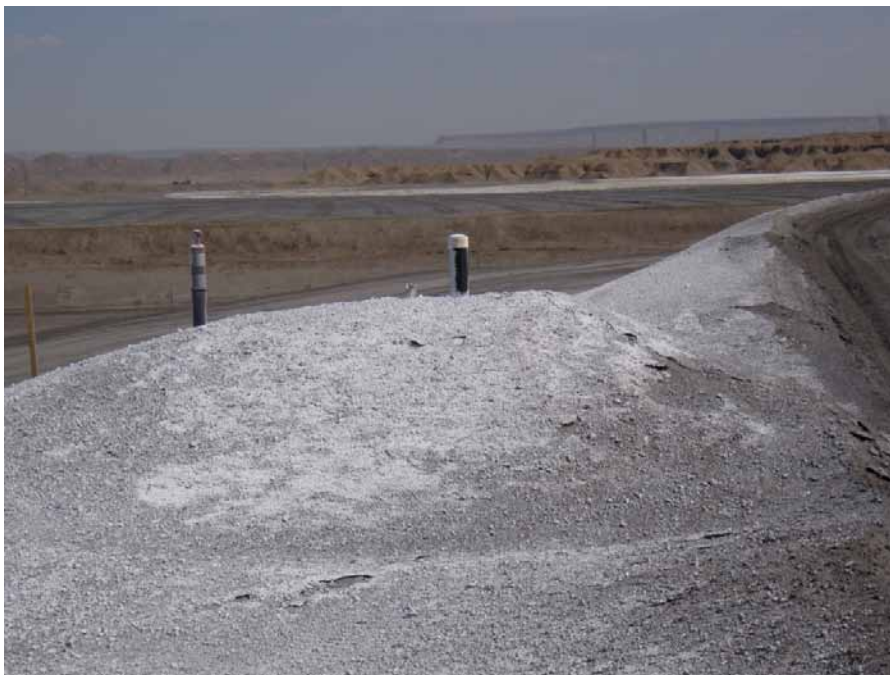
Photo 15 – LAI Instrumentation piezometers located on downstream crest of west dam near the decant drop inlet.

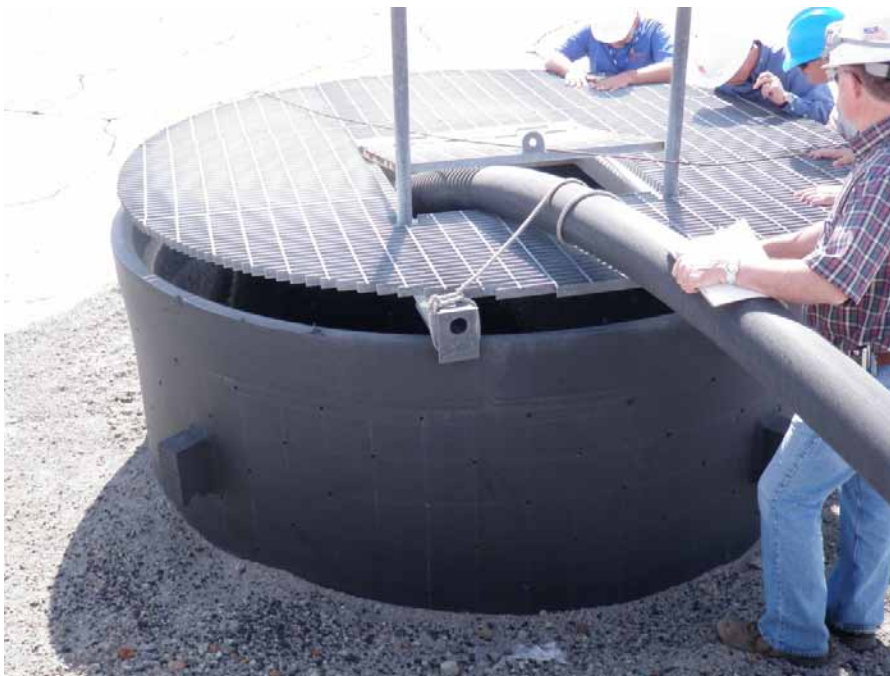
The main structure is the decant inlet, which consists of a eight-foot-diameter HDPE manhole (3.6 inch wall thickness) that has been perforated with approximately one thousand ½-inch-diameter holes to serve as a subsurface drain in addition to functioning as a drop inlet (Photos 16, 17, 18, and 21). The HDPE manhole is founded on a concrete slab that forms the bottom of the decant inlet, but the HDPE riser is not embedded into the slab or otherwise positively connected to the slab. The water level in the decant inlet was above the lower 8-inch-diameter non-slotted HDPE discharge pipe and below the 16-inch-diameter non-slotted HDPE discharge pipe. The decant inlet appeared to be functioning satisfactorily and APS did not report any problems with its function to date. A perforated 8-inch-diameter HDPE pipe located on the pond bottom in the southwest corner of the pond and that serves to drain excess water from the pond could not be observed except where the discharge pipe enters the LDWI.

Photo 16 – LAI Decant drop inlet structure constructed of 8 ft diameter HDPE manhole. Small HDPE pipe is for water supply to construction of dam raise.

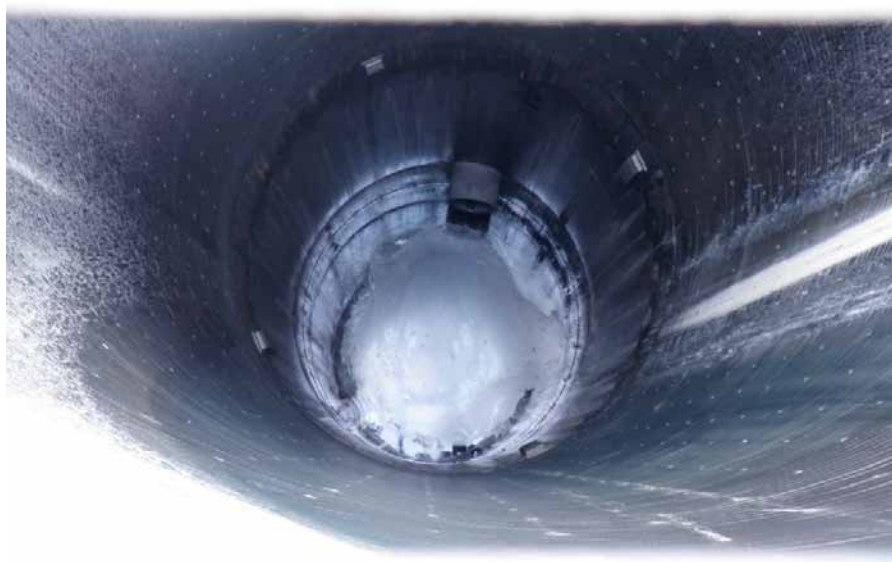
Photo 17 – LAI Looking down into decant drop inlet structure. Note perforations on sides of manhole and 16 inch diameter HDPE outlet pipe located above static water level. An 8 inch outlet pipe is submerged.

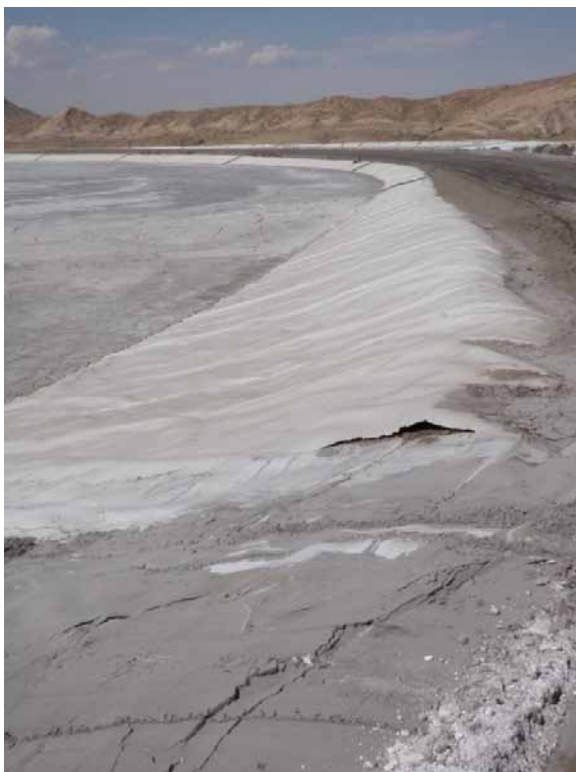
Photo 22 – LAI Upstream slope of north dam. Note tear in HDPE lining caused by construction equipment. APS has noted and plans immediate repair.

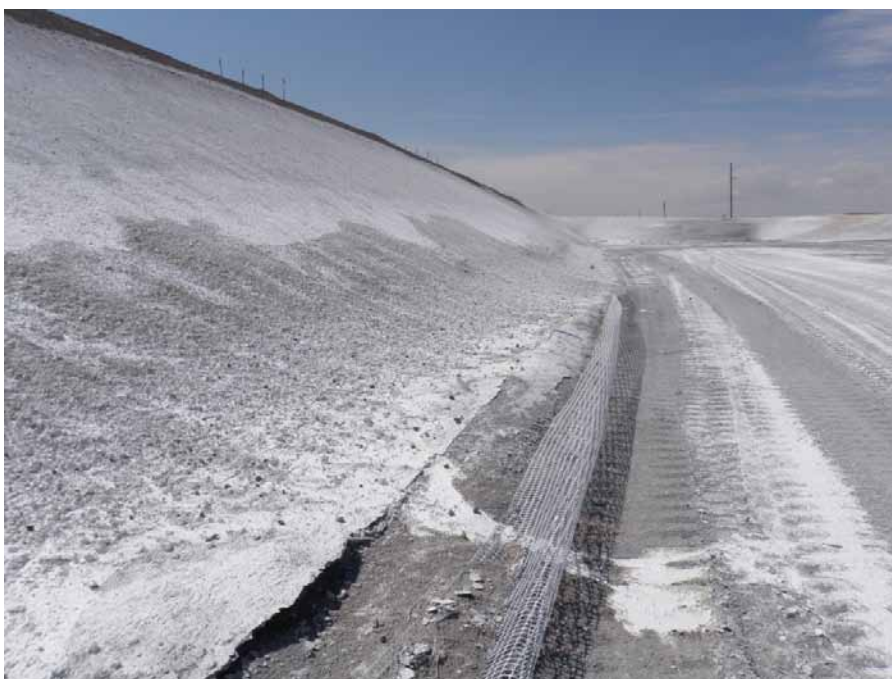
Photo 26 – LAI Downstream slope and toe of west dam, adjacent to LDWI. Note exposed geogrid strengthening layer that has been excavated for tie-in to dam raise fill.

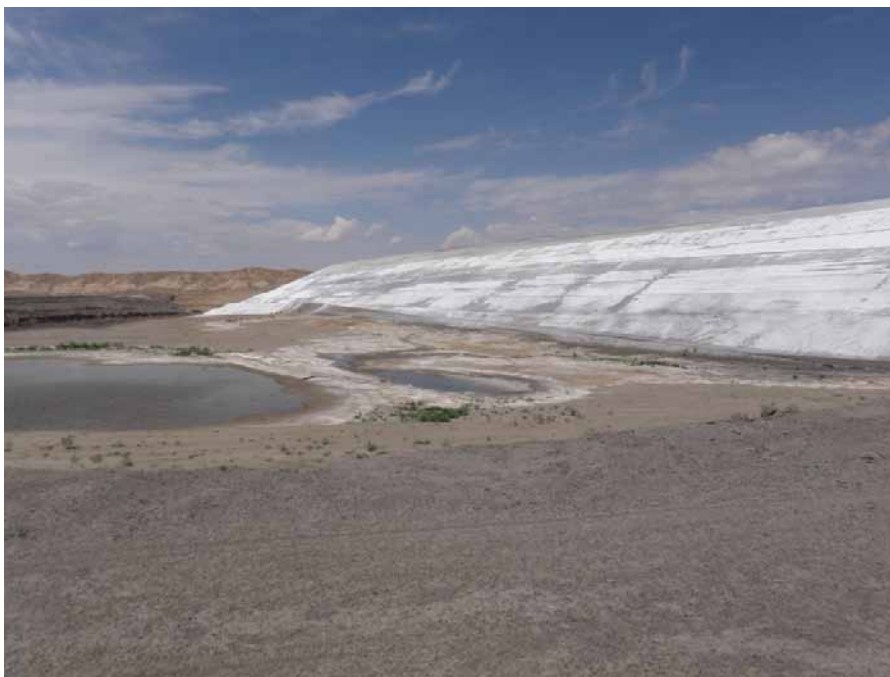
The downstream slope of the dam, which consists of compacted bottom ash, does not have additional erosion protection. Pounded water was observed at the downstream toe of the south embankment of the underlying Pond 3 & 4 embankment (see Photo 29). The seep occurs at a low point in the foundation topography and has been active for many years without significant change. The seep runs clear at a slow rate and there is no evidence of internal erosion of dam materials. There is no toe drain to collect and convey the water away from the embankment. The seepage is expected to reduce as the available water in the Pond 3 & 4 impoundment slowly drains. APS believes that the source of the seepage observed at the downstream toe is construction water that drains from the bottom ash placed to construct the LAI embankment and has found the seepage dries up within a few weeks of stopping construction of the embankment. The downstream slope was observed to be in generally good condition. No seepage was observed at the downstream toe in the northwest corner, where the cutoff trench does not tie in to the underlying 3-4 embankment.

No evidence of significant seepage through the LAI or LDWI dam embankments. Evidence of seepage was observed at the downstream toe (old Pond #4) of the south embankment of the LAI. This has been an area of ongoing seepage according to APS and has not been associated with instability of the surrounding embankment. APS believes that the source of the seepage observed at the downstream toe is construction water that drains from the bottom ash placed to construct the LAI embankment and has found the seepage dries up within a few weeks of stopping construction of the embankment. Tamarisk trees growing at the downstream toe (old Pond #3) of the west embankment of the LDWI may be indicative of local seepage, but likely spread to the embankment slope from an adjacent grove of tamarisk that first became established on the banks of the nearby Pond #6 seepage ditch.

Photo 29 – LAI Downstream slope and toe of south dam, looking to right. Note ponded water near toe that results from seepage from old Pond #4 that underlies the LAI.

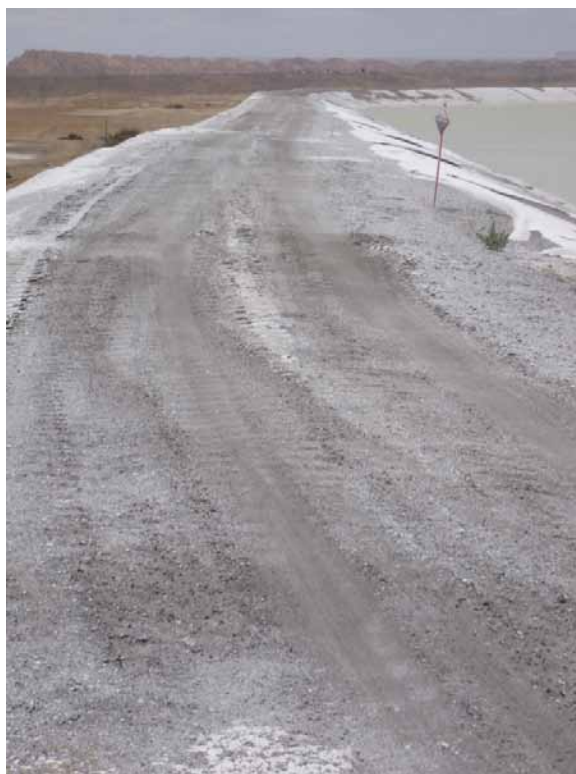
Photo 36 – LDWI Crest of west dam. Note areas of eroded crest material due to wind.

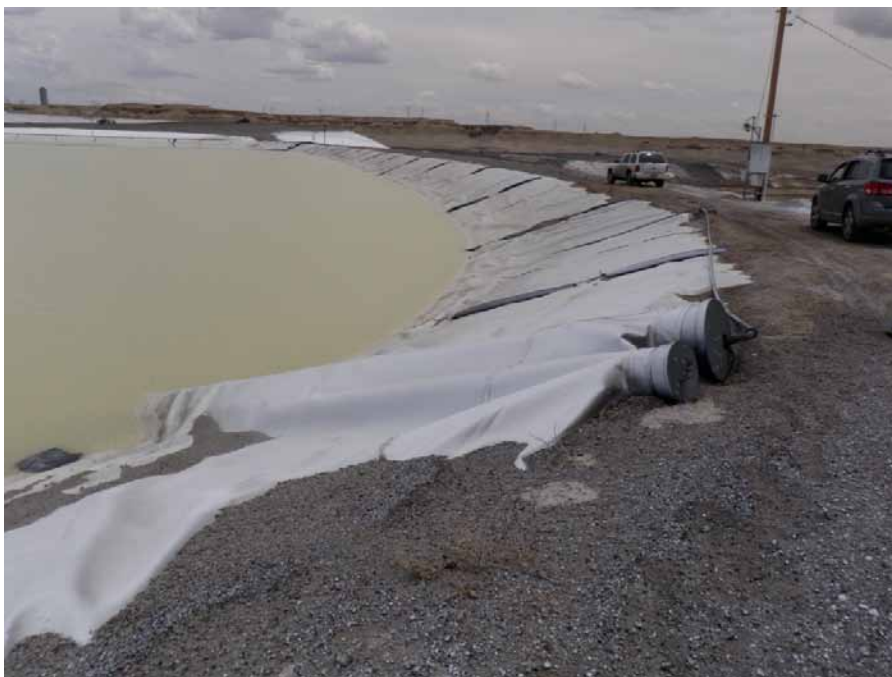
The upstream slope of the dam, which consists of a clay embankment on three sides and a 15-foot-wide clay zone on the west side, is protected with a dual HDPE lining with leak detection system (Photo 38). The upstream slope is mostly obscured by the HDPE lining. There was no visual evidence of slumps or bulges beneath the lining that would be indicative of stability issues. On this basis, the upstream slope was observed to be in good condition.

Photo 38 – LDWI southwest corner of impoundment. Note HDPE pipes used to monitor leak detection system between layers of HDPE lining. Power supply on pole is for automatic leak detection pump system.

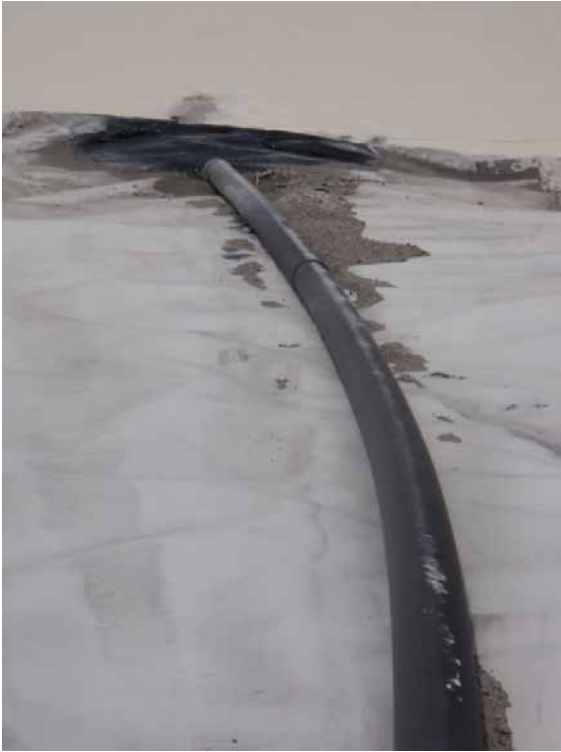
Photo 45 – LDWI Looking directly down slope at pipe from 8" perforated HDPE located in the LAI. Decant water collected by the perforated drain is pumped into the LDWI. Flow was observed to be a few gpm at the time of site visit.
