**DRAFT FINAL**  
**Coal Ash Impoundment**  
**Specific Site Assessment**  
**Report**  
**Arizona Public Service**  
**Cholla Power Plant**

Submitted by:  
**GEI Consultants, Inc.**  
6950 South Potomac Street, Suite 300  
Centennial, CO 80112

October 2009  
Project 091330

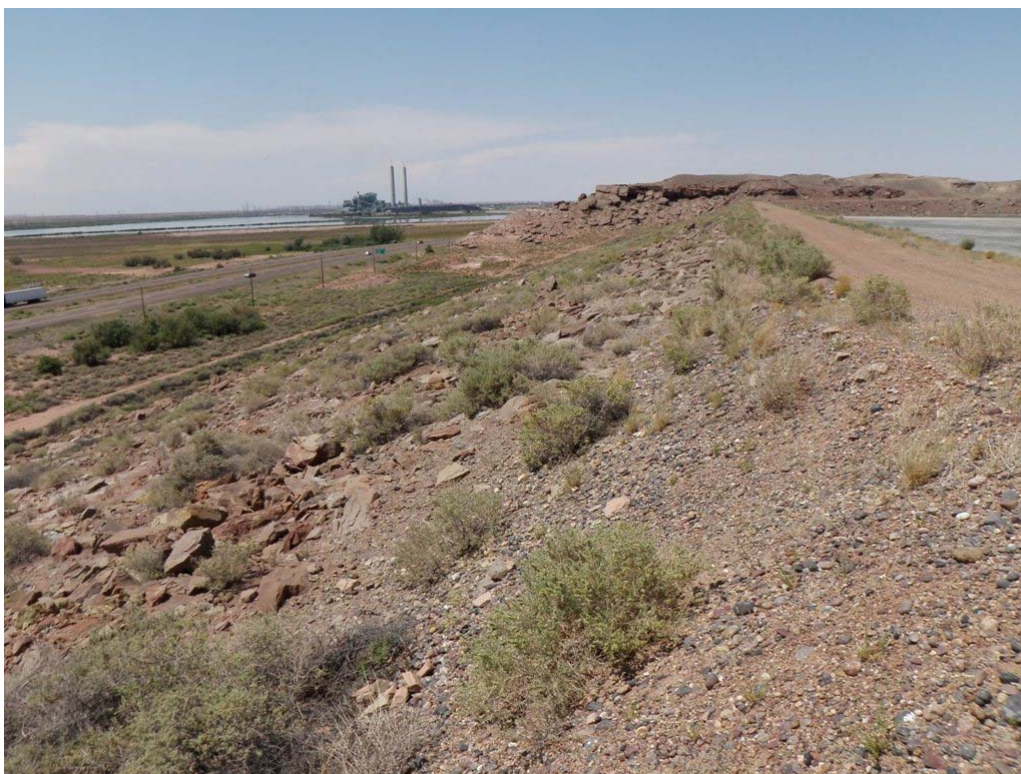
The downstream slope of the embankment is protected from erosion by riprap and appeared to be in good condition, though the riprap is eroding in some areas (Photo 7). Some vegetation was present on the downstream slope. The slurry discharge pipes traversing the downstream face are shown in Photo 8.

There was no significant erosion of the dams or abutments noted during the assessment. Some minor erosion of riprap was observed (e.g. Photo 7 of Fly Ash Pond downstream slope). Eroded riprap should be replaced.

**Photo 7 – Fly Ash Pond Dam: Downstream slope, looking west. Note vegetation and riprap erosion.**

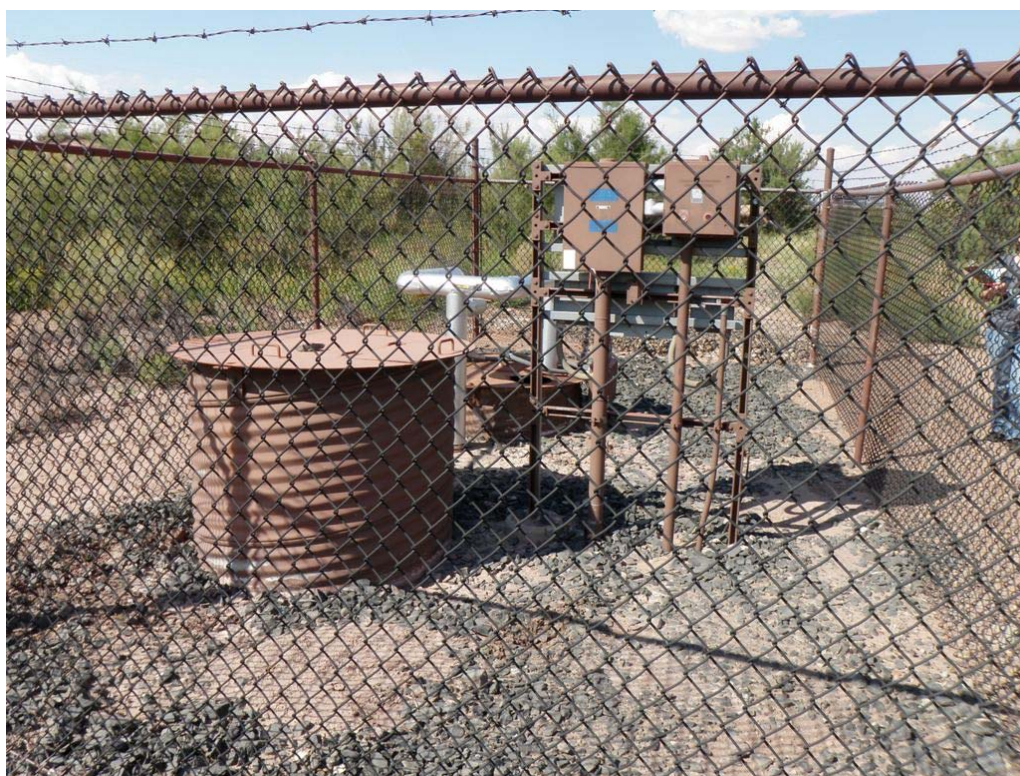
**Photo 29 – Bottom Ash Pond: Seepage collection system for Tanner Wash Seep.**

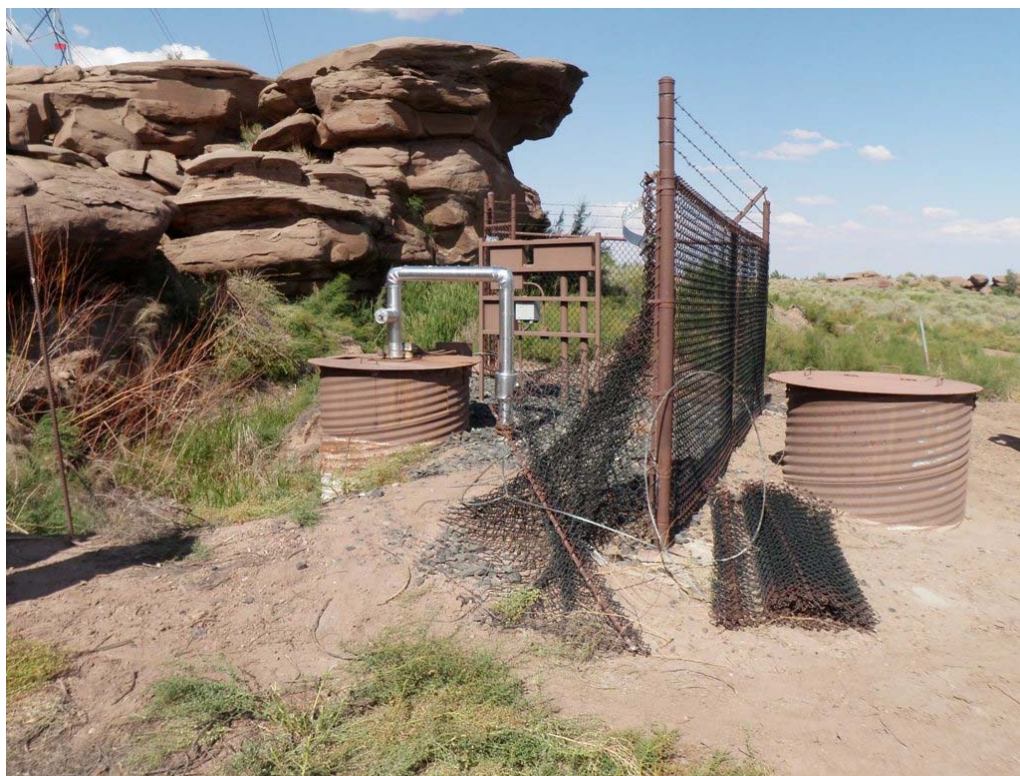
**Photo 33 – Bottom Ash Pond: Seepage collection system for Petroglyph Seep.**

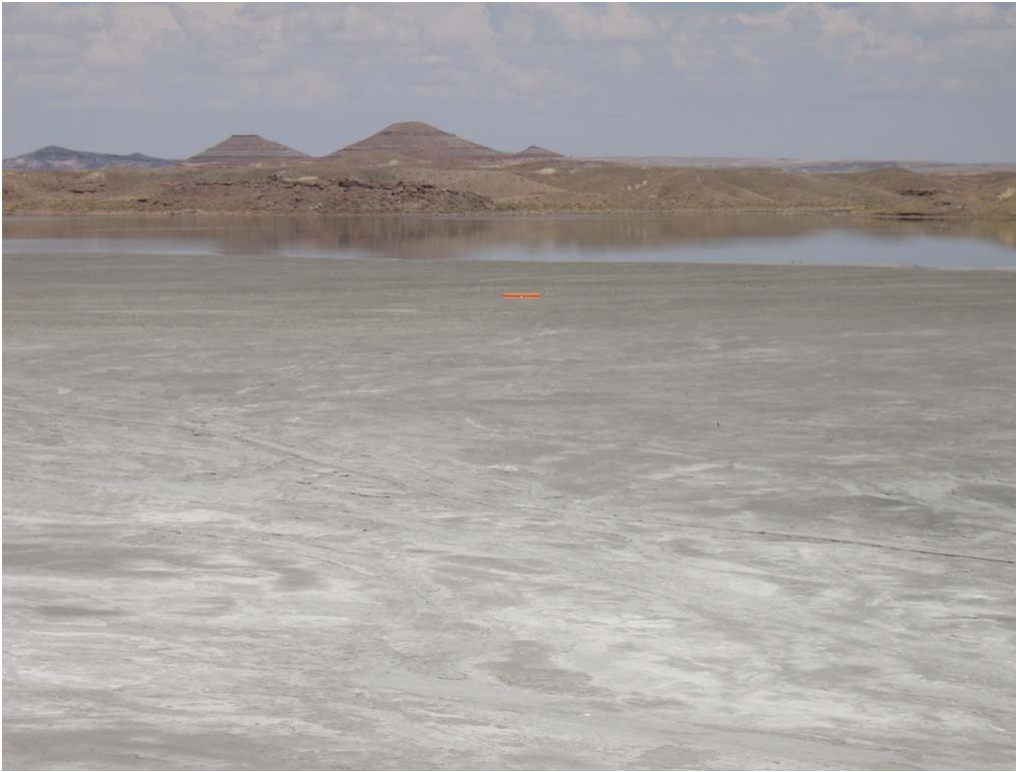
**Photo 35 – Fly Ash Pond: Buoy marking 300-foot distance from area where cracks were observed in embankment crest. Fly ash beach must extend upstream of this distance.**

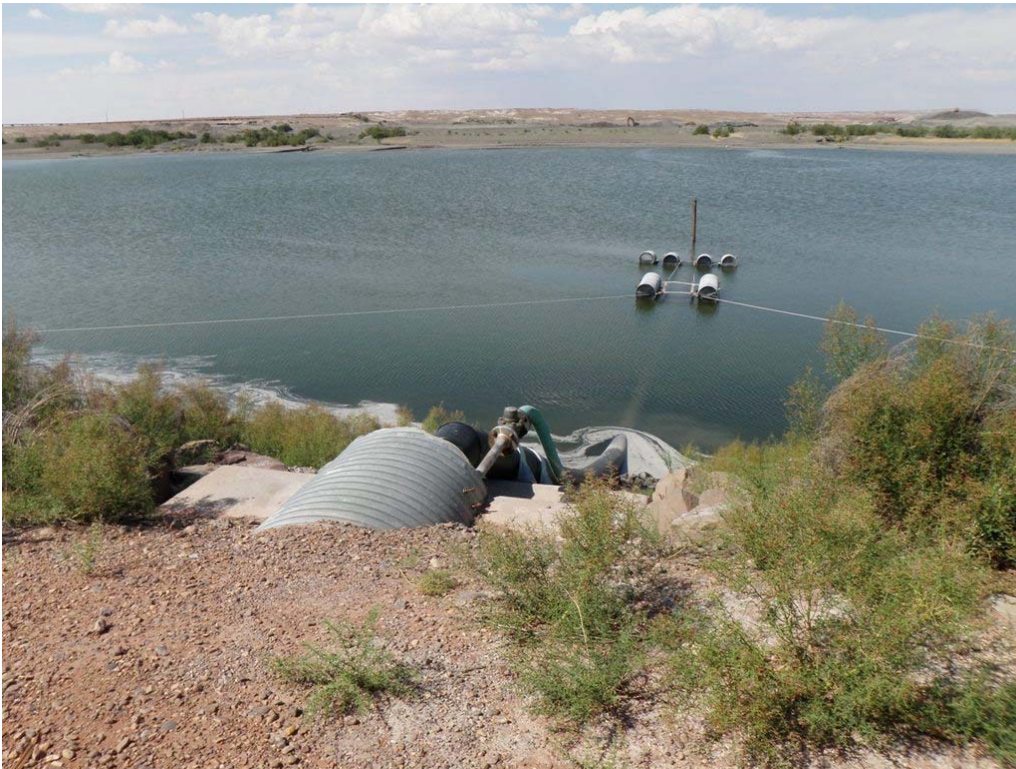
**Photo 36 – Bottom Ash Pond: Floating siphon pipes to return water from main reservoir to power plant – upstream side of dam.**
