**FINAL**  
**Coal Ash Impoundment Specific**  
**Site Assessment Report**  
**Arizona Public Service**  
Cholla Power Plant

Submitted by:  
**GEI Consultants, Inc.**  
6950 South Potomac Street, Suite 300  
Centennial, CO 80112

December 2009  
Project 091330

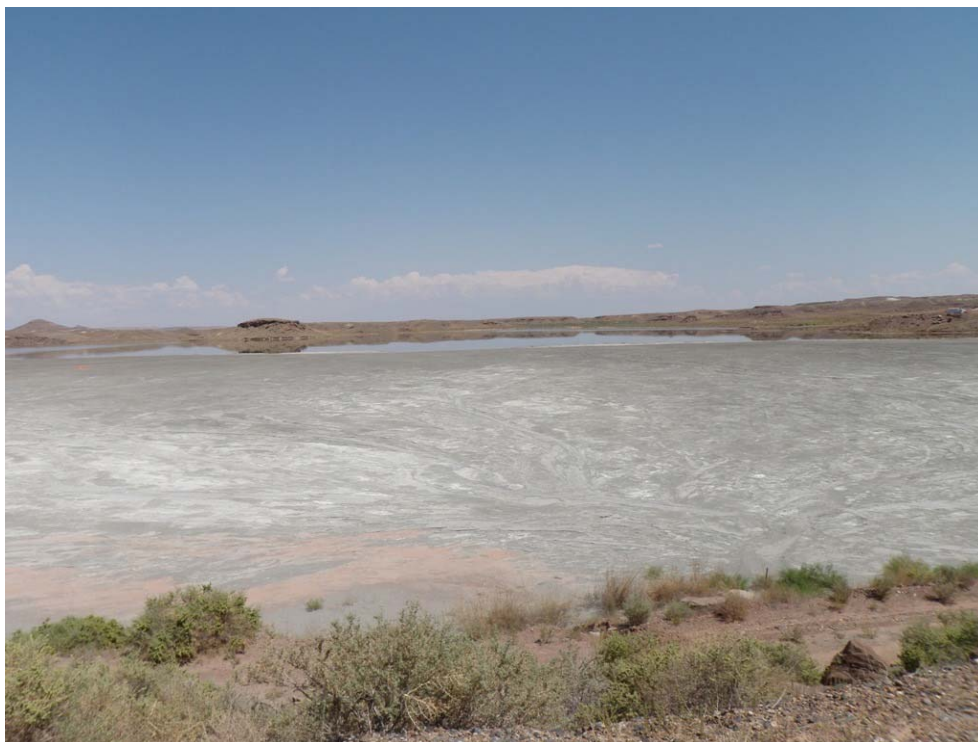
Field assessment of the Fly Ash Pond included driving around the pond and along the entire length of the embankment crest and toe, walking representative sections and closely investigating areas of interest. We saw no obvious signs of settlement or displacement. Several seepage locations were observed at and beyond the downstream toe of the dam. These are closely monitored by APS and are discussed further in Section 6.4.4. A general photo of the Fly Ash Pond is shown in Photo 1.

**Photo 1: Fly Ash Pond - Overview looking north from embankment. Note downstream fly ash beach.**

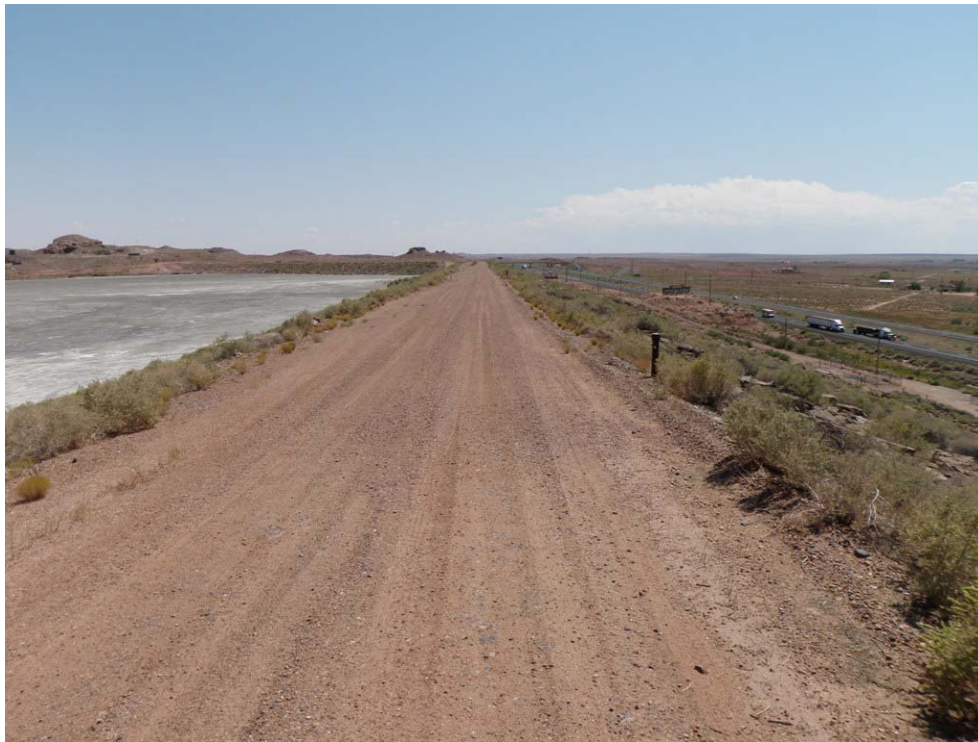
The embankment crest appeared to be in good condition (Photo 2). No signs of cracks or settlement were observed during the assessment. Occasional vegetation (brush) was present on the dam crest. This vegetation should be cleared in routine maintenance. Settlement monitoring points (Photo 3) and piezometers (Photo 4) are present along the dam crest.

**Photo 2: Fly Ash Pond Dam - Crest of embankment with dirt road, looking east.**

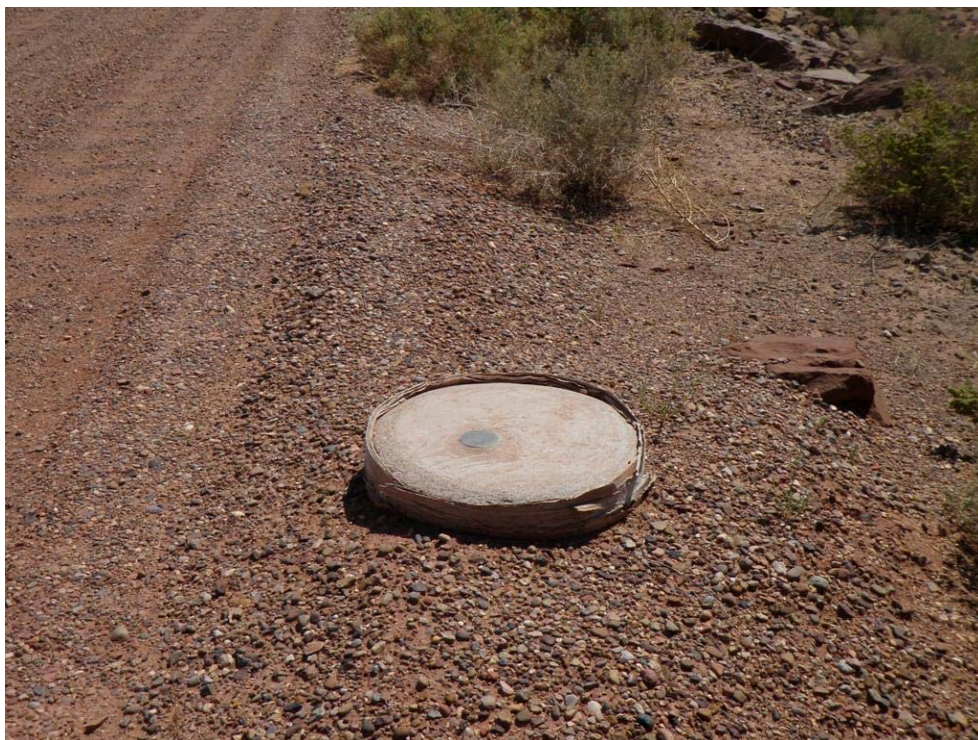
**Photo 3: Movement monument on Fly Ash Pond Dam.**

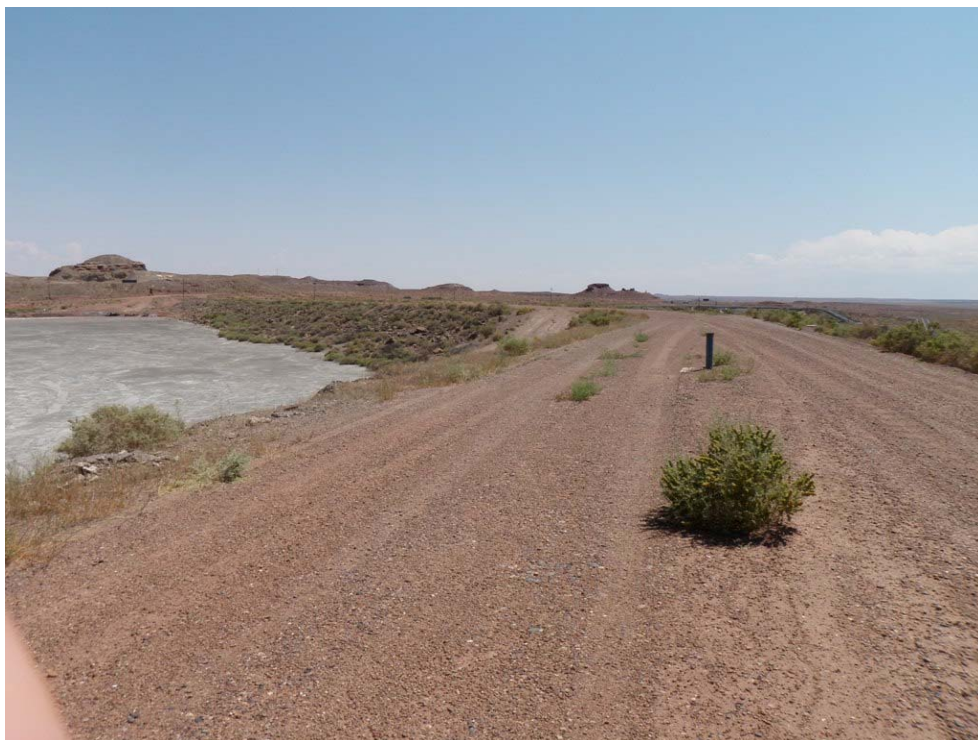
**Photo 4: Crest of Fly Ash Pond Dam with piezometer, looking east at bend in embankment.**

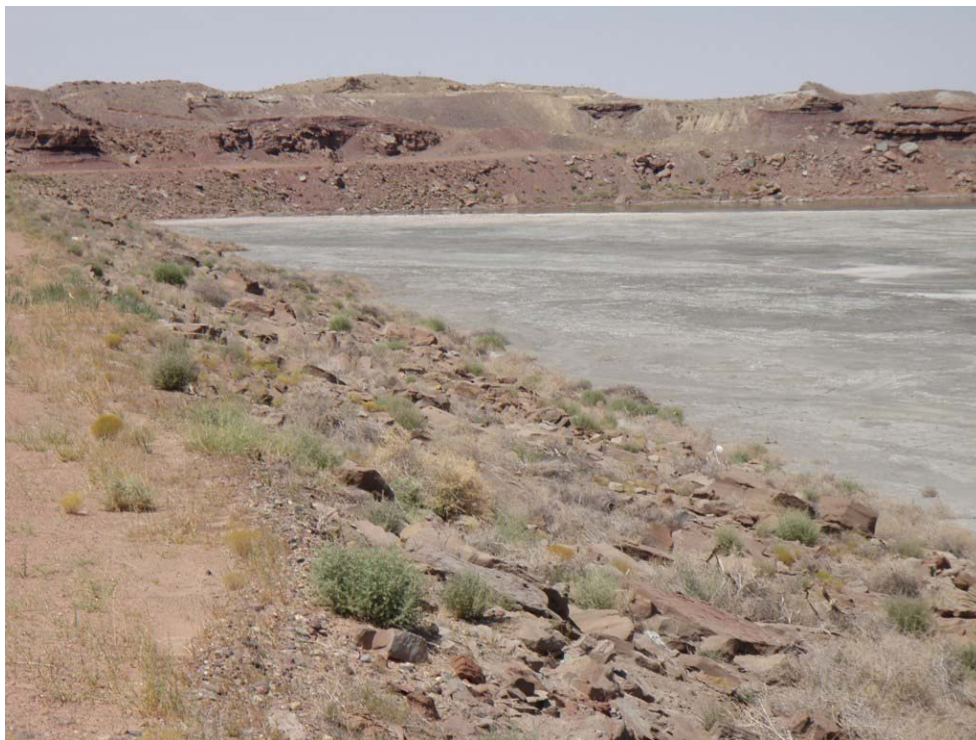
The upstream slope of the bottom ash pond embankment is protected from erosion by riprap (Photo 5) and appeared to be in good condition. Some vegetation is present on the upstream slope. We observed the fly ash slurry discharge pipes on the upstream slope (Photo 6). The discharge system appeared to be in good condition.

**Photo 5: Fly Ash Pond Dam - Upstream slope, looking west. Note vegetation.**

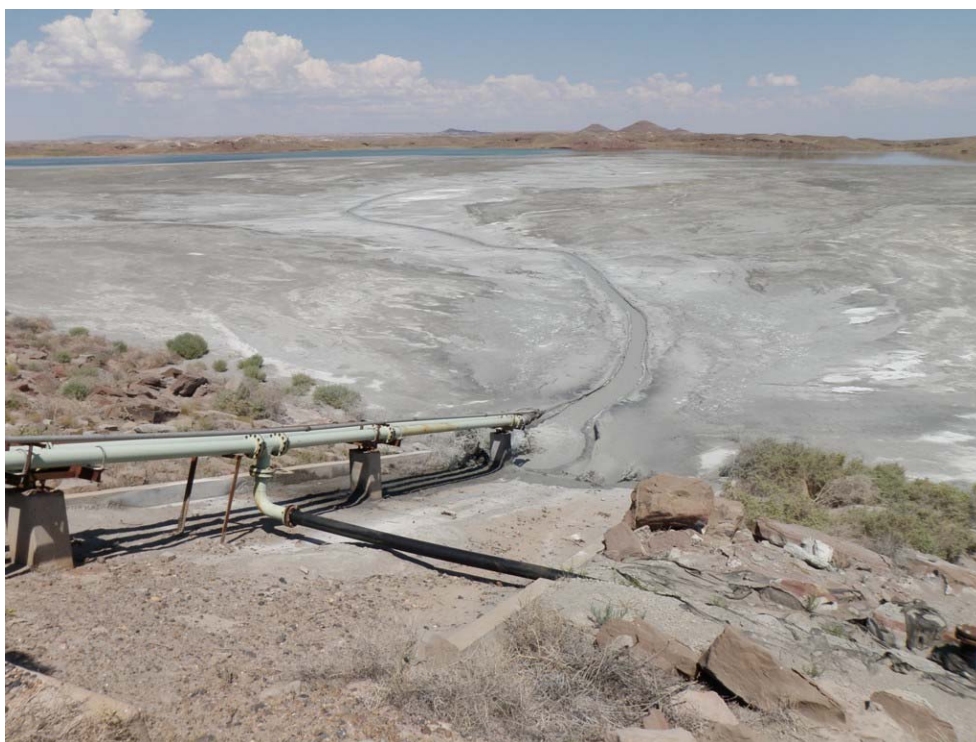
**Photo 6: Fly Ash Pond Dam - Slurry discharge point on upstream face.**

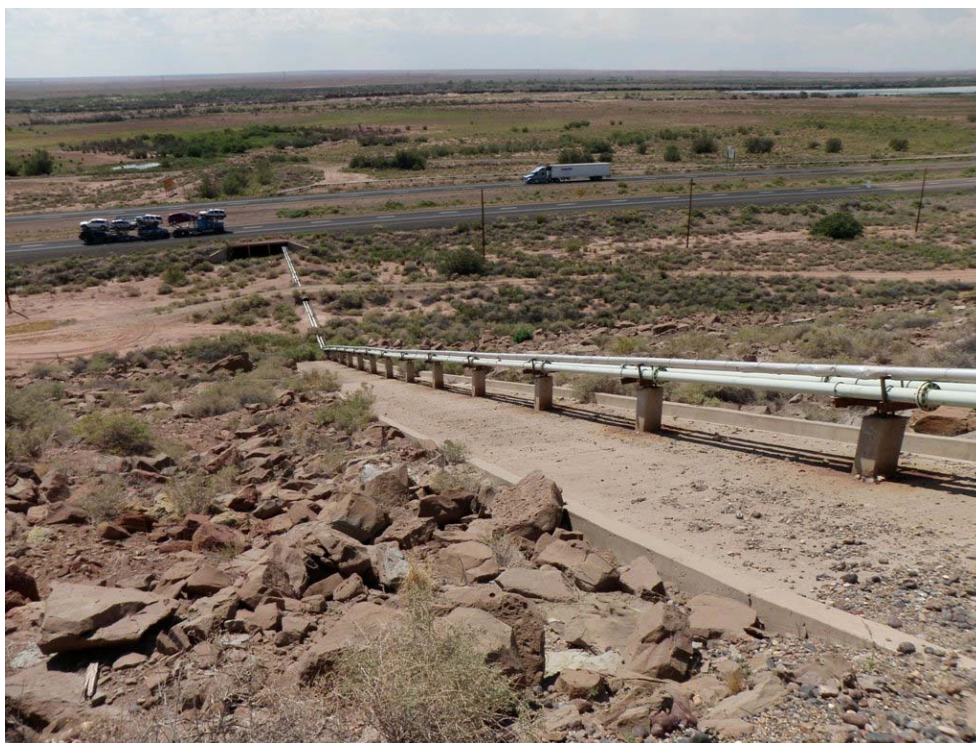
The downstream slope of the embankment is protected from erosion by riprap and appeared to be in good condition (Photo 7). Some vegetation was present on the downstream slope. The slurry discharge pipes traversing the downstream face are shown in Photo 8.

Photo 8: Fly Ash Pond Dam - Slurry pipes on downstream face.

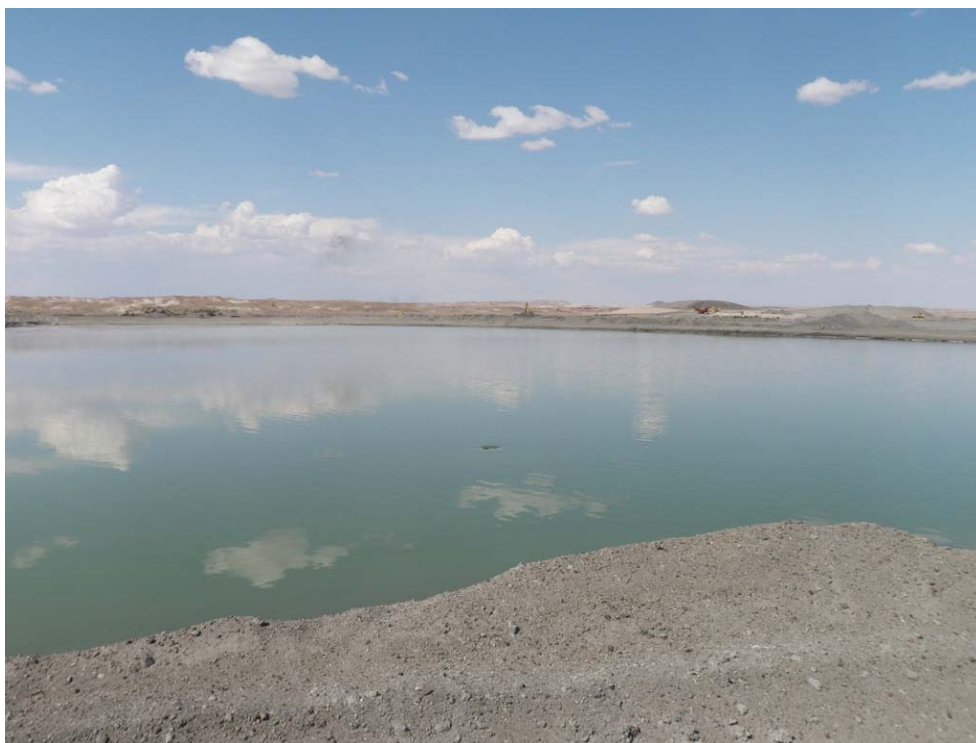
**Photo 12: Bottom Ash Pond - West cell, which is currently being filled with bottom ash slurry. Note vortex through which water flows to main reservoir.**

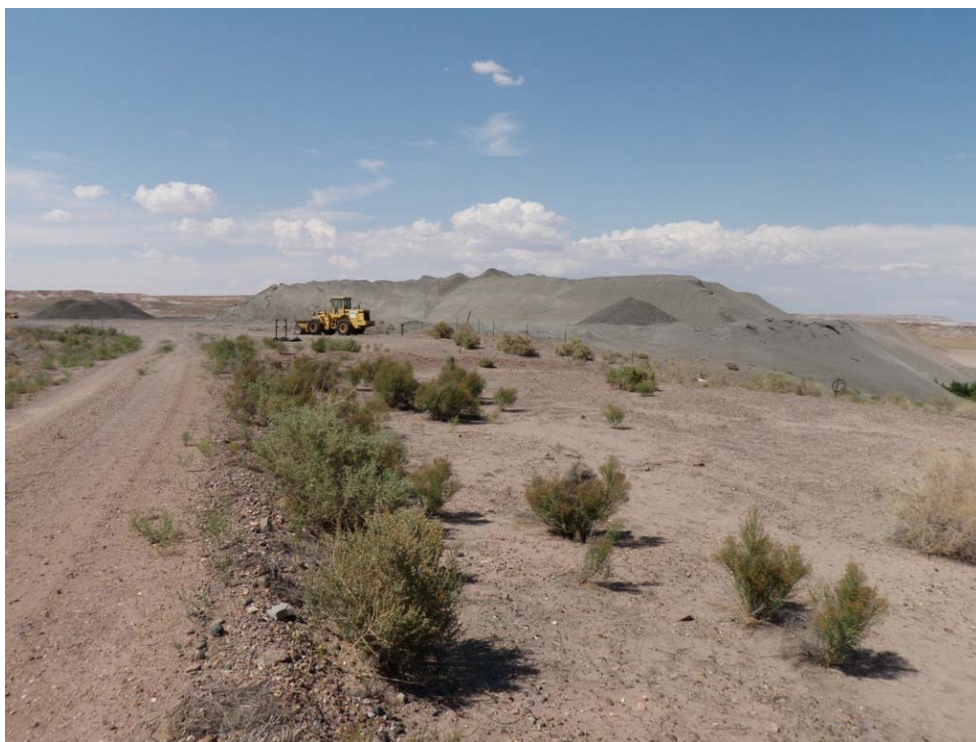
**Photo 13: Bottom Ash Pond - Monofill for final storage of drained bottom ash.**

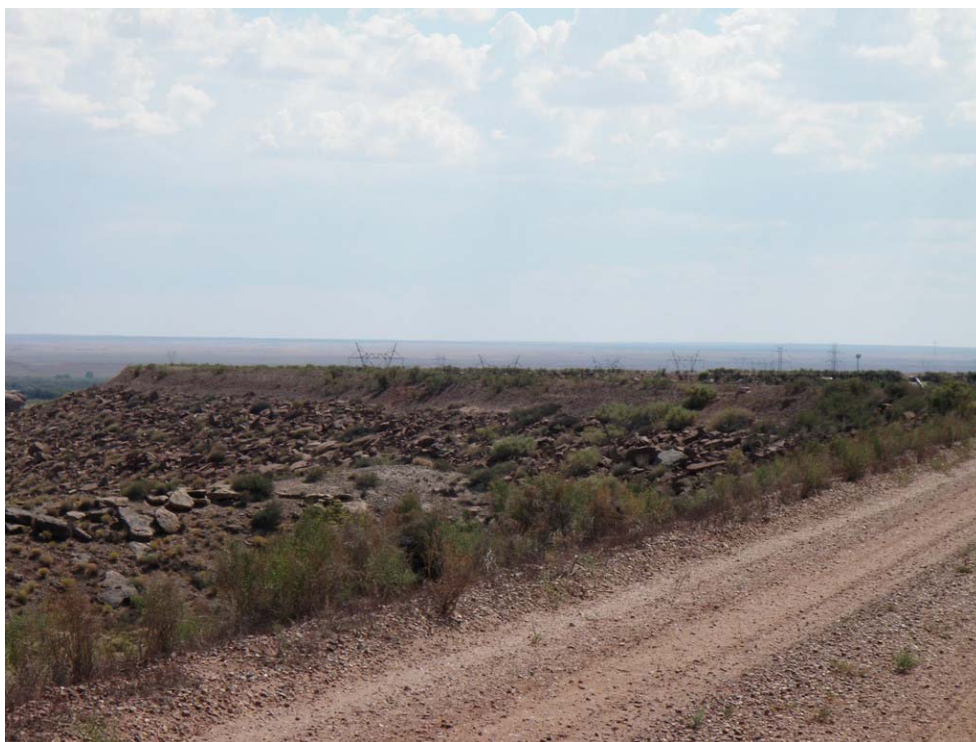
The embankment crest appeared to be in good condition (Photo 15). No signs of cracking or settlement were observed during the assessment. Occasional vegetation (brush) was present on the dam crest. This vegetation should be cleared in routine maintenance. The 3.3-foot dam crest raise that took place in 1993 is evident in Photo 16.

**Photo 16: Bottom Ash Pond Dam - Crest near left abutment with dam raise visible.**

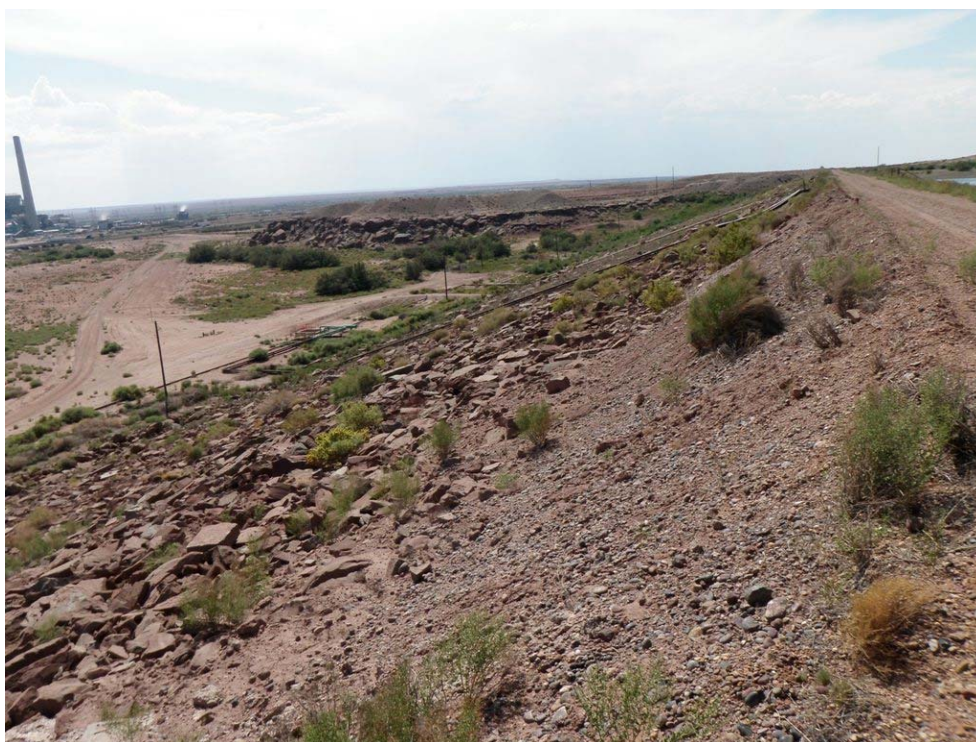
The downstream slope of the embankment is protected from erosion by riprap and appeared to be in good condition (Photo 18). Some vegetation (brush) is present on the downstream slope.

**Photo 18: Bottom Ash Pond - Downstream slope looking west.**

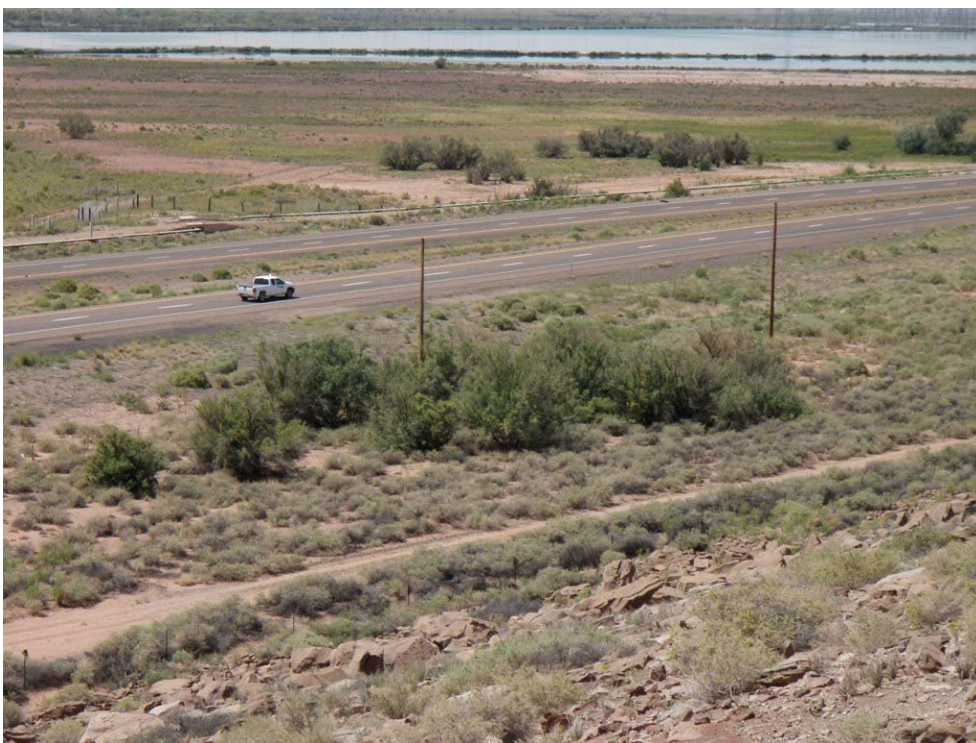
**Photo 20: Fly Ash Pond - Tamarisks near downstream toe indicating seepage.**

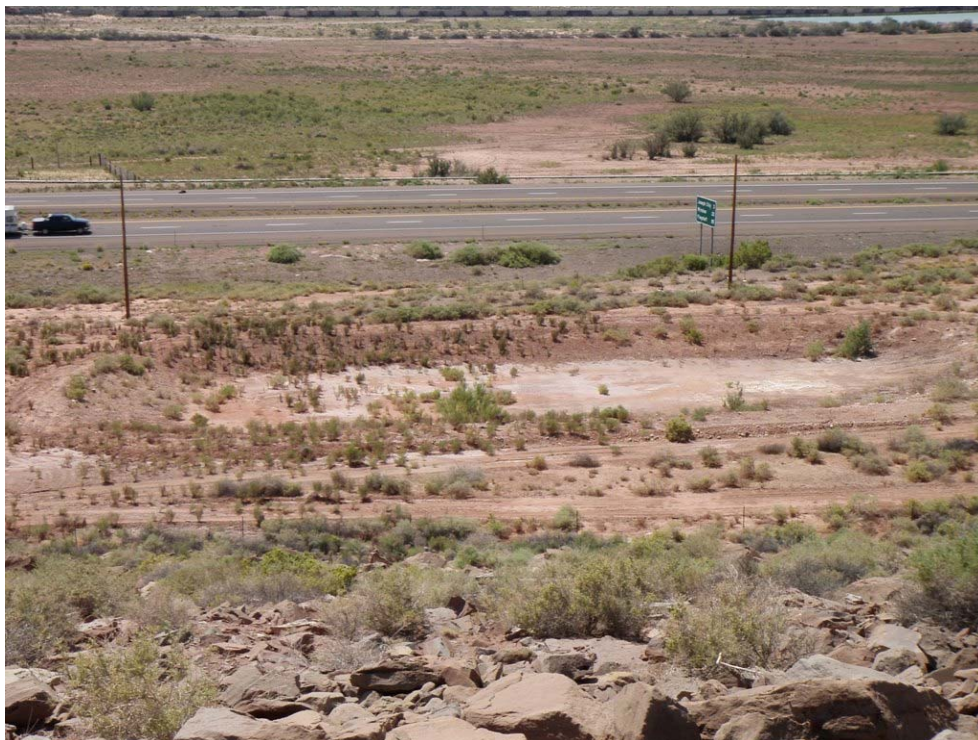
Photo 21: Fly Ash Pond - Evaporation Pond for I-40 Seep.

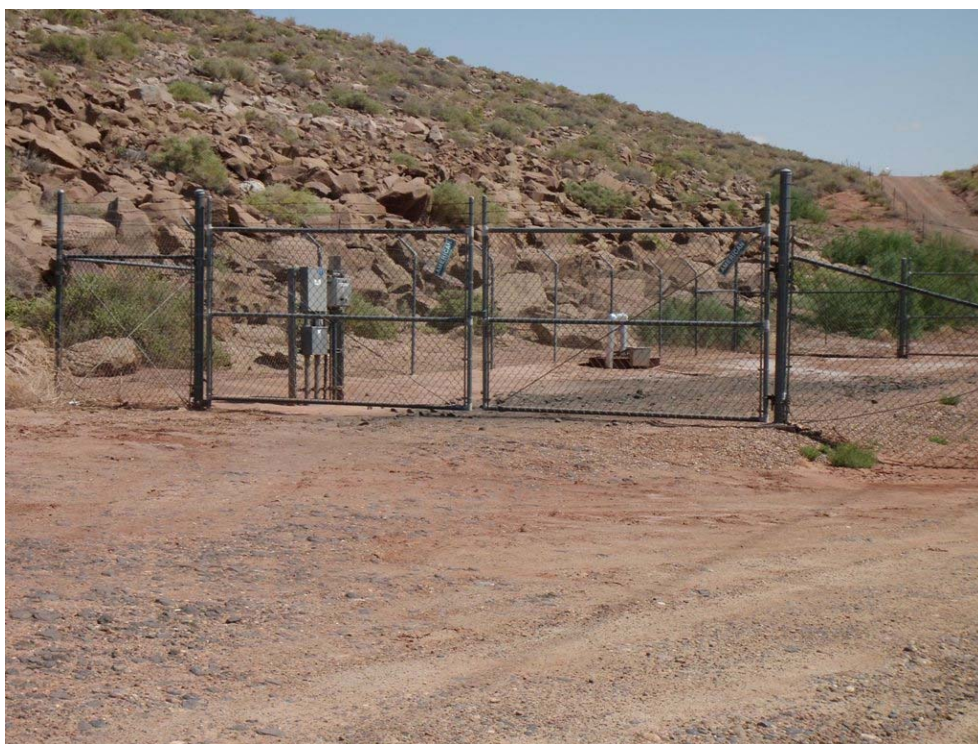
Photo 22: Fly Ash Pond - Seepage collection system for Geronimo Seep.

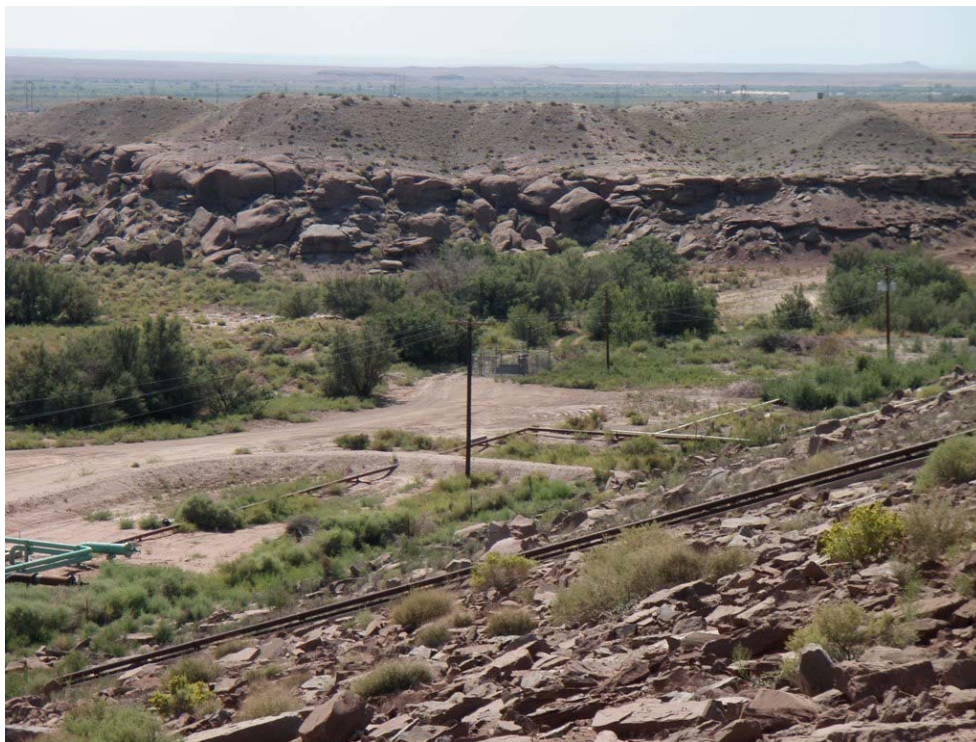
**Photo 25: Bottom Ash Pond - West Abutment Seep from embankment crest. Siphon pipes (center) and siphon collection system (lower left) are also visible.**

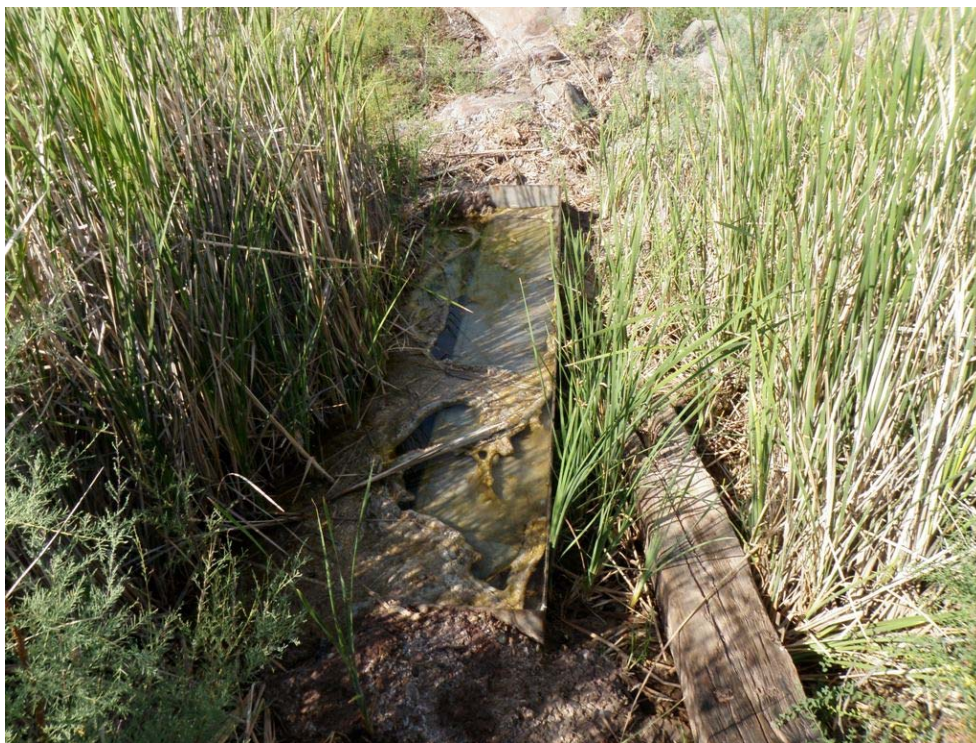
**Photo 26: Bottom Ash Pond - Weir at West Abutment Seep.**

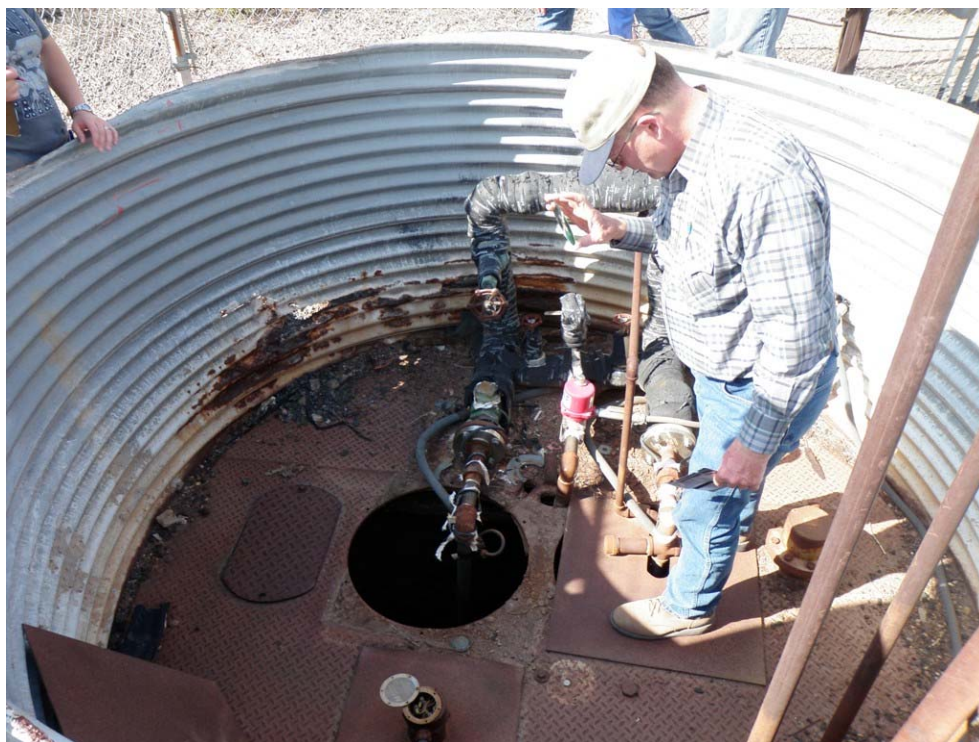
**Photo 27: Bottom Ash Pond - Seepage collection system at West Abutment Seep.**

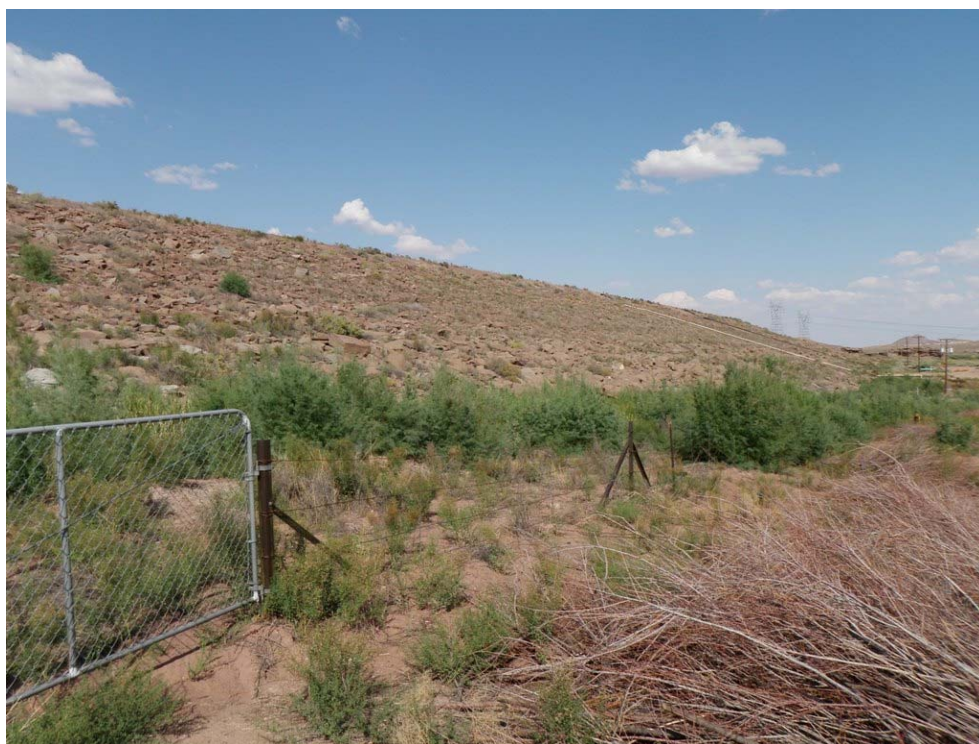
**Photo 28: Bottom Ash Pond - Overview of West Abutment Seep area, looking from weir east toward seepage collection sump.**

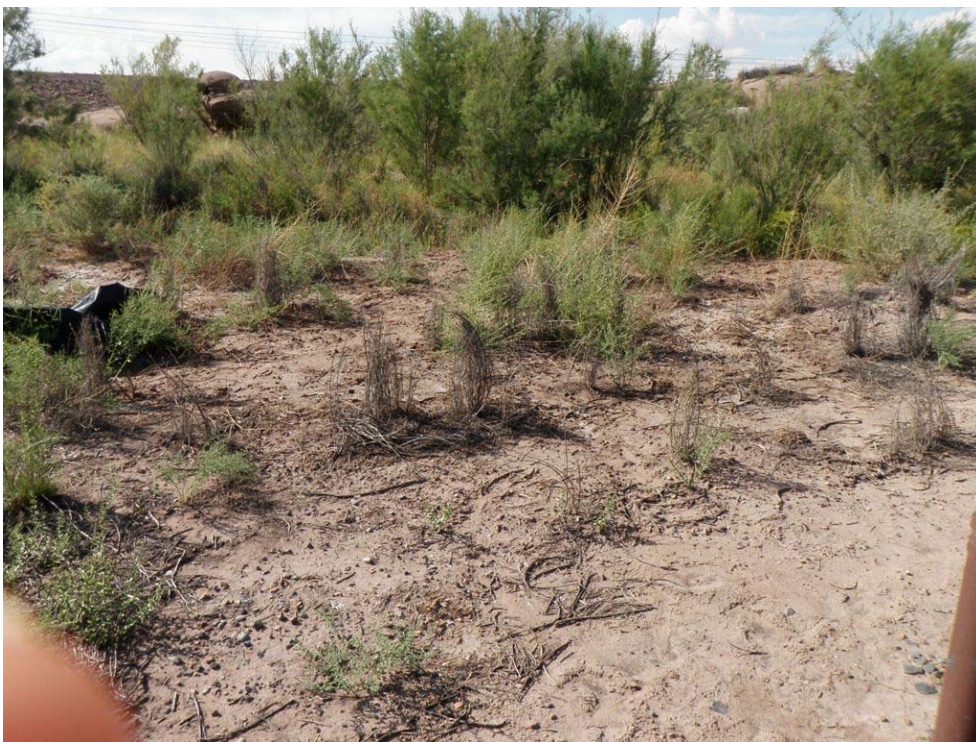
**Photo 30: Bottom Ash Pond - Salt patches at Tanner Wash Seep.**

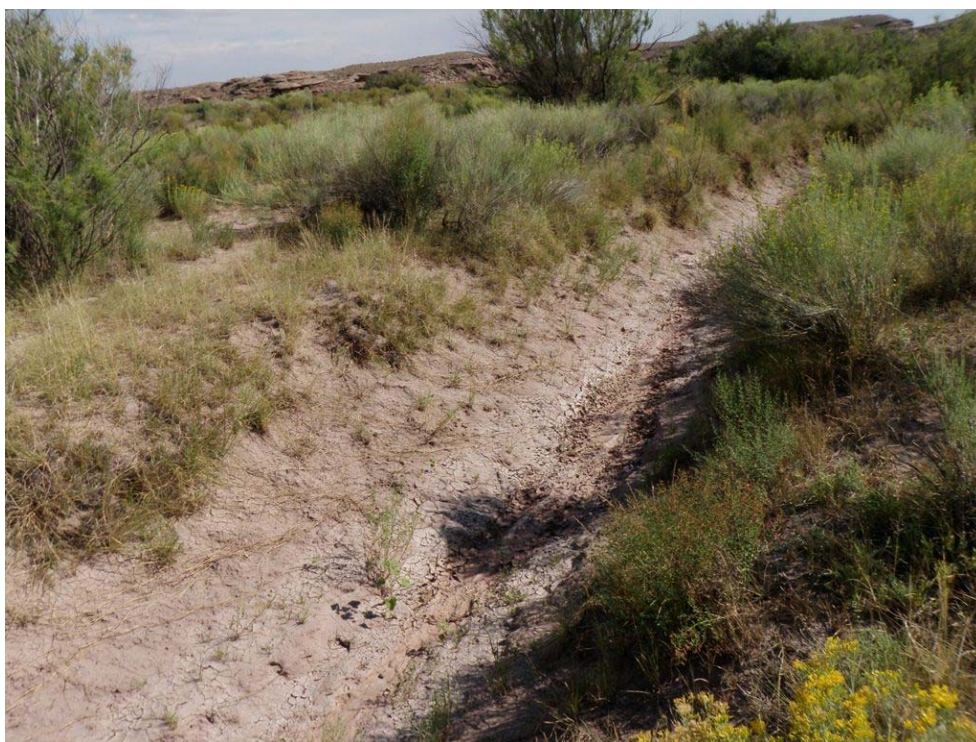
**Photo 32: Bottom Ash Pond - Tanner Wash.**

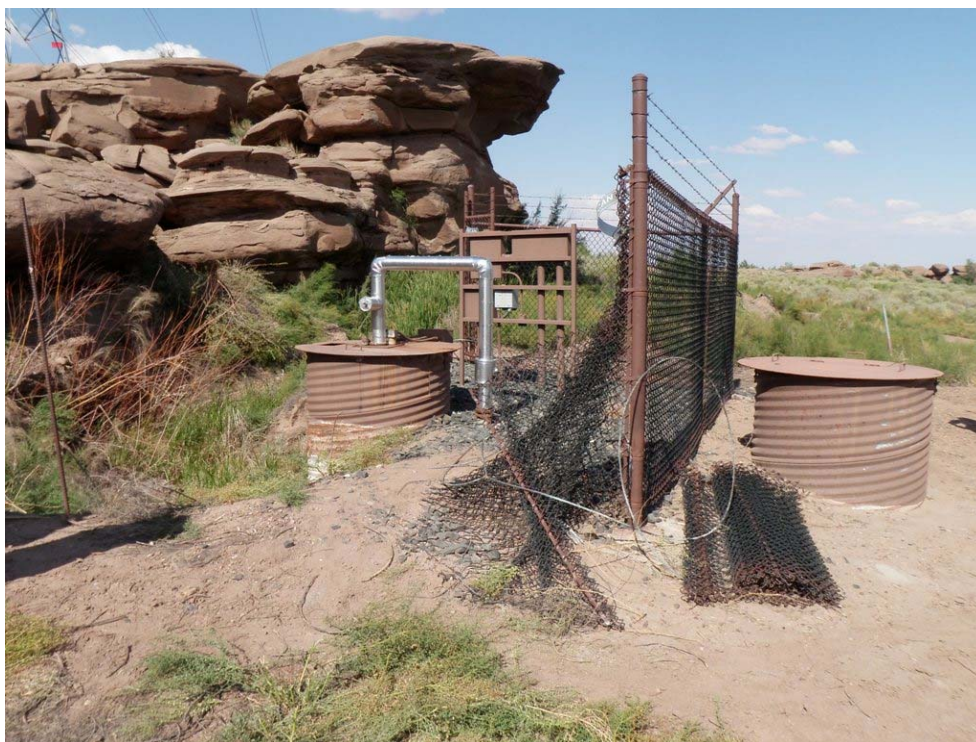
**Photo 33: Bottom Ash Pond - Seepage collection system for Petroglyph Seep.**

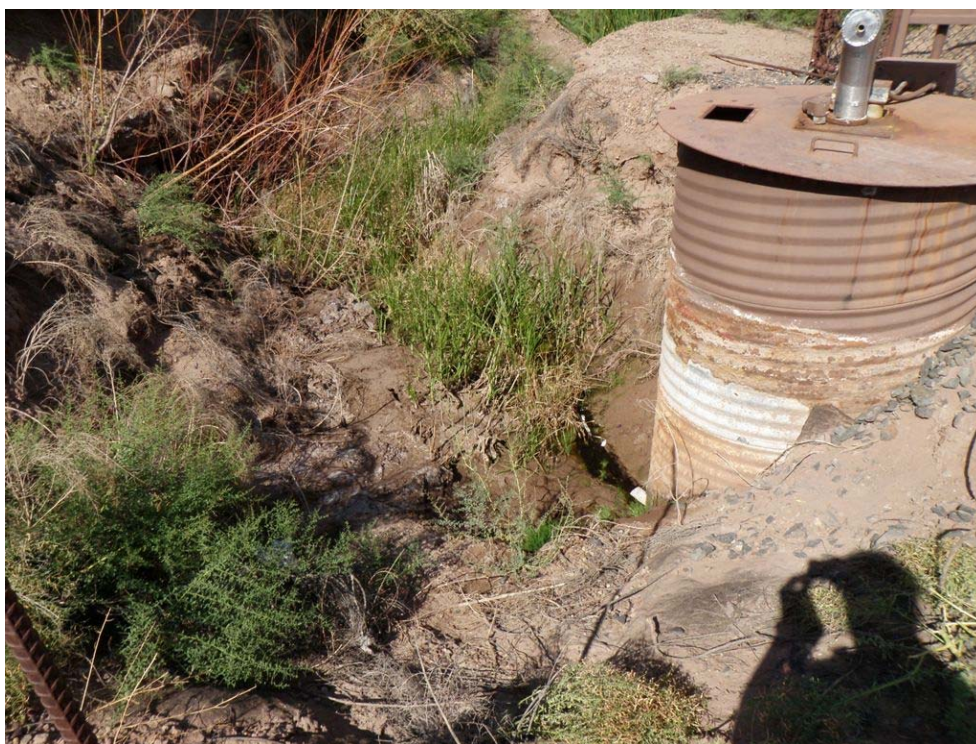
**Photo 34: Bottom Ash Pond - Flowing surface water at Petroglyph Seep.**

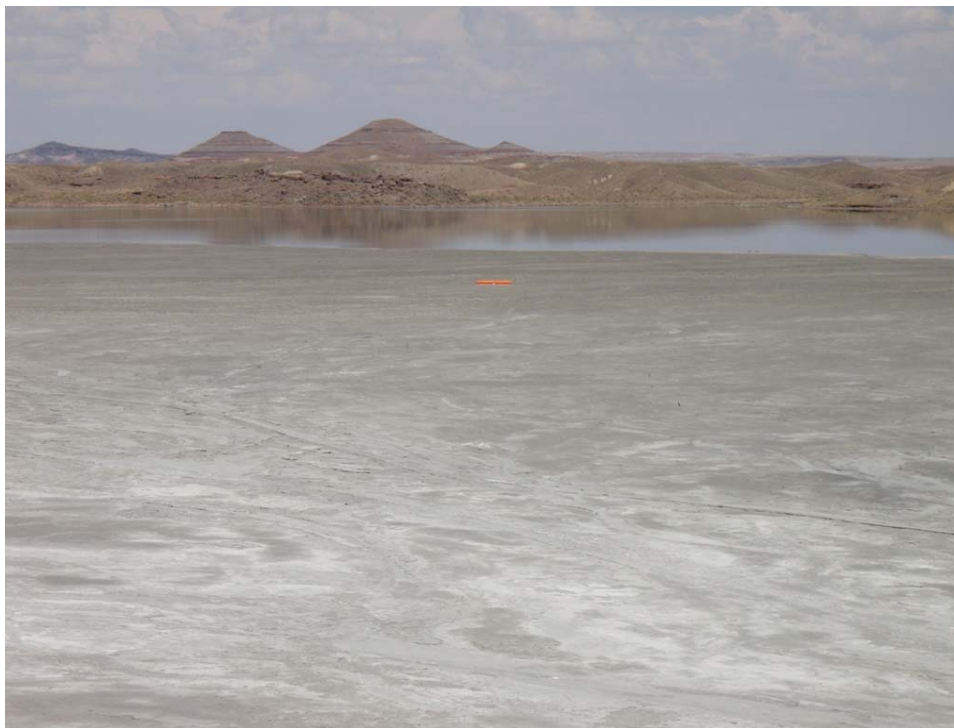
**Photo 35: Fly Ash Pond - Buoy marking 300-foot distance from area where cracks were observed in embankment crest. Fly ash beach must extend upstream of this distance.**

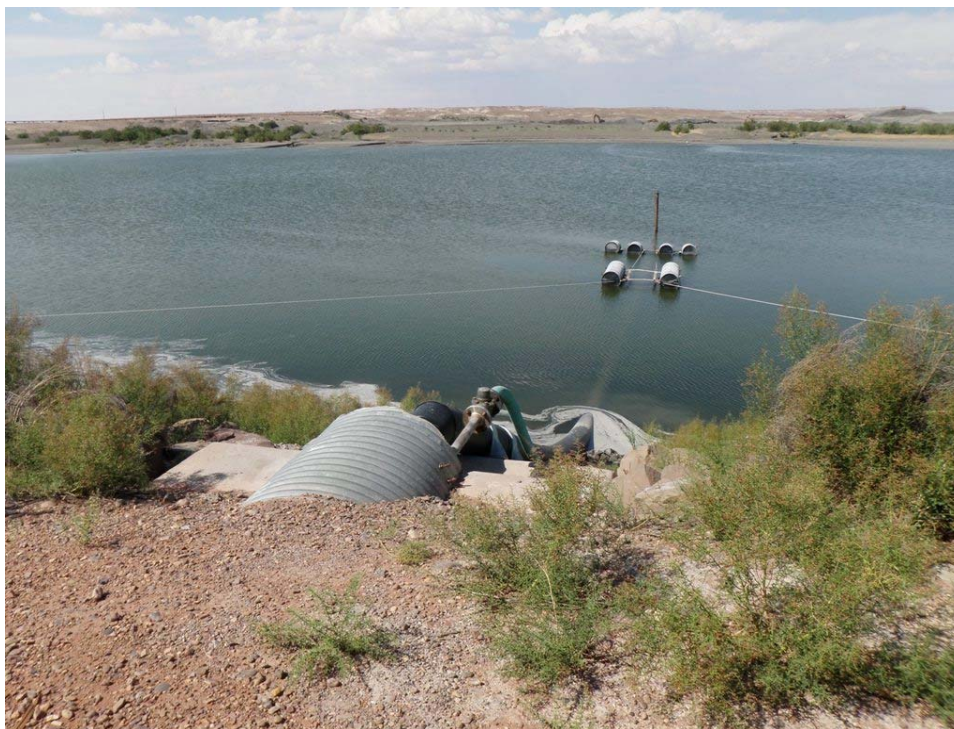
**Photo 36: Bottom Ash Pond - Floating siphon pipes to return water from main reservoir to power plant – upstream side of dam.**

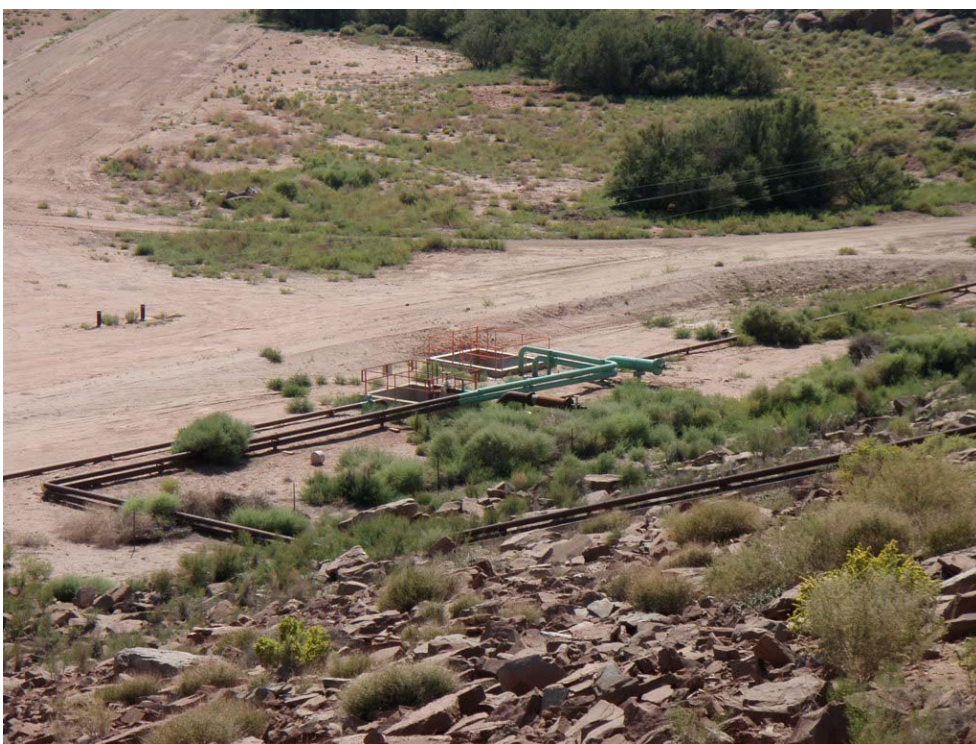
**Photo 38: Bottom Ash Pond - Siphon collection station at toe of dam.**
