**DRAFT FINAL**  
**Specific Site Assessment for**  
**Coal Combustion Waste**  
**Impoundments at Arizona**  
**Electric Power Cooperative**  
**(AEPCO) Apache Power Plant**  
Cochise, Arizona

Submitted by:  
**GEI Consultants, Inc.**  
6950 South Potomac Street, Suite 300  
Centennial, CO 80112

October 2009  
Project 091330

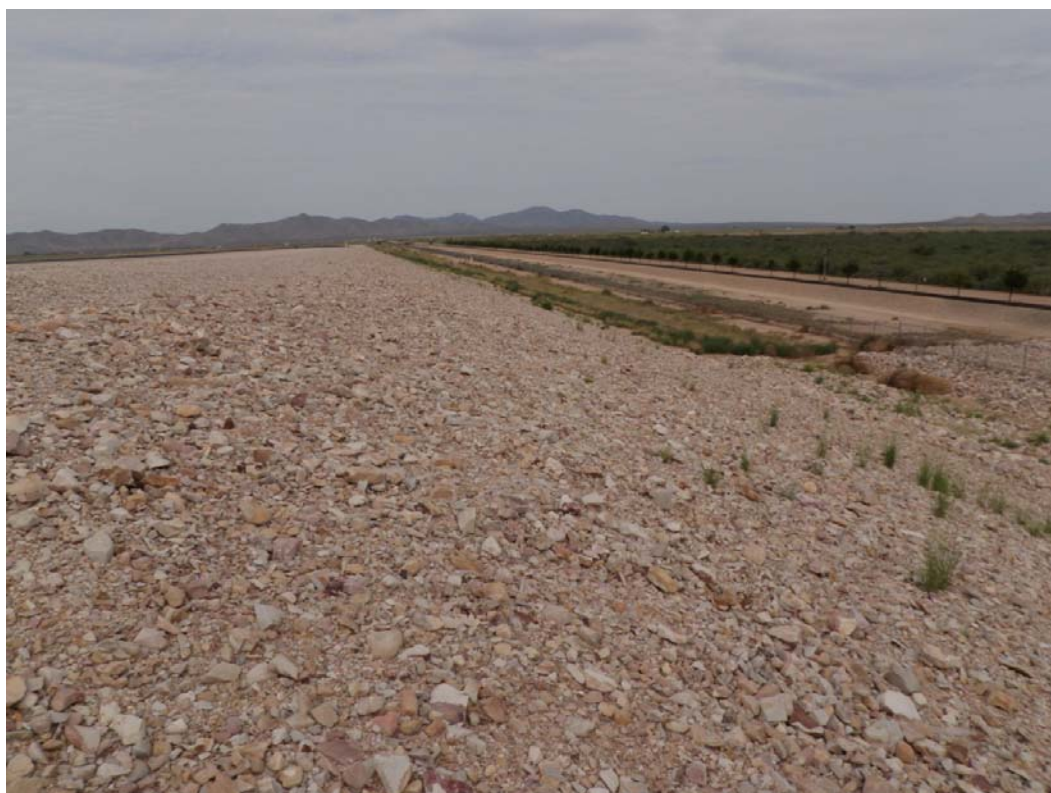
**Photo 3: Downstream slope of north embankment of Ash Pond 4 facing west. Note train tracks located to north of facility.**

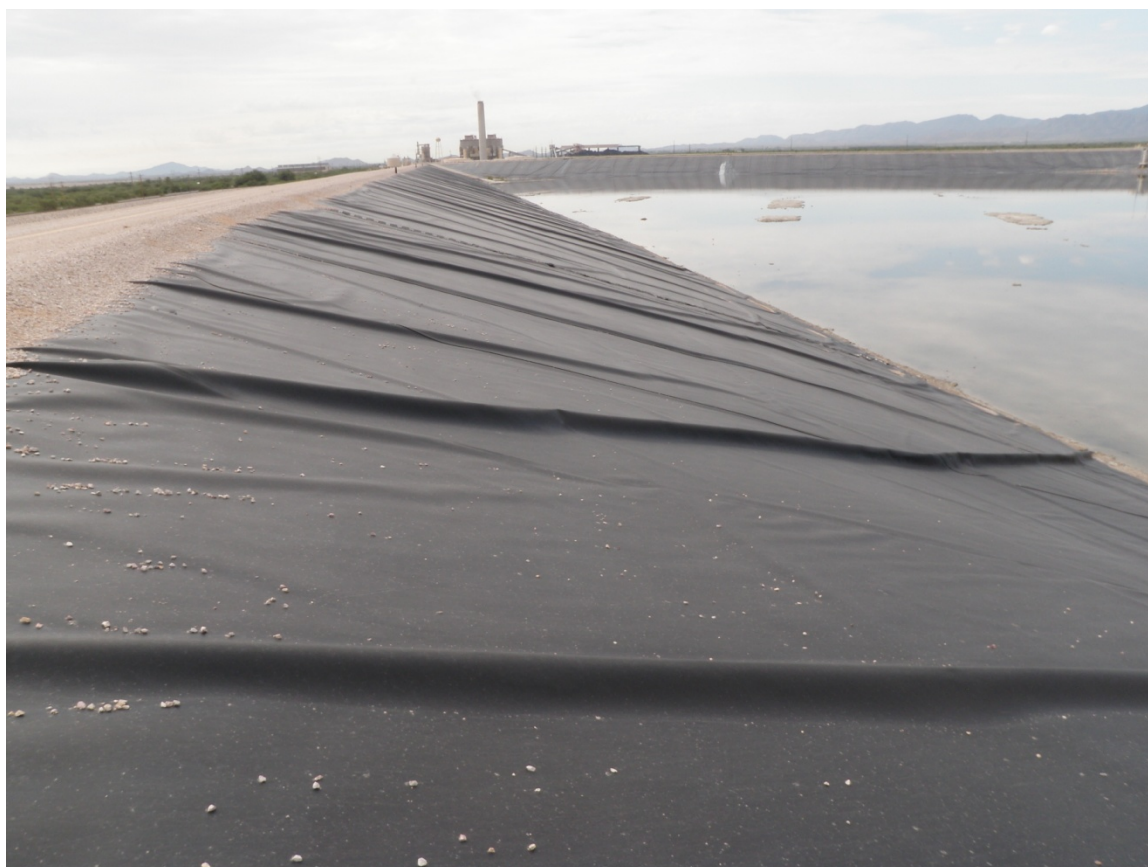
Photo 5: Upstream slope of east embankment of Ash Pond 4 facing south.

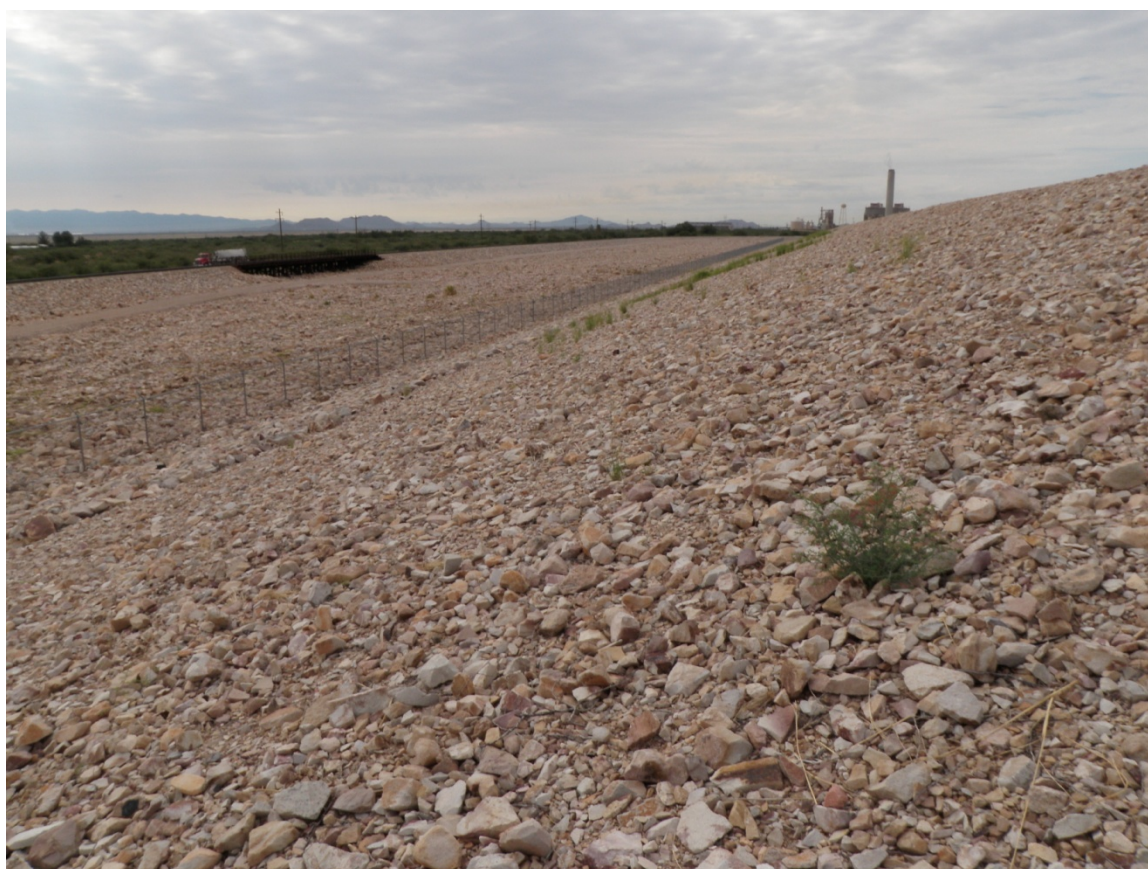
Photo 6: Downstream slope of east embankment of Ash Pond 4 facing south.

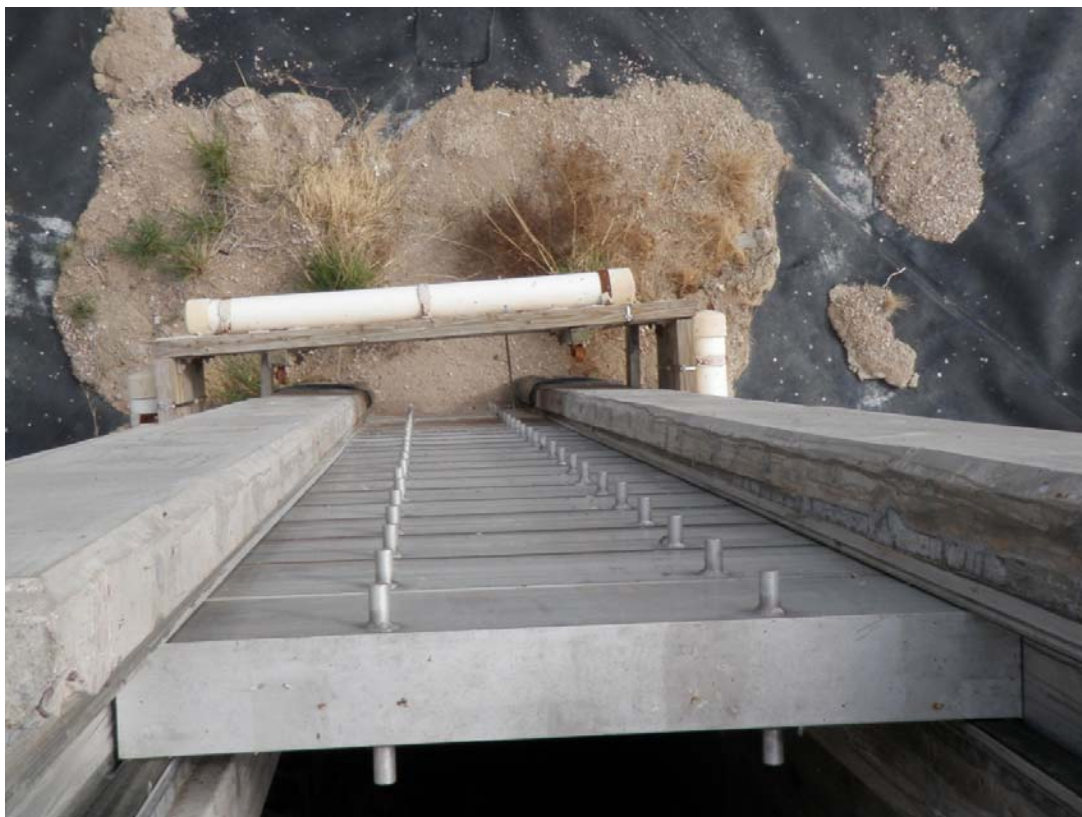
Photo 23: Exterior view of intake tower at Ash Pond 4, looking down. Note the aluminum stop logs that can be adjusted to control pond decant level.

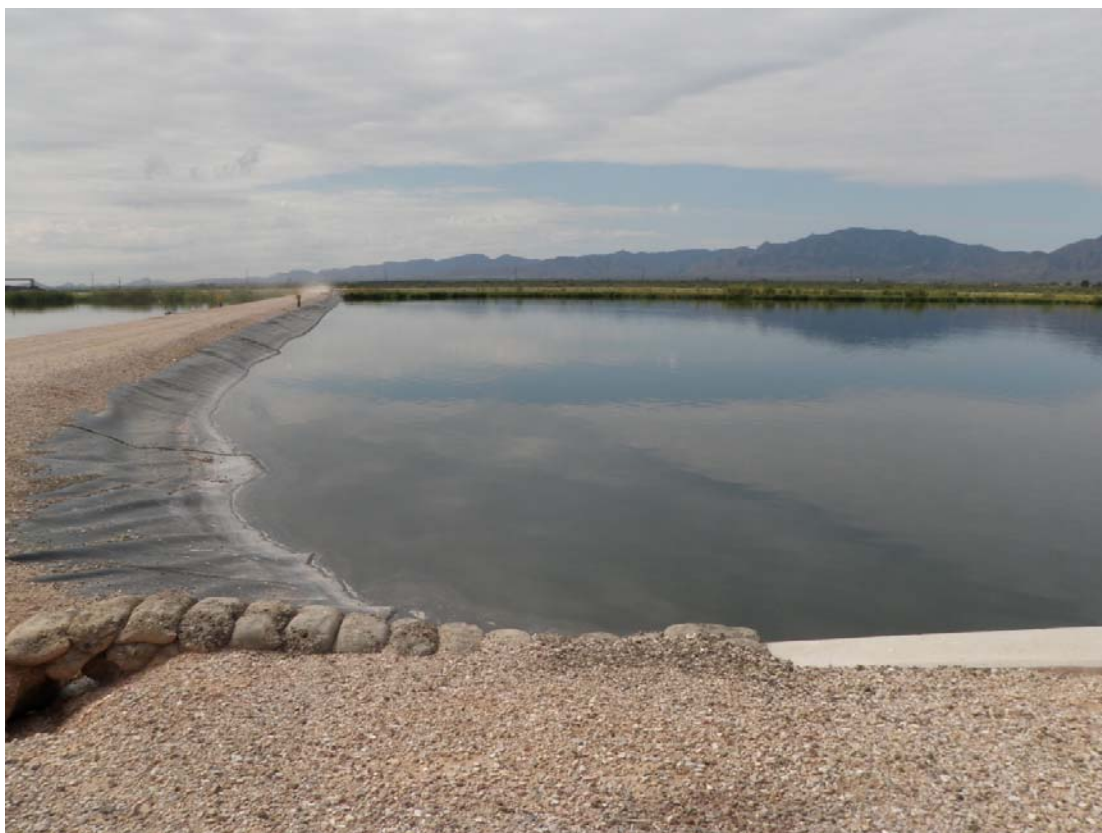
Photo 24: Upstream slope of embankment of Ash Pond 2, looking south. Note erosion of granular crest surface material from behind the wall formed of cement bags.

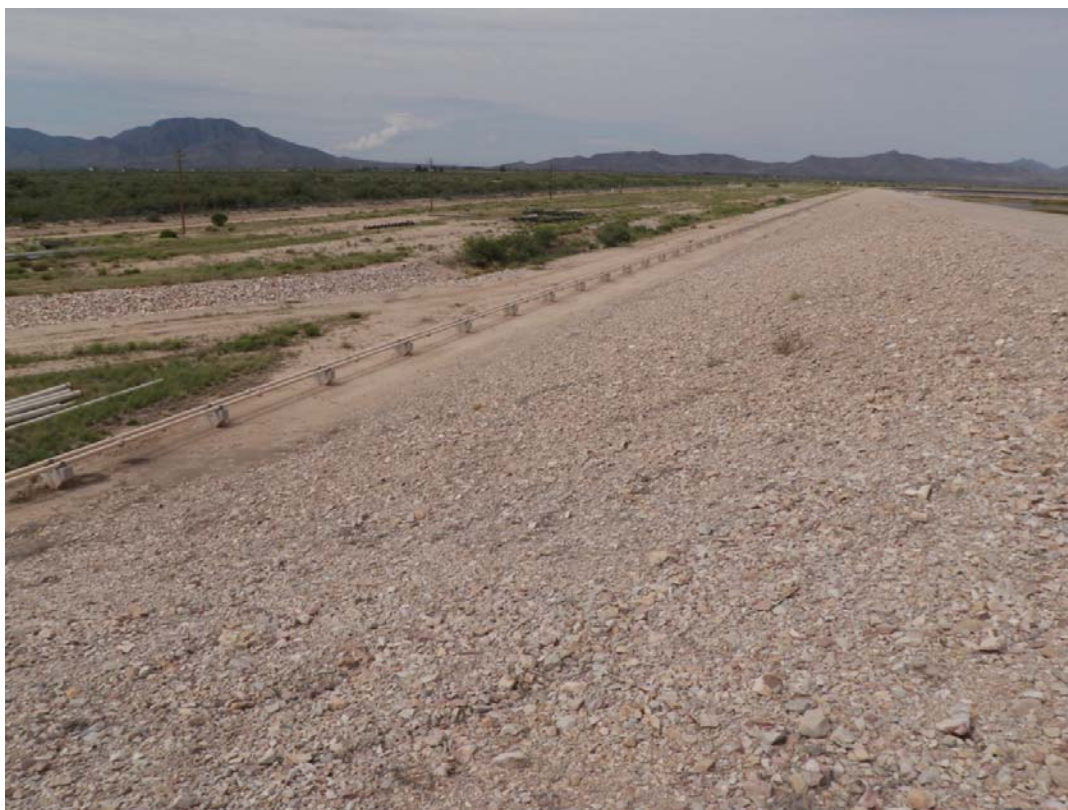
Photo 28: Downstream slope of south embankment of Ash Pond 1, looking west. Note pipes conveying slurried scrubber sludge to Scrubber Sludge Pond 1. Note riprapped stormwater channel located downstream of the embankment.

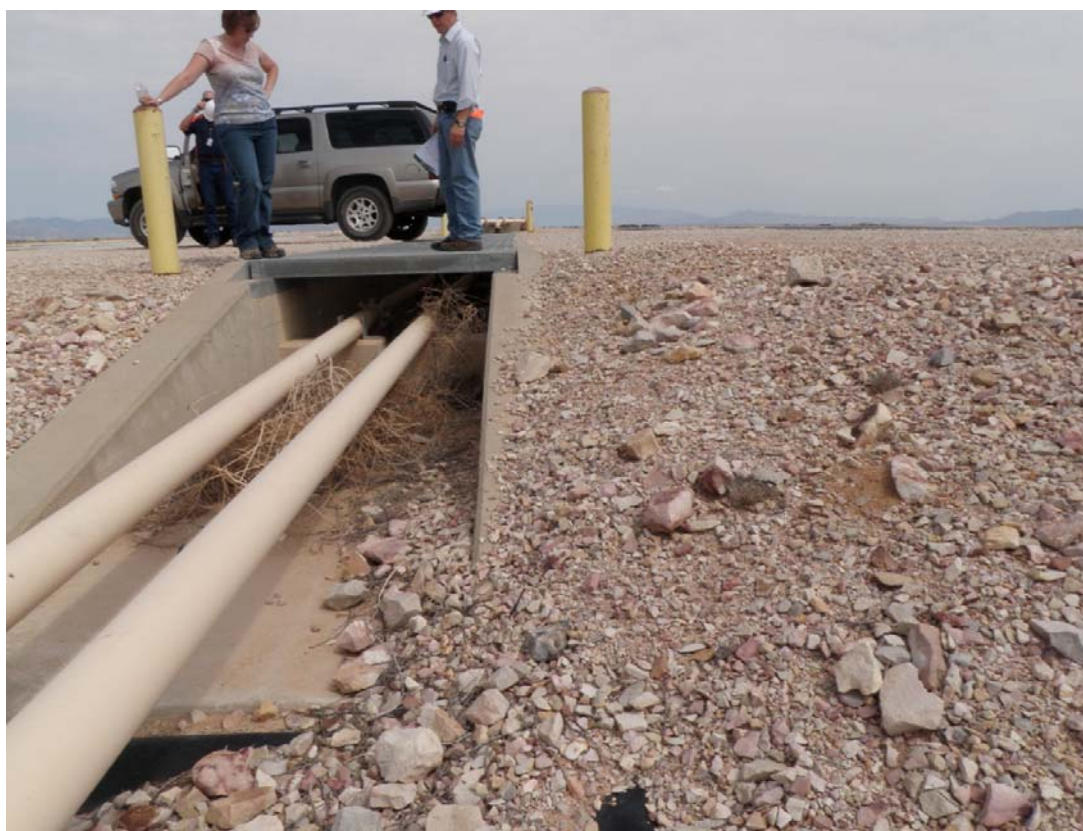
Photo 42: Pipe vault where pipes cross the crest to discharge into Scrubber Sludge Pond 1, looking north. Note the vault lacks a concrete headwall at the downstream end, which could provide a pathway to concentrate discharge of overtopping flows.

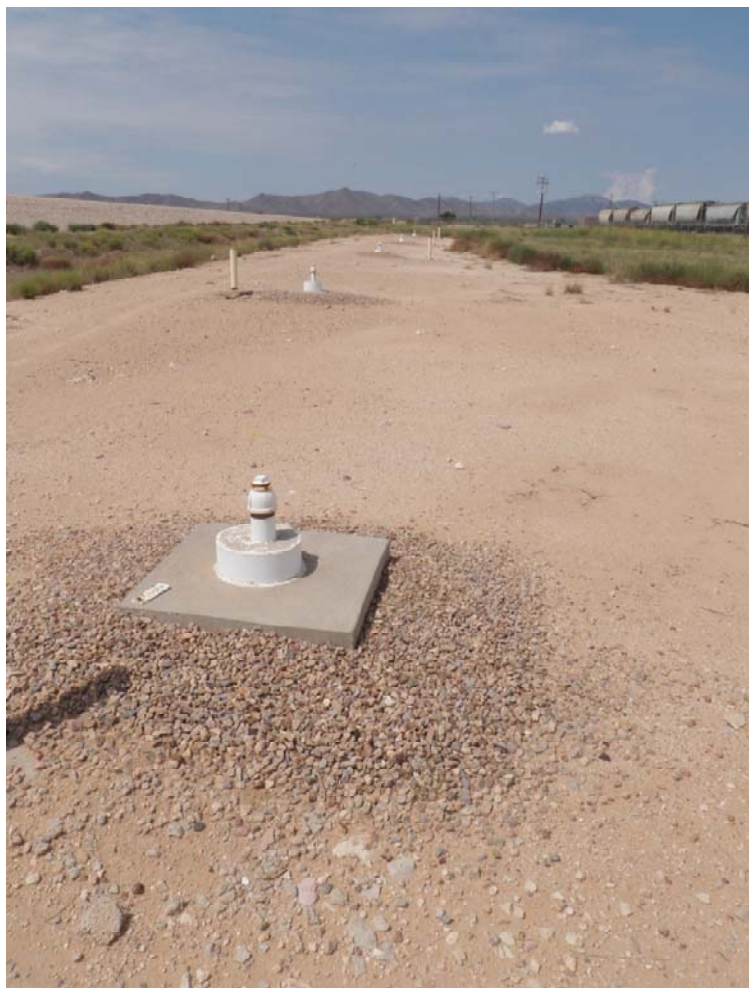
**Photo 61: High precision survey monuments located in area where fissures were identified on north side of Scrubber Sludge Pond 2/ Evaporation Pond prior to construction. Note train on tracks located north of the facility.**
