FINAL

**Specific Site Assessment for
Coal Combustion Waste
Impoundments at Arizona
Electric Power Cooperative
(AEP CO) Apache Power Plant**

Cochise, Arizona

December 2009

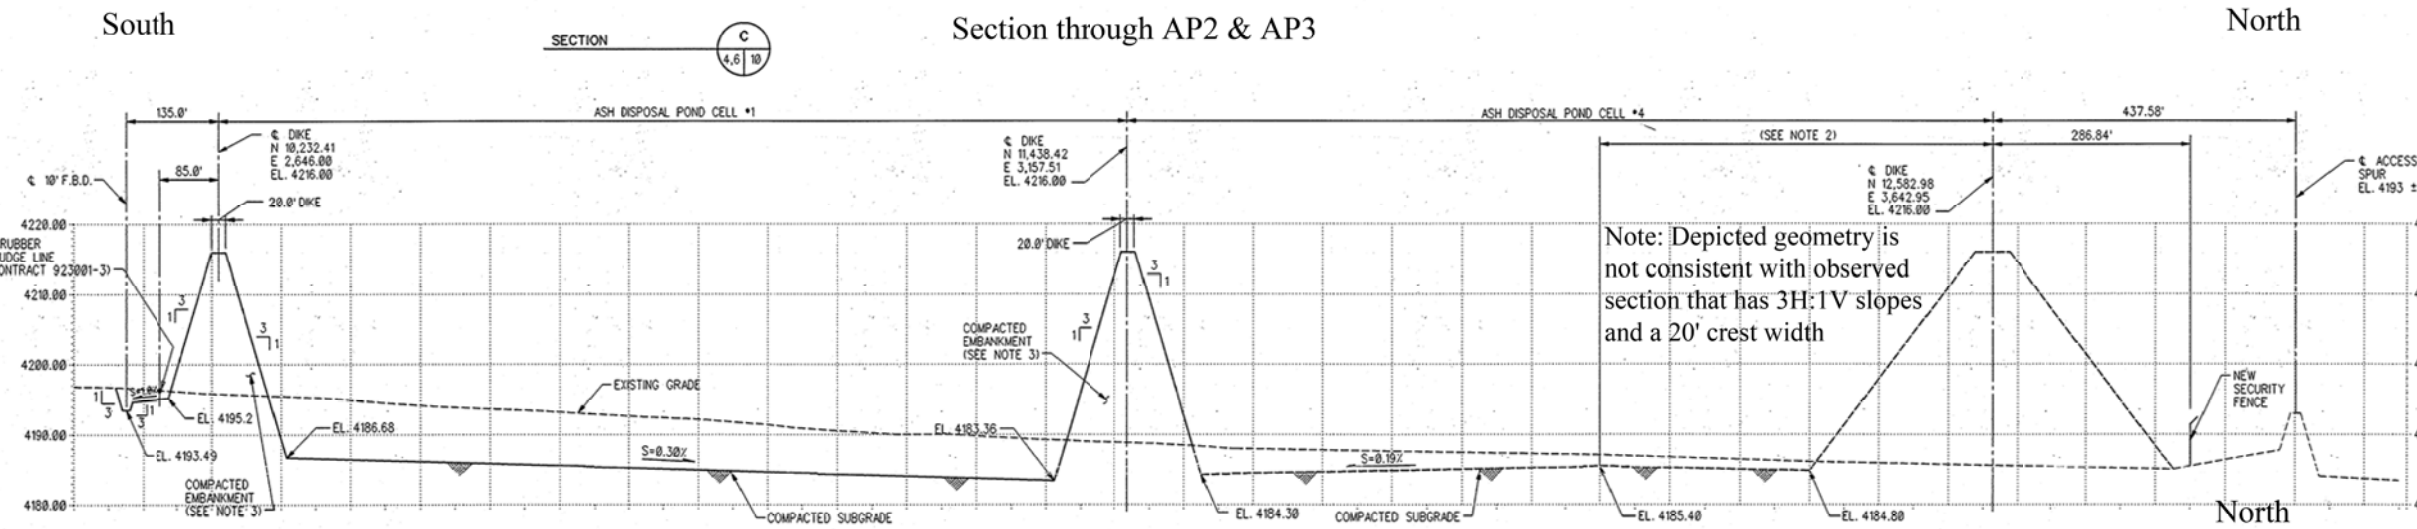
Note: Depicted geometry is not consistent with observed section that has 3H:1V slopes and a 20' crest width

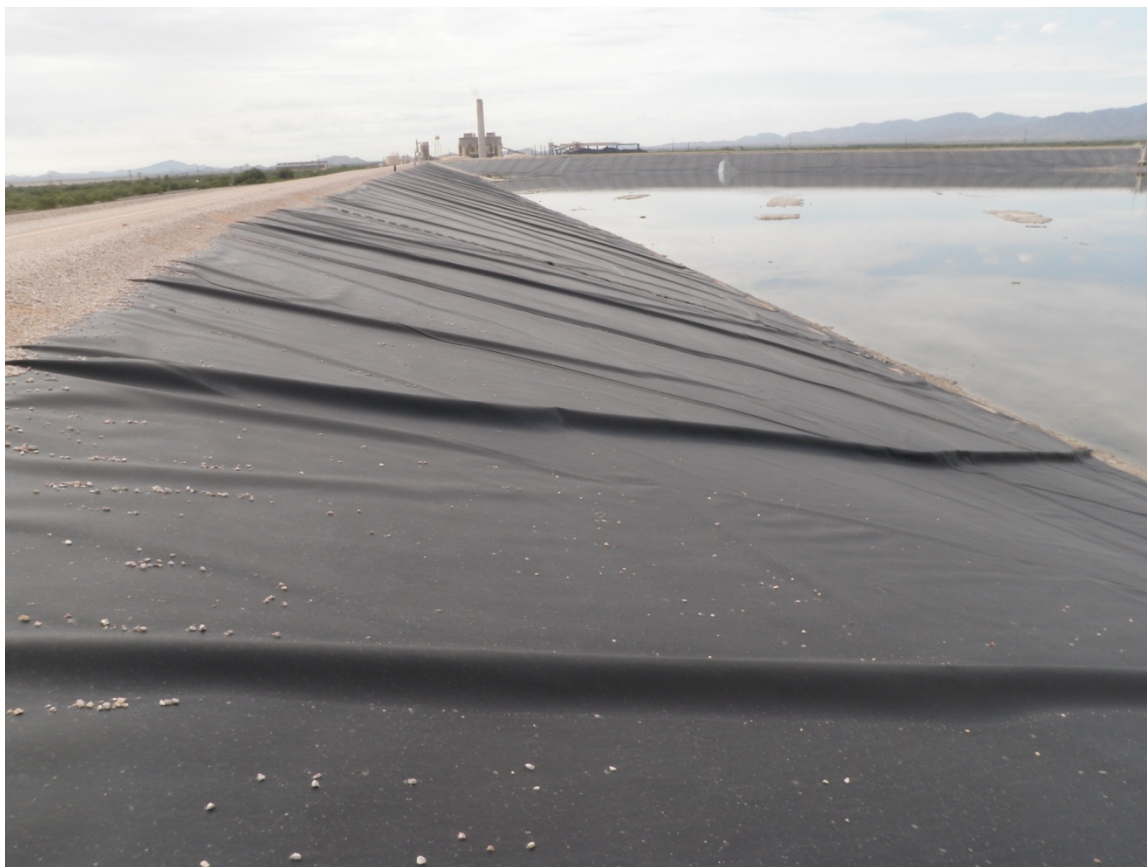
Photo 5: Upstream slope of east embankment of Ash Pond 4 facing south.

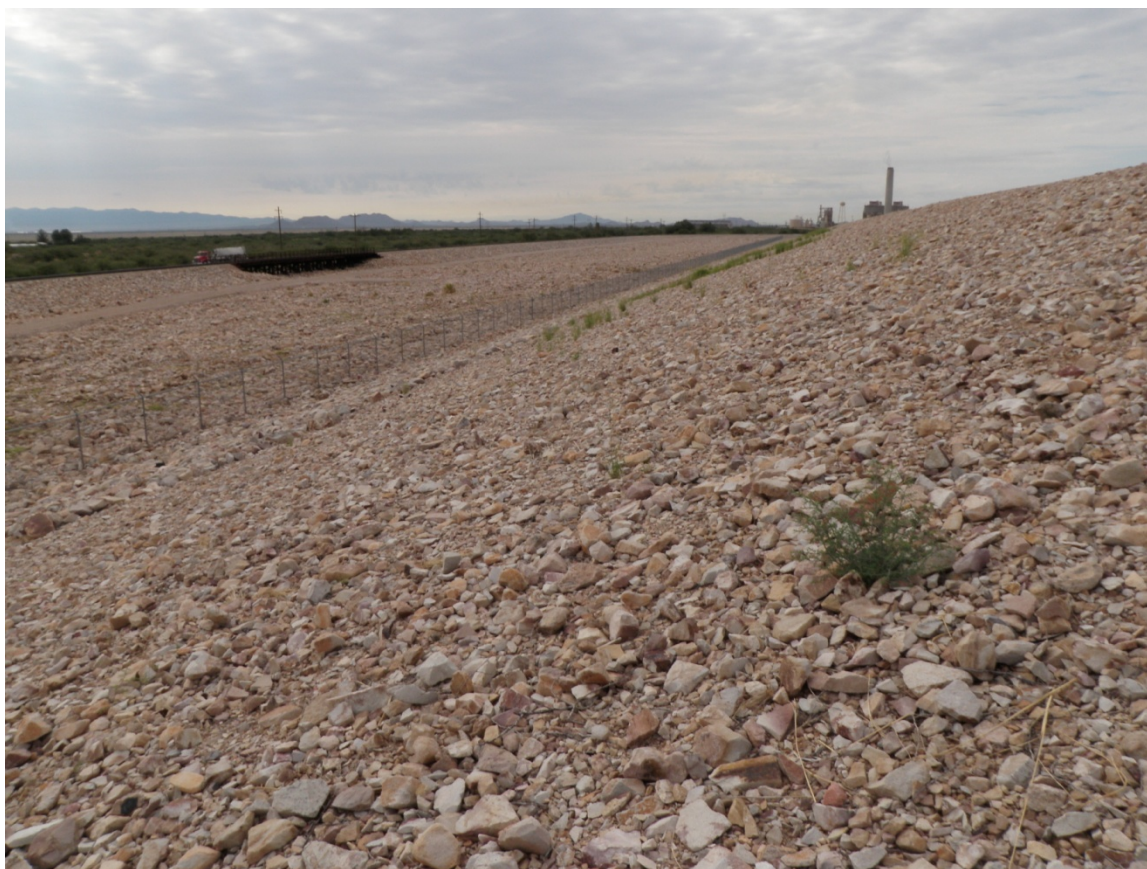
Photo 6: Downstream slope of east embankment of Ash Pond 4 facing south.

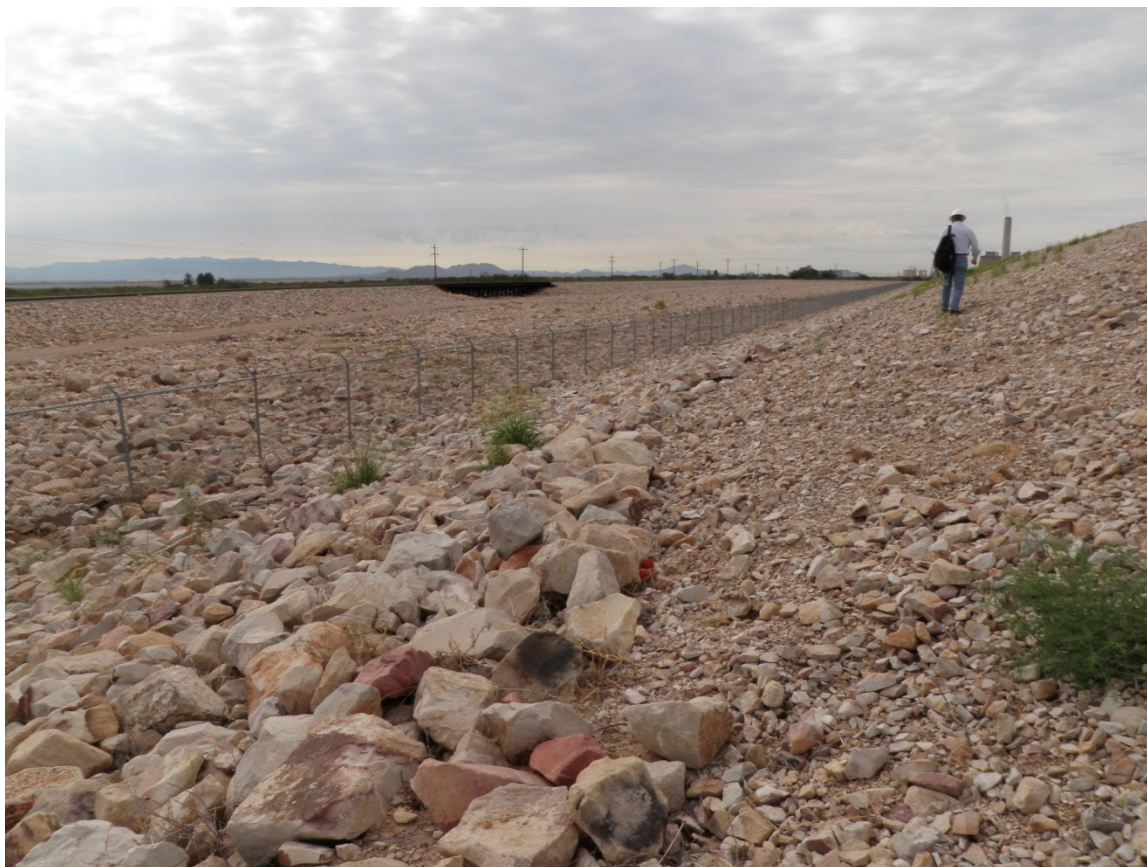
Photo 7: Downstream toe of east embankment of Ash Pond 4 facing south. Note granular rock slope protection and riprap in stormwater ditch at toe.

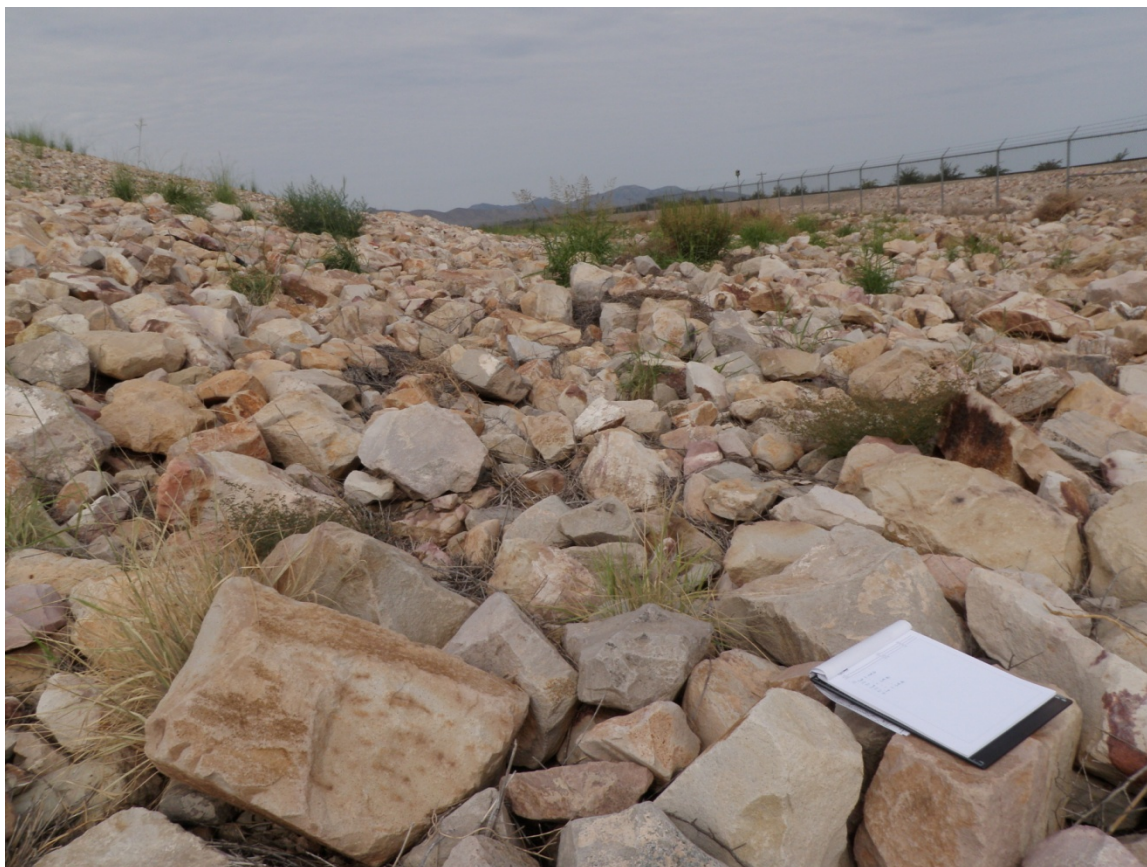
Photo 8: Downstream toe of east embankment of Ash Pond 4 facing north.

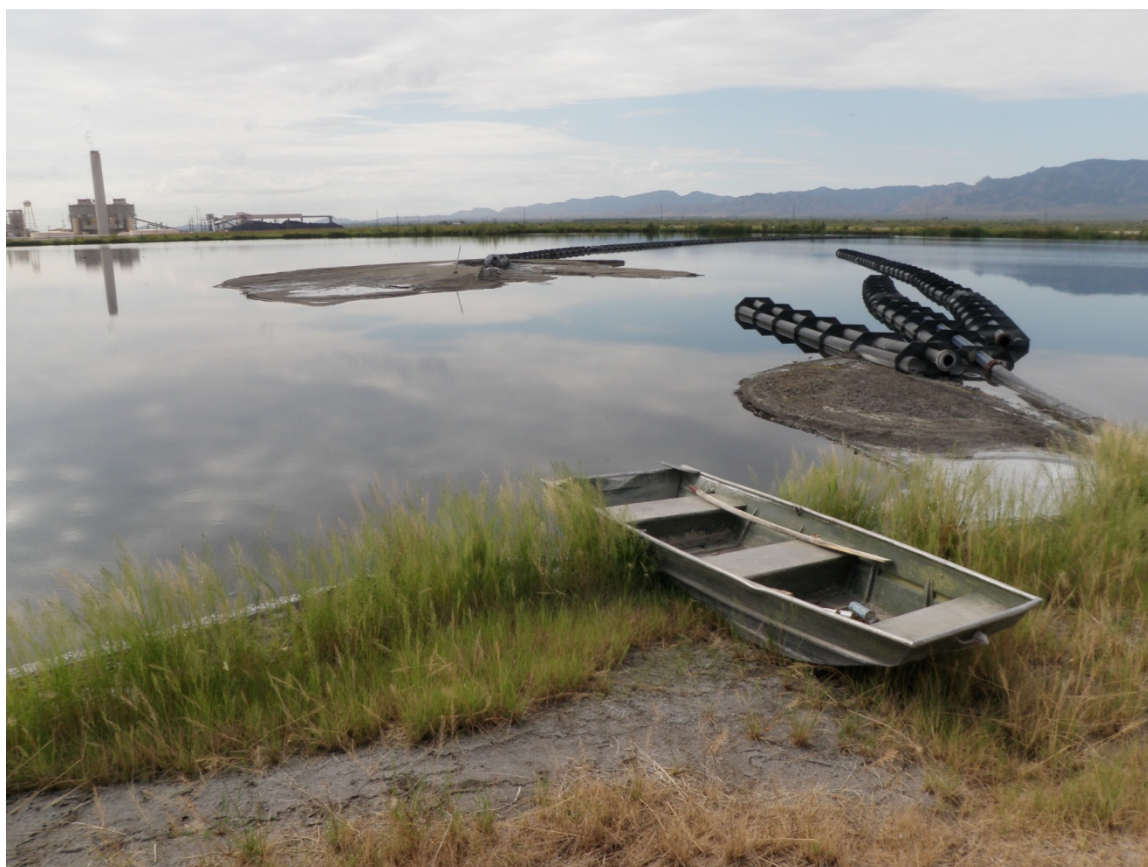
Photo 17: View of broken floating discharge pipe in Ash Pond 1. Occasional breaks occur in the slurried ash and residual discharge pipe due to pressure build-up, possibly associated with clogging.

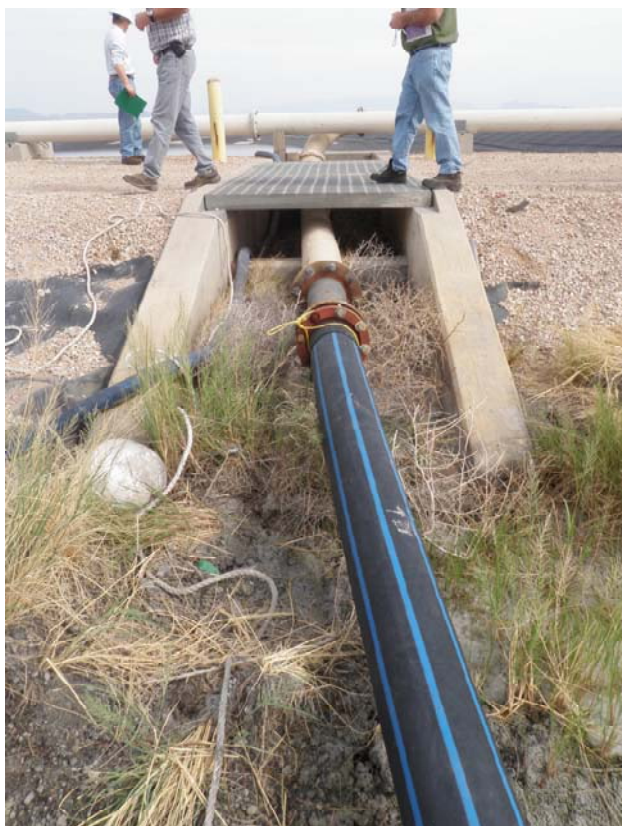
Photo 18: Pipe Vault in crest between Ash Pond 1 and Ash Pond 4 looking north. Note concrete backwall at north end of vault only.

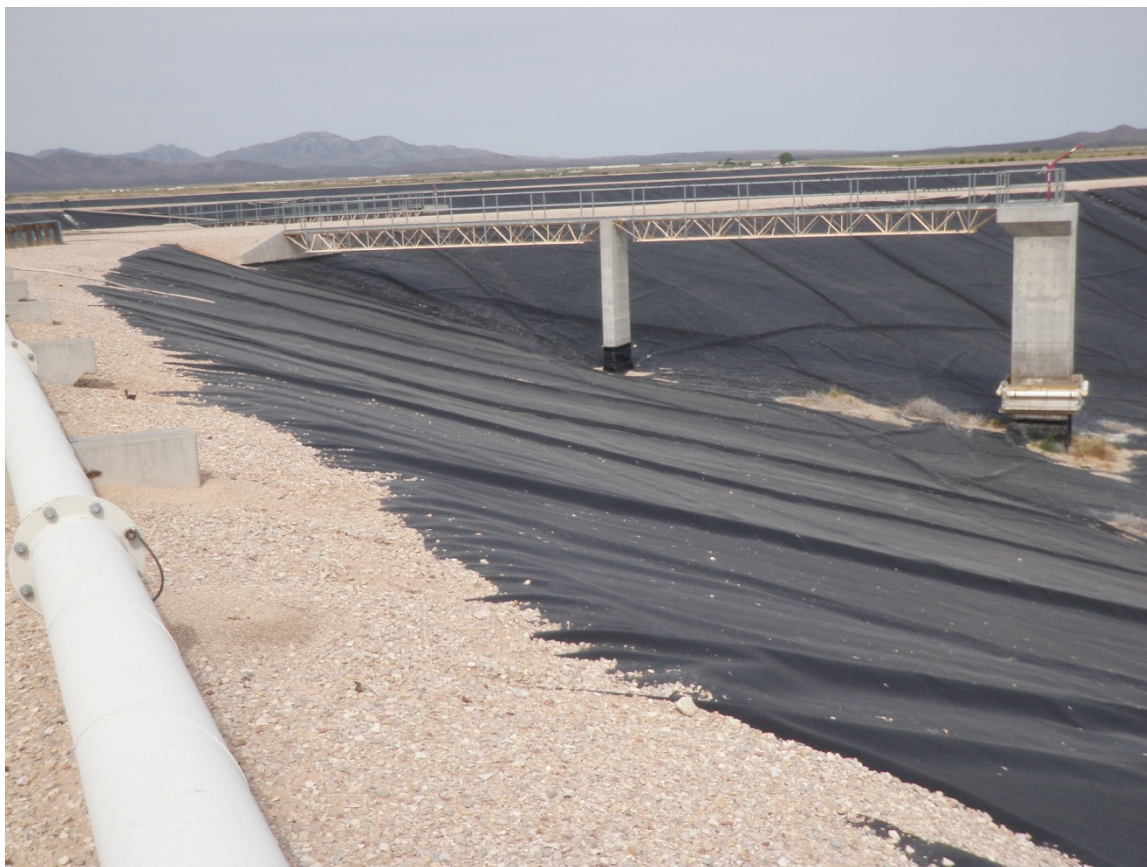
Photo 19: Ash Pond 4 decant drop inlet intake tower and access bridge, looking northwest. Note that Ash Pond 4 is nearly empty.

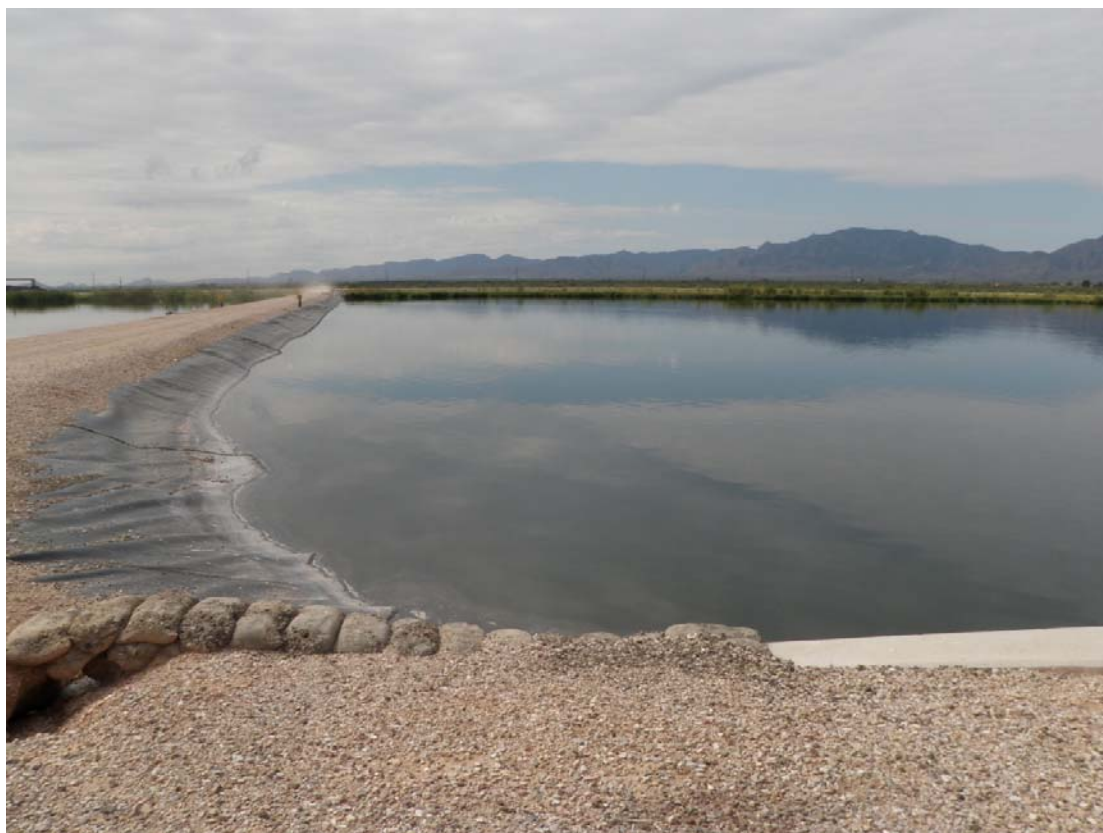
Photo 24: Upstream slope of embankment of Ash Pond 2, looking south. Note erosion of granular crest surface material from behind the wall formed of cement bags.

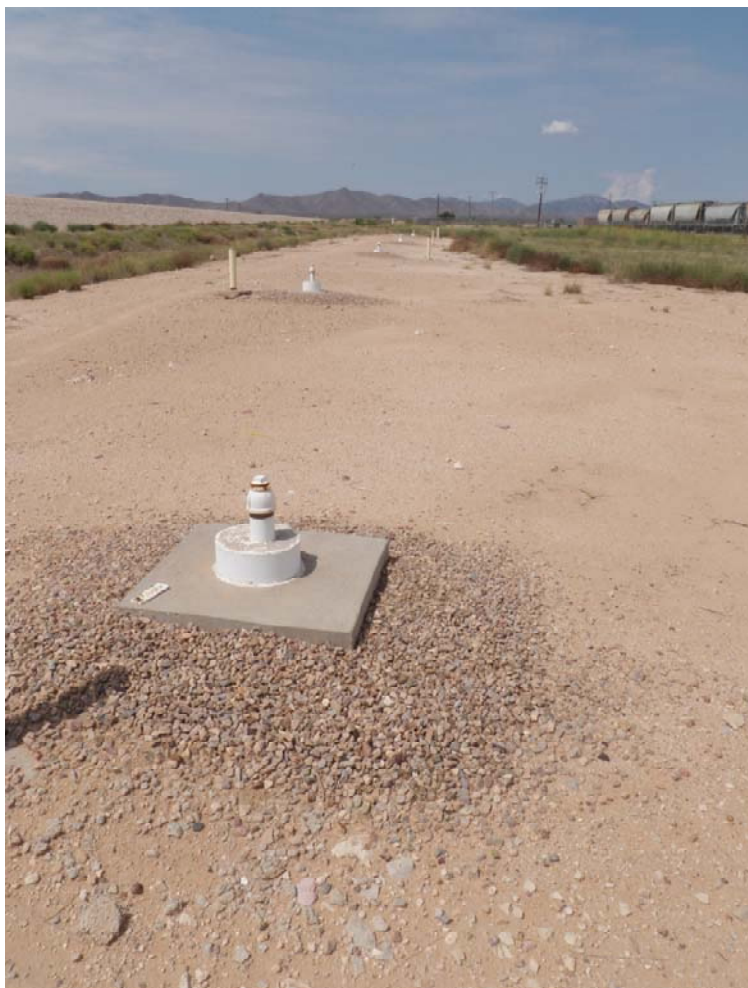
Photo 61: High precision survey monuments located in area where fissures were identified on north side of Scrubber Sludge Pond 2/ Evaporation Pond prior to construction. Note train on tracks located north of the facility.
