**Specific Site Assessment for  
Coal Combustion Waste  
Impoundments at Basin  
Electric Antelope Valley  
Station**

**Beulah, North Dakota**

**GEI Consultants, Inc.**  
4601 DTC Boulevard, Suite 900  
Denver, CO 80237

November 2010  
Project 092884

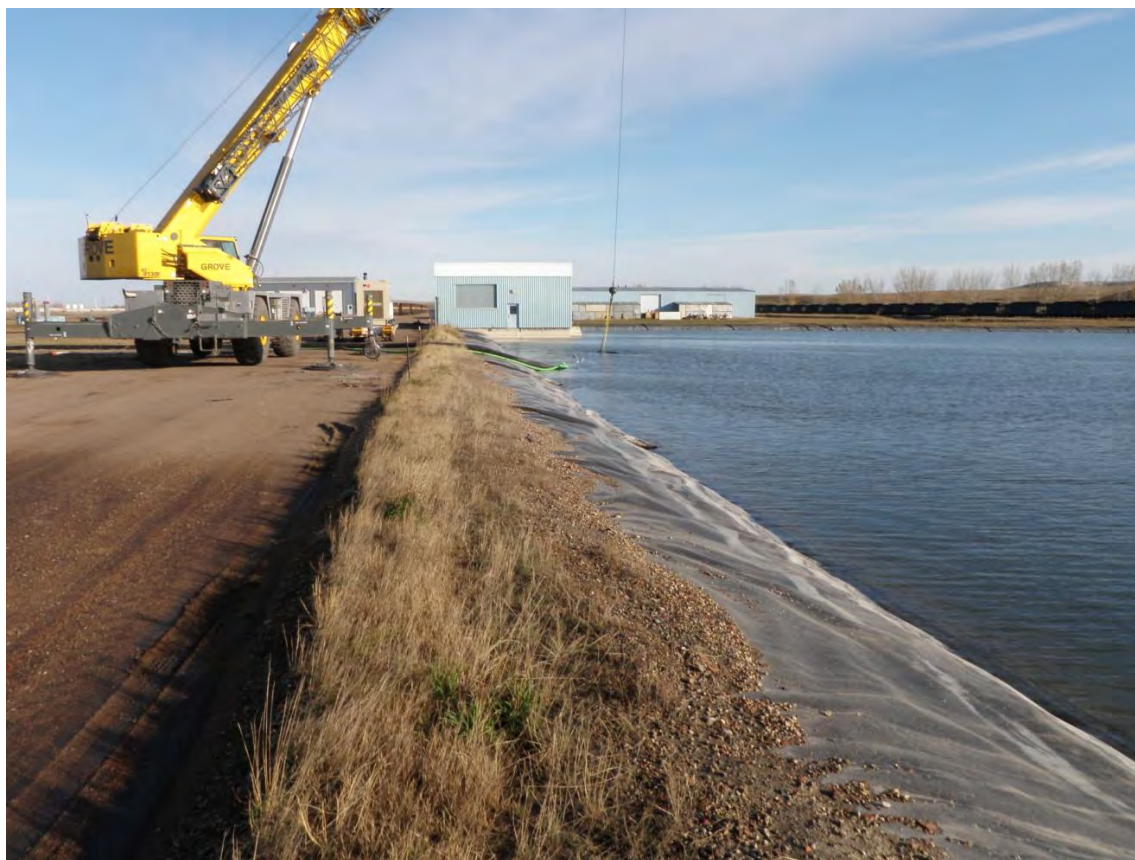
Photo 1: SDA Pond – West dike upstream slope and crest, looking north, note dredging operations

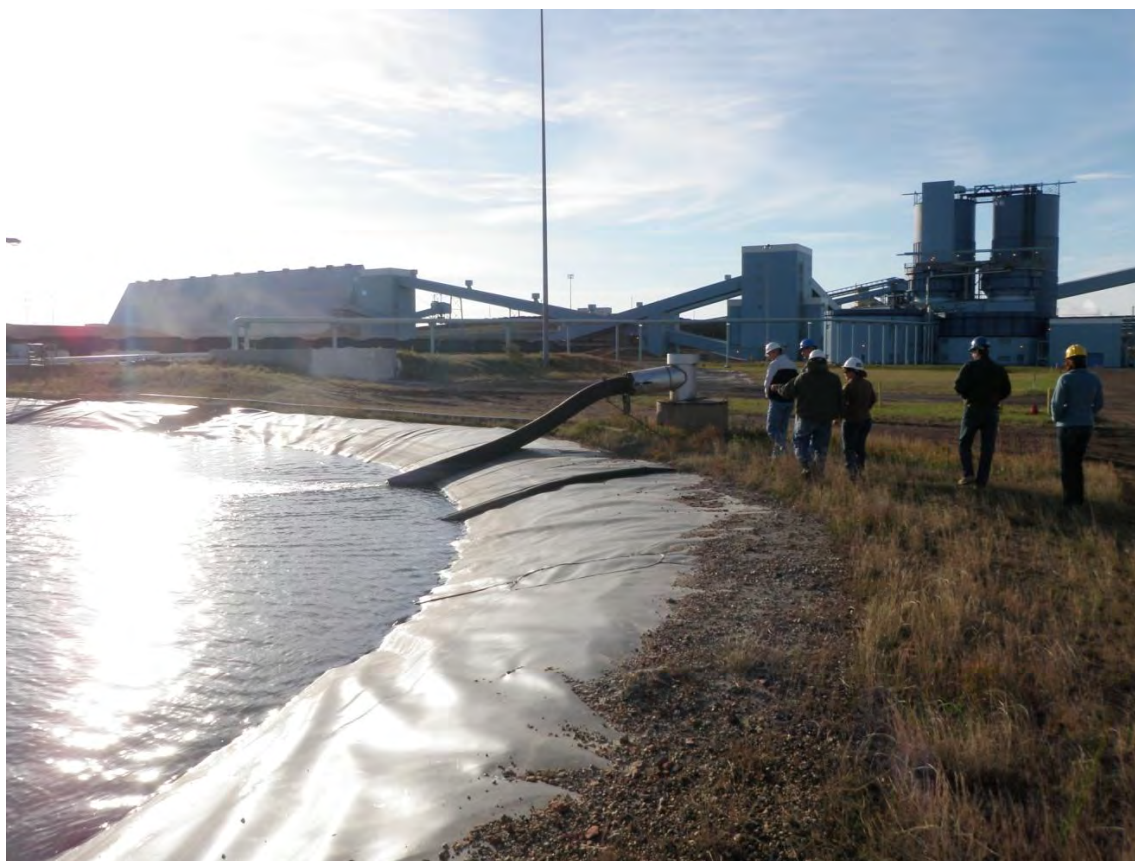
Photo 2: SDA Pond – West dike upstream slope, looking south

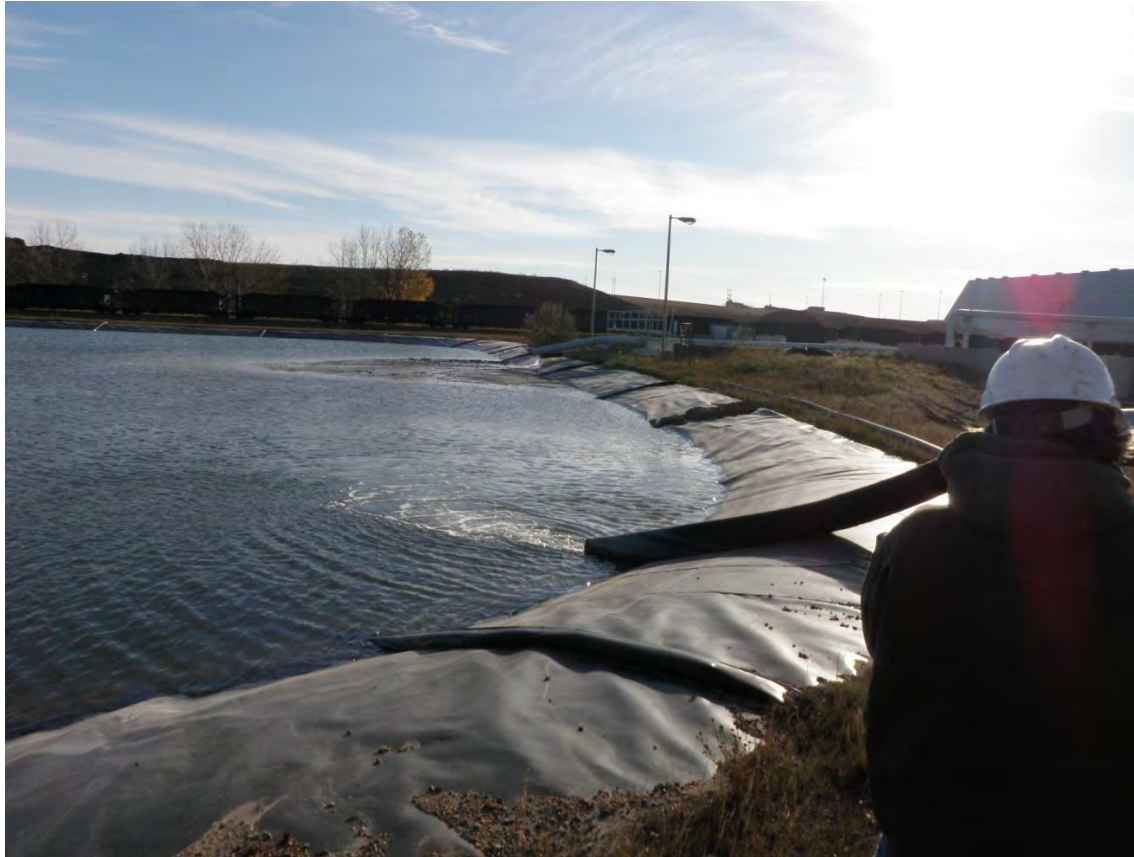
Photo 3: SDA Pond – South dike upstream slope, looking east, note inlet pipes

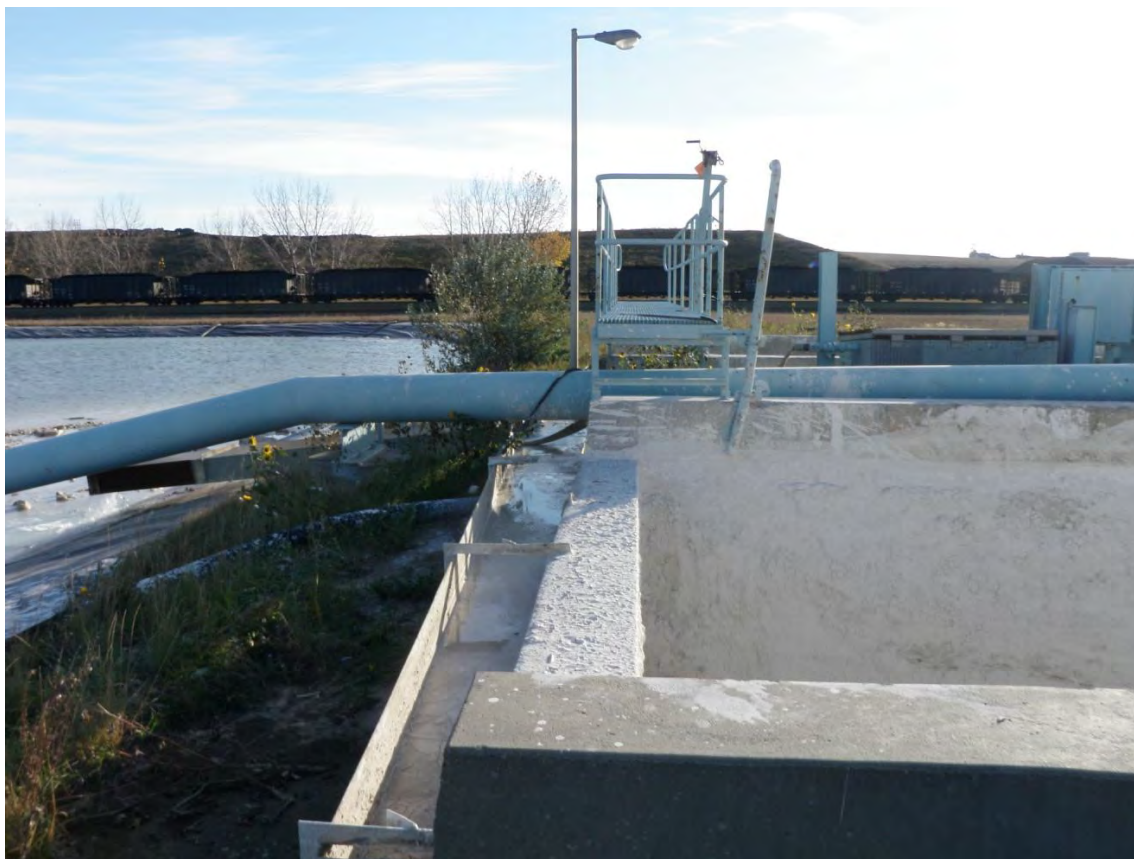
Photo 4: SDA Pond – South dike inlet pipe and west weir, looking east

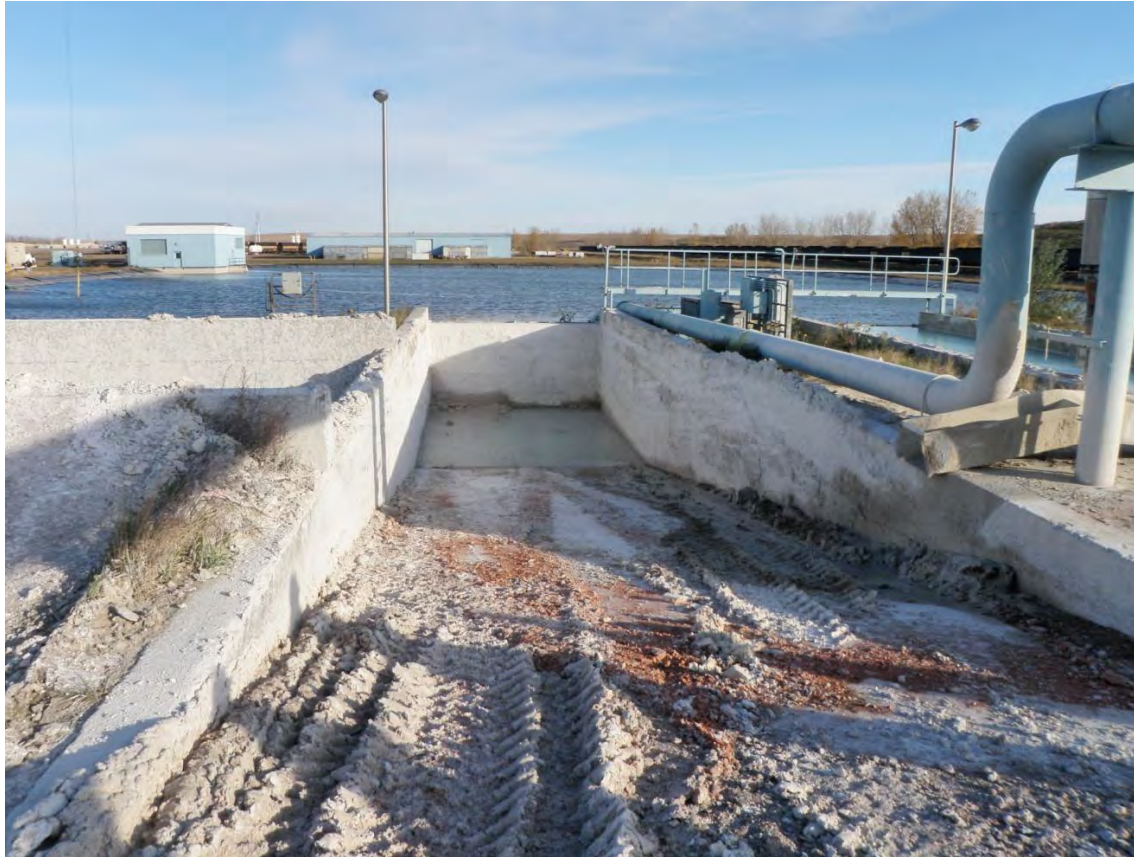
Photo 5: SDA Pond – West weir and inlet pipe, looking north

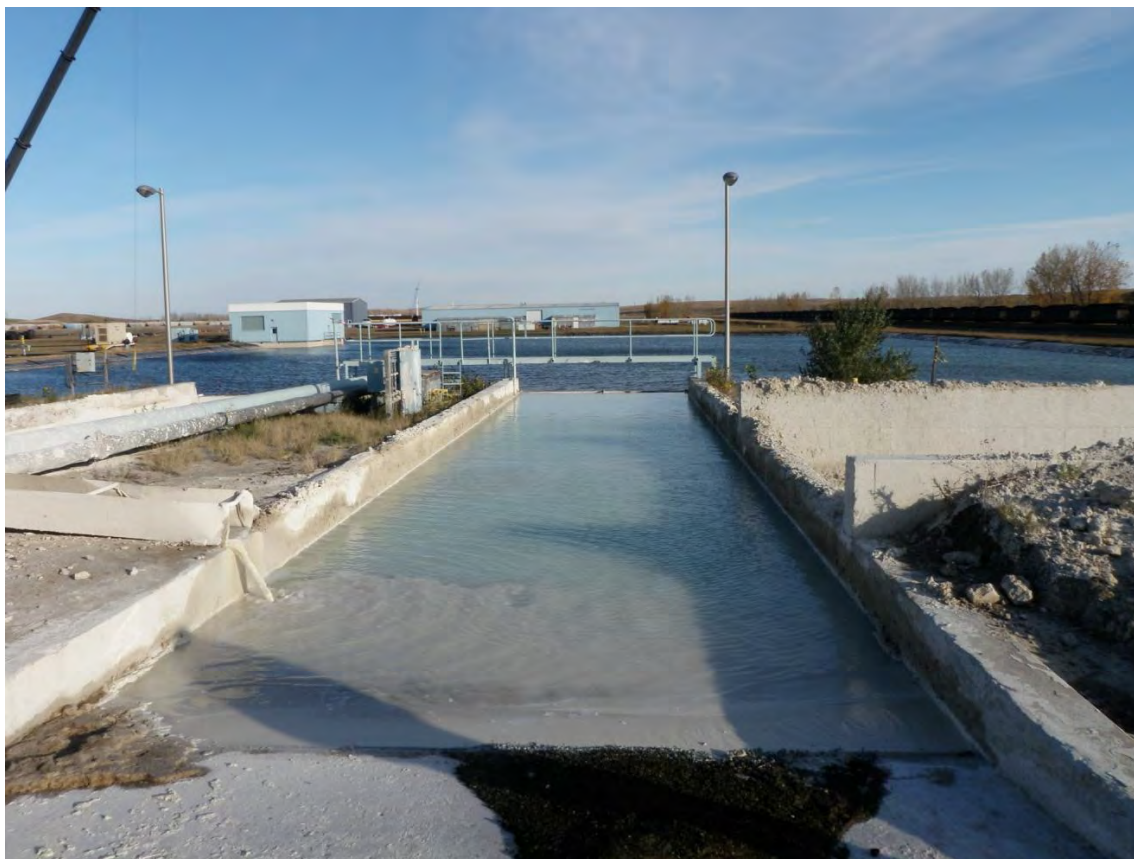
Photo 6: SDA Pond – East weir and inlet pipe, looking north

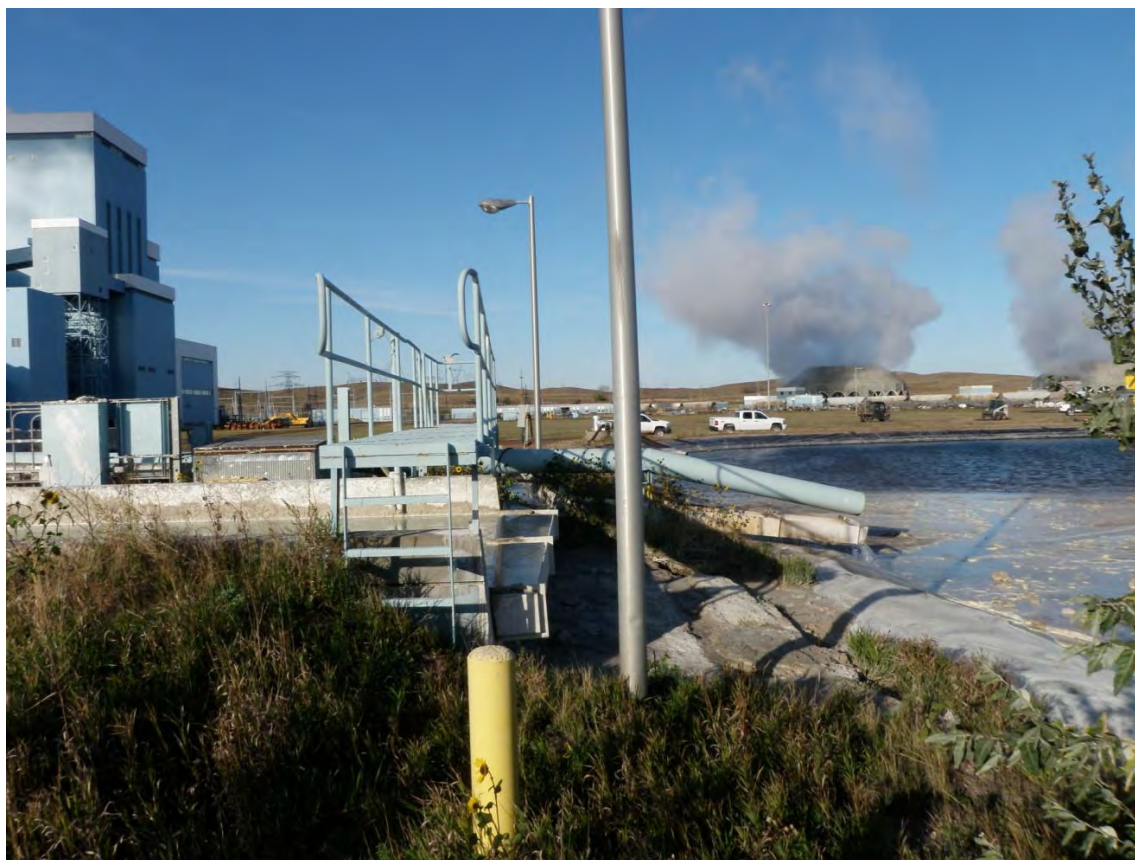
Photo 7: SDA Pond – East weir and inlet pipe, looking west

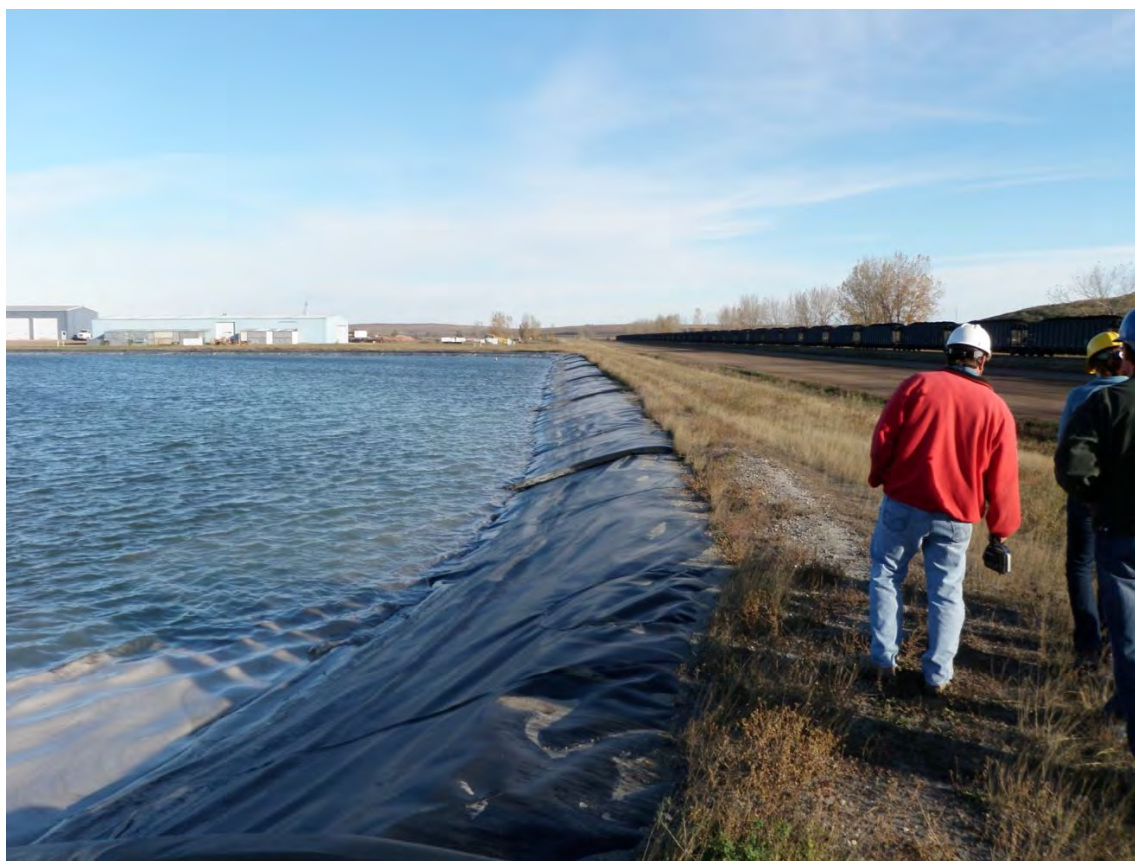
Photo 8: SDA Pond – East dike upstream slope, looking north

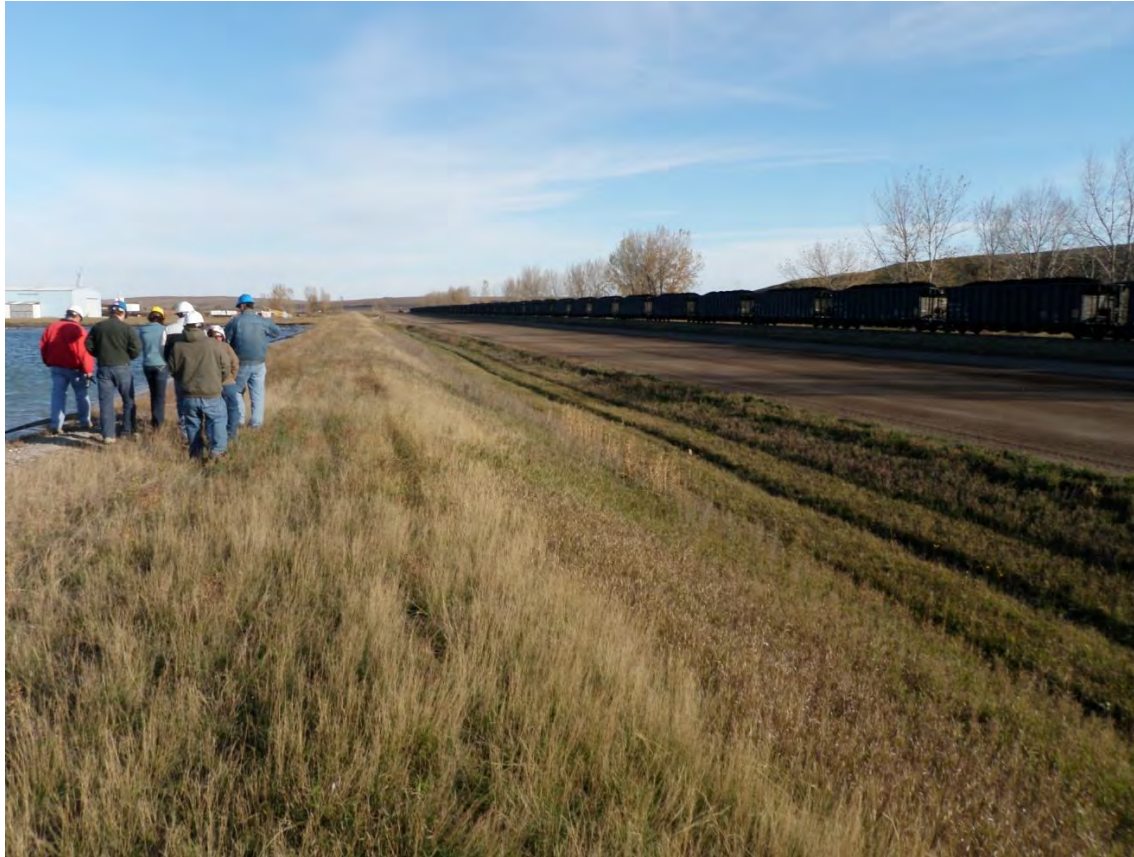
Photo 9: SDA Pond – East dike downstream slope, looking north

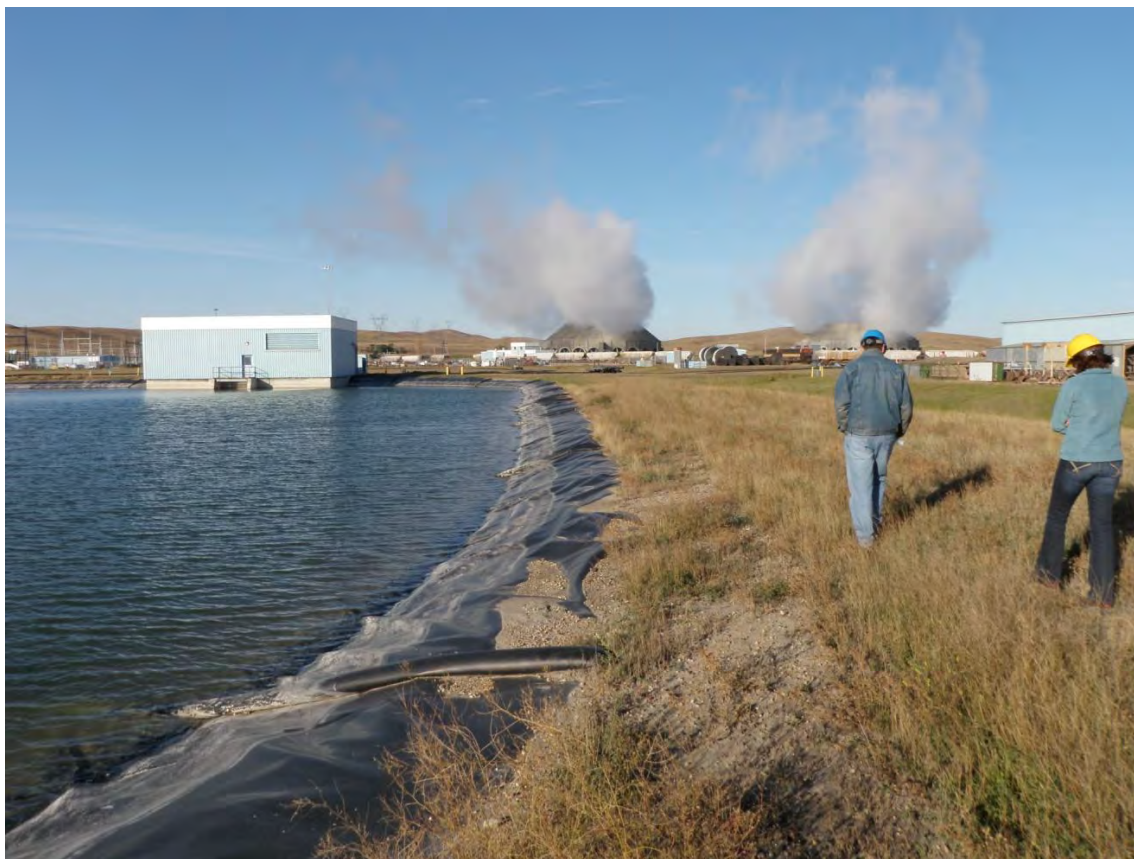
Photo 10: SDA Pond – North dike upstream slope, looking west

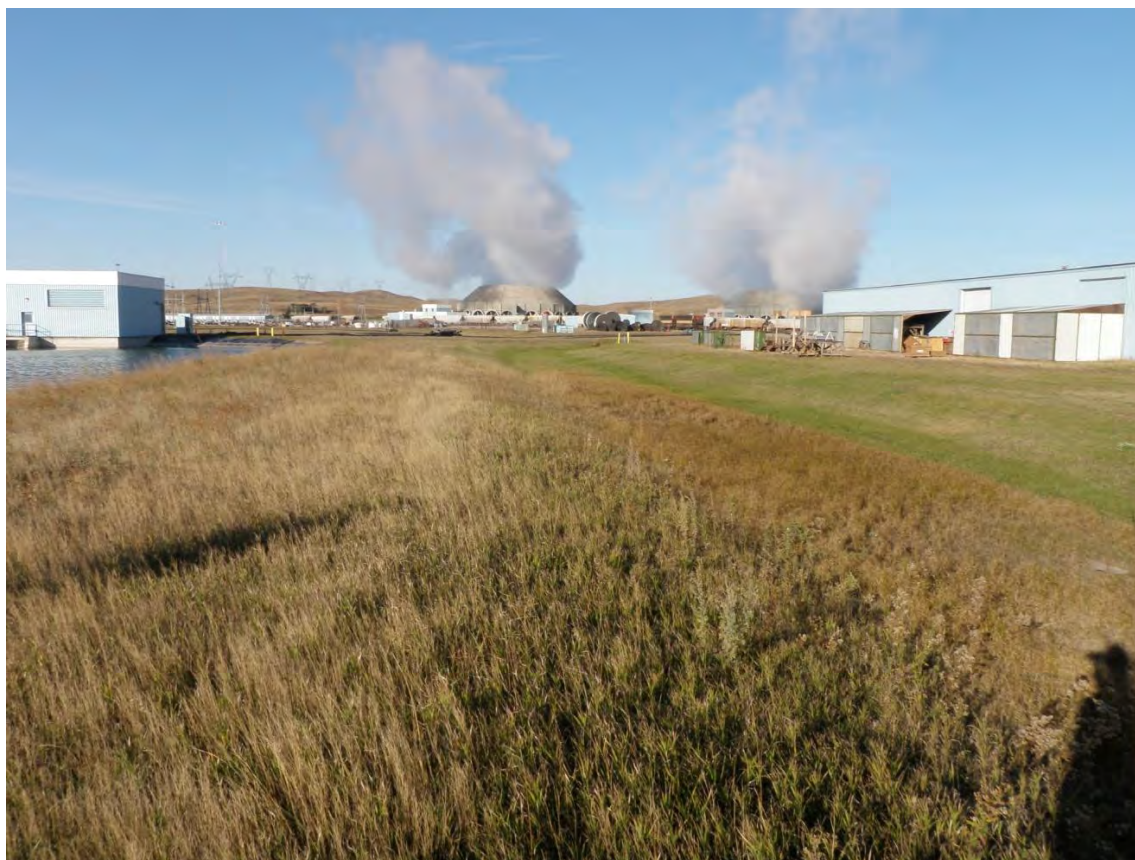
Photo 11: SDA Pond – North dike downstream slope, looking west

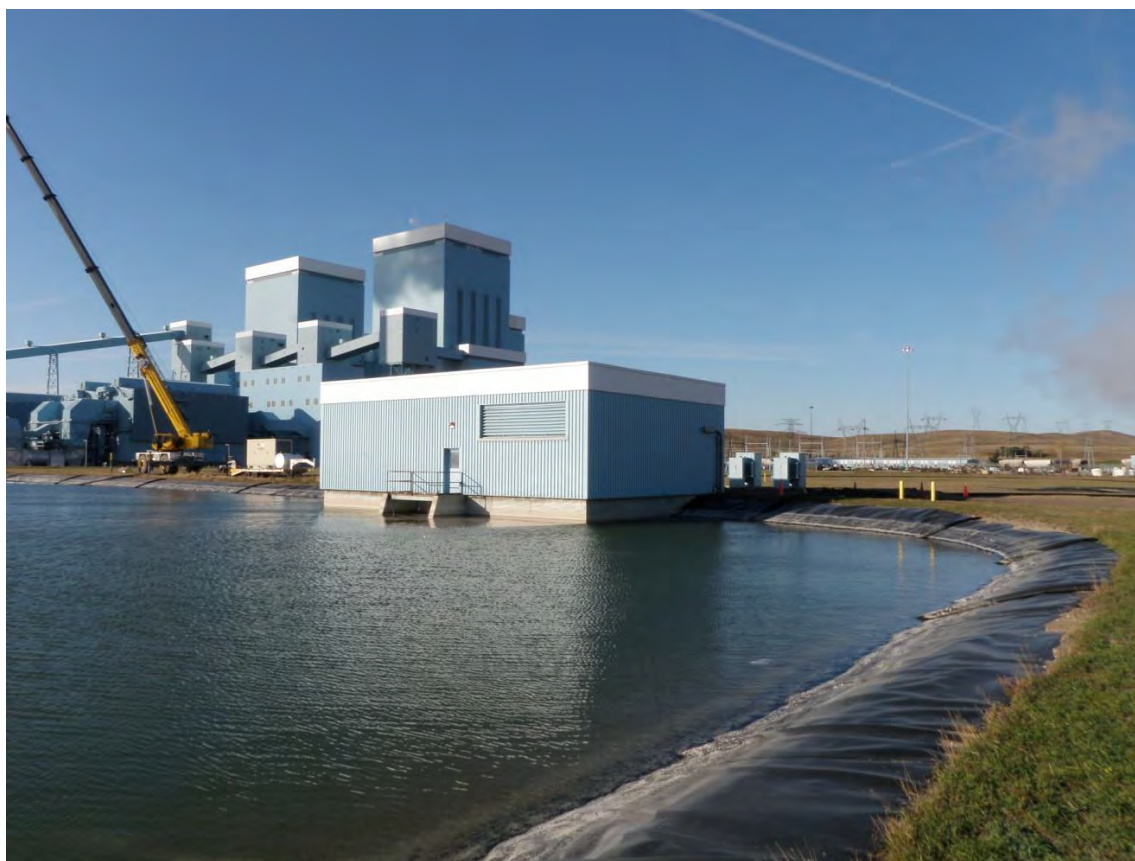
Photo 12: SDA Pond – Pump House, looking southwest

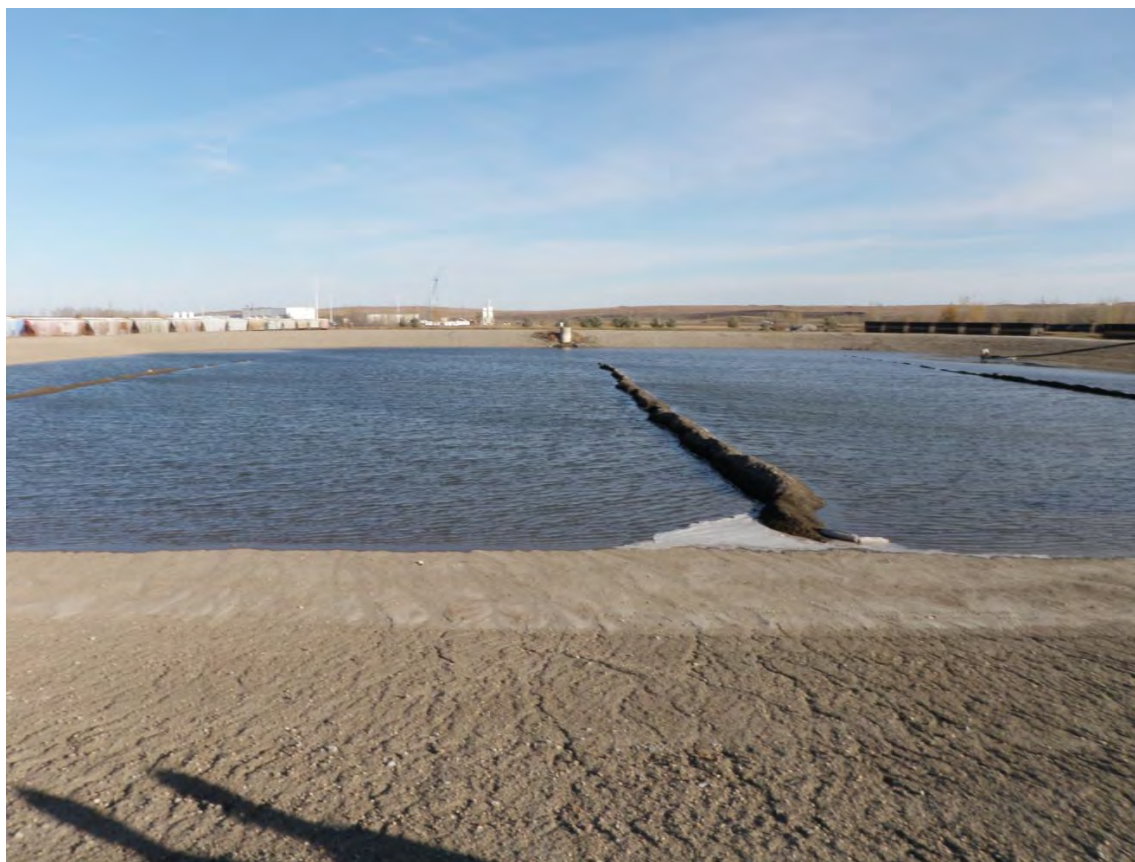
Photo 13: SDA Decantation Pond – Looking north across pond

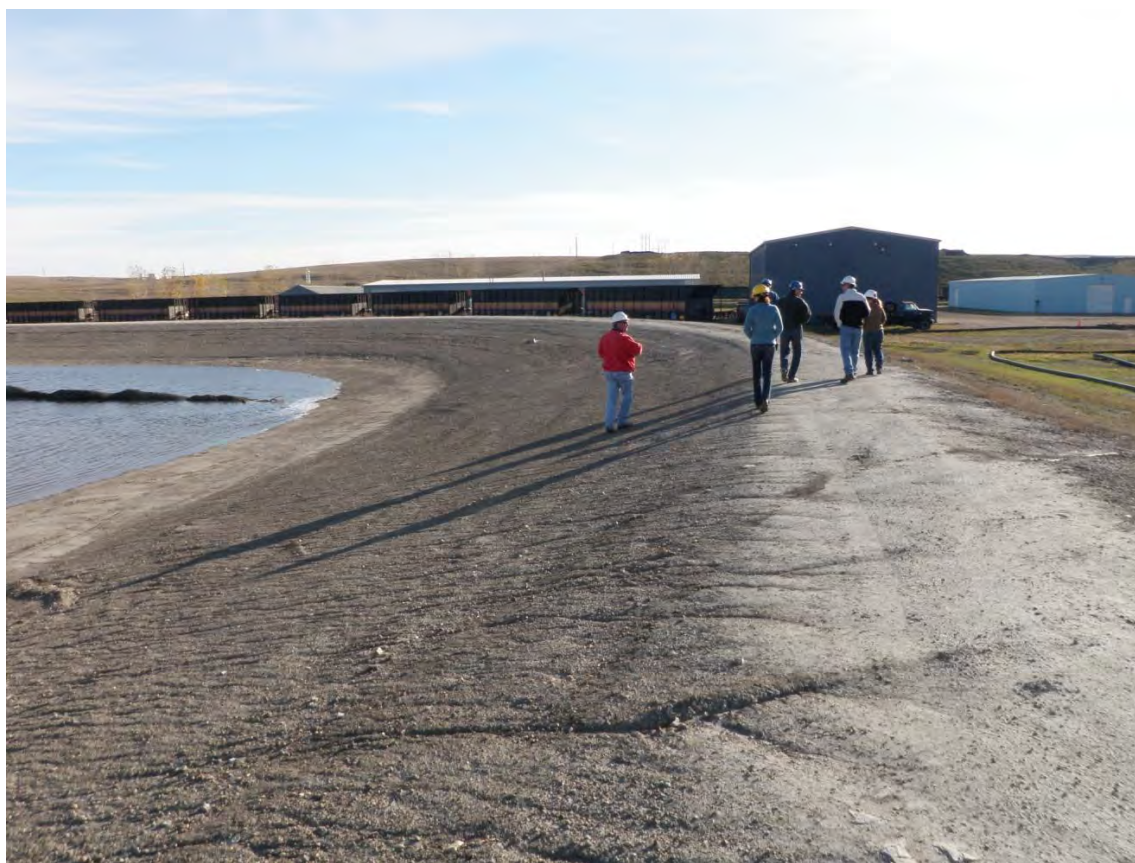
Photo 14: SDA Decantation Pond – South dike upstream slope, looking east

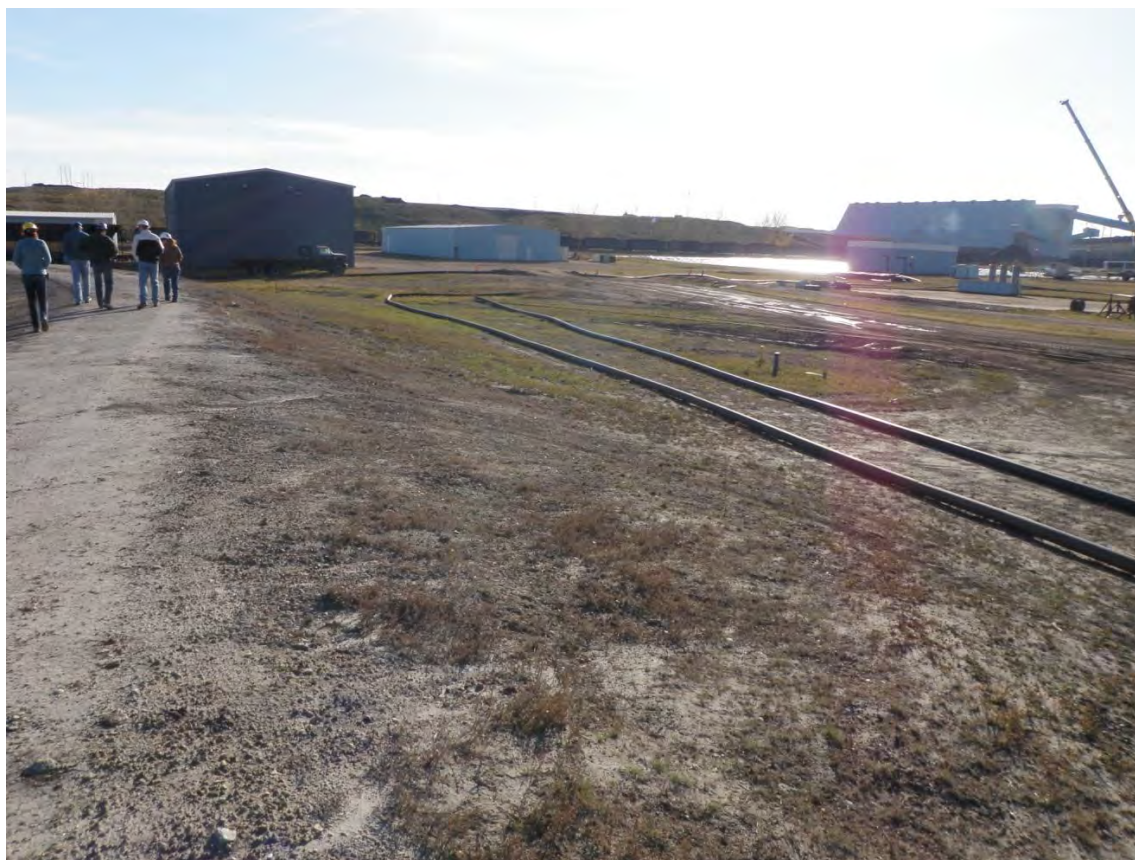
erosion. The downstream slopes of the SDA Decantation Pond were generally exposed earth with a few patches of native grassy vegetation. Minor erosion of the downstream slope of the SDA Decantation Pond was observed, most likely due to surface runoff.

Photo 15: SDA Decantation Pond – South dike downstream slope, looking east

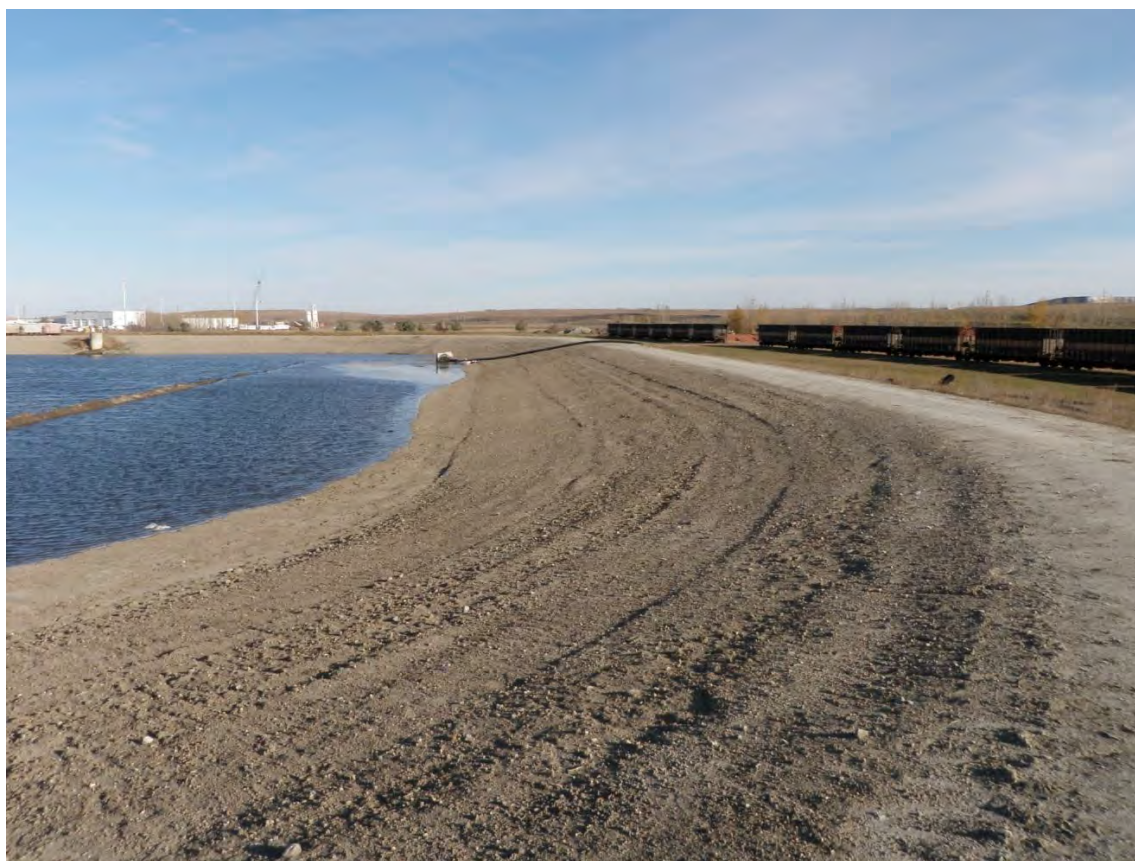
Photo 16: SDA Decantation Pond – East dike upstream slope, looking north

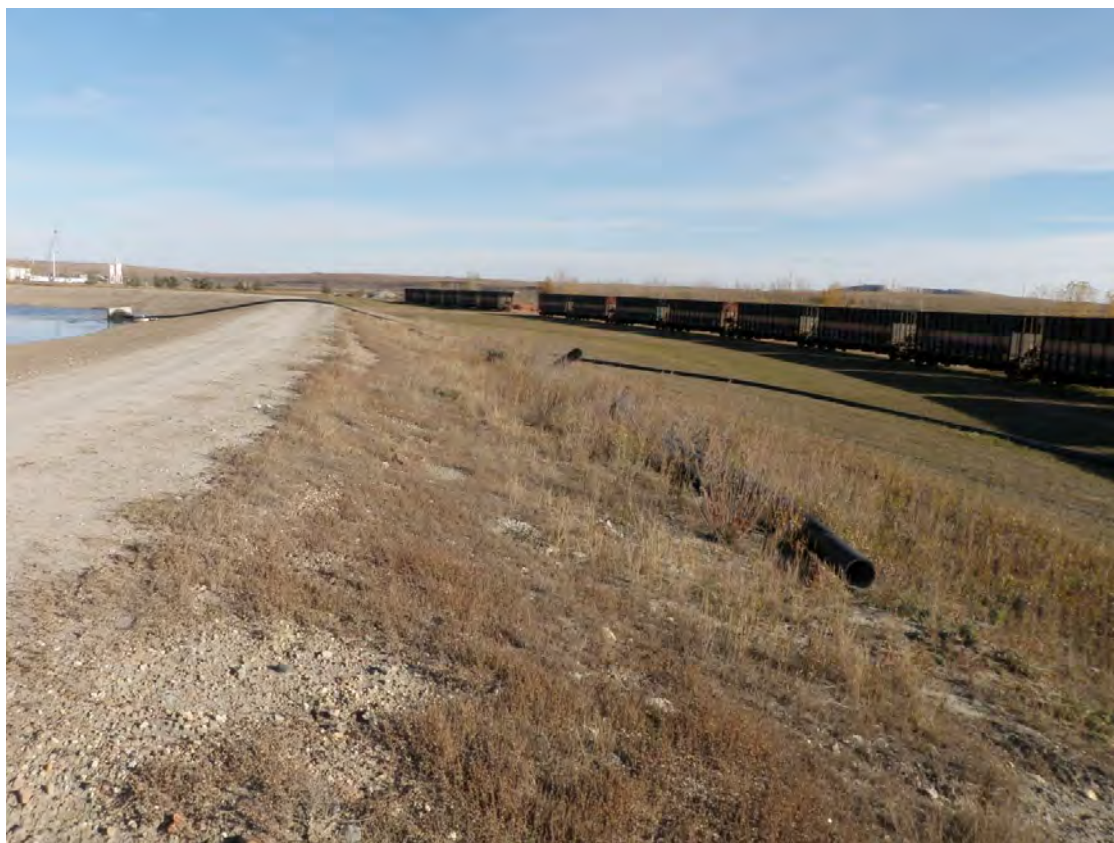
**Photo 17: SDA Decantation Pond – East dike downstream slope, looking north, note inlet pipe over dam crest**

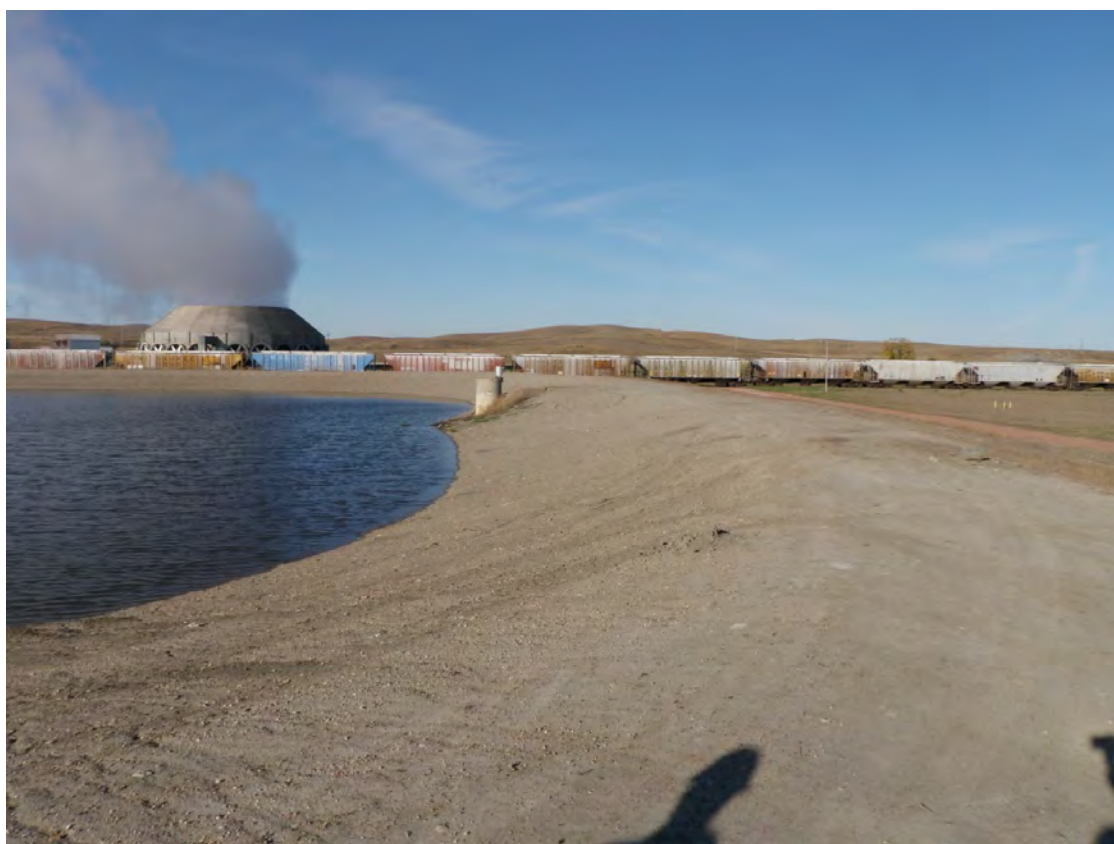
**Photo 18: SDA Decantation Pond – North dike upstream slope, looking west, note leachate manhole**

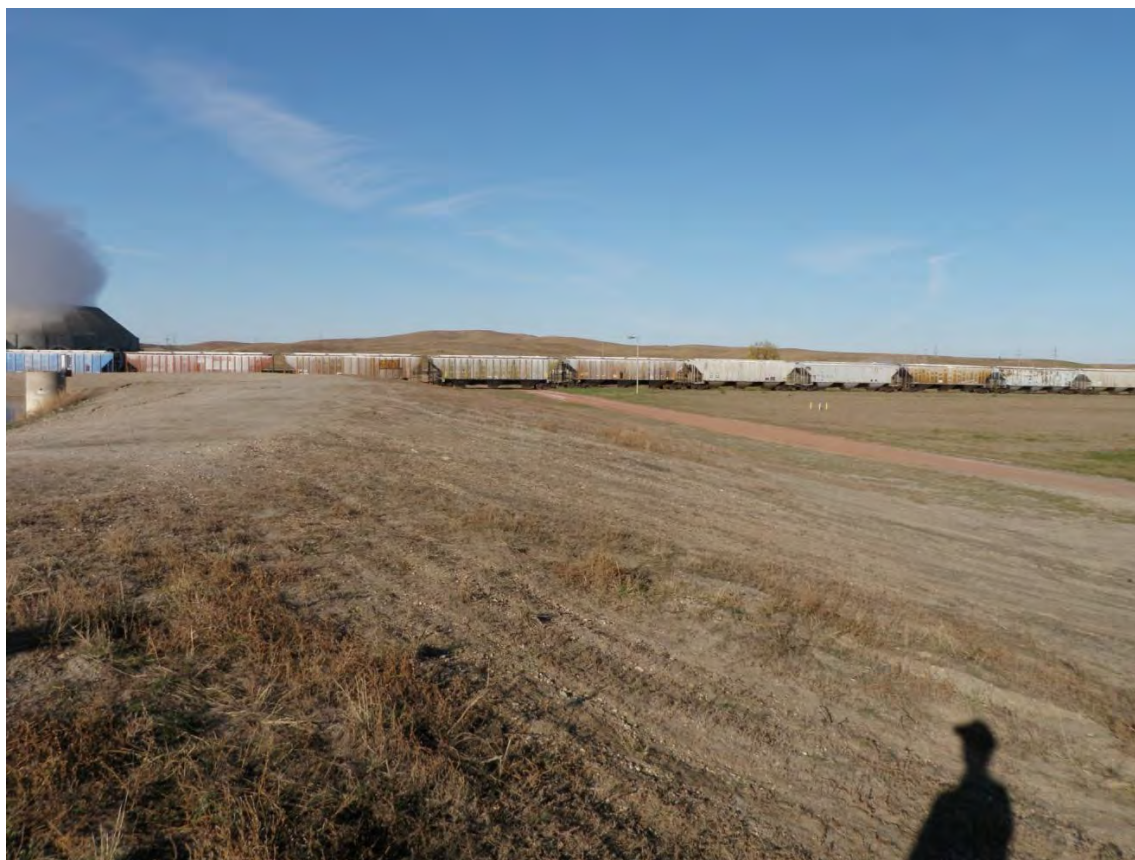
Photo 19: SDA Decantation Pond – North dike downstream slope, looking east

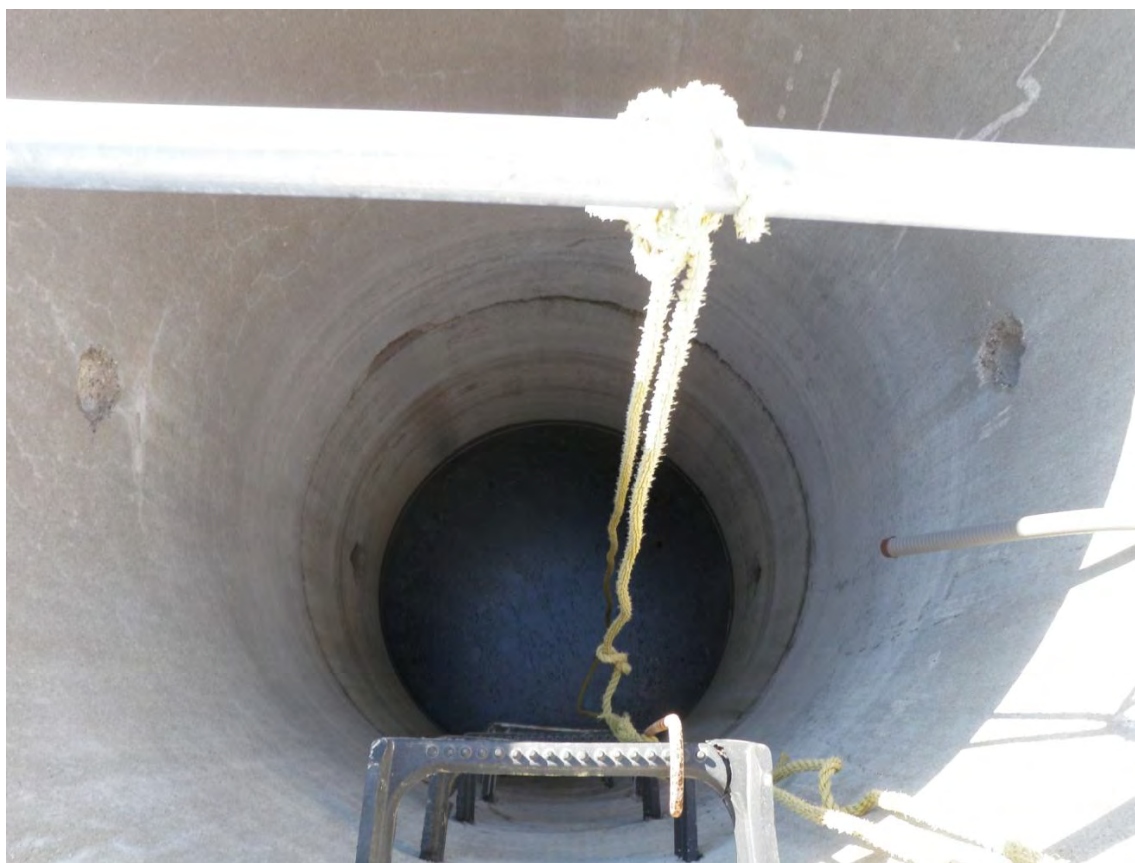
Photo 20: SDA Decantation Pond – Leachate Manhole

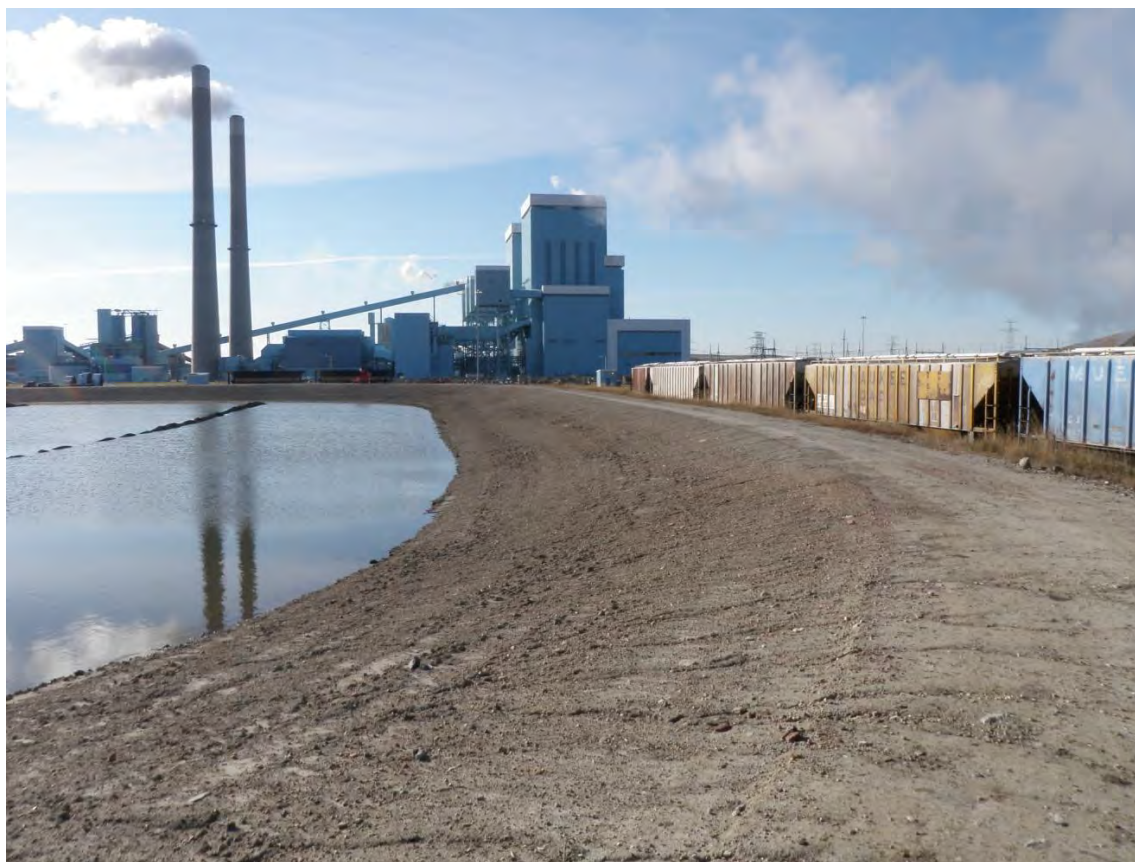
Photo 21: SDA Decantation Pond – West dike upstream slope, looking south

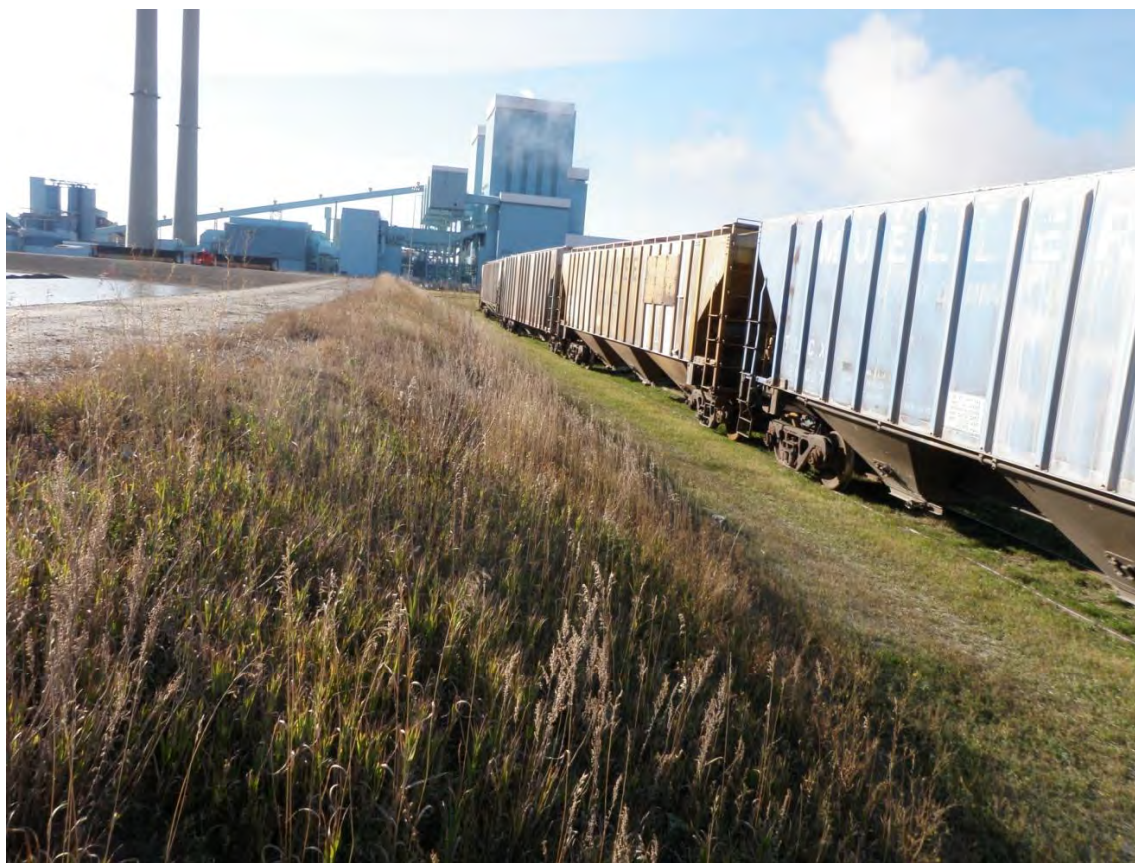
Photo 22: SDA Decantation Pond – West dike downstream slope, looking south

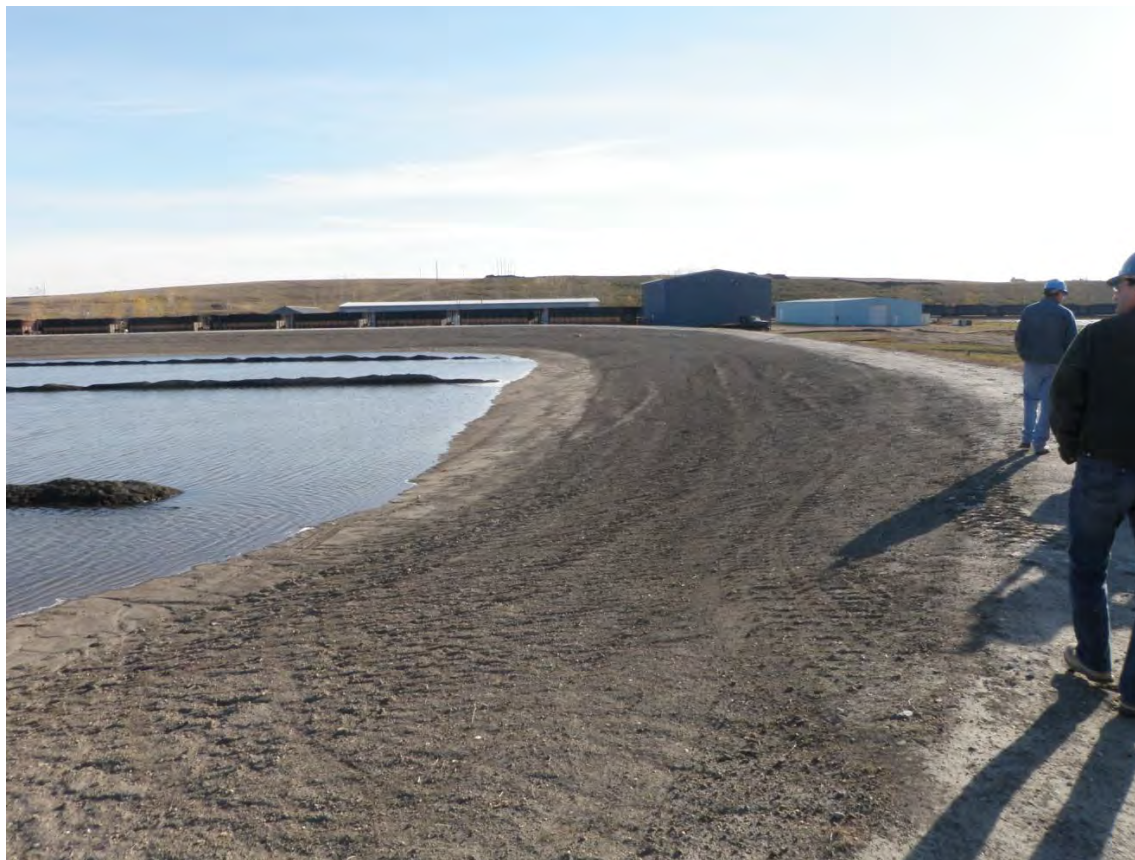
Photo 23: SDA Decantation Pond – South dike upstream slope, looking east
