**Specific Site Assessment for  
Coal Combustion Waste  
Impoundments at Basin  
Electric Antelope Valley  
Station**

**Beulah, North Dakota**

**GEI Consultants, Inc.**  
4601 DTC Boulevard, Suite 900  
Denver, CO 80237

November 2010  
Project 092884

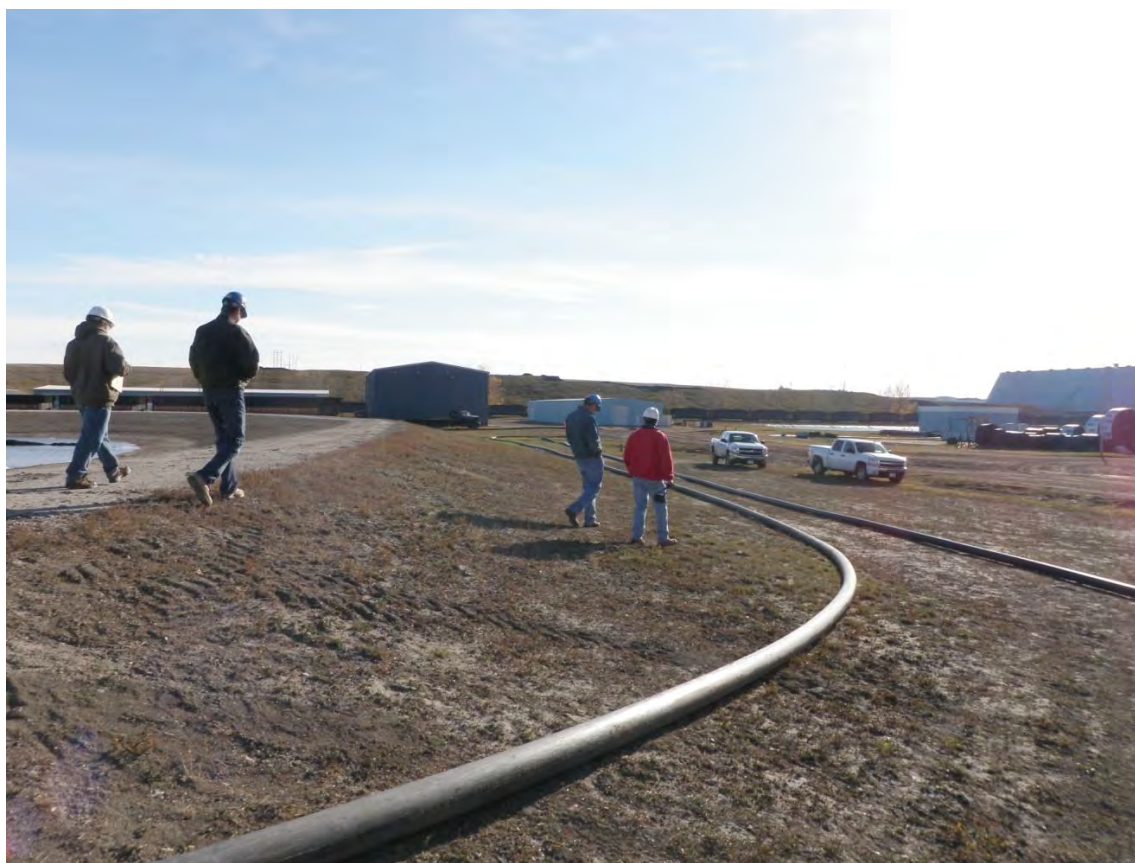
Photo 24: SDA Decantation Pond – South dike downstream slope, looking east
