## **Specific Site Assessment for Coal Combustion Waste Impoundments at Basin Electric Antelope Valley Station**

**Beulah, North Dakota**

March 2011  
Project 092884

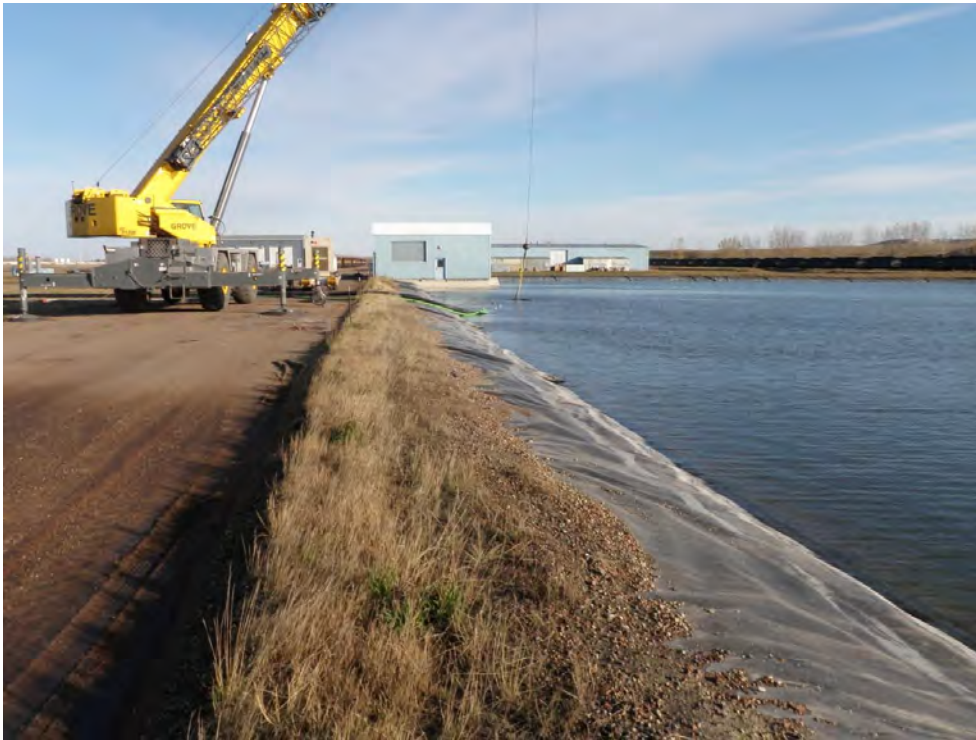
**Photo 1: SDA Pond – West dike upstream slope and crest, looking north, note dredging operations.**

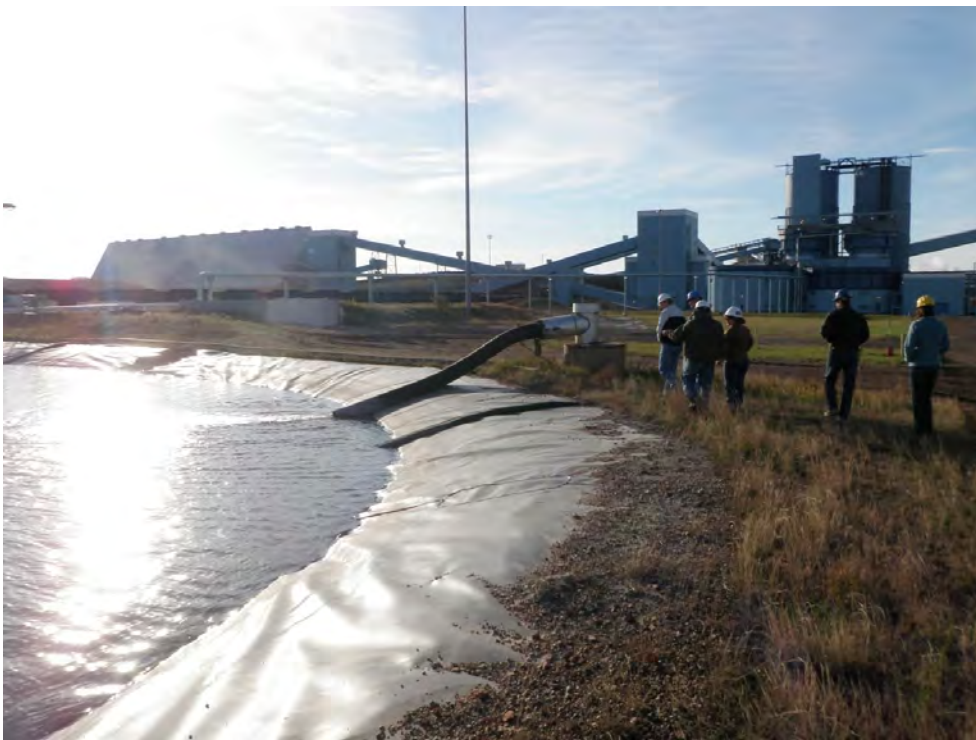
**Photo 2: SDA Pond – West dike upstream slope, looking south.**

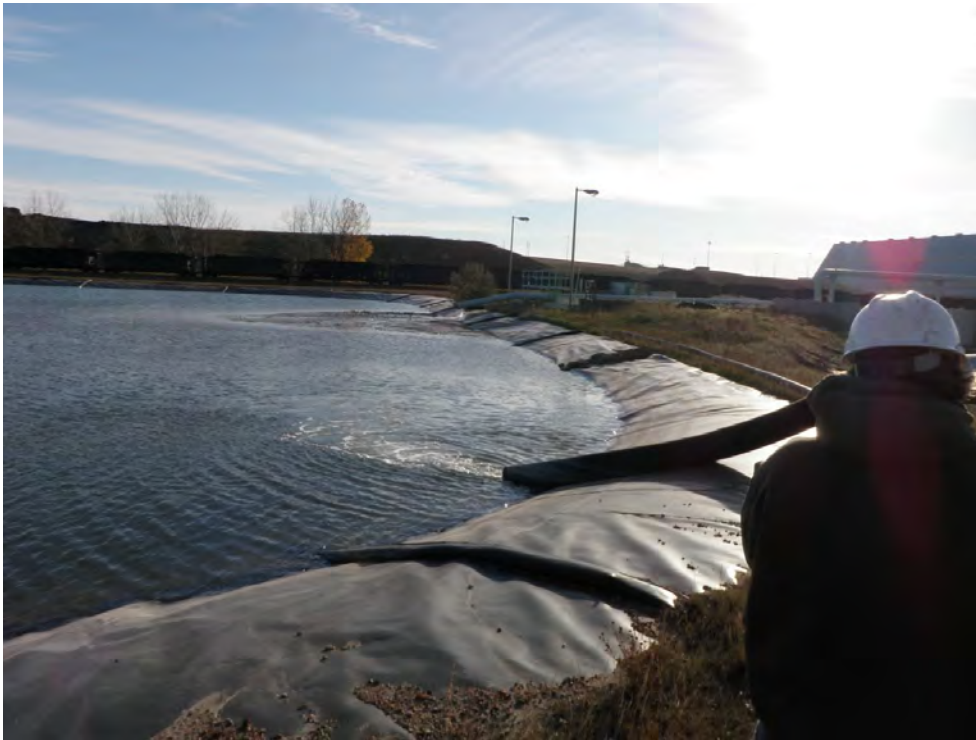
**Photo 3: SDA Pond – South dike upstream slope, looking east, note inlet pipes.**

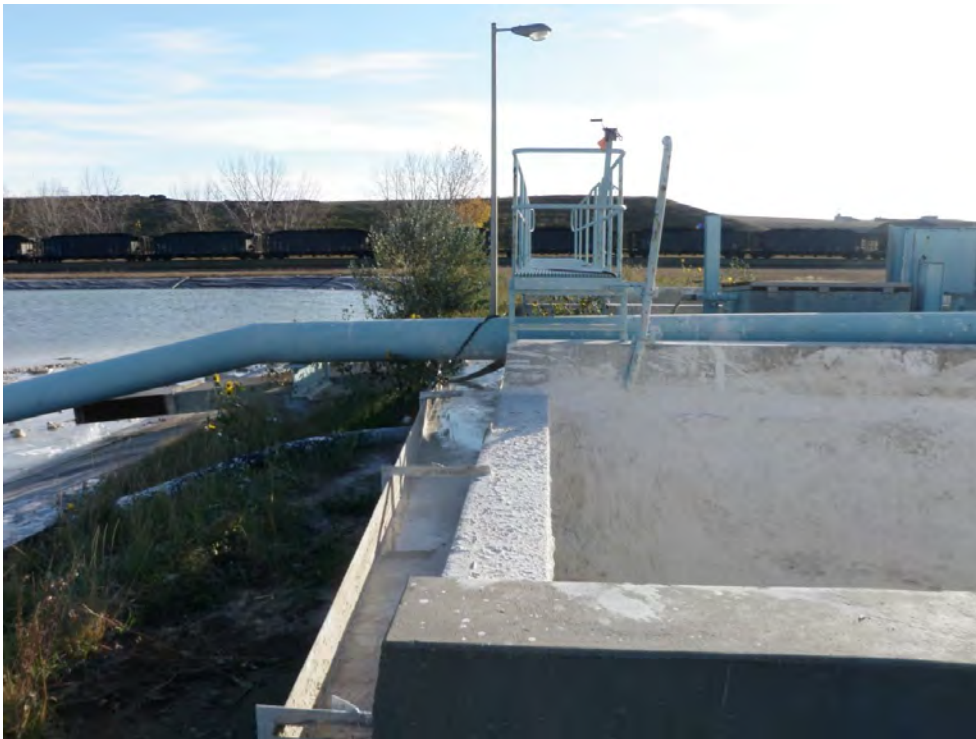
**Photo 4: SDA Pond – South dike inlet pipe and west weir, looking east.**

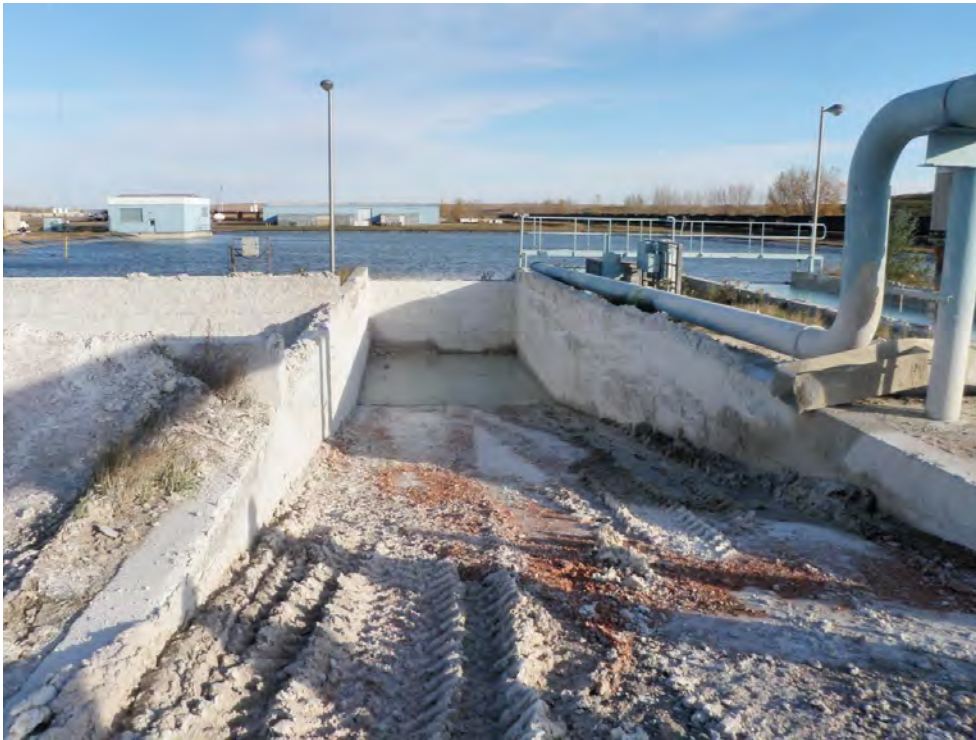
**Photo 5: SDA Pond – West weir and inlet pipe, looking north.**

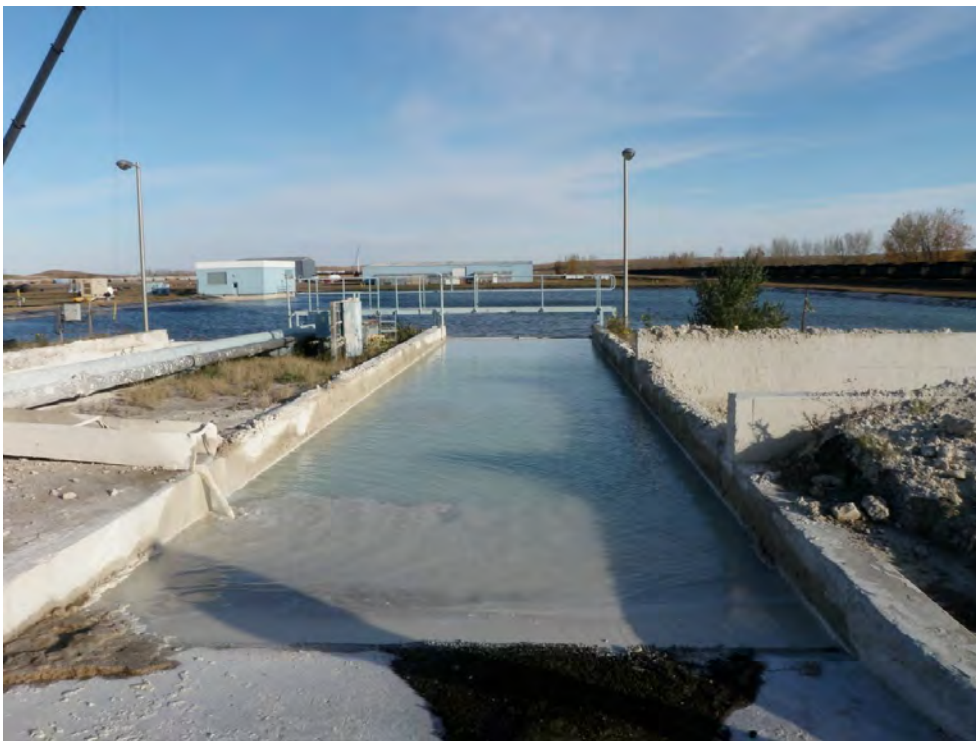
**Photo 6: SDA Pond – East weir and inlet pipe, looking north.**

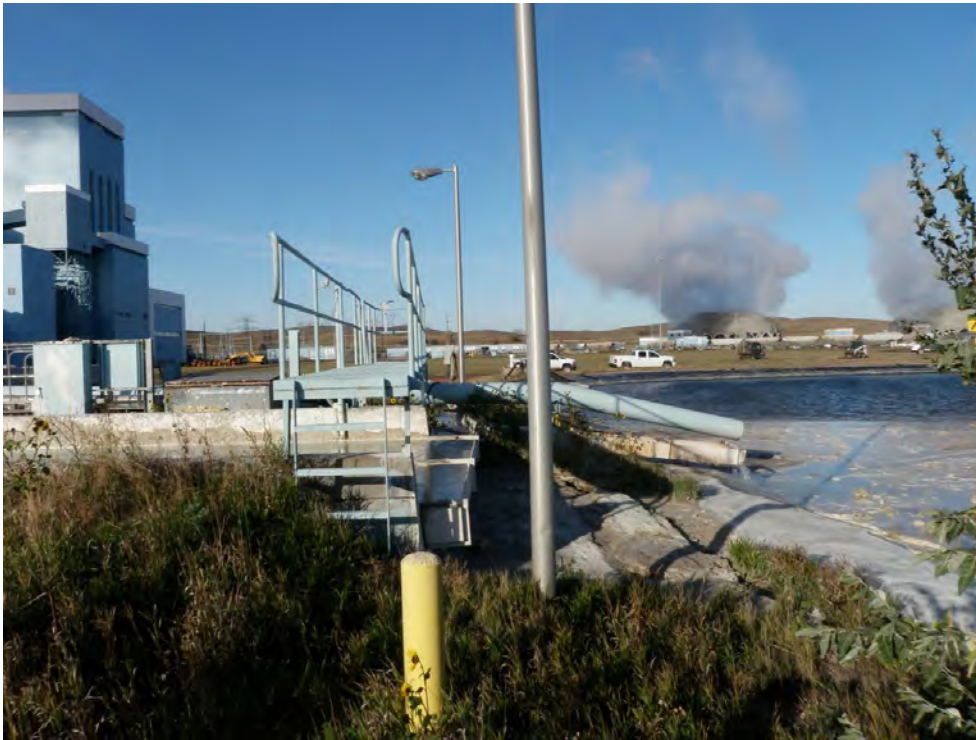
Photo 7: SDA Pond – East weir and inlet pipe, looking west.

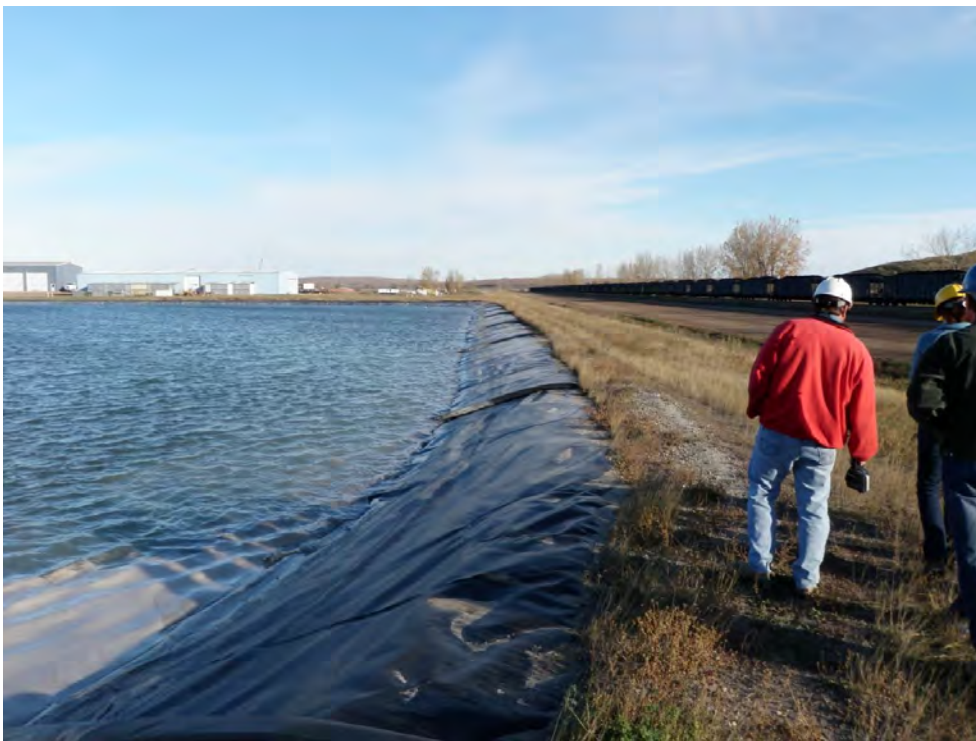
Photo 8: SDA Pond – East dike upstream slope, looking north.

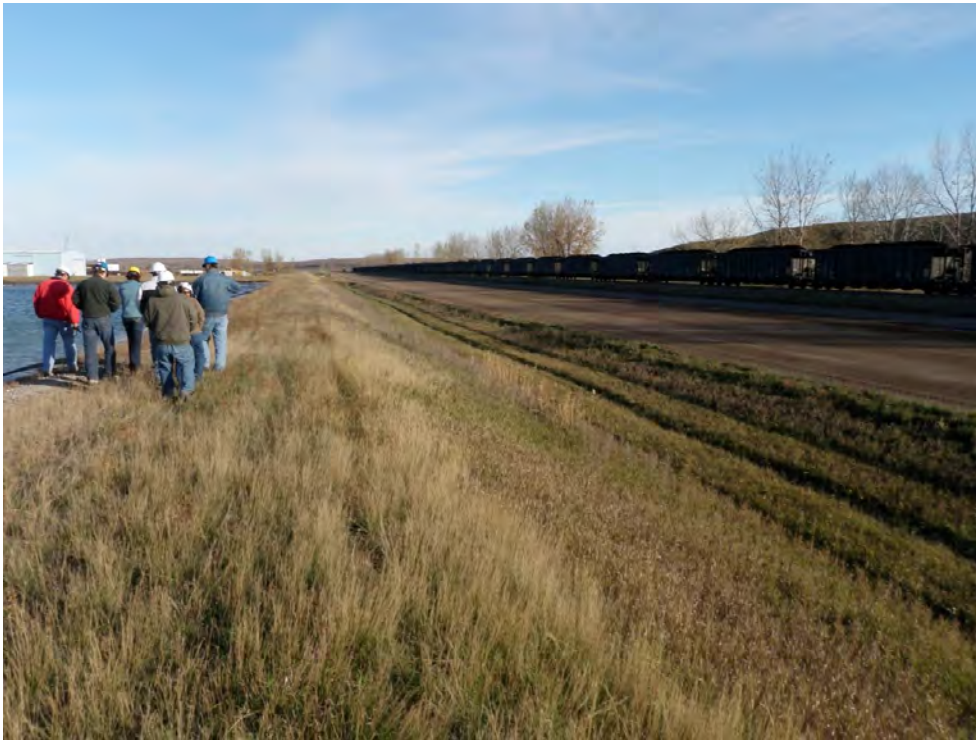
**Photo 9: SDA Pond – East dike downstream slope, looking north.**

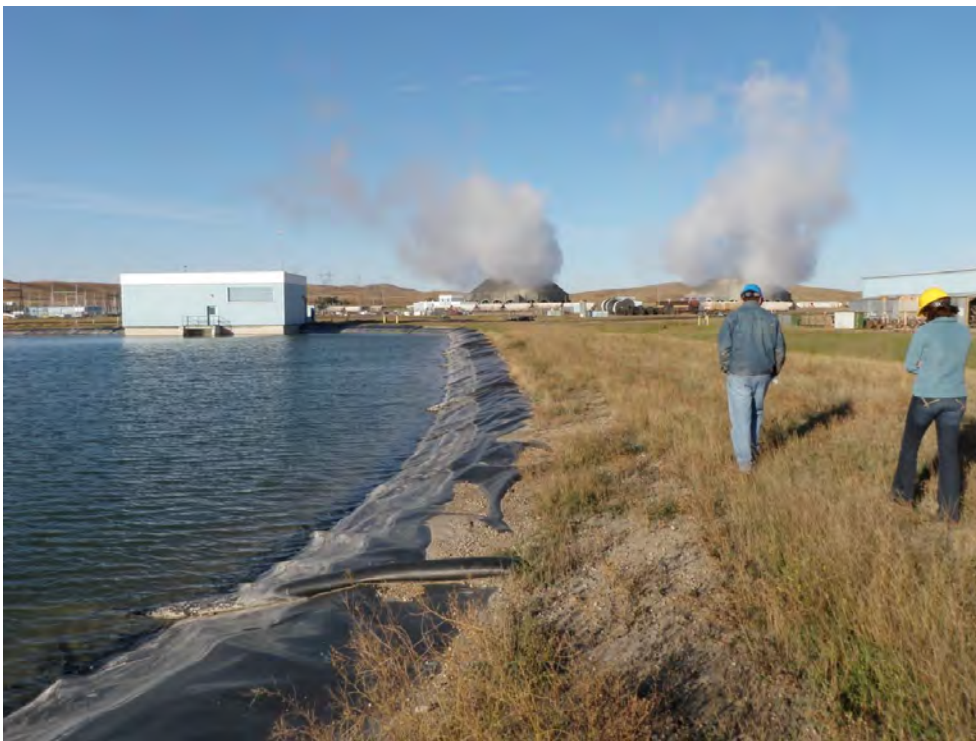
**Photo 10: SDA Pond – North dike upstream slope, looking west.**

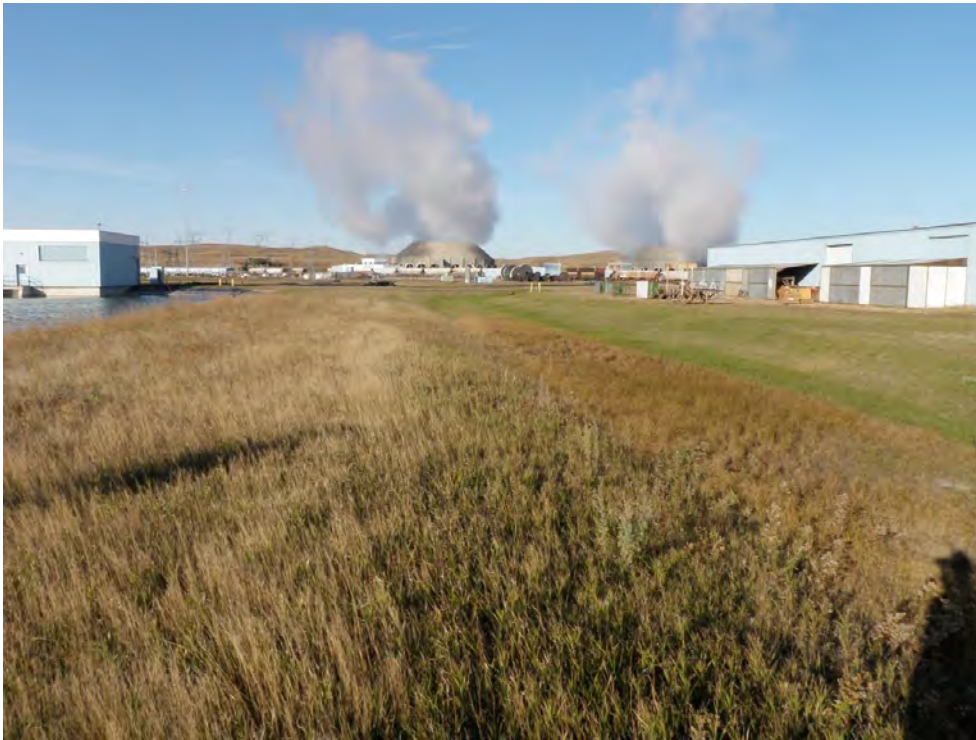
Photo 11: SDA Pond – North dike downstream slope, looking west.

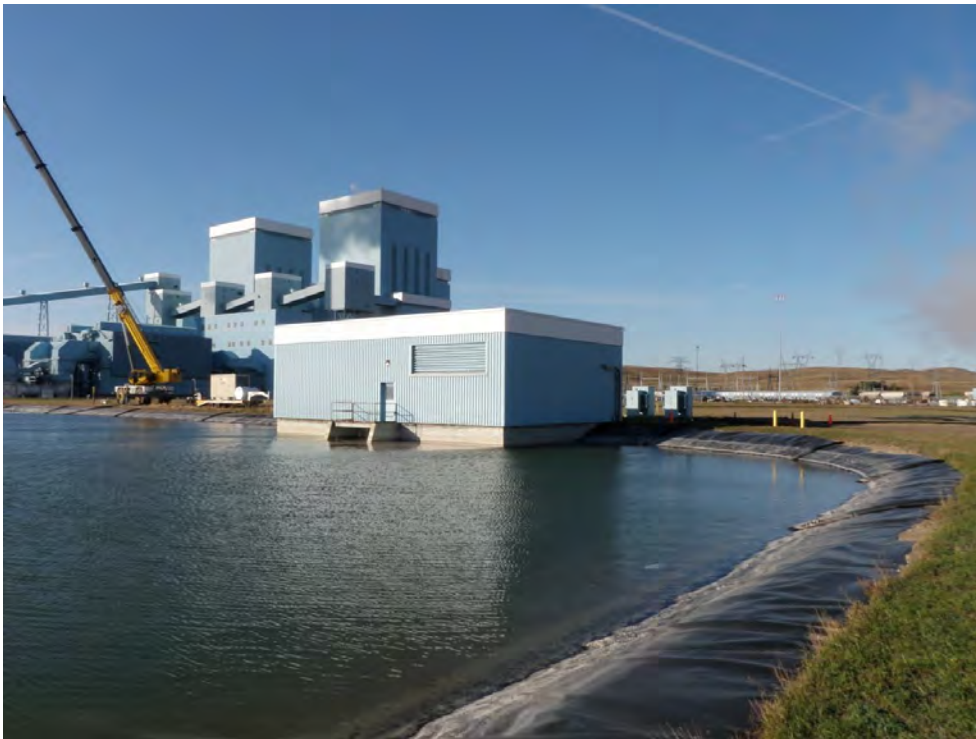
Photo 12: SDA Pond – Pump House, looking southwest.

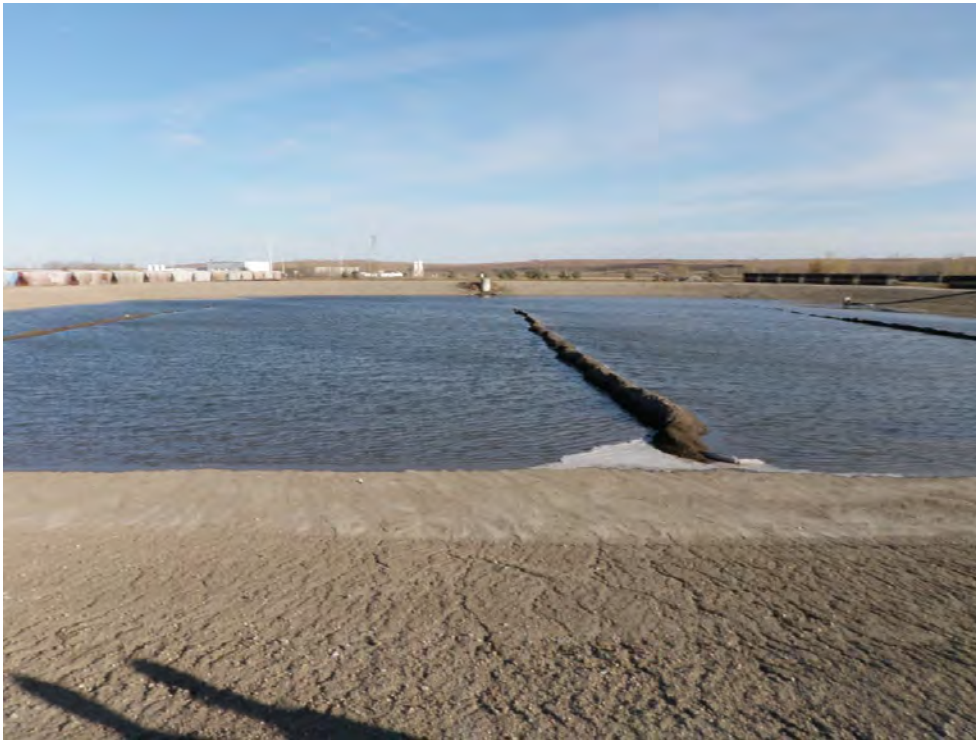
**Photo 13: SDA Decantation Pond – Looking north across pond.**

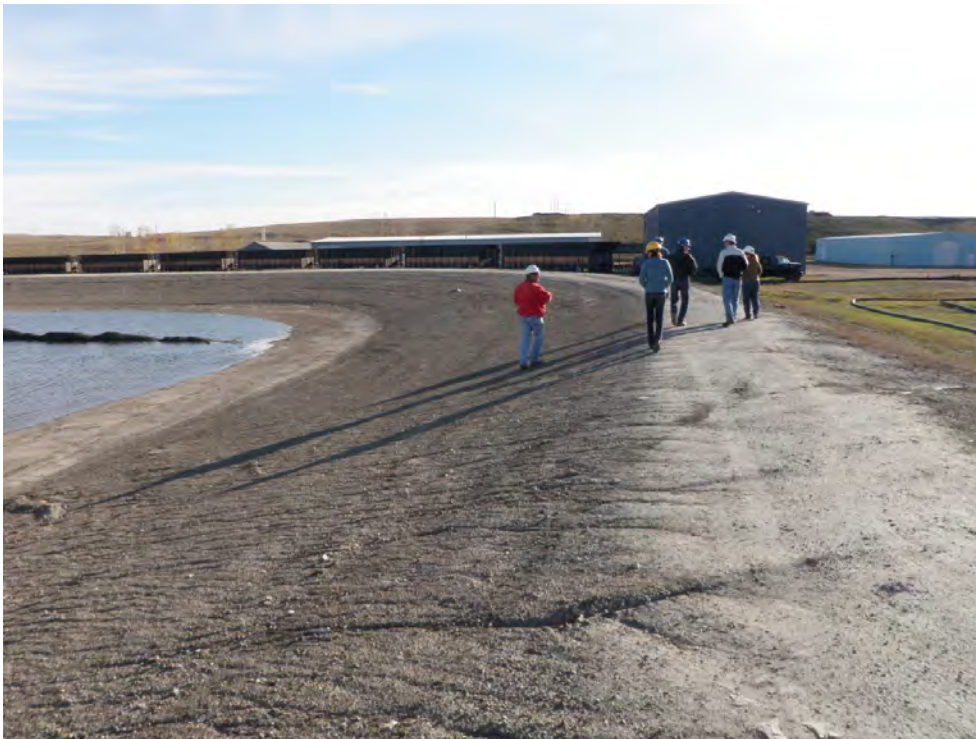
**Photo 14: SDA Decantation Pond – South dike upstream slope, looking east.**

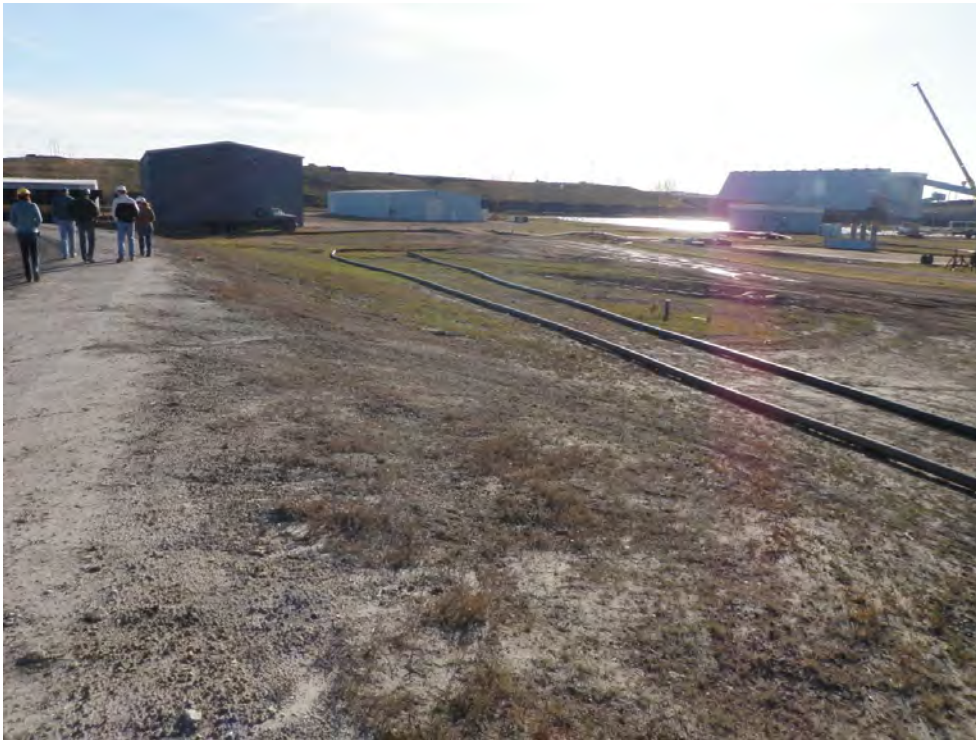
**Photo 15: SDA Decantation Pond – South dike downstream slope, looking east.**

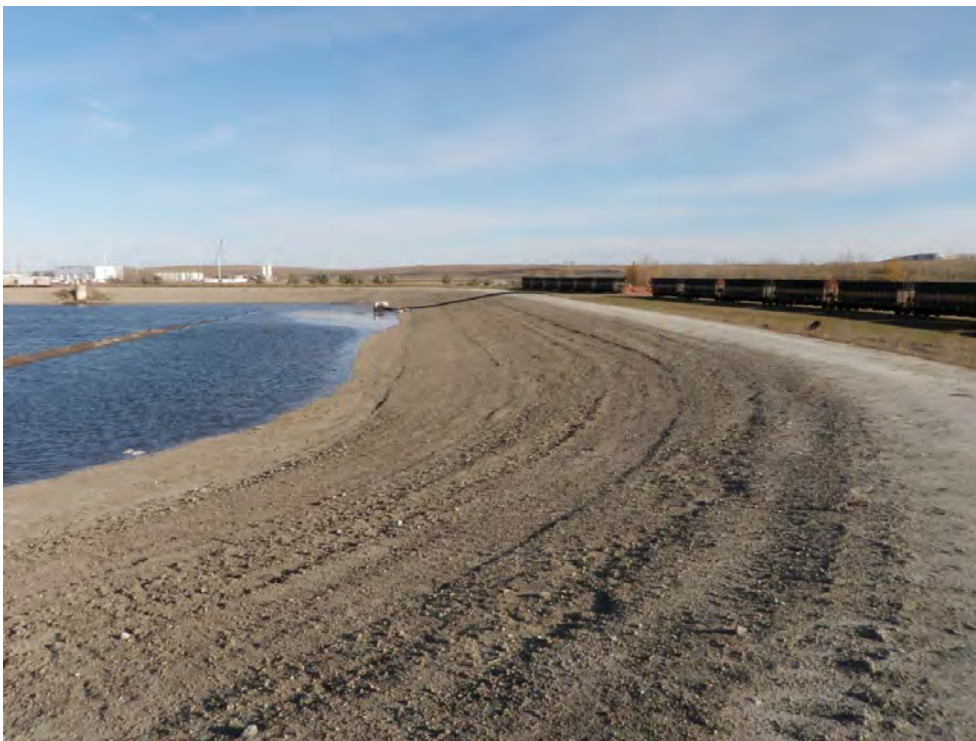
**Photo 16: SDA Decantation Pond – East dike upstream slope, looking north.**

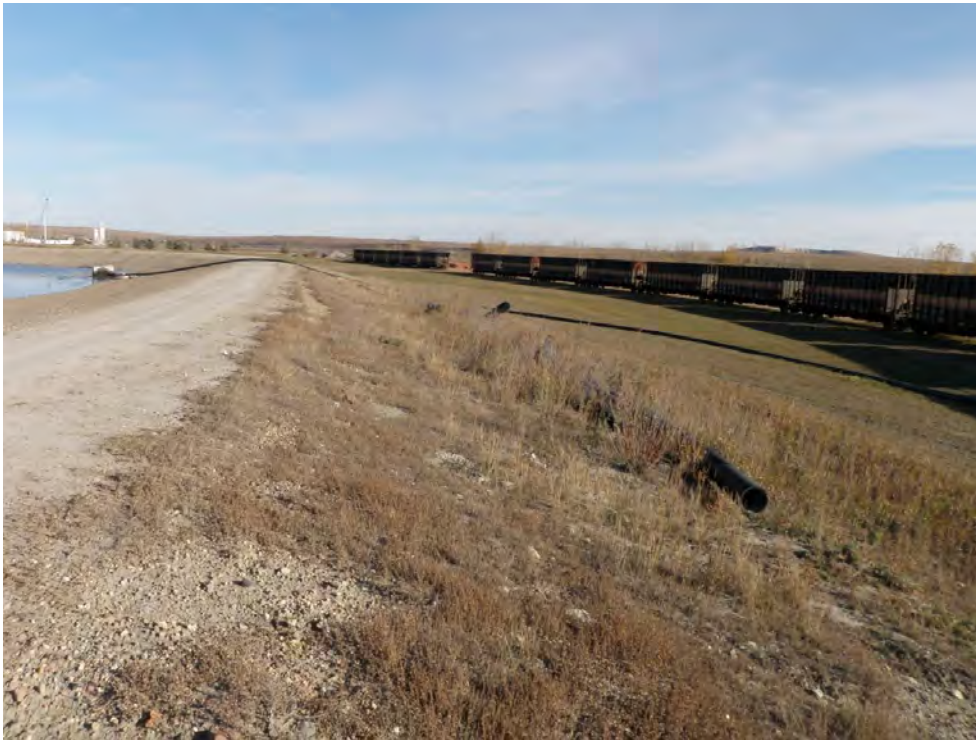
**Photo 17: SDA Decantation Pond – East dike downstream slope, looking north, note inlet pipe over dam crest.**

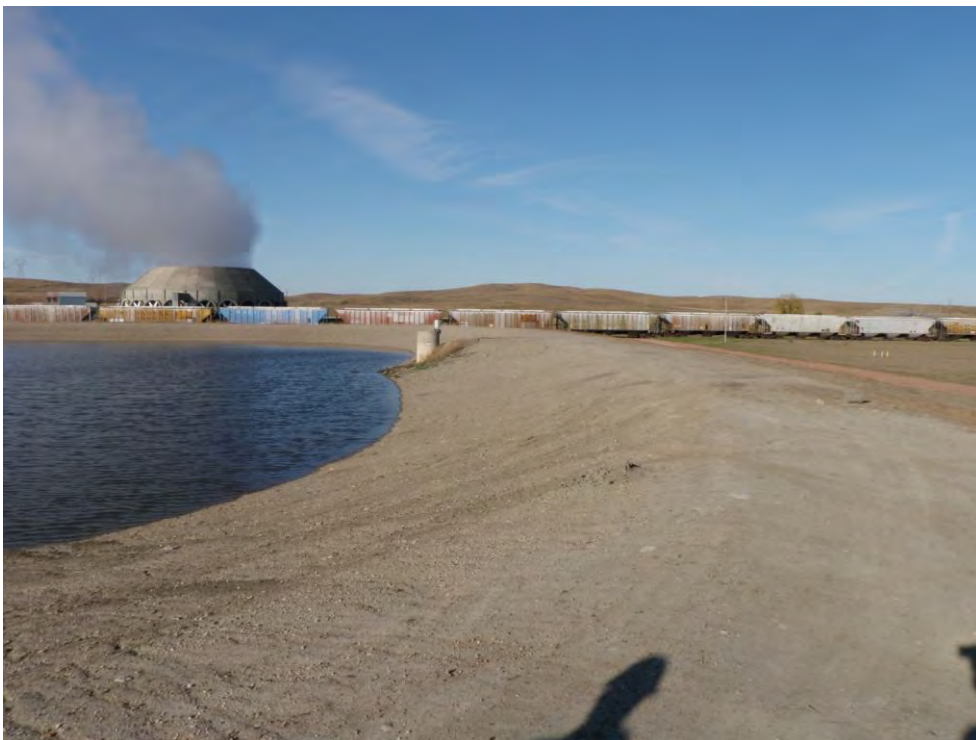
**Photo 18: SDA Decantation Pond – North dike upstream slope, looking west, note leachate manhole.**

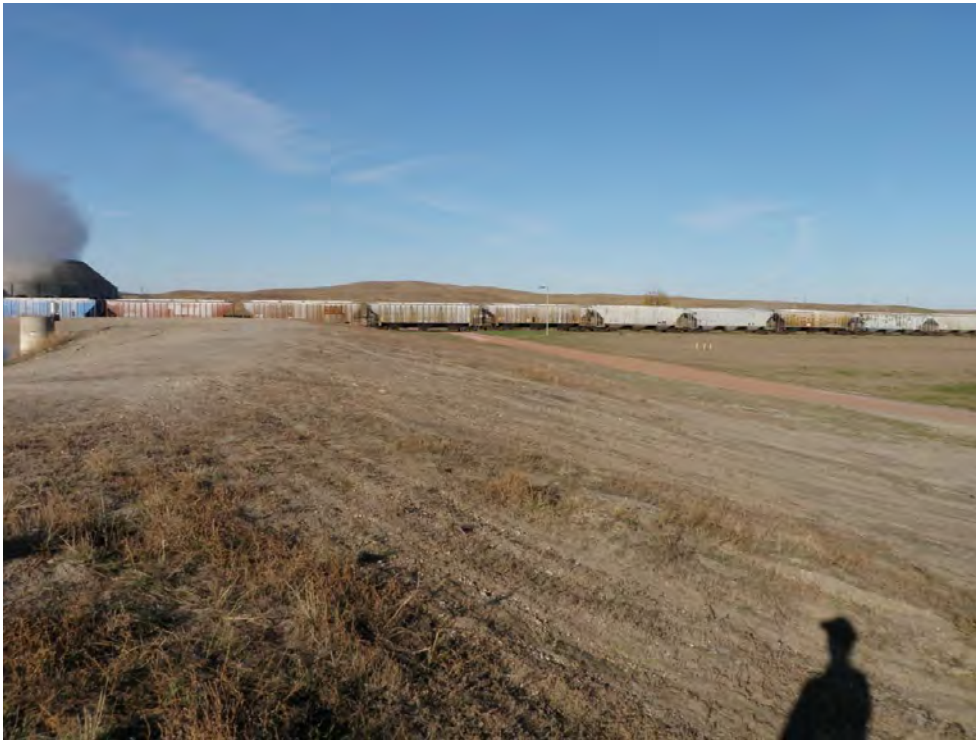
**Photo 19: SDA Decantation Pond – North dike downstream slope, looking east.**

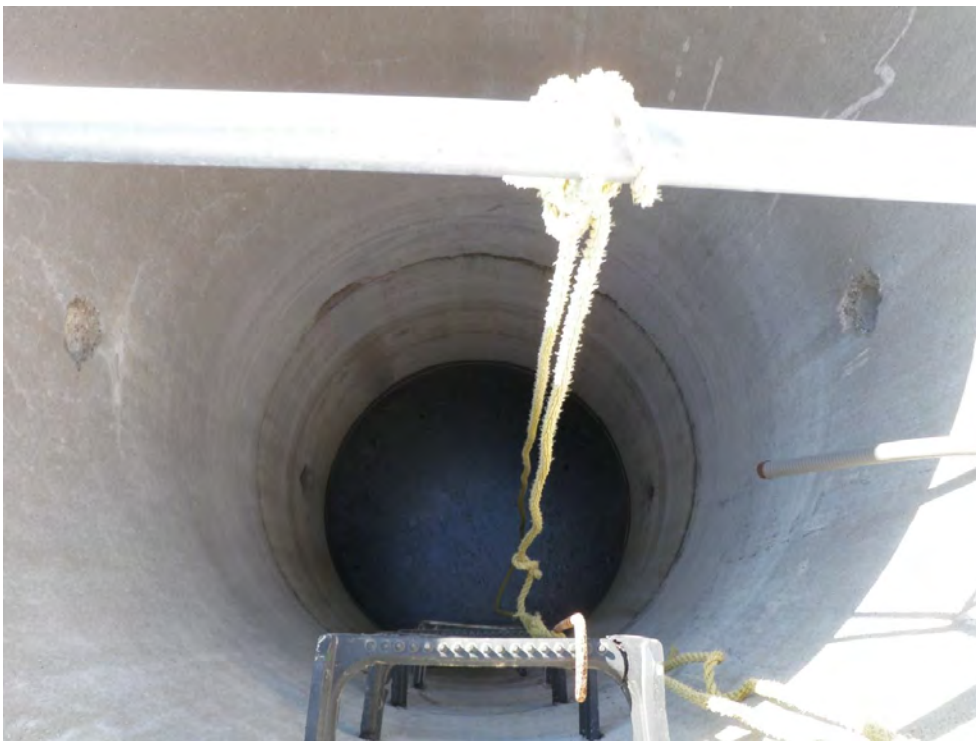
**Photo 20: SDA Decantation Pond – Leachate Manhole.**

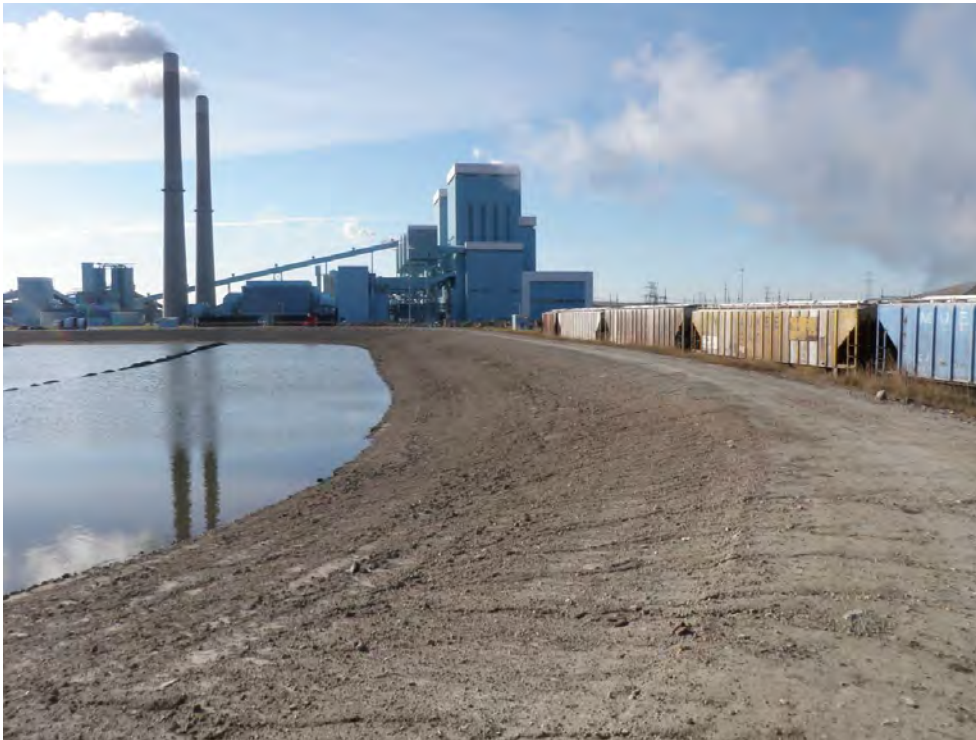
Photo 21: SDA Decantation Pond – West dike upstream slope, looking south.

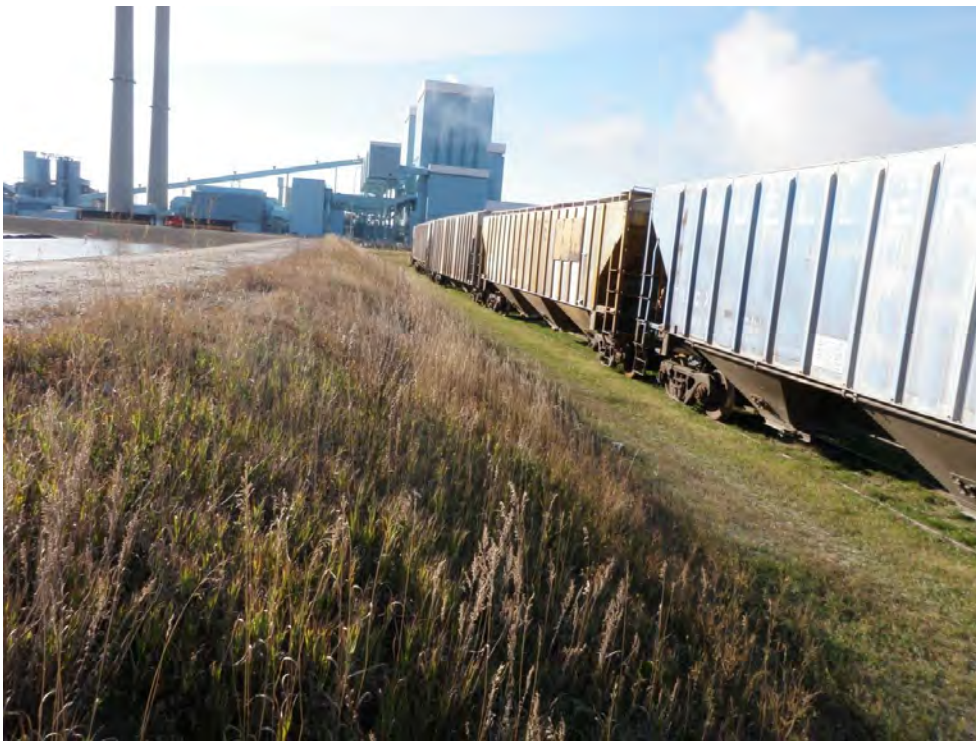
Photo 22: SDA Decantation Pond – West dike downstream slope, looking south.

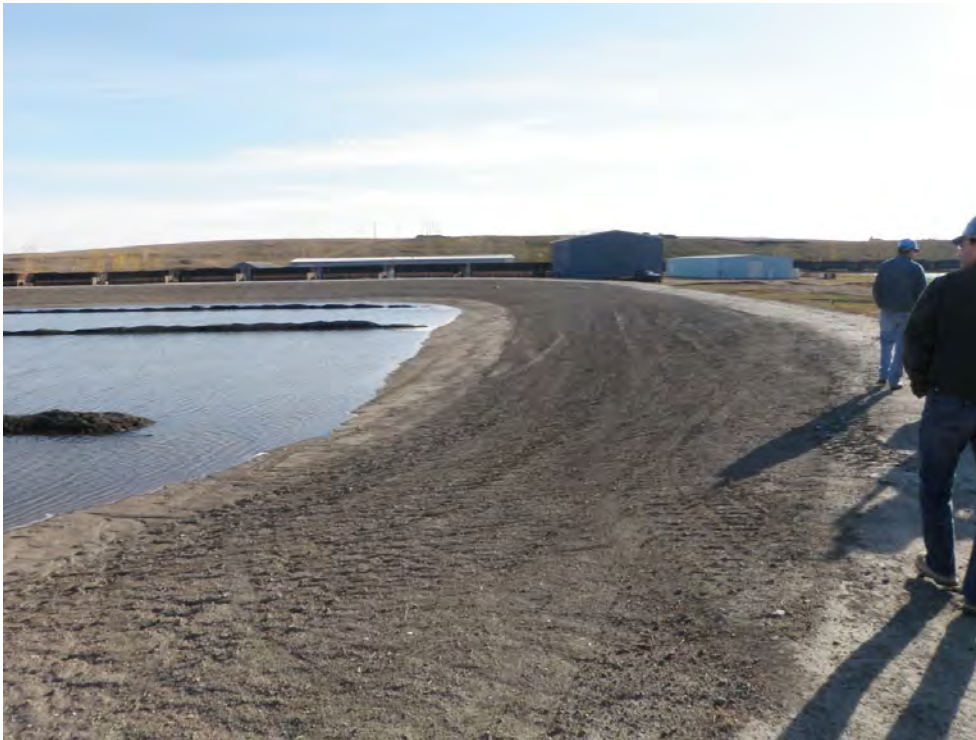
**Photo 23: SDA Decantation Pond – South dike upstream slope, looking east.**

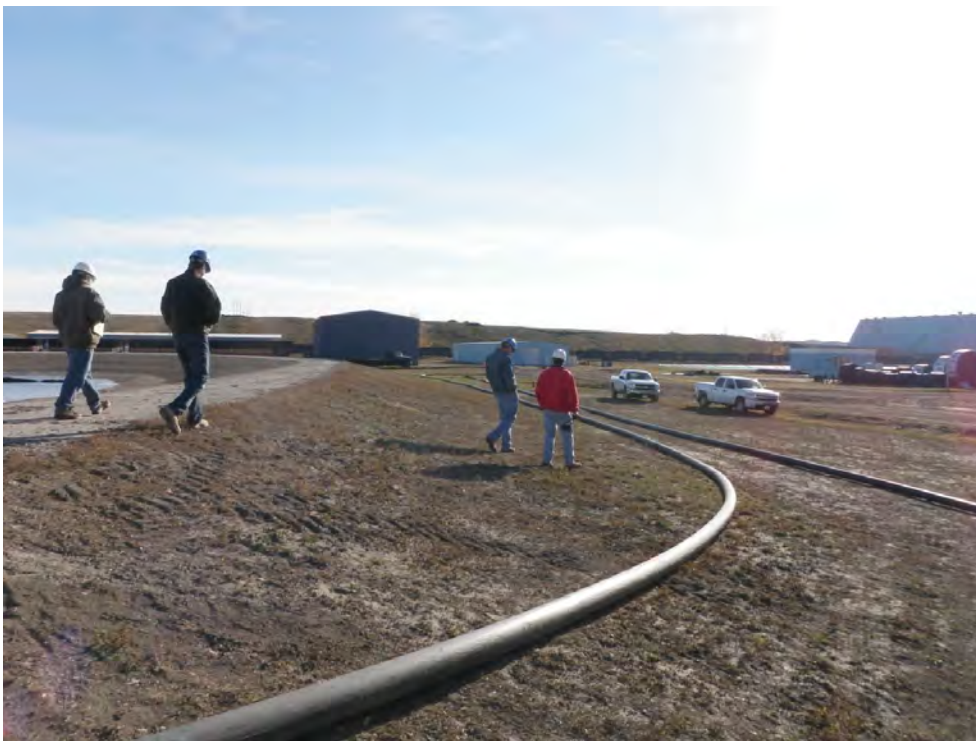
**Photo 24: SDA Decantation Pond – South dike downstream slope, looking east.**
