Specific Site Assessment for Coal Combustion Waste Impoundments at Basin Electric Leland Olds Station Stanton, North Dakota

Submitted to:
U.S. Environmental Protection Agency
Office of Resource Conservation and Recovery
5304P
1200 Pennsylvania Avenue NW
Washington, DC 20460

Submitted by:
GEI Consultants, Inc.
4601 DTC Blvd., Suite 900
Denver, CO 80237

June 2011
Project 092883

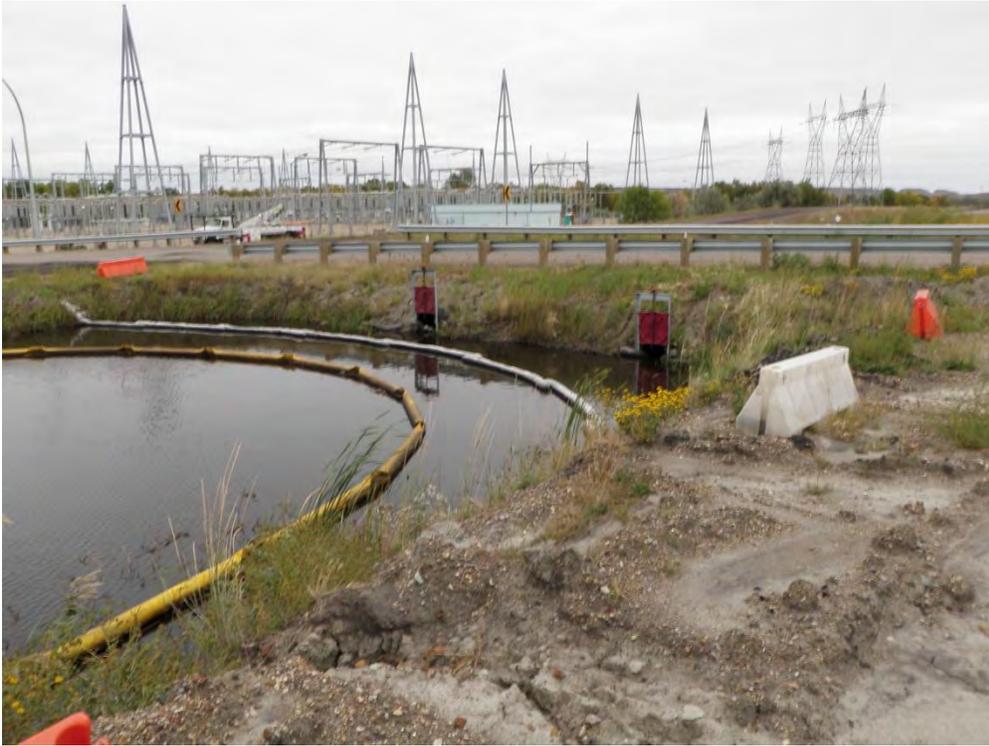
Photo 1: Coal Yard Stormwater Detention Pond, showing gates leading to Drainage Ditch.

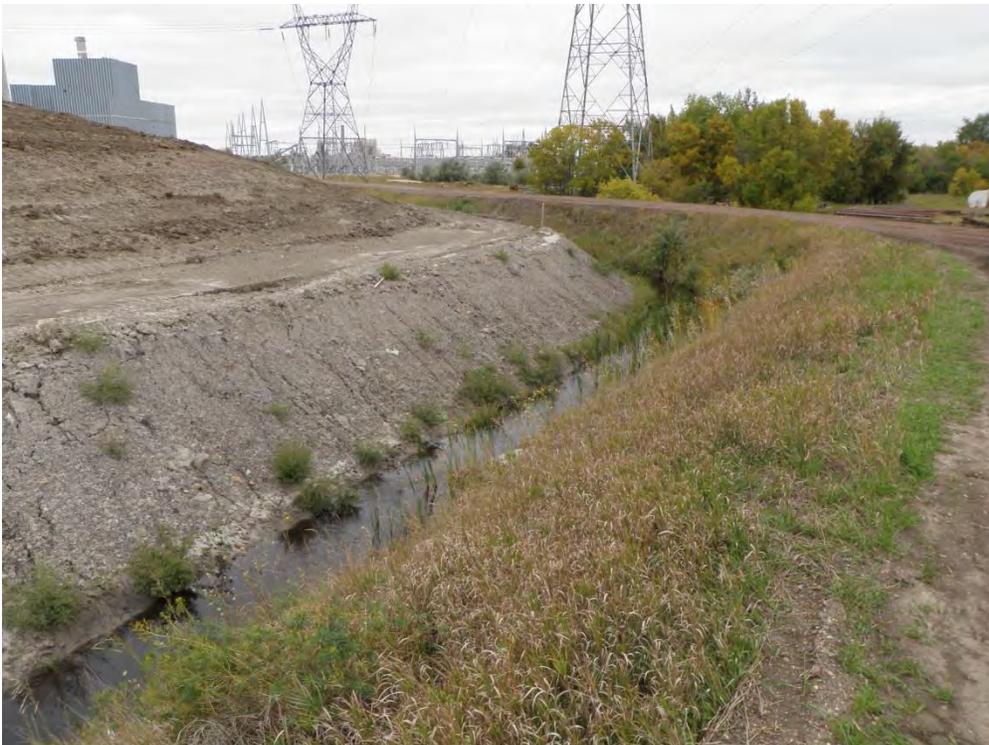
- The three CCW impoundments were generally observed to be in good condition in the field assessment.
- There is minor erosion of the north dike of Ash Pond #1 and currently does not have erosion protection installed.

Photo 2: Coal Yard Drainage Ditch showing north dike of Ash Pond #1 dry ash storage on left.

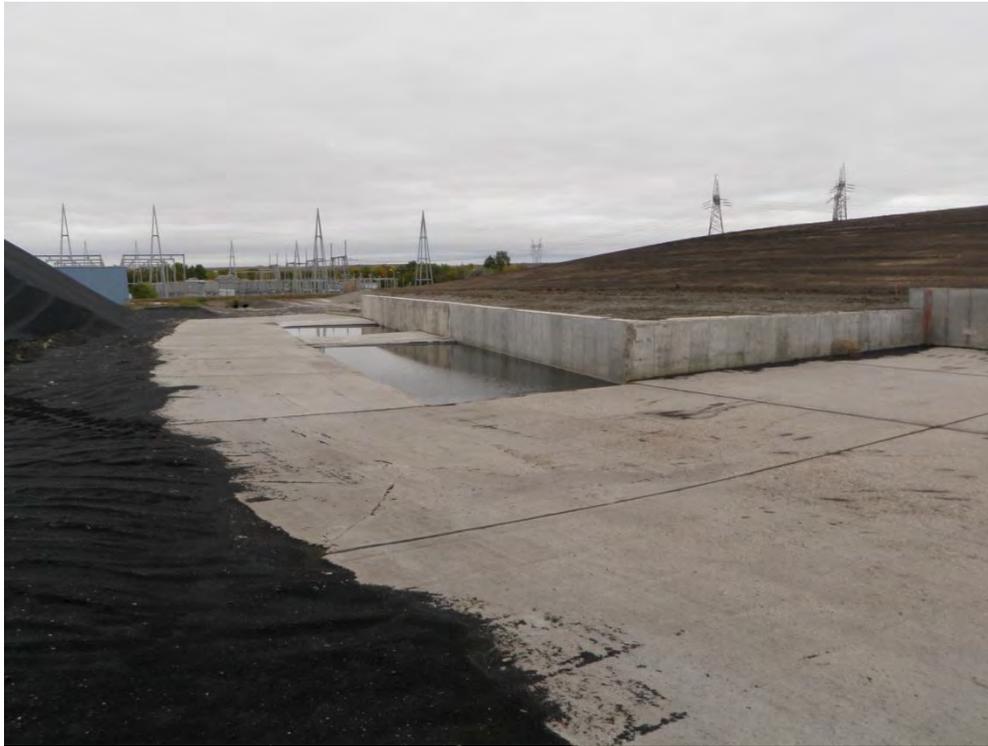
Photo 3: Ash Pond #1: Concrete containment structure for saleable dry ash.

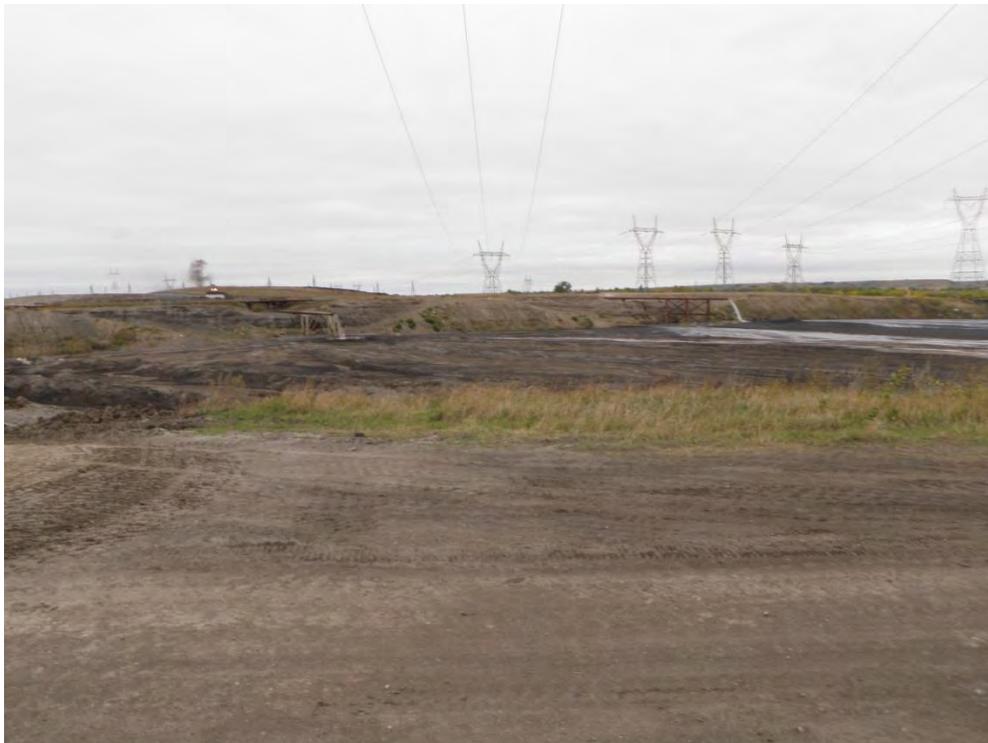
Photo 4: Ash Pond #2: Elevated pipes sluicing ash and water from plant into pond.

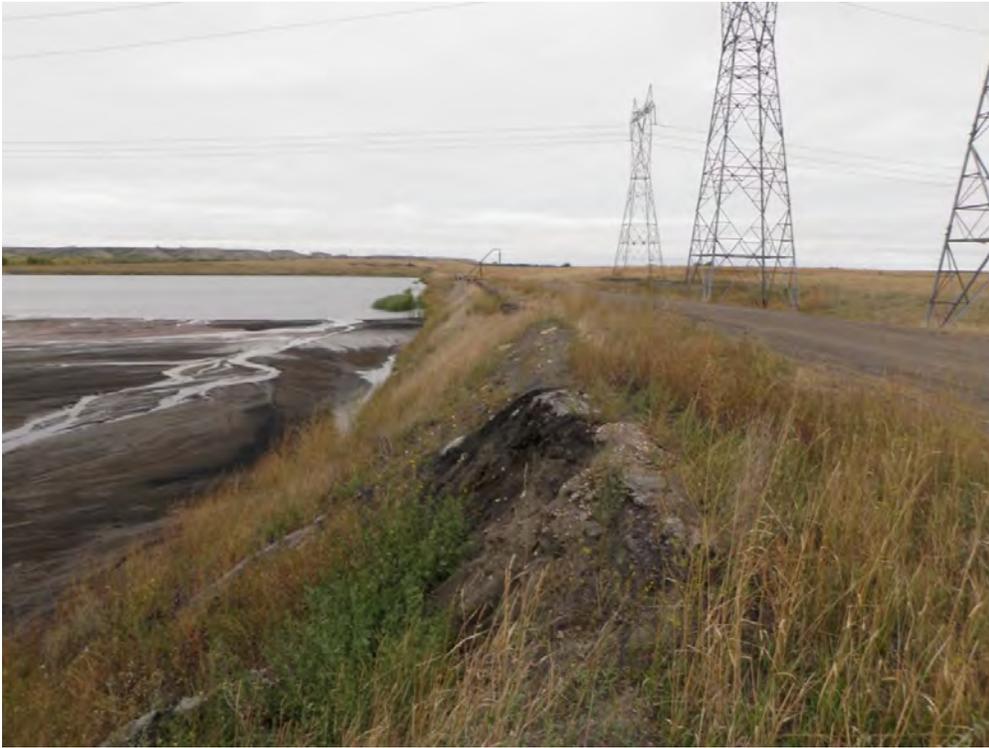
Photo 5: Ash Pond #2 – View of south perimeter dike looking east.

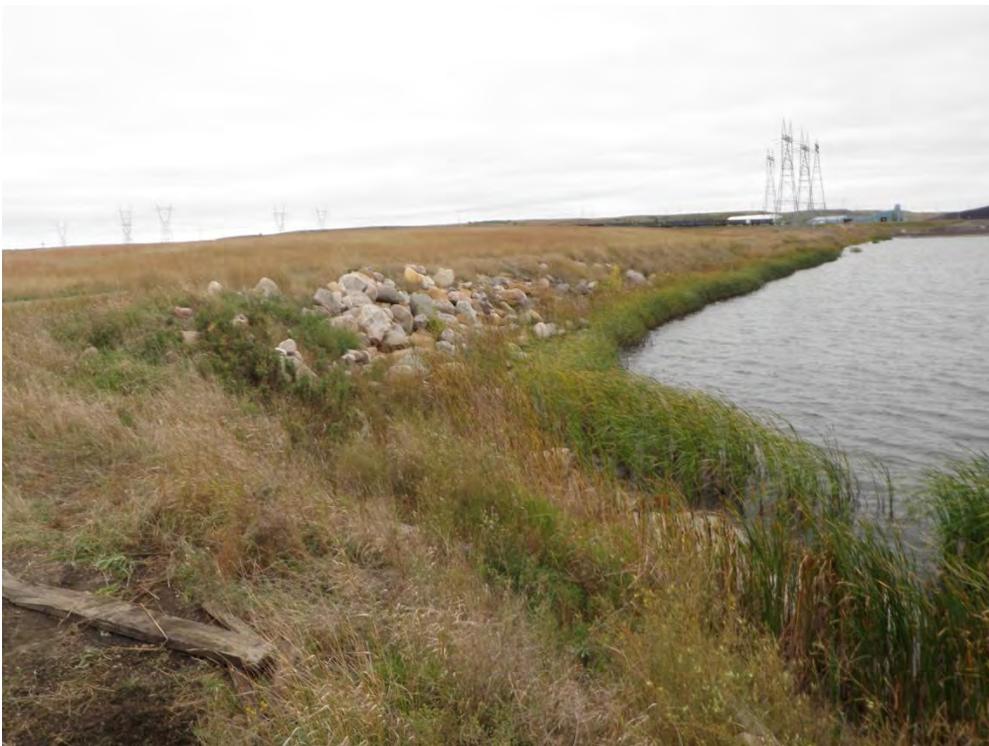
Photo 6: Ash Pond #2 – Grassy vegetation and riprap in southeast corner of pond.

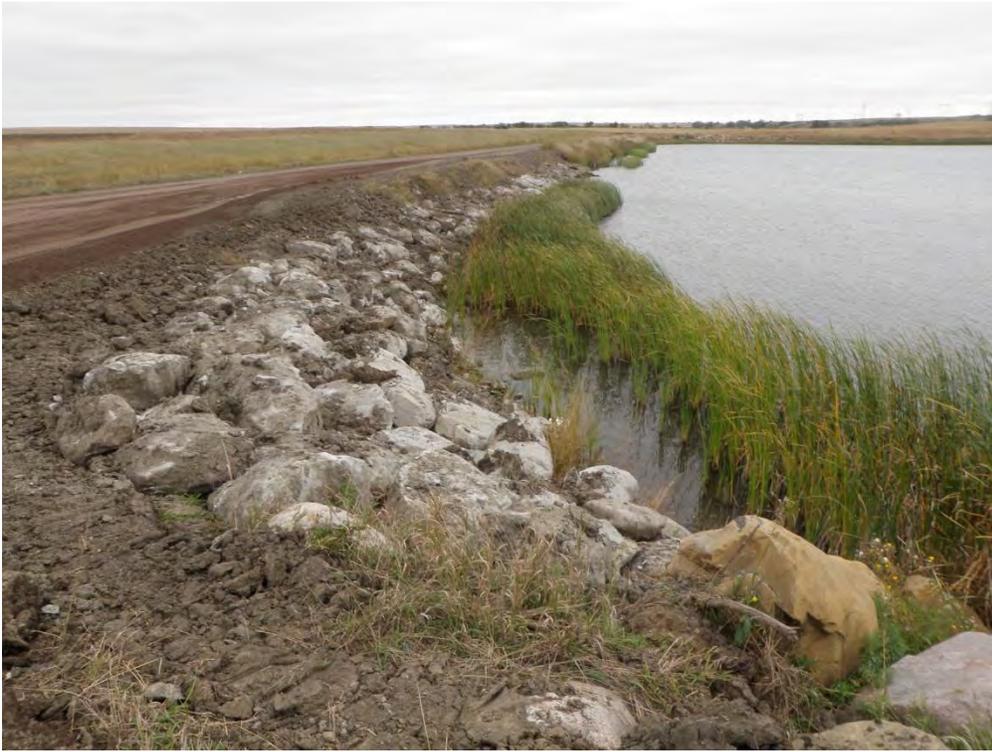
Photo 7: Ash Pond #2 – New riprap placed in northeast corner of pond.

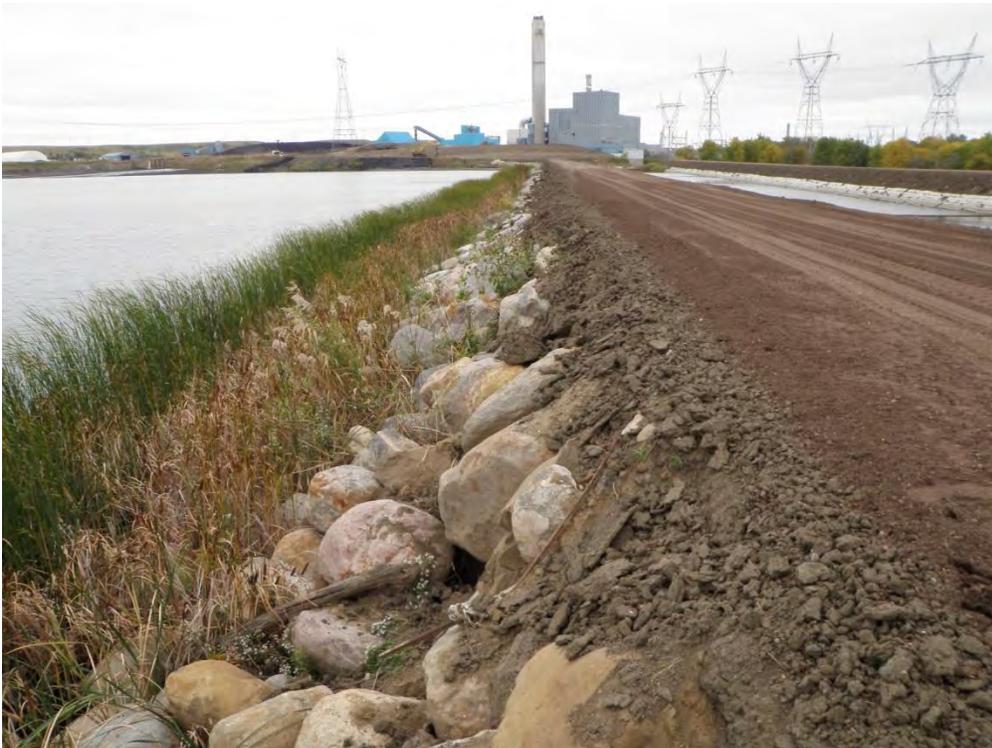
Photo 8: Ash Pond #2 – New riprap along north dike between Ash Ponds #2 and #3. Ash Pond #3 is shown on the right.

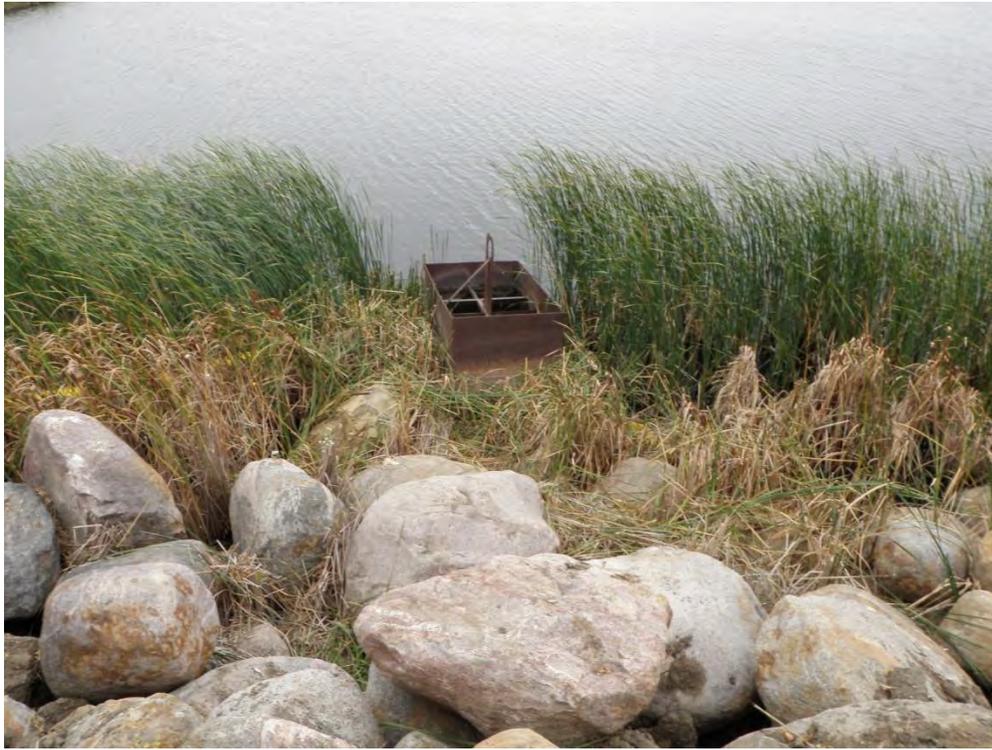
Photo 9: Ash Pond #2 – Decant structure on outlet pipe to Ash Pond #3.

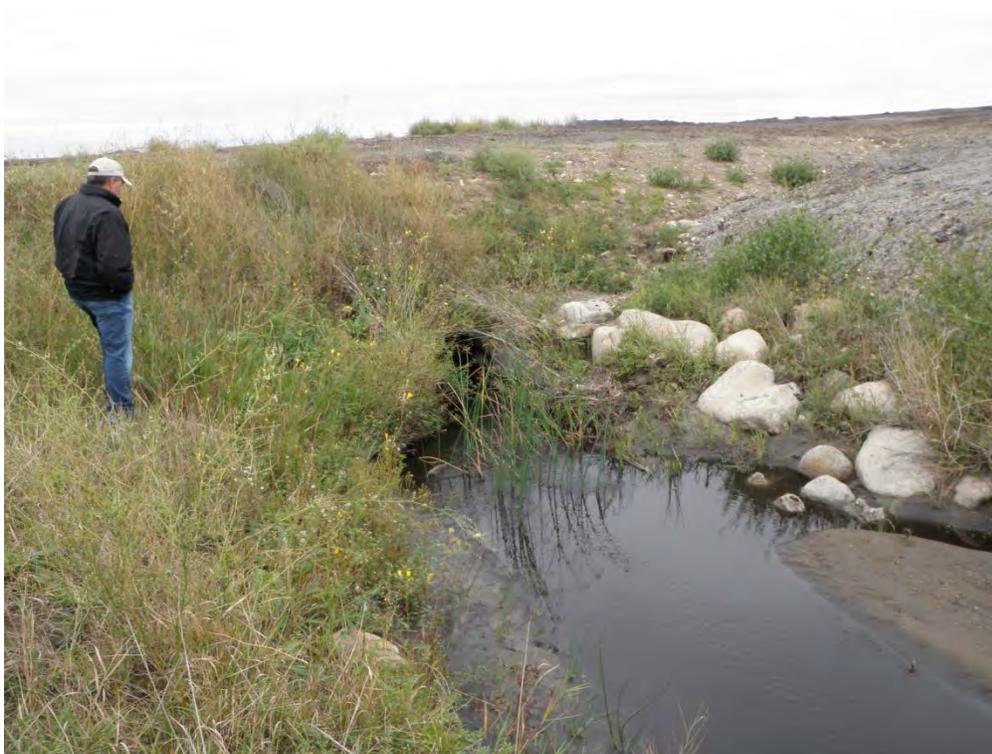
Photo 10: Ash Pond #2 – Outlet from Coal Yard Drainage Ditch to Ash Pond #2, showing drainage ditch in foreground.

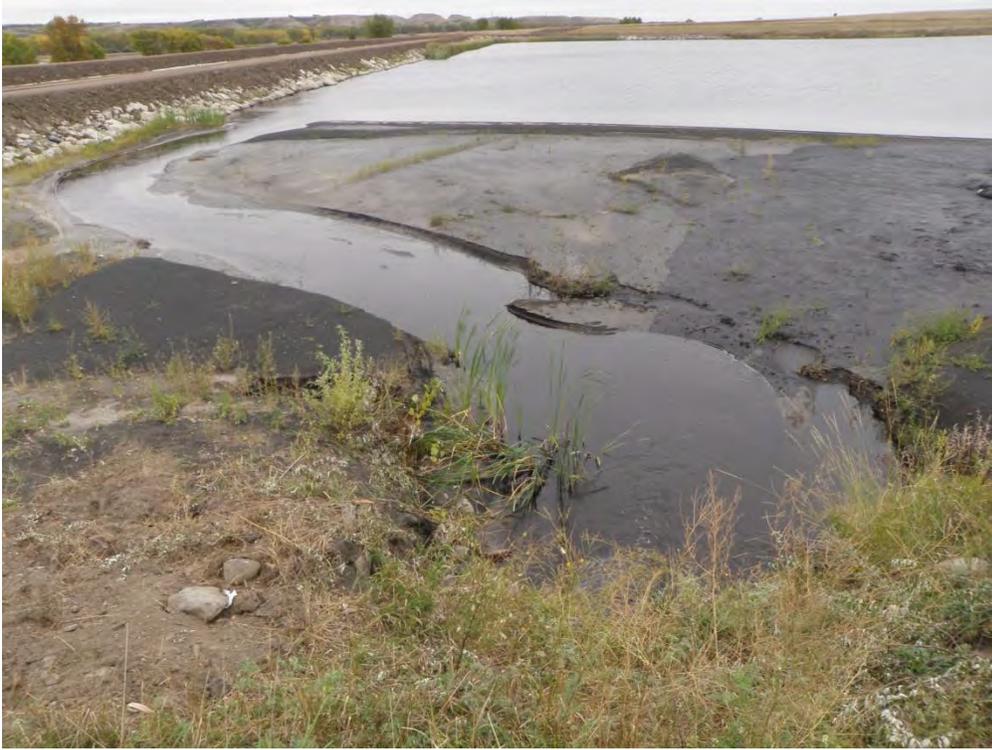
Photo 11: Ash Pond #2 – Outlet from Coal Yard Drainage Ditch to Ash Pond #2, showing northwest corner of Ash Pond #2.

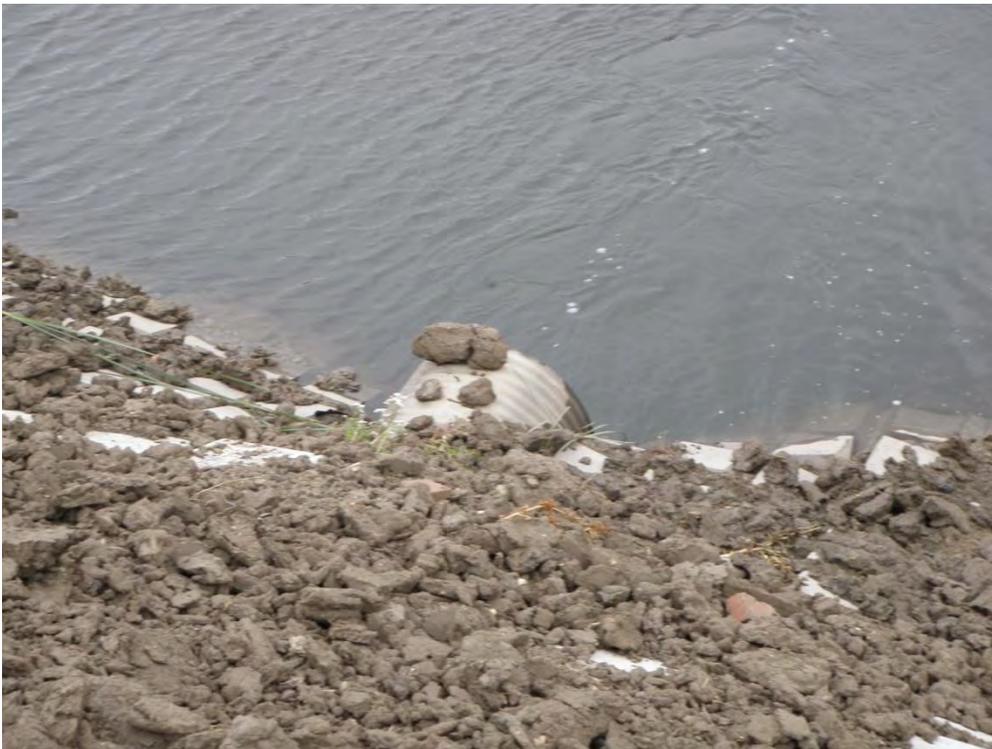
Photo 12: Ash Pond #3 – Outlet pipe from Ash Pond #2.

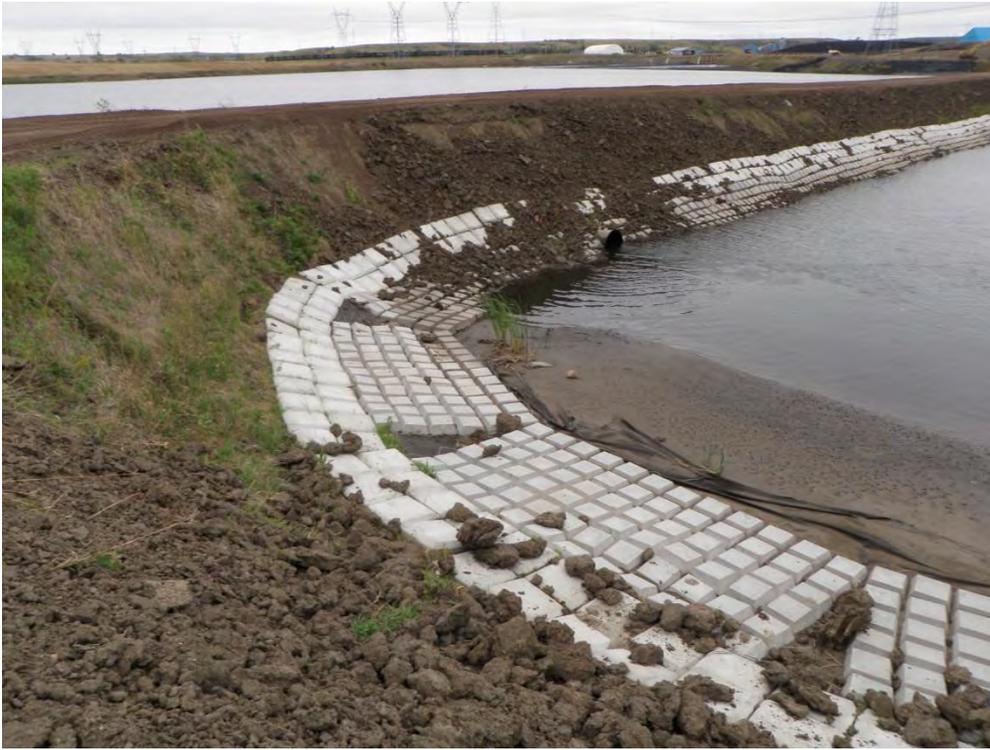
Photo 13: Ash Pond #3 – Cellular concrete mats installed at the upstream toe of the pond.

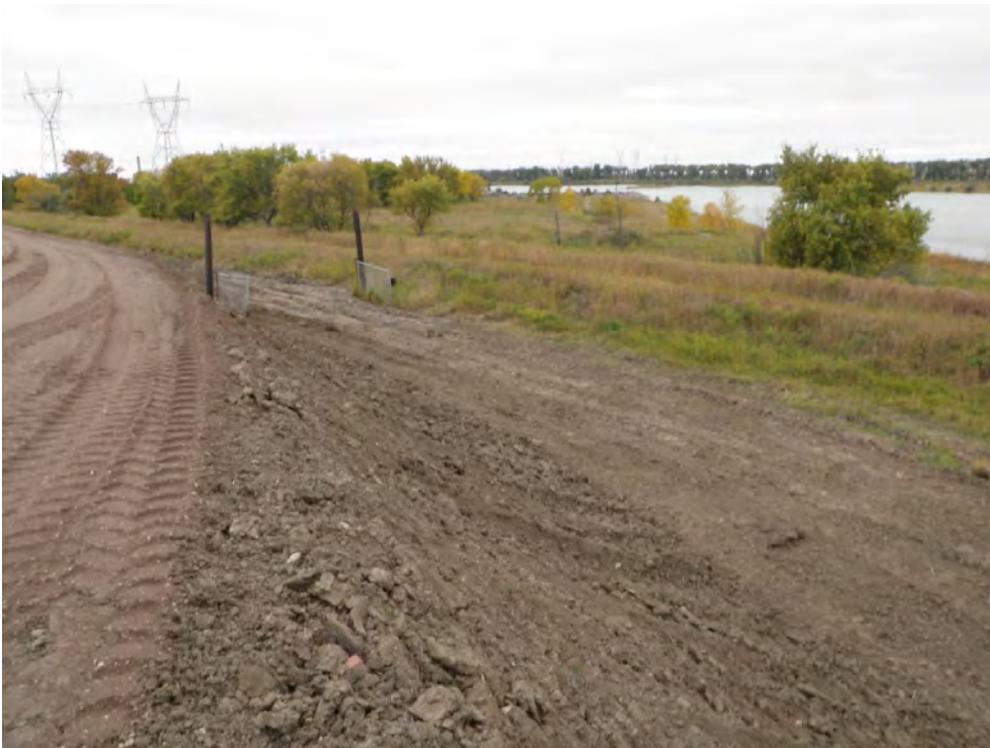
Photo 14: Ash Pond #3 – Re-graded perimeter dike at northeast corner of pond, showing Missouri River in background.

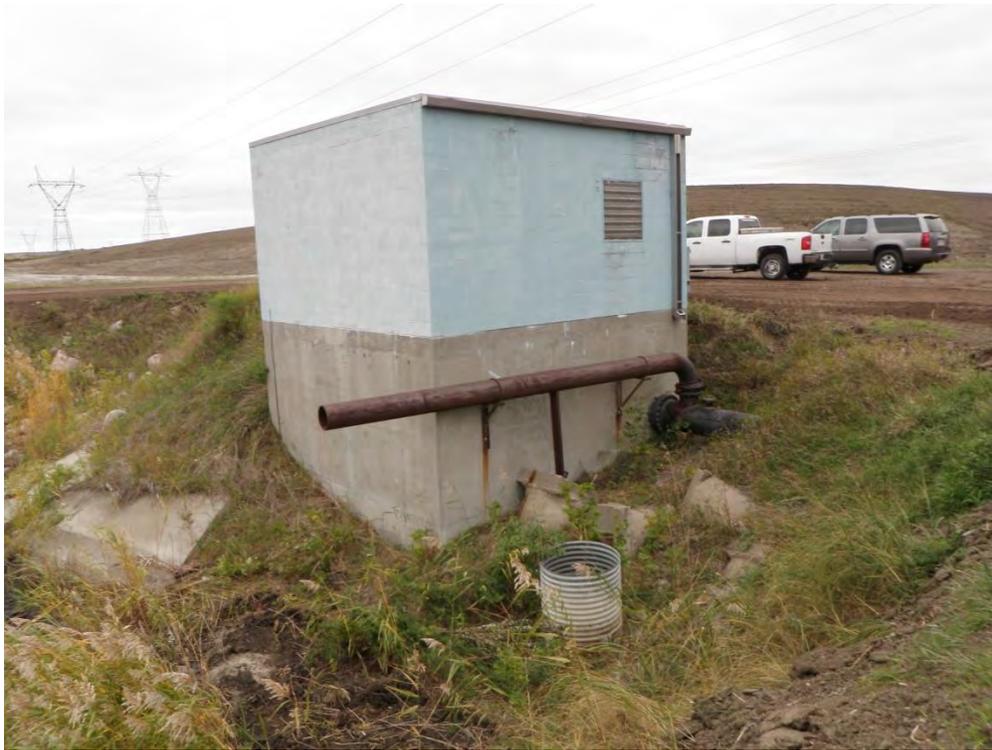
Photo 15: Ash Pond #3 – Pumphouse at the west edge of Ash Pond #3.

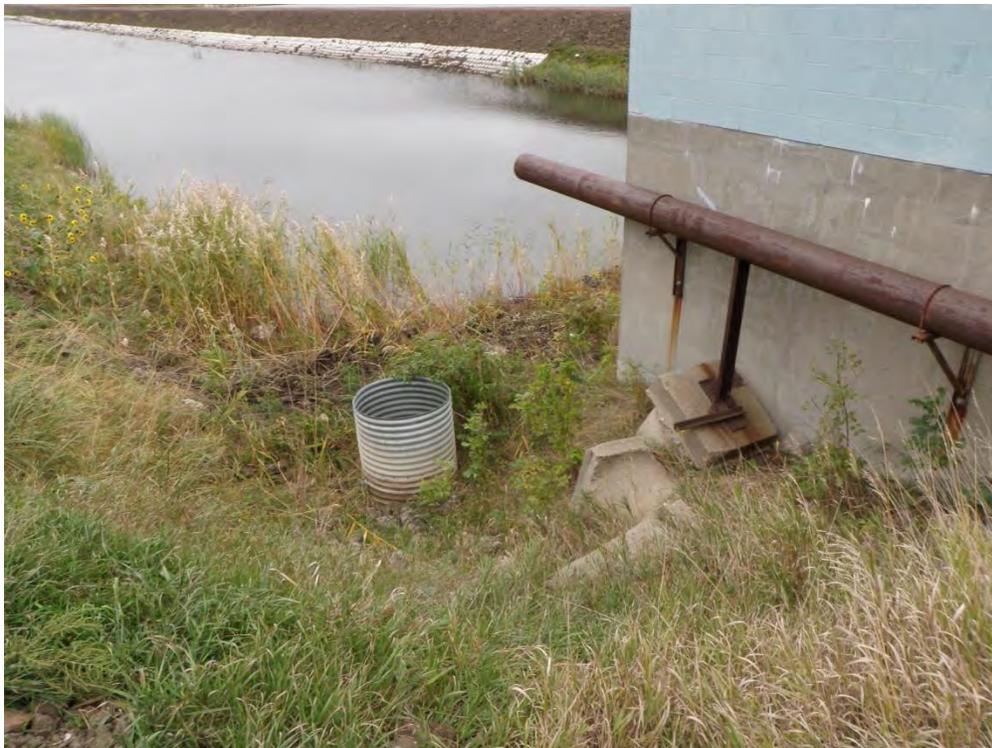
Photo 16: Ash Pond #3 – Decommissioned riser in northwest corner of pond, adjacent to pumphouse.
