**DRAFT**  
**Specific Site Assessment for  
Coal Combustion Waste  
Impoundments at Basin  
Electric Laramie River Station  
Wheatland, Wyoming**

Submitted by:  
**GEI Consultants, Inc.**  
4601 DTC Boulevard, Suite 900  
Denver, CO 80237

February 2012  
Project 092886

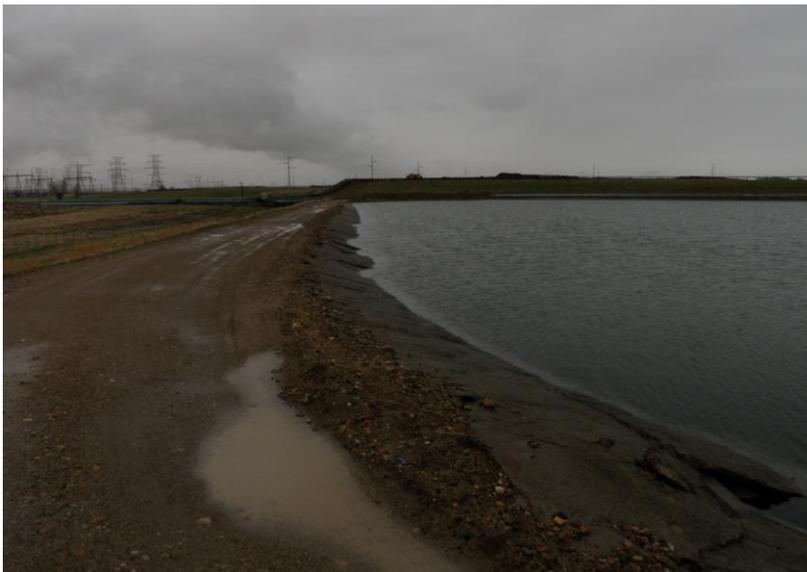
**Photo 2-1: Bottom Ash Pond 1 East Dike Upstream Slope, Looking South. Note damaged concrete lining, as discussed in Section 8 of report.**

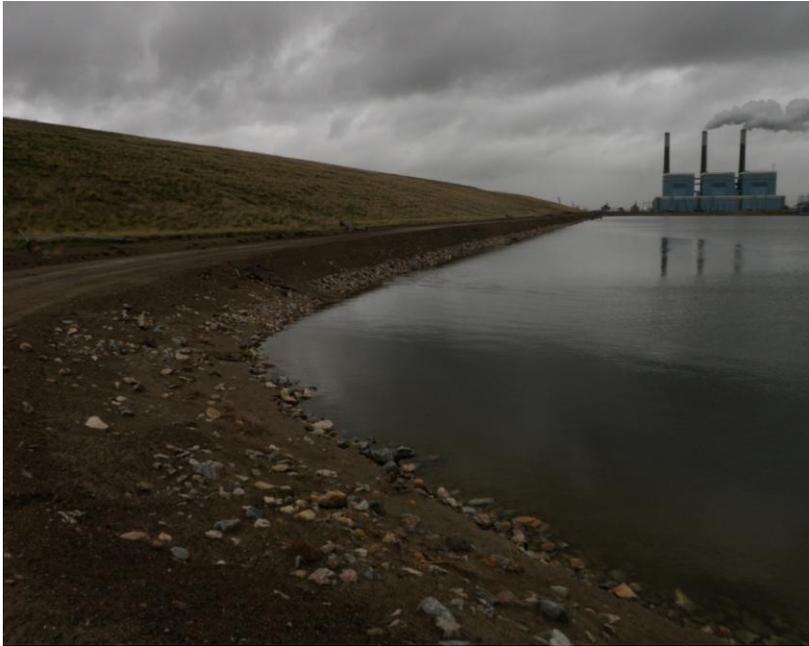
**Photo 2-2: Bottom Ash Pond 2 North Dike Upstream Slope, Looking Northeast. Note slope of landfill that is located directly north of Bottom Ash Pond 2.**

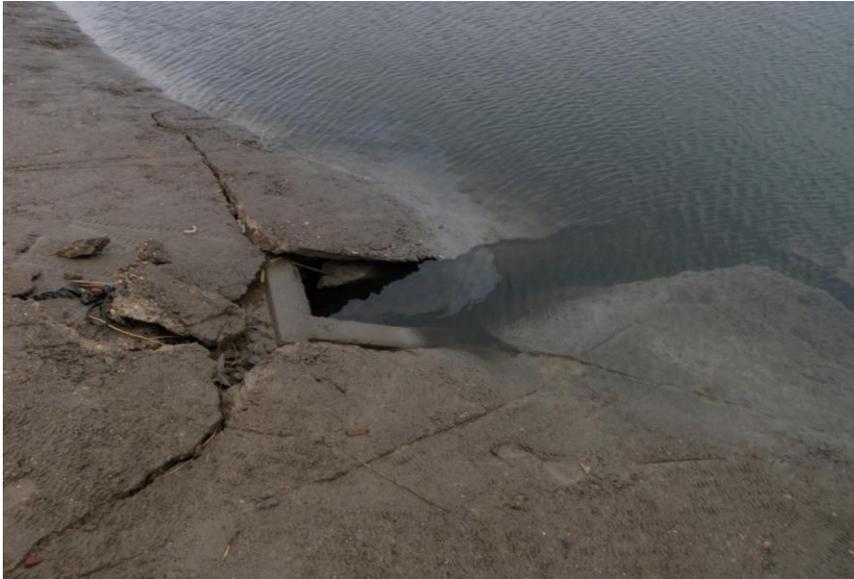
**Photo 8-1: Bottom Ash Pond 1 Upstream Slope Northeast Corner. Note cracked and displaced concrete slope protection and erosion of underlying embankment.**

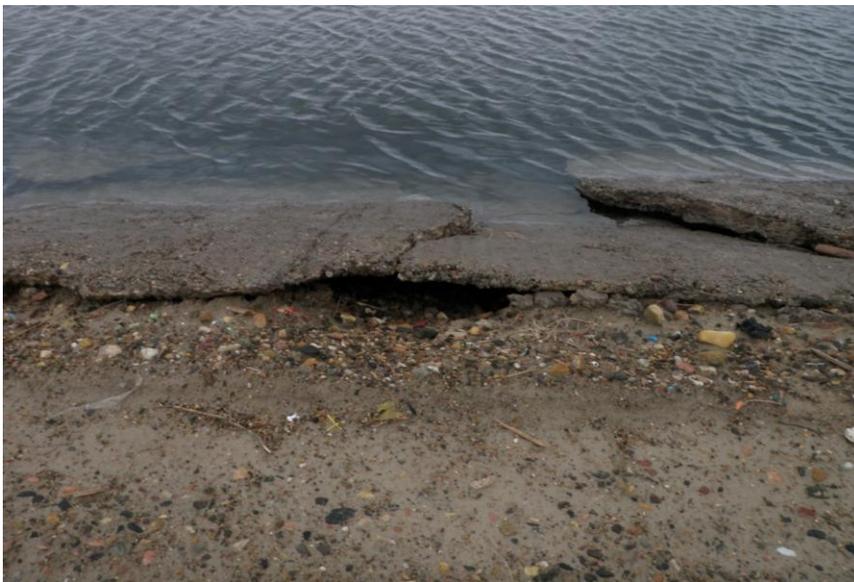
**Photo 8-2: Bottom Ash Pond 1 Upstream Slope Northeast Corner. Note cracked and displaced concrete slope protection and erosion of underlying embankment.**

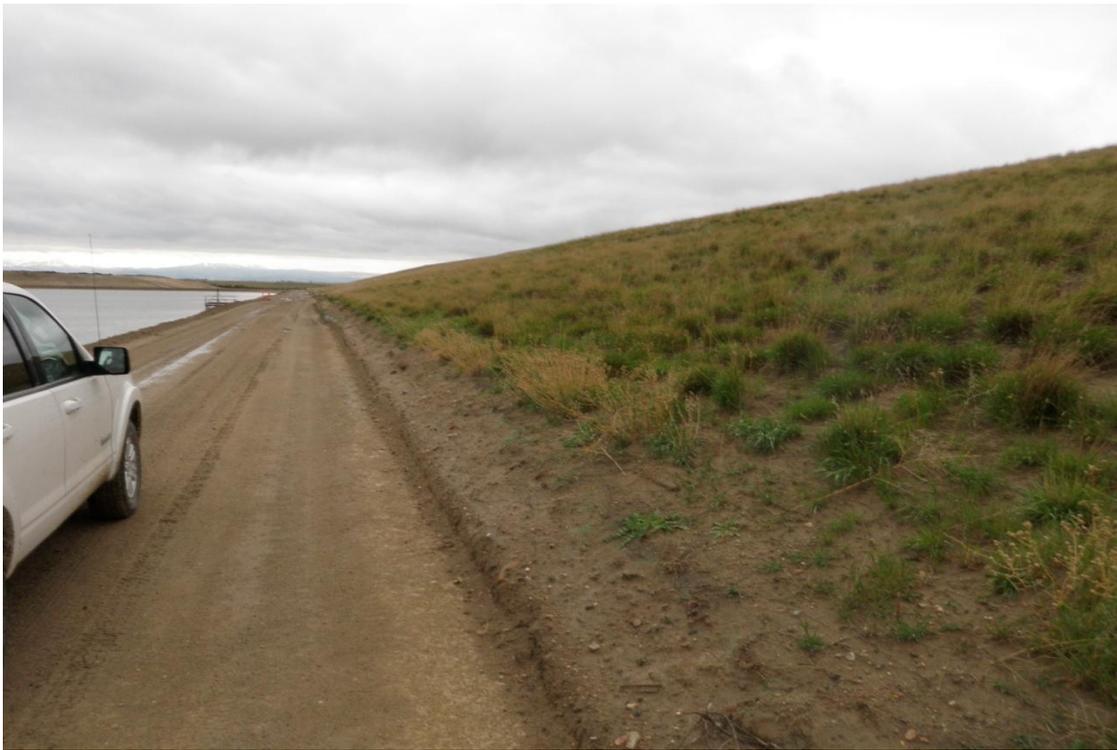
**Photo 19: Bottom Ash Pond 2 North Dike Downstream Slope/Landfill. The landfill is the higher ground located at right of photo.**
