## Specific Site Assessment for Coal Combustion Waste Impoundments at Basin Electric Laramie River Station Wheatland, Wyoming

August 2012  
Project 092886

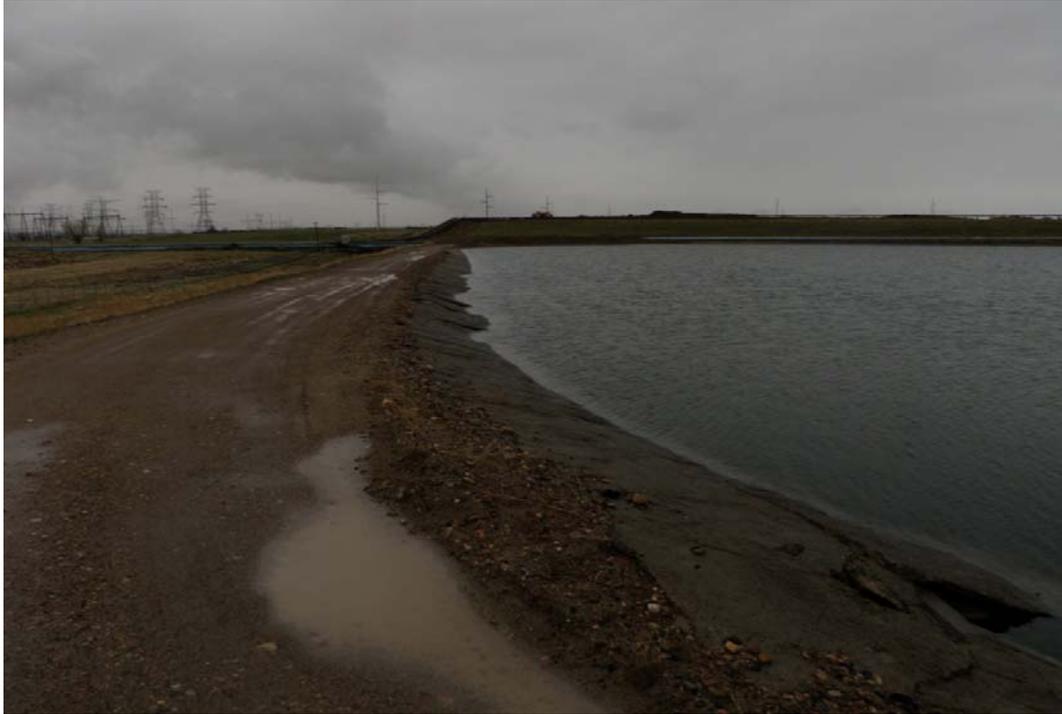
**Photo 2-1: Bottom Ash Pond 1 East Dike Upstream Slope, Looking South. Note damaged concrete lining, as discussed in Section 8 of report.**

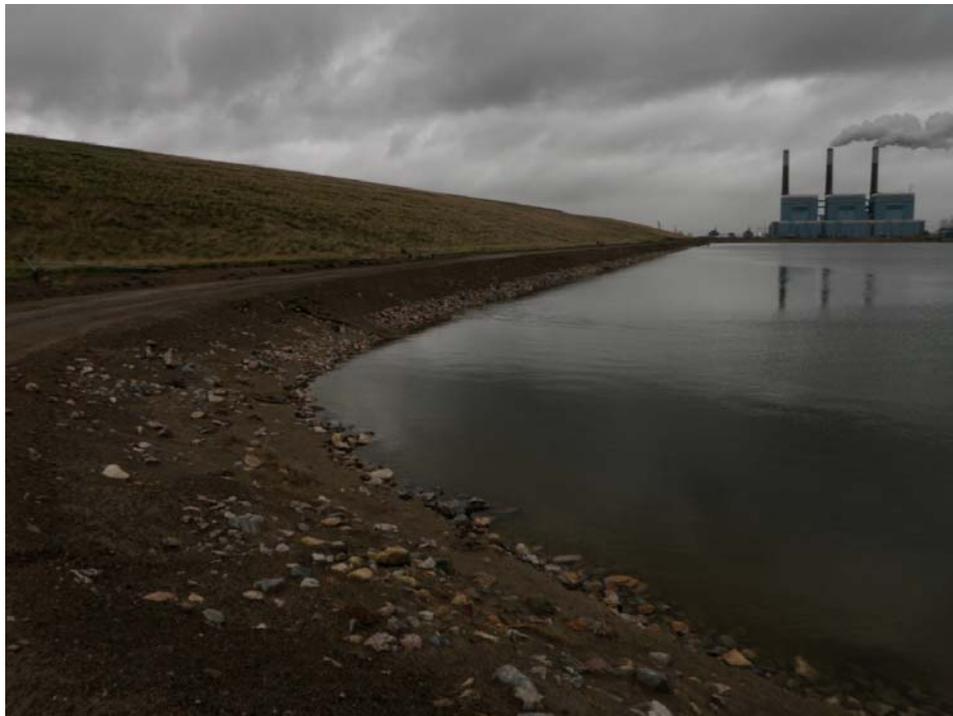
**Photo 2-2: Bottom Ash Pond 2 North Dike Upstream Slope, Looking Northeast. Note slope of landfill that is located directly north of Bottom Ash Pond 2.**

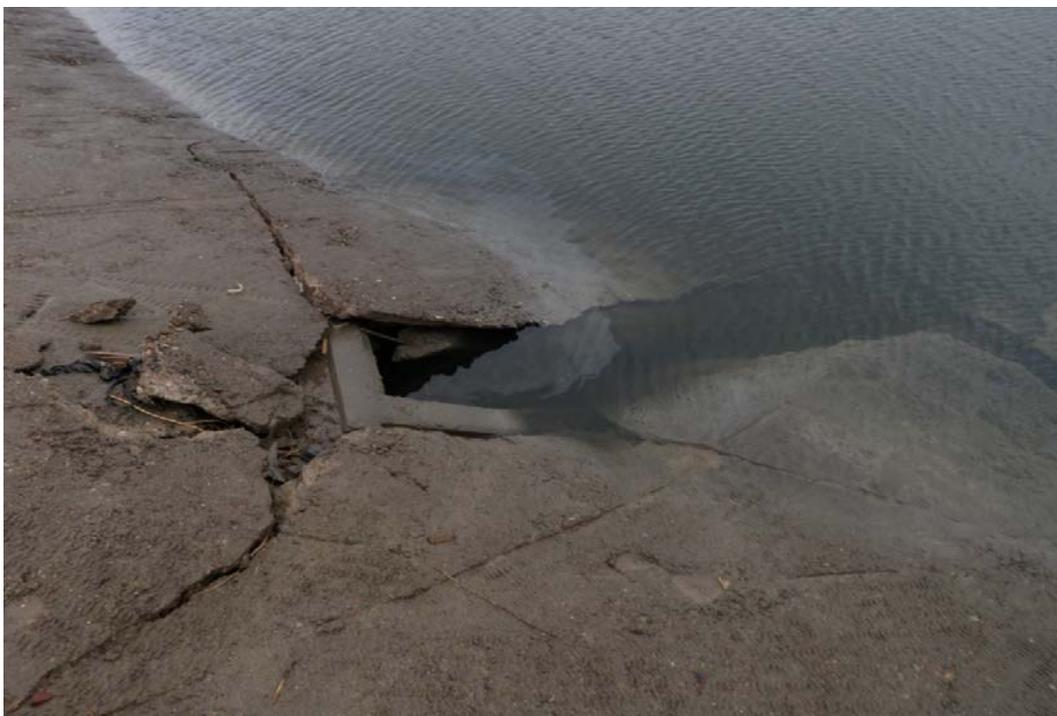
**Photo 8-1: Bottom Ash Pond 1 Upstream Slope Northeast Corner. Note cracked and displaced concrete slope protection and erosion of underlying embankment.**

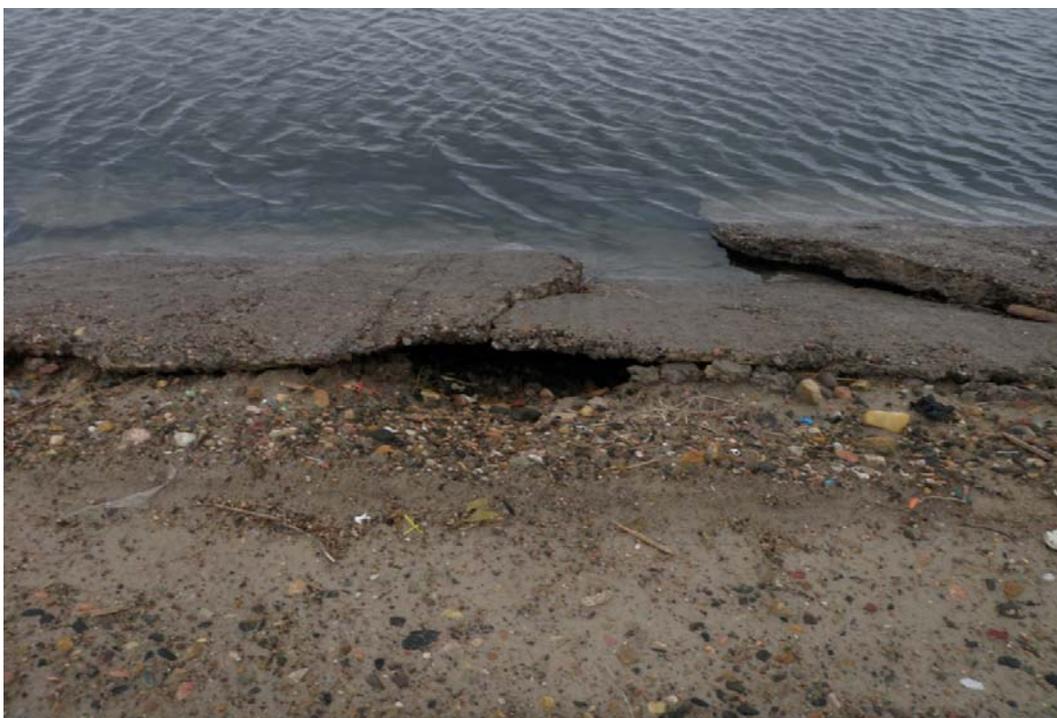
**Photo 8-2: Bottom Ash Pond 1 Upstream Slope Northeast Corner. Note cracked and displaced concrete slope protection and erosion of underlying embankment.**

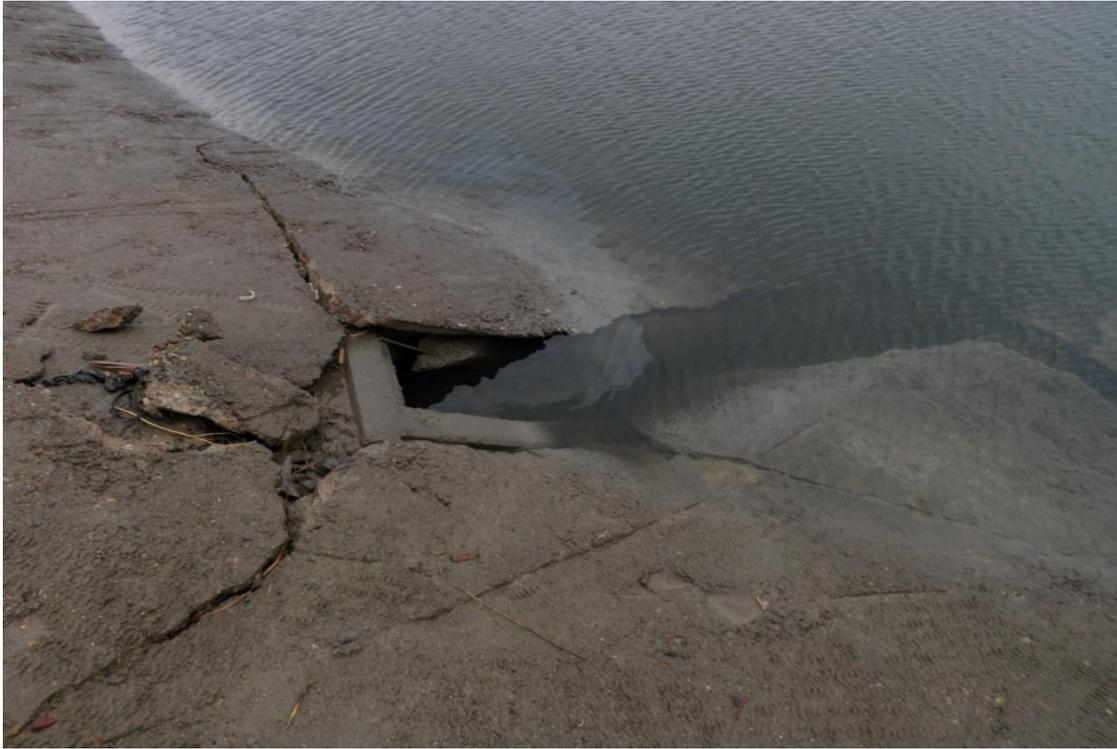
**Photo 3: Bottom Ash Pond 1 Upstream Slope Northeast Corner Erosion.**

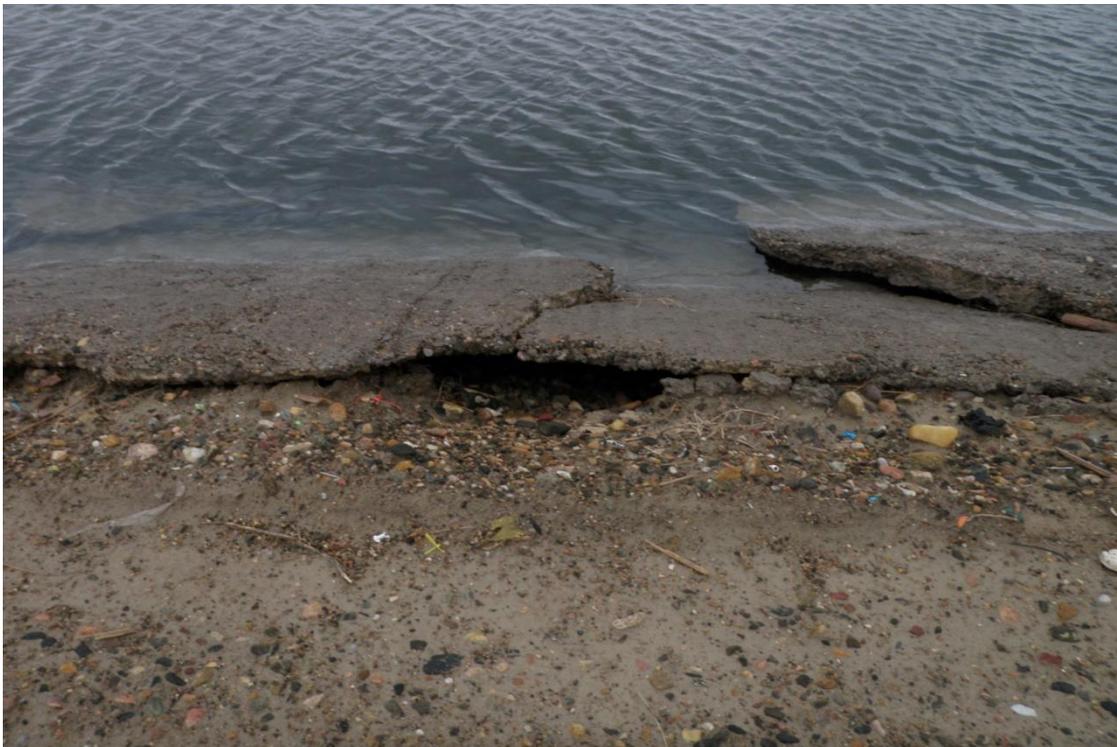
**Photo 4: Bottom Ash Pond 1 Upstream Slope Northeast Corner Erosion.**

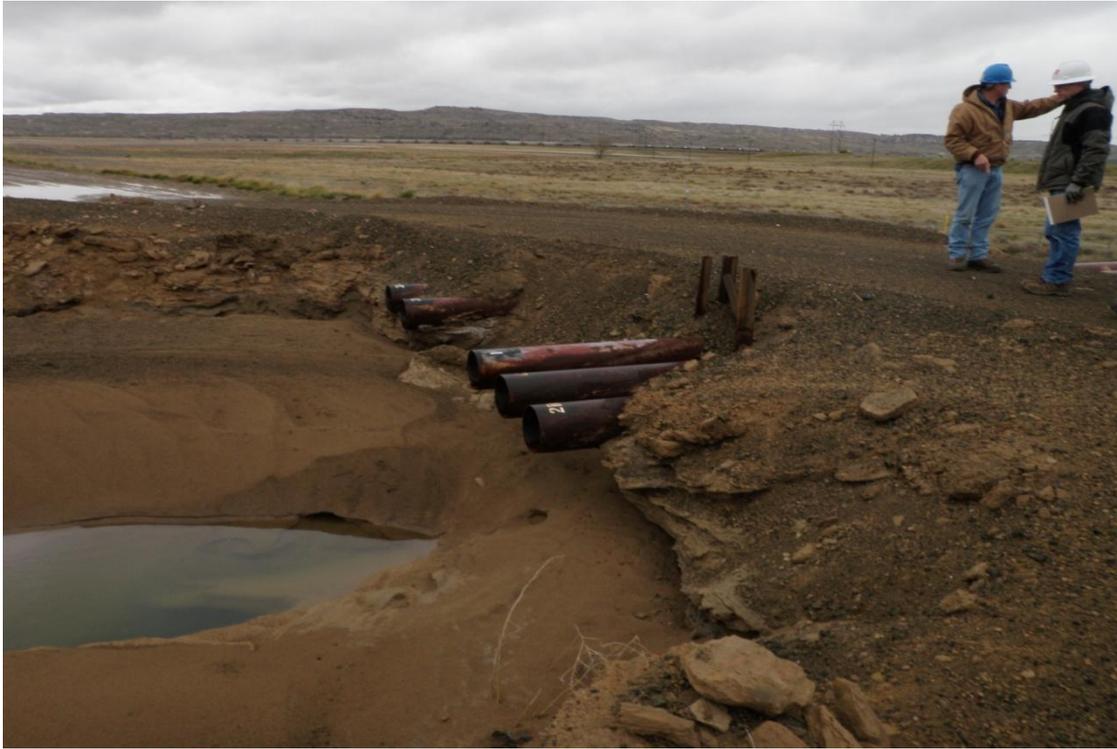
**Photo 7: Bottom Ash Pond 1 Southeast Corner Inlet Pipes. Pipes have been semi-permanently disconnected.**

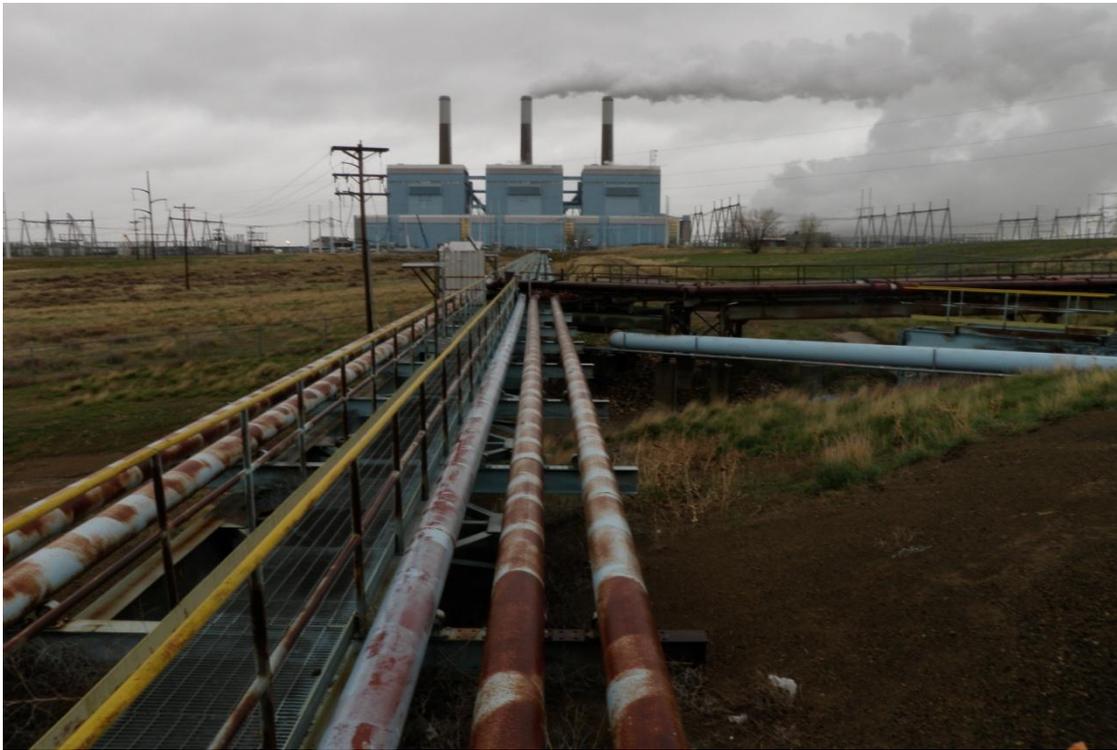
**Photo 8: Inlet Pipes from Plant, Looking East from Bottom Ash Pond 1 Southeast Corner. Pipes have been semi-permanently routed to Bottom Ash Pond 3.**
